PROPERTY INSPECTION REPORT

Concerning: 7773 High Village Dr, Houston TX 77095
(Address or Other Identification of Inspected Property)

By: Charles Pyle - TREC 20638 03/09/2020 9:00 am
(Name and License Number of Inspector) (Date)

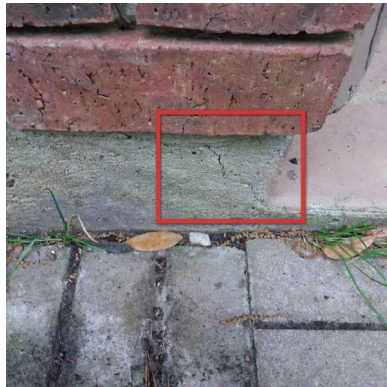
North side

Cracks- Compression crack(s):

Corner cracks were noted at foundation wall. Minor corner compression cracks of triangular shape located at foundation corners are merely cosmetic and not of structural significance. Consider sealing and monitoring as needed to prevent pest intrusion.

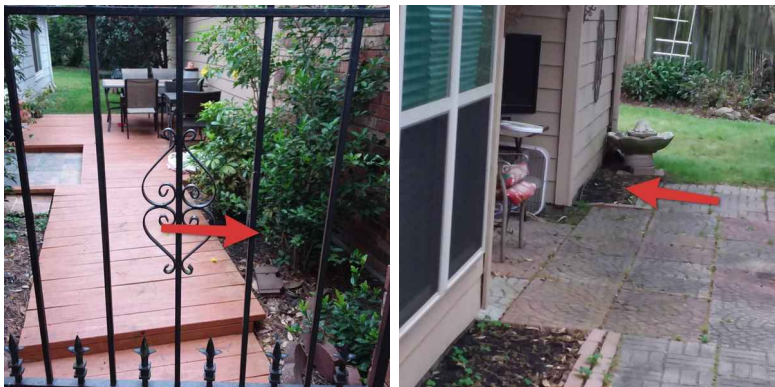
1: Grade Improper Slope

Surface grading/slope is not adequate for proper drainage (minimum 6 inches of slope for 10 foot). Water may become trapped in these areas and could potentially cause differential movement and/or damage to the foundation. If possible, regrade the area to achieve a slope away from the home. If regrading is not possible consider installing underground drain system or install a swell to remove surface water. This will reduce foundation movement, prevent risk of moisture intrusion and prevent pooling.

[IRC R401.3](#)

Recommendation: Contact a qualified landscaping contractor

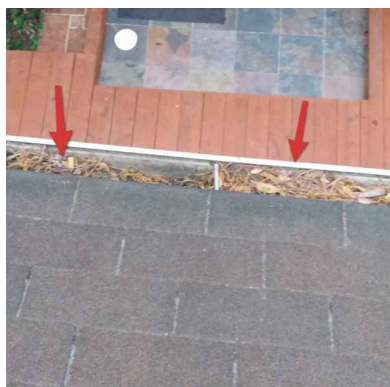
2: Gutter Debris

Debris noted at gutters and/or downspouts. The gutters may clog causing water to overflow and run down fascia board, potentially wearing wood before its time. Consider routine maintenance consisting of clearing leaves from the gutters and downspouts to improve water runoff and reduce moisture related damage.

Recommendation: Contact a handyman or DIY project

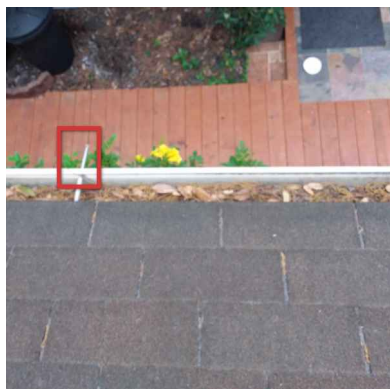
3: Gutters Improper

Loose, damaged or improperly secured gutters observed.

Recommendation: Contact a handyman or DIY project

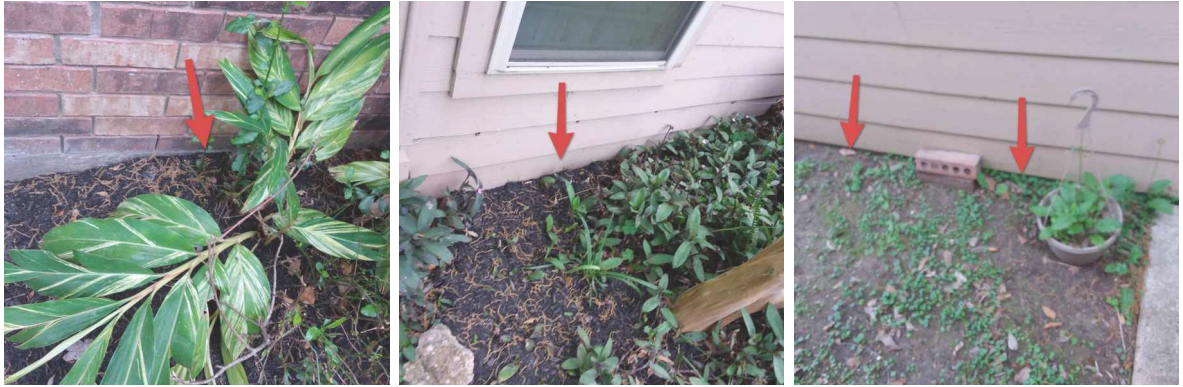
4: High Soil

Some portions of the foundation wall were concealed and could not be inspected due to high soil levels. May allow moisture intrusion through weep holes and conceal pest intrusion. If possible lower soil to a minimum of 4 inches below brick veneer and/or 6 inches below wood or stucco siding to allow proper inspection. Additionally, any soil to wood contact should be thoroughly evaluated by a wood destroying insect inspector.

Recommendation: Contact a qualified landscaping contractor

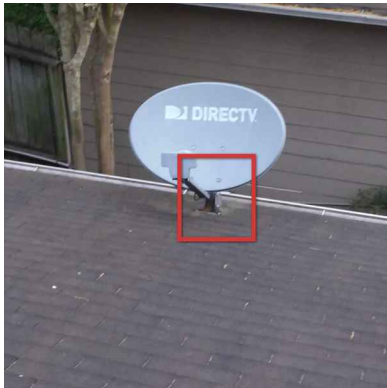
Antenna on Roof:

Satellite penetrations observed at roof coverings. When possible, satellites should not be installed on roof coverings. When no other solution exists, extra caution should be used to ensure that all penetrations are properly sealed and flashed. Monitor periodically.

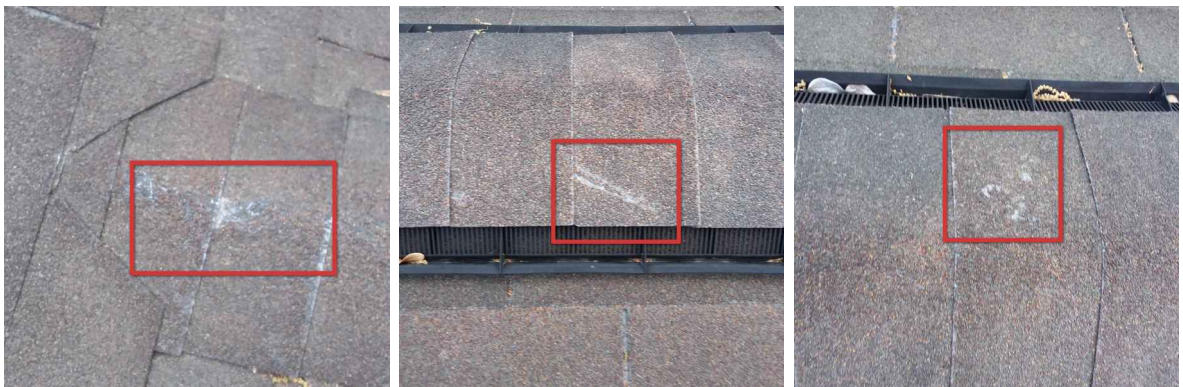
East side, West side

Minor Damage:

Minor damage and/or granulation loss observed. This type of damage is typically the result of foot traffic during high roof temperatures, improper material storage prior to install or manufacturing defects. When not severe, no repairs are typically needed.

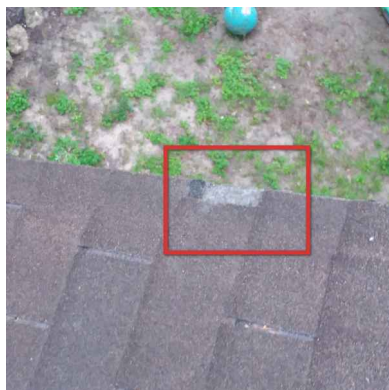
1: Damaged Coverings

Roof coverings exhibited general damage that could affect performance. Consider repair to prevent premature deterioration and/or moisture related issues.

Recommendation: Contact a qualified roofing professional.

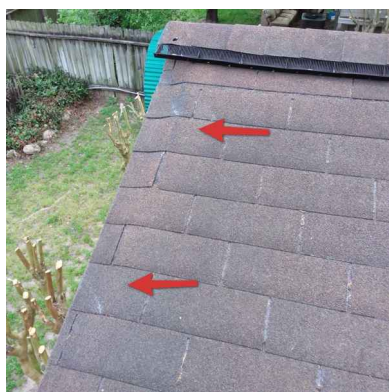
2: Deflections Noted

Deflections observed (warping and/or buckling of roof materials). This condition is typically a result of crowned rafters, expansion of deck materials, improper installation of roofing materials or poor ventilation.

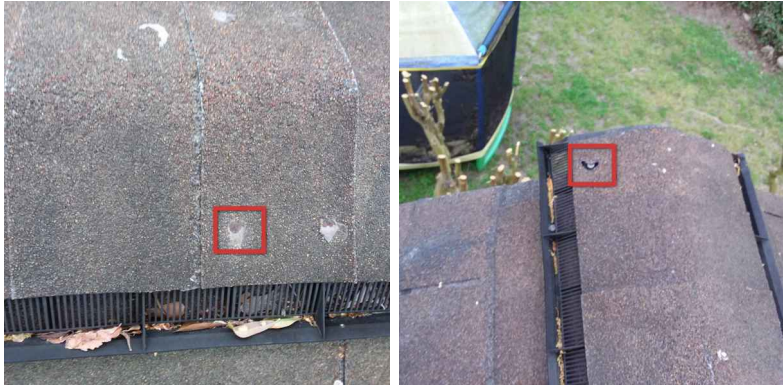
3: Fasteners Exposed

Exposed fasteners observed in shingle or flashing. One or more nails and/or staples observed. Consider sealing all exposed fasteners with an approved sealant to prevent further deterioration.

Recommendation: Contact a handyman or DIY project

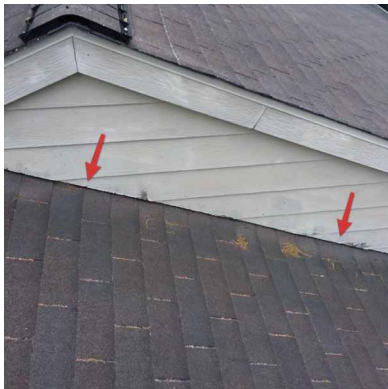
4: Flashing - Counter Flashing

Flashing missing, damaged or improperly installed at the intersection between roof and wall coverings. Masonry wall coverings are porous and should be properly flashed to prevent moisture intrusion or absorption.

Recommendation: Contact a qualified roofing professional.

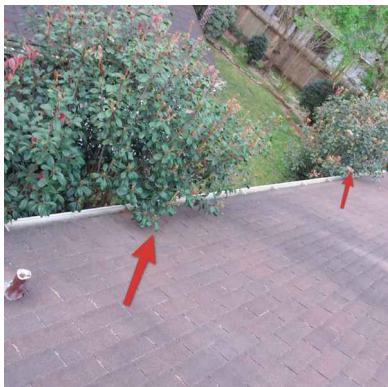
5: Tree Contact

Tree branch contact and/or too close to roof coverings. Recommend trimming all branches to allow a minimum of 4 foot clearance. Tree branches can cause severe damage to roof coverings in windy conditions and allow pest access.

Recommendation: Contact a qualified landscaping contractor

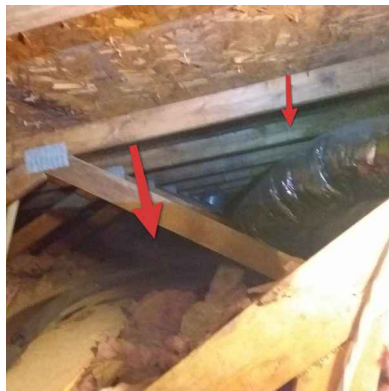
Access Limited:

Access to the attic area was limited by space, storage or mechanical equipment.

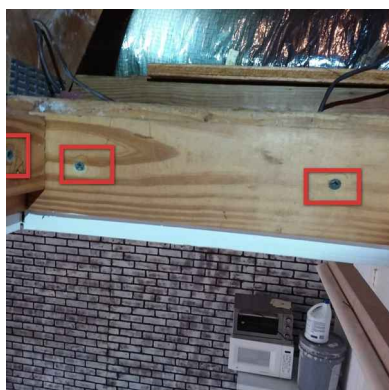
1: Door - Fasteners Missing

Fasteners are missing or improperly installed at the attic service entrance. Manufacturer's specifications require that 16D Nails or 1/4 inch lag bolts shall be installed at the specified intervals including hinge and torsion spring brackets.

Recommendation: Contact a handyman or DIY project

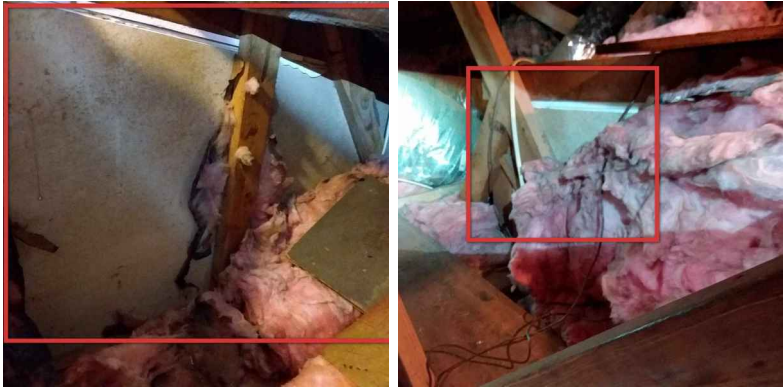
2: Insulation - Low R Value

Observed missing or displaced areas of insulation. This is typically the result of drywall repairs or addition of cable, data or other components. The R value of a space is determined by the average and consistent coverage provided. Void areas will decrease the overall R value.

Recommendation: Contact a handyman or DIY project

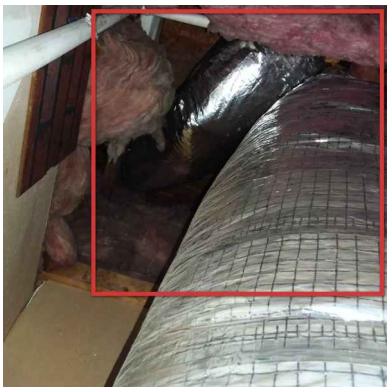
4: Separation Wall - Concealed Spaces

Fire blocking/ Draft stopping missing or improperly installed. Current standards require that all concealed spaces between floor levels or the dwelling and attic shall be properly sealed. Example: dryer exhaust, data cables, electrical and plumbing penetrations.

[2012 IRC R302.11](#)

Recommendation: Contact a qualified insulation contractor.

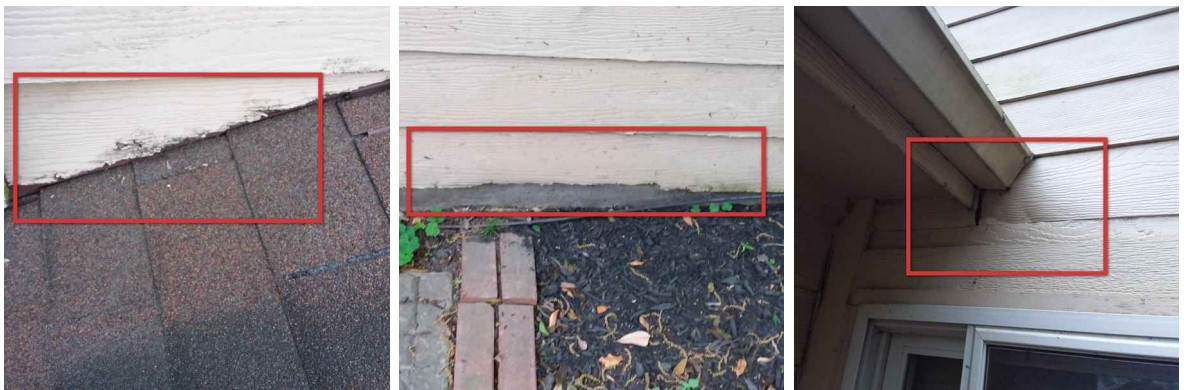
1: Deterioration

Deterioration, rot or decay noted at wall coverings. Rotten and decayed wall coverings will continue to deteriorate if no repairs are made. Moisture intrusion within the building envelope may occur. Consider repair, sealing or replacement affected materials.

Recommendation: Contact a handyman or DIY project

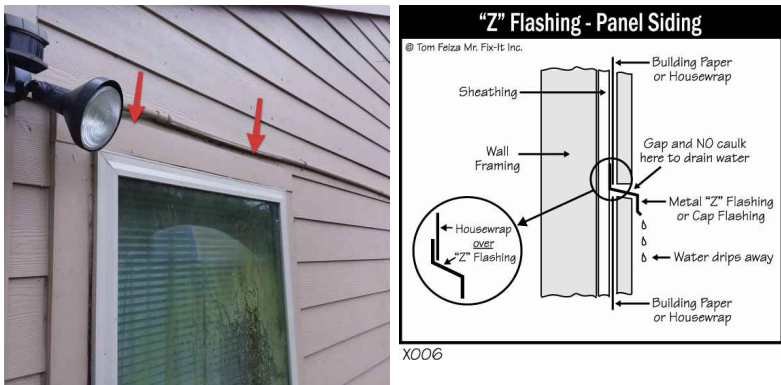
2: Flashing Horizontal Projections

Observed missing and/or improperly installed Z flashing at exterior wall coverings. Without proper flashing, moisture may enter between the horizontal seams. Manufacturers such as James Hardi and LP require all horizontal abutting materials to have flashing installed to divert water to the exterior.

Recommendation: Contact a handyman or DIY project

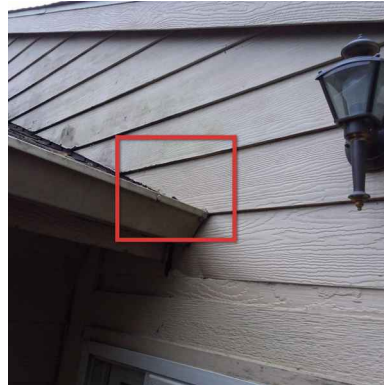
3: Flashing - Kick Out

Flashing (kick out) missing - Roof coverings that terminate at a wall should have "kick out" flashing installed. Without the proper flashing installed at this location, runoff from the roof coverings may enter the wall coverings. Consider installing the proper flashings to prevent moisture intrusion.

[IRC R703.8](#)

Recommendation: Contact a handyman or DIY project

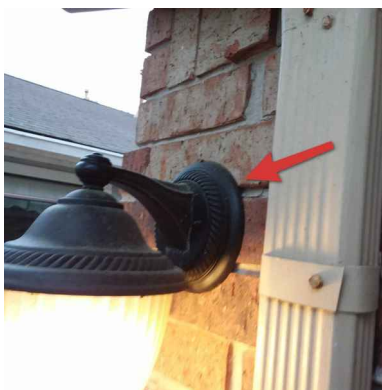
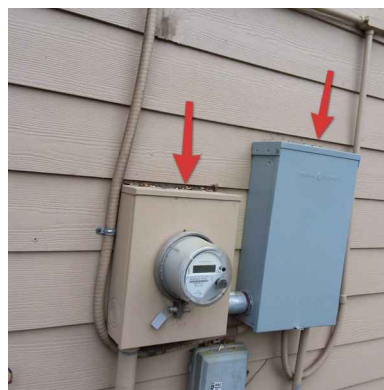
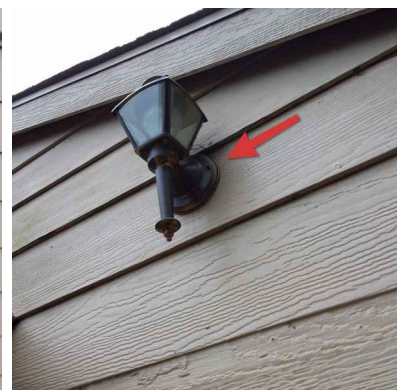
4: Seal - Penetrations

Wall coverings are not properly sealed. All penetrations should be flashed and/or properly sealed to prevent moisture penetration. Typical homeowner/handyman maintenance consisting of sealing cracks with a silicone, polymer or epoxy based product. Example: Electrical and plumbing penetrations, seams in siding, exterior trim, windows and door trim.

[IRC 703.1.1](#)

Recommendation: Contact a handyman or DIY project

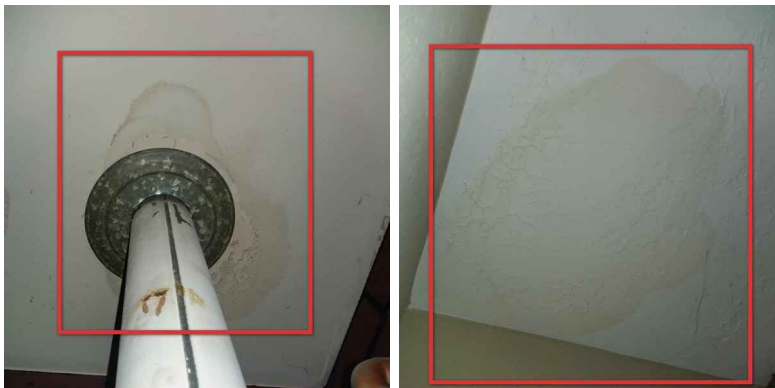
Water heater closet, bedroom 1 closet

Ceiling - Stains Dry:

Evidence of past moisture intrusion and/or damage observed at one or more locations. The area appeared to be dry at the time of the inspection. Consider contacting the seller for additional information pertaining to the cause and what repairs (if any) were made to prevent future moisture intrusion. Monitor for future moisture penetration.

Note from seller: This has been there since the home was purchased. It was an old stain and has been painted

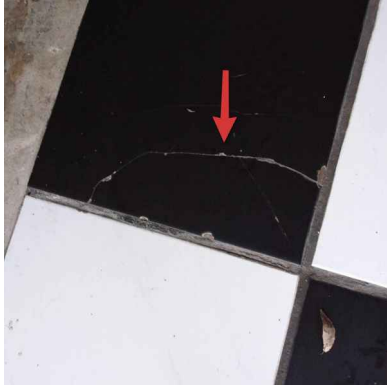
1: Flooring - Damaged

The home flooring had general moderate damage visible at the time of the inspection. Consider sealing as needed to prevent moisture intrusion and subsequent damage.

Note from seller: This is in the garage

Recommendation: Contact a qualified professional.

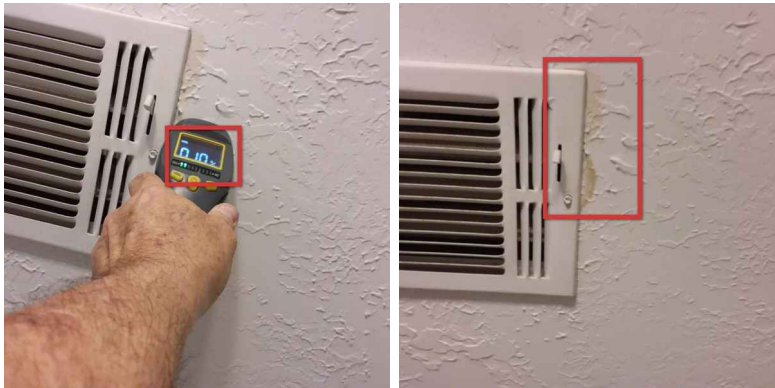
2: Stains - Moisture Present

Ceiling structure showed signs of water intrusion, which could lead to more serious damage to building materials, components or structure. Recommend a qualified contractor identify source or moisture and remedy.

Note from seller: This appears to be condensation from the air vent. We've not had any problems with a leaking roof.

Recommendation: Contact a qualified roofing professional.

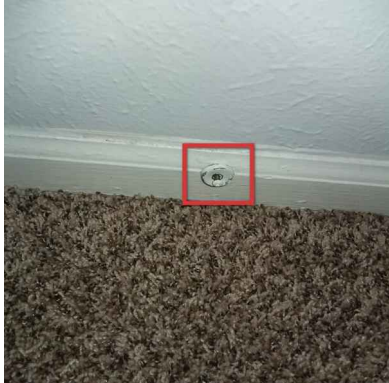
2: Door Stops

Door stops missing, damaged or improperly installed. Door should be allowed to open wide enough to ensure proper egress. Door stops should be used to prevent damage to doors, trim or wall coverings caused by excessive swing. Example: various locations

Recommendation: Contact a handyman or DIY project

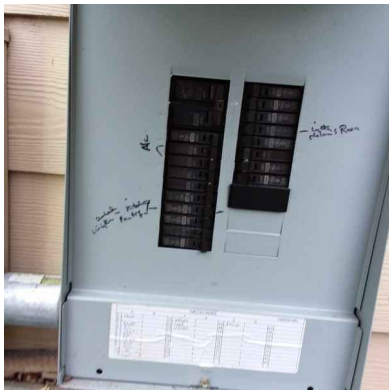
4: Labels INR

Service panel labels were missing/deteriorated or improper.

Note from seller: This panel box was replaced by a licensed electrician approx 2 years ago

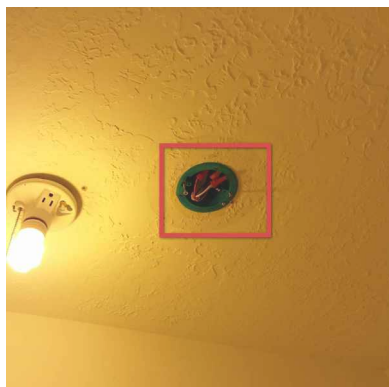
12: Wire - Junction Box Inadequate

Note from seller: Cover has been installed

Recommendation: Contact a qualified electrical contractor.

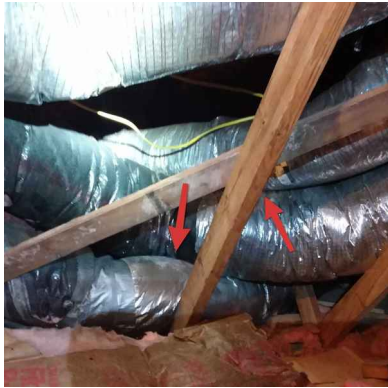
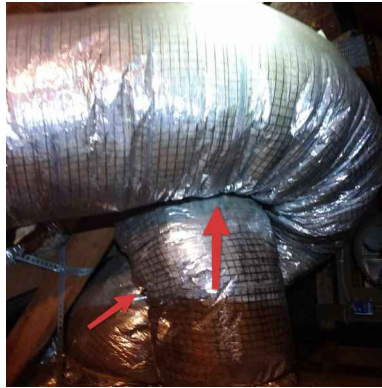
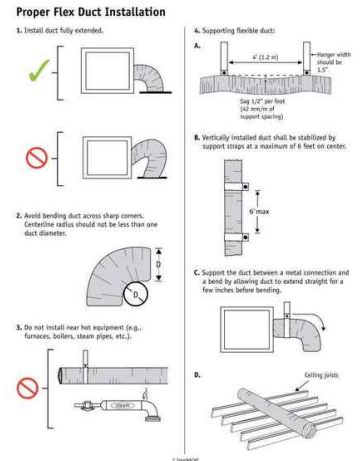
2: Duct - Support

The flexible ducts are improperly supported. Current building practices require that the ducts be hung from the attic framing and supported at 4.5 maximum intervals. Ducts in contact with other ducts and at potentially different temperatures may cause condensate to form (internal or external) on the duct. Consider separating ducts with batt insulation or equivalent.

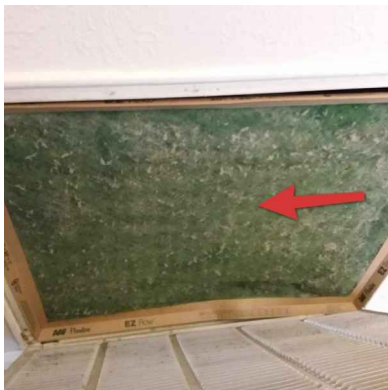
3: Filter

Note from seller: This has been corrected. We also have had the hvac equipment inspected by a licensed hvac technician and has documented the unit is in good working condition.

Recommendation: Contact a handyman or DIY project
