## Property Inspection Report

26910 Gadwall Bayou, Hockley, Texas 77447  
Inspection prepared for: Courtney Fasullo  
Real Estate Agent: Joseph Carranza - Keller Williams - Platinum

Date of Inspection: 3/19/2020 Time: 1:30 pm  
Age of Home: 2012 - 8 years Size: 1,080 sq ft  
Weather: Sunny & 81 degrees

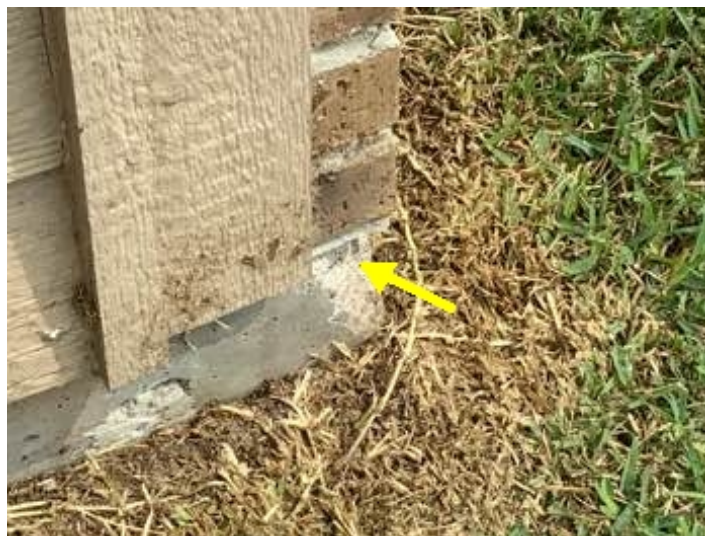
- It is the opinion of this inspector, this homes foundation appeared to be functioning as intended on the day of inspection.
- A corner pop was found on the left front corner of this home. Recommend grouting this corner in order to minimize the potential for pest access and moisture penetration.
- Recommend consulting a general contractor for further evaluation and corrective action.

Corner pop on the left front corner of this home.

STRUCTURAL SYSTEMS		
Page 3 Item: A	Foundations	<ul style="list-style-type: none"> <li>• A corner pop was found on the left front corner of this home. Recommend grouting this corner in order to minimize the potential for pest access and moisture penetration.</li> <li>• Recommend consulting a general contractor for further evaluation and corrective action.</li> </ul>
Page 4 Item: C	Roof Covering Materials	<ul style="list-style-type: none"> <li>• Lifting shingles were found on the right side of this home. Recommend securing the lifting shingles to the roof surface in order to prevent damage due to wind lift and moisture penetration.</li> <li>• Exposed nail heads were found on the ridges and vent flashing. Recommend sealing the nail heads in order to prevent moisture penetration.</li> <li>• Recommend consulting a roofing contractor for further evaluation and corrective action.</li> </ul>
Page 6 Item: E	Walls (Interior and Exterior)	<ul style="list-style-type: none"> <li>• Exterior: <ul style="list-style-type: none"> <li>• Damaged and deteriorating trim was found on the left rear, right front and right rear corners of this home. Recommend replacing the deteriorating trim.</li> <li>• Damaged and deteriorating casing was found at the garage door and several of the interior doors. Recommend replacing the deteriorating casing.</li> <li>• Gaps were found around the condensing unit penetrations on the rear of this home. Recommend sealing these gaps in order to prevent pest and rodent access.</li> <li>• Loose trim was found on both sides of the garage door. Recommend securing the trim to the casing.</li> <li>• Step cracking was found in the brick and mortar on the front of the garage. Recommend monitoring this crack for future development.</li> <li>• A hole was found at the top of the door trim in the garage. Recommend repairing this hole.</li> </ul> </li> <li>• Interior: <ul style="list-style-type: none"> <li>• A crack was found in the drywall inside and above the master bedroom door. Recommend repairing this crack.</li> <li>• Moisture damage was found on the baseboards and trim at several locations in this home. Recommend replacing the damaged baseboards and trim.</li> <li>• Recommend consulting a general contractor for further evaluation and corrective action.</li> </ul> </li> </ul>

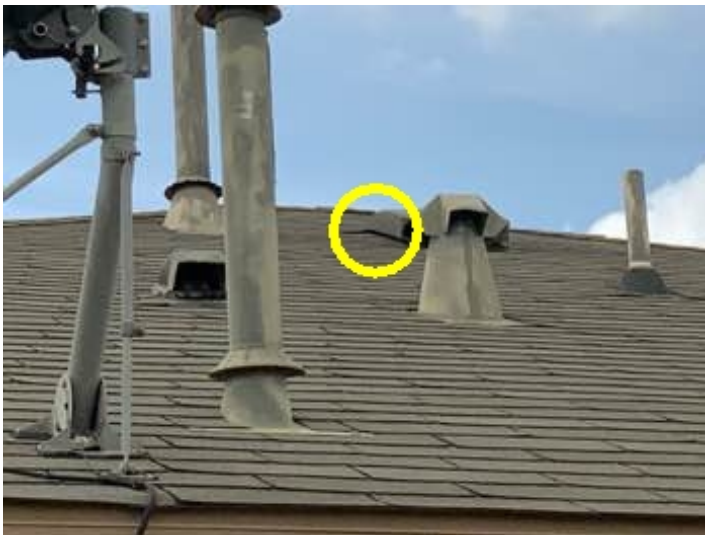
- Recommend sealing around all roof top vent flashing and vent penetrations every 5-6 years in order to prevent moisture penetration.
- Due to the potential to damage the roof covering materials, the shingles were not lifted in order to view the fastener pattern.
- Lifting shingles were found on the right side of this home. Recommend securing the lifting shingles to the roof surface in order to prevent damage due to wind lift and moisture penetration.
- Exposed nail heads were found on the ridges and vent flashing. Recommend sealing the nail heads in order to prevent moisture penetration.
- Recommend consulting a roofing contractor for further evaluation and corrective action.

Lifting shingle on the right side of this home.

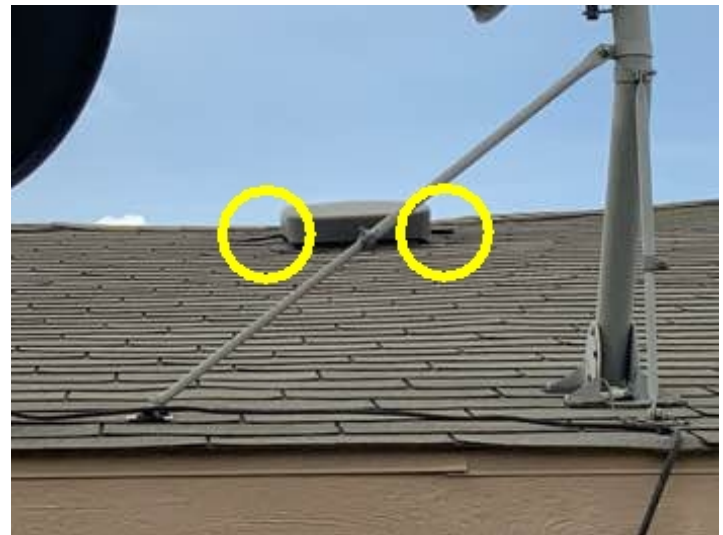
More lifting shingles on the right side of this home.

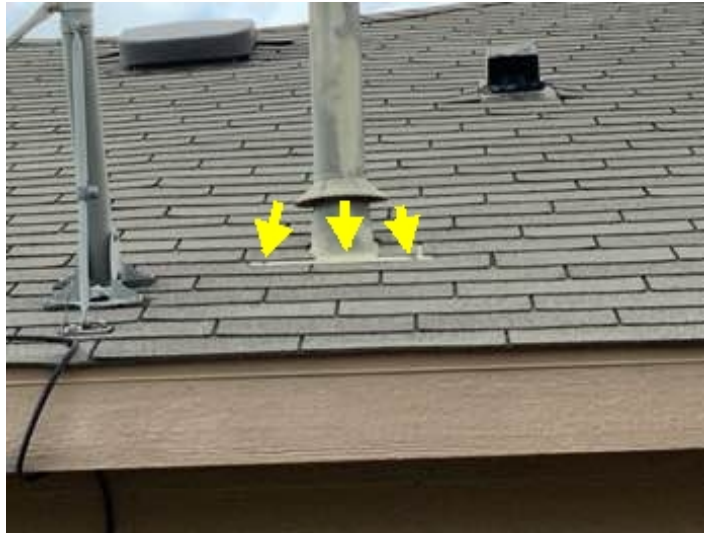
Exposed nail heads on the vent flashing.

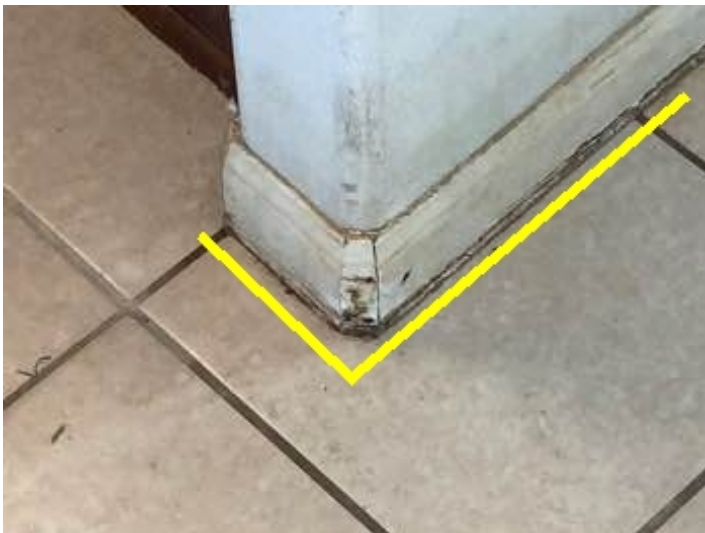
- Moisture damage was found on the baseboards and trim at several locations in this home. Recommend replacing the damaged baseboards and trim.
  - Recommend consulting a general contractor for further evaluation and corrective action.

Moisture damage on the baseboards in the kitchen.

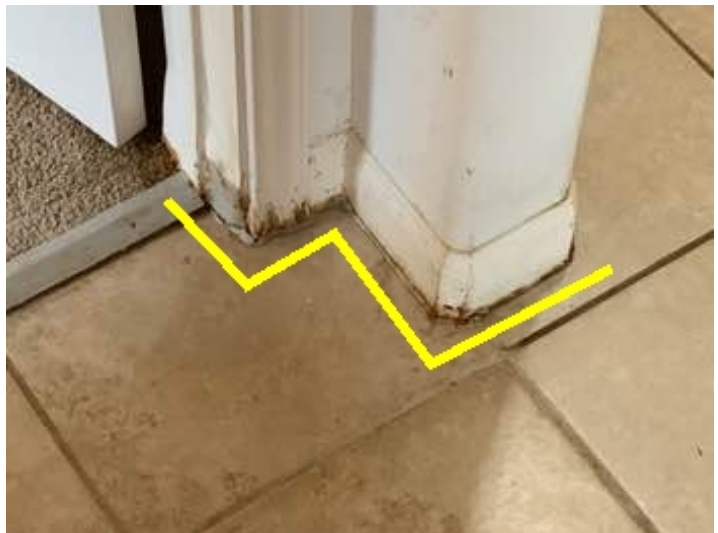
Moisture damage on the baseboards outside the left rear guest bedroom.

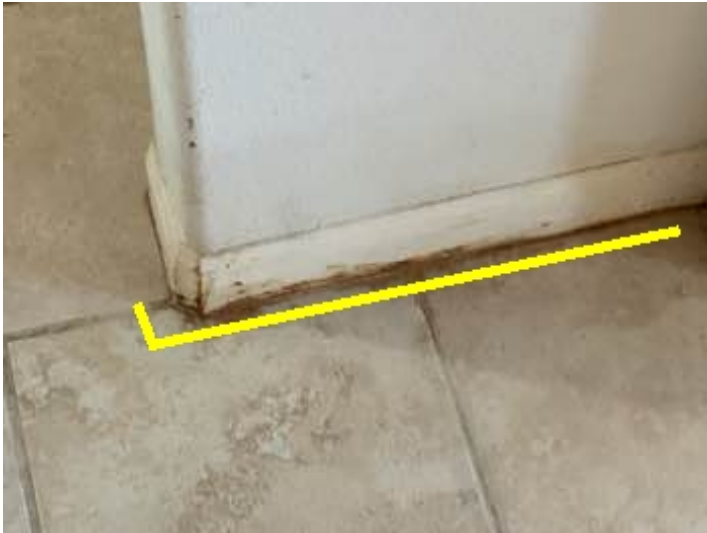
Moisture damage on the baseboards outside the left front guest bedroom.

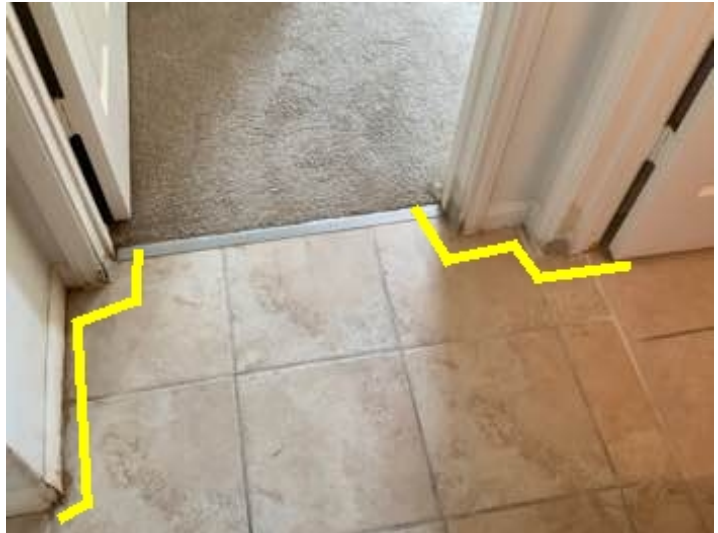
Moisture damaged trim at the front guest bedroom and bathroom doors.

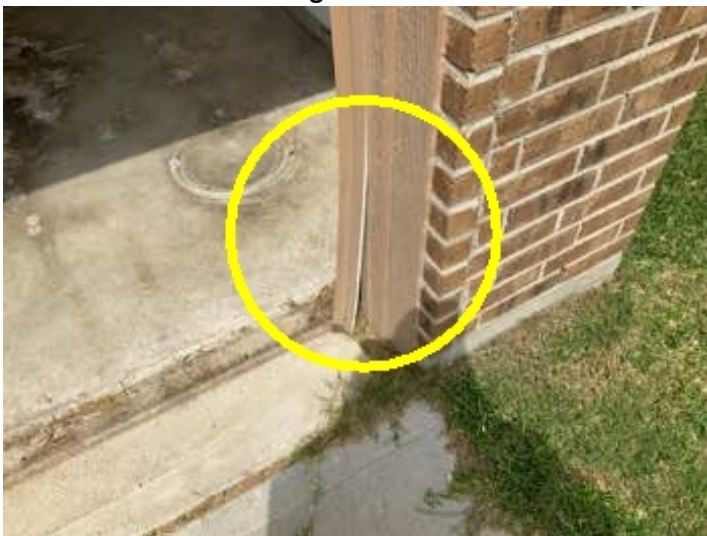
- Loose trim was found on both sides of the garage door. Recommend securing the trim to the casing.
  - Step cracking was found in the brick and mortar on the front of the garage. Recommend monitoring this crack for future development.

Loose trim on the right side of the garage door.

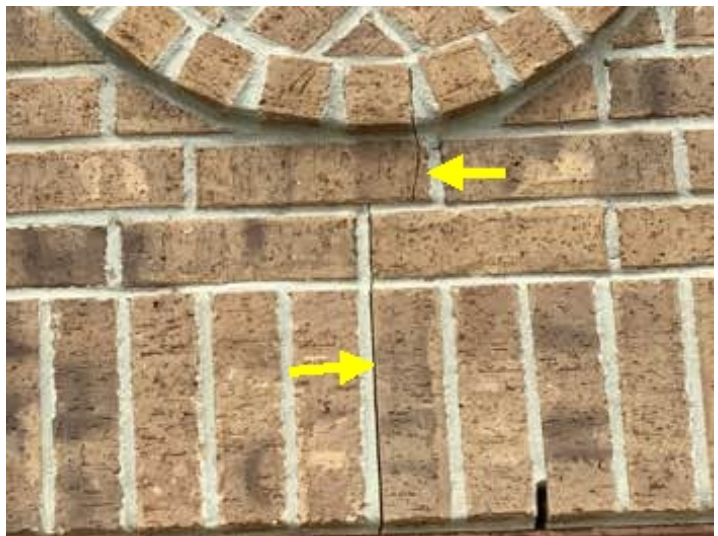
Brick and mortar step crack on the front of the garage.

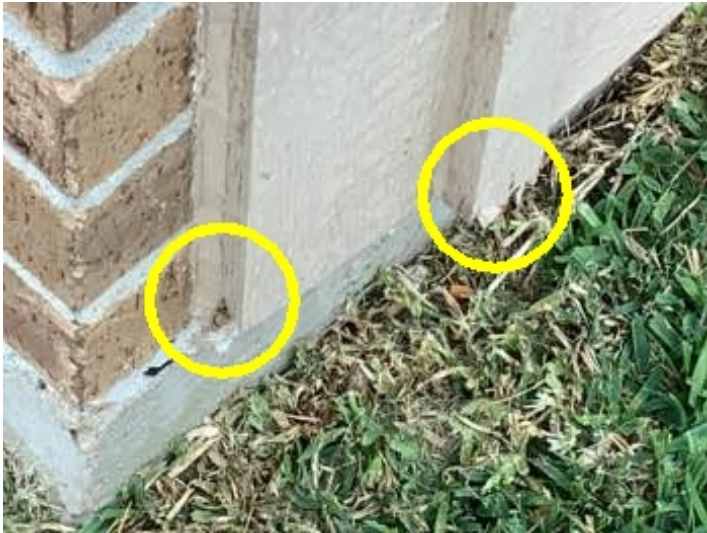
- Exterior:
  - Damaged and deteriorating trim was found on the left rear, right front and right rear corners of this home. Recommend replacing the deteriorating trim.

Damaged and deteriorating trim on the right front corner of this home.

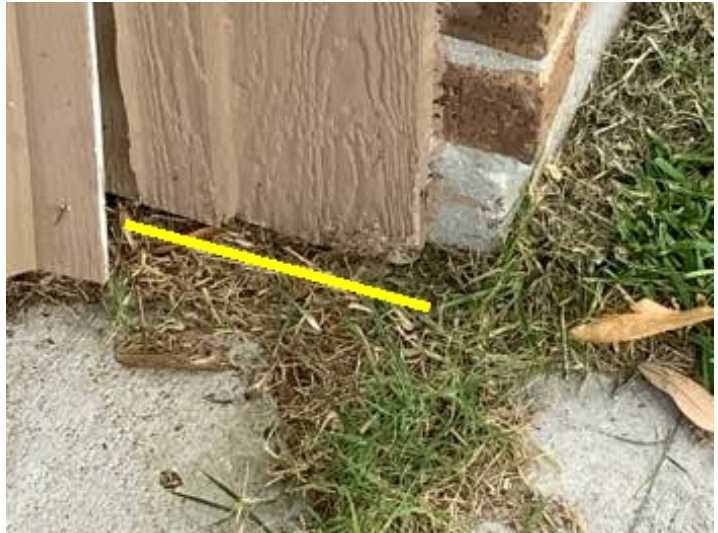
- Damaged and deteriorating casing was found at the garage door and several of the interior doors. Recommend replacing the deteriorating casing.
  - Gaps were found around the condensing unit penetrations on the rear of this home. Recommend sealing these gaps in order to prevent pest and rodent access.

Damaged and deteriorating casing at the garage door.

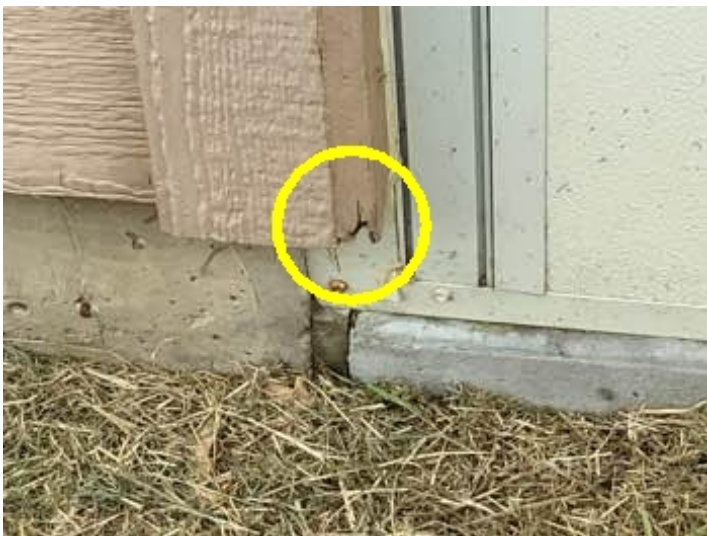
Damaged trim on the right rear corner of this home.

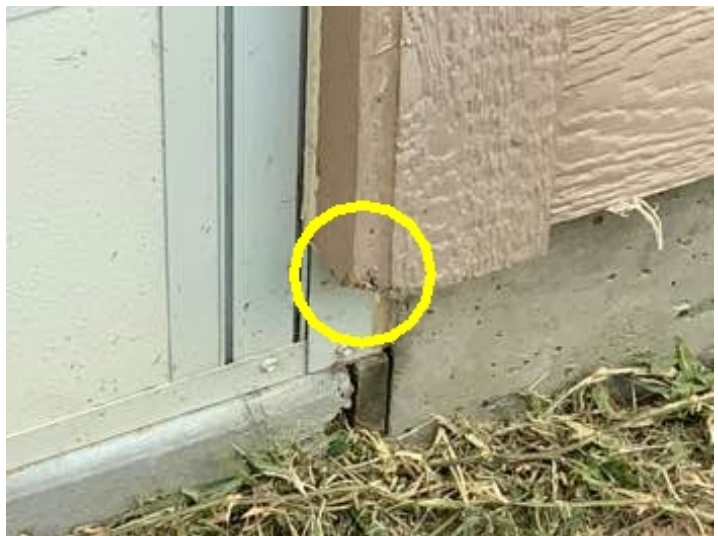
Damaged trim on the left rear corner of this home.

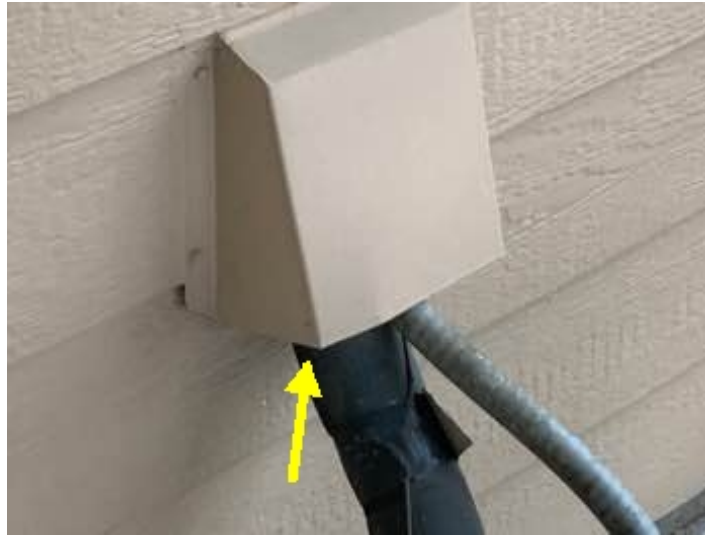
Gap around the condensing unit penetrations on the rear of this home.

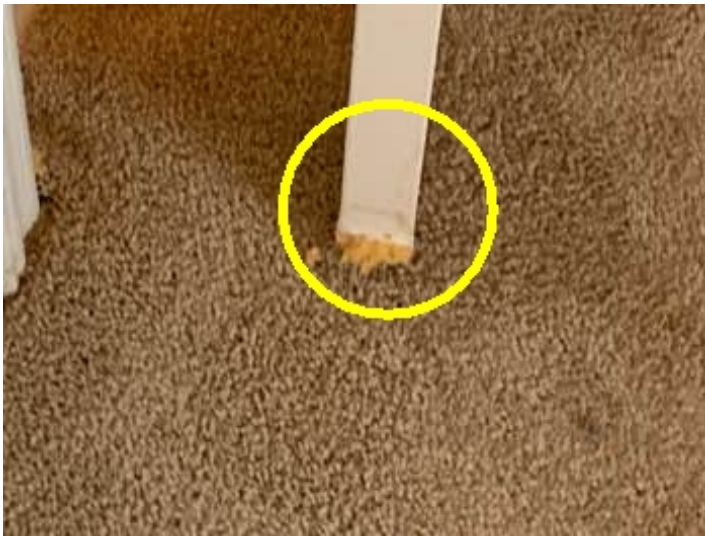
- The front guest bedroom door is damaged. Recommend replacing this door.
- The rear egress door is damaged and deteriorating. Recommend replacing this door.

Moisture damaged front guest bedroom door.

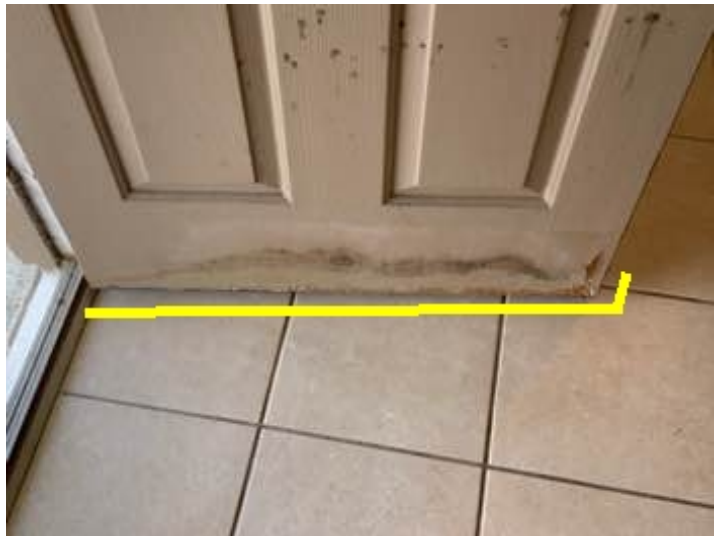
Damaged and deteriorating rear egress door.

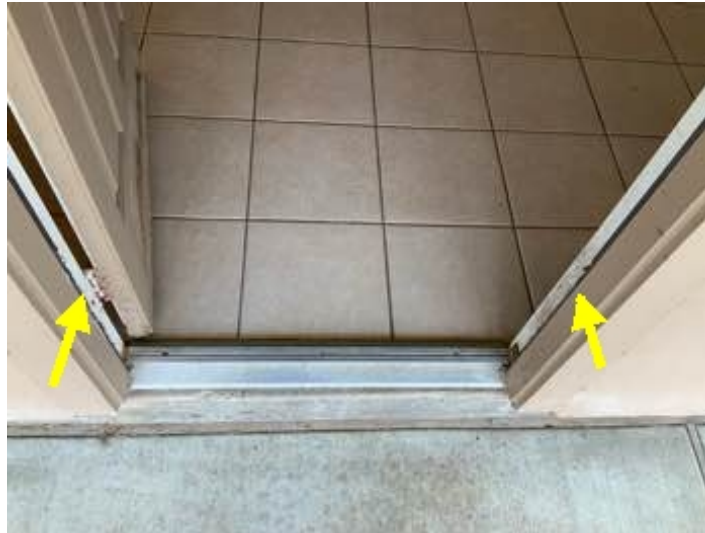
- A safety chain is missing for the right storm door. Recommend installing a safety chain in order to prevent damage or injury from high winds.
- Damaged weather stripping was found at the rear egress door. Recommend replacing damaged and deteriorating weather stripping in order to prevent the loss of conditioned air and allowing access for pests.

Damaged weather stripping at the rear egress door.

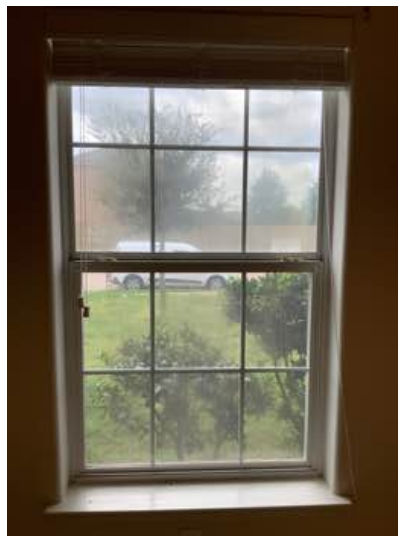
- It appears there is moisture between panes of the window in the front guest bedroom. Recommend consulting a glass company for further evaluation and corrective action.

Moisture between the panes of the front guest bedroom window.

Page 11 Item: H	Windows	<ul style="list-style-type: none"> <li>• It appears there is moisture between panes of the window in the front guest bedroom. Recommend consulting a glass company for further evaluation and corrective action.</li> </ul>
Page 12 Item: L	Other	<ul style="list-style-type: none"> <li>• The kitchen cabinets at left of the sink and right of the refrigerator are damaged. Recommend replacing these cabinets.</li> <li>• Exposed bolt heads were found at the satellite dish mounts on the right side of this home. These bolt heads should be sealed with roof mastic in order to prevent moisture penetration. A roofing contractor should be consulted for corrective action.</li> <li>• Recommend consulting a general contractor for corrective action.</li> </ul>

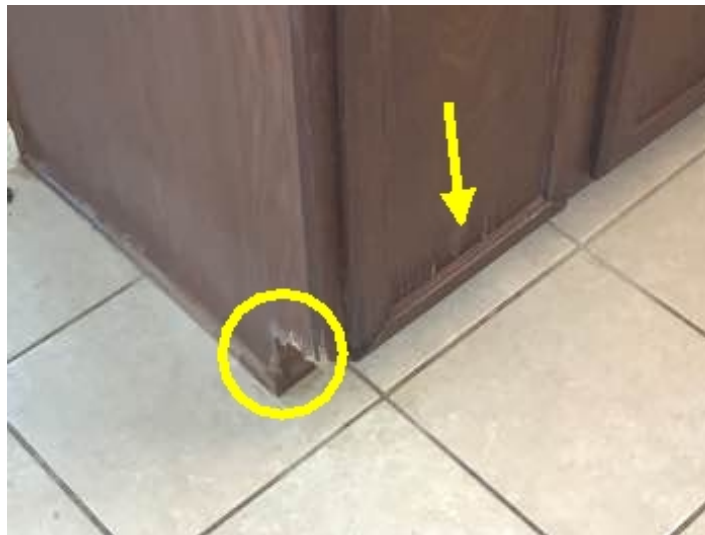
- The kitchen cabinets at left of the sink and right of the refrigerator are damaged. Recommend replacing these cabinets.
- Exposed bolt heads were found at the satellite dish mounts on the right side of this home. These bolt heads should be sealed with roof mastic in order to prevent moisture penetration. A roofing contractor should be consulted for corrective action.
- Recommend consulting a general contractor for corrective action.

Damaged kitchen cabinets.

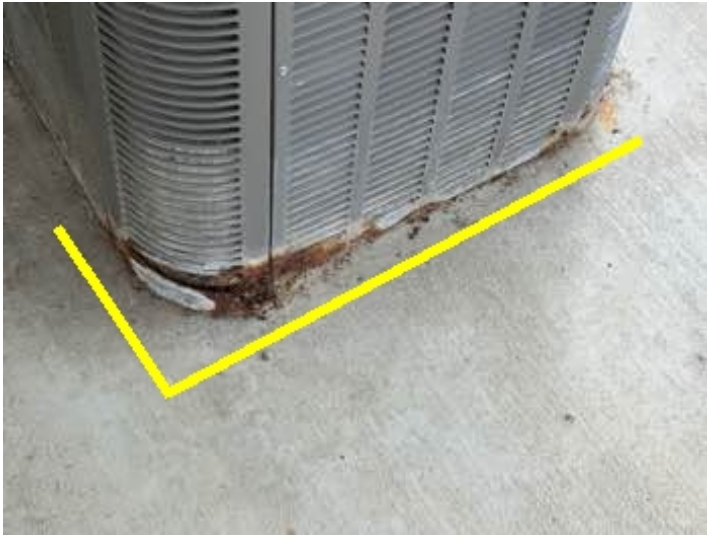
- Damaged and deteriorating suction line insulation was found at the condensing unit. Recommend replacing the suction line insulation.
- The condensing unit cabinet is damaged and deteriorating.

Damaged and deteriorating condensing unit cabinet.

- Recommend consulting a licensed HVAC professional for further evaluation and corrective action.

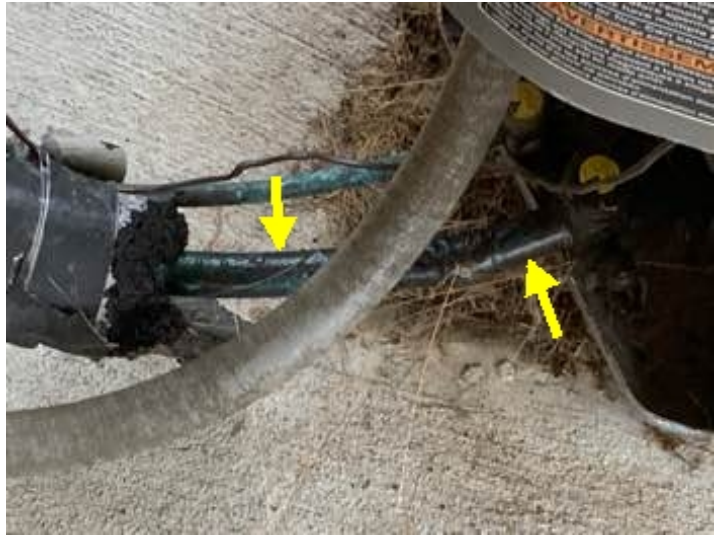
Damaged suction line insulation at the condensing unit.

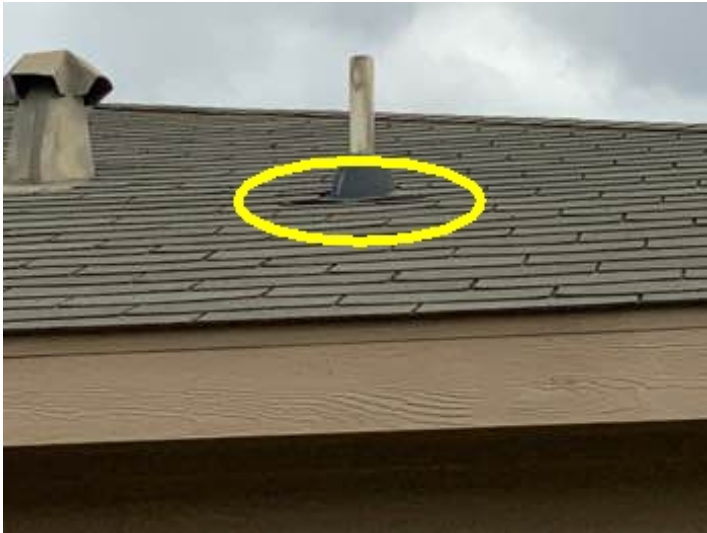
- There were no visible access panels present to allow for inspection of the plumbing supply and drain line assemblies at the bathtubs or showers.
- Lifting vent boot flashing was found on the left side of the home. Recommend securing the vent boot flashing to the roof surface in order to prevent damage due to wind lift and moisture penetration. A roofing contractor should be consulted for further evaluation and corrective action.
- A slow drain was found in the master bathtub. Recommend consulting a licensed plumber for further evaluation and corrective action.
- Recommend consulting a licensed plumber for further evaluation and corrective action.

Lifting vent boot flashing on the left side of this home.

Page 16 Item: B	Drains, Wastes, and Vents	<ul style="list-style-type: none"> <li>• Lifting vent boot flashing was found on the left side of the home. Recommend securing the vent boot flashing to the roof surface in order to prevent damage due to wind lift and moisture penetration. A roofing contractor should be consulted for further evaluation and corrective action.</li> <li>• A slow drain was found in the master bathtub. Recommend consulting a licensed plumber for further evaluation and corrective action.</li> <li>• Recommend consulting a licensed plumber for further evaluation and corrective action.</li> </ul>
-----------------	---------------------------	---

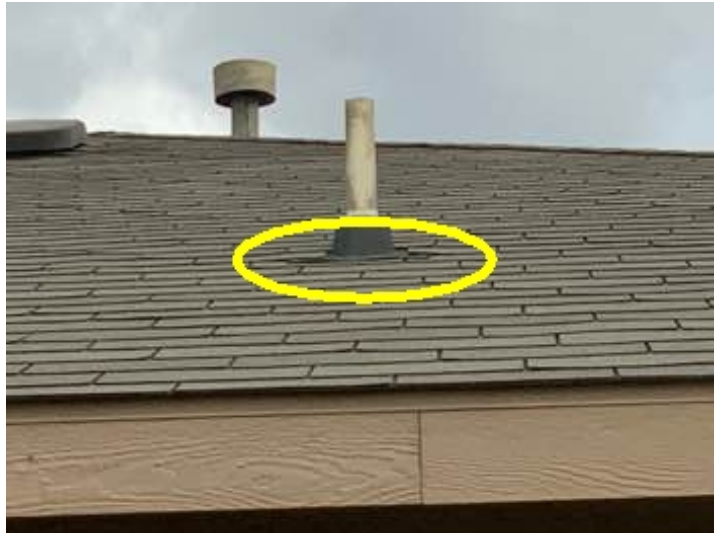
Another lifting vent boot flashing on the left side of this home.
