PROPERTY INSPECTION REPORT

Concerning: 10311 Olivia View Ln., Cypress, TX 77433
(Address or Other Identification of Inspected Property)

By: Robert Frandsen TREC #22091 Mar 17, 2017
(Name and License Number of Inspector (Date
(Name, License Number and Signature of Sponsoring Inspector, if required)

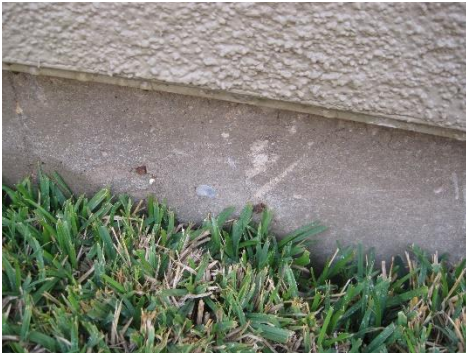
Post tension cable anchor cap exposed.

I recommend that this gets repaired/sealed to prevent future rusting and possible failure.

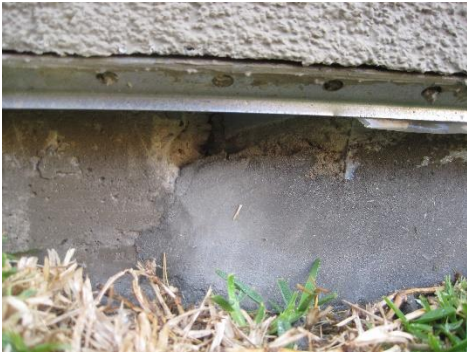
A large void was present in the foundation. It appears to be the remnant of a previous repair attempt.

I recommend that this be patched/sealed.

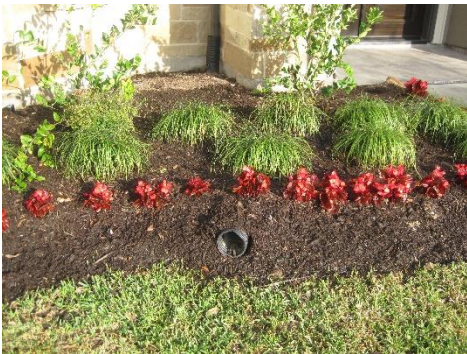
Grading away from the house does not appear to meet the minimum of 6" vertical in 10' horizontal. The yard was flooded at the time of the inspection. There was standing water of 1" to 3" deep in multiple locations all around the house.

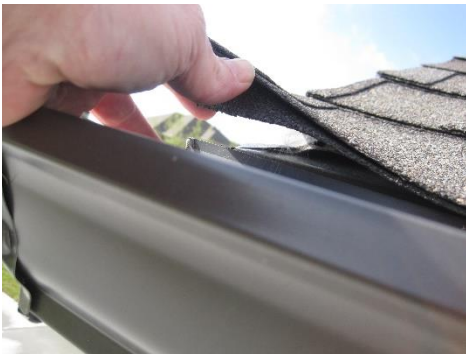
Starter strip damaged/not properly adhered, in multiple locations.

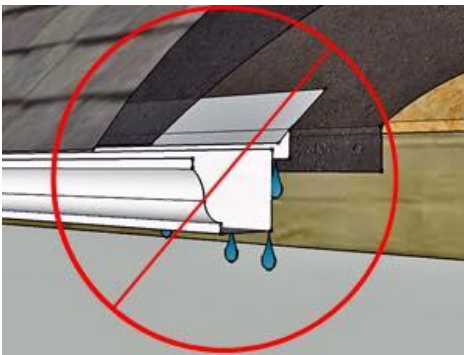
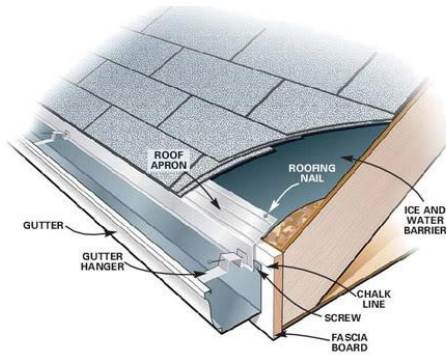
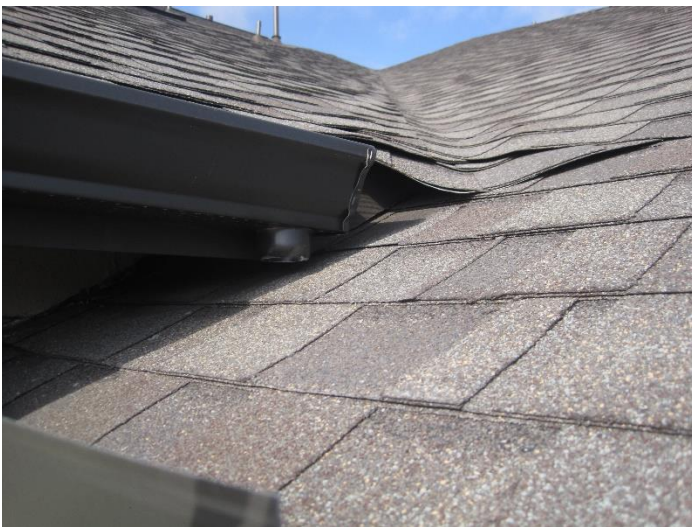
Gutters discharge directly onto the roofing material in multiple locations.

Gutters should not discharge directly onto the roofing material. This can cause erosion of the roofing material, and possible penetration underneath the roofing material.

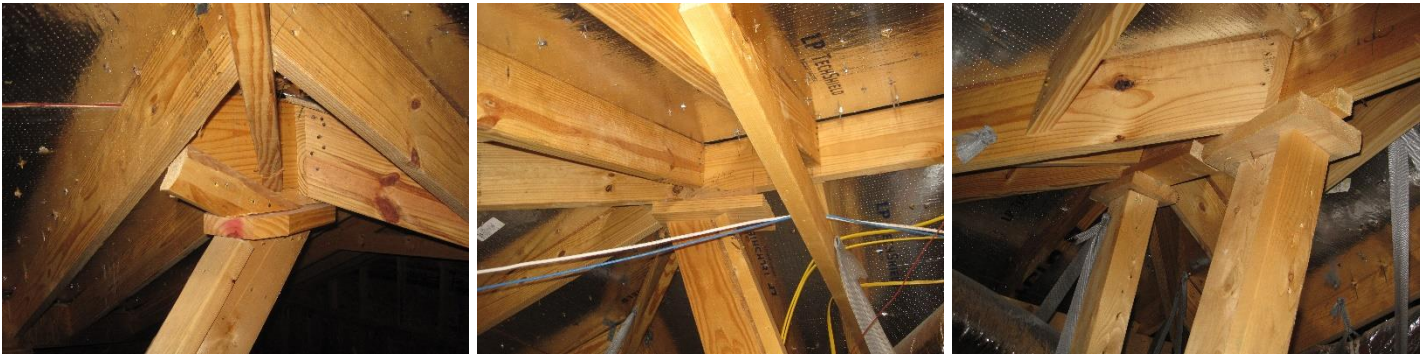
Rafters are not properly braced in numerous locations. The inspector was able to move multiple bracing with slight pressure of his hand.

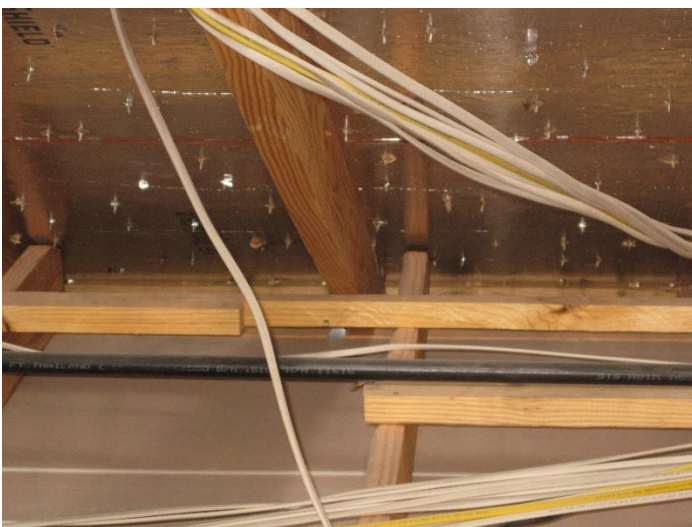
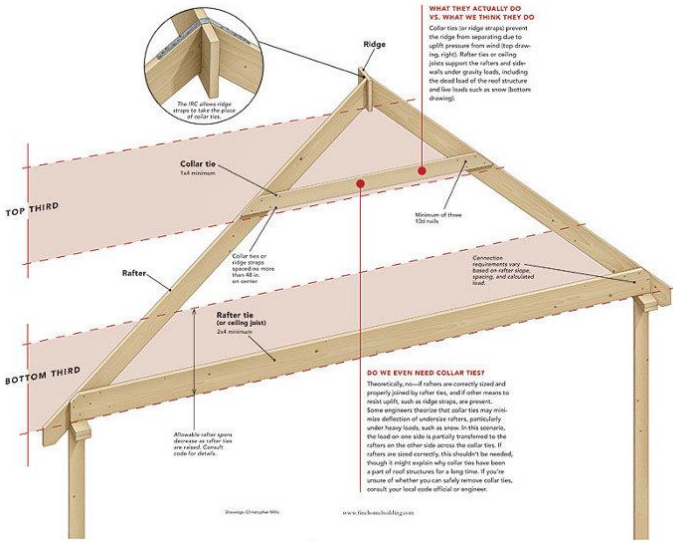
Rafters are not properly tied with the joists in numerous locations. This can allow the rafters to lift off the top plate during high winds.

I highly recommend that the rafters get tied to the ceiling joists to prevent possible lifting of the roof surface.

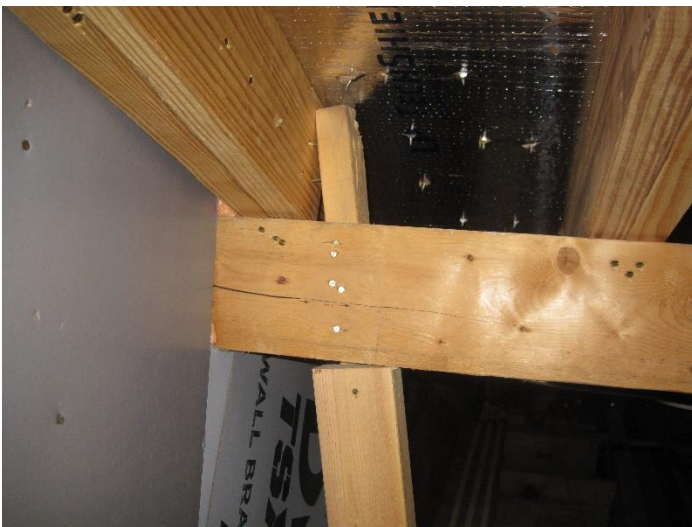
Purlins and Purlin Supports are cracked in multiple locations.

I recommend that the framing issues detailed above be reviewed by a structural engineer to ensure that the original design requirements are met, and if not, supply a recommendation on possible corrections.

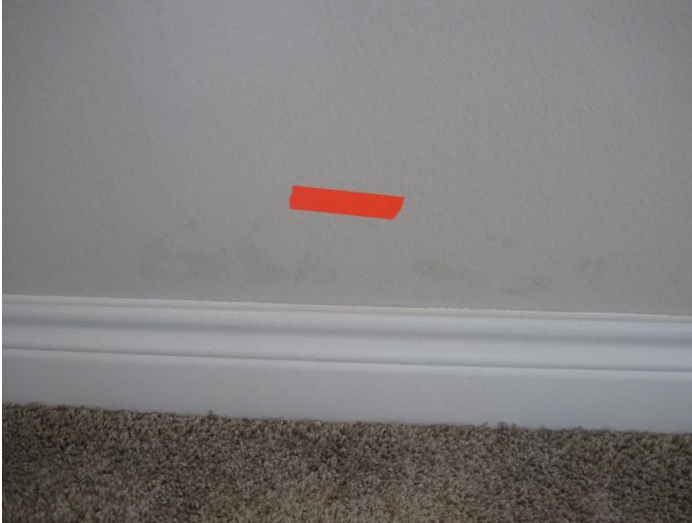
Evidence of possible previous water penetration noted under window.

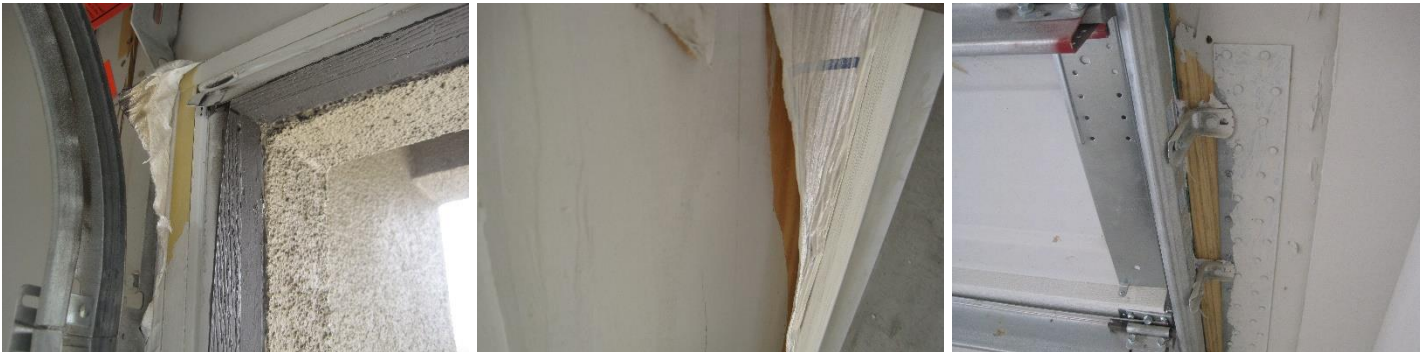
Walls and trim around the garage doors are not properly painted to protect from moisture penetration and deterioration.

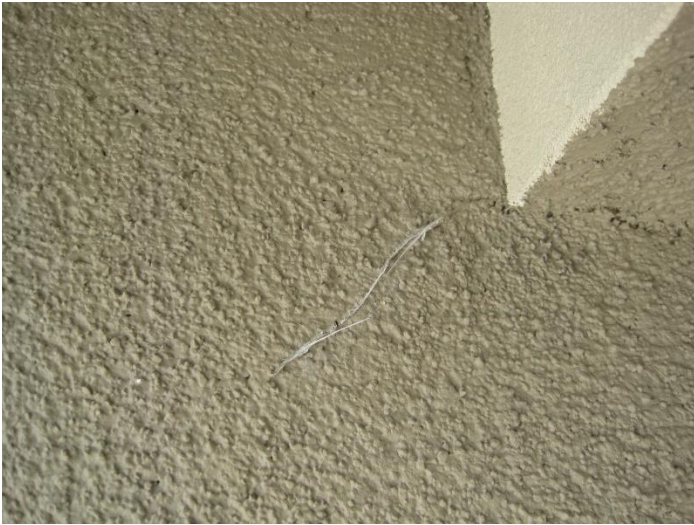
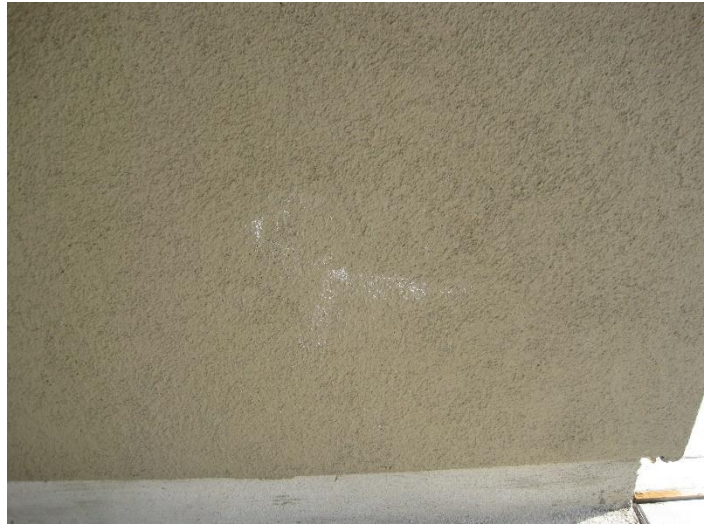
Exterior wall stucco coating not complete in multiple locations.

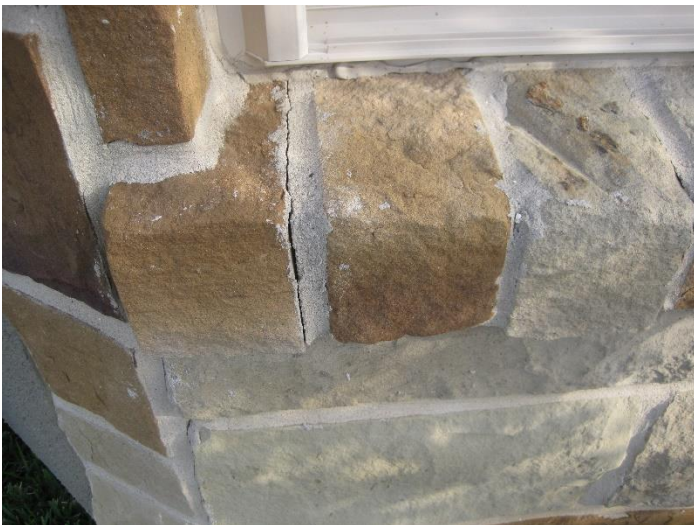
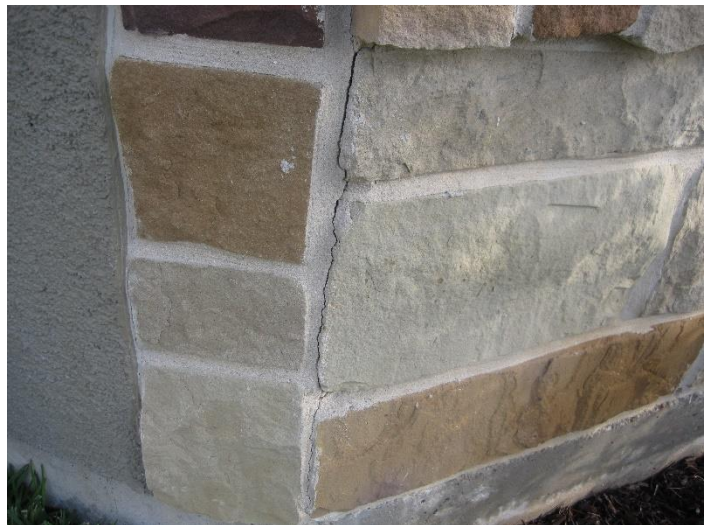
The Masonry and Stucco veneer is too close to grade, in multiple places. It should be a minimum of 4" above grade.

There are small cracks in multiple places around the house. It is not possible to determine if these cracks are active. You should monitor them over time to determine if they are active. The cracks in the stone veneer should be repointed by a skilled mason to match the existing structure.

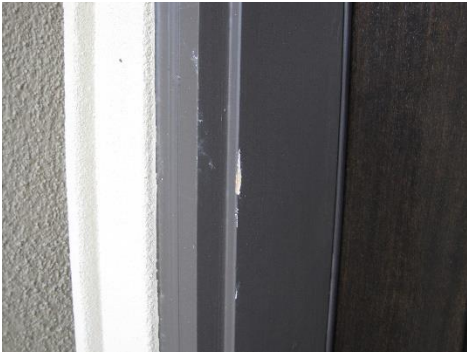
Trim around front door damaged.

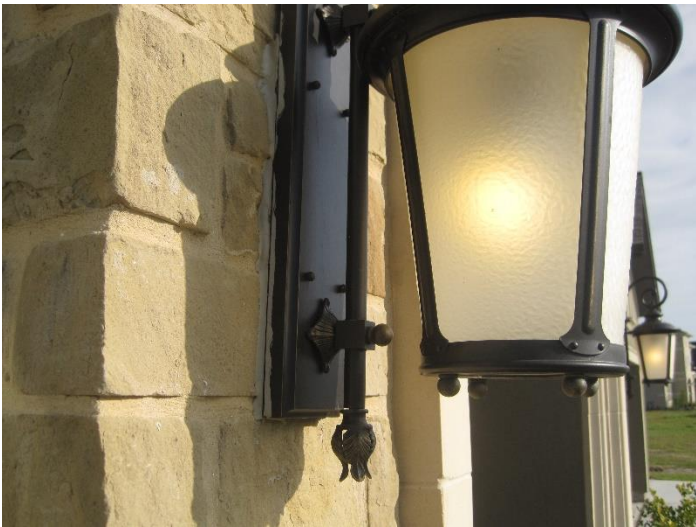
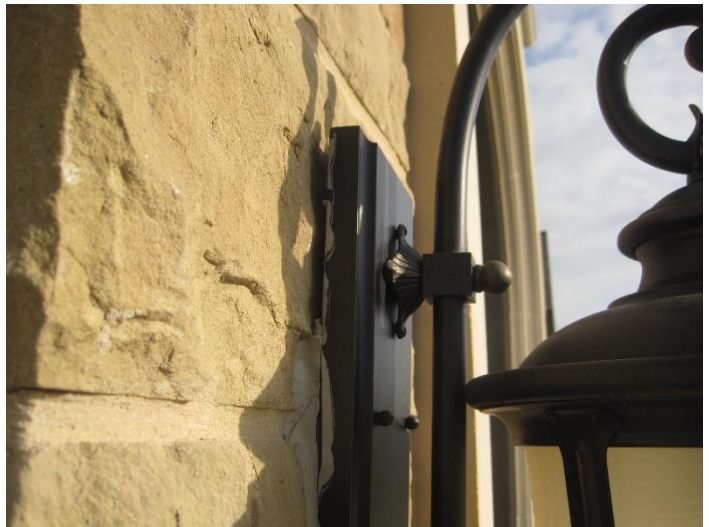
External luminaires not properly flashed/sealed.

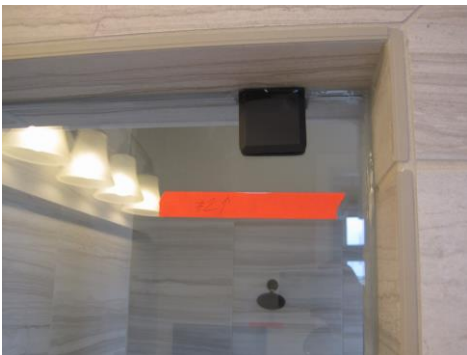
Glass on the back of the master shower is cracked.

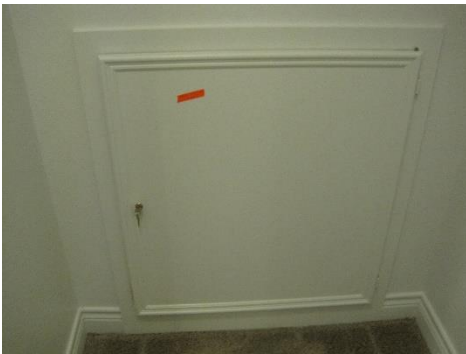
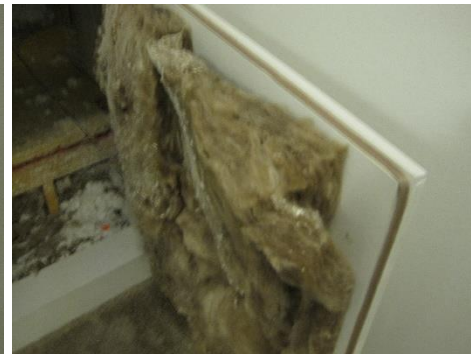
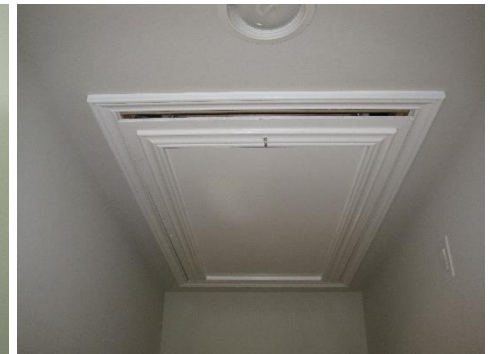
Attic access doors are not properly sealed or insulated.

I recommend installing solutions that are specifically designed for these types of attic access doors.

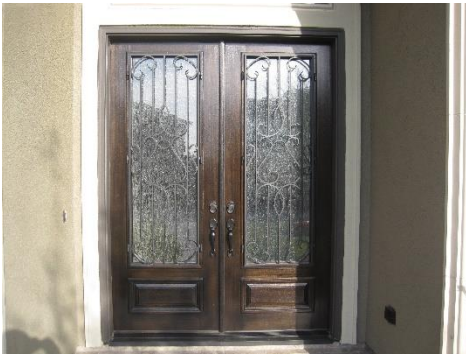
Front door metal bars have openings and rust in multiple locations.

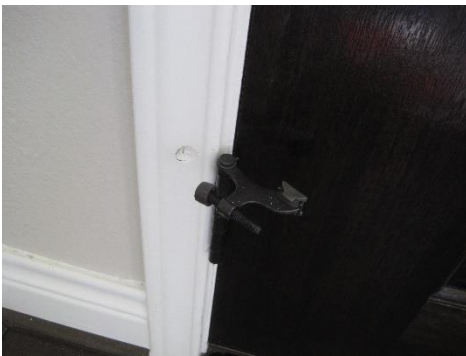
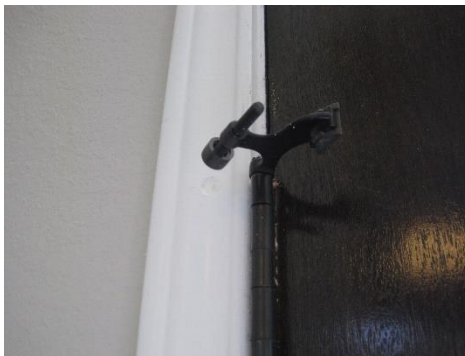
Front door trim damaged from installed door stops.

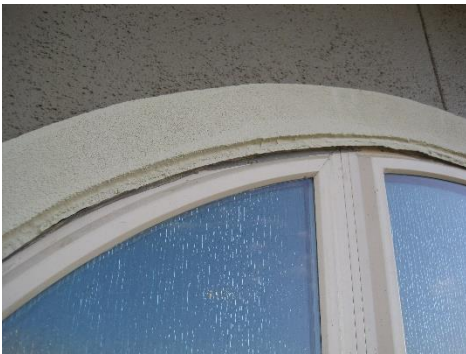
Windows not properly flashed in multiple locations.

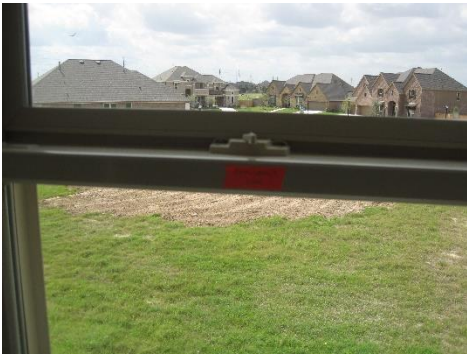
Window latch does not operate properly in upstairs bathroom.

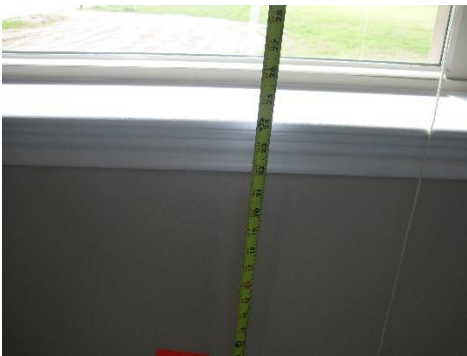
Window seal height of the upstairs windows is too low.

Information: The 2012 IBC and 2012 IRC require the bottom of openings created by operable windows to be a minimum height above the adjacent interior floor when they are 72 inches or more above the grade outside the window. In the 2012 IBC the required height of that window sill above the adjacent interior floor is 36 inches.

I recommend that approved window locks be installed to prevent the possibility of a child falling out of the window.

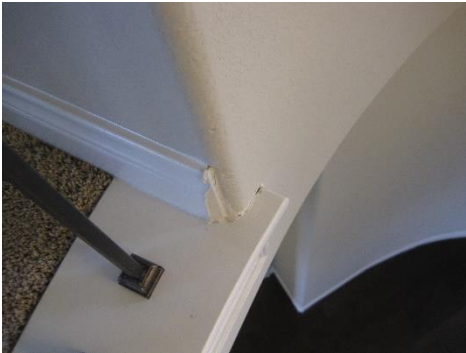
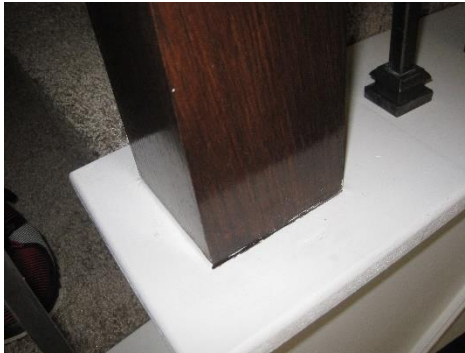
Areas of the stairs are not sealed.

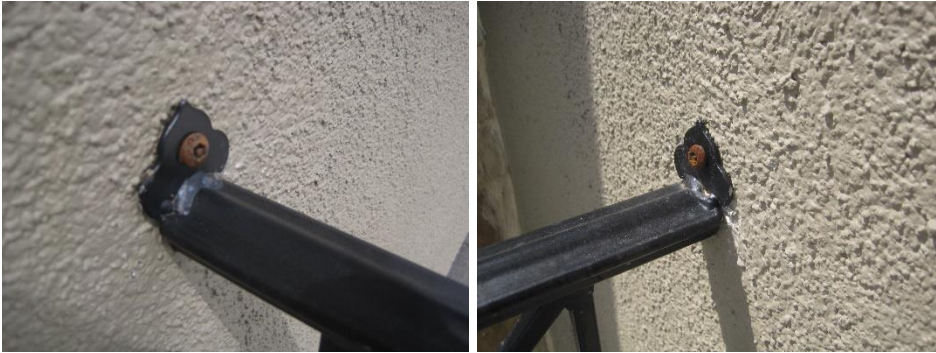
Railing anchor hardware not painted/rusted.

These should be cleaned and painted to prevent possible premature failure.

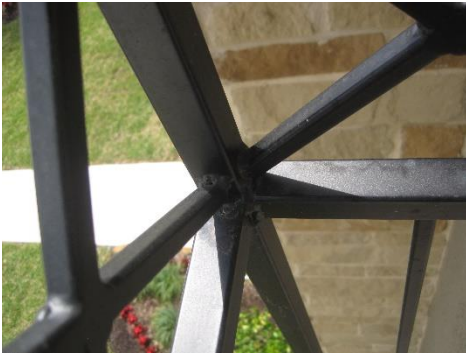
Balcony guard has openings in multiple locations.

These should be sealed and painted to prevent water penetration and possible premature failure due to rust.

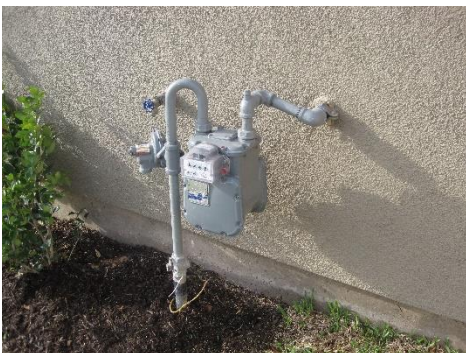
Gas meter is not properly bonded.

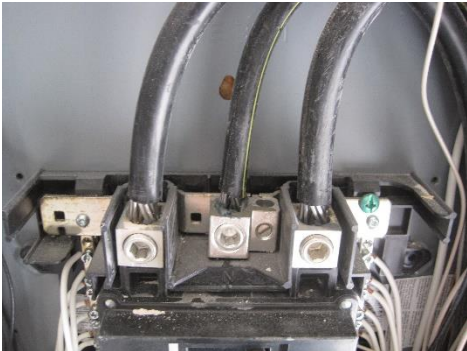
Aluminum Service Entrance conductors do not have sufficient Anti-Oxidant compound installed.

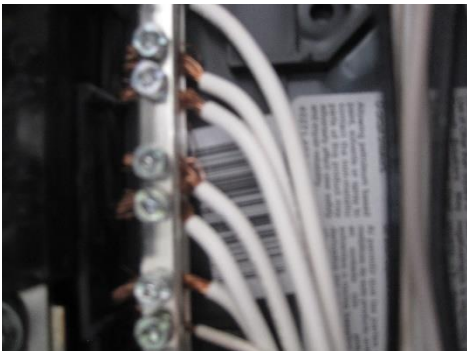
Neutral conductors not properly installed.

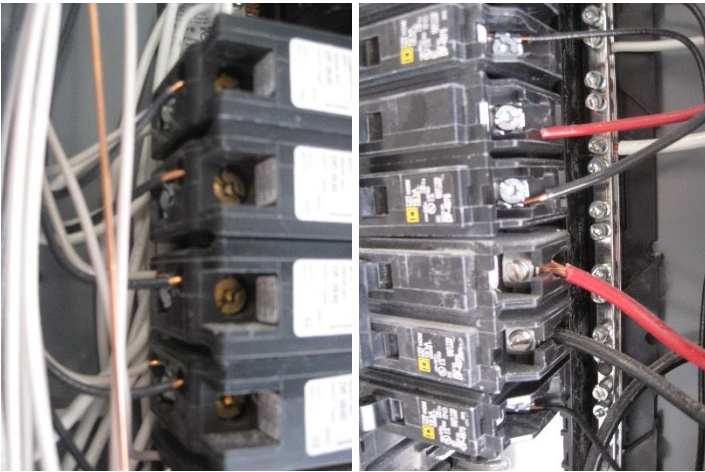
Excessive conducting material exposed beyond the breaker, in multiple locations.

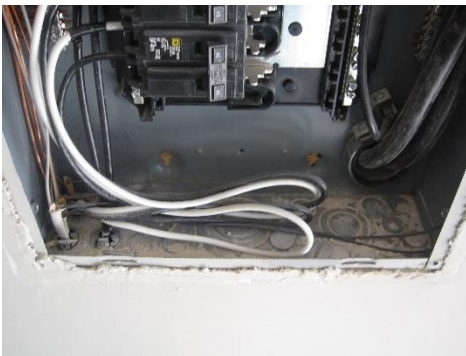
There is debris in the bottom of the panel.

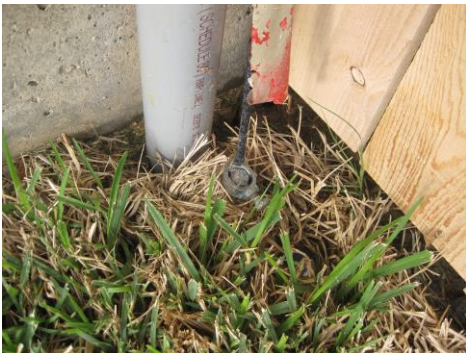
Grounding electrode system does not meet current code. Two electrodes should be installed, not closer than 6', and be connected together.

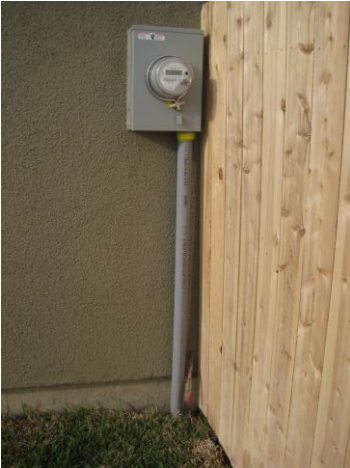
A slip joint is not installed on the electric meter.

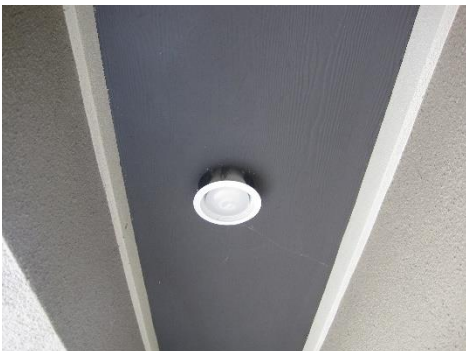
Luminaire in front of the garage door is not properly installed/secured.

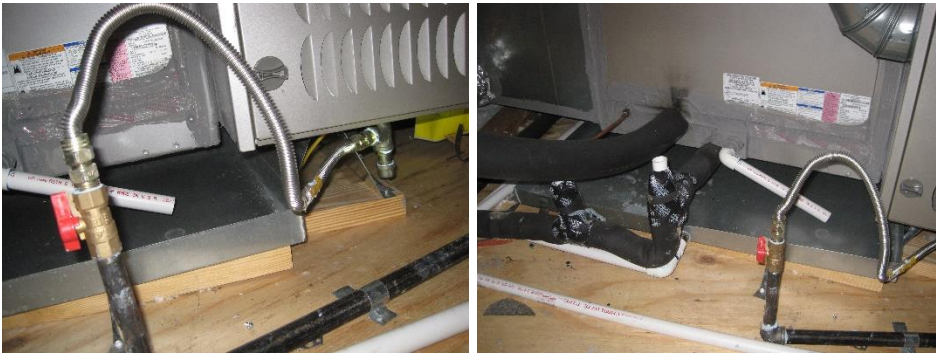
The gas lines are Corrugated, and not properly bonded. Since there is a history of failures in these types of connections as a result of gas lines that get energized due to lightning strikes, I recommend that they be replaced with an alternative that does not have this deficiency.

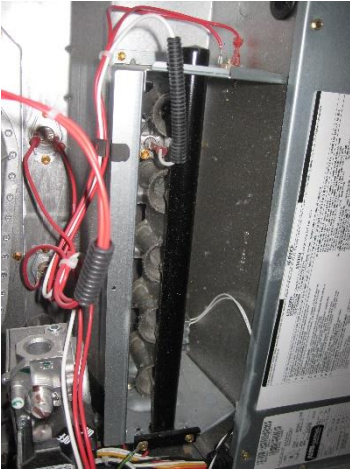
Burner nozzles are dirty.

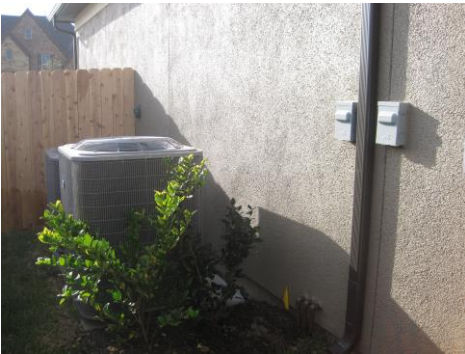
Vegetation too close to condenser unit.

Due to defects observed, recommend service by qualified H.V.A.C Service Company
 Note: RECOMMEND MAINTENANCE AND SERVICE PRIOR TO USE.

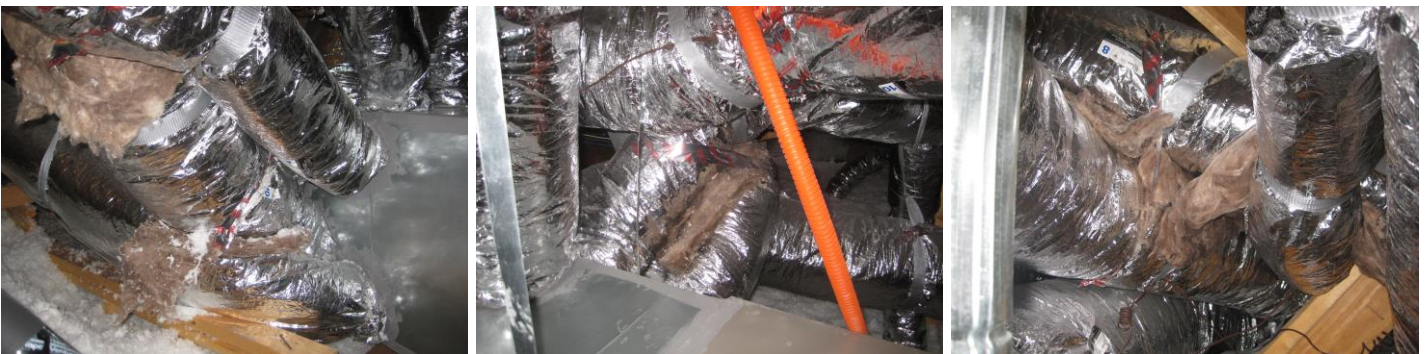
The conditioned air distributing system ducts rested on each other in numerous areas.

Information: Flexible ducts are not designed to support the weight of another duct. One duct resting on top of another duct can also create zones where condensation can occur. The ducts should be separated, made as straight and tight as possible and the ducts should be properly supported.

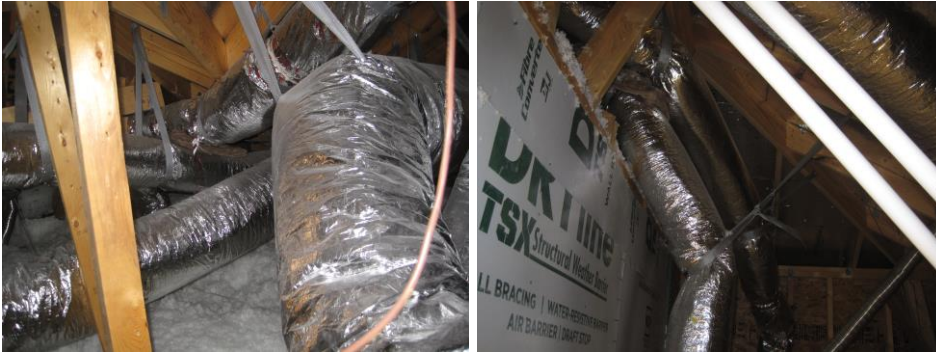
Ducts are bent/constricted in excess of the manufacturer's installation instructions, in multiple locations.

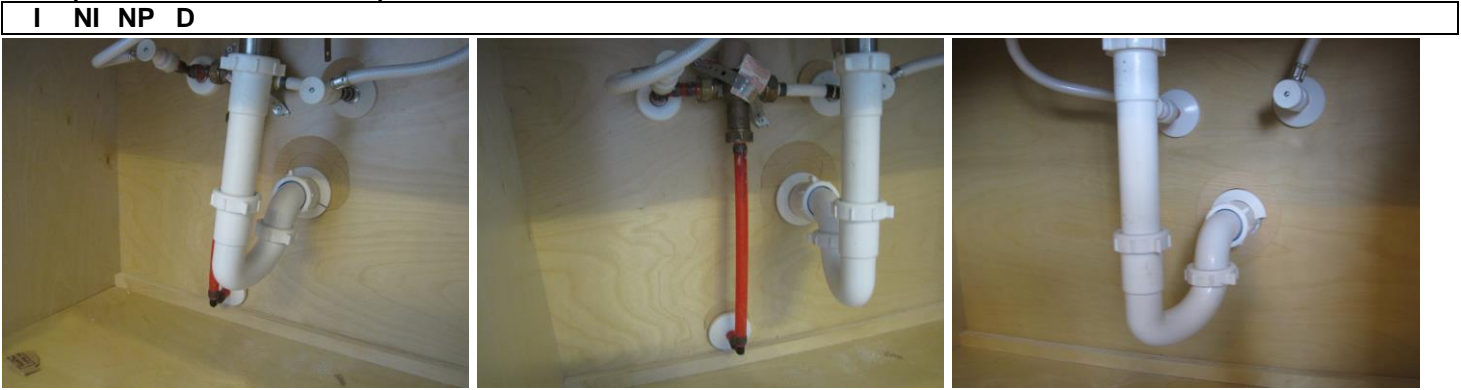
Drain pipes in the master bath sinks appear to have excessive slope. This could possibly prevent the P-Trap from functioning properly, and allow sewer gas to enter the house.

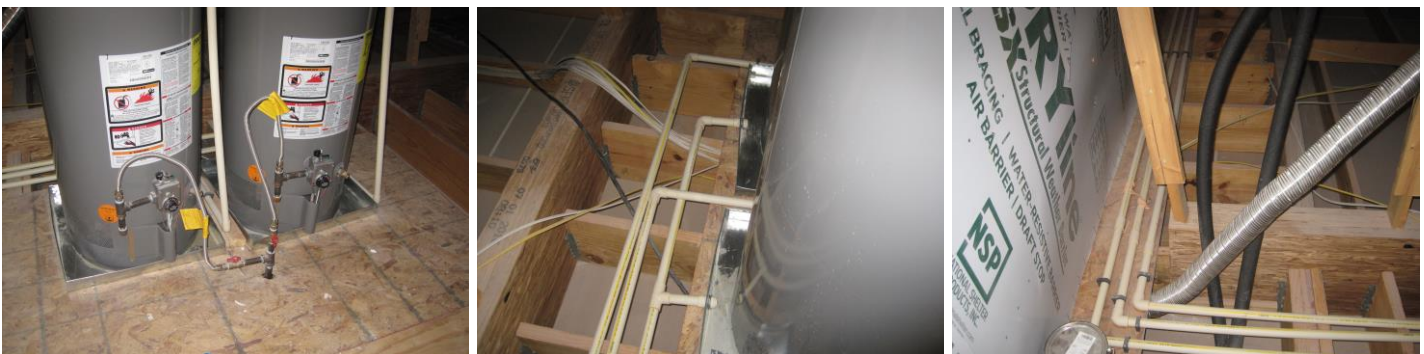
Temperature and Pressure Relief valve drains have more 90 degree elbows than the 4 total allowed by code.

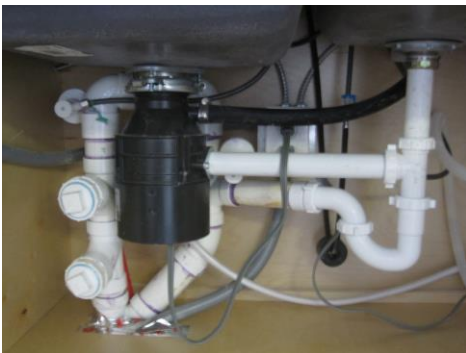
The self-retracting faucet in the kitchen sink does not function properly.

It appears to run behind a water line that prevents it from retracting, as designed.

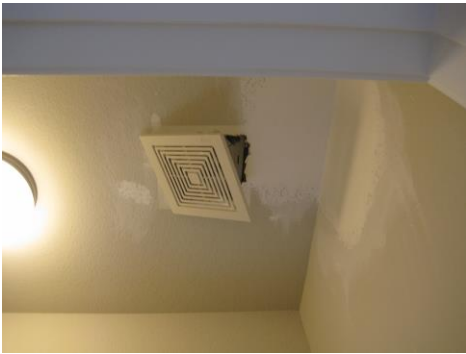
Vent in master bedroom not properly installed/secured.

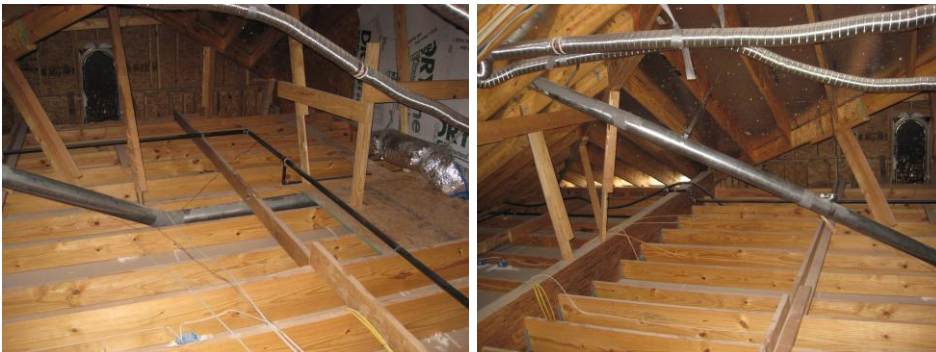
The dryer exhaust vent exits out through the roof.

This far exceeds the lint exhaust capability of most dryers. I strongly recommend that a dryer booster fan be installed with a backflow prevention exhaust cap. There are several know instances of fires starting in the dryer due to the exhaust getting plugged with lint.

I also recommend that the dryer exhaust system be cleaned on an annual basis.
