**Friday, February 17, 2017**

**PROPERTY INSPECTION REPORT**

**Concerning:** 25403 Elm Green St, Spring, TX, 77373  
(Address or Other Identification of Inspected Property)

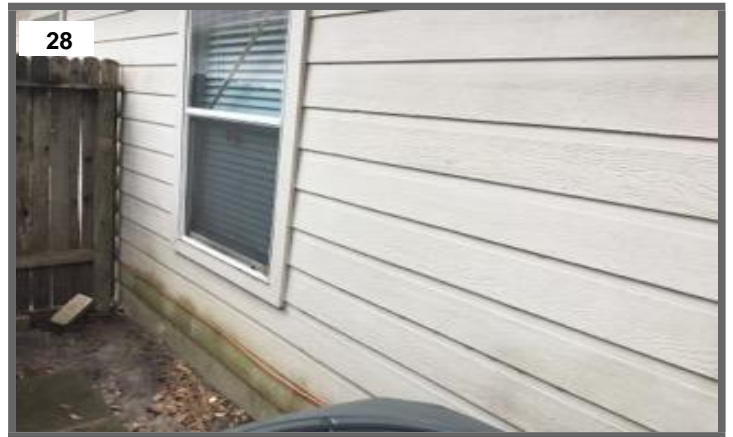
minor mildew

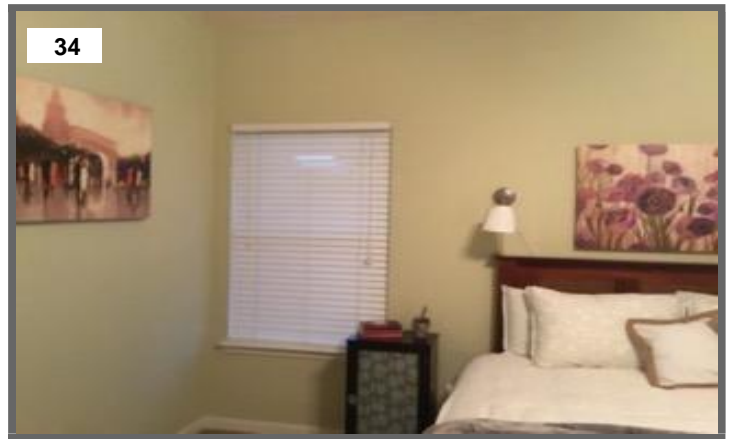
Minor bumps and bruises on the interior walls were noted. Nail holes should be filled and touch up paint may be needed .  
In the hall there are several wall scars (poor workmanship on repairs) .

Wall patch in the hall

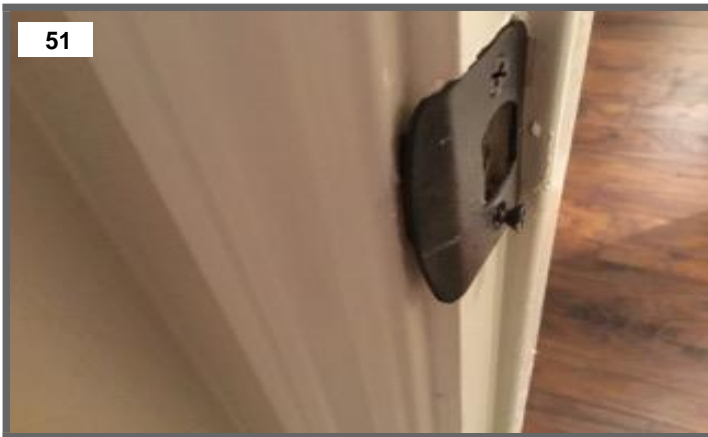
Front right quest bedroom, loose screw on door latch.

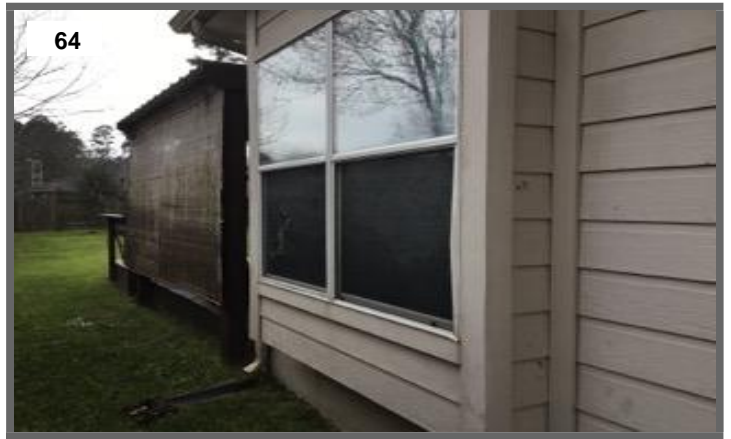
Torn screen

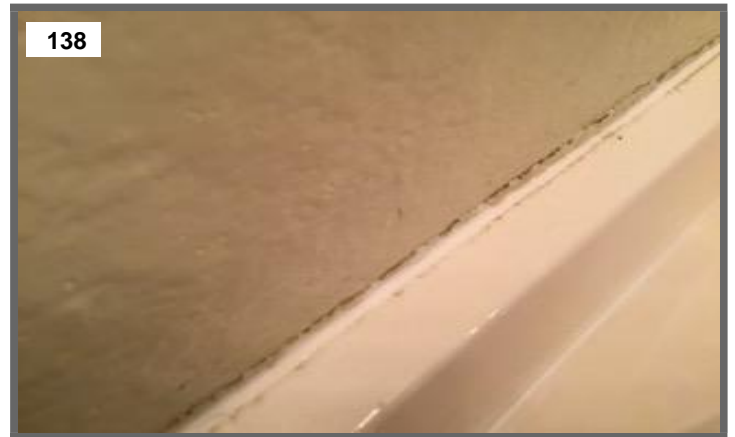
Master bathroom left sink does not drain properly, possibly clogged with hair .  
 Master bathroom, splashguard to left of sink is loose .  
 Good overall condition

Master bathroom, splashguard to left of sink is loose.
