PROPERTY INSPECTION REPORT

Prepared For: WADE & BAILEY DILLENBECK
(Name of Client)

Concerning: 16131 RIDGE PARK
(Address or Other Identification of Inspected Property)

By: DON MIDURA TREC PI # 375 5/11/2020
(Name and License Number of Inspector) (Date)

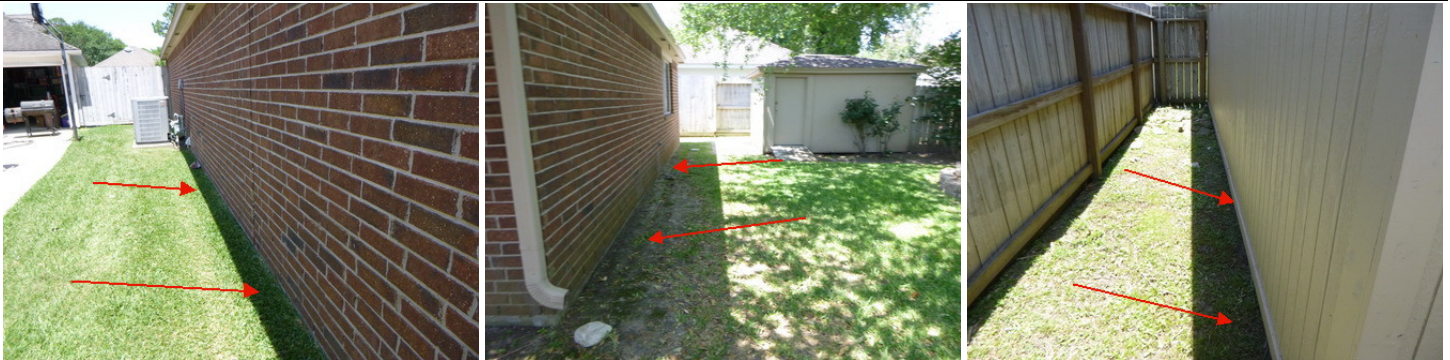
*Adjust the finish grade to channel water away from the building

1. A. FOUNDATION: See Comments in the Main Body of the Report.
2. B. GRADING /DRAINAGE: Adjust the finish grade to allow 4" – 6 inches of concrete foundation grade beam exposure and to channel water away from the building.

3. Install splash blocks for the rain gutter down spouts.
4. A professional drainage control contractor should be contacted to examine the site to determine an effective remedy.

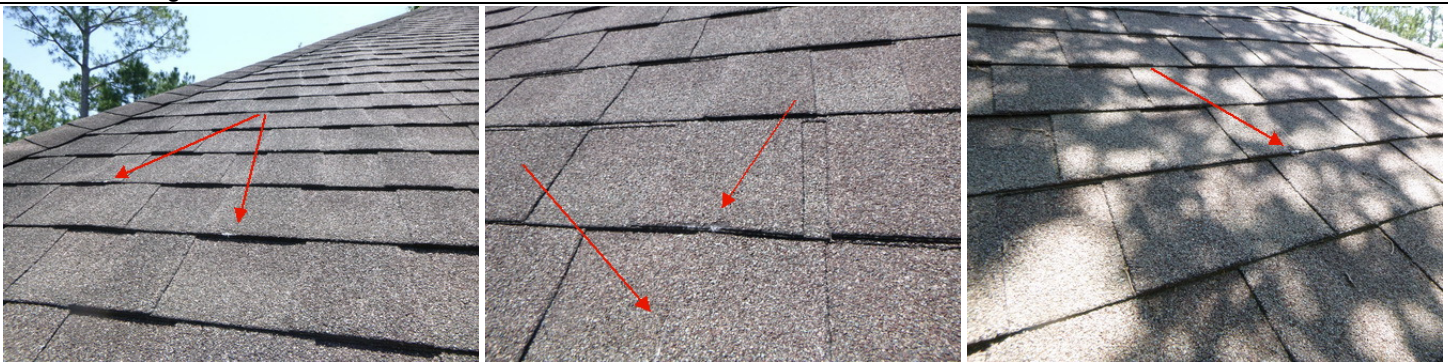
- 5. C. ROOF COVERING MATERIALS: Install / provide additional attic and soffit venting.
- 6. Granule loss, exposed substrate are apparent with evidence of suspected inclement weather (hail) related damaged at various locations

*Evidence of suspected inclement weather / possible hail related damage

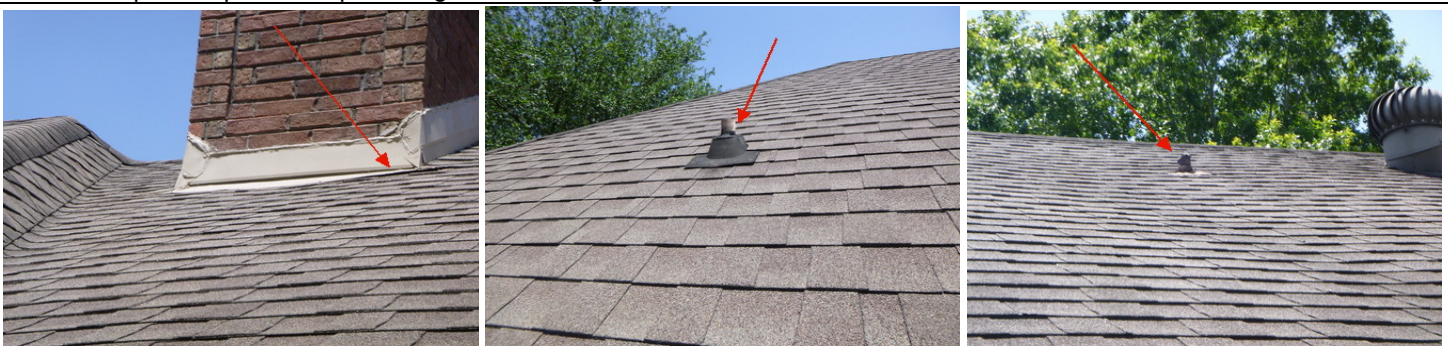
*Reset the chimney flashing

*Replace damaged plumbing vent flashings

- 7. Trim the tree branches from in contact with the roof.
- 8. Remove the over-hanging tree limbs from above the roof surface. Reset/ seal the chimney flashing.
- 9. Repair / replace the plumbing vent flashings.

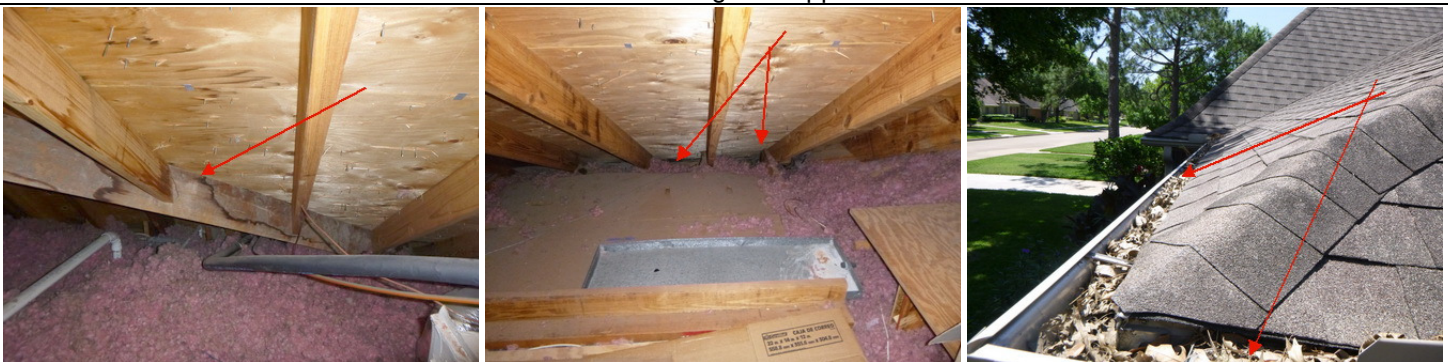
- 10. Water stains /evidence of leaking conditions in the valley near the HVAC equipment and at the roof deck above the fascia board.
- 11. Note: the entire underside of the roof decking is not accessible with a limited view from the HVAC work platform only. Remove the debris from the rain gutters.
- 12. A professional roof contractor / insurance loss specialist should be contacted to (A): examine the roof to determine the full extent of damage / cost of repair to insure leak free performance and (B) to provide an opinion as to whether or not there is sufficient surface damage to support an insurance loss claim.

*Water stains at the underside of the roof deck

*Clogged rain gutters

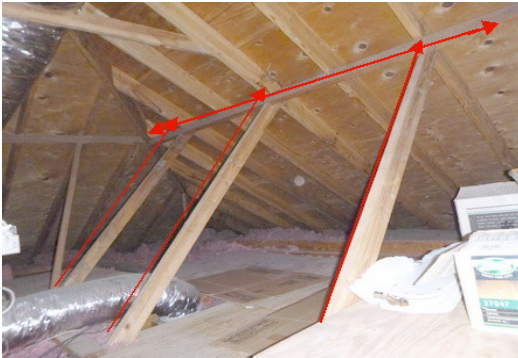
*Example of undersized purlin support

13. D. ROOF STRUCTURE and ATTICS: Stiffen the existing purlin bracing and ridge support.
14. Install additional blown insulation to achieve a full R-30 value.

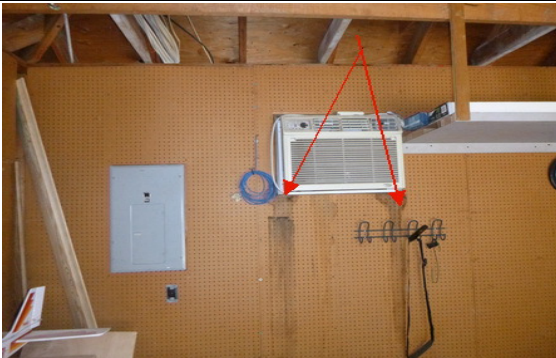
16. E. WALLS: Caulk / seal at all penetrations in the exterior finish walls – (ie) utility lines, light fixtures and electrical panels.
17. Water staining/ slight damage is visible to the peg board at the rear interior wall of the detached garage – (leak from the window / portable AC unit?).

*Leaky portable AC / water damaged peg board

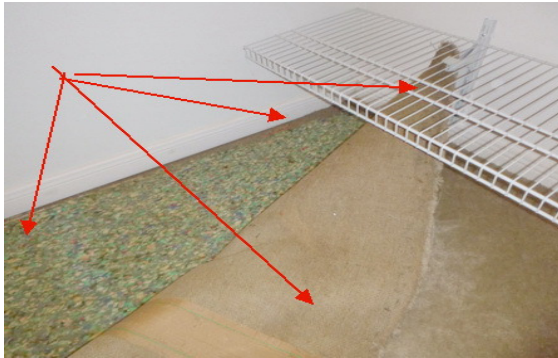
22. **Blue:** the carpet, tack strip and base trim are water stained / damaged in the main bath closet to the right of the shower – (cause for the water intrusion has not been determined).

*Previous water intrusion / main bath closet

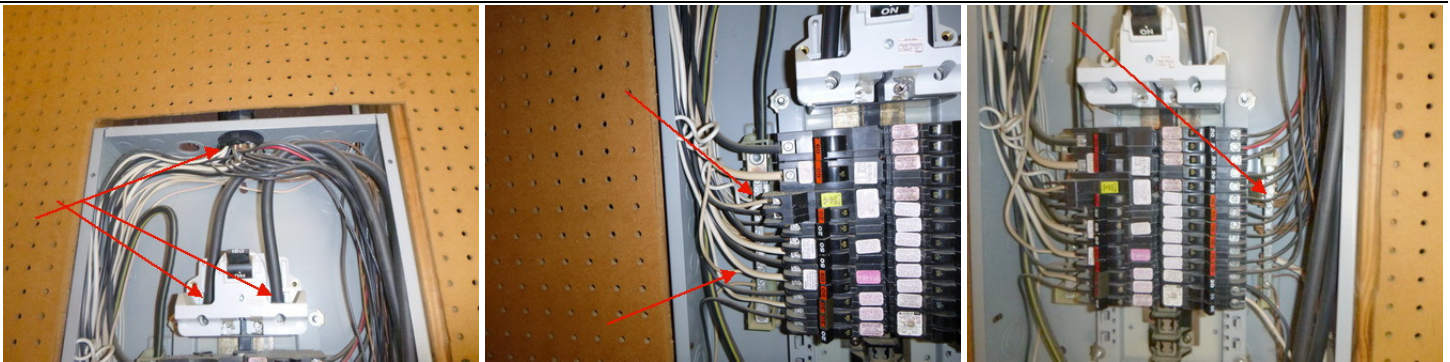
37. The neutral wires at the buss bar should be connected to separate terminals.

*Over-bundled wiring; apply an oxide reducer; identify neutrals as "hot"; multi-tapped neutrals and grounds

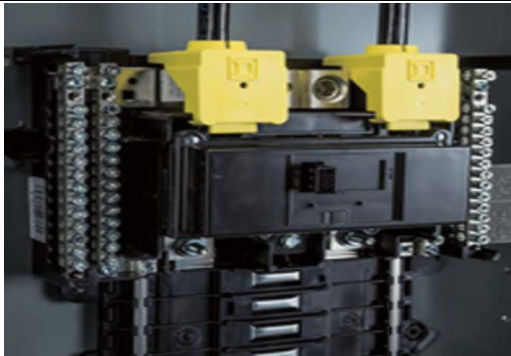
*Service entrance barriers

38. Install Service Entrance Barriers - the UL67 standard has been updated for the purpose of enhancing safety in electrical distribution panels. The revision, which takes effect January 1, 2017, requires panel manufacturers to provide protective devices that guard against inadvertent contact with exposed energized parts

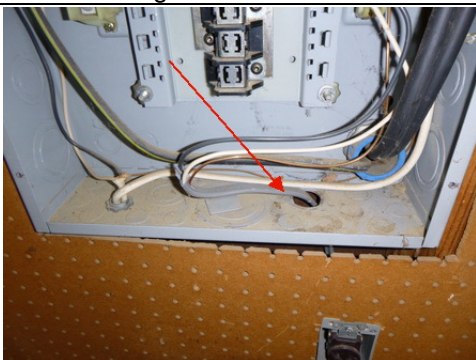
*Missing knockout insulators

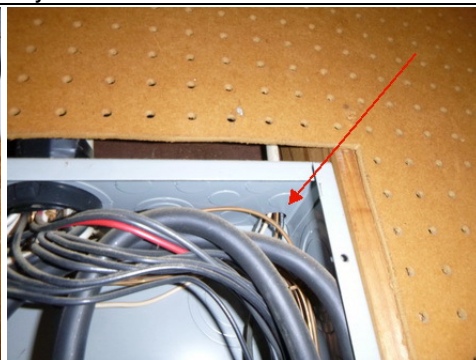
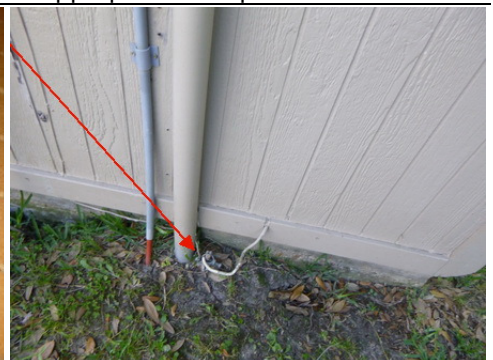
*Drive the ground rod fully into earth

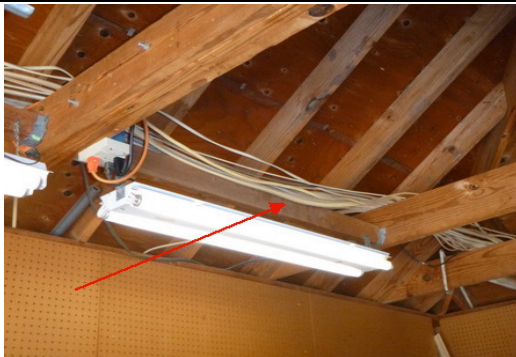
*Support wiring at the ceiling

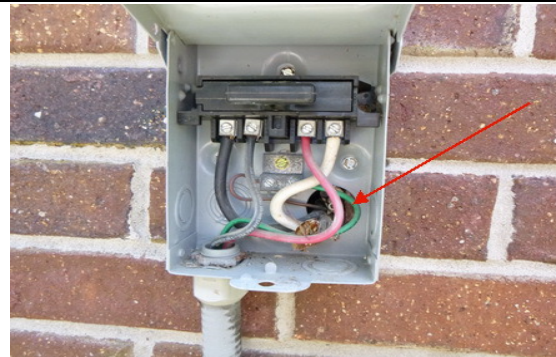
*Missing conduit and knockout insulator

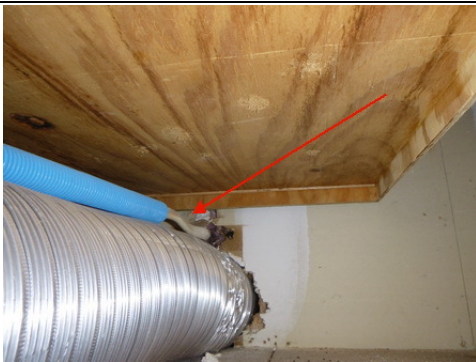
*Complete electrical conduit

- 56. Complete the conduit at the 220V power supply line in the kitchen range base cabinet.
- 57. The light fixture above the hall bath tub should be a wet niche type.
- 58. Secure the loose transformer at the junction box in the attic.
- 59. Replace the damaged switch box cover in the attic.
- 60. The switch in the attic labeled "attic fan" did not seem to control any fixture – (attic fan, if installed, is not visible from the HVAC equipment work platform).
- 61. Pull the insulation from the recessed can fixture – attic floor.

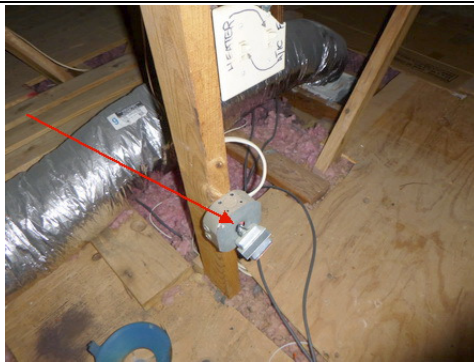
*Secure loose transformer

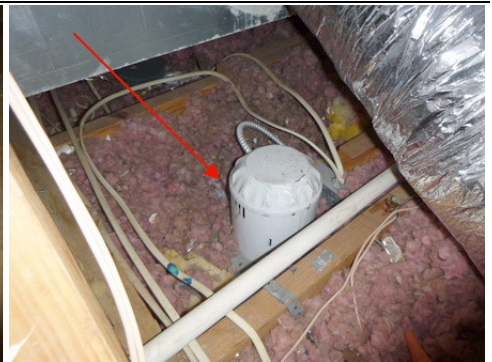
*Pull insulation from fixture

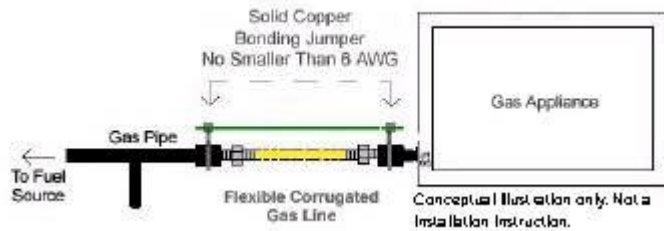
62. Install bonding jumpers at all metal gas piping interrupted by metal flex lines – (the NEC Section 250-104(b) reads as follows: “Metal Gas Piping. Each aboveground portion of a gas piping system upstream from the equipment shutoff valve shall be electrically continuous and bonded to the grounding electrode system).

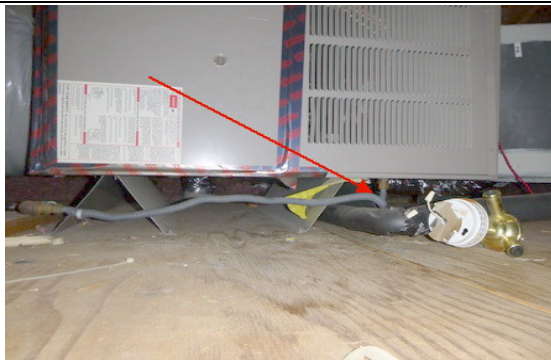
*Install a sediment trap

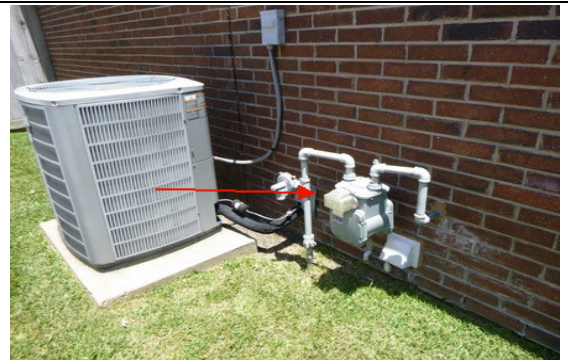
*Condenser / gas meter – too close

- 68. B. COOLING: Complete the refrigerant line insulation at the exterior wall adjacent to the condenser.
- 69. The condenser is installed too close to the gas company utility meter.
- 70. The condenser /evaporator coils are plugged with debris and the return air filter is dirty – (clogged coils-dirty filters will reduce the ability of the units to effectively transfer heat, increasing the operating pressures, temperatures and expense while reducing system efficiency).

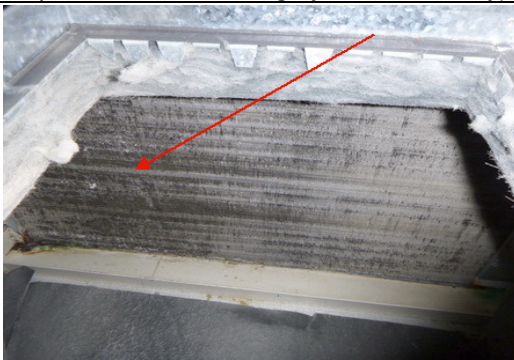
*Dirty evaporator coil

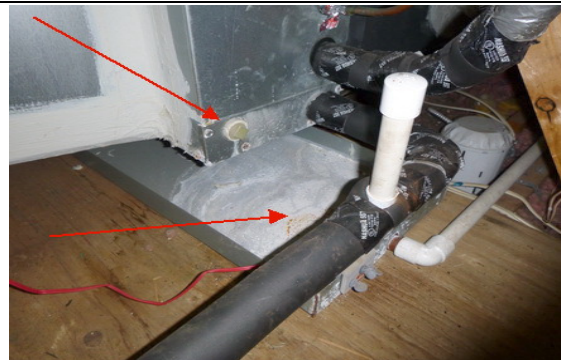
*Install drain at secondary and rust in emergency pan

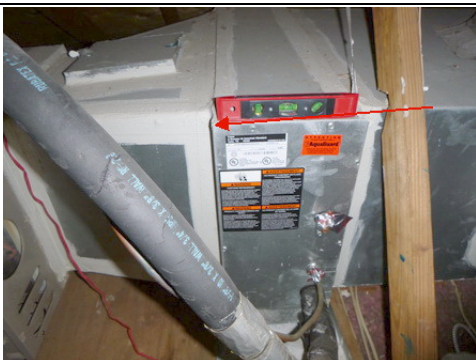
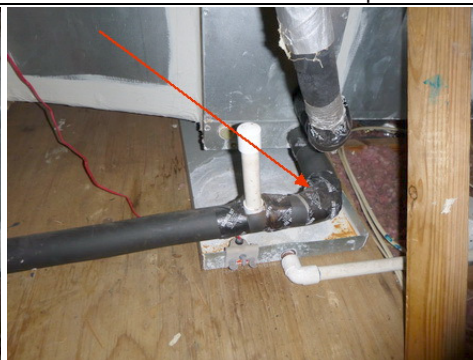
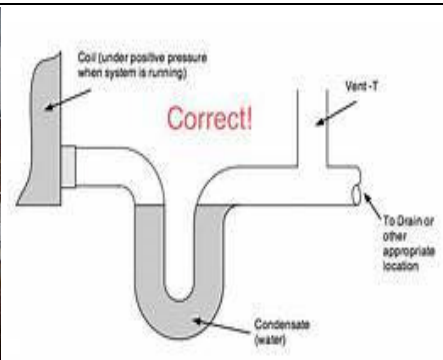
*Adjust the slope of the evaporator / p-drain pan; install a p-trap in the drain line at the evaporator

- 71. Adjust the position of the evaporator / primary drain pan to insure for a positive gravity flow.
- 72. Install a p-trap in the drain line adjacent to the evaporator.
- 73. Install a secondary drain line from the knockout in the lower evaporator coil casing.
- 74. Rusting is apparent in the emergency pan – (evidence of a primary drain pan leak).
- 75. A moderate temperature differential was measured at the interior of the home – (ie) about 13oF and the system is not operating properly.
- 76. A licensed HVAC contractor should be contacted to make all repairs / improvements as needed.

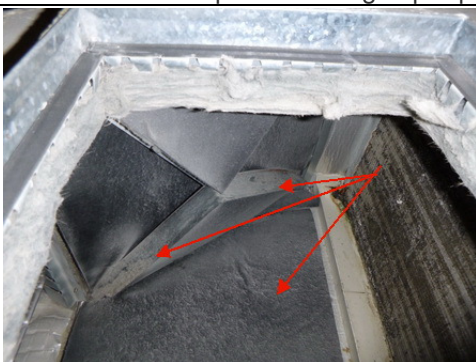
*Replace the duct liner-transition box

82. Replace the damaged / dirty duct liners in the supply side transition box between the air handler and the evaporator.

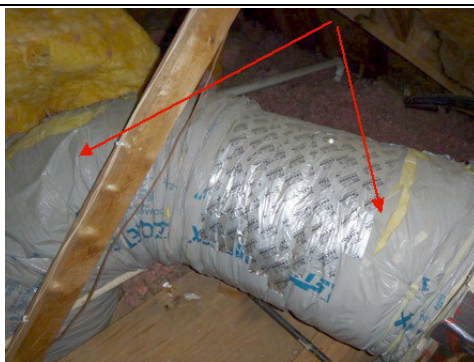
*Replace grey flex duct

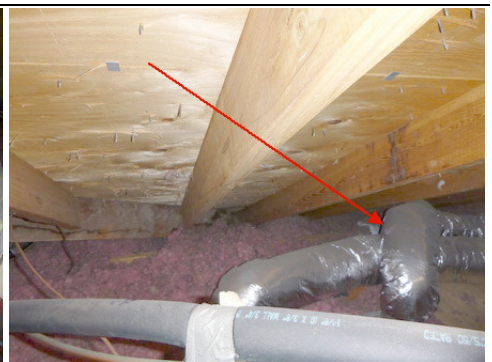
83. The airflow ducts were observed to be in contact with each other or other insulation material at various locations creating the potential for thermal bridging or condensation buildup. Clearance or separation should be established by strapping with HVAC nylon strapping. Where ducts are separated by insulation blankets condensation moisture is generally increased (as the insulation traps hot air against the cooler ducts) – ductwork can be separated using vapor permeable barriers.

*Separate the flex ducting

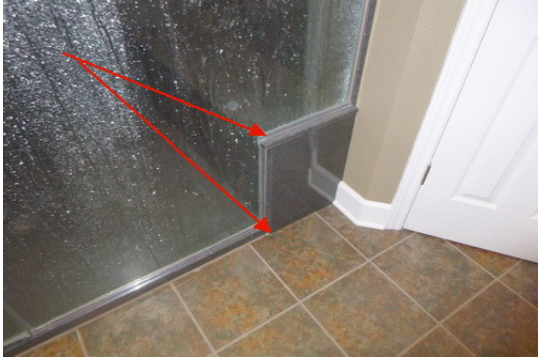
88. Main bath: a water leak was observed from the shower glass panels at the bench area.

*Water leak at shower surround

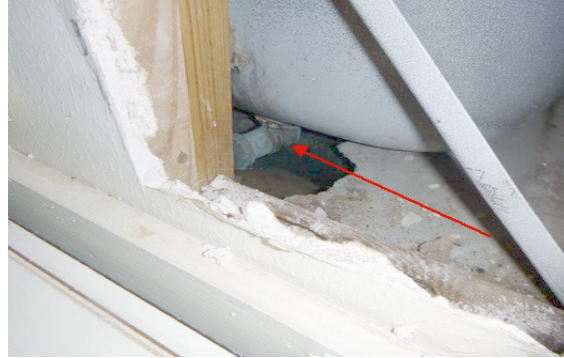
*Hall bath tub drain leak

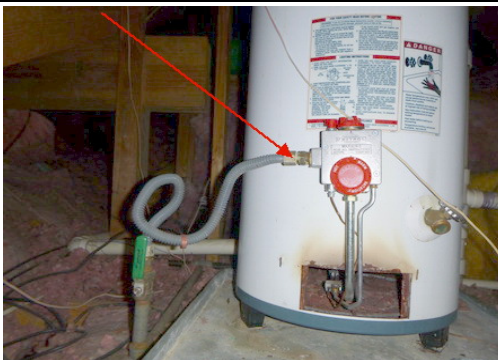
*Install a sediment trap

95. Install a sediment trap at the gas branch supply line. Note: sediment traps are designed to cause the gas flow to change direction 90 degrees at the sediment collection point, thus causing the solid or liquid contaminants to drop out of the gas flow.

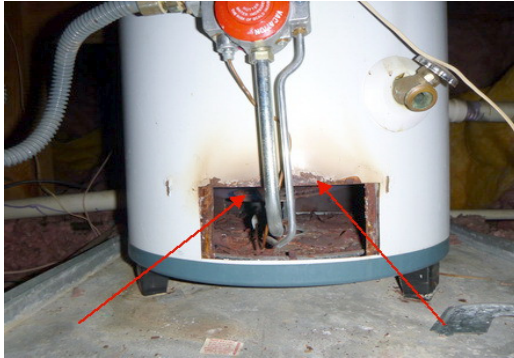
- 96. Heavy rust / corrosion is apparent at the burner assembly and in the combustion chamber with a smoky char at the exterior of the tank at the access port to the burner assembly.
- 97. Install dielectric fittings for the water lines top of the tank and replace corroded piping.
- 98. Review the information in the Main Body of the Report regarding T&P valve maintenance.
- 99. Replacement of the tank is recommended

*Corrosion / smoky char

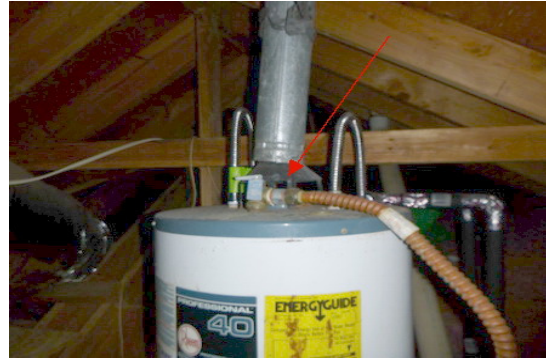
*Corrosion at water line fitting(s)

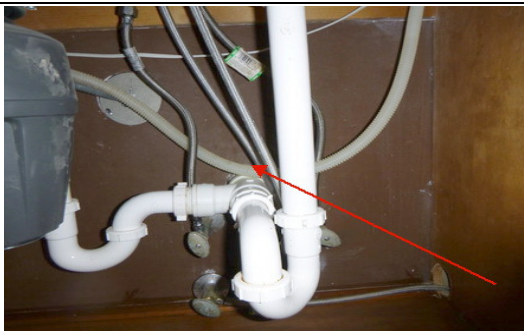
*Redo the drain line – eliminate the negative slope

- 100. A. DISHWASHER: Redo the drain line to allow for proper routing – (eliminate the negative slope).

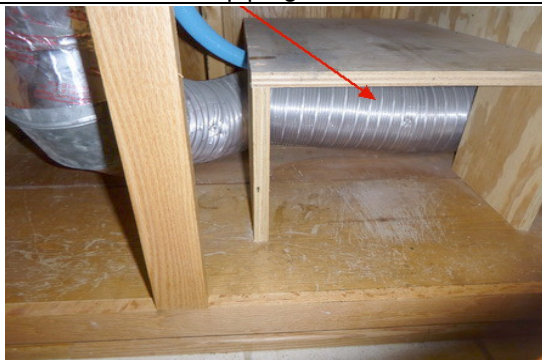
*Solid / smooth wall vent required

- 101. C. RANGE HOOD AND EXHUAUST SYSTEMS: Replace the flexible exhaust vent duct with solid / smooth wall piping.

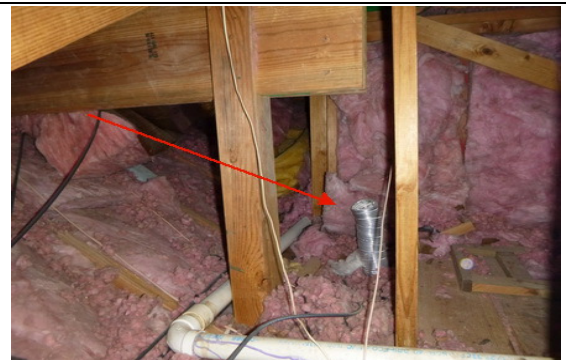
*Extend bath vents to the exterior

- 102. F. MECHANICAL EXHAUST VENS AND BATHROOM HEATERS: The exhaust vent ducting should extend through to the exterior – (existing vents discharge into the attic space).
