PROPERTY INSPECTION REPORT

Concerning: 8426 Garden Parks Dr, Houston TX 77075

By: Richard Kinder - Trec #21699

01/15/2020 9:00 am

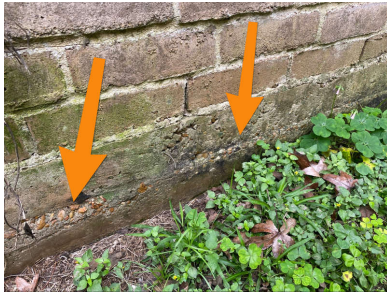
2: Deterioration/Spalling

⊖ Moderate/Repair Recommended

Deterioration (known as spalling) was observed. Spalling refers to concrete that has become pitted, flaked, and/or broken up.

Recommendation: Contact a foundation contractor.

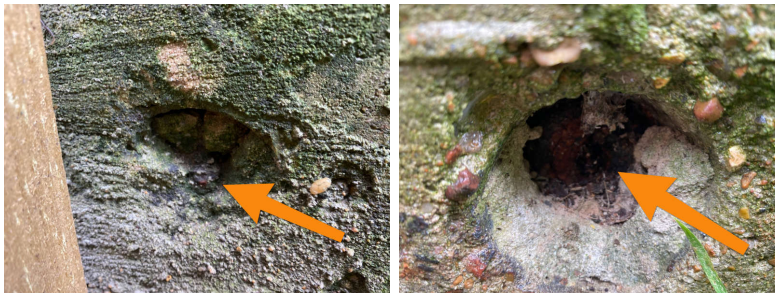
3: Post Tension Cabel Ends Exposed

⊖ Moderate/Repair Recommended

Exposed post tension cable ends were observed. Post tension cables should be cut flush with the foundation edge and sealed to prevent moisture intrusion. Moisture could enter the stranded cable and wick way further down the cable inside the sheath that surrounds it, causing it to rust and will eventually fail if not corrected.

Recommendation: Contact a foundation contractor.

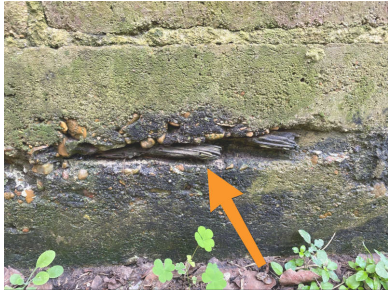
4: Exposed Rebar

🟡 Moderate/Repair Recommended

Exposed rebar in the foundation was observed. Exposed rebar if left untreated can cause extensive structure damage and may cause the rebar to break away.

Recommendation: Contact a foundation contractor.

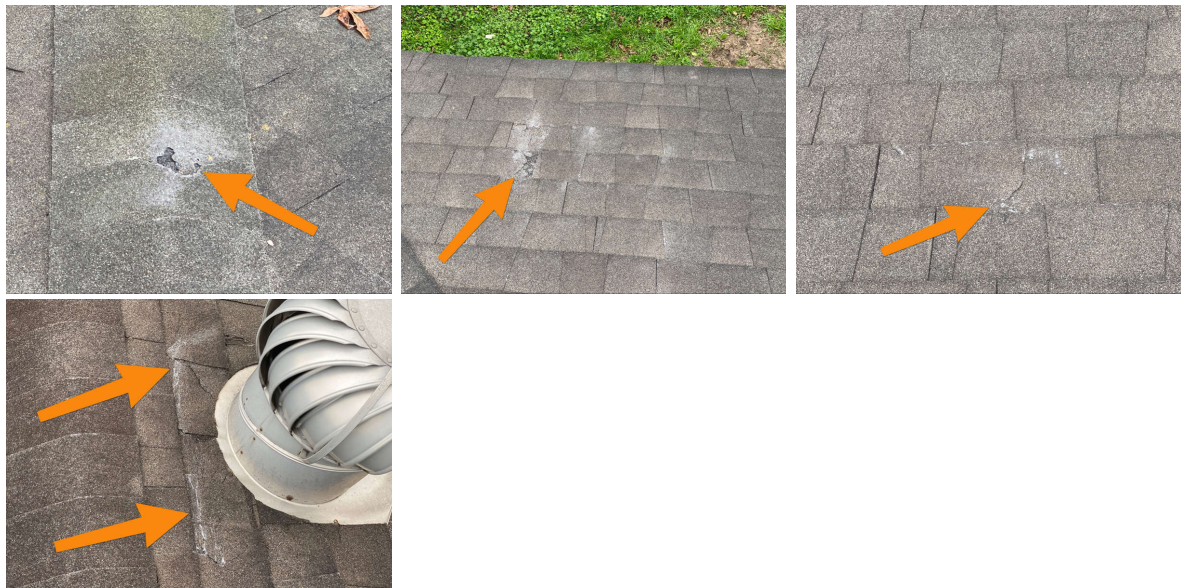
7: Surface: Damaged Shingles

🟡 Moderate/Repair Recommended

Damaged shingles were observed.

Recommendation: Contact a qualified roofing professional.

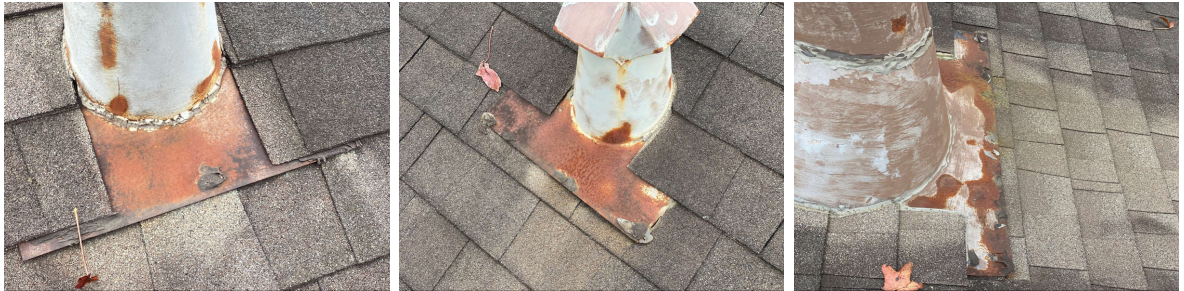
13: Flashing: Rust

🟡 Moderate/Repair Recommended

Rust was observed on areas of roof flashing. Rust can eat away at the flashing leaving openings that can allow moisture to enter the structure.

Recommendation: Contact a qualified roofing professional.

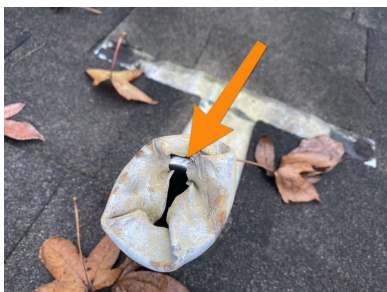
14: Flashing: Damaged Roll Flashing

🟡 Moderate/Repair Recommended

Damaged roll flashing was observed at plumbing stacks at the roof level.

Recommendation: Contact a qualified roofing professional.

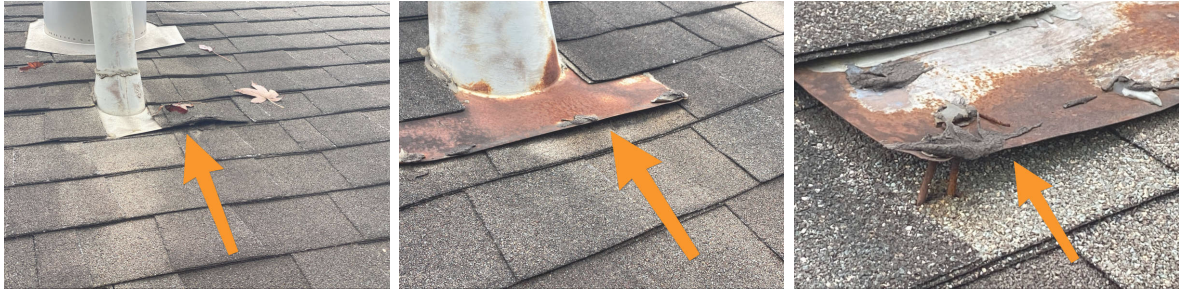
15: Flashing: Raised Roof Penetration

🟡 Moderate/Repair Recommended

Raised flashing around one or more roof penetrations was observed.

Recommendation: Contact a qualified roofing professional.

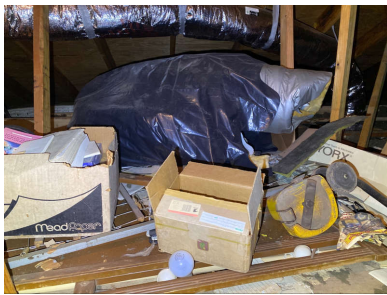
1: Loose Debris

Loose debris was observed in the attic structure.

Recommendation: Contact a qualified professional.

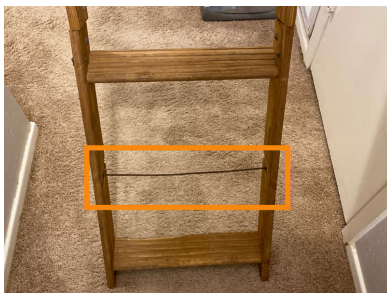
2: Attic Ladder Frame Cracked/Damaged

Moderate/Repair Recommended

The attic access ladder was noted to be cracked, damaged and/or missing members.

Recommendation: Contact a qualified professional.

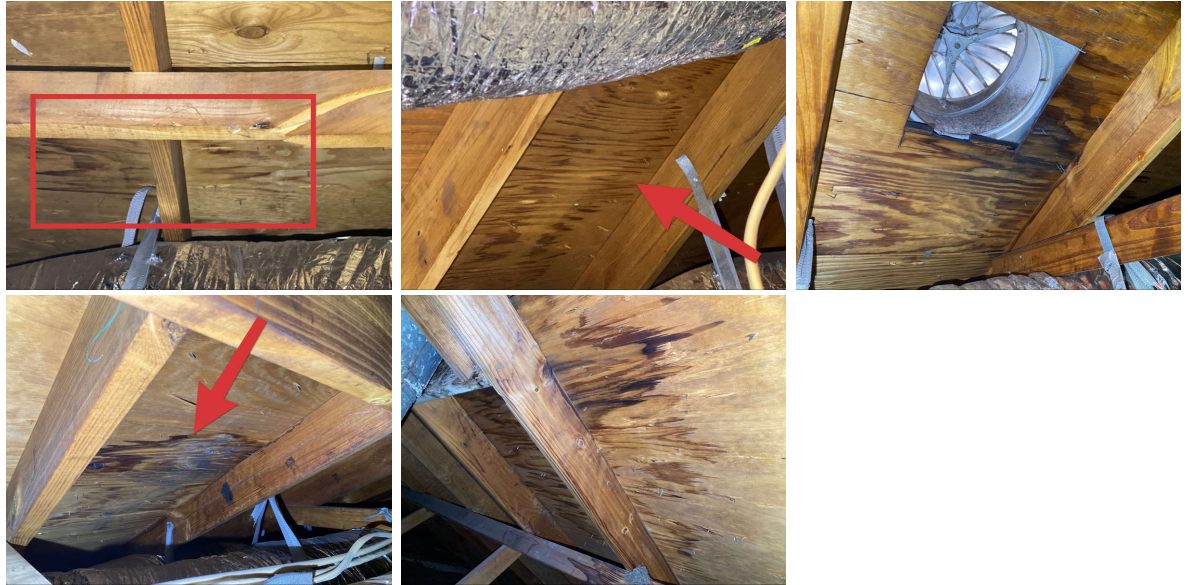
4: Moisture Staining/Damage

Moisture staining/damage was observed on areas of the roof structure. This indicates a previous/present leak has occurred in the roof.

Recommendation: Contact a qualified professional.

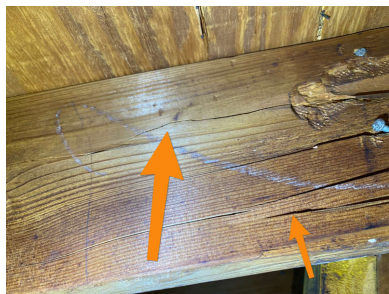
5: Rafters Cracked/Damaged

⊖ Moderate/Repair Recommended

Cracked/damaged rafters were observed.

Recommendation: Contact a qualified professional.

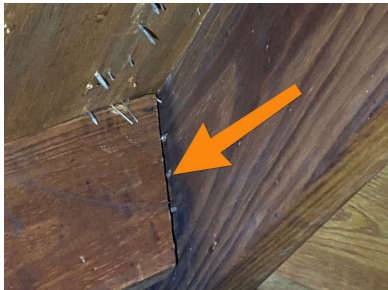
6: Rafters Separation

⊖ Moderate/Repair Recommended

What appeared to be separation between roof rafters and the ridge board was observed. This could be an indicator of structural movement. The rafters should make full contact with the ridge board to insure the load is properly transferred.

Recommendation: Contact a qualified professional.

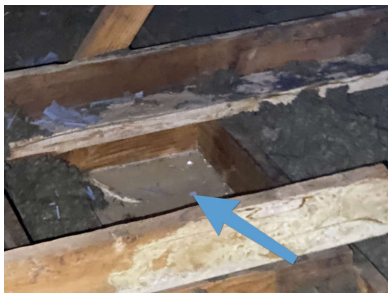
8: Insulation: Missing

Areas of the attic was missing insulation. Additional insulation should be added.

Recommendation: Contact a qualified professional.

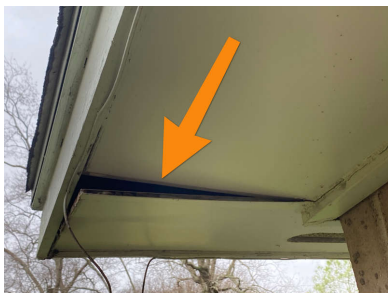
10: Soffits/Eaves Loose

🟡 Moderate/Repair Recommended

Areas of the soffits/eaves were observed to be loose.

Recommendation: Contact a qualified professional.

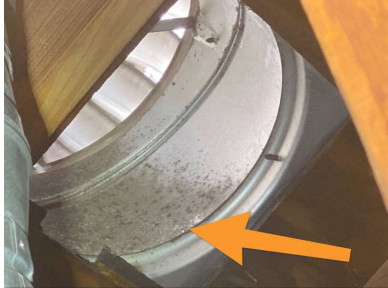
11: Organic Growth

🟡 Moderate/Repair Recommended

What appeared to be organic growth was observed on the interior of the attic structure.

Recommendation: Contact a qualified professional.

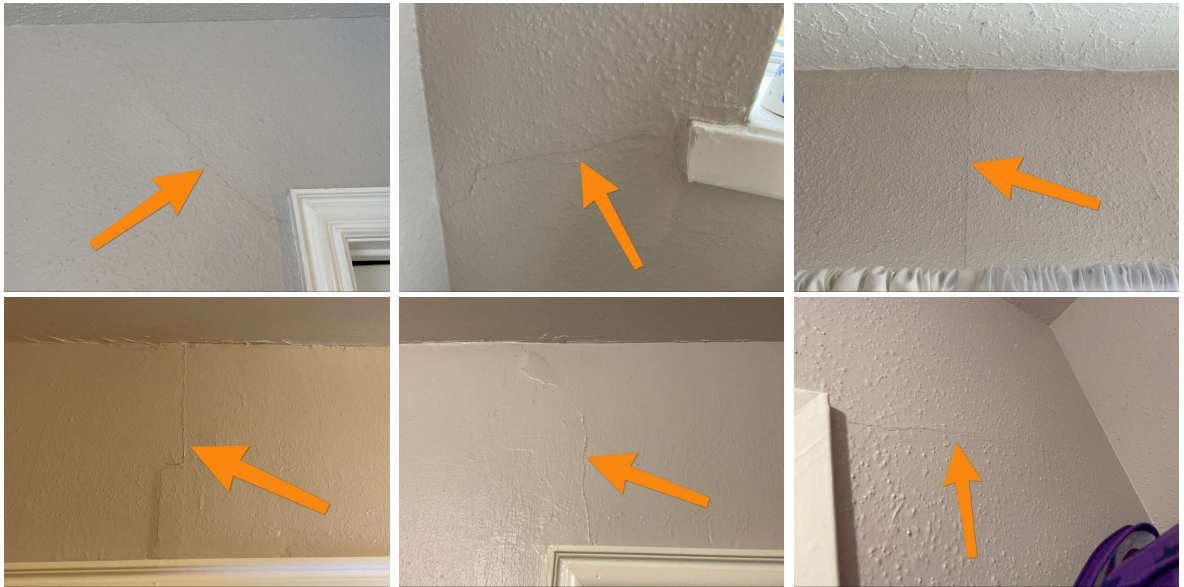
1: Interior Wall Cracks/Fractures

🟡 Moderate/Repair Recommended

Interior wall cracks/fractures were observed.

Recommendation: Contact a qualified professional.

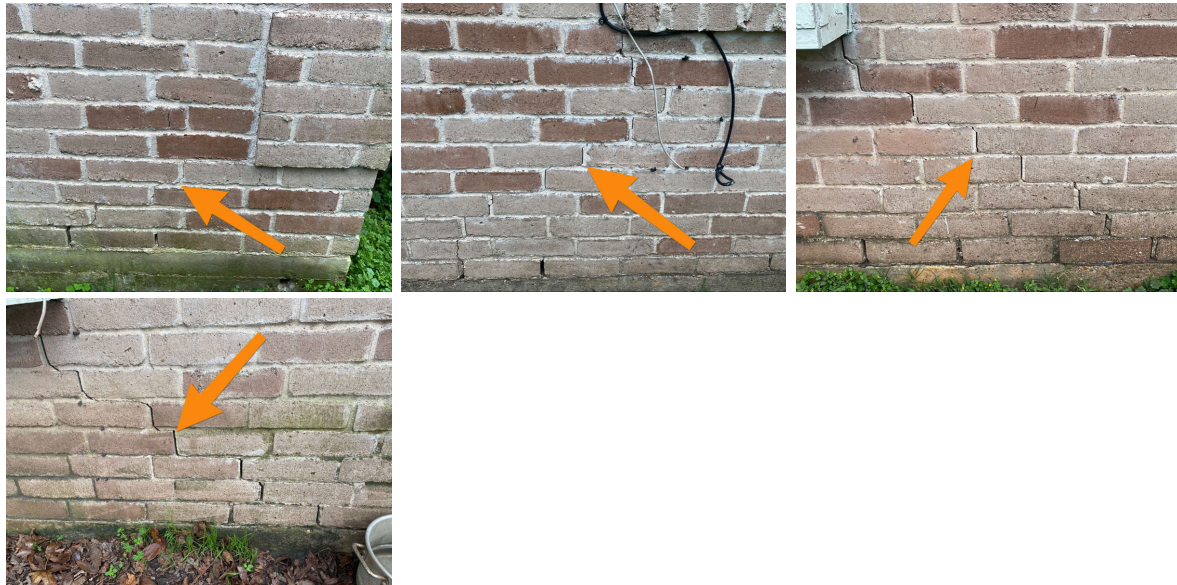
4: Exterior Wall Cracks/Fractures

🚫 Moderate/Repair Recommended

Exterior wall cracks/fractures were observed.

Recommendation: Contact a qualified professional.

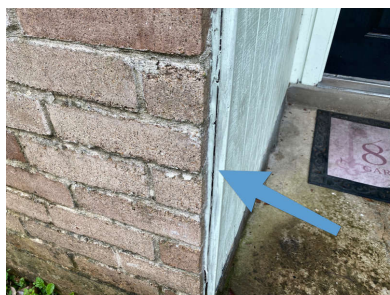
6: Deficient Exterior Wall Connection Joint Sealant

Cracking, deteriorated, and/or missing sealant was observed around exterior wall connection joints. It is recommended all joints be properly sealed to prevent moisture intrusion.

Recommendation: Contact a qualified professional.

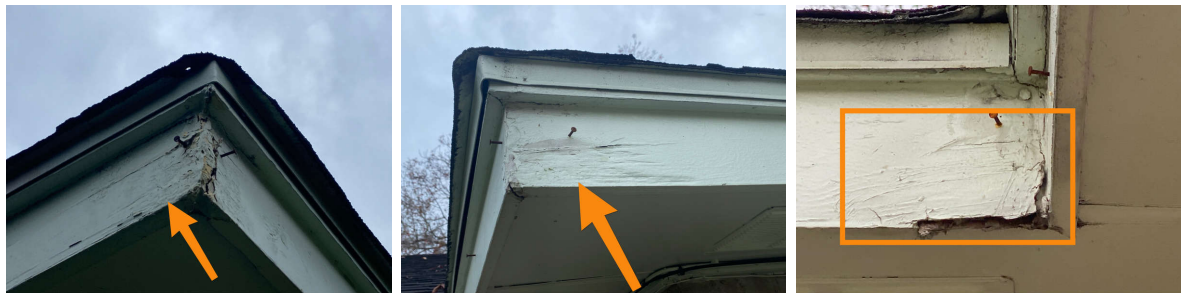
8: Siding/Trim Damaged/Rotted

🟡 Moderate/Repair Recommended

Areas of the exterior siding/trim were observed to be damaged/rotted.

Recommendation: Contact a qualified professional.

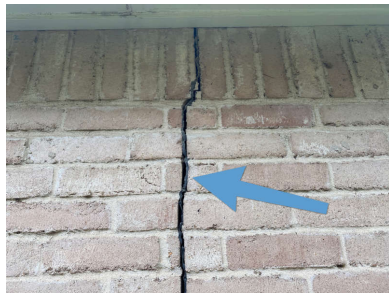
9: Deficient Expansion Joint Sealant

🔧 Minor; Improve as necessary

Cracking, deteriorated, and/or missing expansion joint sealant was observed.

Recommendation: Contact a qualified professional.

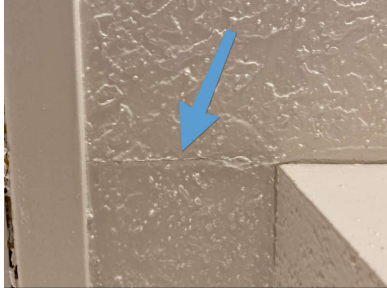
1: Interior Ceiling Cracks/Fractures

Interior ceiling cracks/fractures were observed.

Recommendation: Contact a qualified professional.

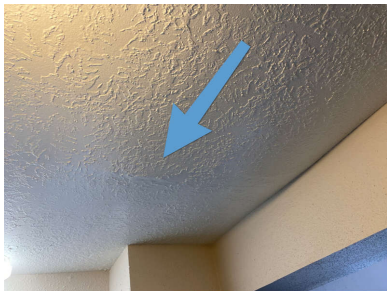
Kitchen

2: Ceilings: Patches

✦ Minor; Improve as necessary

Interior ceiling patches were observed. The reason for the ceiling patches was not determined.

Recommendation: Contact a qualified professional.

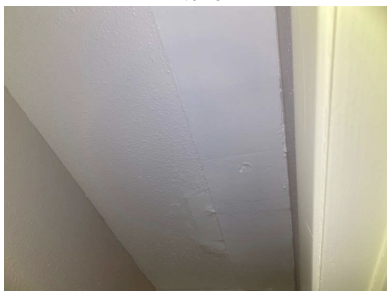
Closet Bedroom #1; Patch Inadequate

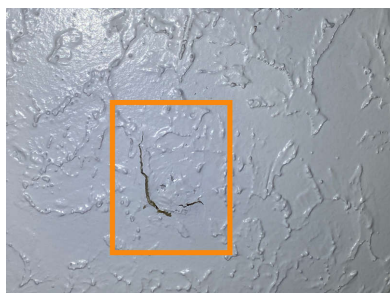
Living Room

Damage to the interior ceiling was observed.

Recommendation: Contact a qualified professional.

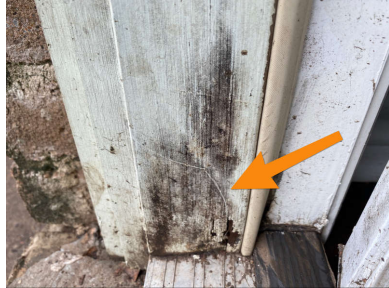
Back Door

Damage/rot was observed at the base of exterior door entry ways.

Recommendation: Contact a qualified professional.

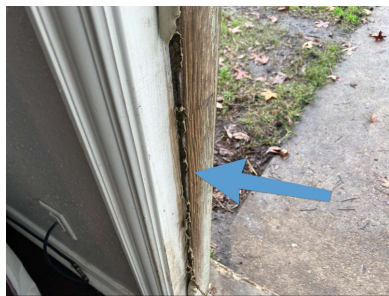
Back Door

5: Damaged Weather Stripping

Damaged weather stripping at exterior doors was observed.

Recommendation: Contact a qualified professional.

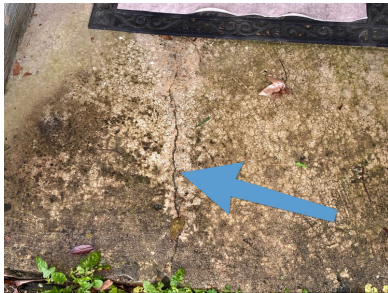
Front Porch

Some deflection/cracking was observed in the slab.

Recommendation: Contact a qualified professional.

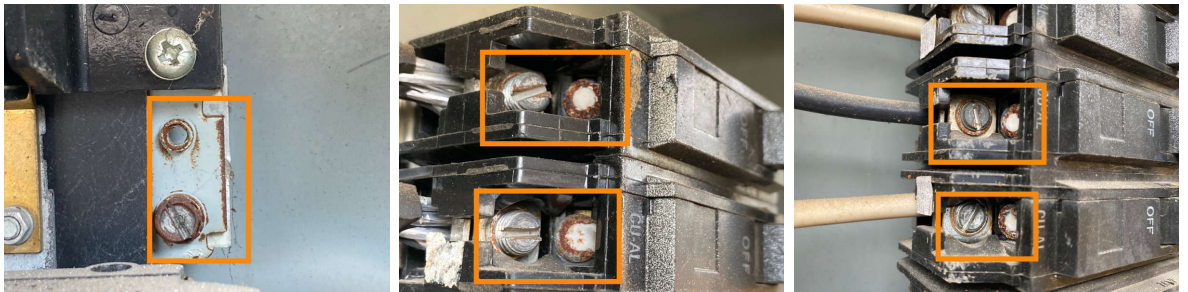
15: Rust On Components

🚫 Moderate/Repair Recommended

Rust was observed on multiple components on the interior of the electrical panel.

Recommendation: Contact a qualified electrical contractor.
