BRYAN & BRYAN INSPECTIONS

Inspection Report For:
8426 Garden Parks Drive, Houston, TX 77075

Inspection Date: 9/14/2017

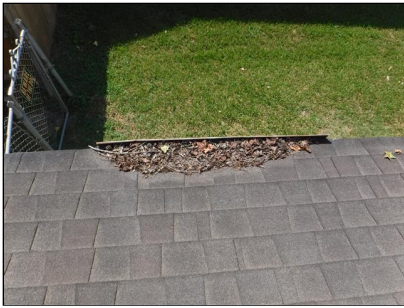
C. Item 2(Picture)

(2) Further evaluation of the roof covering is recommended. Multiple deficiencies were observed including, but not limited to, the following; popped up nails, excessive granule loss, moisture staining on roof decking indicating leaks, exposed fasteners, torn shingles, damaged shingles, wind lift, rusted flashings, satellite dish on roof, soft sections of roof decking cupping/curling shingles,. Consult with a qualified roofing contractor to determine the best method of remedy and estimates for repairs and/or replacement.

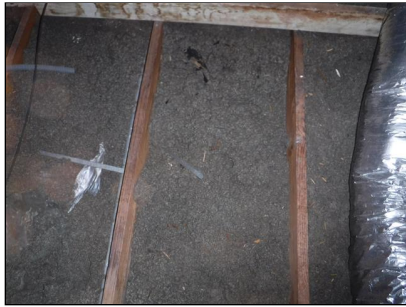
D. Item 2(Picture)

(2) Noted gaps in the blown insulation in several locations in the attic. This may reduce the R value of the insulation system.

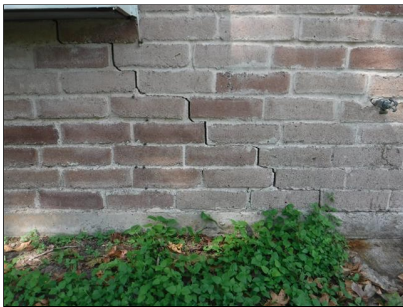
E. Item 5(Picture)

(4) Stress cracks were observed in the exterior brick veneer. The cracks noted are consistent with the structural settlement of the home. Seal as needed or consult with a qualified brick mason to determine the best method of remedy.

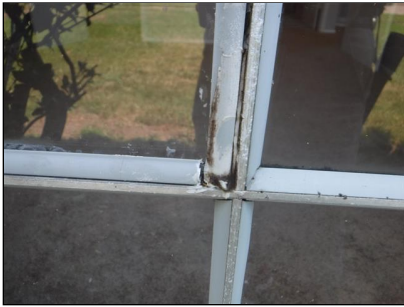
H. Item 3(Picture)

(2) Damaged/missing plastic trim was observed around windows.
Location(s): Multiple Locations

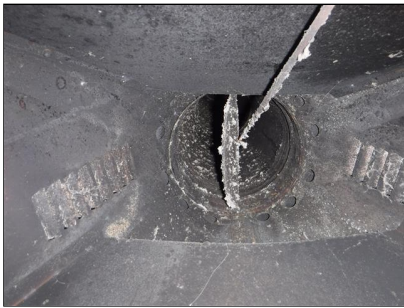
J. Item 1(Picture)

Creosote build up was noted in fireplace and chimney. Cleaning and reinspection by a chimney sweep are needed.

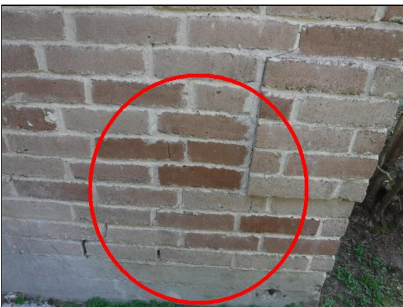
E. Item 2(Picture)

(2) Hairline cracks were observed in the masonry siding. Cracks may be the result of thermal expansion of the veneer and/or normal movement. Monitor and/or seal as needed.

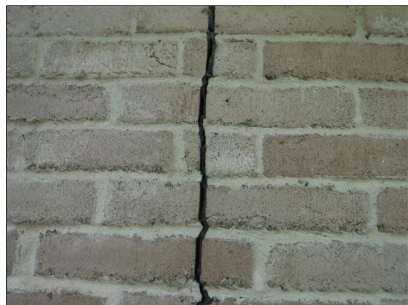
E. Item 4(Picture)

(3) Sealant in the expansion joints around the home is missing and/or deteriorated. Sealing between the brick veneer walls is recommended to prevent moisture and/or pest intrusion.

Location(s): Left Side of Home,

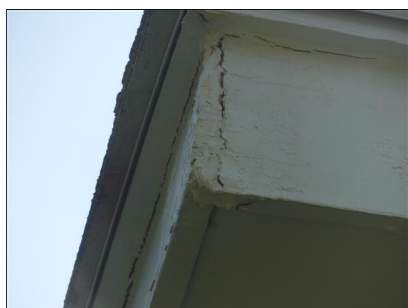
E. Item 6(Picture)

(5) Separation in caulking at trim was observed. Seal as needed to prevent moisture between the trim and siding material.

Location(s): Random Areas

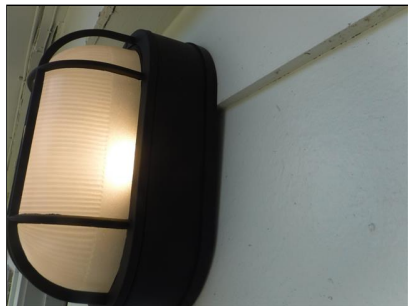
E. Item 10(Picture)

(6) Seal (caulk) the gap between exterior wall mounted light fixtures and the exterior wall to prevent water intrusion.

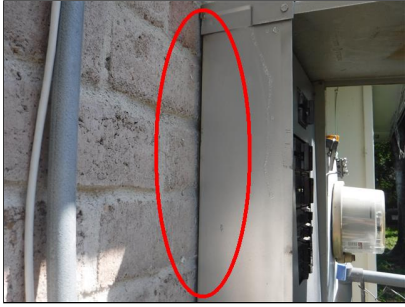
E. Item 11(Picture)

(7) Ensure meter and panel boxes are sealed to exterior wall to prevent moisture and/or pest intrusion.

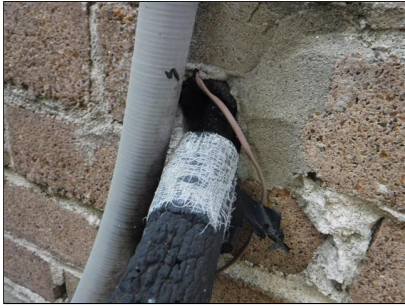
E. Item 13(Picture)

(8) The area in which A/C refrigerant lines enter the building should be sealed to prevent moisture and/or pest intrusion.

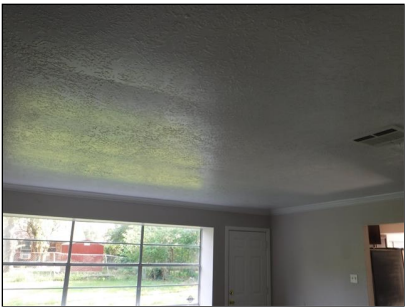
F. Item 3(Picture)

(2) Pillowing/sagging in the drywall ceiling was observed. This is common in older homes due to undersized drywall and/or improper spacing on ceiling joists. This is considered cosmetic. If further evaluation is desired, consult with a qualified contractor.

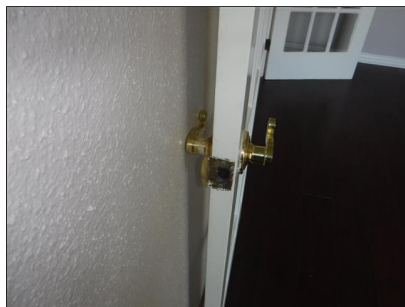
G. Item 2(Picture)

(2) Door stops are missing/need adjustment to prevent doors from hitting other interior components.
Location(s): Multiple Locations

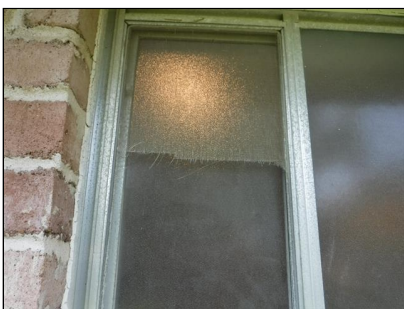
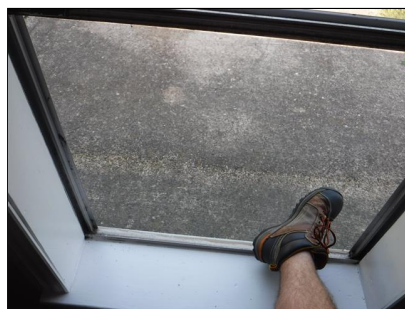
(1) Screens were observed damaged/missing.

Location(s): Multiple Locations

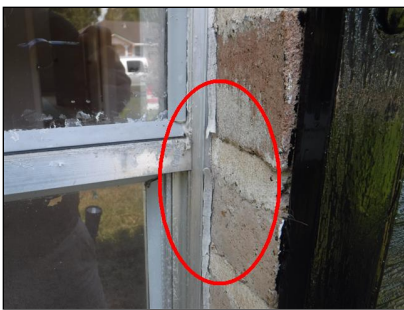
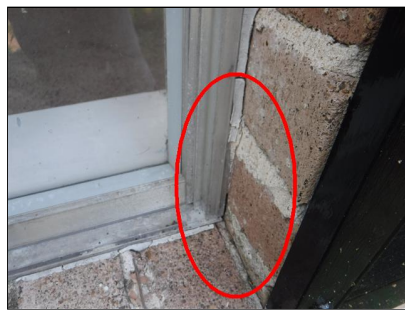
(3) Window caulk is showing signs of deterioration.

Location(s): Multiple Locations

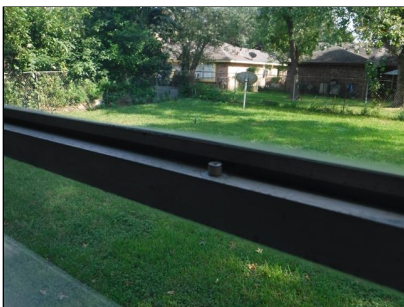
H. Item 9(Picture)

(4) Missing/damaged window latches were observed. Replacement is recommended to properly secure windows.

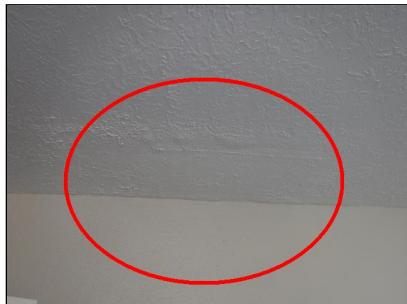
F. Item 1(Picture)

(1) **Note:** Previous repairs were observed at the ceiling. The cause could not be determined. Request any repair documentation and/or explanation from the seller owner for the repair.

Location(s): Random Areas

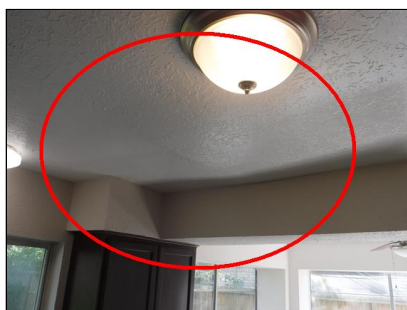
F. Item 5(Picture)

(3) Observed ceiling in the kitchen area to be sagging. Contact a general contractor for correction.

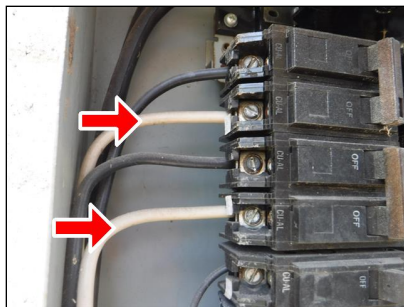
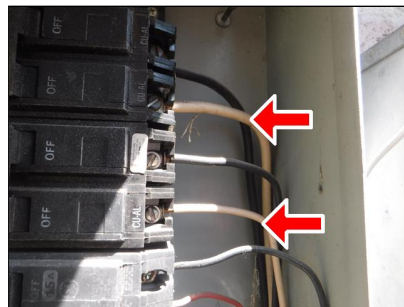
(3) White wires connected to breakers should be marked as hot with black or red electrical tape.

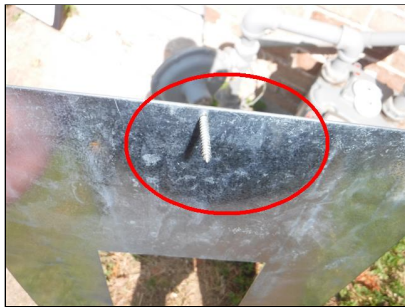
A. Item 5(Picture)

(4) Sharp tipped screws are used on the panel cover (hazard). Blunt tipped screws are recommended to prevent puncturing electrical wiring insulation.

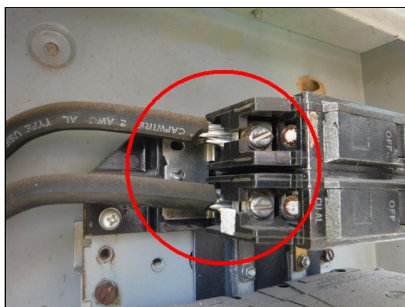
A. Item 6(Picture)

(5) There does not appear to be any antioxidant paste on the aluminum service wires.

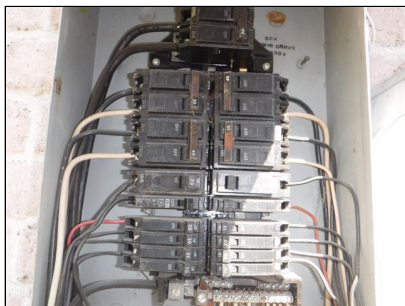
A. Item 8(Picture)

(7) Arc-fault safety protection is not installed for all of the living and bedroom areas. This protection was required by the National Electric code for homes built after 2008. The Texas Real Estate Commission requires inspectors to list as "deficient" any arc-fault protection not installed in these areas; regardless of the homes age.

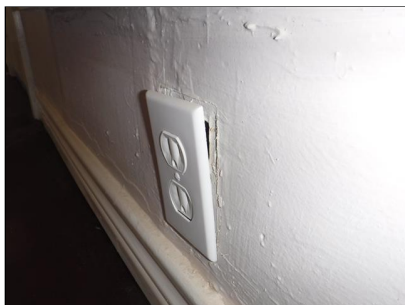
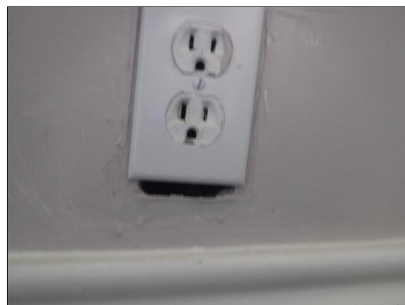
(1) Several outlets in the home are loose in the wall. For safety purposes, recommend evaluation of all outlets to insure they are tight to prevent overheating and electrical hazards.

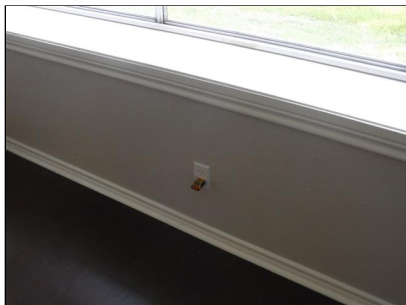
B. Item 4(Picture)

(4) No power was observed to receptacle(s) at the time of inspection. The cause could not be determined. Evaluation by a qualified electrician is recommended.

Location(s): Living Room Master Bath Hall Bath

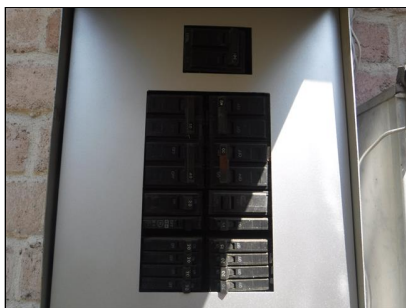
A. Item 7(Picture)

(6) The distribution panel is not properly labeled to identify circuit locations.

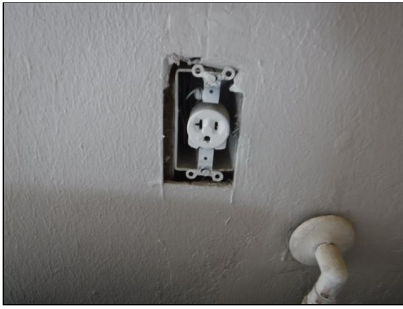
B. Item 3(Picture)

(2) Missing receptacle cover(s) were observed. Installation of covers is recommended for safety.

Location(s): Utility Room

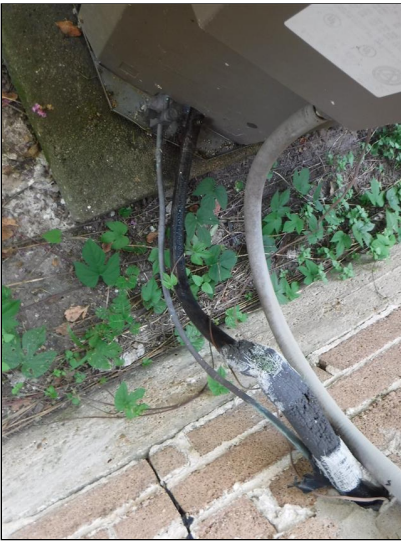
B. Item 2(Picture)

(2) The insulation around the refrigerant line is missing/deteriorated. Replacement of the insulation around the refrigerant line is recommended to prevent condensation build-up and decreased system performance.

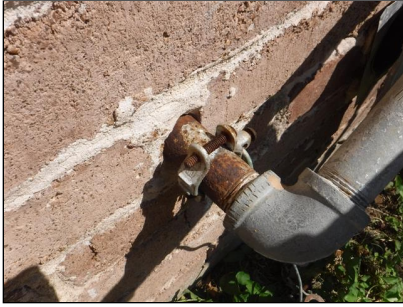
A. Item 1(Picture)

(2) Rusting was observed on the gas service line from the meter into the home. Proper preparation and paint is recommended to prevent further deterioration, or if further evaluation is desired, consult with a qualified plumber.

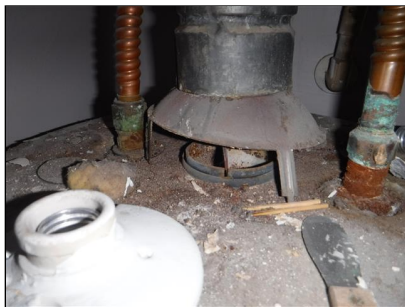
C. Item 3(Picture)

(4) The combustion vent pipe is displaced at the top of the unit preventing proper venting to the exterior of the structure (hazard): remedy as needed.

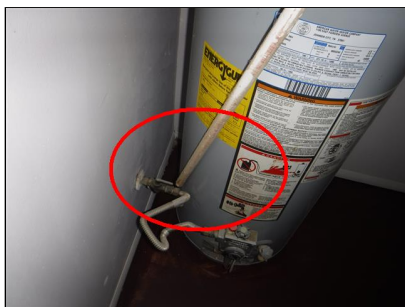
C. Item 4(Picture)

(5) The pressure relief valve drain line is too high. The drain line should terminate 6" above grade for safety.

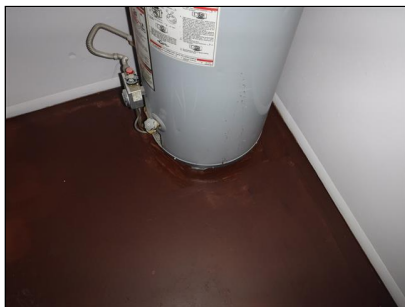
C. Item 5(Picture)

(6) Installation of an emergency overflow pan and proper drain line is recommended under the water heater to prevent damage to interior components in the event of a leak.

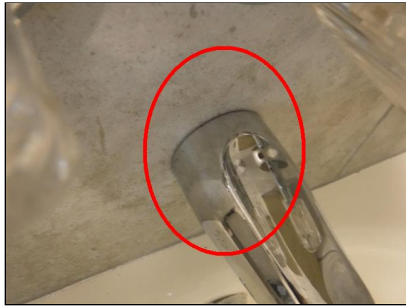
A. Item 2(Picture)

(3) The escutcheon plate(s) and tub spigot are not properly sealed to the wall to prevent moisture intrusion.
Location(s): Master Bath Hall Bath

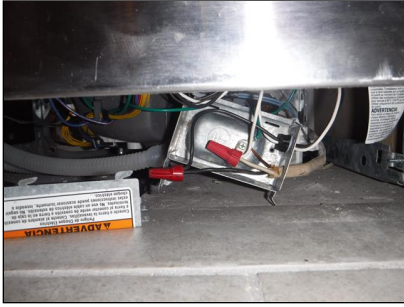
A. Item 1(Picture)

Exposed wire splices were observed at the dishwasher inside the cabinet. The wire splices should be sealed in a junction box for safety.

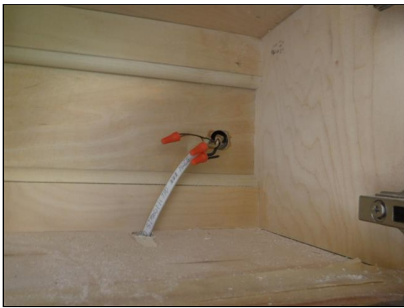
C. Item 1(Picture)

Exposed wire splices should be inside a covered junction box.

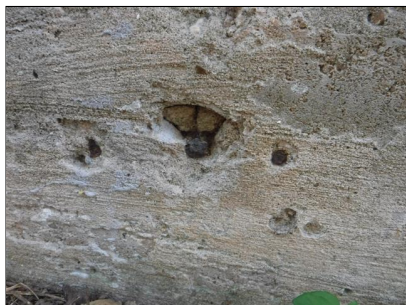
A. Item 1(Picture)

(2) The ends of post tension cables are not properly sealed. Seal these areas to prevent further spalling of surrounding concrete and possible future foundation performance.

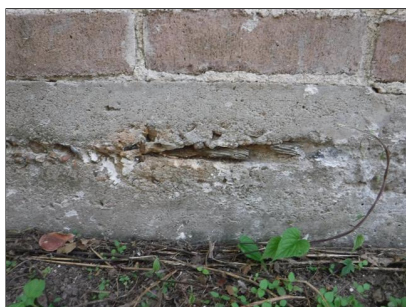
A. Item 3(Picture)

(3) Rebar is exposed along the foundation perimeter. Remedy these areas as needed to prevent further deterioration.

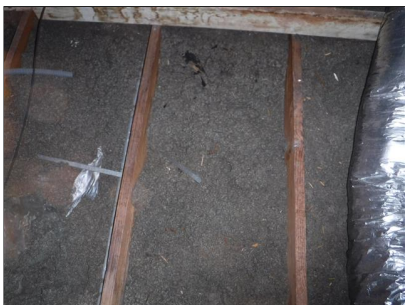
D. Item 2(Picture)

(2) Noted gaps in the blown insulation in several locations in the attic. This may reduce the R value of the insulation system.

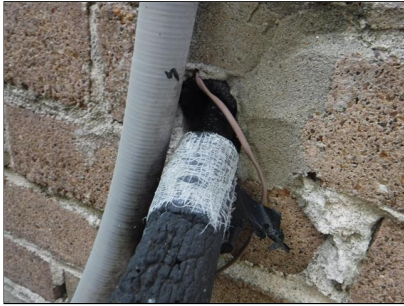
E. Item 13(Picture)

(8) The area in which A/C refrigerant lines enter the building should be sealed to prevent moisture and/or pest intrusion.

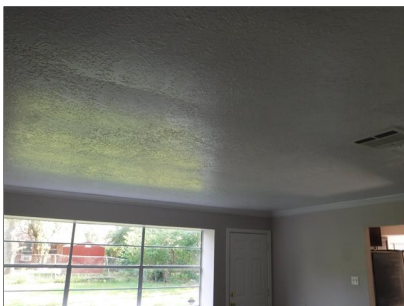
F. Item 3(Picture)

(2) Pillowing/sagging in the drywall ceiling was observed. This is common in older homes due to undersized drywall and/or improper spacing on ceiling joists. This is considered cosmetic. If further evaluation is desired, consult with a qualified contractor.

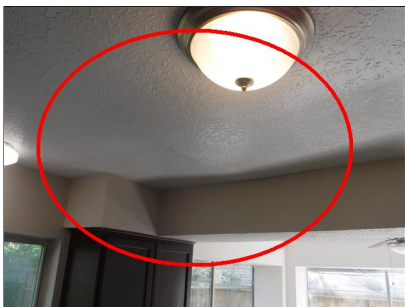
F. Item 5(Picture)

(3) Observed ceiling in the kitchen area to be sagging. Contact a general contractor for correction.

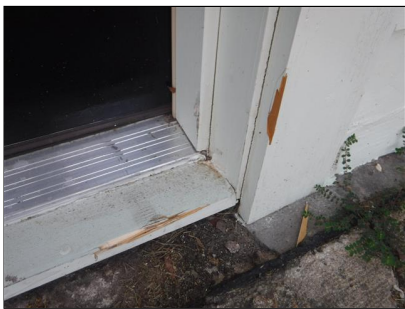
G. Item 1(Picture)

(1) Observed mechanical damage to door frame at front entry of the garage conversion entry.

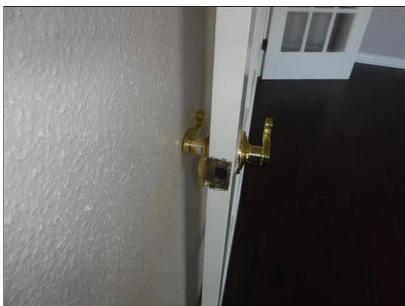
G. Item 2(Picture)

(2) Door stops are missing/need adjustment to prevent doors from hitting other interior components.

Location(s): Multiple Locations

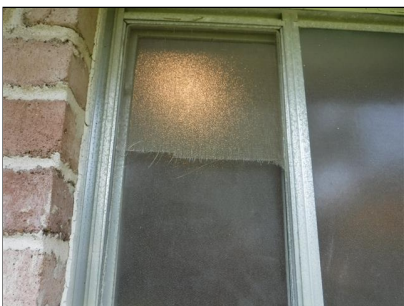
H. Item 1(Picture)

(1) Screens were observed damaged/missing.

Location(s): Multiple Locations

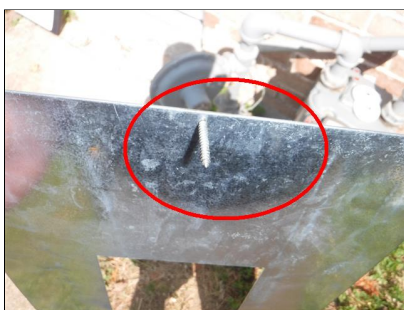
A. Item 5(Picture)

(4) Sharp tipped screws are used on the panel cover (hazard). Blunt tipped screws are recommended to prevent puncturing electrical wiring insulation.

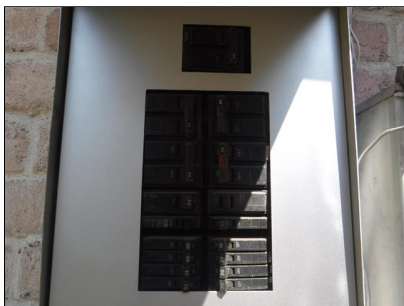
A. Item 7(Picture)

(6) The distribution panel is not properly labeled to identify circuit locations.

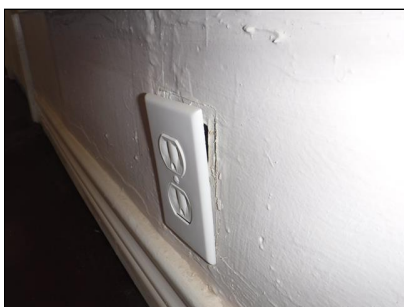
B. Item 1(Picture)

(1) Several outlets in the home are loose in the wall. For safety purposes, recommend evaluation of all outlets to insure they are tight to prevent overheating and electrical hazards.

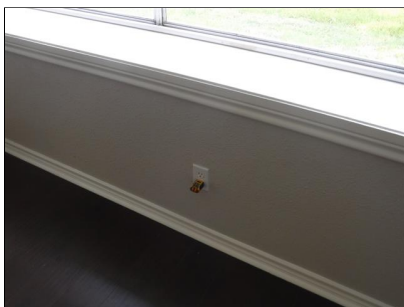
B. Item 4(Picture)

(4) No power was observed to receptacle(s) at the time of inspection. The cause could not be determined. Evaluation by a qualified electrician is recommended.

Location(s): Living Room Master Bath Hall Bath

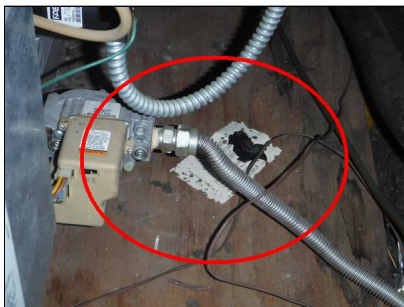
A. Item 2(Picture)

(3) Gas line drip-leg is not installed at the gas branch line (near gas valve) as specified in the manufacturers installation guidelines.

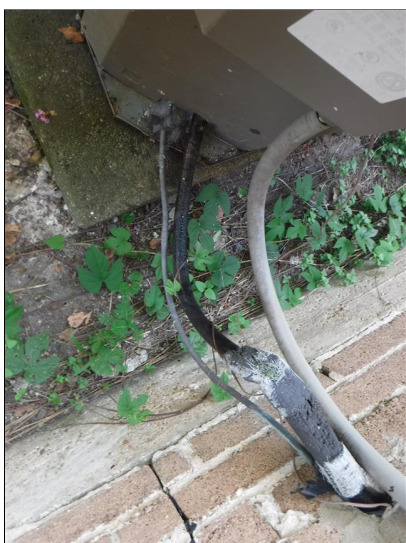
B. Item 2(Picture)

(2) The insulation around the refrigerant line is missing/deteriorated. Replacement of the insulation around the refrigerant line is recommended to prevent condensation build-up and decreased system performance.

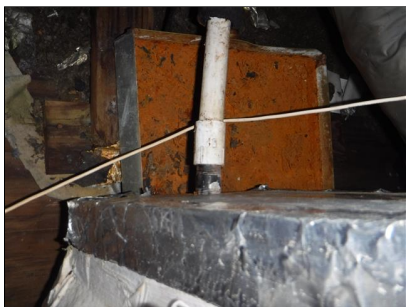
B. Item 4(Picture)

(4) Rusting in the evaporator condensate overflow pan indicates possible blockage of the condensate drain line(s) and a dirty evaporating system: service of the system is recommended.

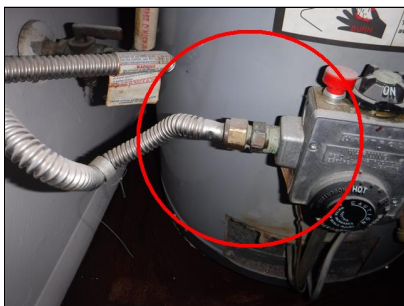
C. Item 2(Picture)

(3) There is no sediment drip leg installed near the gas branch line (before the gas regulator) to catch moisture from the gas line before reaching the gas regulator.

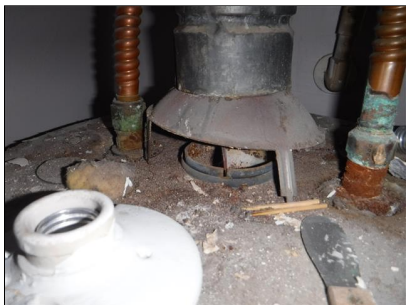
C. Item 3(Picture)

(4) The combustion vent pipe is displaced at the top of the unit preventing proper venting to the exterior of the structure (hazard): remedy as needed.

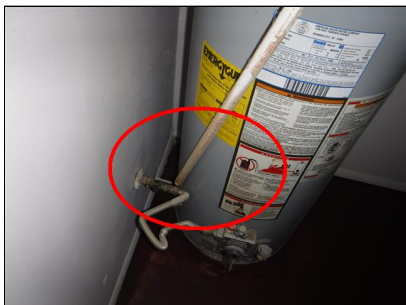
C. Item 4(Picture)

(5) The pressure relief valve drain line is too high. The drain line should terminate 6" above grade for safety.

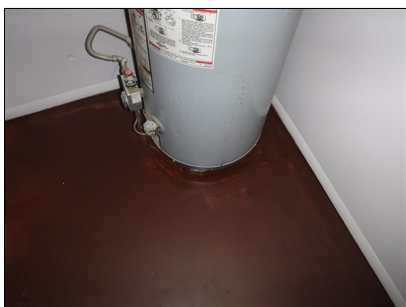
C. Item 5(Picture)

(6) Installation of an emergency overflow pan and proper drain line is recommended under the water heater to prevent damage to interior components in the event of a leak.
