Inspection Report

Property Address:
722 Last Arrow Dr
Houston TX 77079

PROPERTY INSPECTION REPORT

722 Last Arrow Dr, Houston, TX 77079

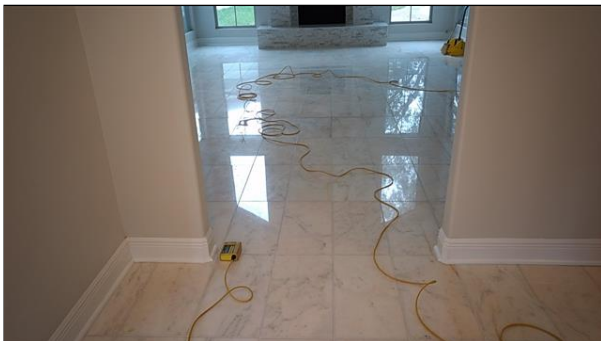
- As is commonly observed with a home of this age and construction some indications of foundation movement were observed. It should be noted that this foundation does have indications of more than average movement. In my opinion these conditions do not represent a failure of the foundation at this time. The future performance of foundation is difficult to predict and other foundation inspectors or foundation experts may from a different opinion when evaluating this foundation. It may be advisable to consult with a foundation specialist before purchasing the home, regarding both its current condition, and the best measure to prevent further movement in the future. Some notable indications of foundation movement observed are cracks in the brick veneer and minor deflection of floor surface.

- A reading of - 0. 8 inches was taken at the southwest corner of the family room. Floor covering tile.
- A reading of - 0. 3 inches was taken at the southwest corner of the home. Floor covering tile.

- A reading of - 0. 1 inches was taken at the southwest corner of the kitchen. Floor covering tile.

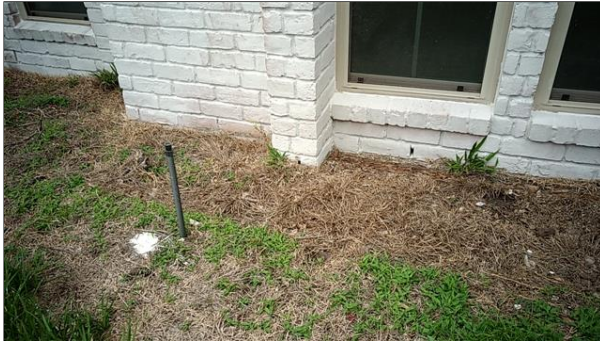
- High soil levels were observed at the foundation walls in various locations. A minimum of four inches of foundation wall should be exposed under the brick veneer and a minimum of six inches of foundation wall should be exposed under the wood surfaces. High soil levels are conducive to wood destroying insect infestation, and possible water penetration into the home. When repaired, the grade should slope downward away from the home directing runoff away from the foundation. Improvements should be undertaken by professional landscaper.

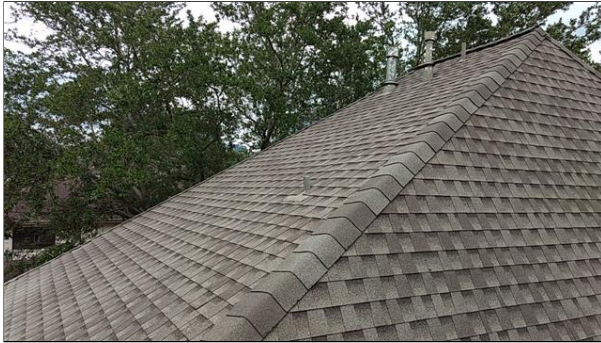
- Rodent damage was observed at the plumbing vent jacks. Repairs will be needed to prevent leakage into the home.

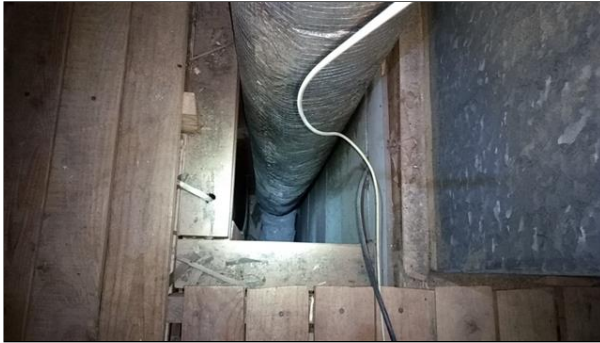
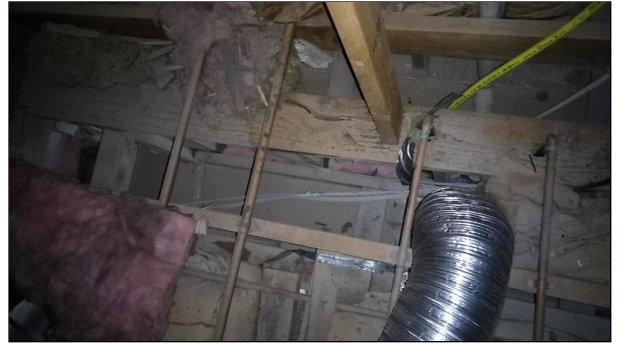
above kitchen

- Open chases were observed in the attic. The open chase expose interior walls to attic temperatures. The chases should be insulated in the attic.

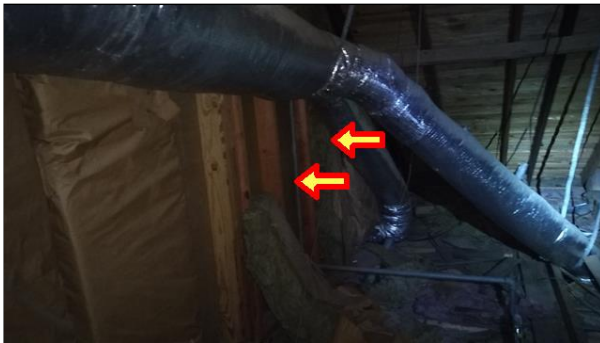
- Vertical insulation in the lower attic has fallen down in some locations. Recommend installing insulation where missing.

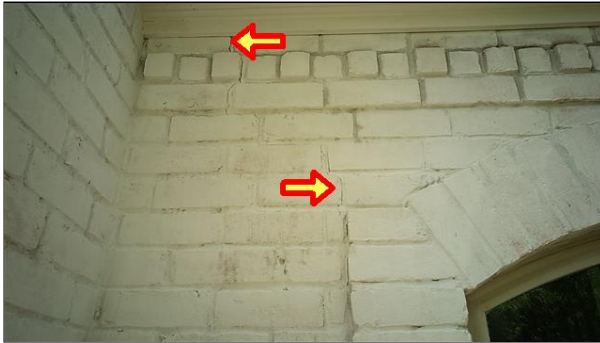
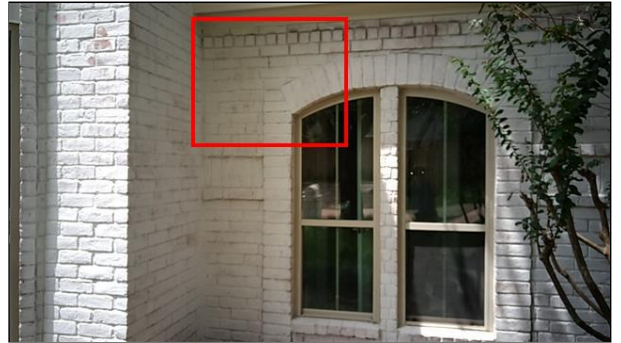
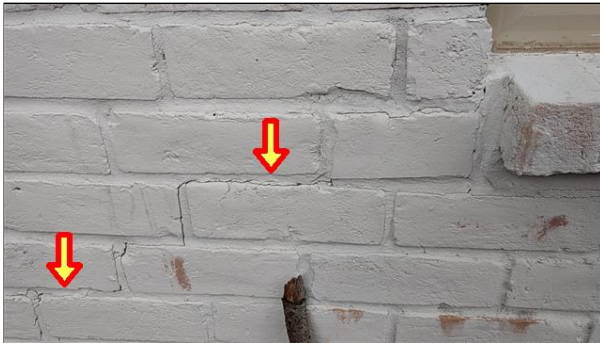
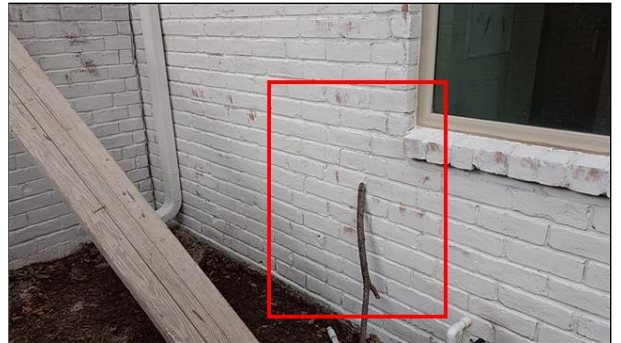
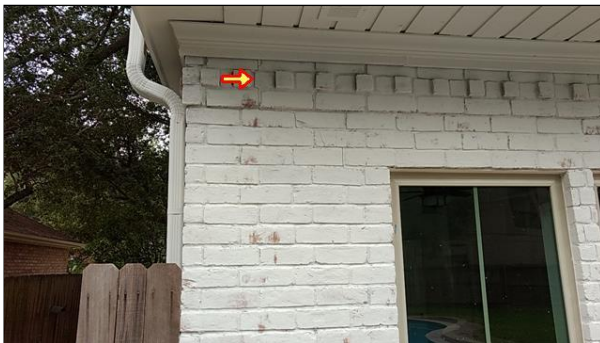
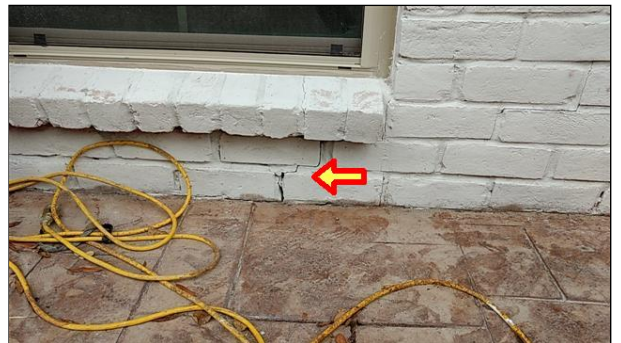
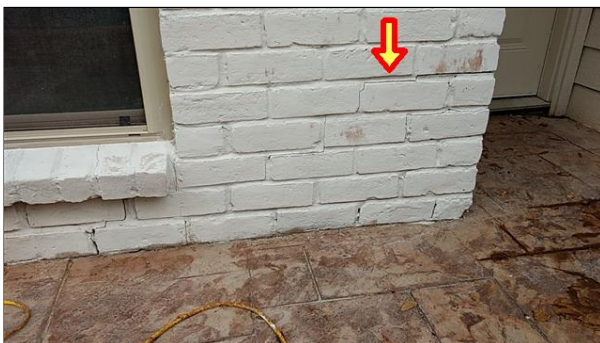
- Masonry (brick / stone / mortar) cracks were observed on the right half of the home. These cracks are likely associated with previous foundation moment.

fixed after addressing the foundation and settlement. All gaps in brick and mortar addressed.

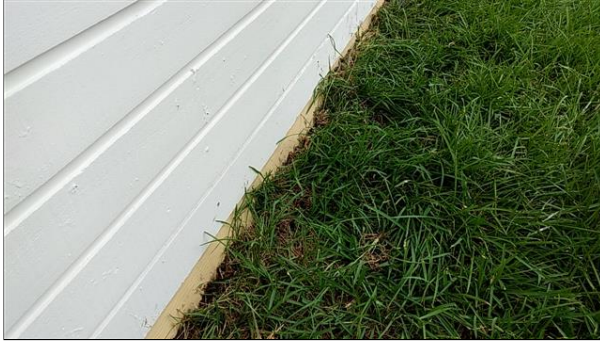
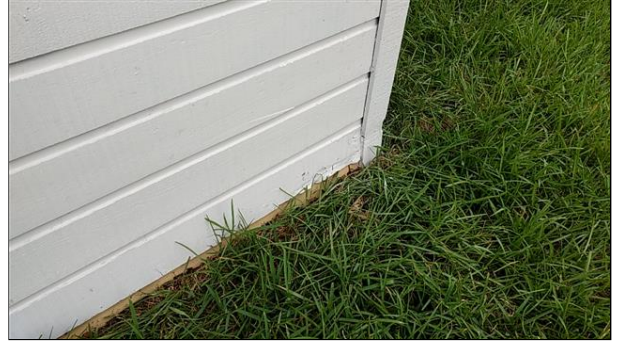
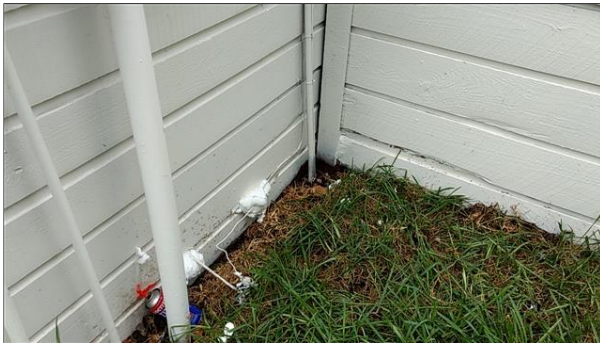
- The at the siding at the garage is. .
- Siding in contact with ground at the garage. Because the siding is in contact with ground it is possible for framing to be deteriorated. We did not inspect behind this siding. Recommend a ground clearance of six to eight inches where possible.

addressed

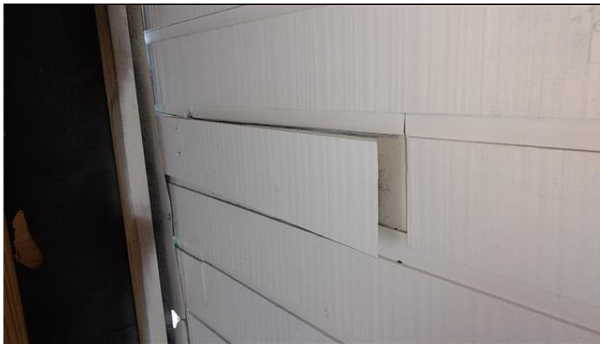
- A loose board on the the siding was observed in the storage shed attached to the rear of the garage.

addressed

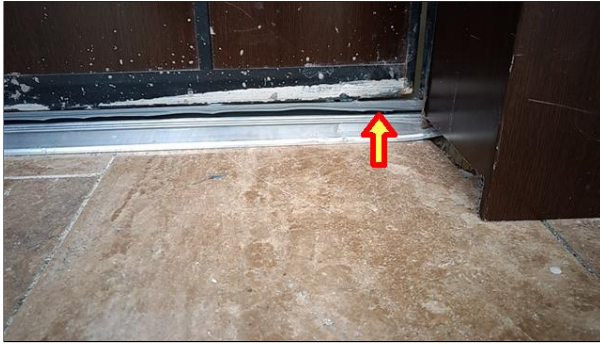
- The exterior door front of the home was observed to have the following deficiencies: binds at the threshold and the rubber threshold seal is loose. The door should be adjusted to function properly.

addressed

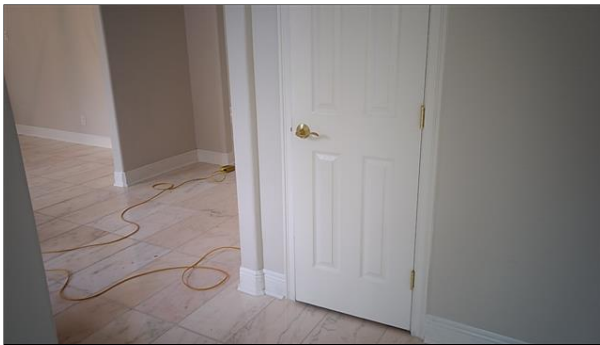
- The interior door in the study and the master water closet has the following defects: door does not latch.

study addressed

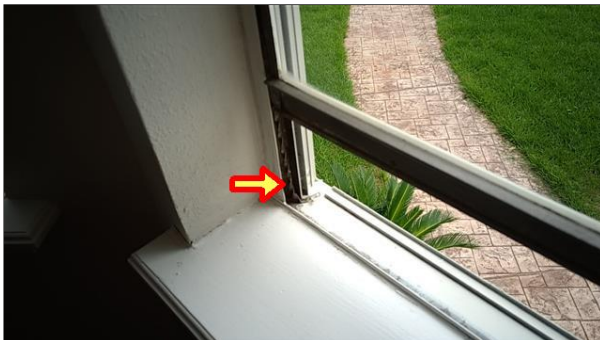
- Loose "sprung" window balancers were observed on at least one window(s) in the front middle bedroom. This affects proper operation of the window.

addressed

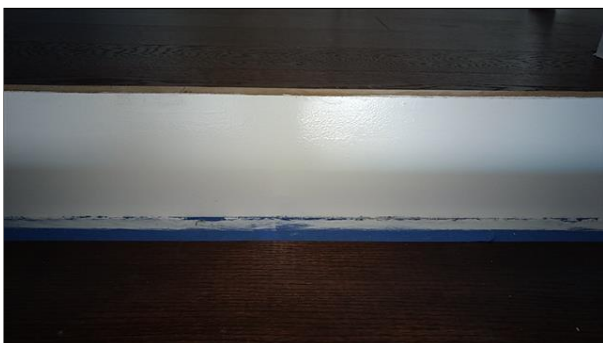
- Top nosing is not installed at the top of the stairs.

addressed

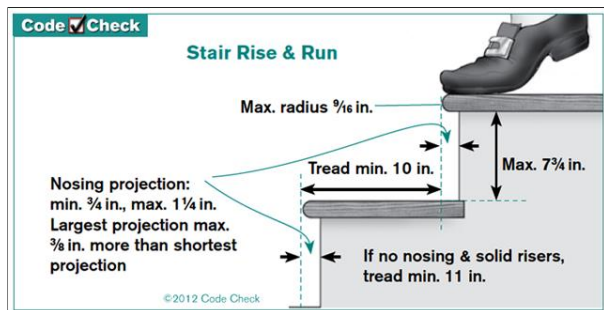
Riser ILLUS

- The stair risers are inconsistent in height at the top of the stairs. Stair defects can be significant safety hazards.

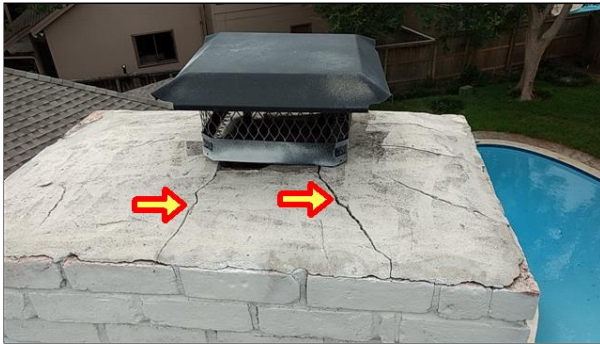
- The masonry fireplace coping is cracked. Repairs are needed to prevent water intrusion.

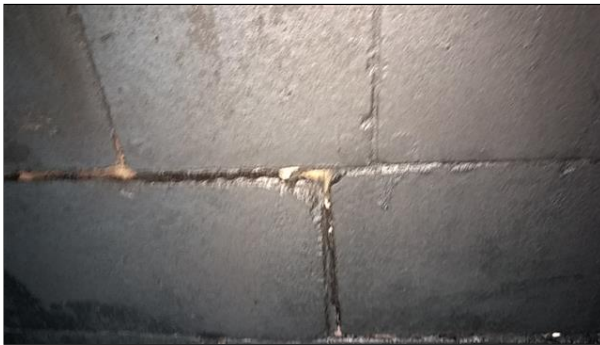
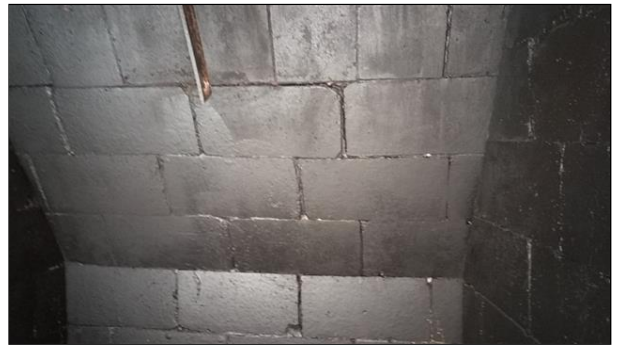
- Gaps in the fire brick were observed. Recommend the fire box should be inspected by a chimney sweep prior to using the fireplace.

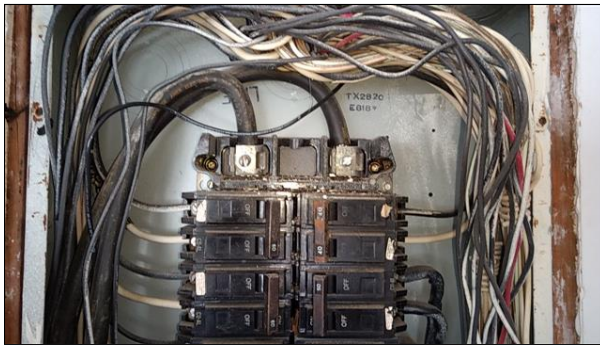
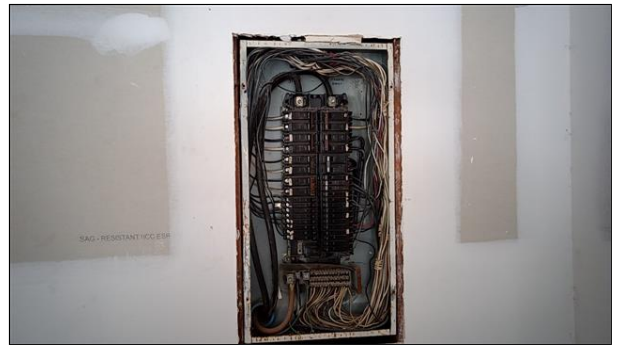
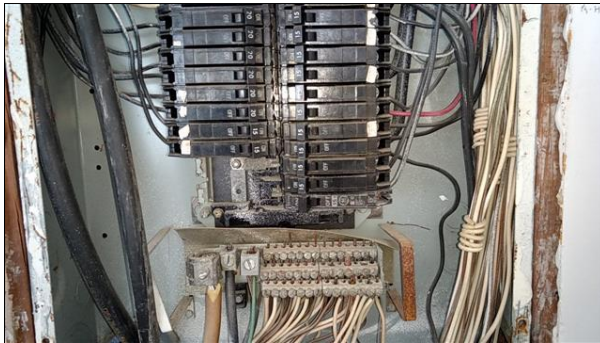
- The main panel enclosure was inspected with the deadfront removed. Conditions needing repair were observed. These repairs should be performed by a licensed electrician. Additional defects may be discovered when inspected by the licensed electrician.

- The main panel enclosure does not have a disconnect or main breaker as currently required.
- The aluminum feeder wires are not coated with anti-oxidant paste to prevent corrosion. addressed
- "Hot" wires terminating at breakers main panel enclosure are improperly colored. These wires should be red or black in color. Marking the wires with a marker is acceptable. addressed

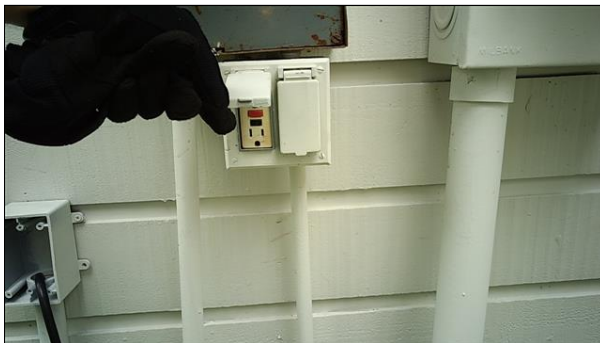
- One ground fault interrupt receptacle(s) exterior of the home shows to have power even after being tripped. Repairs should be undertaken by a licensed electrician.

addressed

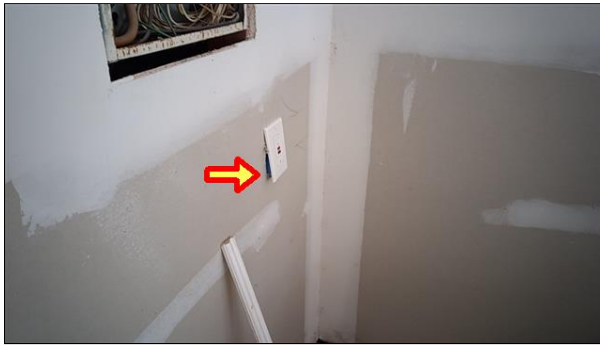
- One electrical junction box(s) in the garage is loose and should be properly secured.

addressed

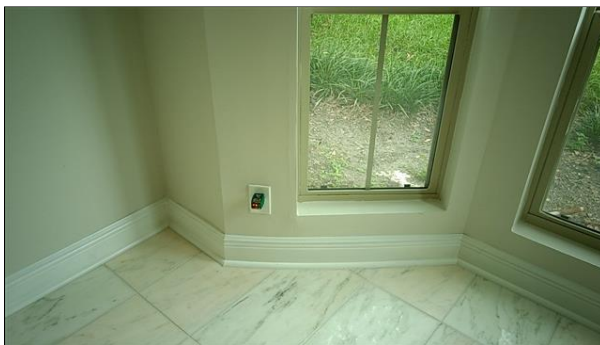
- One receptacle(s) in the study show to have hot/ neutral reversed when tested. Repairs should be performed by licensed electrician.

addressed

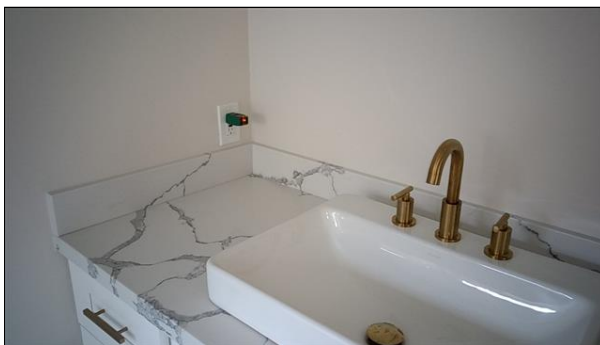
- One receptacle(s) in the master bathroom show to have an open ground when tested. Repairs should be performed by licensed electrician.

addressed

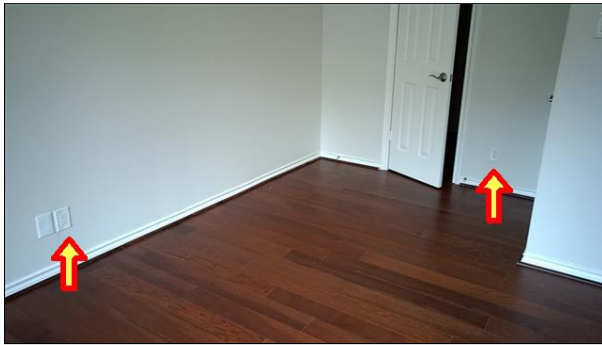
- One receptacle(s) in the second level left front bedroom show to have an open ground when tested and a second receptacle is inoperative. Repairs should be performed by licensed electrician.

addressed

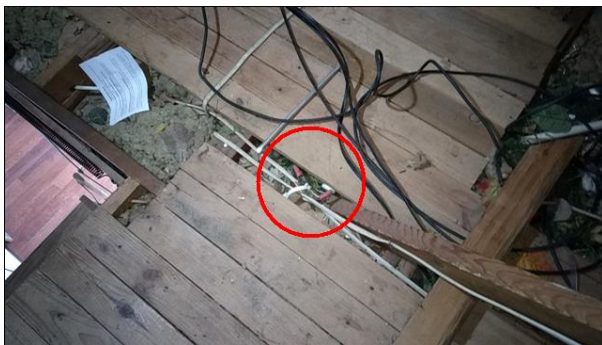
- One open splice in the upper attic space. Repairs should be performed by licensed electrician..

addressed

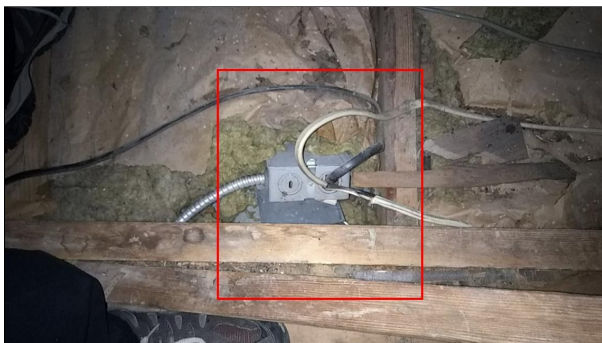
- One electrical junction box(s) in the lower attic is missing a cover and is loose and should be properly secured.

addressed

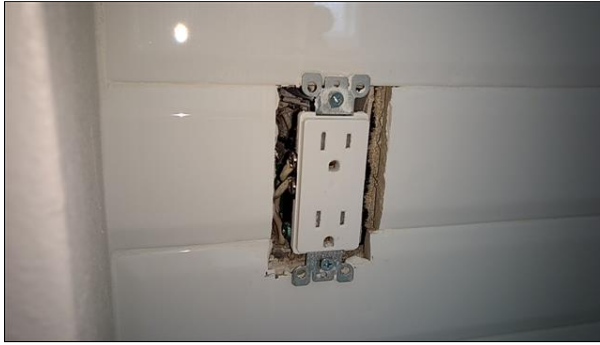
- Junction box extension are needed at the kitchen counters to bring the edge of the junction box flush with the edge of the finished wall surface.

addressed

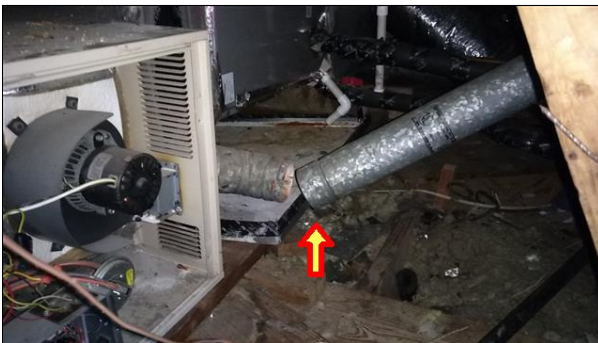
- The gas utility was off at the time of inspection preventing the furnace from being inspected while operating.
- The vent connector is disconnected at the furnace for the first level of home. This condition is a safety hazard that should be corrected.

addressed

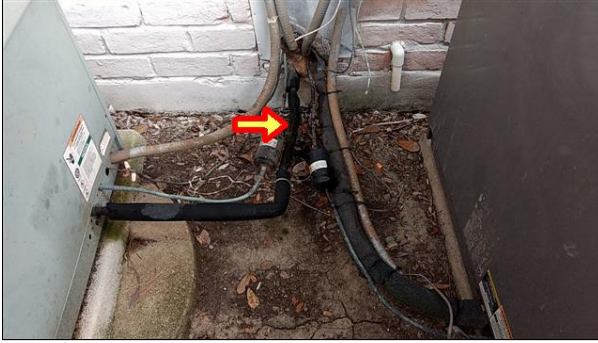
- The insulation at the condensing unit(s) refrigerant line(s) are damaged and they should be replaced.

addressed

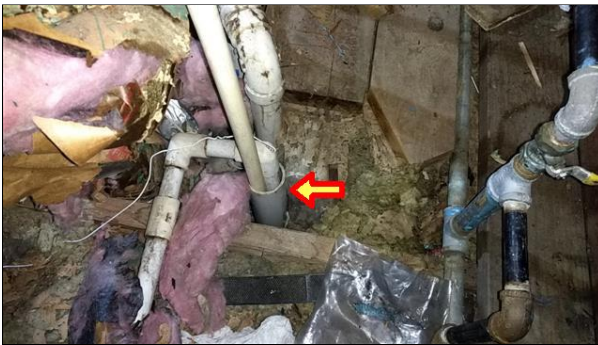
- Two open drain connections at the separate air conditioning condensate drains were observed. If water backs up to this point in the drain, damage to the structure could occur.

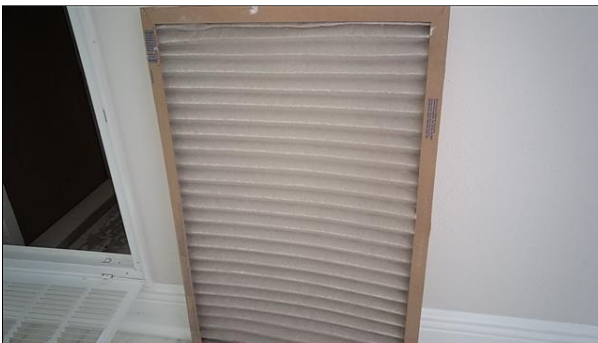
- Air filter(s) are dirty. The filter(s) should be replaced.

addressed

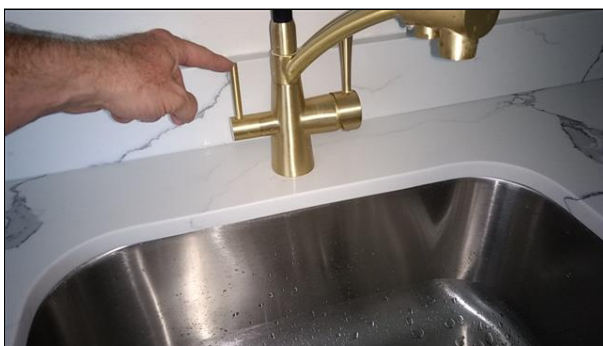
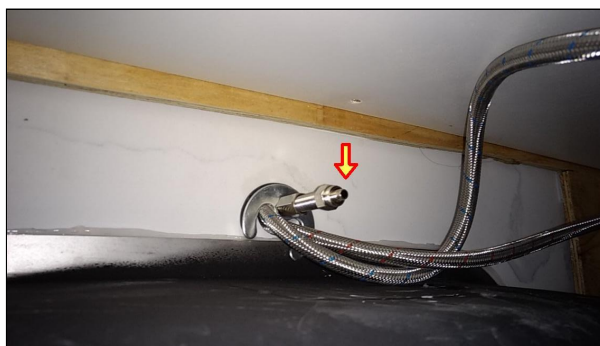
- Installation of the faucet may be incomplete

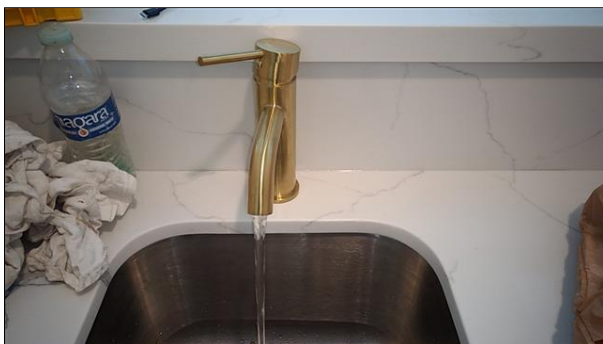
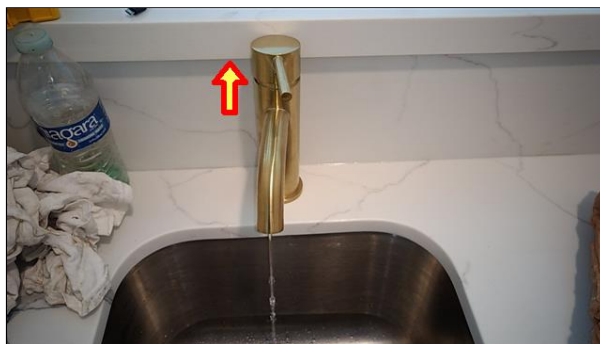
- Countertop ledge interferes with operation of faucet valve

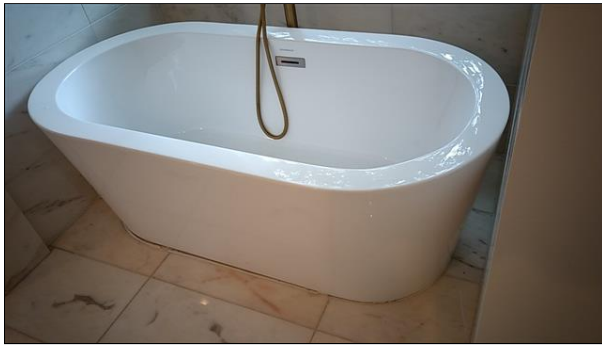
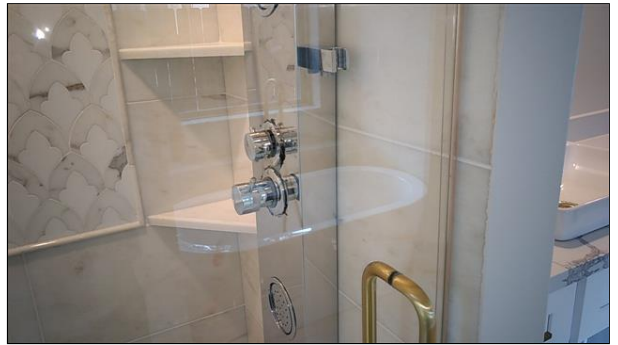
- Bathtub is loose on floor. This should be secured.
- Shower faucet was inoperative and installation was incomplete.

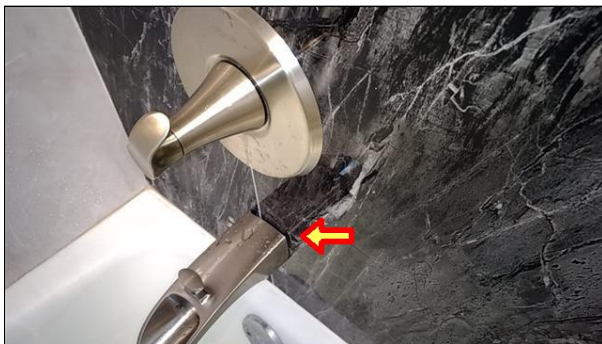
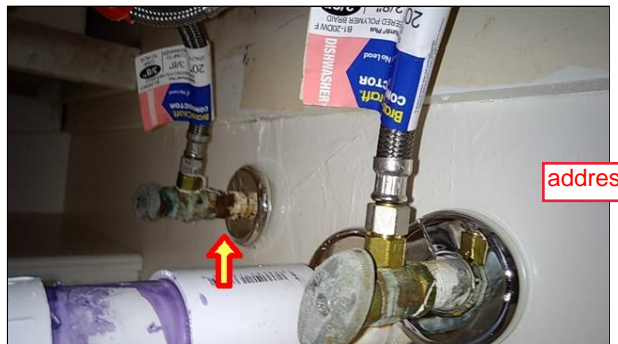
- Caulk / grout improvements are needed at the tub.
- The supply line or valve at the sink is corroded. The wall or cabinet area around the valve should be inspected for water damage.

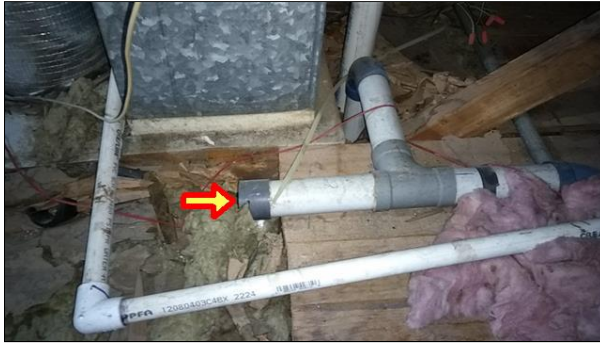
- A plumbing vent near the second level HVAC equipment is not terminated through the roof. Repairs are needed to vent the plumbing to the exterior of the structure.

addressed

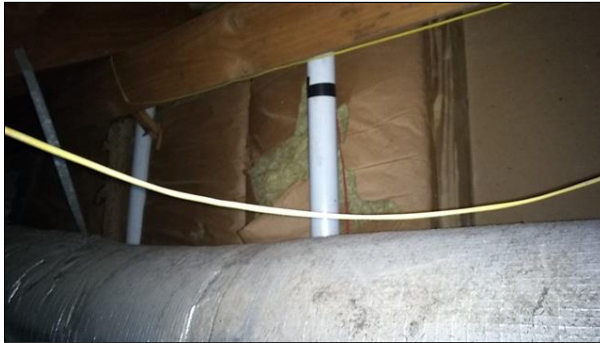
- A plumbing vent in the lower attic above the kitchen is not terminated through the roof. Repairs are needed to vent the plumbing to the exterior of the structure. A section of the vent has been cut out and removed.

addressed

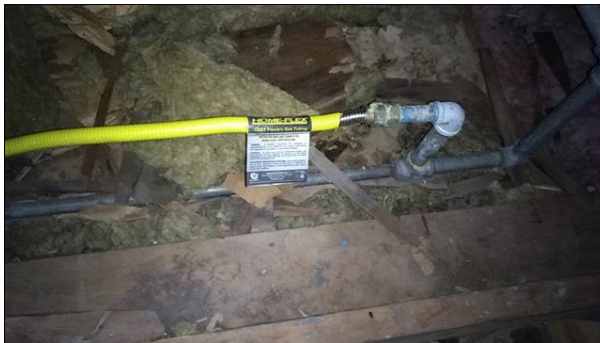
- CSST, corrugated stainless steel tubing, was observed serving as as gas supply piping. This flexible tubing system has specific requirements related to electrical bonding, designed to reduce the potential for lighting related arcing and other electrically related defects that can perforated the tubing and result in gas leaks or fires. At the time of inspection, the CSST could not be verified to be integrally bonded or to have a bonding attachment. A licensed electrician should further evaluate all CSST at this property to assure the presence of a proper electrical bonding path.

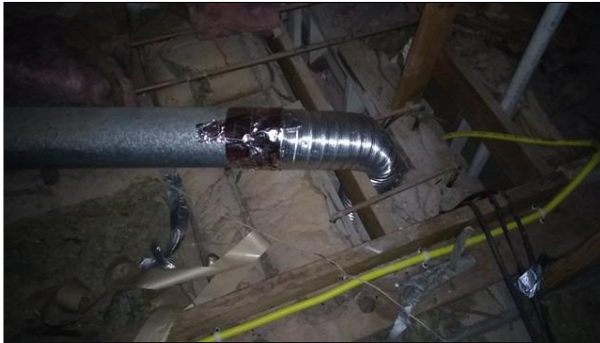
- The range hood vent is constructed of an improper material ,flex duct. The range hood vent should be constructed of rigid metal duct.

addressed

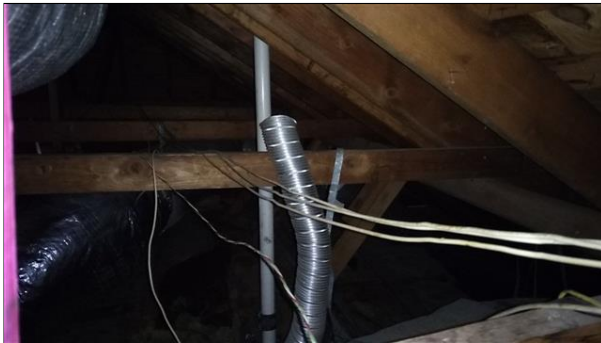
- The exhaust fans were observed to discharge into the attic. Repairs should be undertaken to vent the the exhaust fans to the exterior of the home. Venting of the soffits is not acceptable.

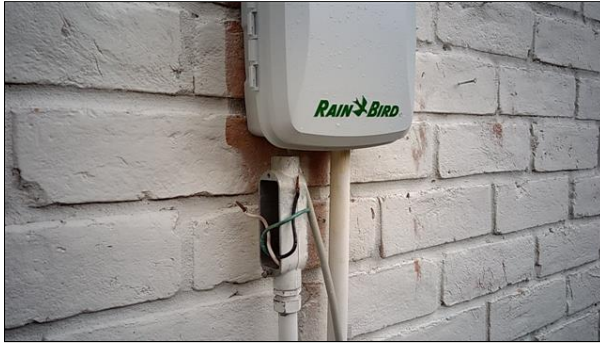
- The sprinkler system was found to be without power and inoperative when attempting to operate the system manually.

addressed
