# Property Inspection Report

1623 Cantrell Blvd,  
Conroe, TX 77301

Cory Alan Haddox, P.E.

Issued: 17 February 2017

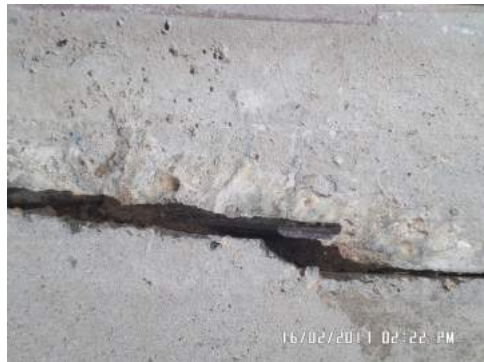
*Photo 1*

1. Exposed reinforcement was noted at the front of the right garage door. See Photo 1.
2. Cracks were found throughout the garage floor. See Photos 2 through 4.
3. A few cracks were observed on the back left of the foundation. See Photo 5.
4. Cracks were noted at the front patio. See Photos 6 and 7.

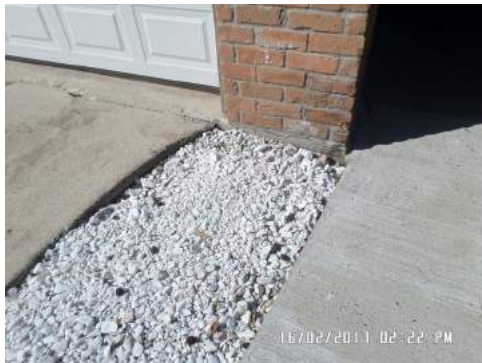
Photo 8

1. The rock landscaping area at the right of the garage was found to be lower than the surrounding concrete. This would not allow water in this area to drain off properly. See Photo 8.
2. To the right of the front entry, a place where the water from the roof was creating a hole in the landscaping was noted. A splash pad is recommended at this location. See Photo 9.
3. The back yard was noted to be graded to drain towards the house. It is recommended that water drain away from a foundation. See Photos 10 and 11.

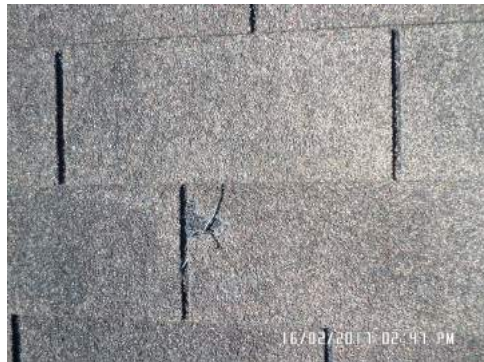
*Photo 12*

1. Some damaged and deteriorated shingles, with exposed and rusted nails, were noted. See Photos 12 through 14.
2. Some of the vents were found to be deteriorated and rusted with exposed and rusted nails. See Photos 15 through 18.
3. Signs of shingle replacement were observed in a few locations. See Photos 19 through 22.
4. The cover for the entry point for the electrical service was noted to be rusted. See Photo 23.
5. The flashing around the chimney was found to be deteriorated and rusted, especially on the top side. As well, the caulk on this flashing was observed to be deteriorated. See Photos 24 through 26.
6. The flashing on the bottom side of the chimney was noted to be painted, however, the nails were found to not be covered with caulk properly. This could allow the nails to rust prematurely. See Photo 27.

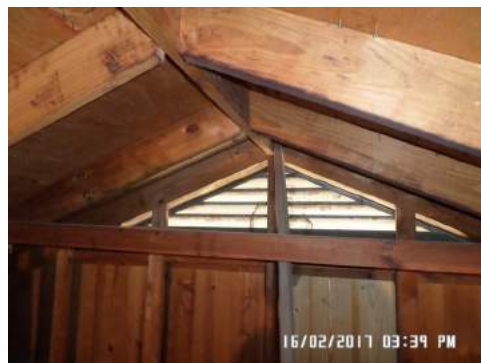
Photo 35

1. The attic temperature was observed to be higher than expected. This is an indication of poor ventilation and insulation. Improvements to the insulation and ventilation could improve the efficiency of the house.
2. The attic ladder was found to be damaged. See Photo 28.
3. The insulation was noted to be missing or out of place in many places throughout the attic. See Photos 29 through 33.
4. Some of the framing was observed to not be secured properly. See Photo 34.
5. The screen on the right louver was found to be damaged. See Photo 35.

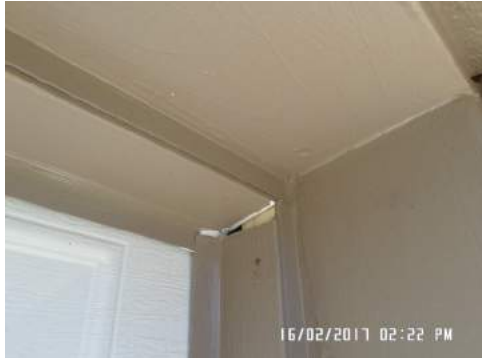
*Photo 36*

1. The trim at the garage door was found to be separated. Some of these separations were found to be filled with expandable foam. See Photos 36 and 37.
2. Several brick and mortar separations and repairs of brick separations were noted on the exterior of the house. See Photos 38 through 49.
3. Some of the bricks were observed to be deteriorated and to have voids in the mortar. See Photos 50 through 54.
4. The tile grout in the guest bathroom was found to be separated. See Photos 55 through 59.
5. A few drywall separations were noted throughout the house. See Photo 60.

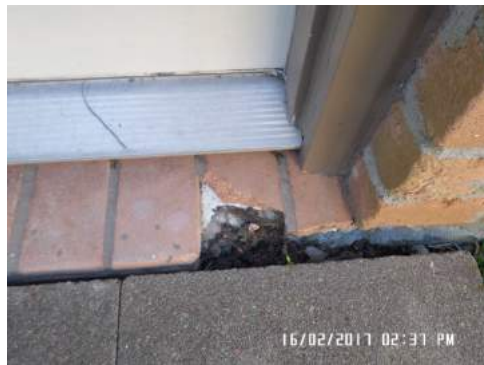
*Photo 61*

1. The tile at the back door was found to be damaged. See Photo 61.
2. A few ceiling drywall separations were noted. See Photos 62 through 65.
3. The area around one of the ceiling vents was observed to have some discoloration and to not be flush with the ceiling. See Photo 65.
4. The ceiling drywall in the garage was found to have some separations. See Photos 66 and 67.

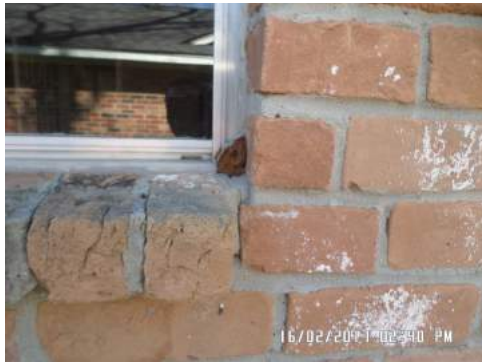
*Photo 68*

1. Screens were noted to be missing from the windows.
2. Expandable foam was found to be used at a window on the right side of the house. See Photo 68.
3. Some of the window seals, although recently replaced, were found to be damaged in a few places. See Photo 69.

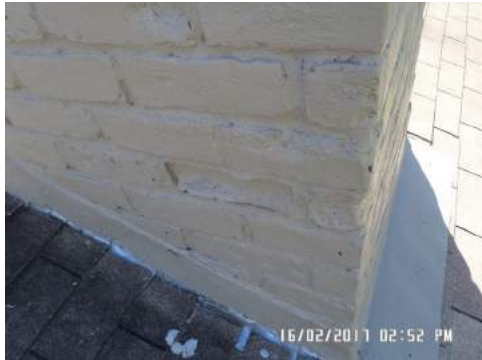
Photo 70

1. The bricks on the chimney were found to be deteriorated and damaged in multiple places. See Photos 70 through 73.
2. The top section of the flue and chimney cap were observed to have been recently replaced. See Photo 74.
3. The mortar chimney cap was noted to be damaged at the corners. See Photos 75 through 77.
4. Debris and rust were found on the inside of the fireplace. See Photos 78 and 79.
5. It is recommended to have the fireplace cleaned and serviced before use.

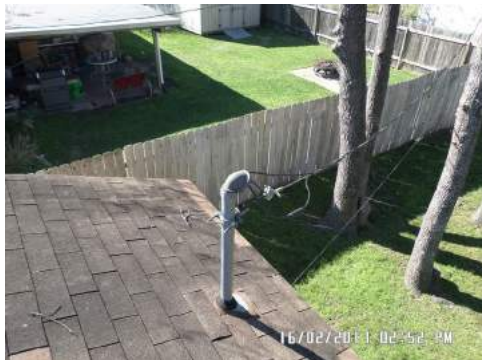
1. The service cables were noted to not have a definite drip loop. See Photo 80 and Drawing 1.
2. Also, the service cables were observed to be lower than expected across the back yard. See Photo 81 and Drawing 2.
3. The meter box was noted to be quite rusted. See Photo 82.
4. This 100 amp panel was found to be Brand Sylvania, most likely original to the house, and was noted to located at the back left corner of the house. See Photo 83.
5. The breakers were observed to not be labeled. See Photo 83.
6. A large amount of pest debris was noted to be built up in the bottom of the panel cabinet. See Photo 84.
7. It is recommended to have the panel, meter box and service cables further evaluated by a qualified electrician.

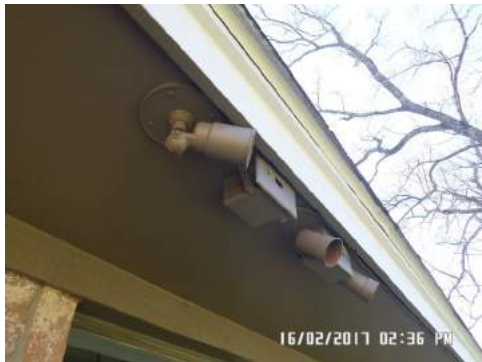
Photo 85

2. Light fixtures were found at the back of the house. These fixtures did not have bulbs, and appeared to not be in use. As well, a switch cover was observed to be covering one of the junction boxes, however, no switch was found in the box. The remaining opening could allow water into the box. See Photo 85.

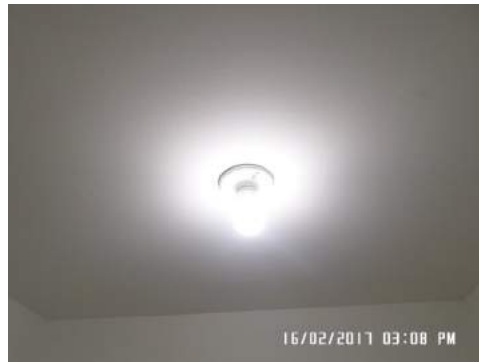
Photo 86

4. An uncovered incandescent light fixture was found in the front middle bedroom clothes closets. This could be a safety hazard. See Photo 86.
5. The ceiling fan in the front middle bedroom was noted to not be secured to the ceiling properly. See Photo 87.

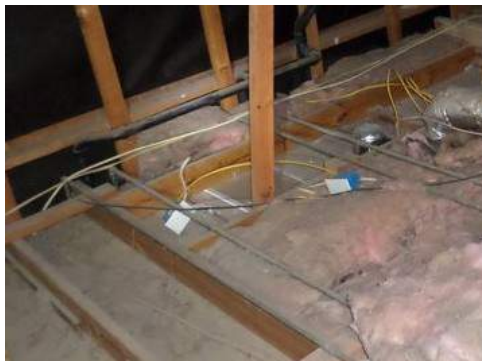
*Photo 91*

10. Junction boxes in the attic were found to not be secured to the framing properly. See Photo 91.

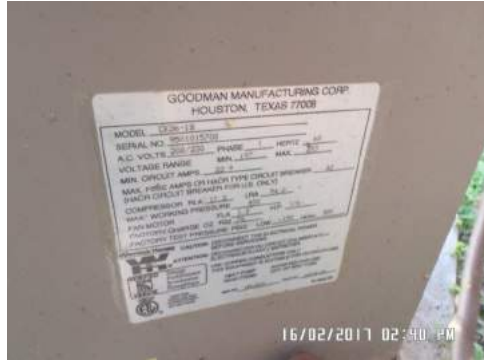
Photo 92

1. The exterior AC unit was observed to have been manufactured in 1995. See Photo 92.
2. Rust was noted on top of the exterior AC unit. See Photo 93.
3. Interior electrical cables were found to used to power the exterior AC unit. Exterior cabling should be used, or interior cabling should be shielded. See Photo 94.
4. Some rust was observed to be in the overflow pan under the AC unit in the attic. See Photo 95.
5. It is recommended that both the heating and cooling systems be serviced before use and annually thereafter.

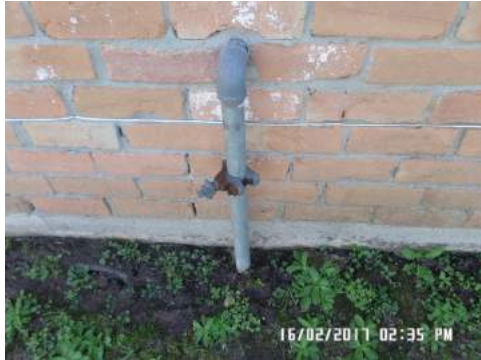
Photo 98

1. No shut off valve was found for the gas supply system. This could be a safety hazard.
2. The gas supply system was observed to not be bonded. See Photos 98 through 100.
3. The guest bathroom toilet valve was noted to be corroded. See Photo 101.

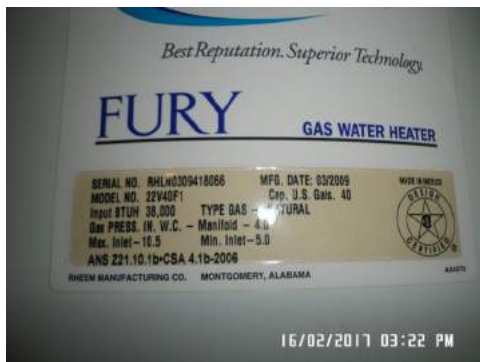
Photo 102

1. The water heater was found to have been manufactured in 2009. The life expectancy of a typical gas water heater is 9 to 12 years. See Photo 102.
2. The piping at the temperature and pressure relief valve was observed to be corroded. See Photo 103.
3. As well, one of the pipe connections on the top of the heater was noted to be corroded. See Photo 104.
