YOUR INSPECTION REPORT

406 Colchester Ln
League City, TX 77573

INSPECTION DATE:
Thursday, January 18, 2018

BRYAN & BRYAN
INSPECTIONS
281.484.8318 ♥ InspectorTeam.com

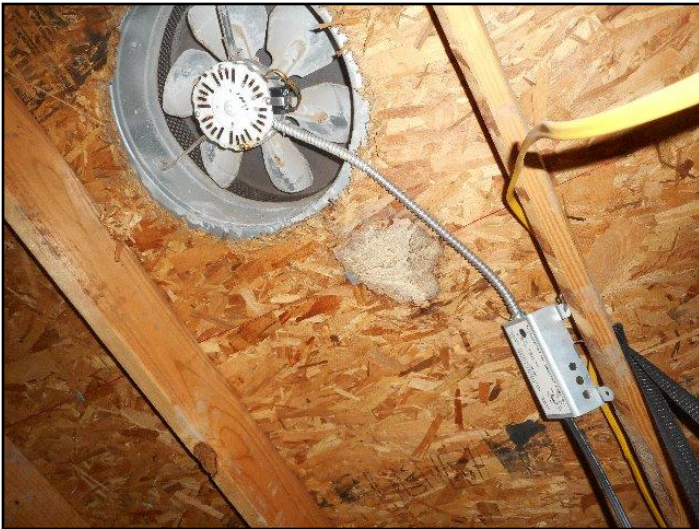
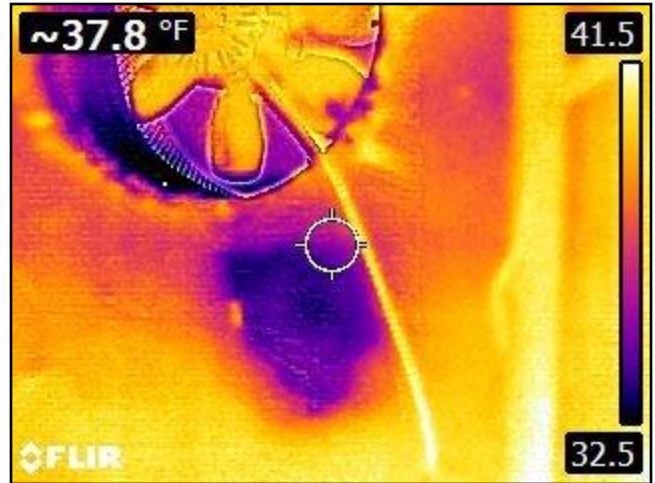
2. **Condition:** • There is evidence of active moisture on roof decking under attic fan. Recommend evaluation and repair costs estimates by a roofer.

Task: Evaluate and remedy as needed

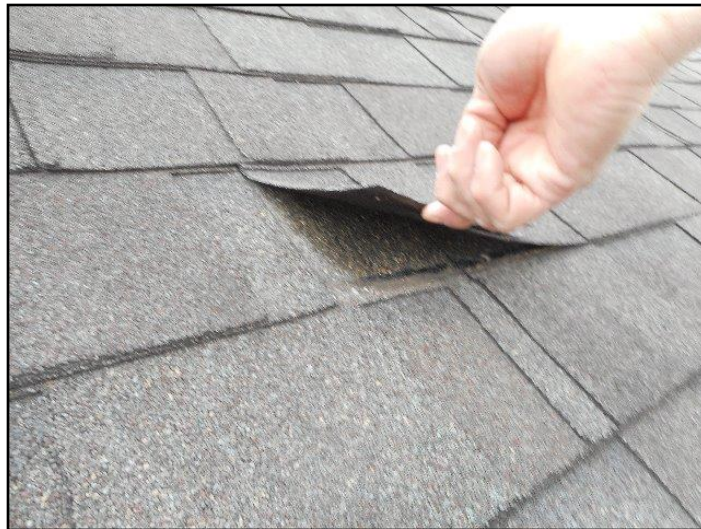
3. **Condition:** • Adhesive strips not fully bonded

Note: Shingles with this condition can be vulnerable to wind uplift

Adhesive strips not fully bonded Note:...

Task: Remedy as needed

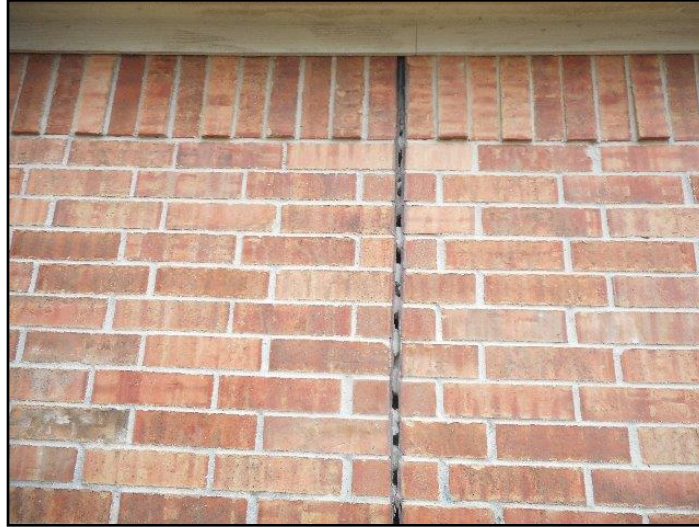
4. Condition: • Sealant in the expansion joints has deteriorated

Sealant in the expansion joints has...

Task: Remedy as needed

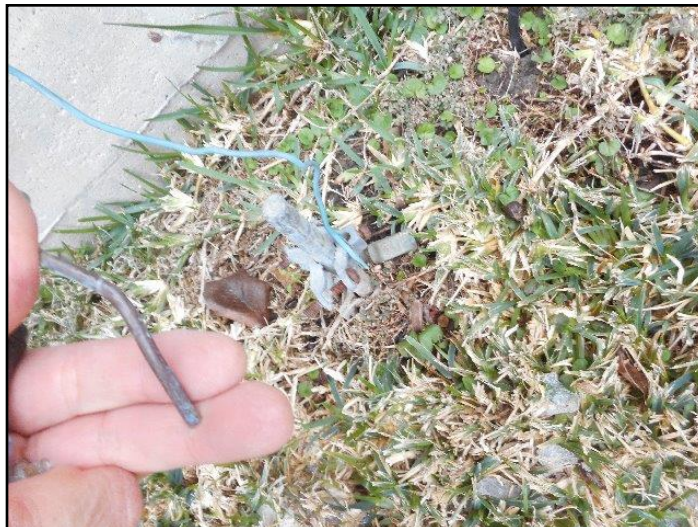
6. Condition: • Ground wire is not properly secured to grounding rod

Ground wire is not properly secured to...

Task: Remedy as needed

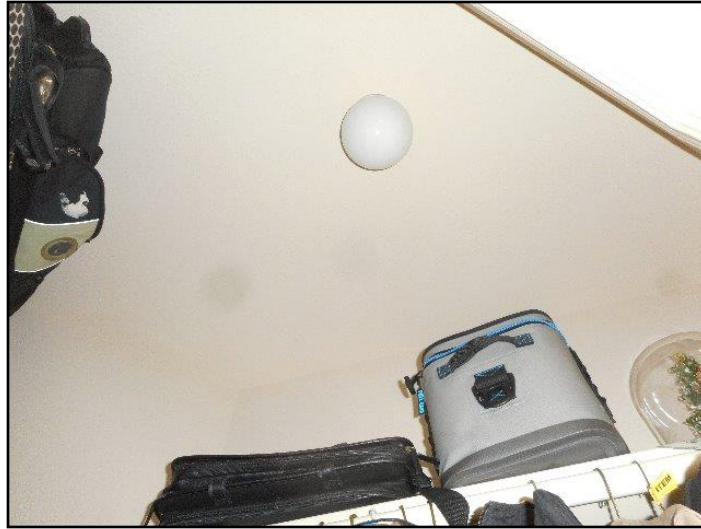
8. Condition: • [Inoperative](#)

Implication(s): Inadequate lighting

Location: office closet

Inoperative

Task: Remedy as needed

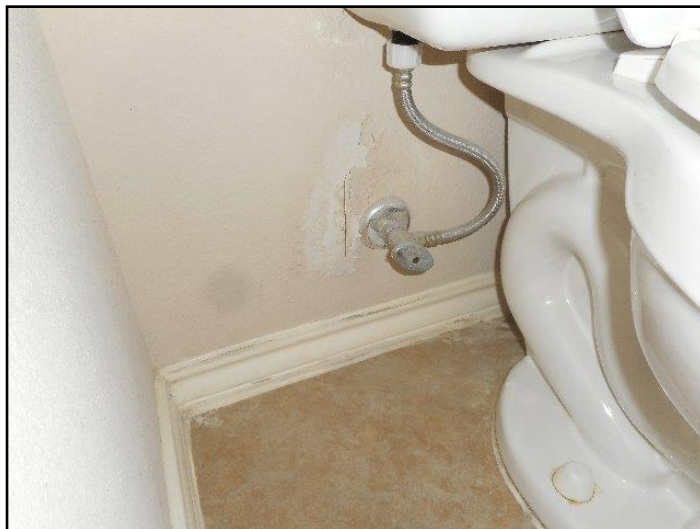
12. Condition: • There is evidence of prior moisture contact on wall behind master toilet. No moisture was detected at time of inspection.

Task: Remedy as needed

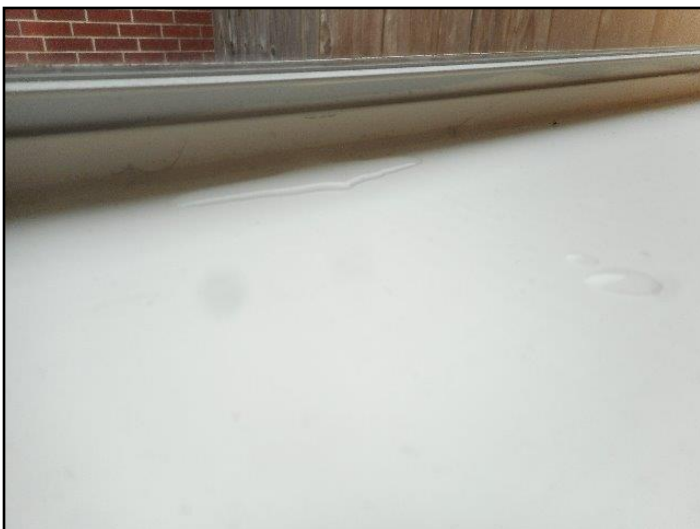
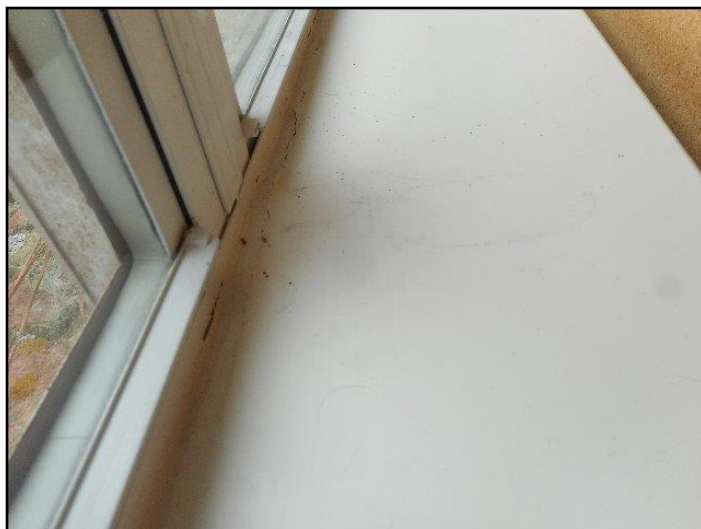
13. Condition: • Note: Water stains observed on the window sill. This is typically caused by condensate build up on metal frames or single pane glass, and is not generally due to window leaks. Keeping the sill painted will protect it.

Note: Water stains observed on the window...

Task: Monitor

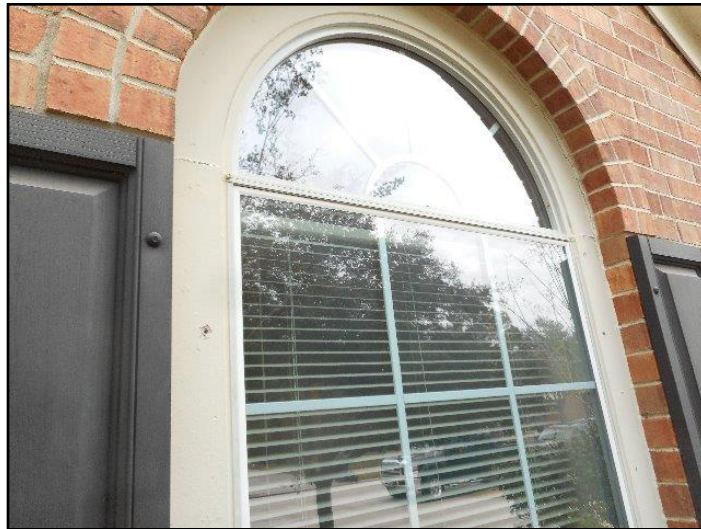
14. Condition: • The low-e coating inside the window shows signs of deterioration.

Note: This condition affects window clarity (it can appear as streaks on the glass or as bronze colored flecks) and can be indicative of a failed seal.

The low-e coating inside the window shows...

Task: Remedy as needed

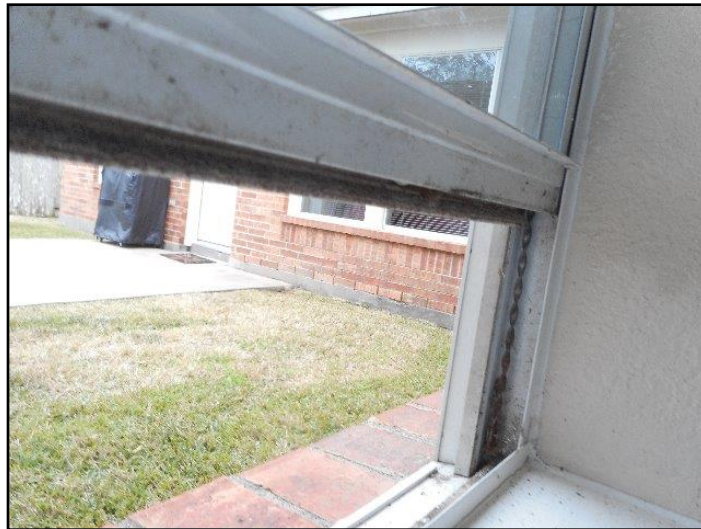
15. Condition: • Detached window guide spring/balance

Location: Master Bedroom

Detached window guide spring/balance

Task: Remedy as needed

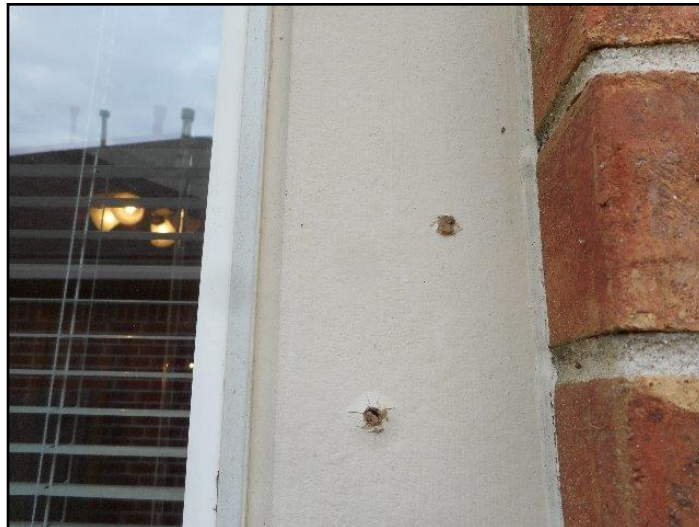
17. Condition: • Storm shutter bolt holes should be sealed to prevent moisture penetration.

Task: Remedy as needed

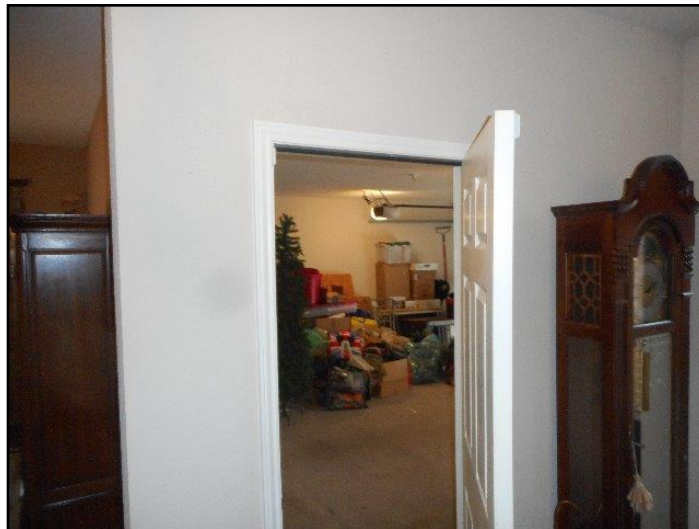
18. Condition: • Self closing hinges do not shut door

Self closing hinges do not shut door

Task: Remedy as needed
