TEXAS REAL ESTATE CONSUMER NOTICE CONCERNING HAZARDS OR DEFICIENCIES

Joseph and Cara Stogner, 3318 S. Lake Village Drive, Katy, TX 77450

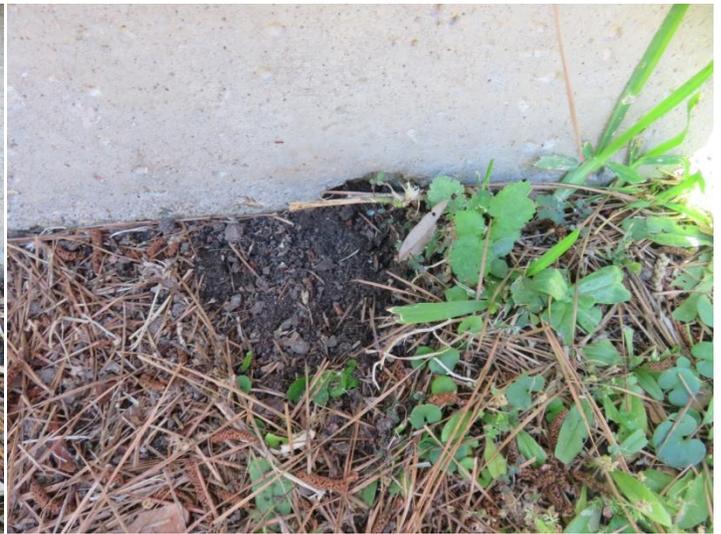
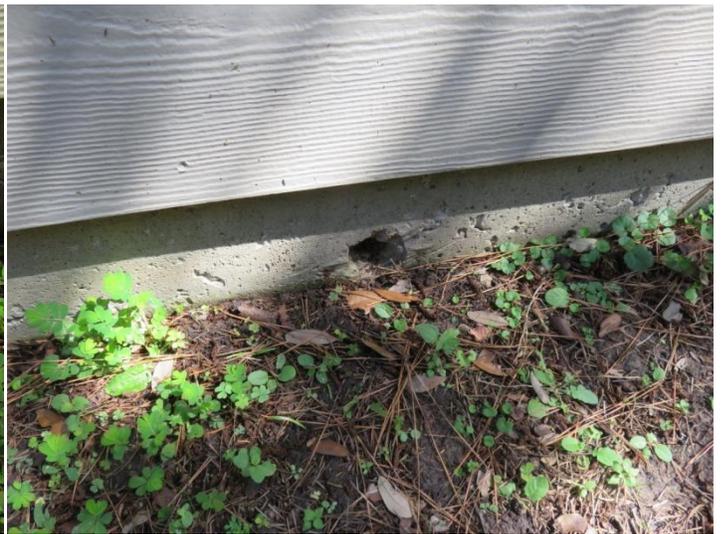
Examples at the rear and side of the garage (4) and at the right rear corner/right side of the home (3)

- Post tension foundation cable ends about the home are exposed. Allowing these cable ends to remain exposed to moisture and weather elements could eventually cause the cable to weaken and possibly lose strength. Evaluation by a professional foundation contractor familiar with decay of post tensions cables may be required. All exposed cable ends should be properly covered/protected to prevent further deterioration.

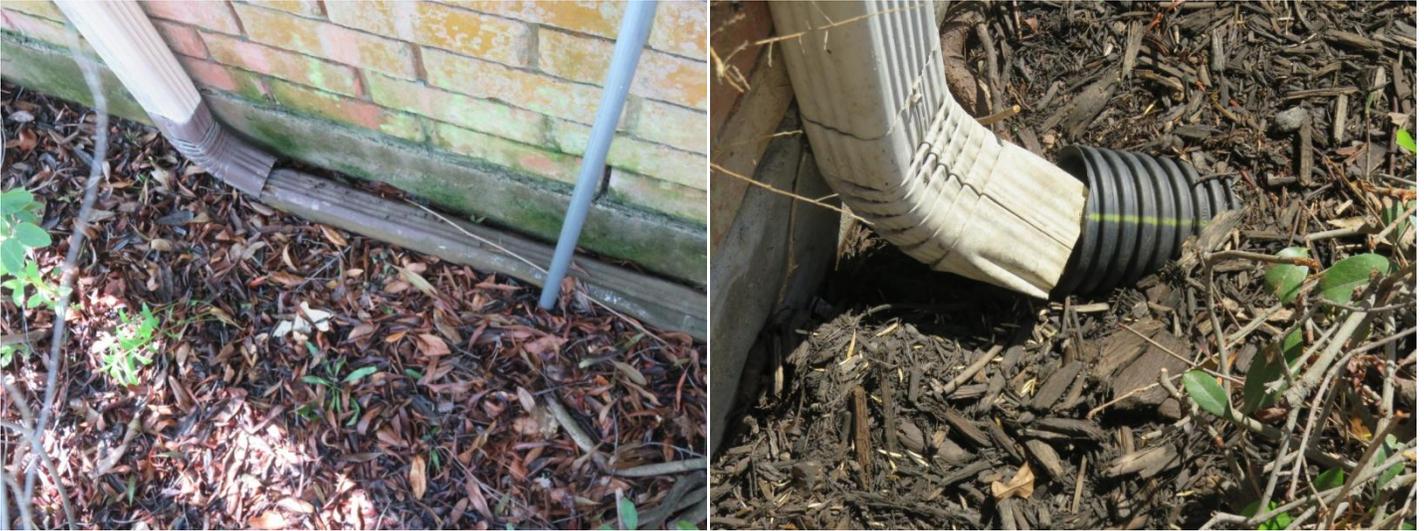
➤ At the area adjacent to the rear deck drainage requires improvement.

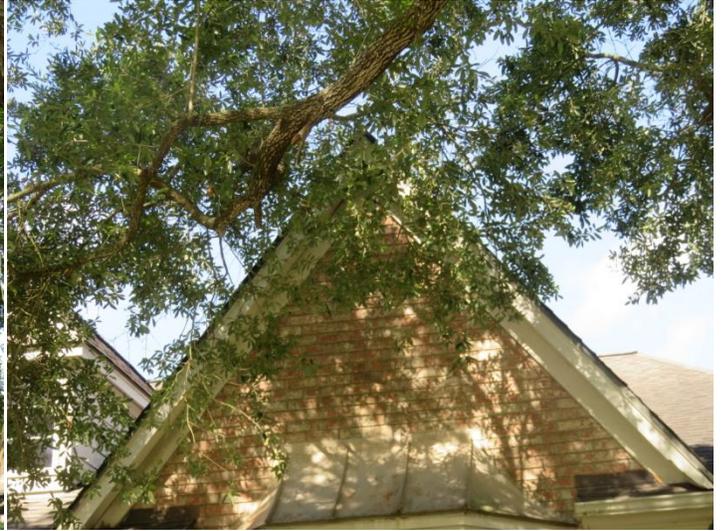
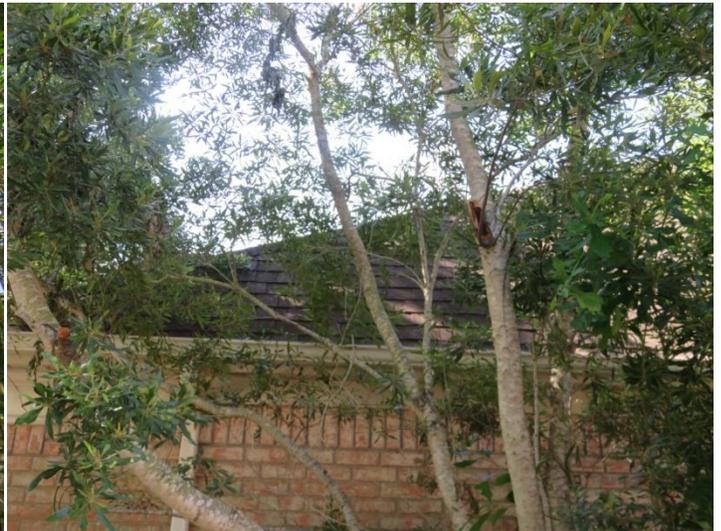
Examples

- Trees are too close to the home and foundation. Branches raking across wall and roof surfaces can damage these areas. Roots in close proximity to the home and foundation can cause the foundation to fail due to their thirst for water in the areas. A landscaping professional should be engaged to evaluate and suggest remedies to these issues.

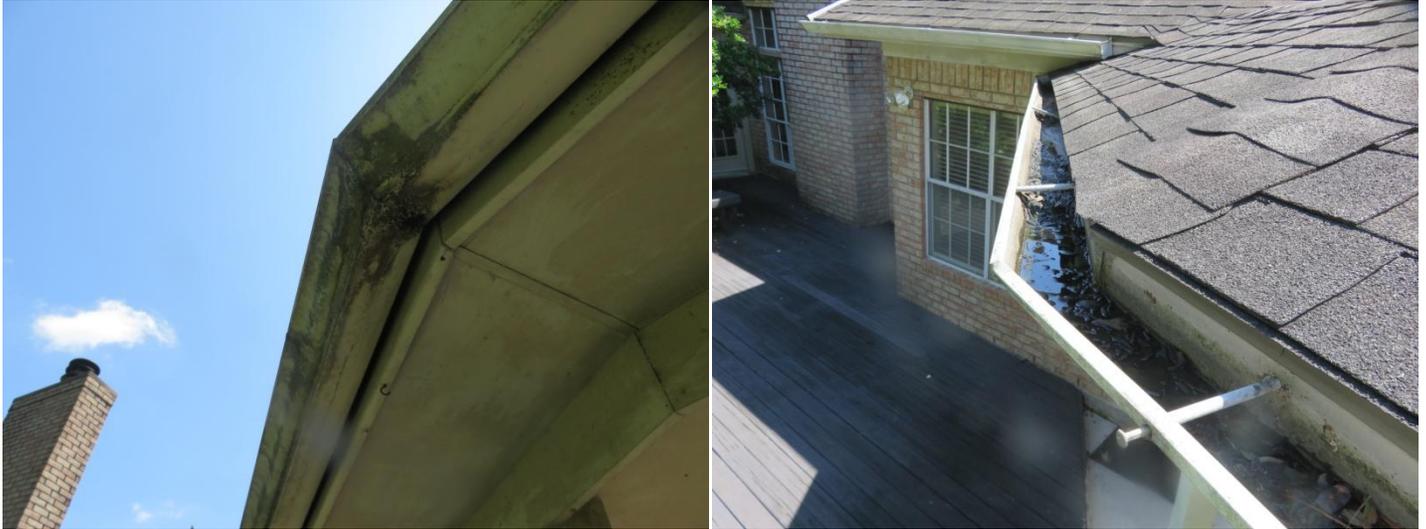
Example at the rear breezeway

- Some rain gutters display deterioration and lack of adequate drainage ability.

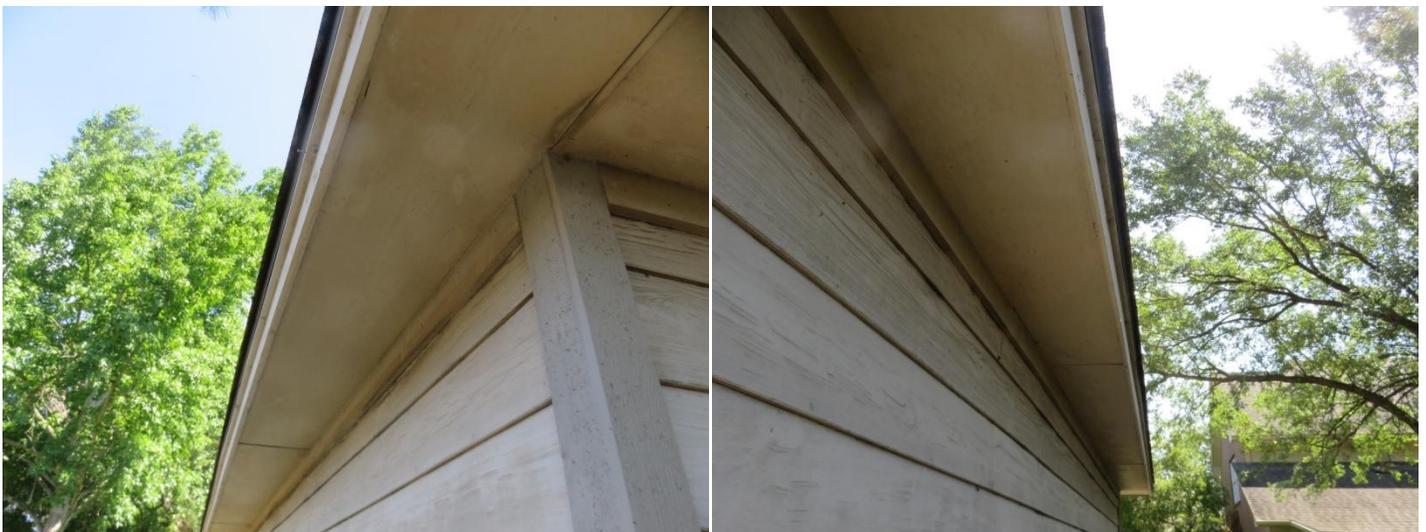
- The garage lacks soffit vents and roof top venting hood to move hot and humid air through the structure.

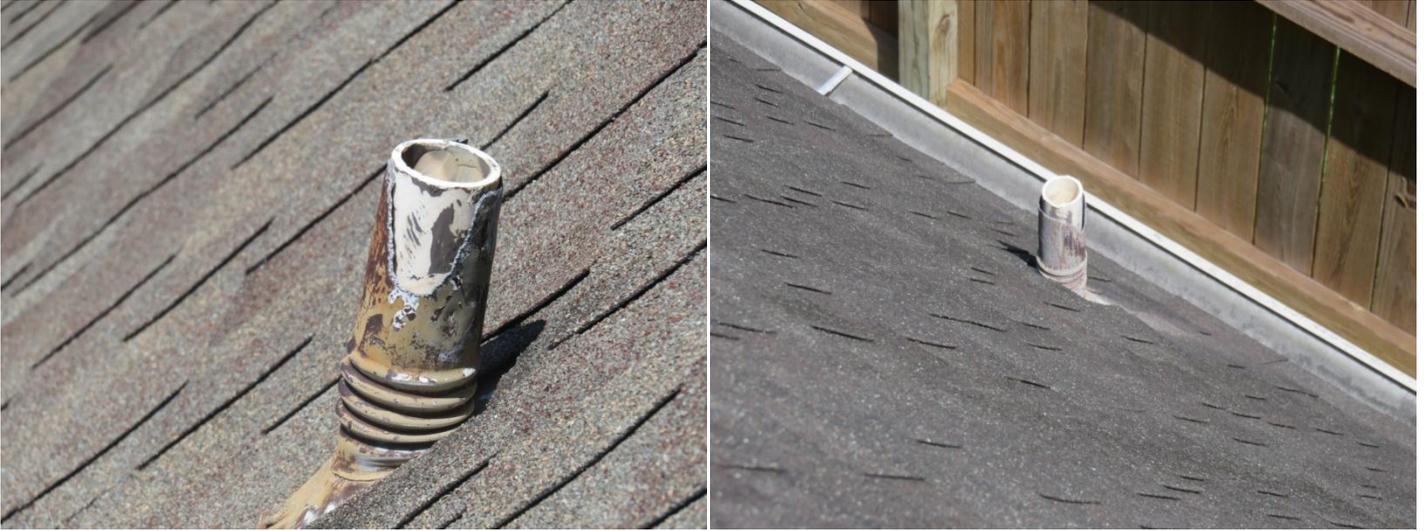
Examples

- Roof top plumbing vent covers are damaged.

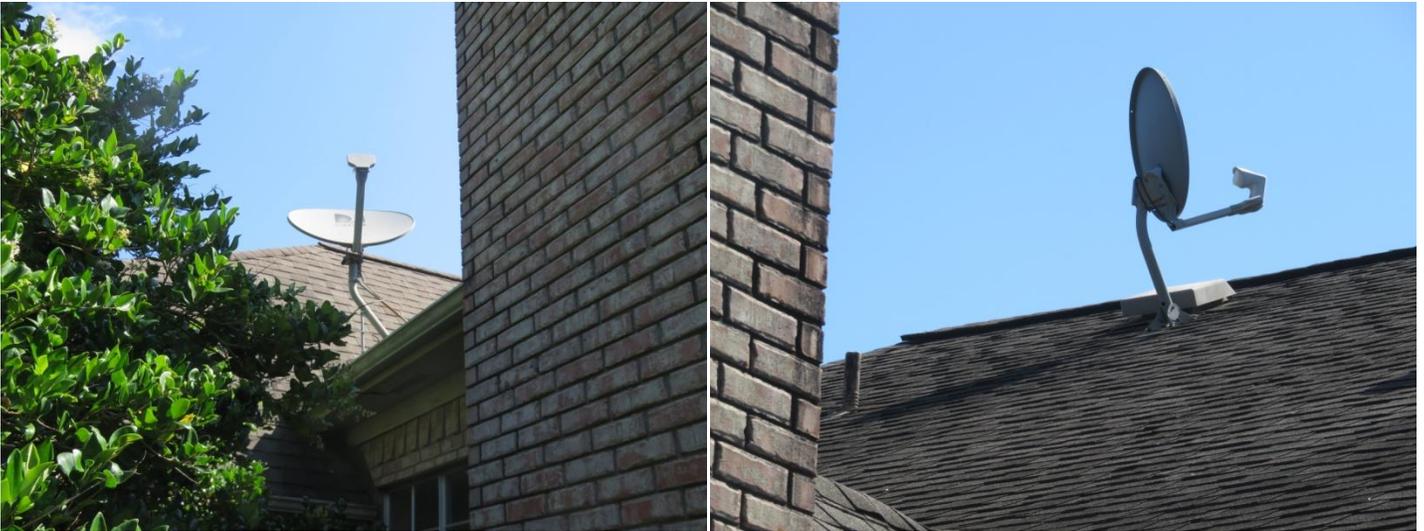
- Roof mounted equipment with penetration through the roof deck should be monitored during use and removed if leakage is detected. A manufactured holder is available for installation of the dish hardware. It is said to reduce the potential for leakage through the roof.

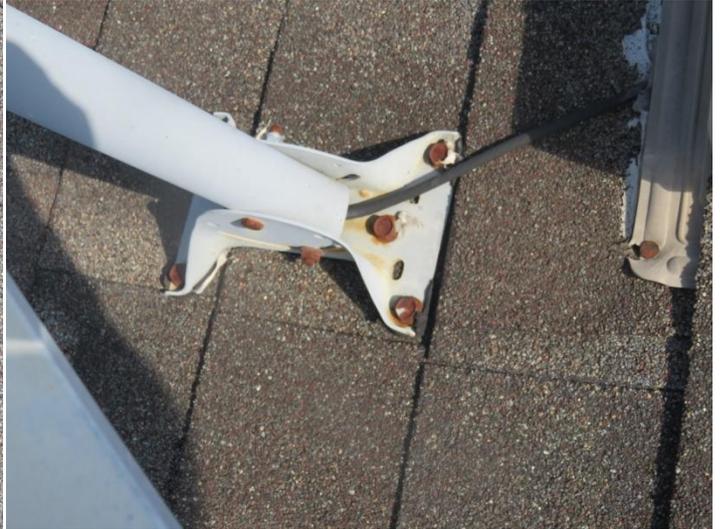
Current and required application

- Nails exposed to weather and moisture will rust and fail prematurely creating the potential for shingle elevation and movement. Weather protective caulk or other appropriate roofing material should be applied to the nails.

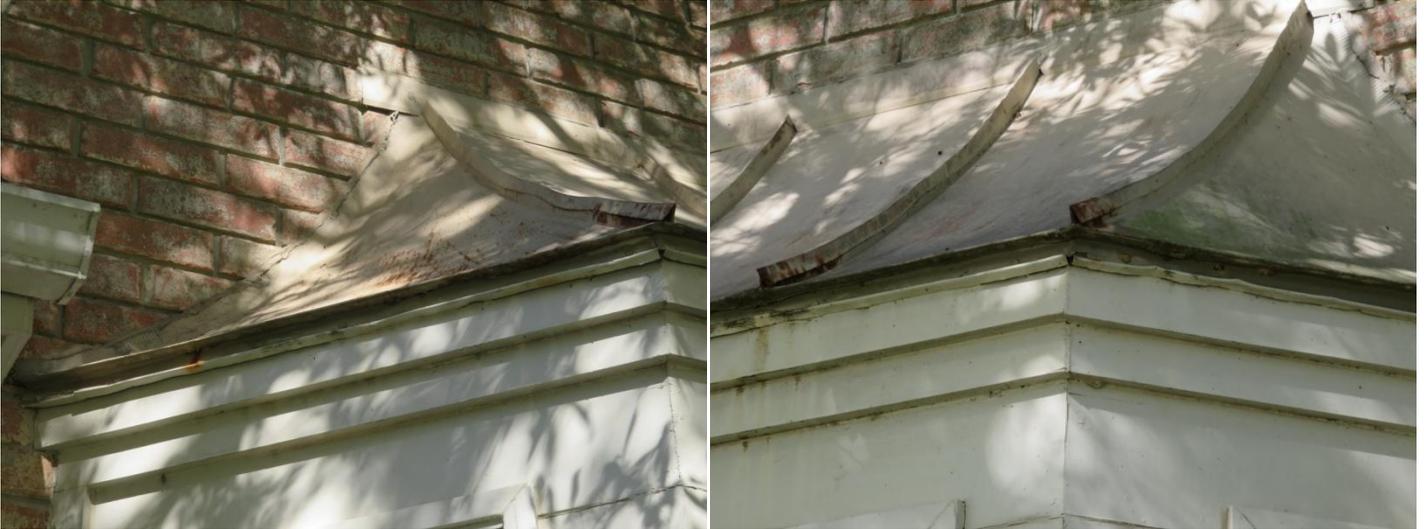
- The front metal roof is rusty.

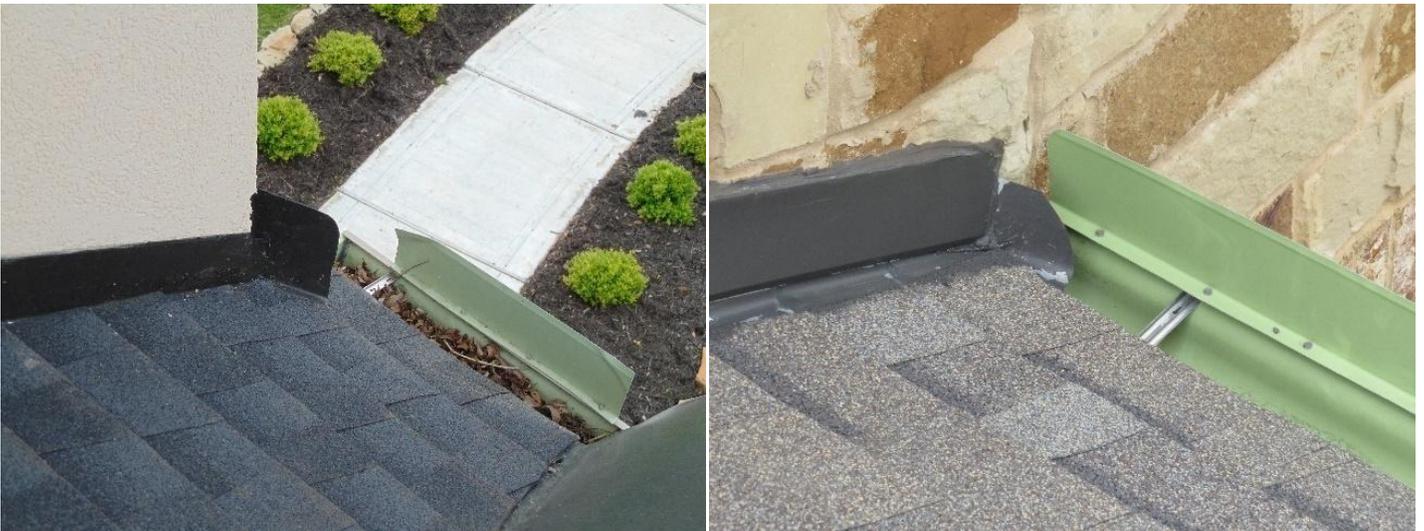
Examples

- Kick-out flashing is required at the lower run of rain gutters to divert water away from the wall at the rain gutter/end of the roof.

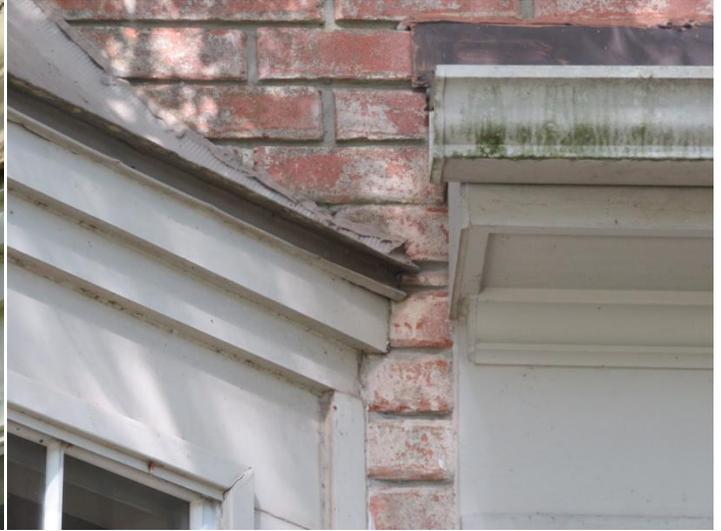
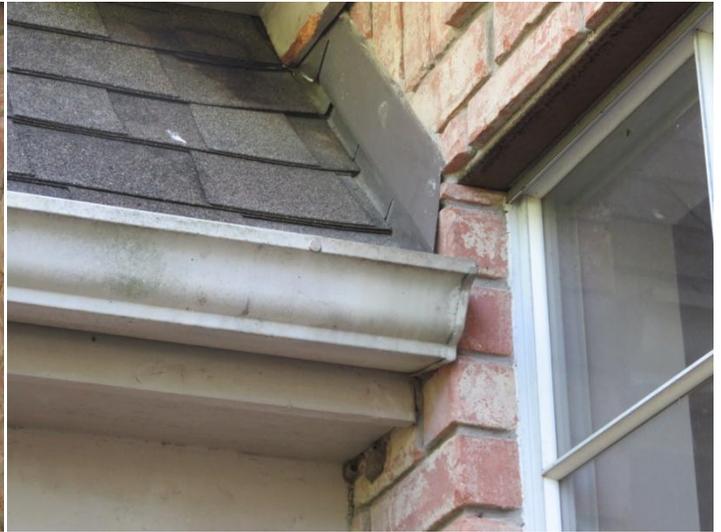
Examples around the home roof lacking this flashing

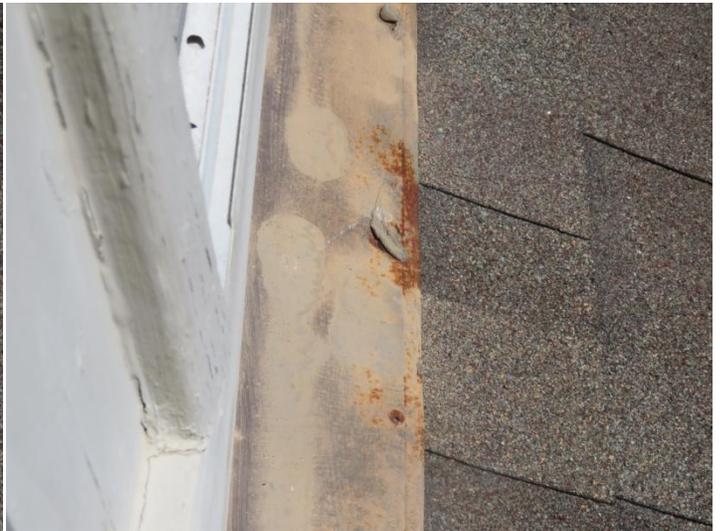
➤ Front dormer flashing displays rust.

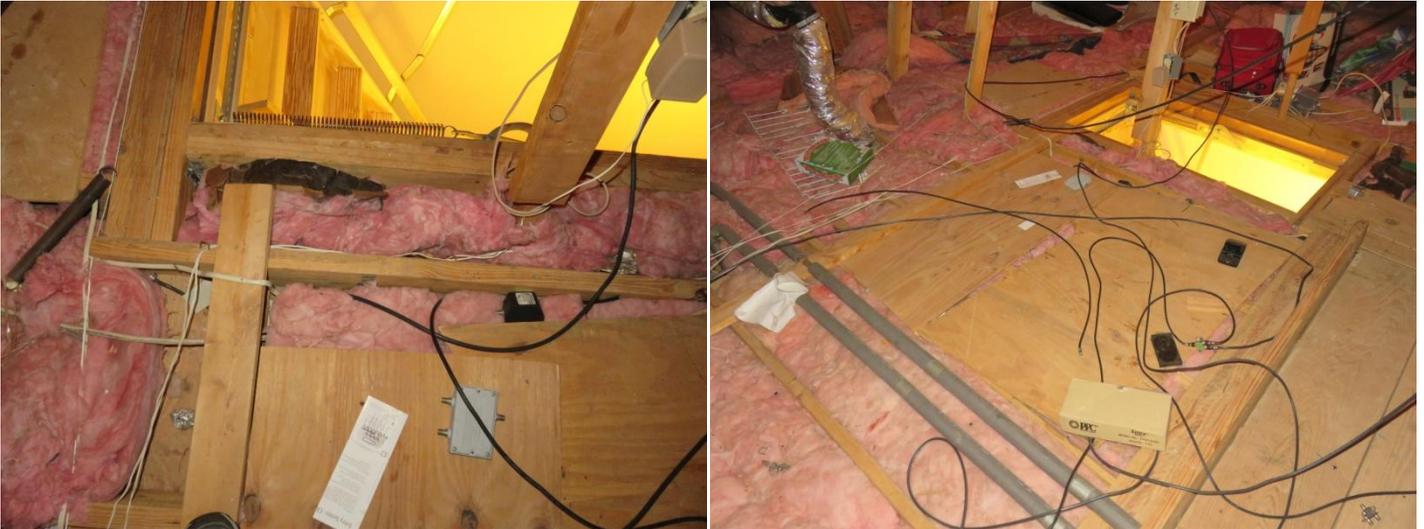
- Flooring in the attic is insufficient/is unsafe for a user walkway. Paneling is incomplete, flimsy and weak.

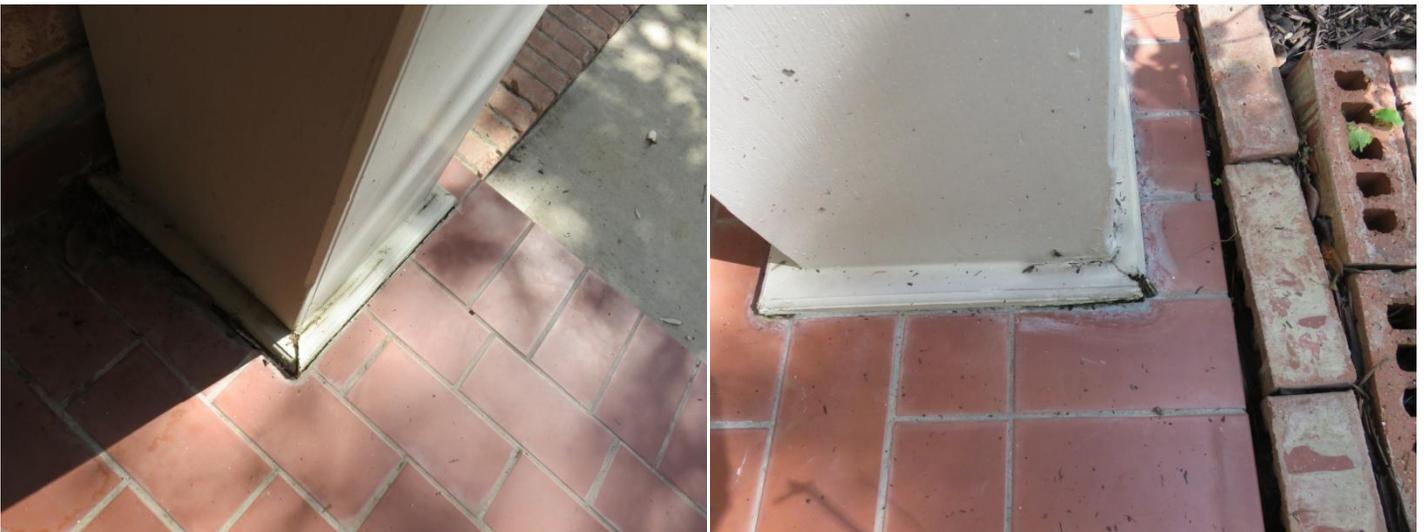
Examples

- The roof support posts at the front porch deterioration and water related damage. Surface deterioration is only noted at the time of the inspection.

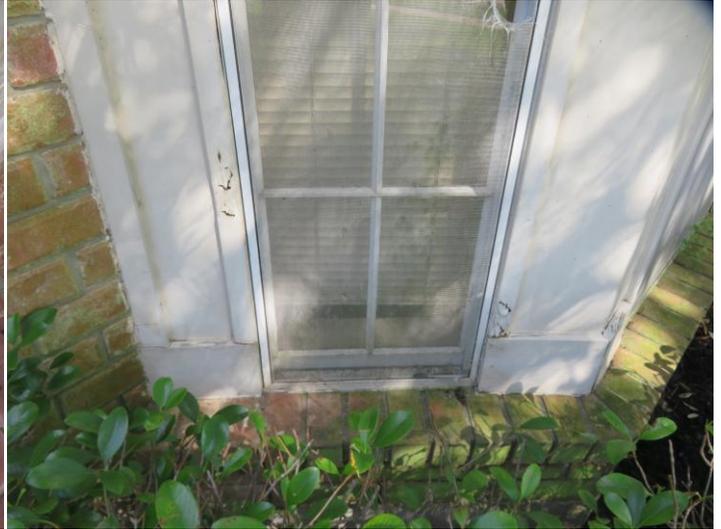
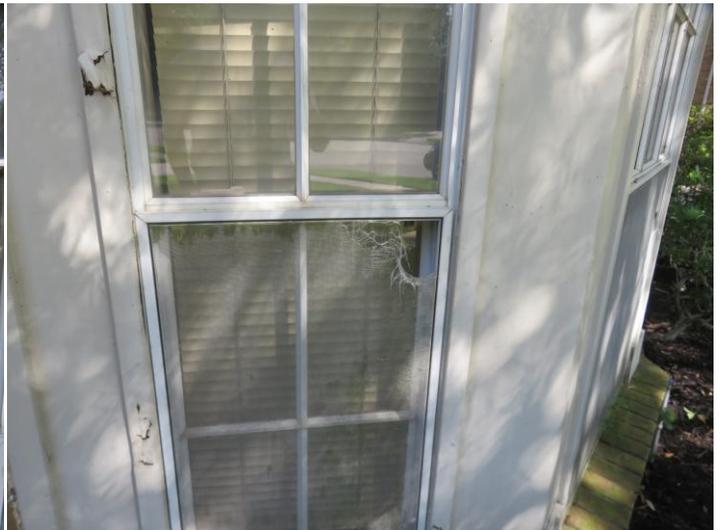
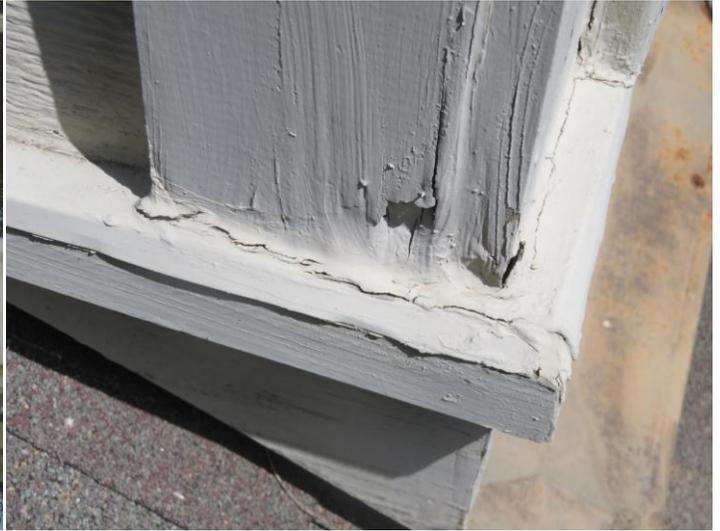
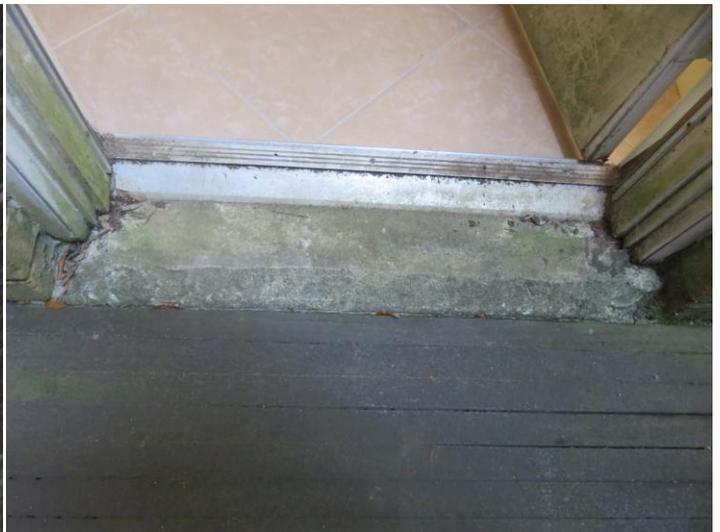
Examples

- Around the house, especially in the front, trim and framing materials display deterioration.

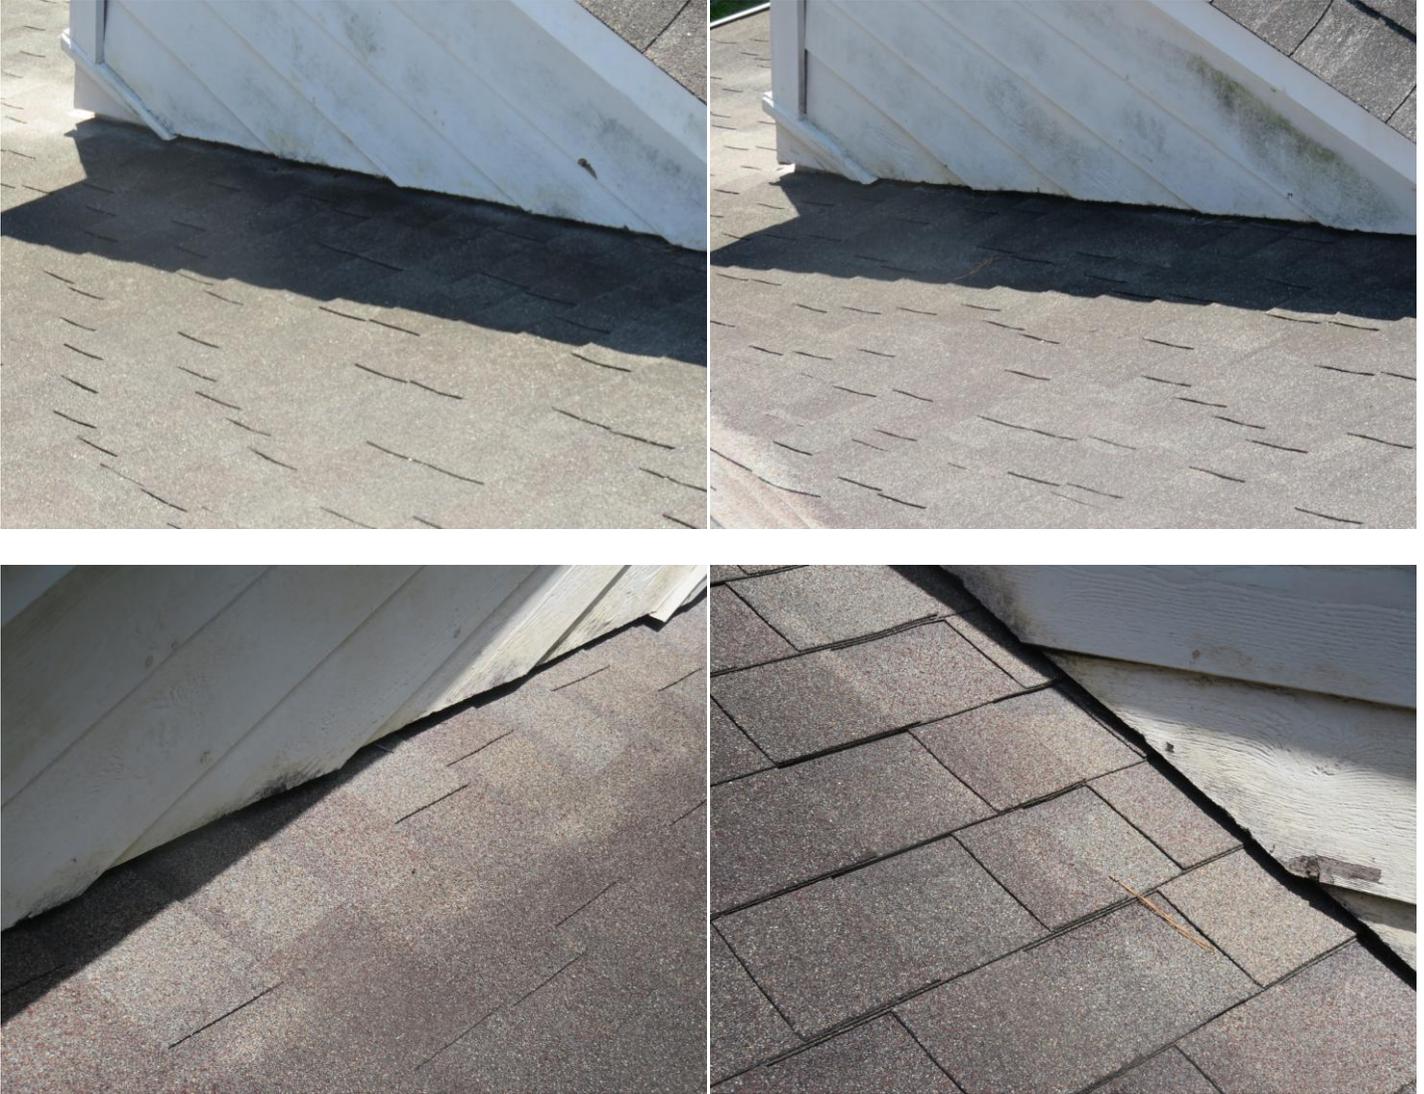
Examples

- Siding and roof shingles should be installed so that there is at least a 2” gap between the roof shingles and the siding. This prevents premature deterioration of siding from constant exposure to and contact with water. Siding deterioration is present.

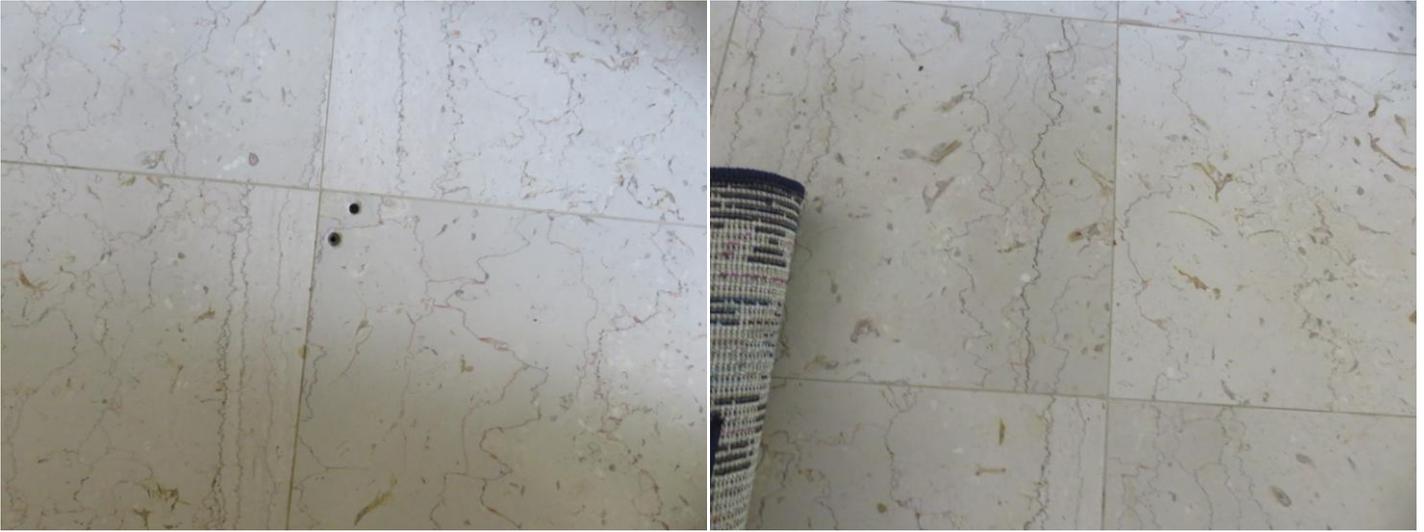
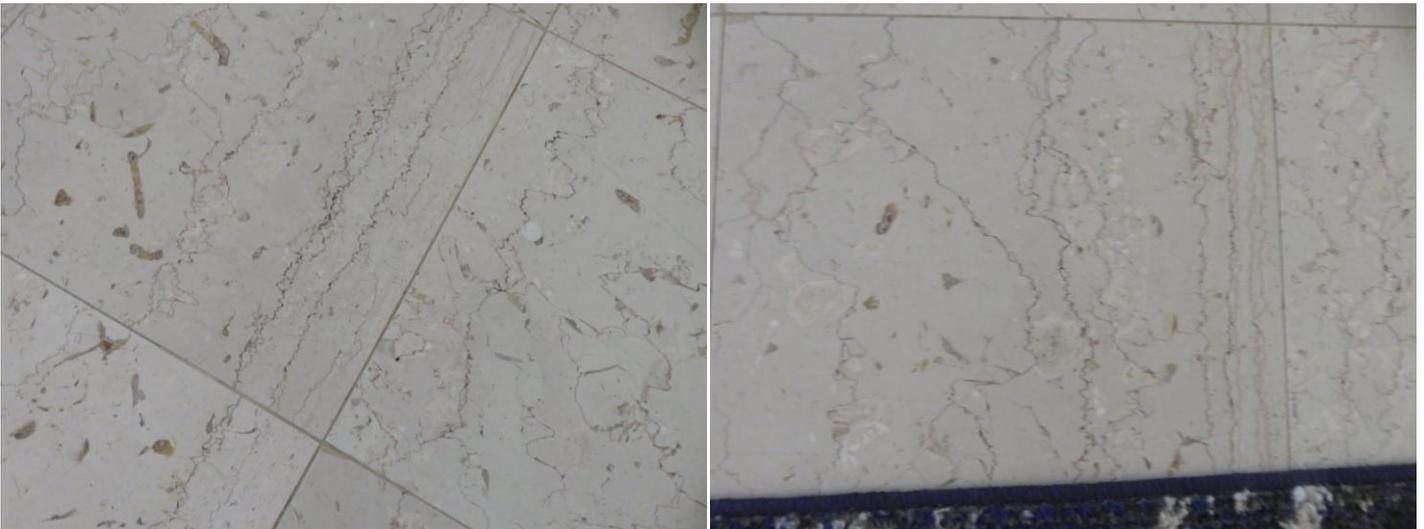
Examples

- Flooring in the foyer displays holes and cracks.

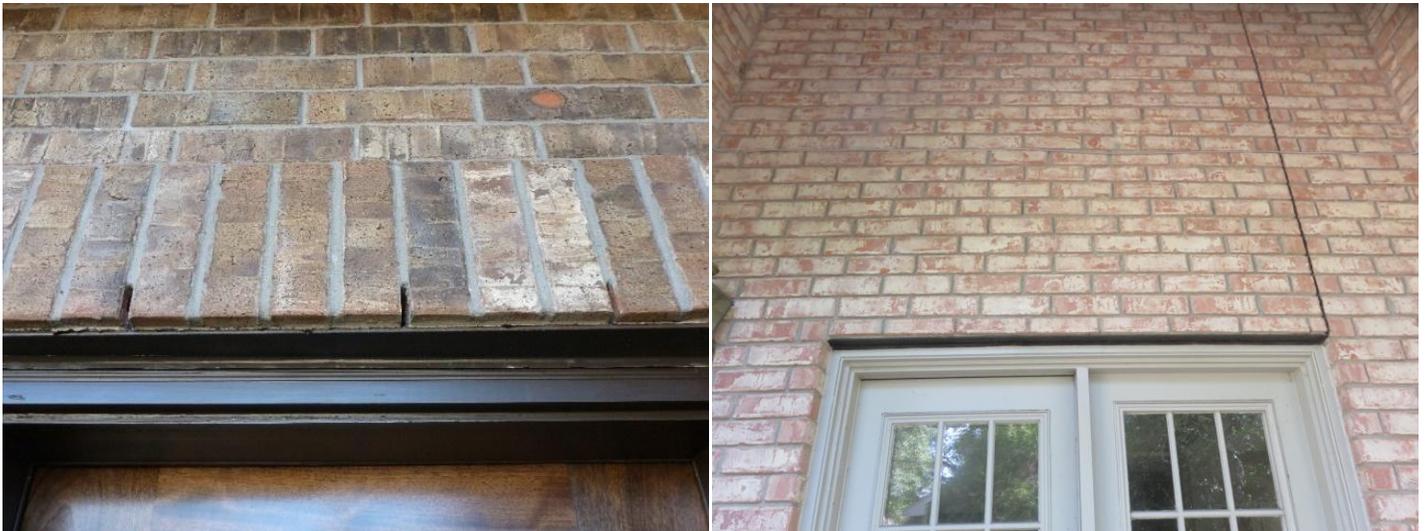
Weep hole example and current installation example

- Doors with brick walls supported by steel lintels will rust if condensation/water is allowed to accumulate or penetrate behind the wall of brick. The top of the lintel should be installed with flashing between the bottom of the first row of brick and the lintel. [IRC - 703.7.5]. It could not be ascertained to what degree, if any, flashing is installed in this manner. Weep holes can be provided by drilling/removing a portion of the mortar between bricks at the top of the lintel. Weep holes are required to be 3/16" in width and installed in pairs above a door and/or at least within 33" of each other. [IRC - 703.7.6]. Already rusting lintels should be scraped and painted with a rust preventing paint.

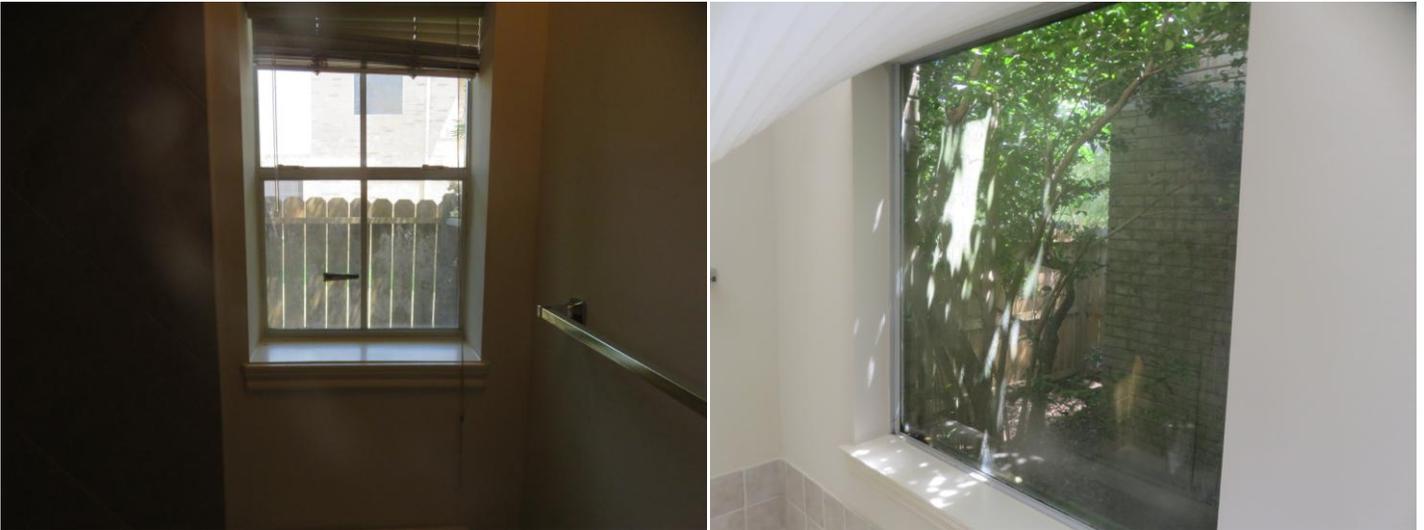
- Windows adjacent to the guest and above the Master bathroom bathtub (within 5') are required to be safety glass. It does not appear that these windows are of such quality. Verification was not available.

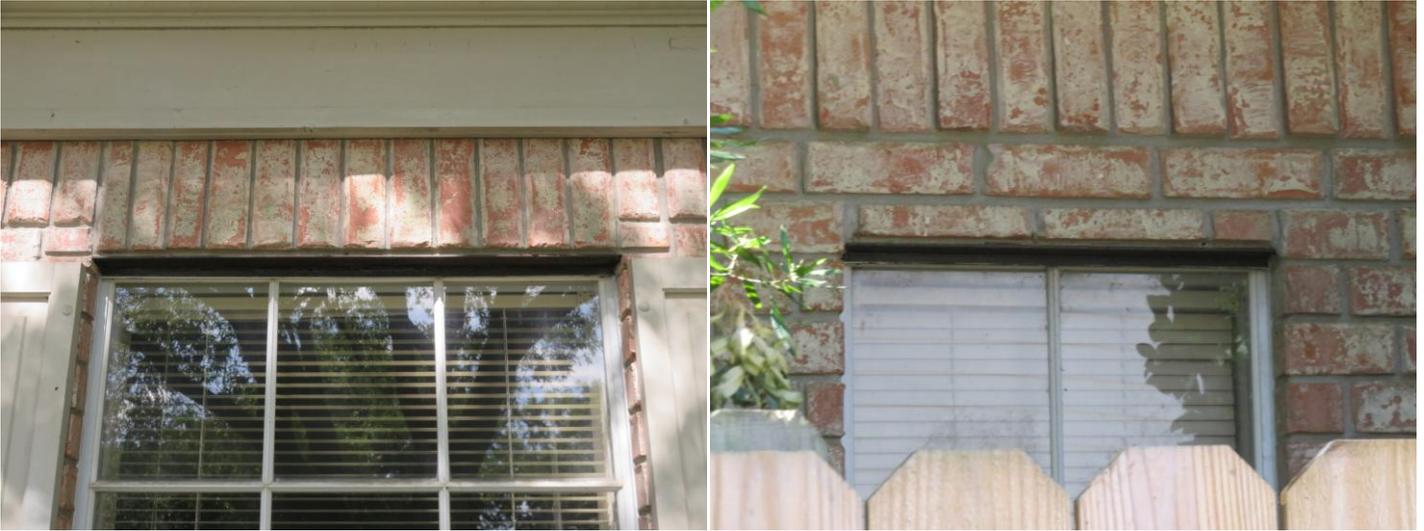
Weep hole example and current installation examples

- Windows with brick walls supported by steel lintels will rust if condensation/water is allowed to accumulate or penetrate behind the wall of brick. The top of the lintel should be installed with flashing between the bottom of the first row of brick and the lintel. **[IRC - 703.7.5]**. It could not be ascertained to what degree, if any, flashing is installed in this manner. Weep holes can be provided by drilling/removing a portion of the mortar between bricks at the top of the lintel. Weep holes are required to be 3/16" in width and installed in pairs above a window and/or at least within 33" of each other. [IRC - 703.7.6]. Rusting lintels should be scraped and painted with a rust preventing paint.

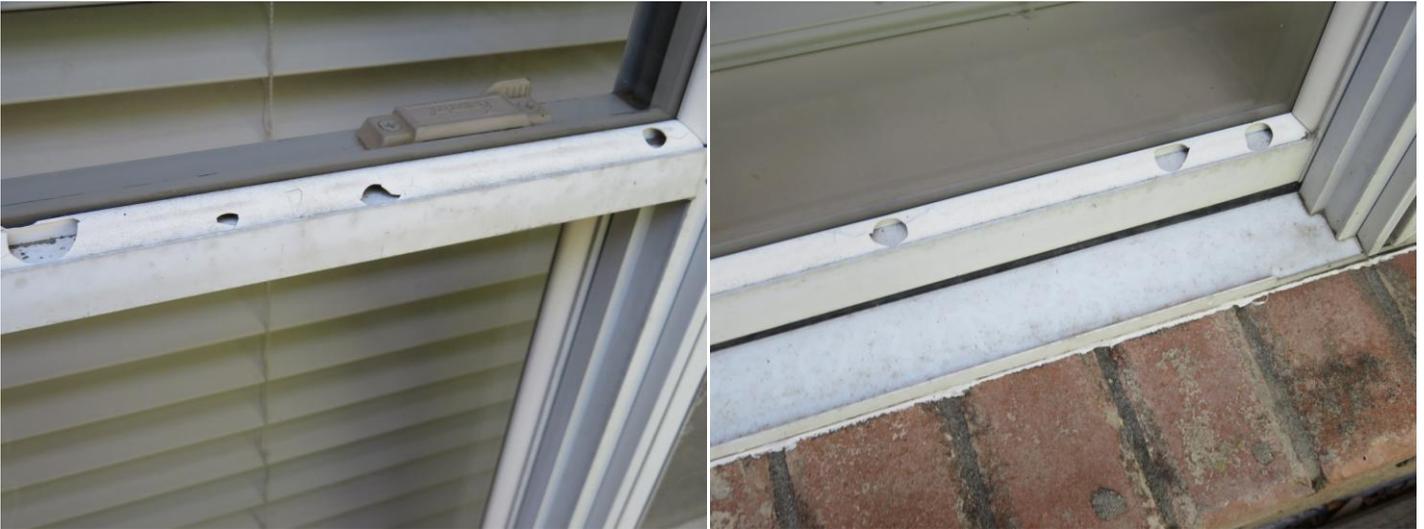
Examples

➤ Several windows display damaged plastic glazing.

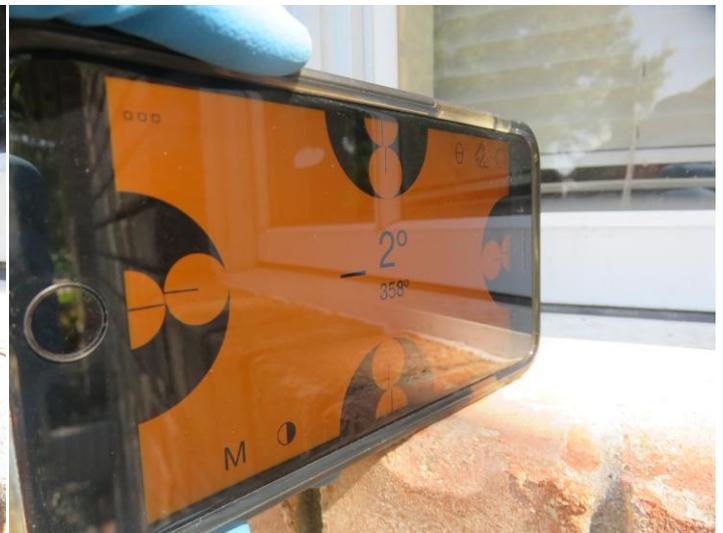
Illustration and current example

- Exterior window sills are required to be installed to slope at least at a 15* angle away from the home/window to properly drain/shed water away from the home. Maintain window caulk/sealant to assist in preventing window leakage.

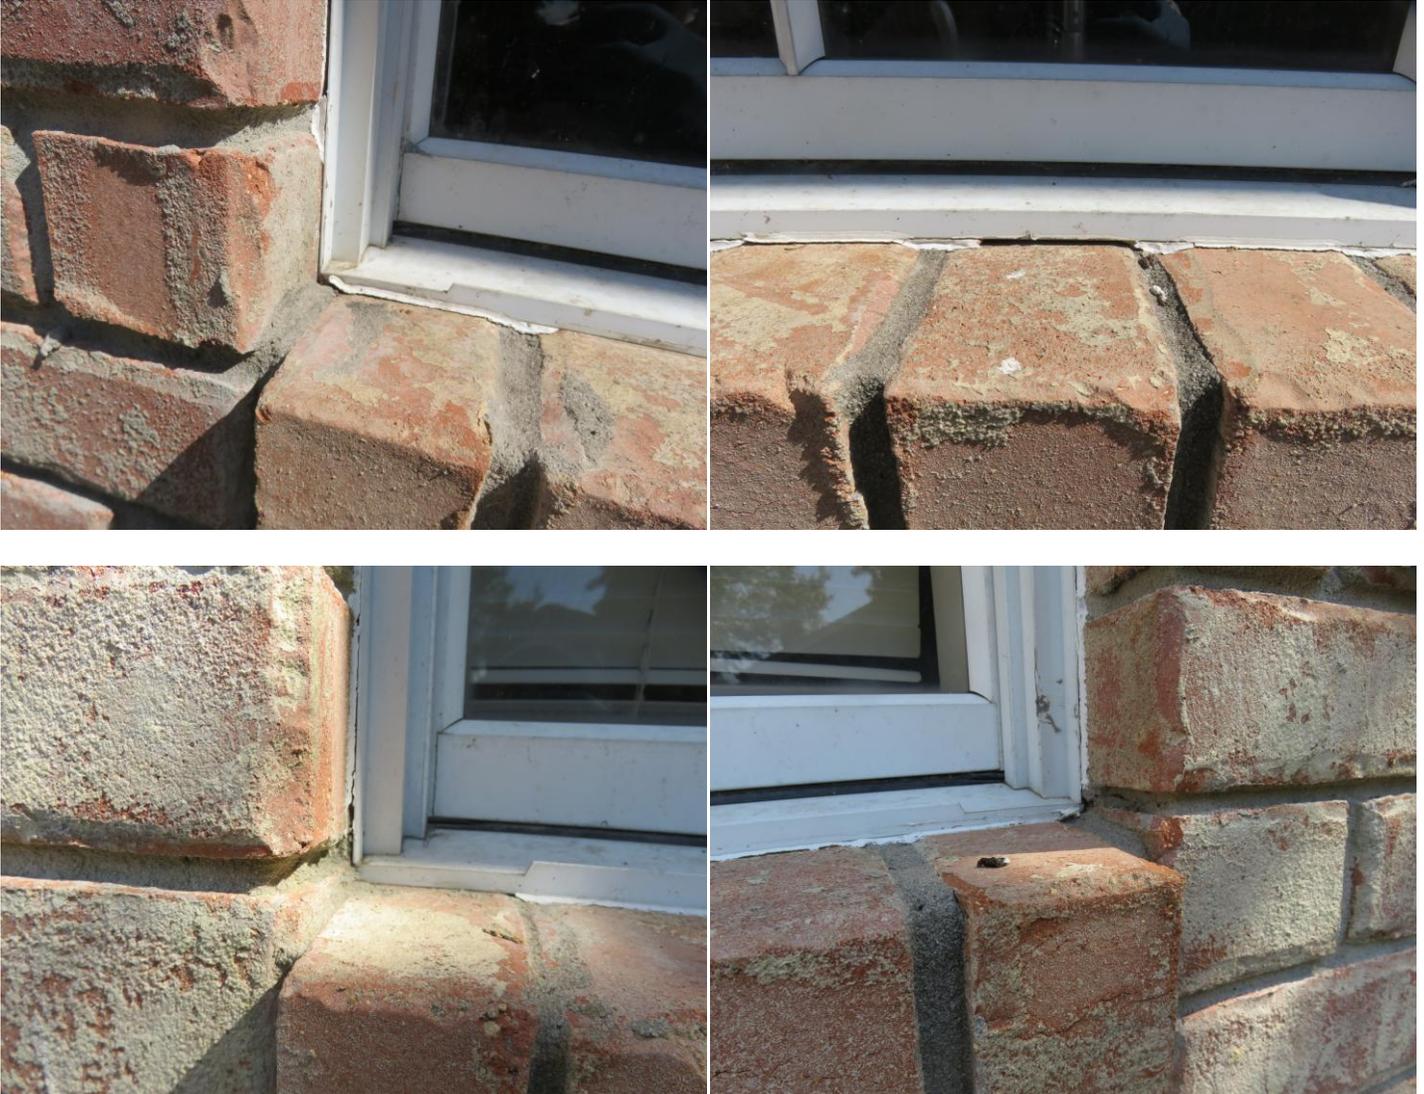
Examples of a window at the front porch lacking adequate sealant/caulk

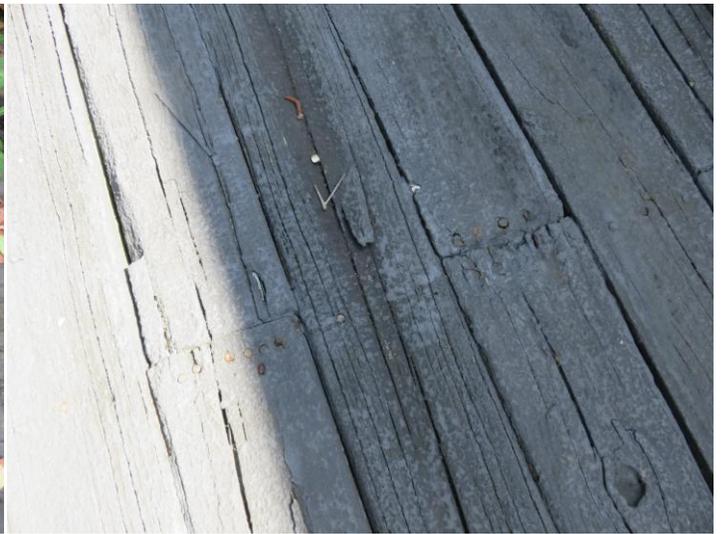
Examples

- In the opinion of the inspector the wooden decks appeared in below average condition displays deterioration, splintering and the potential of retaining water beneath them.

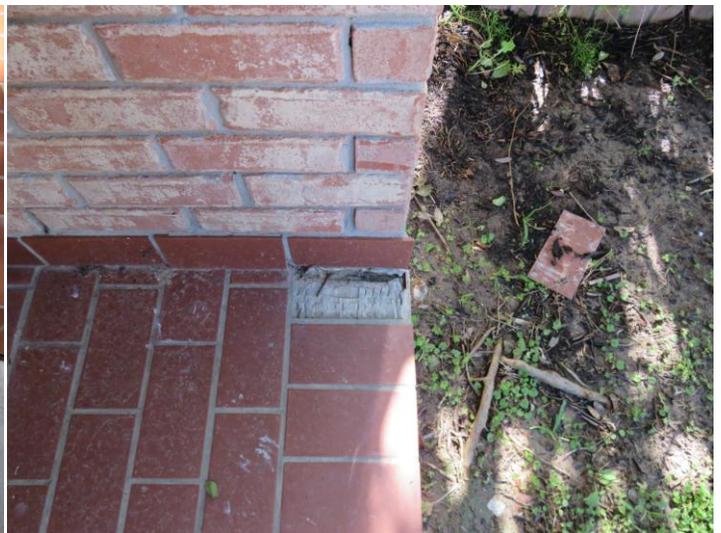
- The front and left side porches display loss of tile.

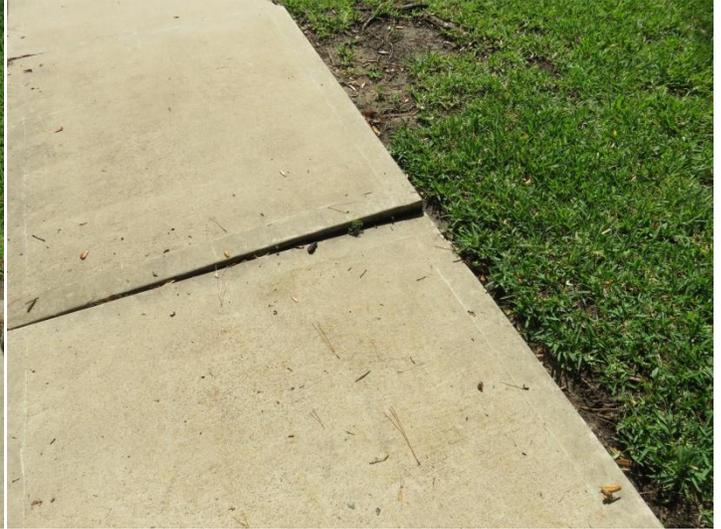
- The front sidewalk displays elevated/uneven surfaces and a dip where soils have been washed out from beneath the walkway.

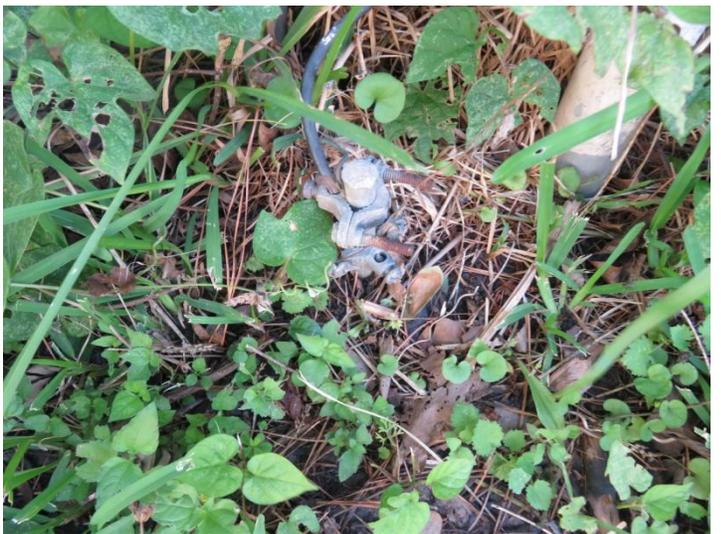
Example of an acorn clamp and current installation

- The installed grounding clamp at the ground rod is for use in a natural gas pipe application. Grounding rods are required to have an acorn grounding clamp.

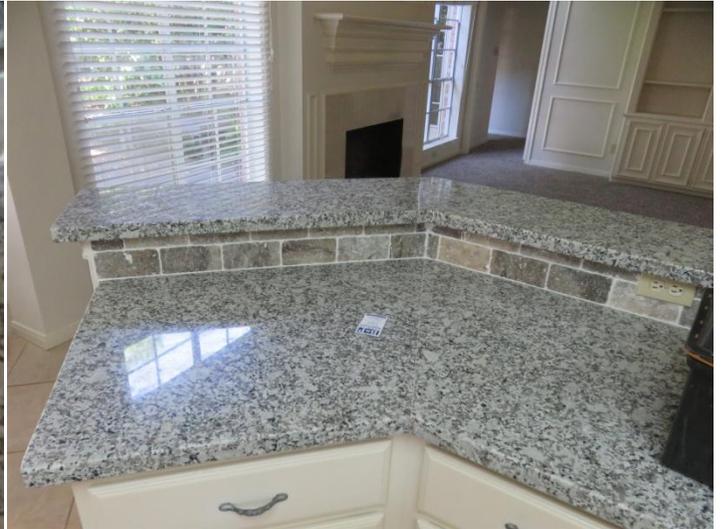
- The outlet at the bar sink lacked power and is required to be GFCI rated. Additionally an additional outlet is required at the far left of the bar sink.
