TEXAS REAL ESTATE CONSUMER NOTICE CONCERNING HAZARDS OR DEFICIENCIES

Joseph and Cara Stogner, 3318 S. Lake Village Drive, Katy, TX 77450

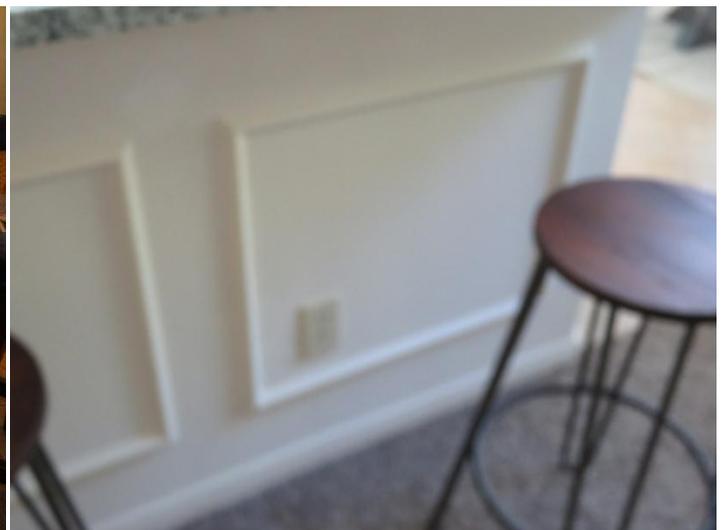
Required and current installation

- As of 9/2014, all 15 – 20 AMP laundry room outlets are required to be GFCI and AFCI safety rated/protected - IRC{210.8(A)(9)}
- The outlet(s) on the family room side/dining side of the kitchen sink countertop are required to be GFCI safety rated and no lower than 12” beneath the countertop for safety of crawling toddlers and smaller children. (IRC 3901.4.5X). While not specifically intended for use at the countertop the outlet is GFCI protected and would undoubtedly be used at the countertop and electrical cords may not reach the outlet of an appliance creating a safety hazard. This outlet lacked power at the time of the inspection.

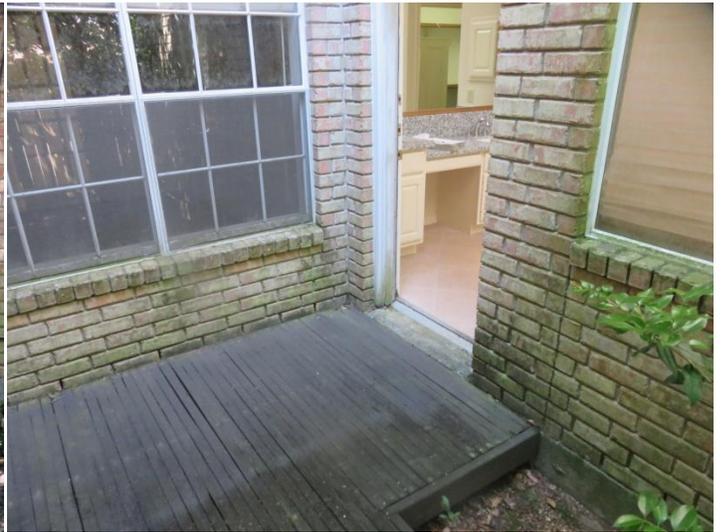
- An outlet (GFCI) is a required installation at the exterior walls of the left side porch and atrium off the Master bathroom.

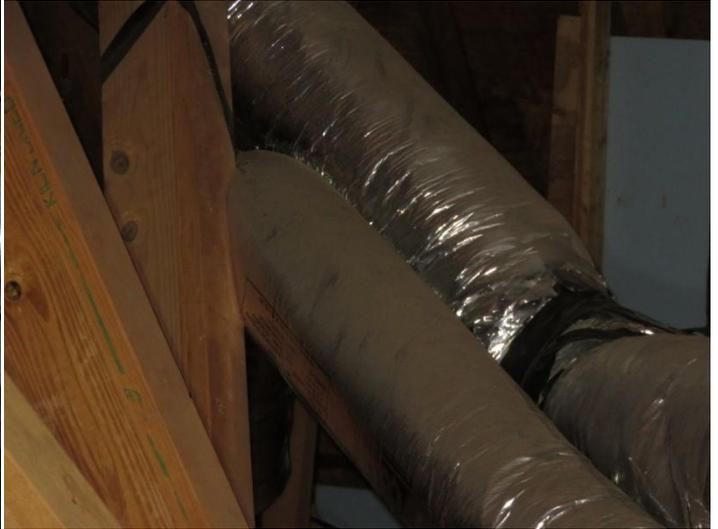
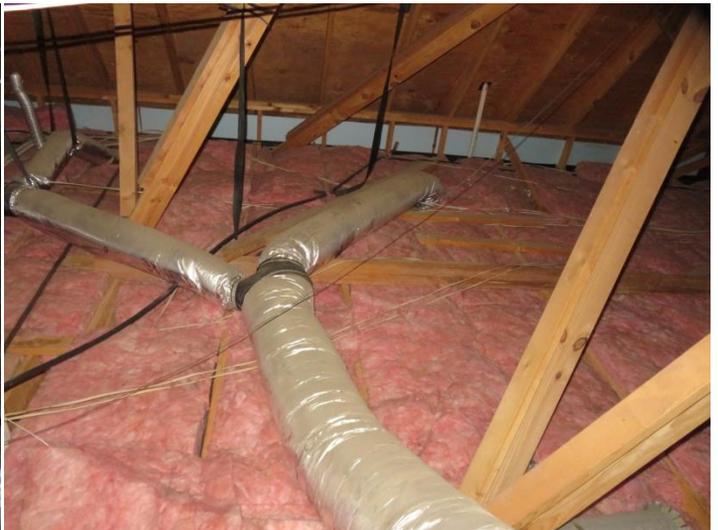
- Attic ductwork in general is prohibited from touching/coming into contact with other ductwork or installed lying on the attic floor. Insulation placed between sections is not a remedy. Damaging condensation can result.

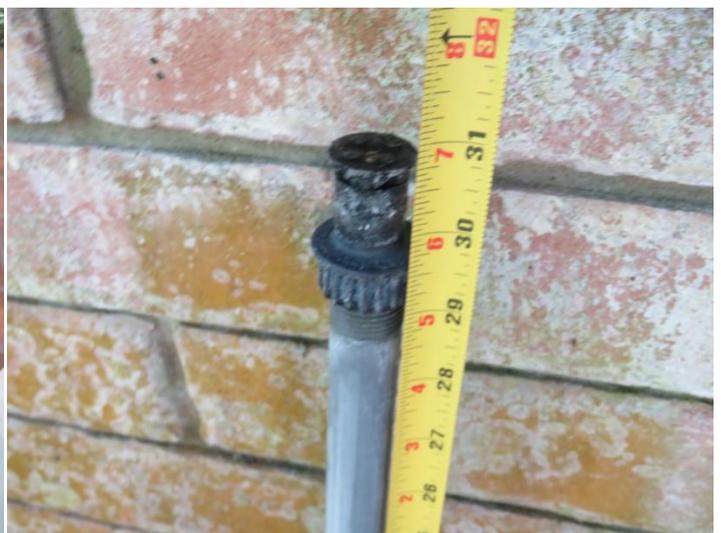
- The installed backflow device for the sprinkler system has been installed too low to the ground in relation to the highest sprinkler heads about the home. To prevent gray water reversal to the home and fresh water system, the backflow device should be installed at least six inches (6") higher than the highest sprinkler head.
