X X **B. Grading & Drainage**

Joseph and Cara Stogner, 3318 S. Lake Village Drive, Katy, TX 77450

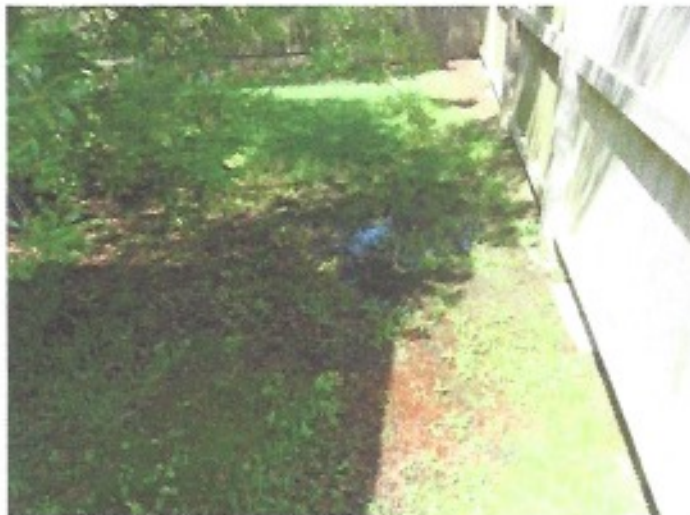
- At the right rear corner of the home ponding of water is noted.

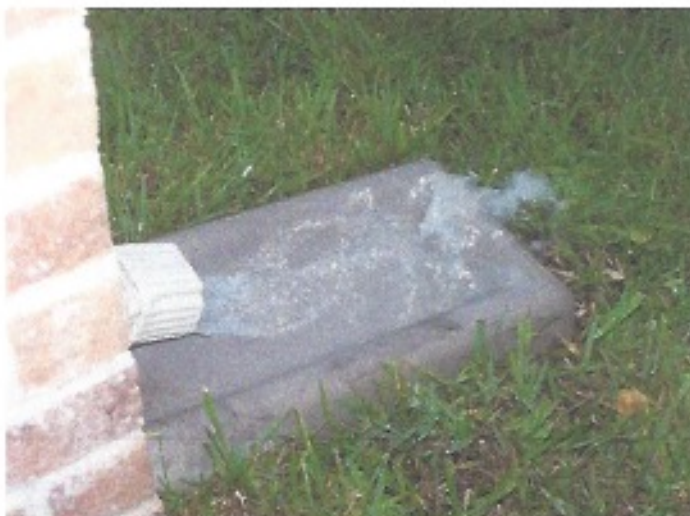
- Downspout splash backs should be installed at the delivery point of each rain downspout. Splash backs should be positioned so that the high side or "block" is positioned away from the home and not against the foundation. They prevent rushing water from eroding the soil and provide an increased directional flow of water away from the home and foundation.

I will install at downspouts

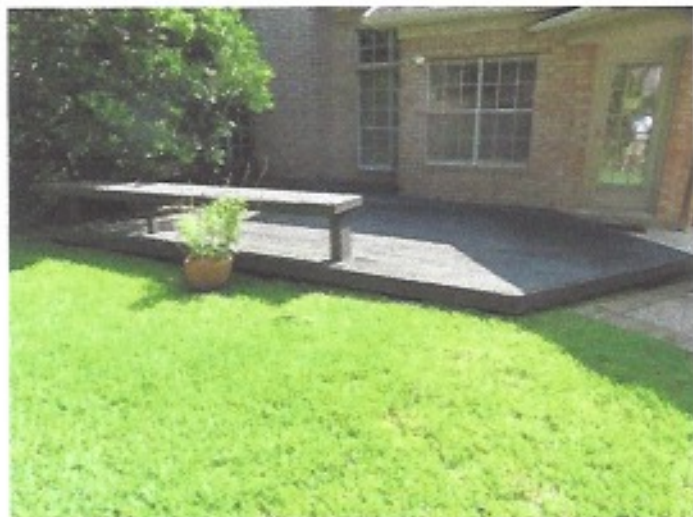
- The deck may inhibit drainage at the back of the house and outside the Master bathroom.

** Removing back deck*

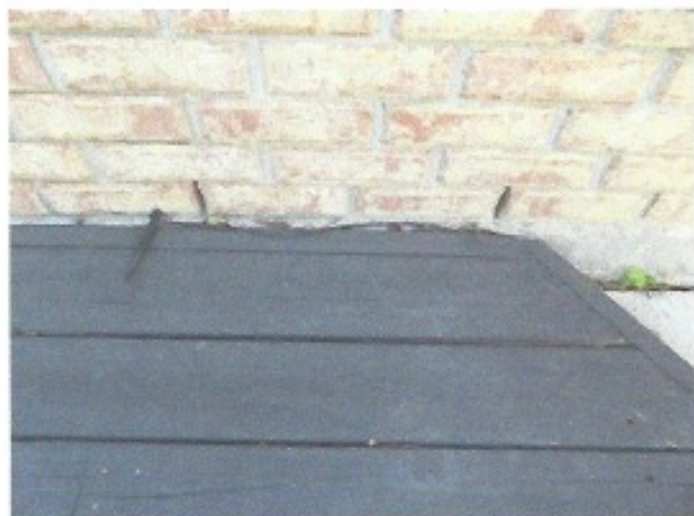
- The deck is of equal height as the foundation weep holes which could cause water to flow into the weep holes affecting the interior of the home.

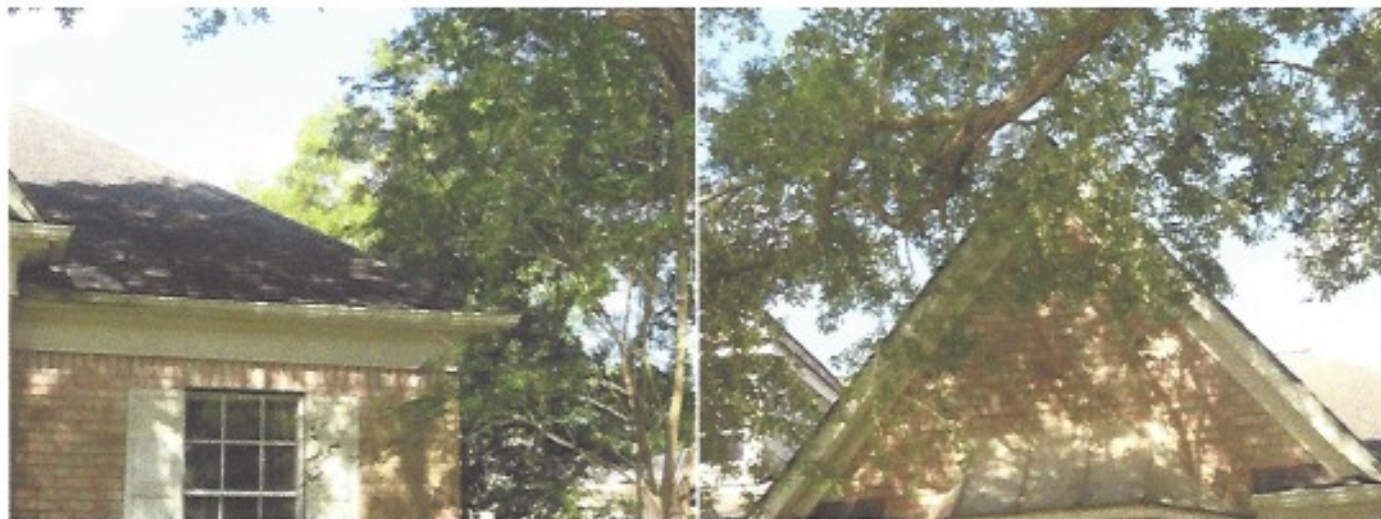
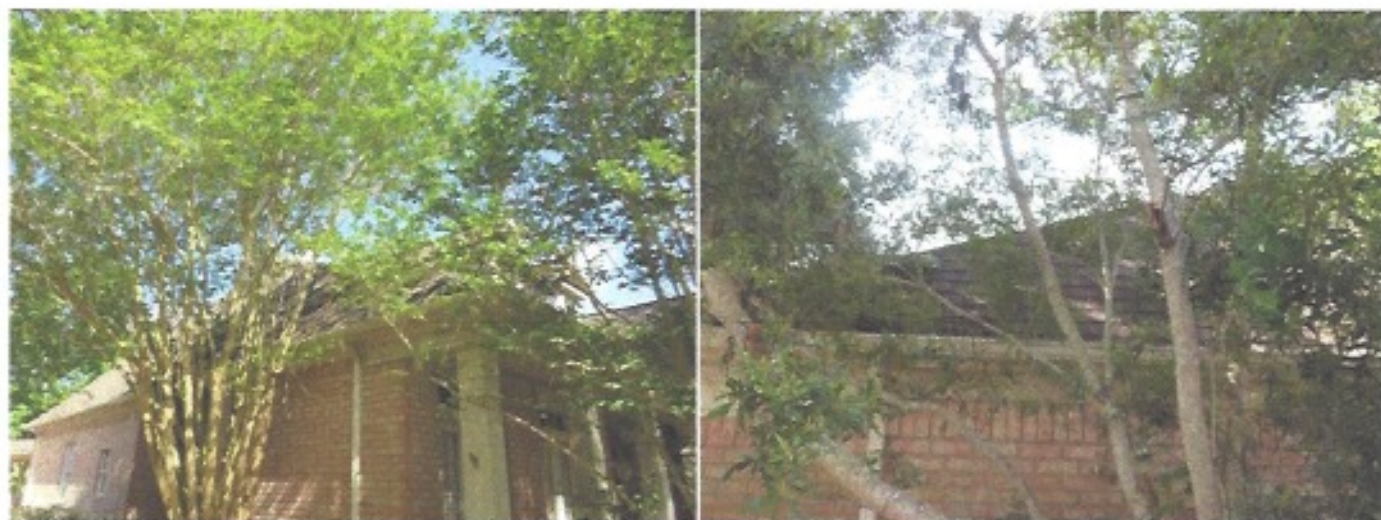
- Trees are too close to the home and foundation. Branches raking across wall and roof surfaces can damage these areas. Roots in close proximity to the home and foundation can cause the foundation to fail due to their thirst for water in the areas. A landscaping professional should be engaged to evaluate and suggest remedies to these issues.

* trees trimmed

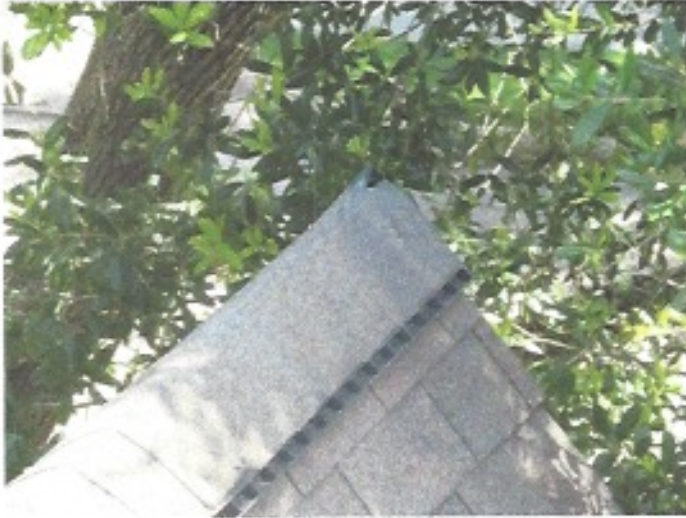
- At the front right dormer peak shingles are damaged/opening in roof.

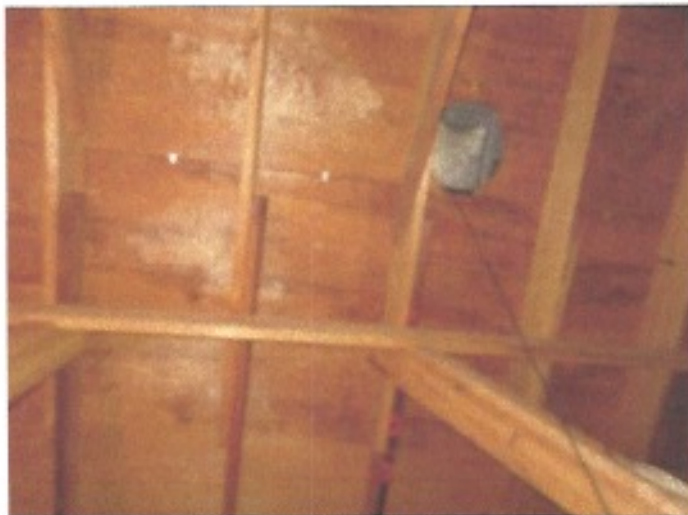
- To the right of the furnace it appears that there may have been/is a leak as indicated by water staining.

✦ NEVER leaked during my ownership. Not leaking now.

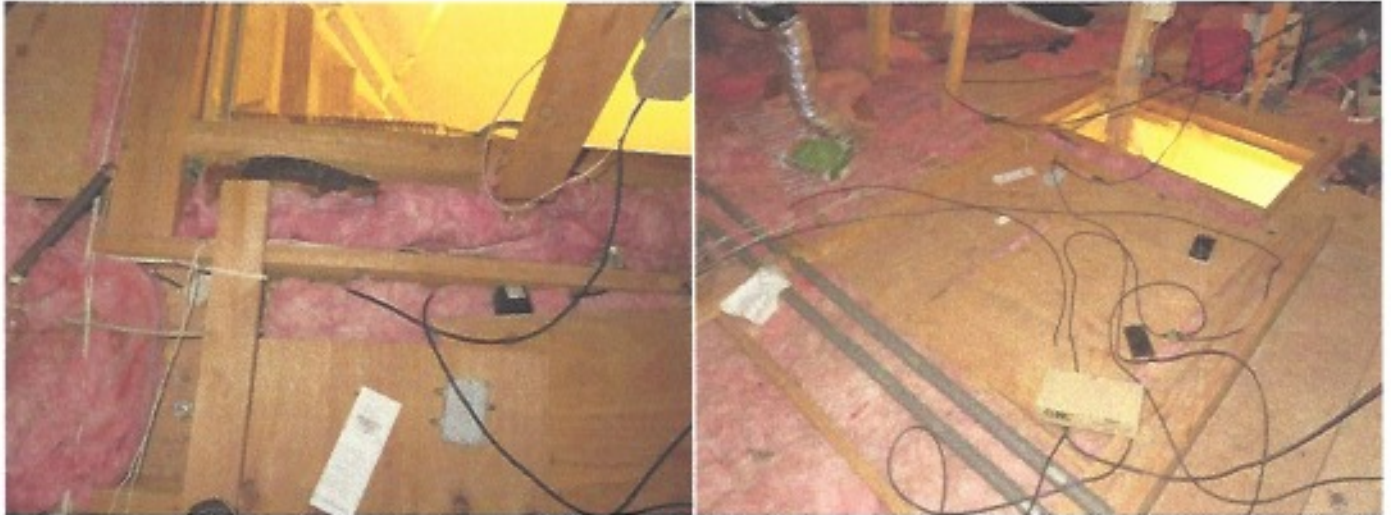
- Flooring in the attic is insufficient/is unsafe for a user walkway. Paneling is incomplete, flimsy and weak.

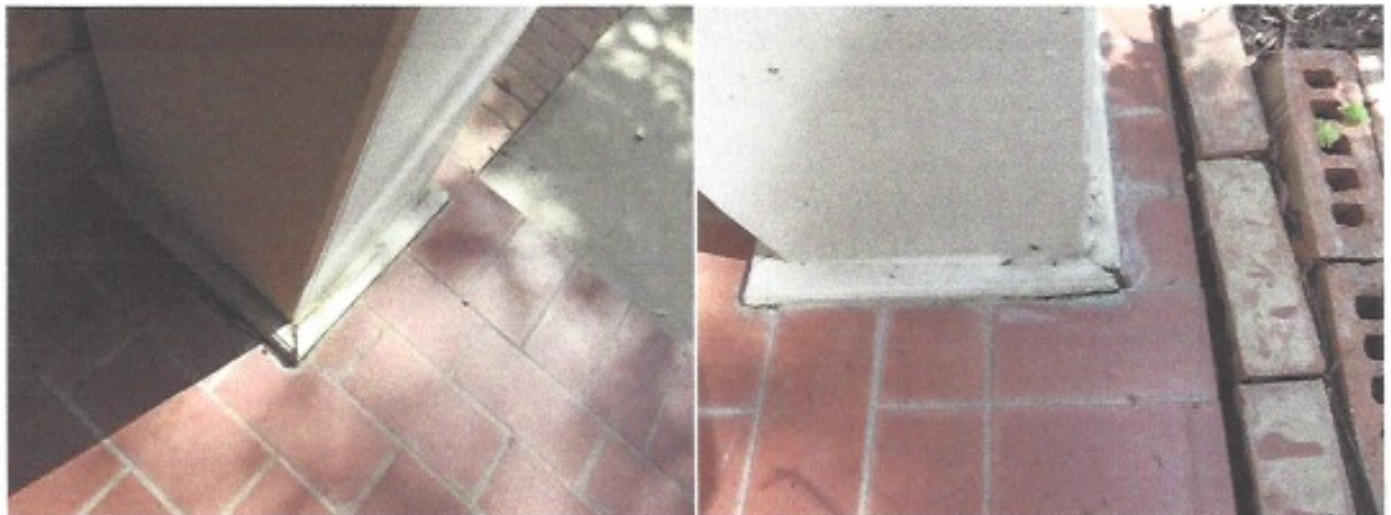
- The roof support posts at the front porch deterioration and water related damage. Surface deterioration is only noted at the time of the inspection.

* Repairing base of posts

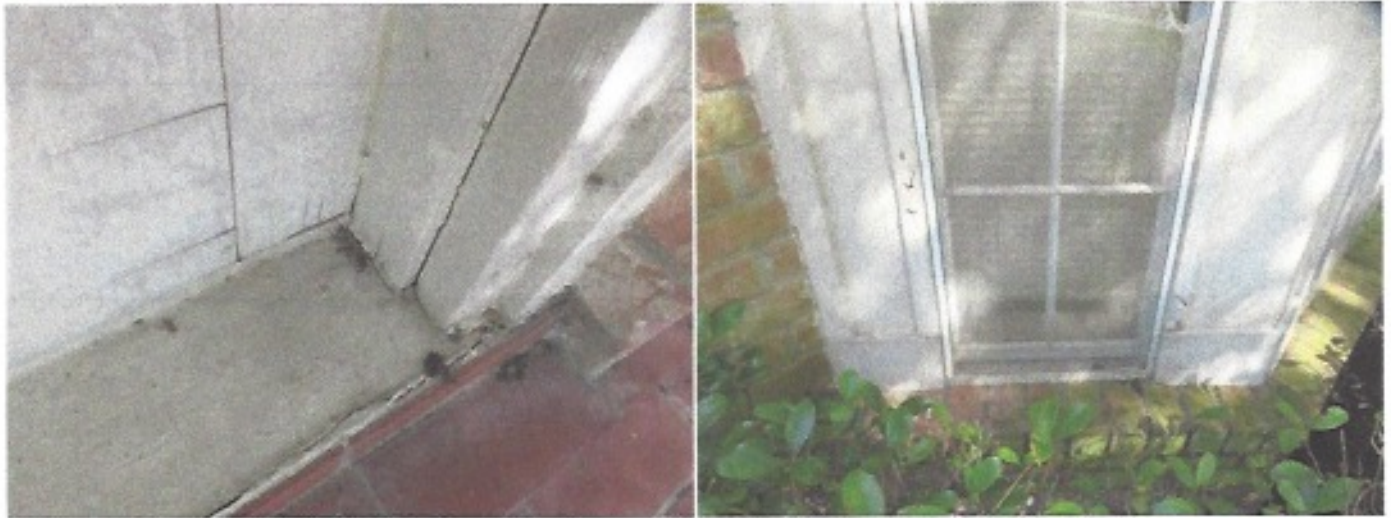
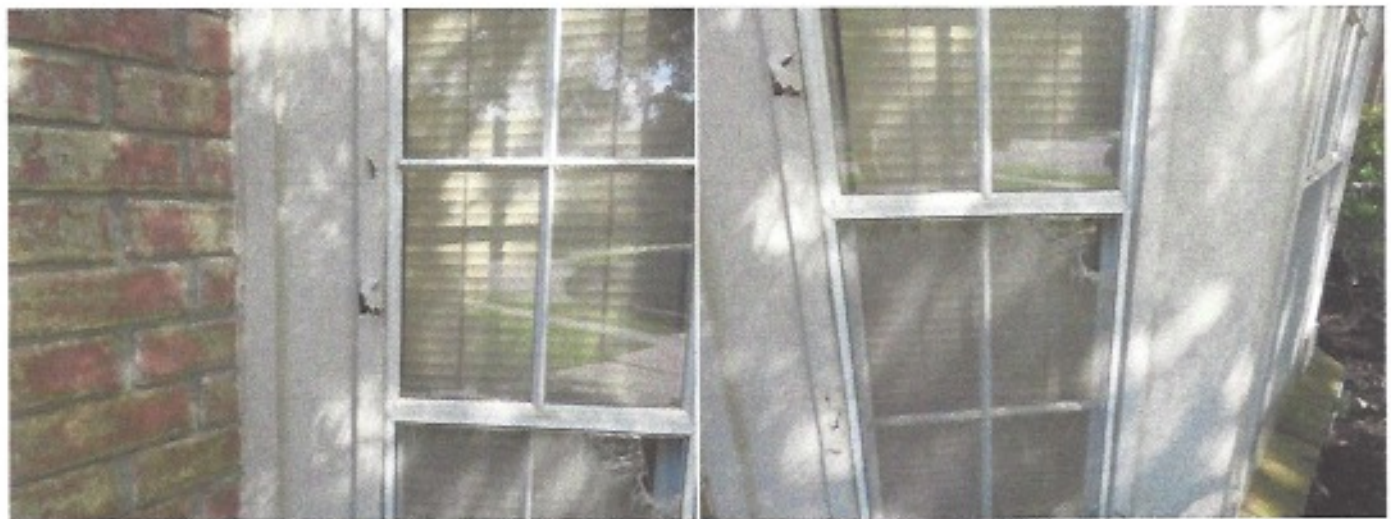
- Around the house, especially in the front, trim and framing materials display deterioration.

* Repairing & painting

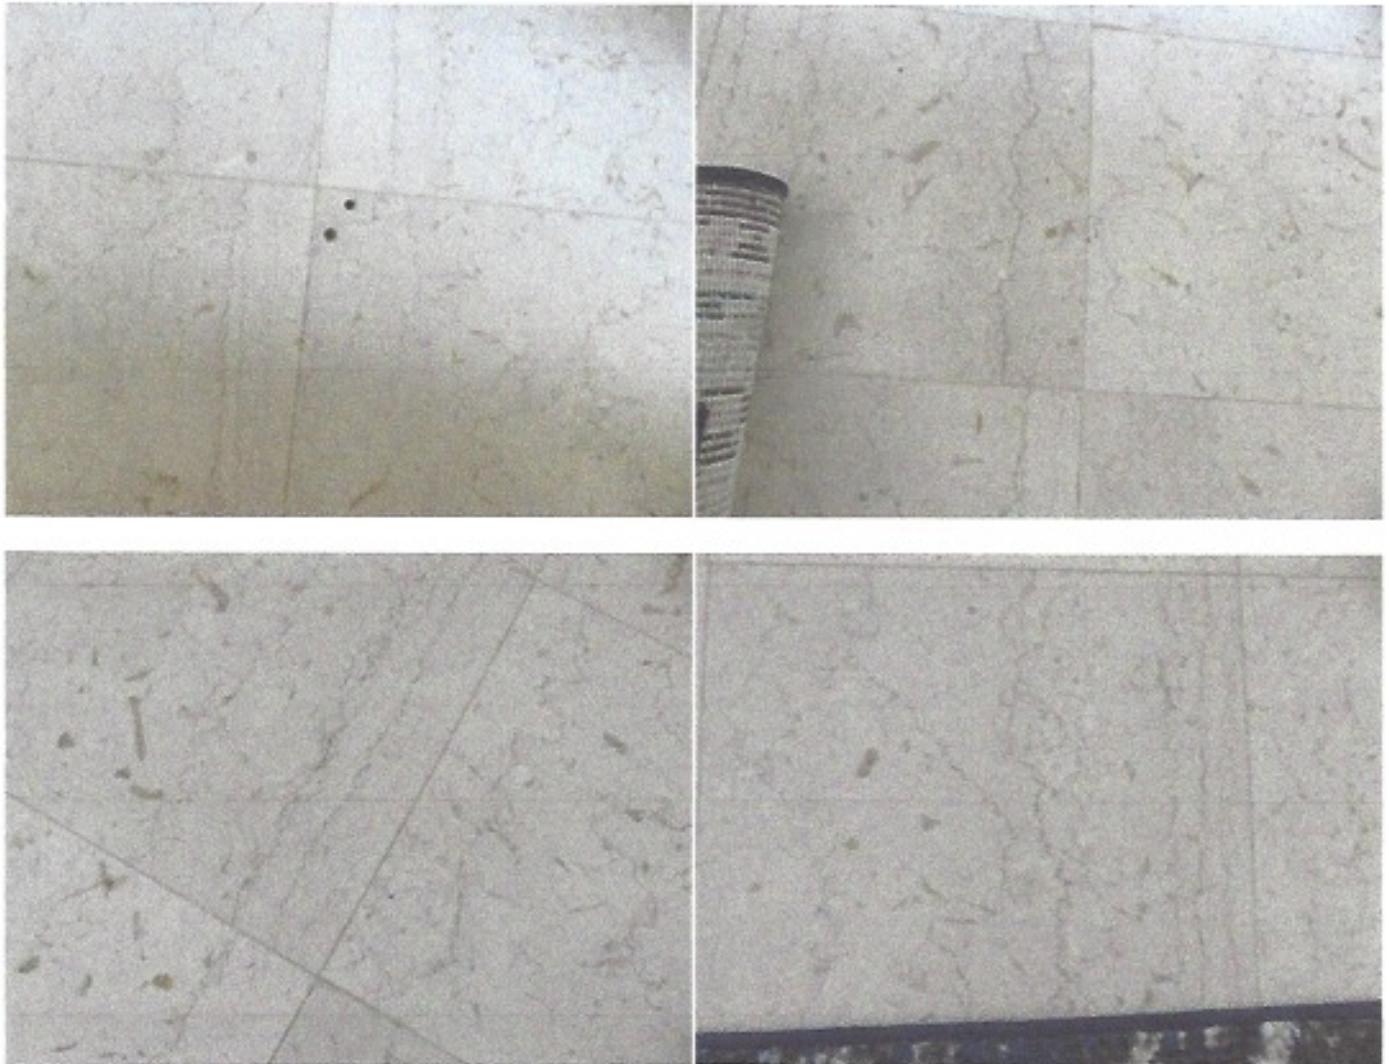
➤ Flooring in the foyer displays holes and cracks.

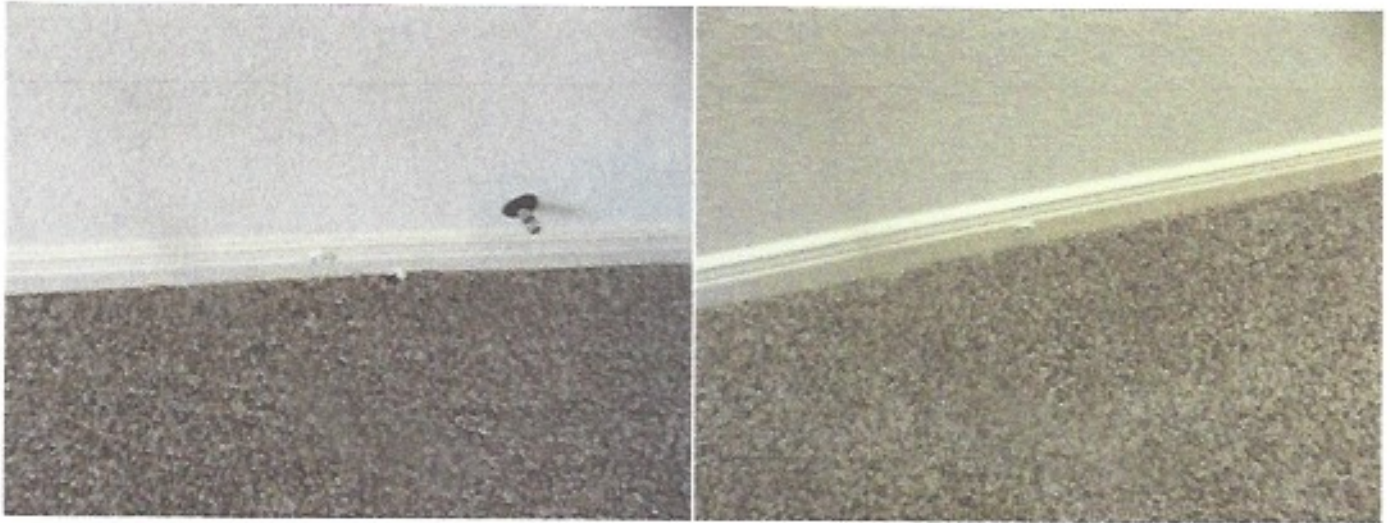
- Doors lacking stoppers should be so supplied.

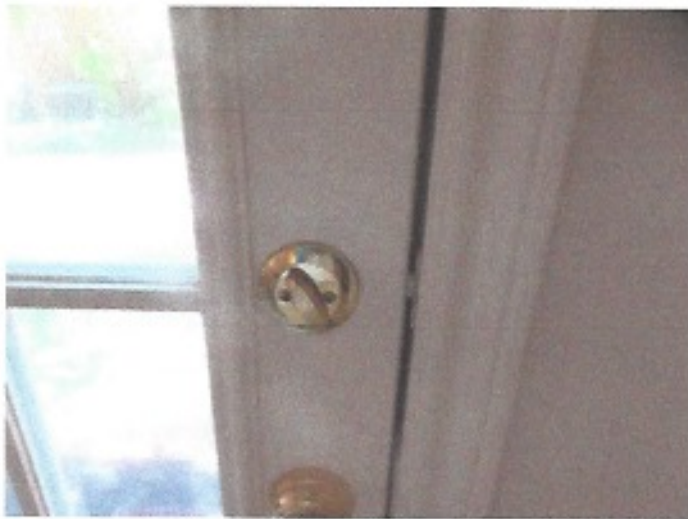
- The left side porch door was unable to be opened.

* Replacing deadbolt

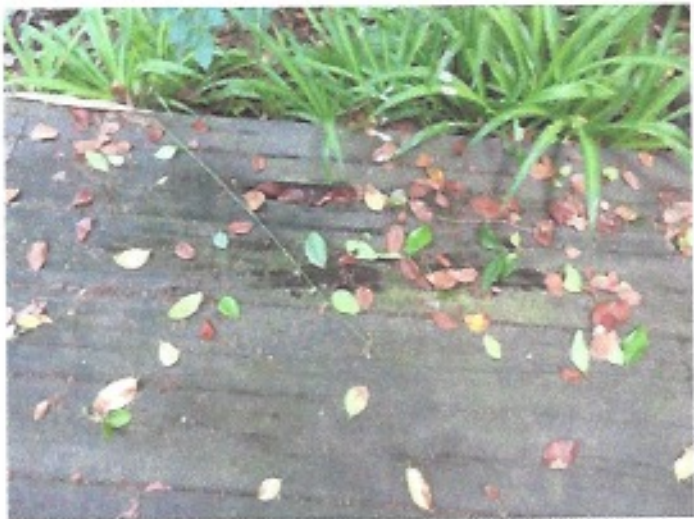
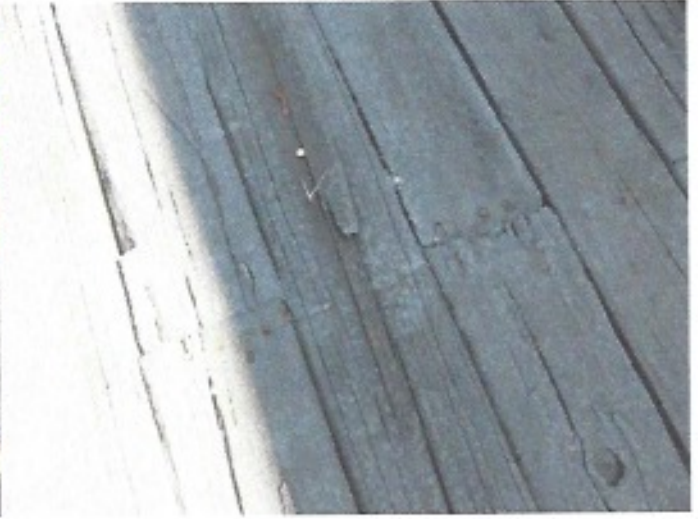
- In the opinion of the inspector the wooden decks appeared in below average condition displays deterioration, splintering and the potential of retaining water beneath them.

Examples * Removing back deck

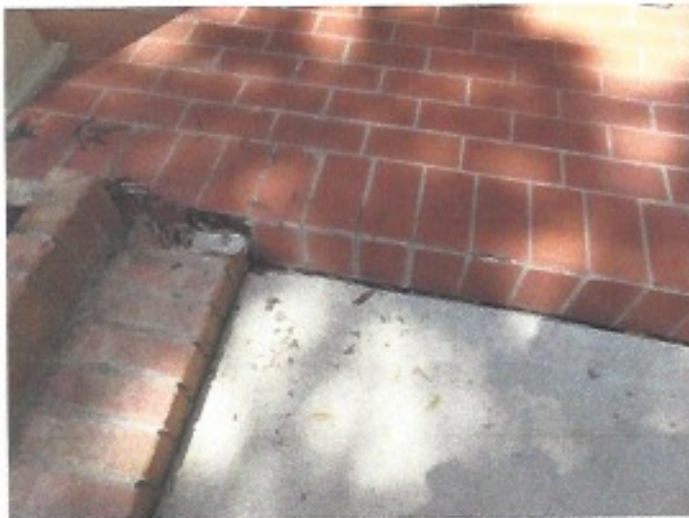
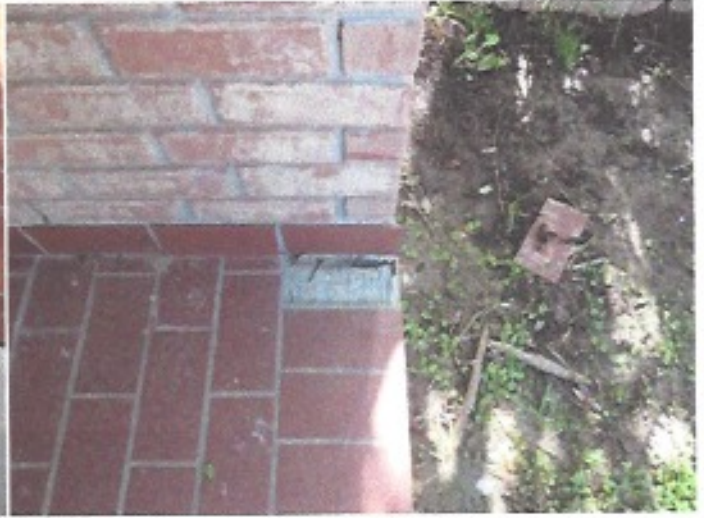
- The front and left side porches display loss of tile.

fixing tile

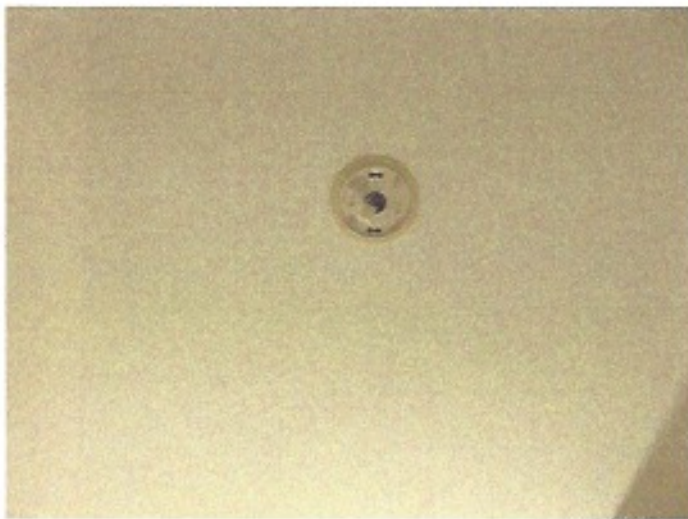
- TX State Law requires bedrooms, and rooms that will be utilized as sleeping rooms, to be equipped with smoke detectors. Current requirements also require smoke detectors in hallways outside the bedrooms and in the general living areas of the home (all floors). Hard wired, rather than battery operated, smoke detectors are required in all instances and must be synchronized and sequential in their operation with sufficient audible resonance to alert all bedrooms and residents of the home in the event of fire outbreak. Monthly inspection and testing of these appliances is recommended. Do not install smoke detectors within 3' of climate control vents or ceiling fans. IRC {314.3}.

* there is one in the
hall. Inspector did
not include the
picture

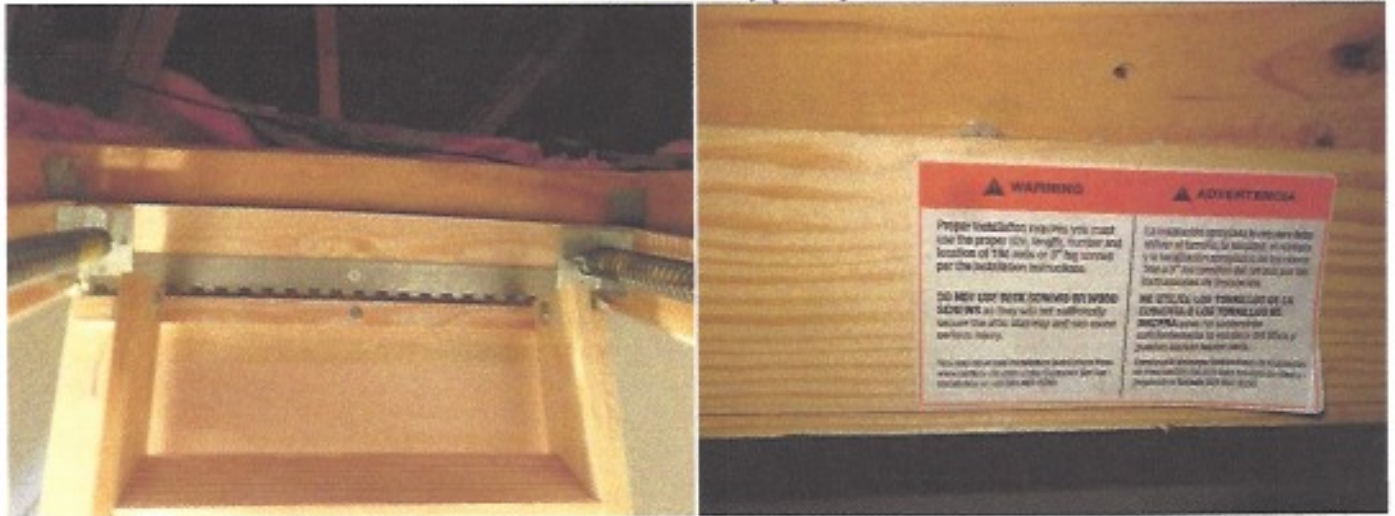
- The attic stairs are not properly secured. Securing the frame of the attic stairs to the home requires the use of either 16D nails and/or 1/4 X 3" lag bolts.

Current and statement of requirements ** PROPER SCREWS WERE USED instead of nails*

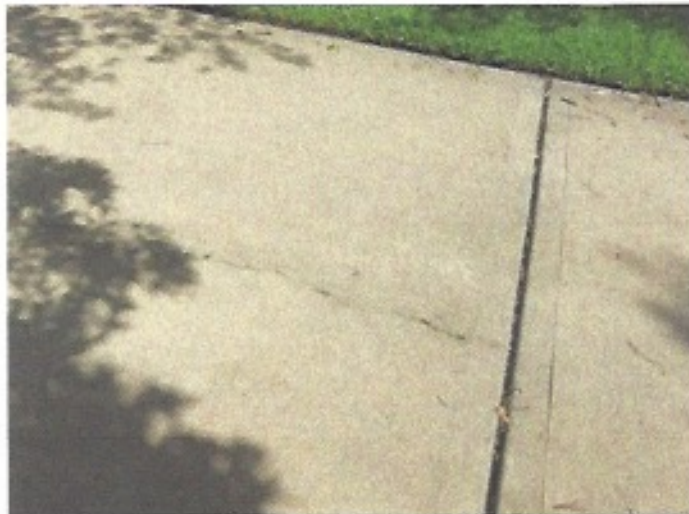
- The driveway displays cracks and loss of expansion joint materials.

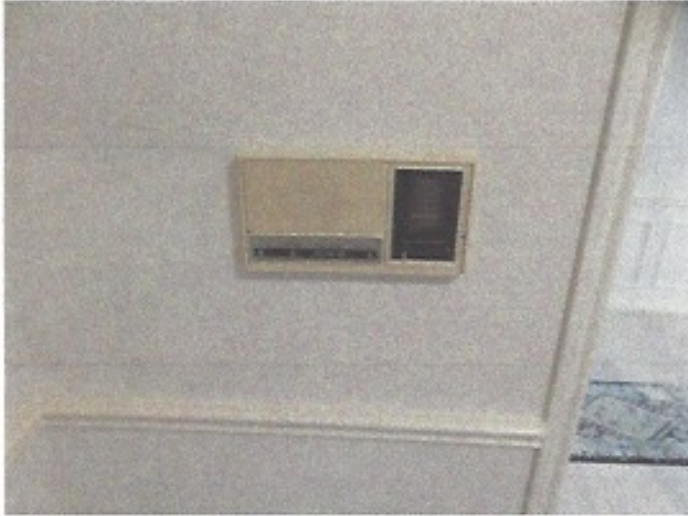
✚ The intercom system was not tested/inspected.

intercom does not work

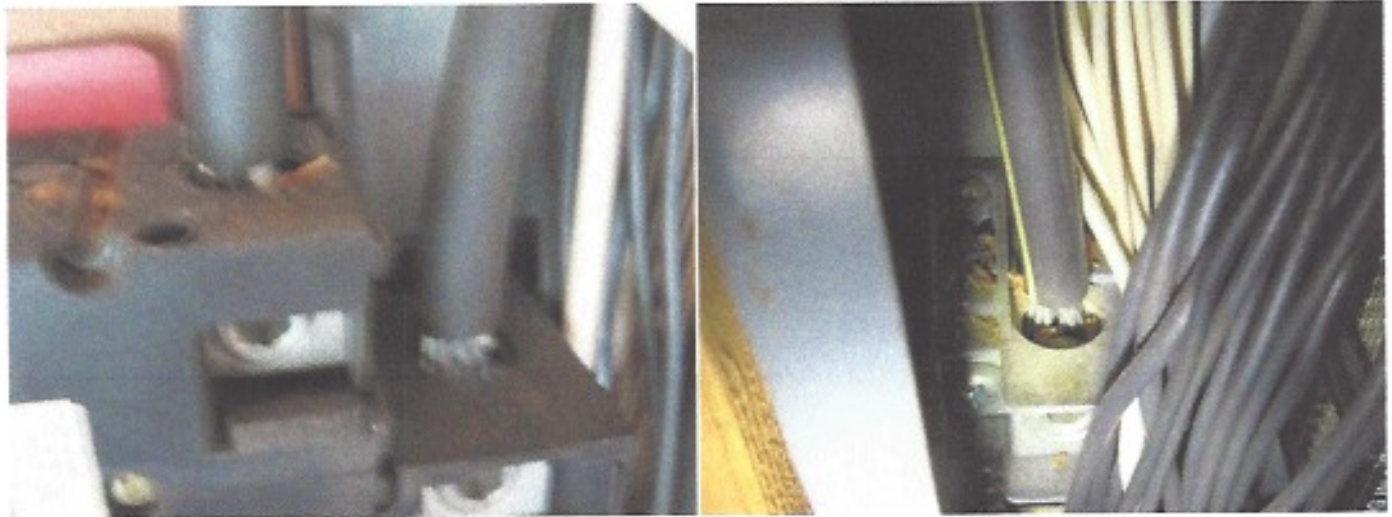
- Aluminum service wiring requires anti-oxidizing agent at entry points to the main breaker and neutral bar.

* Repaired

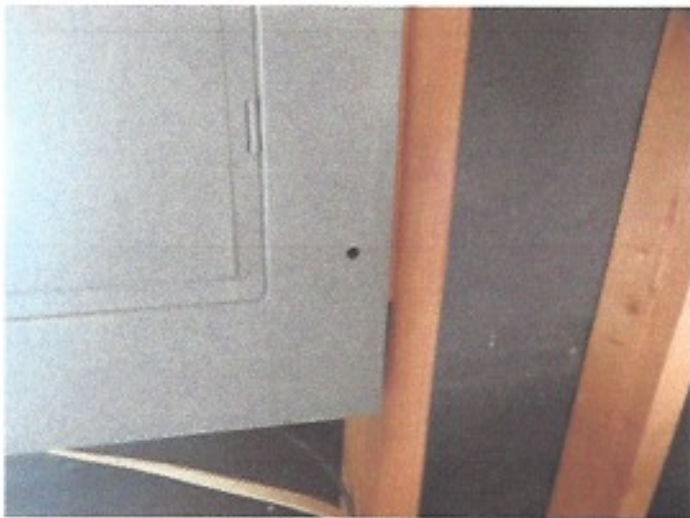
- All screws are required to secure the dead front to the panel.

** Repaired*

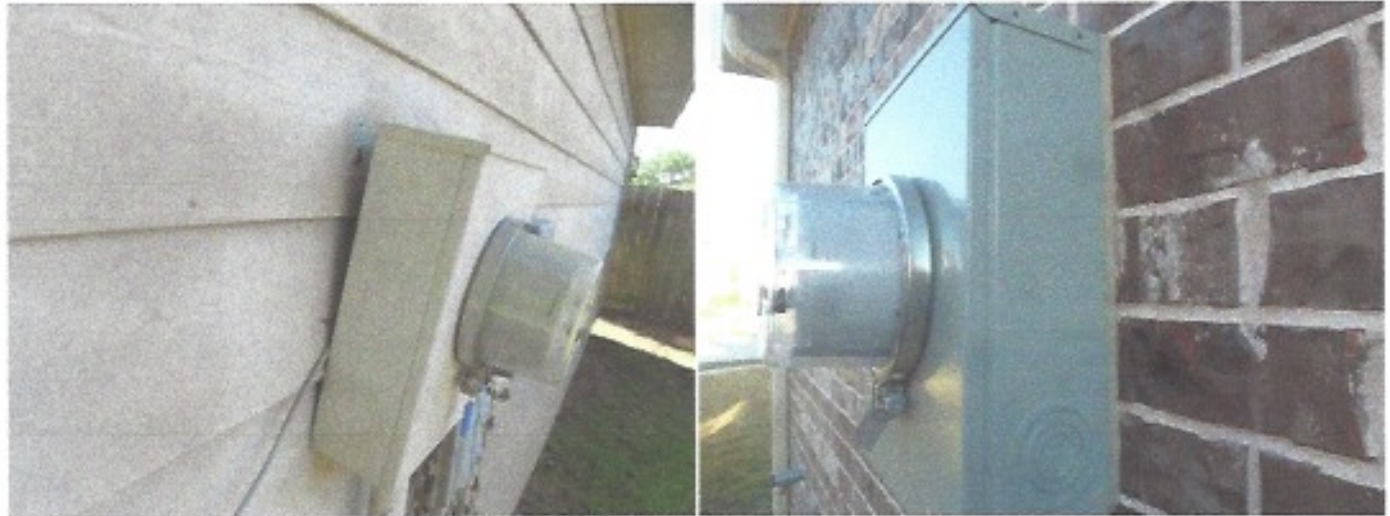
- The electric panel box(s) should be secured to the structure and caulked around its perimeter (including between panels) to assist in preventing water from accumulating behind the box at the porous wall substrate creating the potential for wall damage.

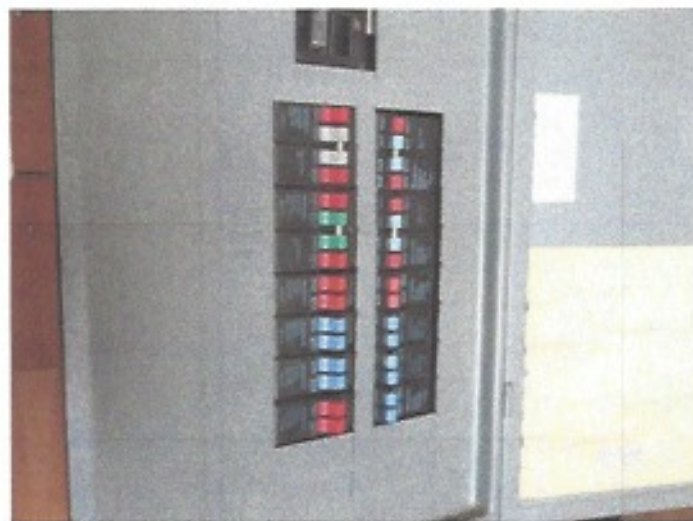
- Individual circuit breakers for the home are not labeled in the service entrance panel for specific areas, fixtures and/or appliance as required. General labeling is prohibited. The purpose of an accurate and legible circuit breaker directory is to provide clear identification of the breakers that may need to be operated by service personnel or others who may need to operate a breaker in an emergency. (NEC 408.4)

** repaired*

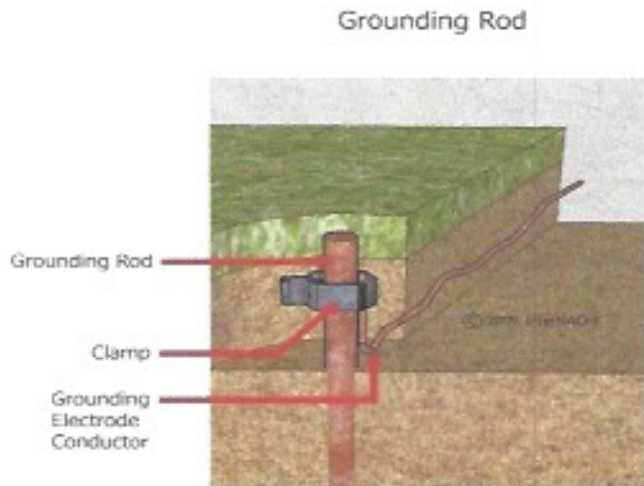
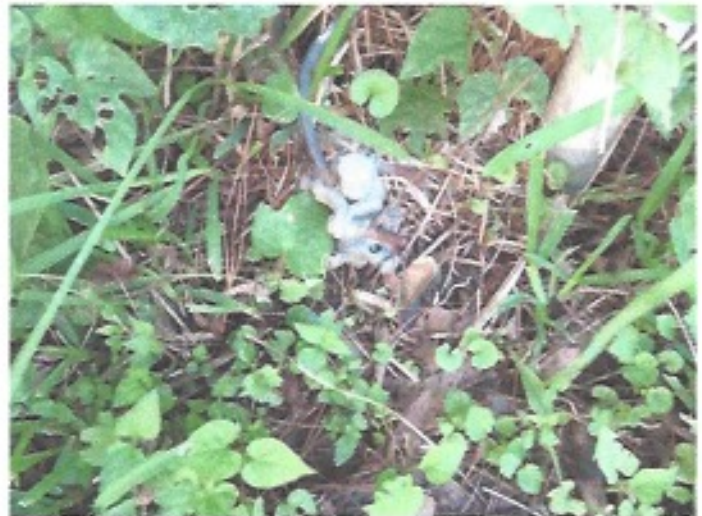
- The electric system grounding rod is required to be 8' long (not verified) and should be fully driven into the ground to provide optimum grounding connection to earth and to prevent it being accidentally damaged or personal injury result from contact.

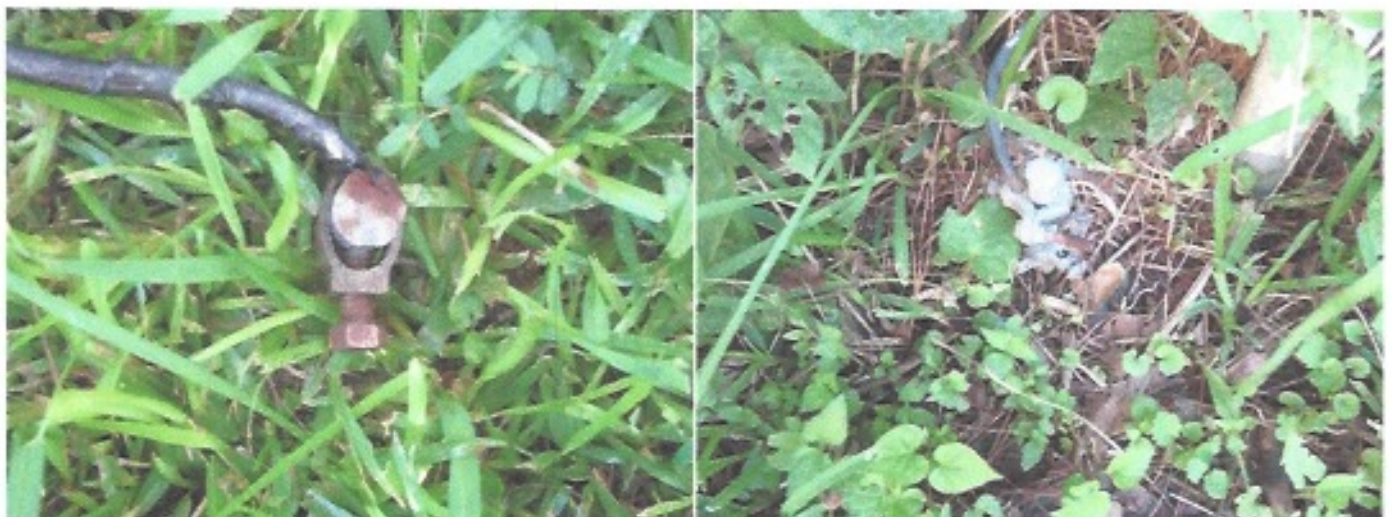
- The installed grounding clamp at the ground rod is for use in a natural gas pipe application. Grounding rods are required to have an acorn grounding clamp.

** Repaired*

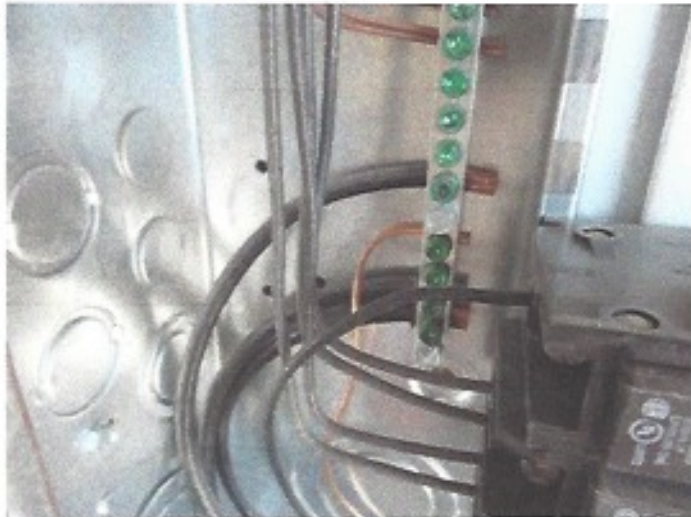
- Panels are required to have at least 2 points of grounding to earth via ground cables.

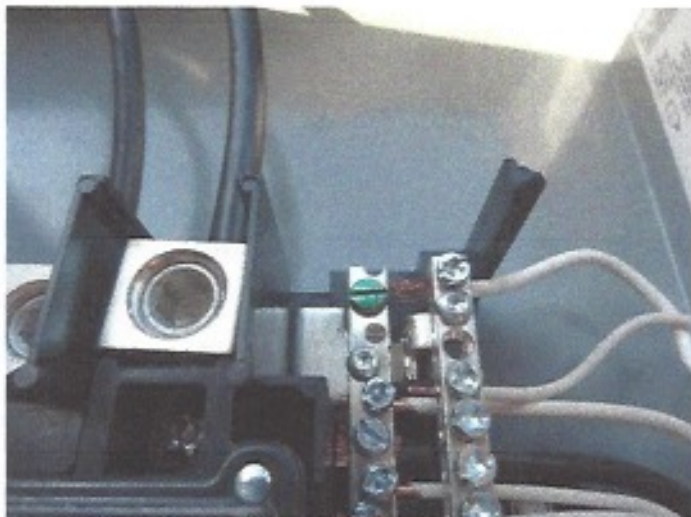
- The ground and neutral bar, required to be in contact with the panel, do not appear to be. Normally a green grounding screw inserted in the bar at the top through the hole provided is present.

to repaired

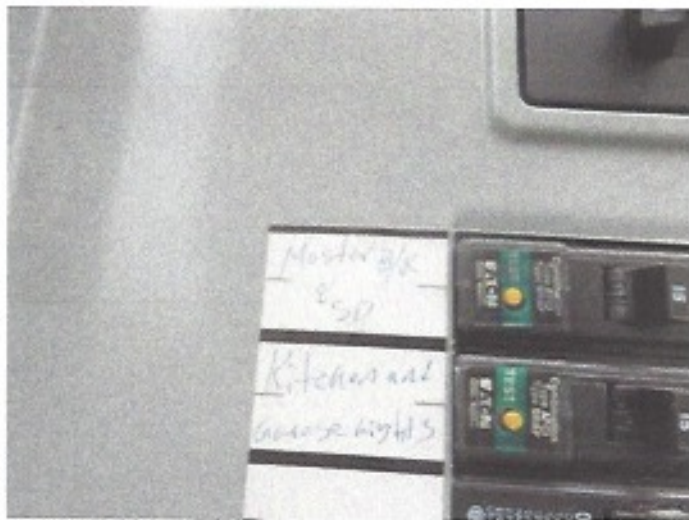
As of approximately 1/1/2008, all electrical fixtures, outlets, switches and smoke detectors in the home wired to single-pole 15 or 20 AMP circuit breakers {3902.11/IRC}, other than those apparatus protected by GFCI or GFCI/AFCI combination safety device, are required to be wired to AFCI safety circuit breakers in the main panel. Arc Fault Circuit Interrupt's are not installed as per the construction date of this home but can be added for fire safety coverage.

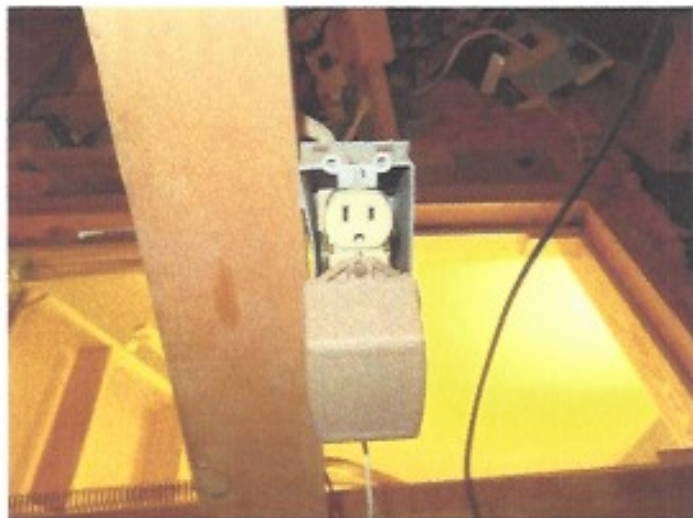
- All light switches and outlets are required to be provided a safety cover plate.

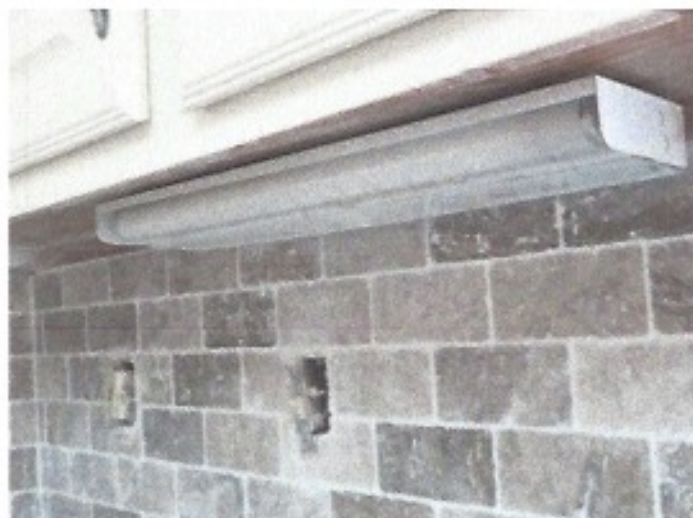
- The left kitchen under-cabinet light did not illuminate.

changed the bulb

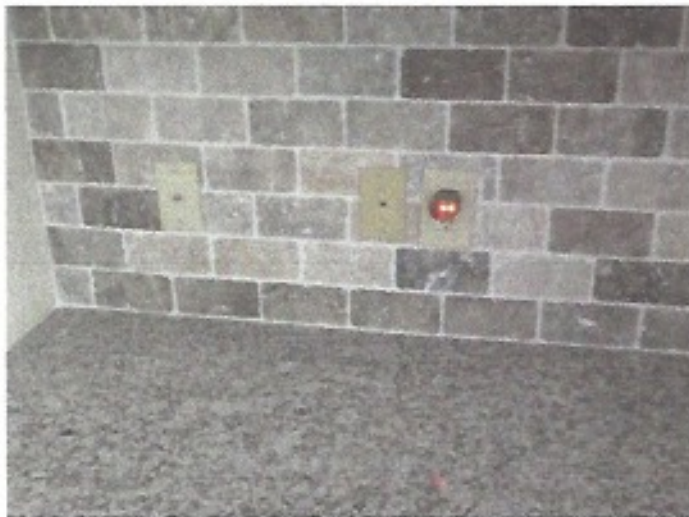
- All 15 – 20 AMP kitchen countertop outlets are required to be GFCI safety rated/protected. As of 9/2014, this includes the dishwasher and disposal outlets, if accessible - IRC{210.8(D)}.
- The outlet to the right of the oven is not GFCI rated as required.

* this is a desk - not a kitchen counter. no water next to it

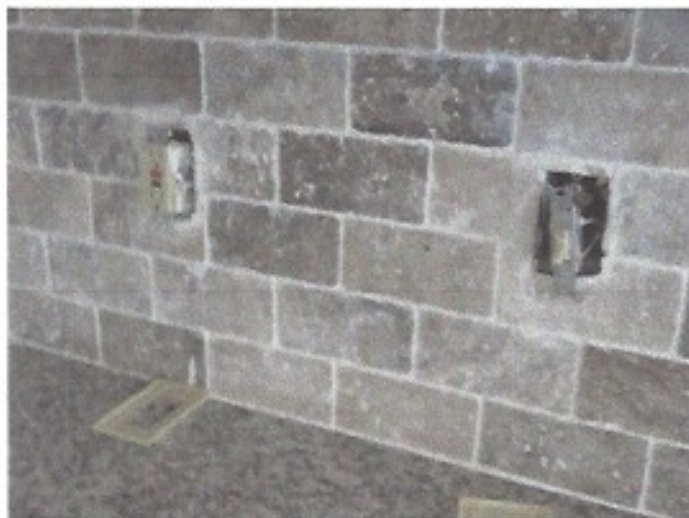
- All outlets and light switches are required to have safety cover plates.

* put the covers back

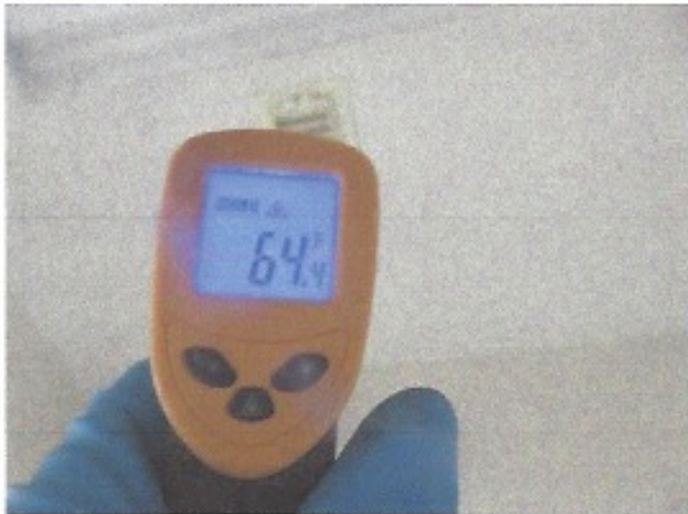
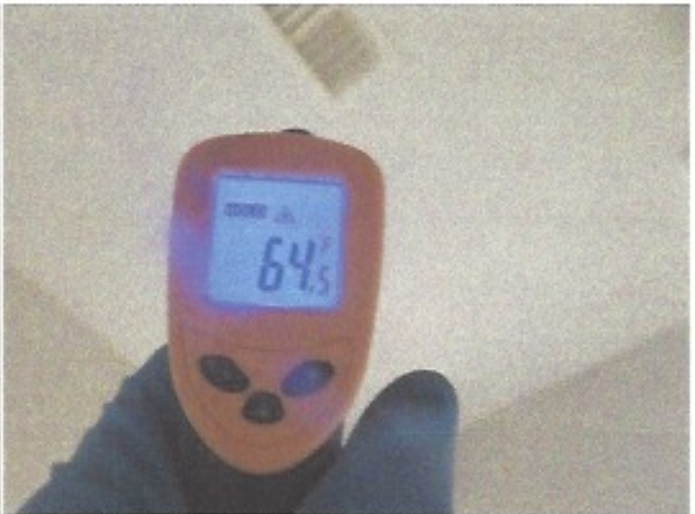
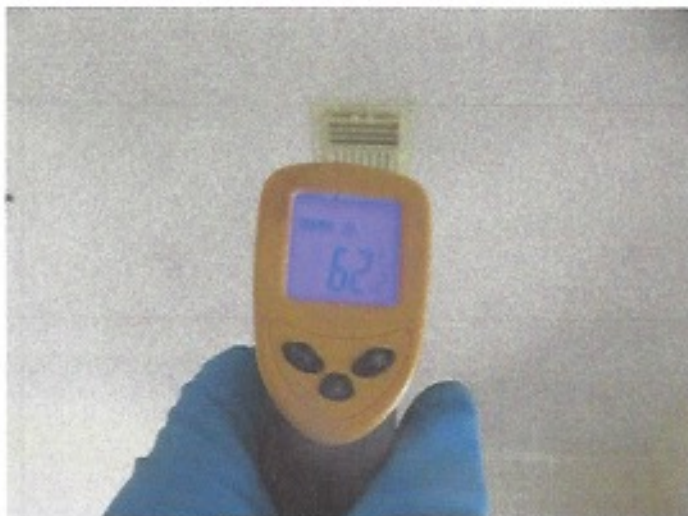
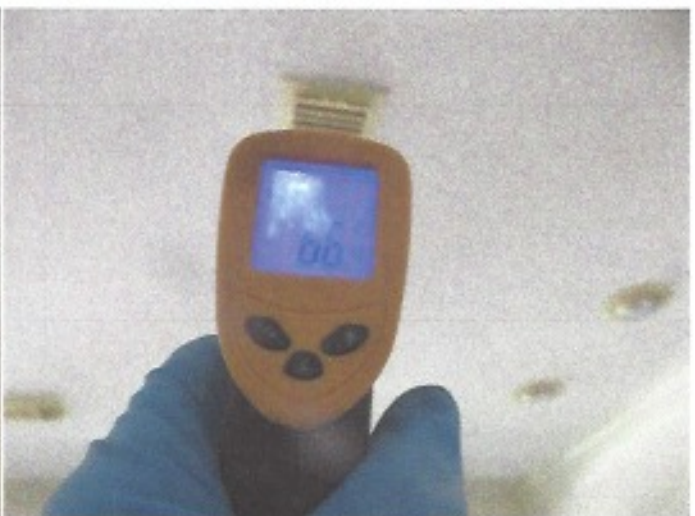
When operationally tested, the temperature differential between supply (conditioned air) and return air measured between 9°F and 13°F throughout the home. This measurement is outside the acceptable range of temperature differential of 16°F to 21°F and the unit did not appear to be installed or functioning as intended at the time of the inspection as noted by example(s):

- Supply (4) and return temperature examples around the house (10°F to 13°F temperature differential)

* added coolant
A/C is cooling
properly

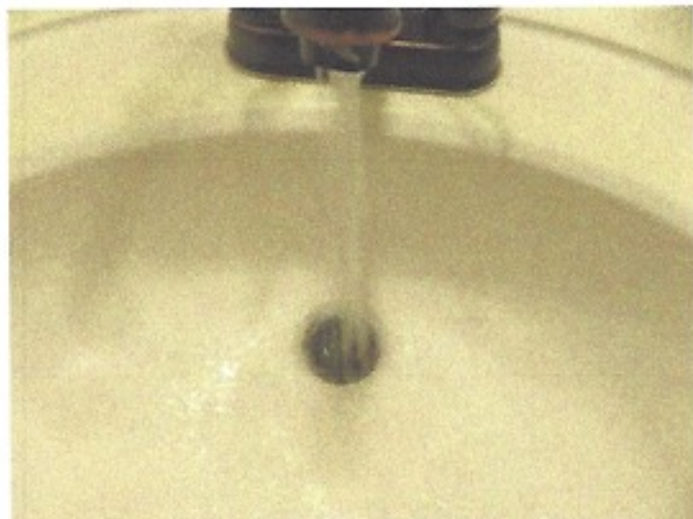
- The left sink in the guest bathroom lacked adequate water flow.

changed filter

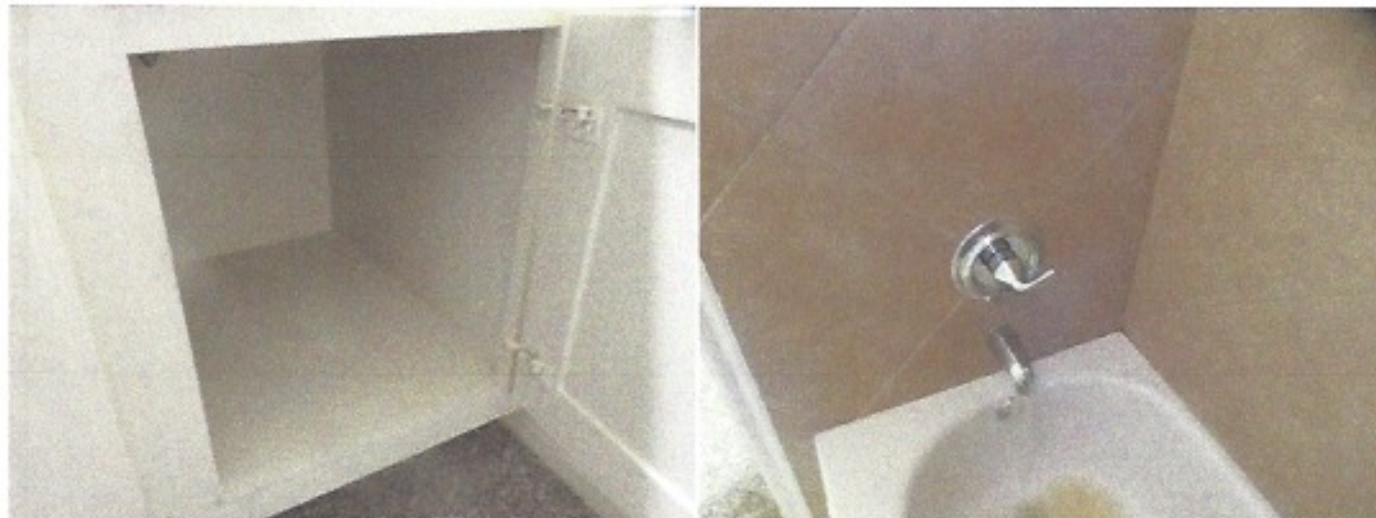
- Guest bathroom tub lacking ready access

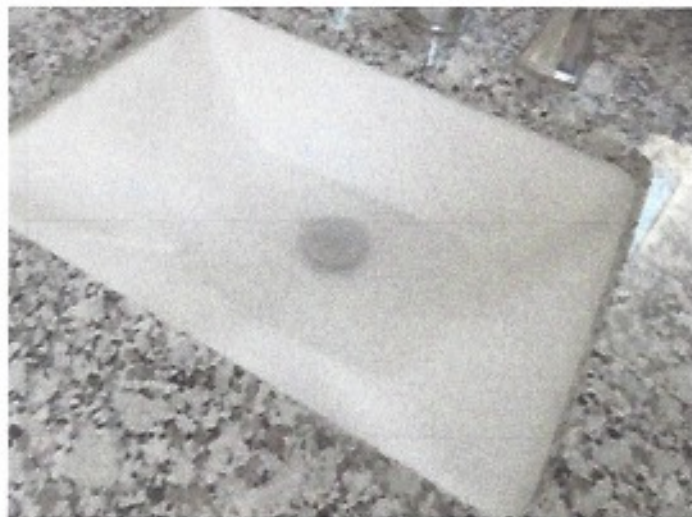
- The left sink in the Master bathroom was not functioning.

* could not duplicate
It drains fine
