X X **B. Grading & Drainage**

Joseph and Cara Stogner, 3318 S. Lake Village Drive, Katy, TX 77450

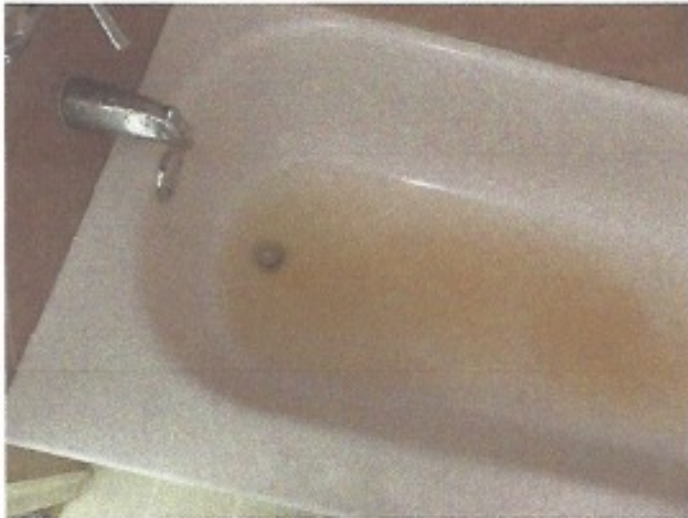
- The bathtub stopper in the guest bathroom was not functioning. Initial brownish water was present.

water in the bath
had not been turned
on in a long time.
That's why brown
came out.

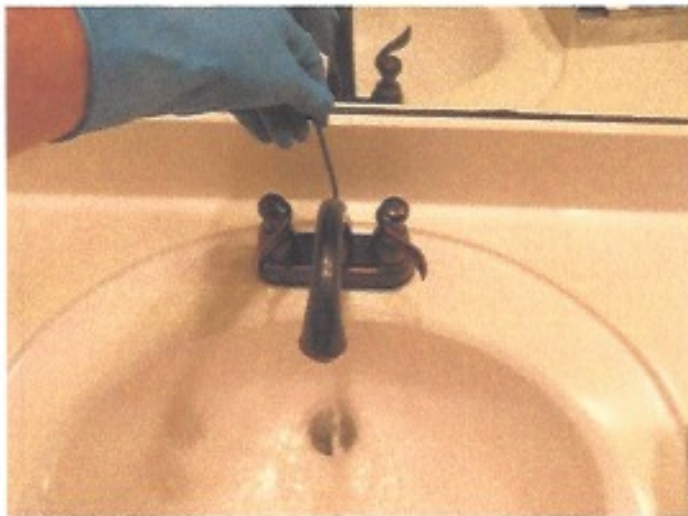
- The left sink stopper in the guest bathroom was not functioning.

* Repairing

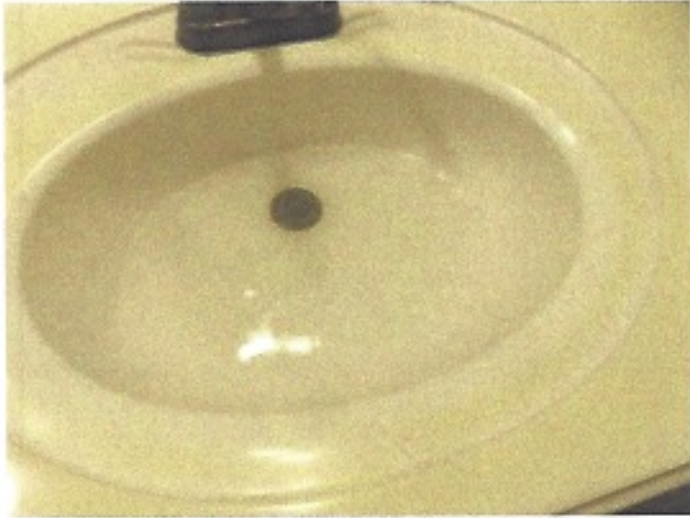
- The right sink in the guest bathroom was not functioning.

* will evaluate

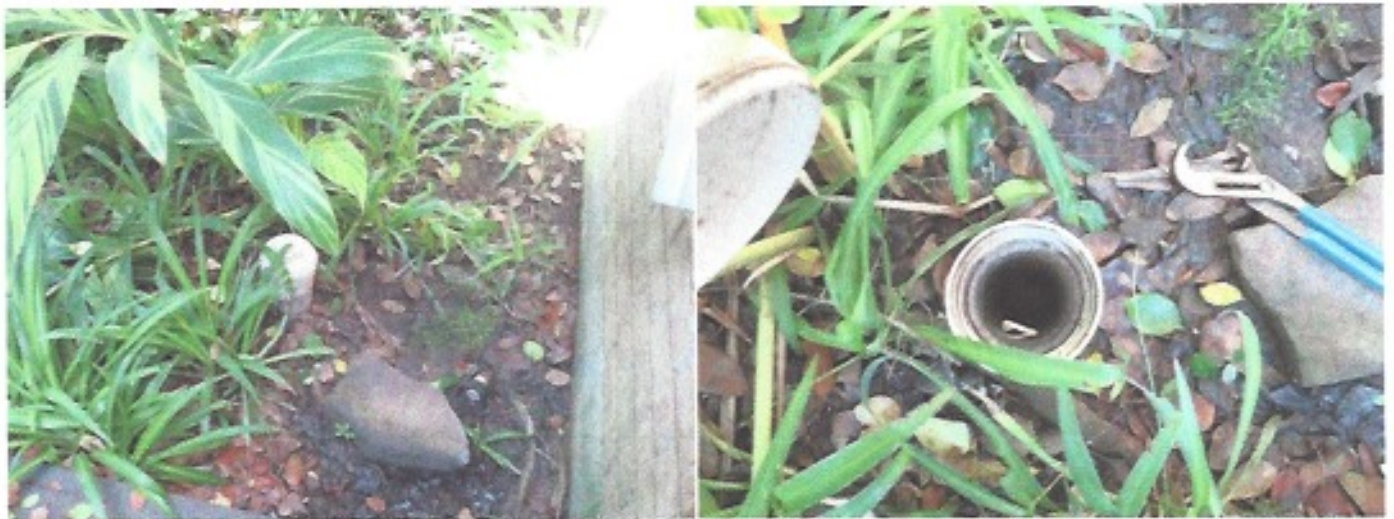
- The main drain clean-out for the home is located in the rear plantings adjacent to the deck. There is a wire extended into the drain pipe.

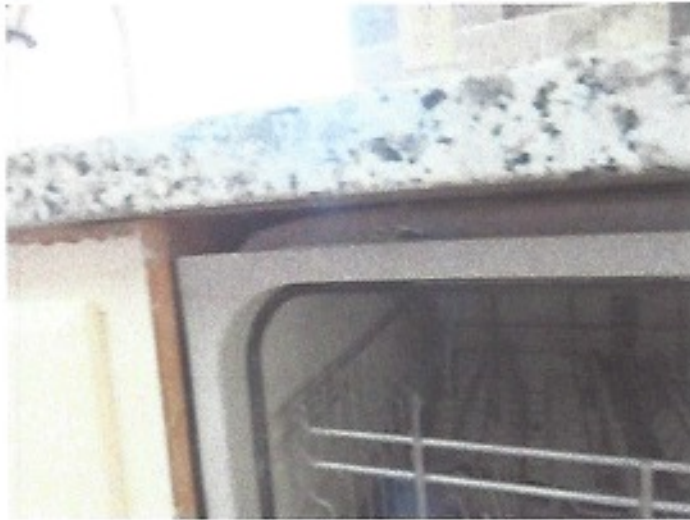
- The appliance is not secure beneath the countertop and can easily tip forward.

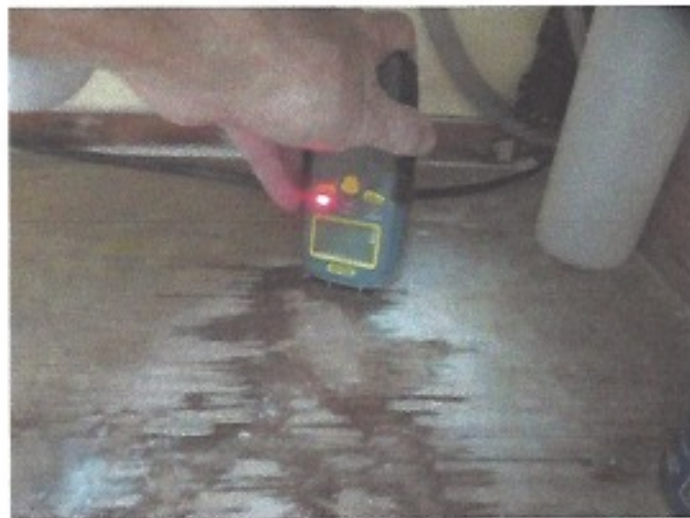
- There is a wet spot/leak beneath the kitchen sink.

* this is a stain
could not duplicate
a leak

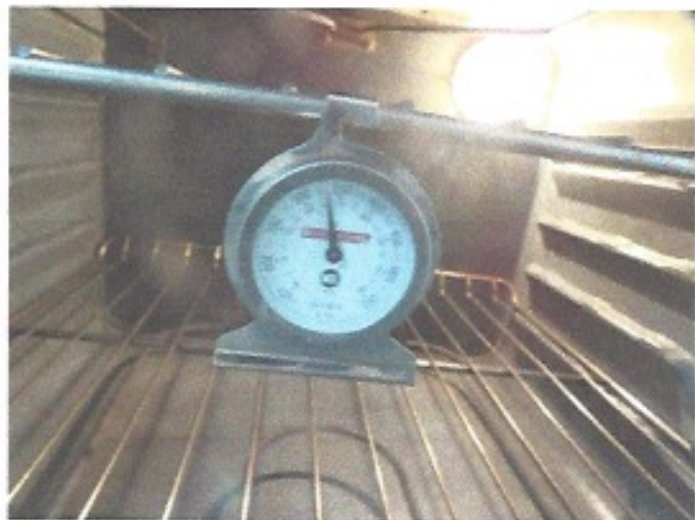
- The oven set at 350°F failed to achieve this temperature.

** could not duplicate
my thermometer
Reached 350*

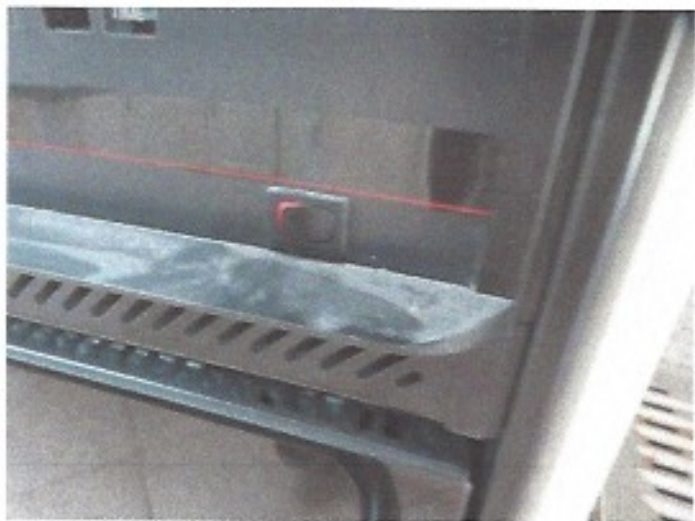
- The oven light switch did not function.

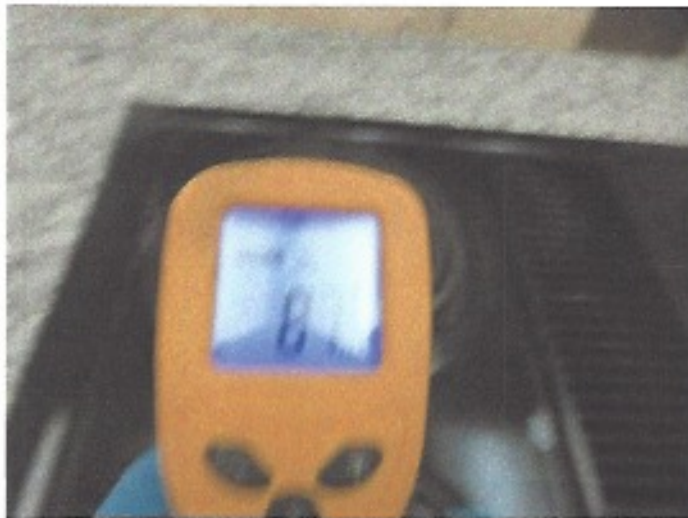
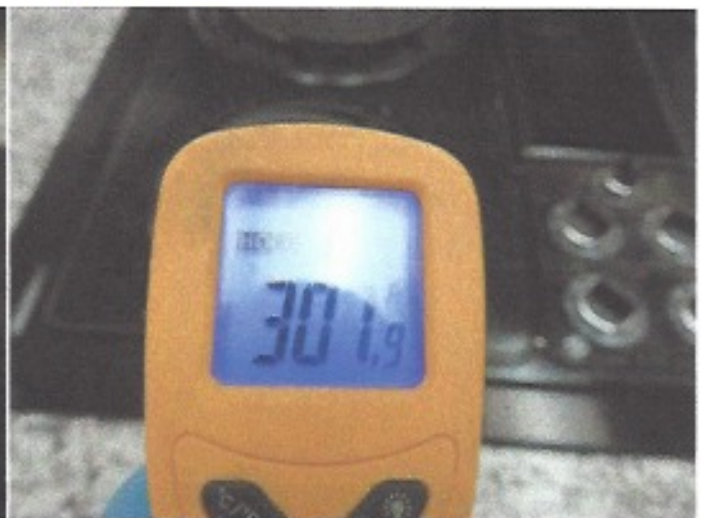
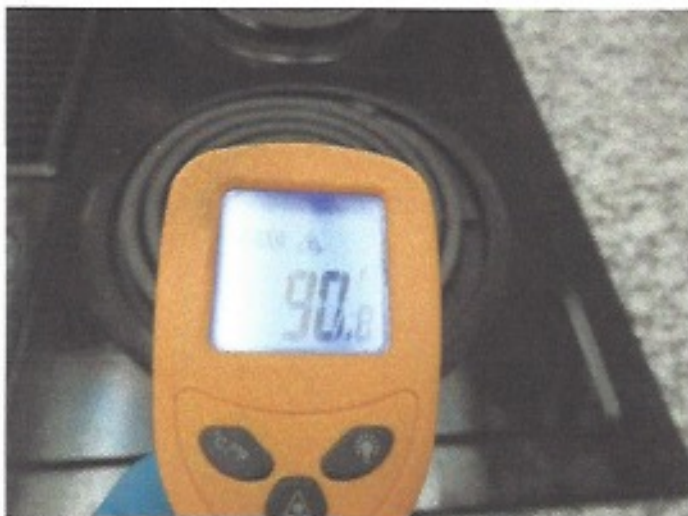
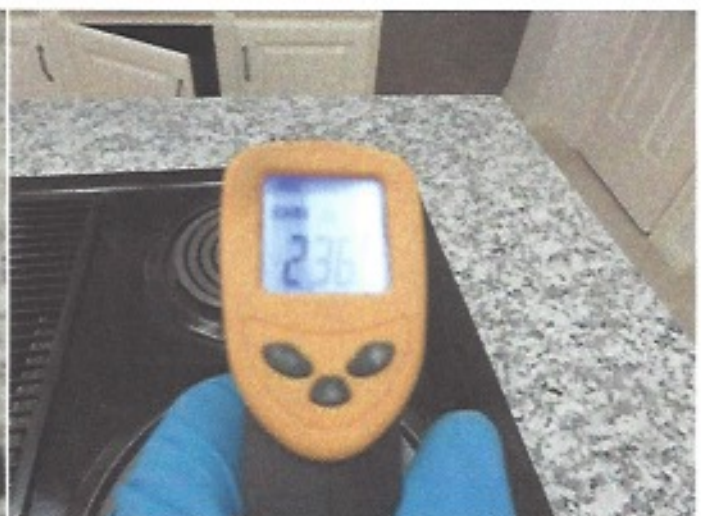
Top left, bottom left, bottom right and top right

- The top left and bottom right burners did not achieve like temperatures as others while on the LO setting.

** all 4 burners reached "Red hot" - could not duplicate*
