HOME INSPECTIONS, LLC

Inspection Report

Property Address:

210 W Bayou Dr
Dickinson TX 77539

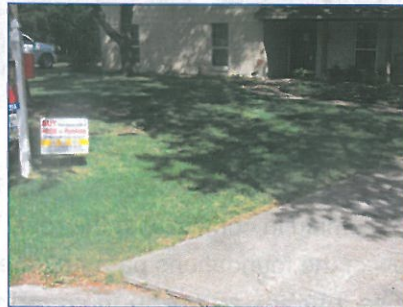
B. Item 4(Picture)

(2) **Grade Lines too High:** There are several areas where the grade lines are too high along the slabs parameter. These areas of Grade Line need to be lowered to prevent water from leaking into the weep holes and Subject Property. **Recommend lowering the grade lines along these areas.**

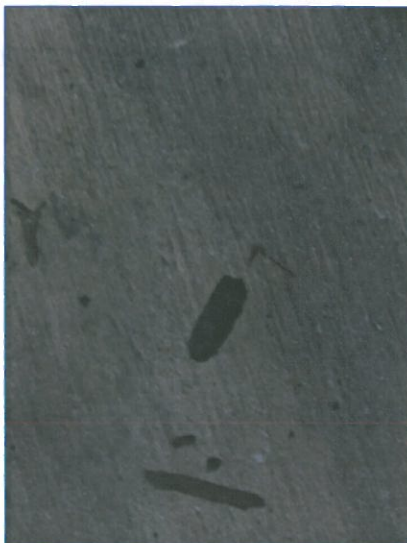
D. Item 1(Picture)

(1) **Possible Rodent Infestation:** The disturbed condition of the attics insulation indicates that this home may have had (or currently has) rodent infestation. **Recommend asking current owner about this condition and (if already treated) obtaining paperwork on any and all treatments.**

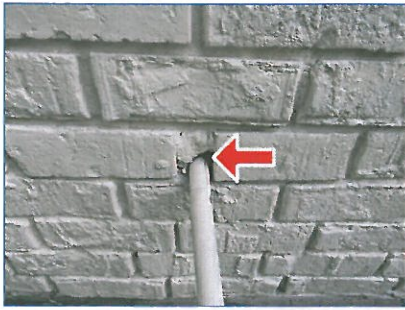
E. Item 3(Picture)

(3) **Stress Cracking on Exterior Walls:** Stress cracking in mortar lines is typically the result of foundation movement caused by differential soil movement. It will follow the rules for crack closures but is typically oriented diagonally. Cracks follow mortar lines because the mortar is weaker than the brick. We observed a number of stress cracks on the exterior walls. This could be caused by foundation settlement or other house movement. **Recommend having these areas fixed and repaired as needed.**

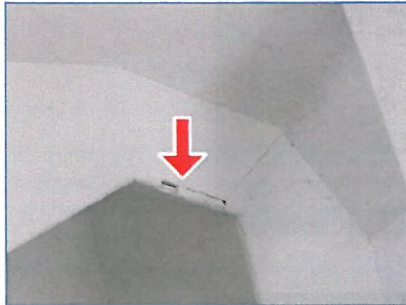
F. Item 1(Picture)

- (1) **Ceilings:** Below are some documentation photos followed by any noted deficiencies or concerns (if any):
- (2) **Floors:** Below are some documentation photos followed by any noted deficiencies or concerns (if any):
- (3) **Stress Cracking on Ceilings:** We observed a number of stress cracks on the ceiling. This could be caused by foundation settlement or other house movement. **Recommend having these areas fixed and repaired as needed.**

(3) **Stress Cracking on Ceilings:** We observed a number of stress cracks on the ceiling. This could be caused by foundation settlement or other house movement. **Recommend having these areas fixed and repaired as needed.**

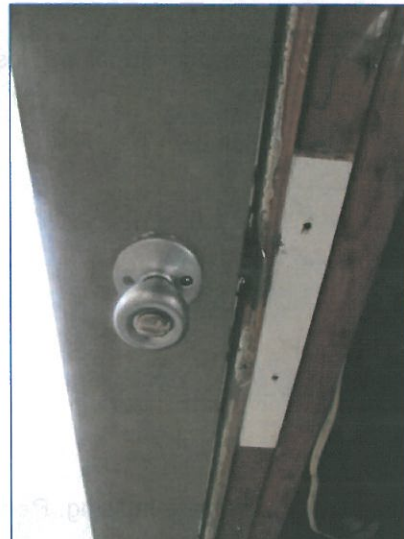
G. Item 16(Picture)

(2) **Weather Stripping:** Weather stripping is inadequate. **Recommend having this replaced with new weather stripping.**

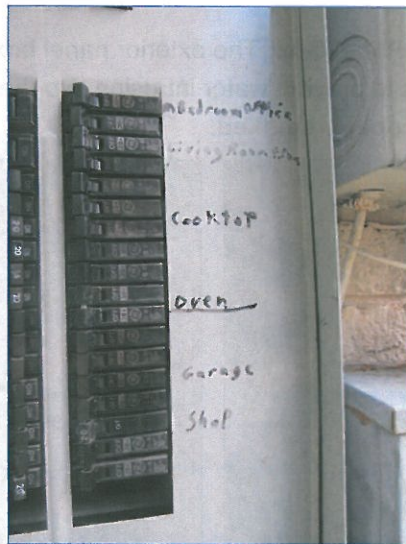
A. Item 11(Picture)

(4) **Dead Front Repair:** Dead front is in need of repair. **Recommend having this corrected as needed.**

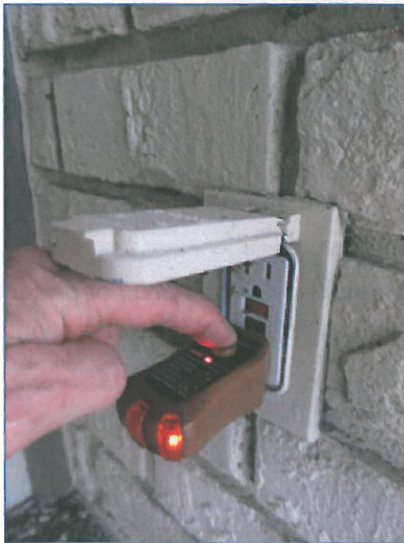
B. Item 1(Picture)

(1) **GFCI - Exterior:** The exterior outlets are not properly equipped or protected with GFCI outlets.

Recommend having this corrected by a licensed electrician.

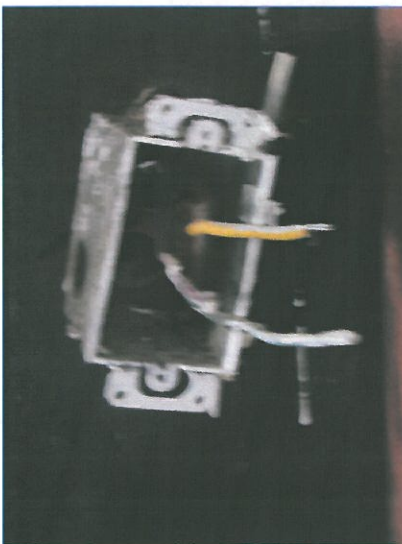
B. Item 11(Picture)

(7) Garage has exposed wiring that should either have a light attached or be properly terminated.

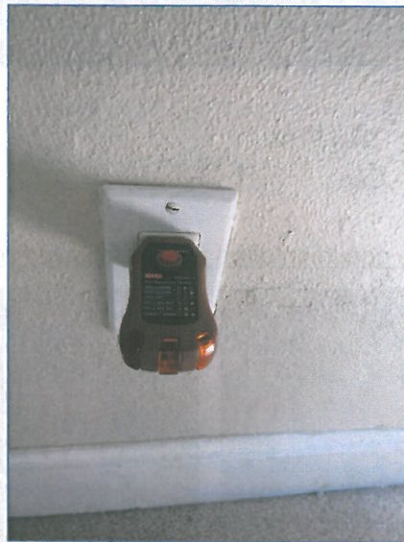
B. Item 18(Picture)

(10) **Interior Outlet Covers:** We discovered several interior outlet covers in need of replacement.

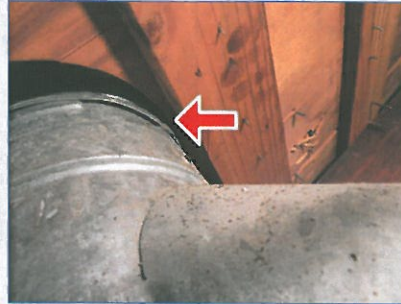
A. Item 8(Picture)

(3) **2 Inch Clearance Required:** The furnaces flue does not have the required 2 inch clearance between flue and (roofs) sheathing. This could be a safety issue and needs to be corrected. **Recommend having this fixed or repaired as needed.**

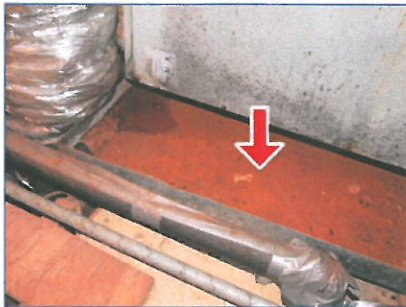
A. Item 9(Picture)

(4) **Drip Pan (Excessive Rust):** We observed excessive rust in the drip pan under the furnace. **Recommend this drip pan be replaced.**

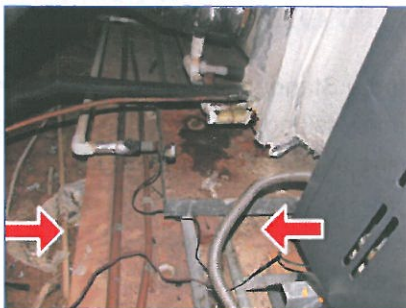
A. Item 10(Picture)

(5) **Inadequate Decking for Furnace:** Furnace does not have the required 36 inches of decking in front of the unit. The is required to give adequate space for and HVAC technician to perform service to the unit. **Recommend having decking installed in this area.**

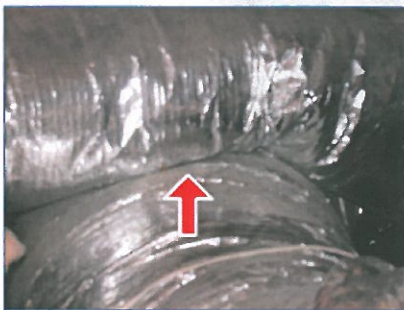
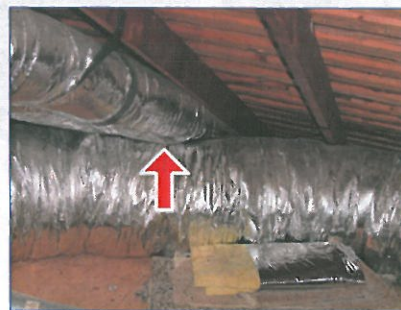
Ducts in Contact: Some of the duct systems are coming in contact with each other. This could cause excess sweating which could, in turn, cause water stains on the ceiling below. **Recommend placing batt insulation between these duct to prevent this from happening.**

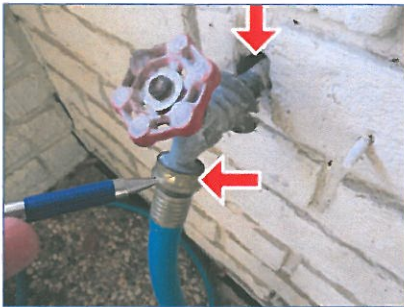
A. Item 8(Picture)

(4) **Exterior Faucet Leaks:** Several of the exterior faucets leak when turned on. **Recommend having fixed or repaired as needed.**

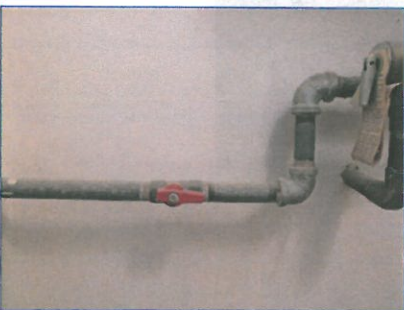
C. Item 5(Picture)

(2) We were unable to gain direct access to the tankless water heater located in attic space outside of rear door.

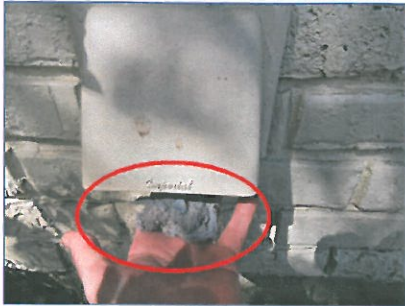
H. Item 1(Picture)

(1) **Clean Dryer Vent:** We observed excess lint caught in the dryer vent. **Recommend having dryer vent cleaned.**

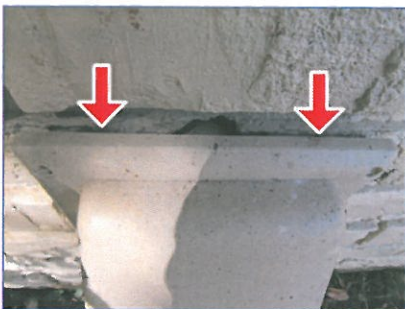
H. Item 2(Picture)

(2) **Exterior Dryer Exhaust Vent:** Exterior Dryer Exhaust Vent is not properly attached. **Recommend having this fixed or repaired as needed.**

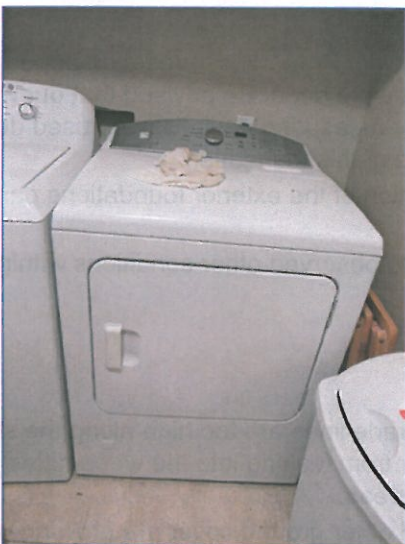
H. Item 3(Picture)

(3) **Unable to Inspect:** We were unable to inspect the dryer exhaust system directly due to a dryer obstructing our view.
