### HOME INSPECTION REPORT

# PROPERTY INSPECTION REPORT

<b>Prepared For:</b>	Eric Cantu	
	(Name of Client)	
<b>Concerning:</b>	17247 Mitchell Pass Ln, Humble, TX, 77346	
	(Address or Other Identification of Inspected Property)	
<b>By:</b>	David Jones (# 22116) Charles Rowden (# 22155)	2-13-2020
	(Name and License Number of Inspector)	(Date)
	(Name, License Number of Sponsoring Inspector)

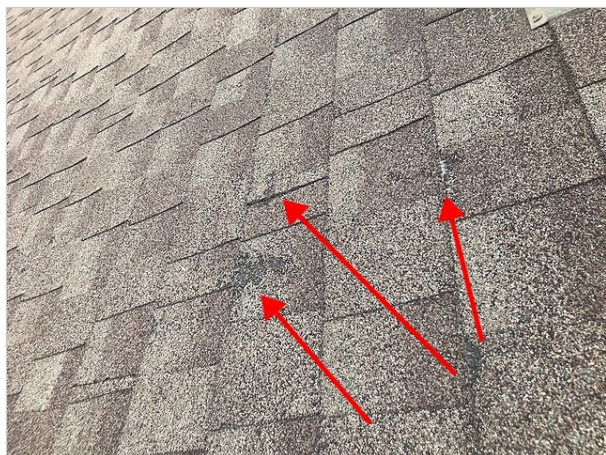
Some of the shingles were damaged.

Damaged shingles

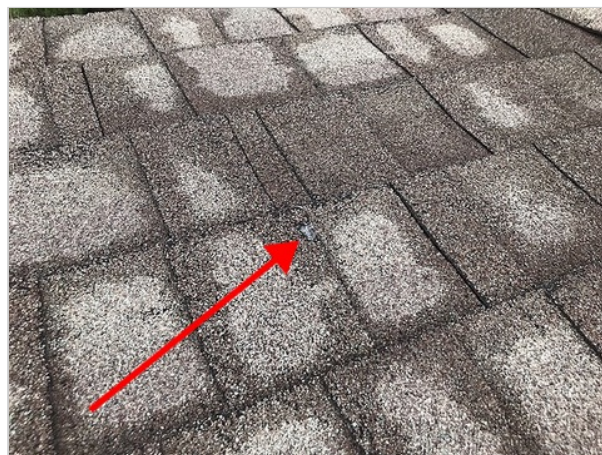
Damaged shingle

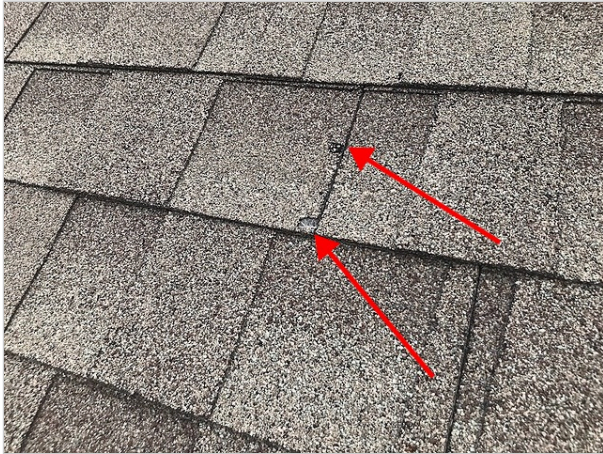
Damaged shingle

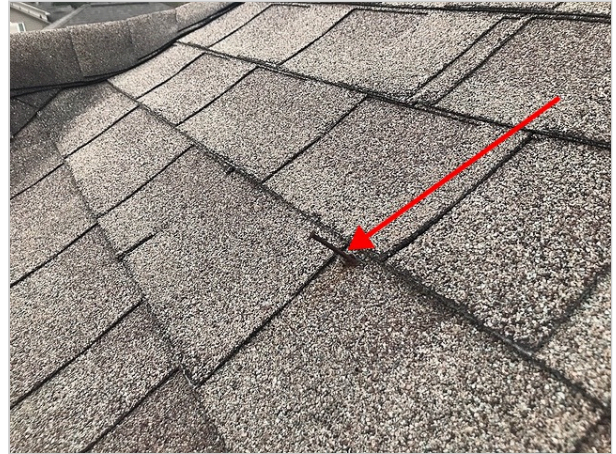
Nails were backed out or driven through shingles in one or more locations. These are known to be leak points in a roof system.

Nail driven through shingle

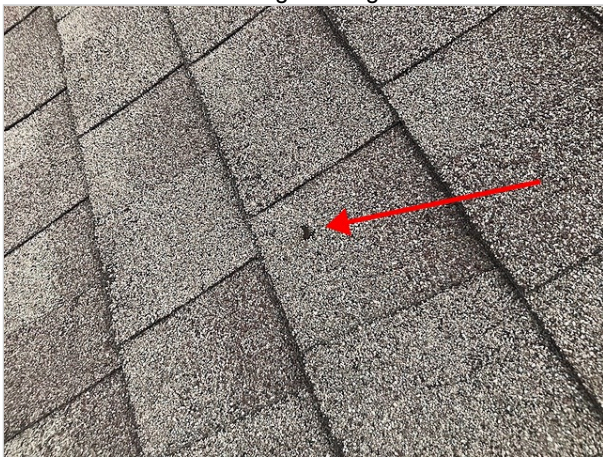
Nail backed out through shingle

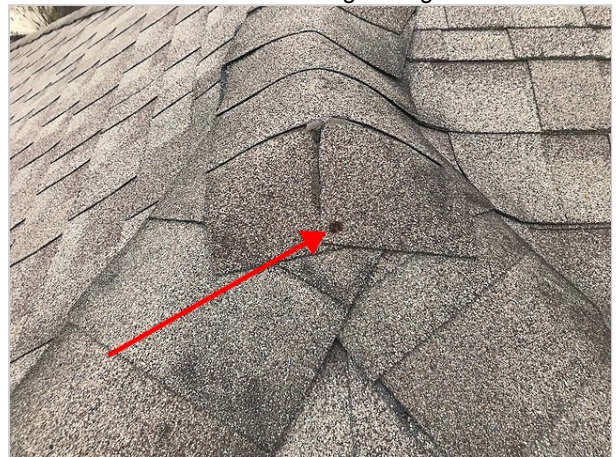
Caulking was deteriorated at several nail head locations, were exposed to the elements and showing signs of rust corrosion. As the nail rusts, its diameter shrinks but the original hole stays the same size. Possibly creating a direct path for water to enter the attic.

Nail not caulked/showing rust corrosion

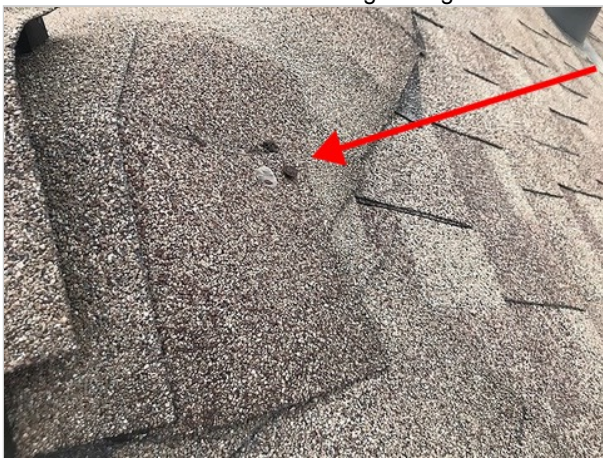
Nails not caulked/showing rust corrosion

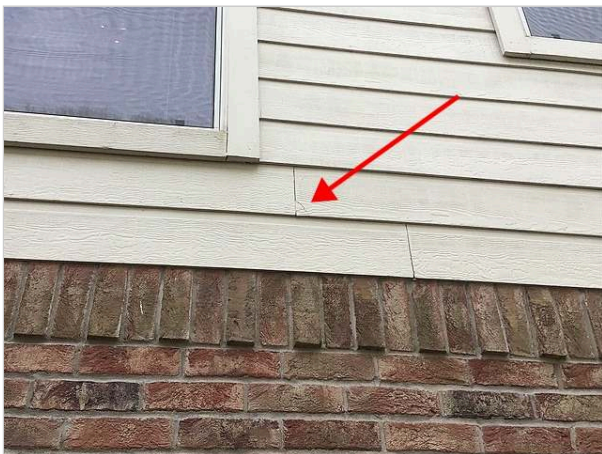
There was minor damage to the exterior wall covering in several areas.

Minor damage

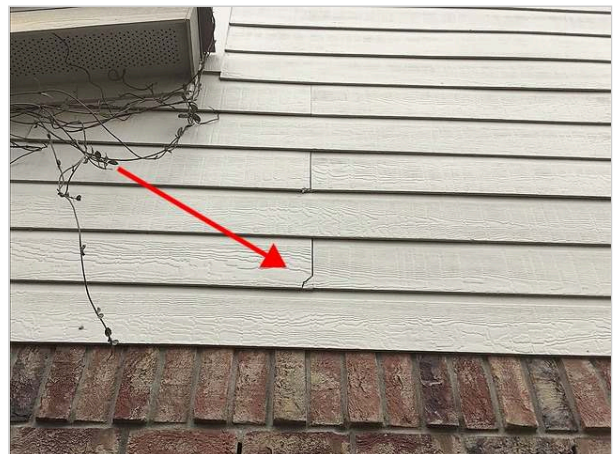
Minor damage

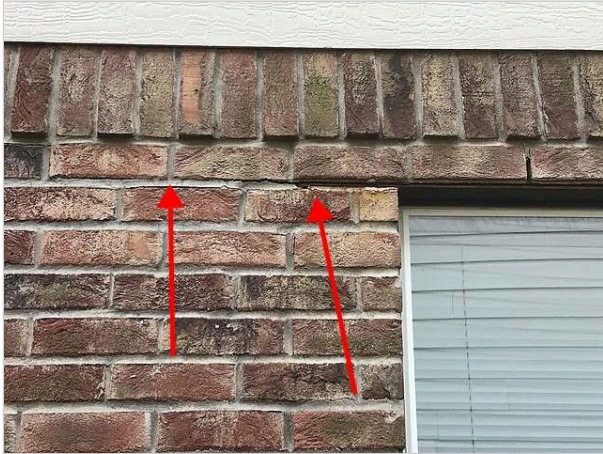
There were cracks in the brick/stone above the windows in several locations. Possibly due to a sagging header/lintel that supports the brick above the garage door opening and did not appear to be structurally concerning/significant at the time of inspection.

Crack in the brick/rusted header/lintel (right exterior wall)

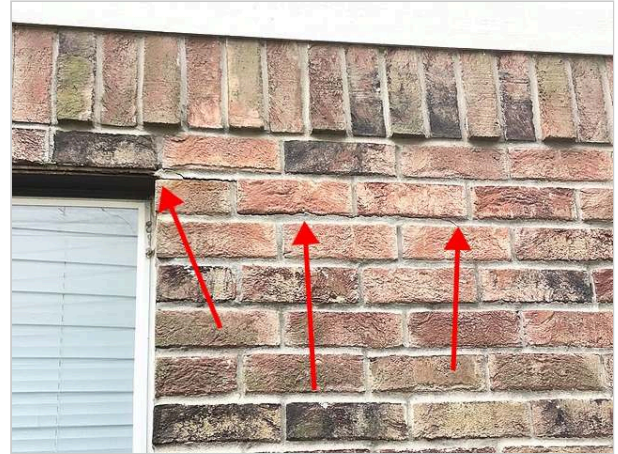
Crack in the brick/rusted header/lintel (right exterior wall)

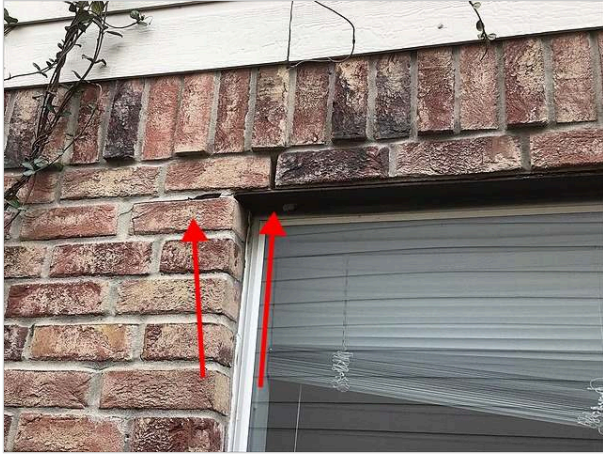
Crack in the brick/rusted header/lintel (left exterior wall)

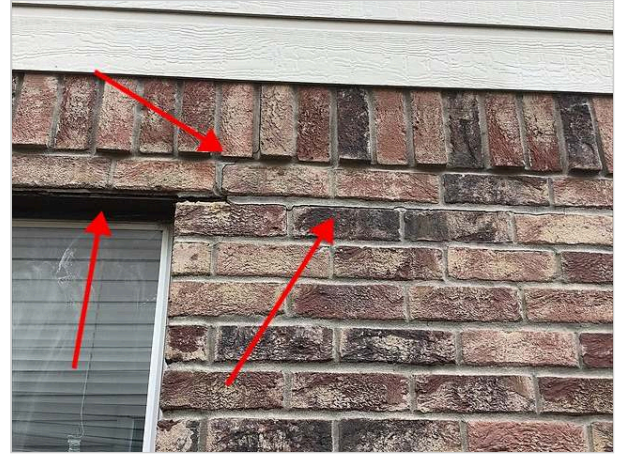
Cracks in the brick/rusted header/lintel (left exterior wall)

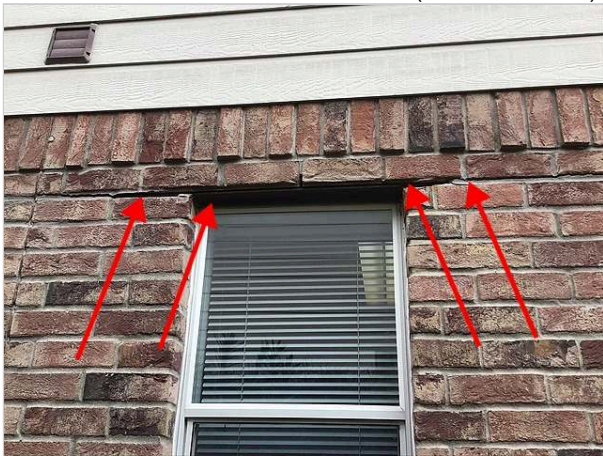
Cracks in the brick/rusted header/lintel (left exterior wall)

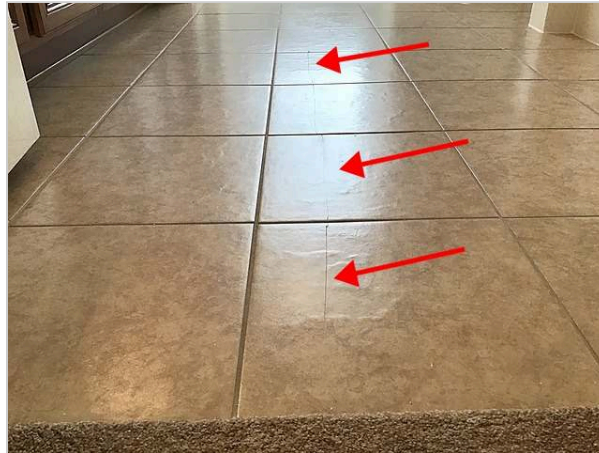
There were several cracked/damaged floor tiles in the master bathroom.

Cracked/damaged floor tiles (master bathroom)

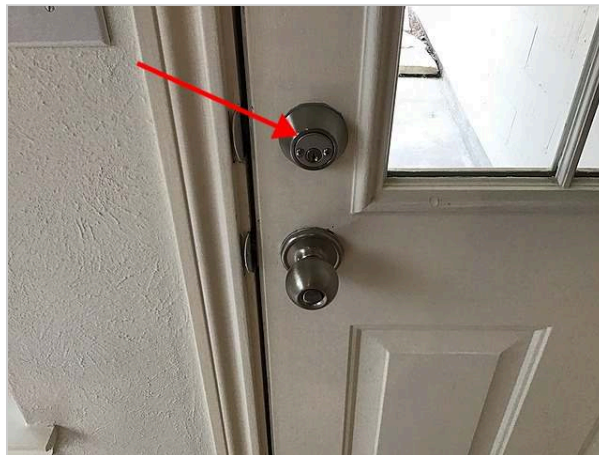
Note: Rear exterior door was keyed on the inside. Possibly hindering emergency egress.

Keyed on the inside (rear exterior door)

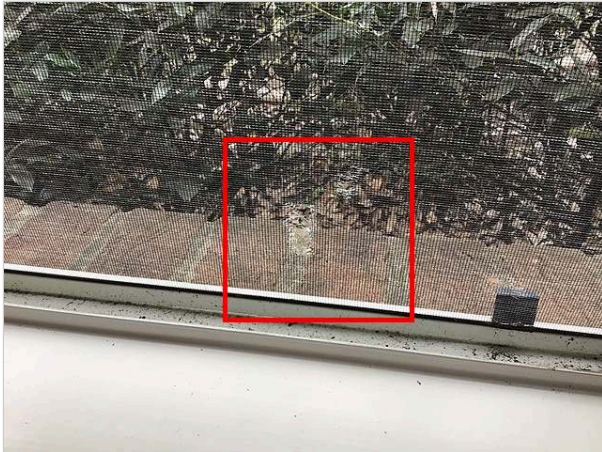
One or more screens were damaged. The Texas Real Estate Commission (TREC) considers this to be a deficiency according to the standards of practice (SOP).

Damaged screen (dining room)

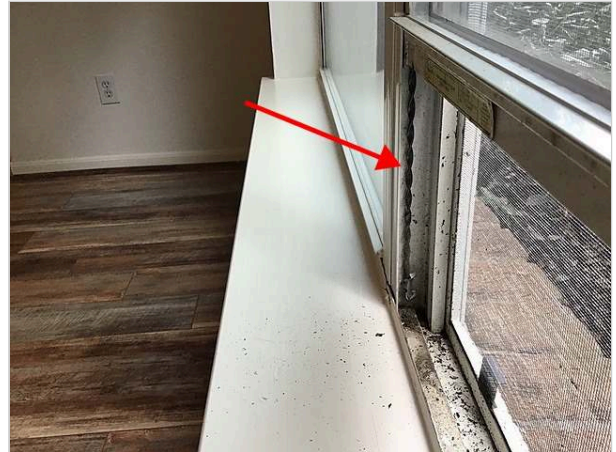
Windows were double pane construction and inspected for function such as open, close, and locking mechanisms. The following deficiencies were identified at the time of inspection. The balances on several of the windows were broken/defective.

Broken/defective balance (dining room)

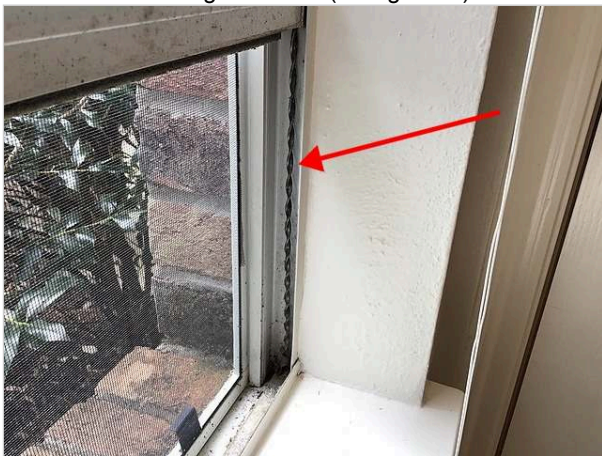
Broken/defective balance (half bathroom)

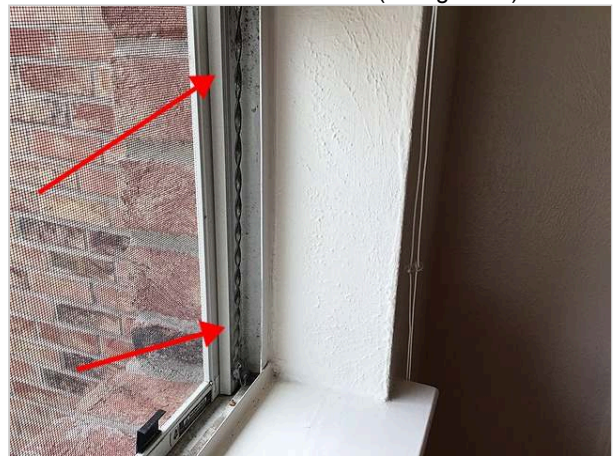
Broken/defective balance (second floor hall window)

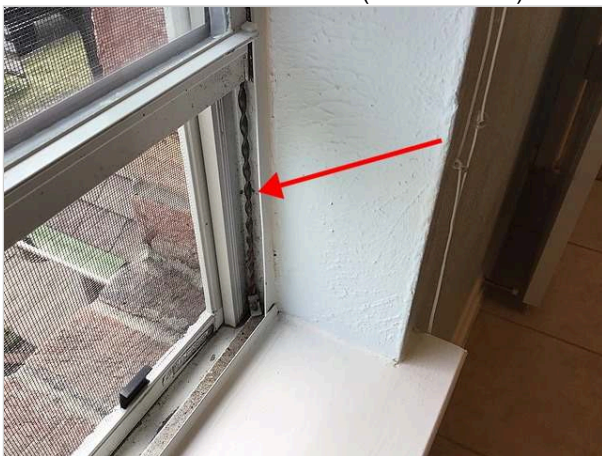
Broken/defective balance (hall bathroom)

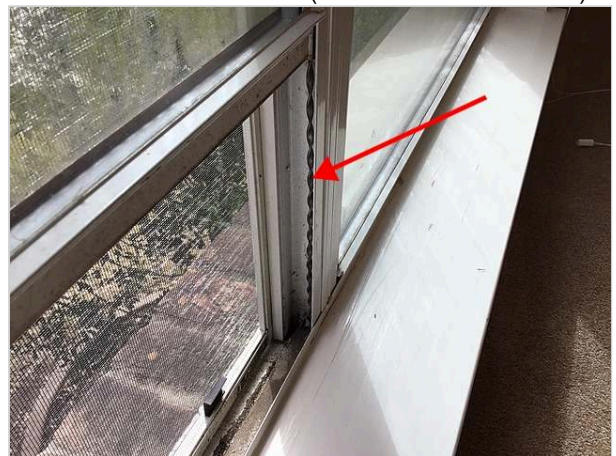
Broken/defective balance (front bedroom)

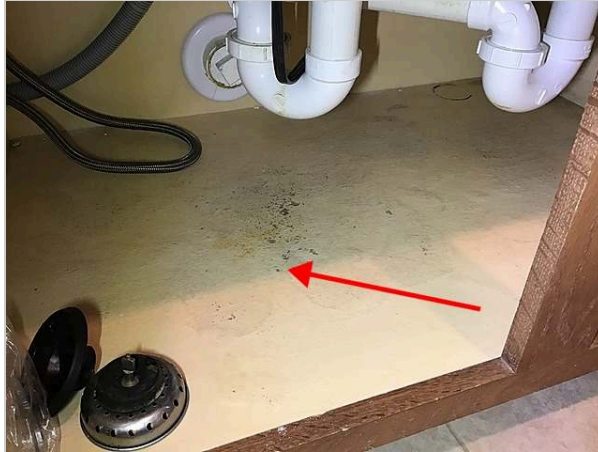
There were signs of previous leaks (staining) to the cabinet below the kitchen sink.

Signs of previous leaks (kitchen)

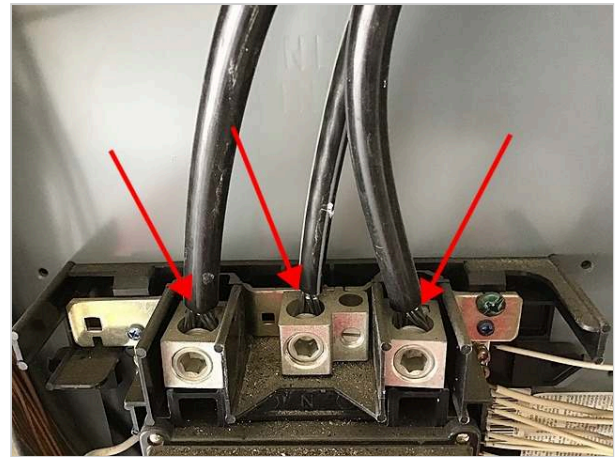
No anti-oxidant was present on the aluminum service wire ends. Anti-oxidants should be applied to aluminum conductor terminations beneath the tension screws in the distribution panel board(s). However, not all aluminum wire manufacturers require the use of an anti-oxidant compound.

No anti-oxidant present

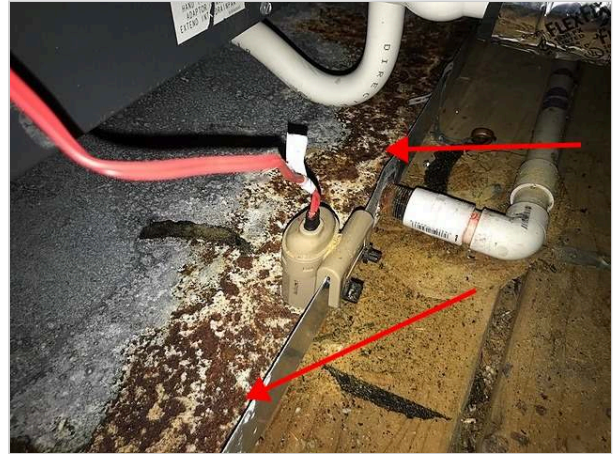
There was rust in the secondary drain pan. Once the galvanized coating is used up and rust sets in, it will continue to rust even without liquid water present.

Rust in the pan

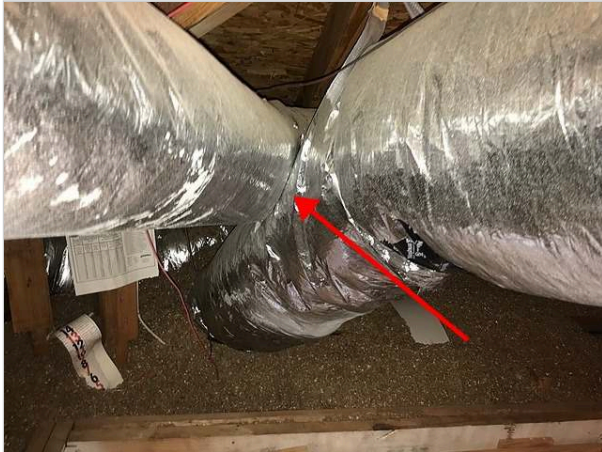
Ducts in the attic space were in contact with other duct and the gas line.. Points of contact between ducts has been known to create condensation in the attic space and the gas line connection to the furnace unit should not have any weight bearing down on it. Common industry standard calls for supply ducts to be elevated over insulation, not in contact with refrigerant lines/other flex ducts and/or HVAC units or components in the attic space.

In contact with other duct

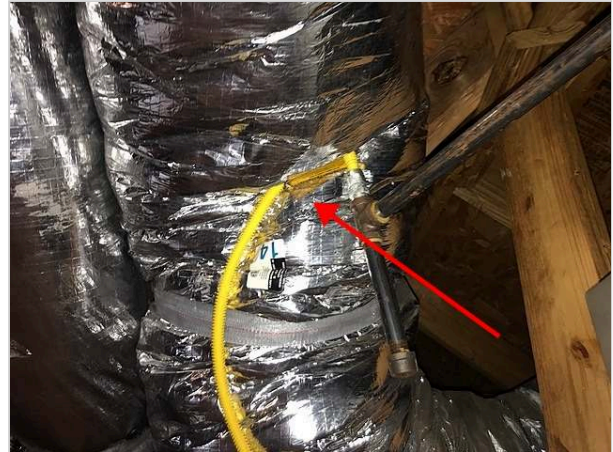
In contact with the gas line

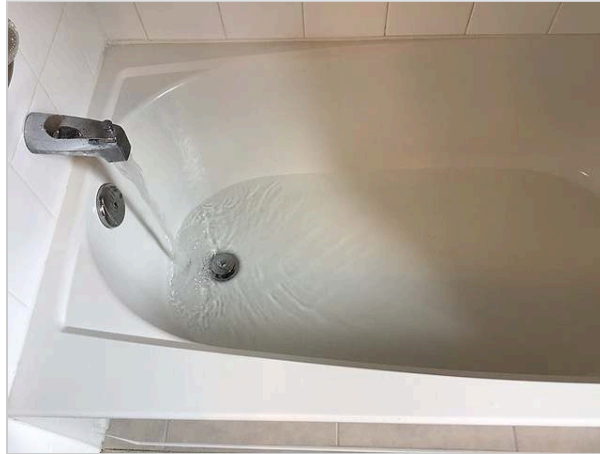
Hall bathtub was slow to drain.

Slow to drain (hall bathtub)

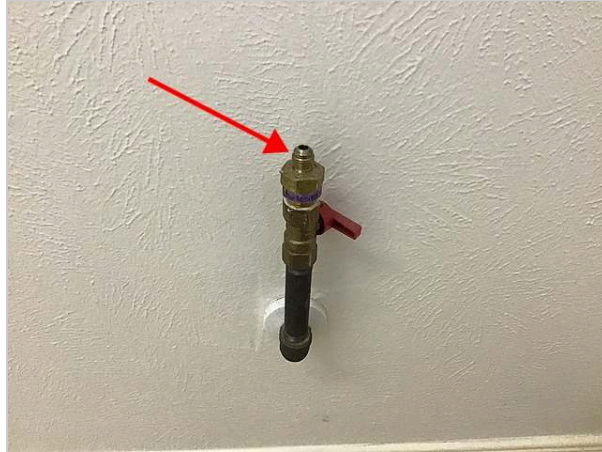
Gas valve in the utility room was not properly capped.

Not properly capped (utility room)

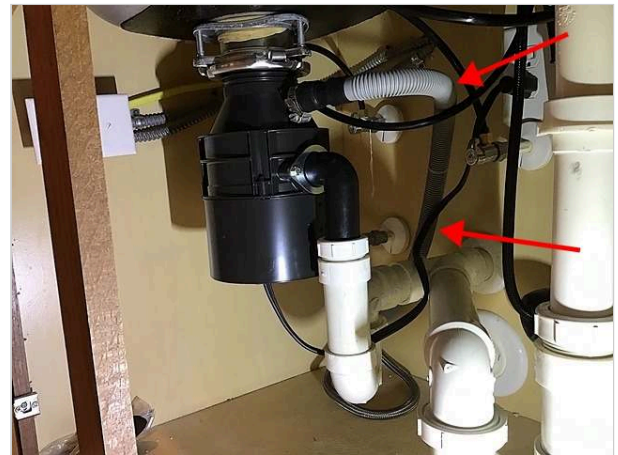
The drain line was not properly looped (no visible air-gap).

Not properly looped

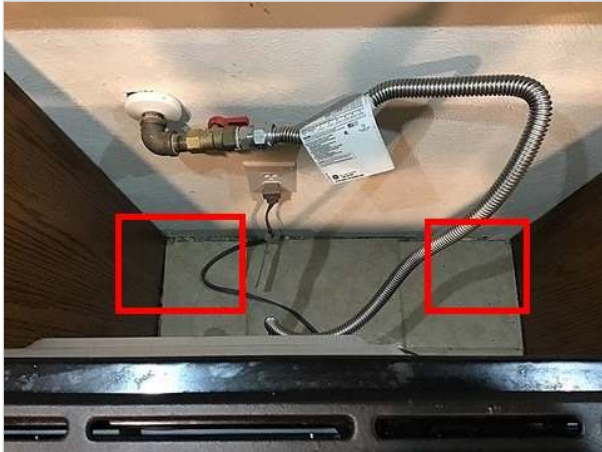
There was no anti-tip device installed for the oven at the time of inspection.

No anti-tip device

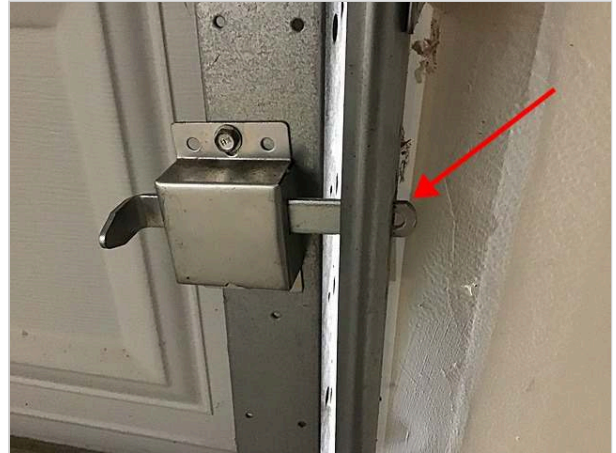
Manual door lock had not been disabled. Not disabling the door lock for the garage has the potential of operating the door opener while locked, which can lead to damaging the door and connected components.

Door lock not disabled

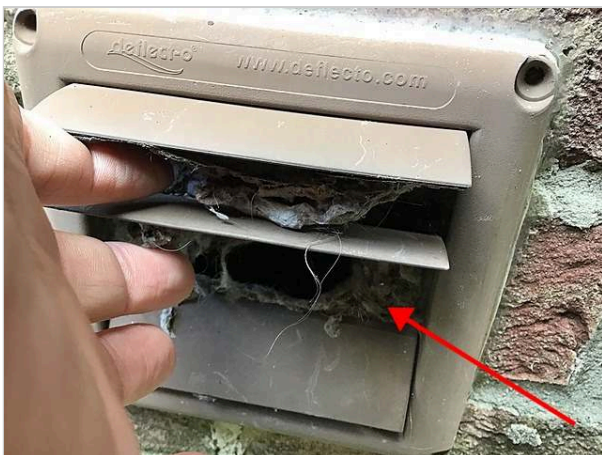
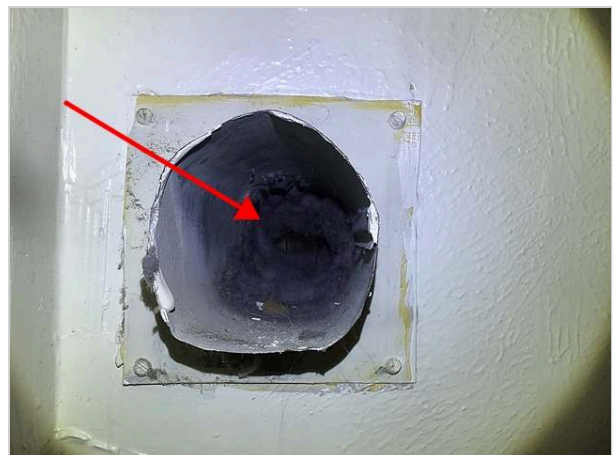
The dryer exhaust had excessive lint buildup and needed to be cleaned.

Needed to be cleaned
