PROPERTY INSPECTION REPORT

Prepared For: Ron Nelson
(Name of Client)

Concerning: 4042 Wilderness Falls Trail, Kingwood, TX 77339
(Address or Other Identification of Inspected Property)

By: Thomas Christopher Duhon, Lic #10577 04/13/2020
(Name and License Number of Inspector) (Date)

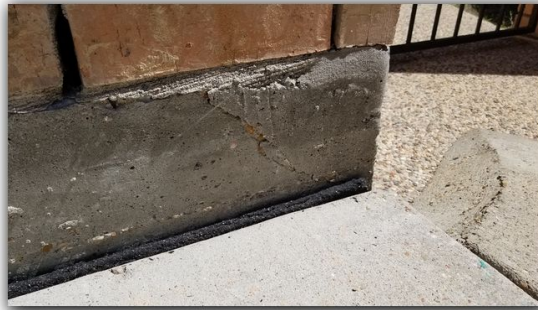
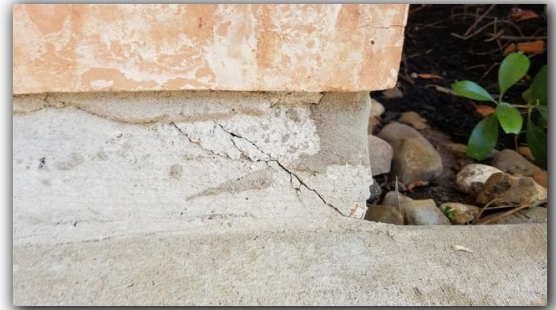
Corner cracks visible at one or more corners of exterior foundation. These are common and usually do not indicate a foundation problem. However, non-repaired corner cracks could lead to brick separations or loosening over time at corner areas.

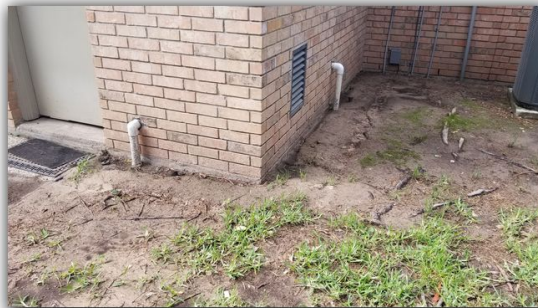
High soil levels noted at north side of home exterior at foundation wall. These conditions could be conducive for moisture back-up or wood destroying insects.

Keep soil lowered at least 3-4" below top of slab and graded away from foundation across back and down sides of house and garage to the street for positive drainage.

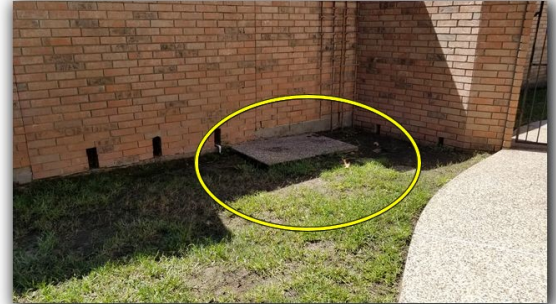
What appears to be a low area is noted at north and east exterior. If water stands for over 48 hours, or does not flow to street, contact landscaping company to determine if

yard needs regrading at swales or elsewhere or otherwise corrected, possibly with French drains, to facilitate proper drainage away from house, across back and to the street.

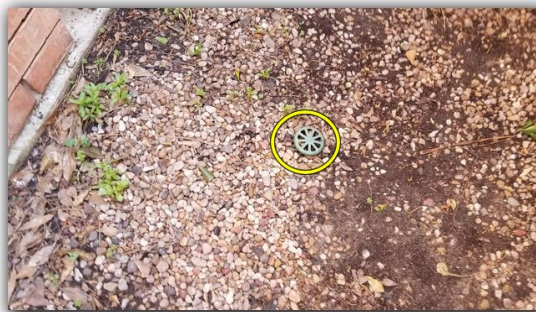
French drains noted at backyard and courtyard. Recommend buyer monitor these drains to ensure proper drainage during or after rainfall. Properly clean al drain basins (courtyard) and/or properly secure/replace loose or damaged grates, as needed.

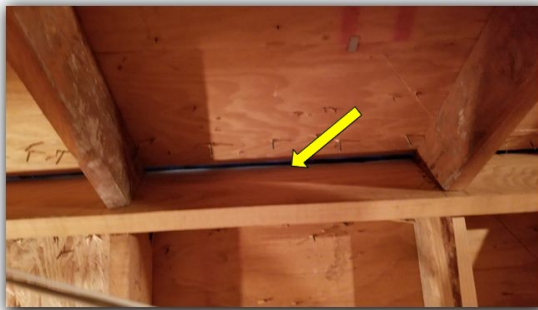
In multiple areas at roof peak(s) where peak ridge vent are installed may have insufficient air flow due to roof decking not cut or too close to peak ridge board. Roof decking at peak(s) with peak ridge venting should be cut back 1" to 2" on each side of peak ridge board for proper exhausting, per manufacturers specification.

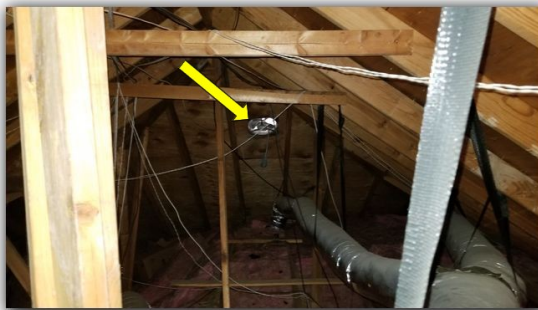
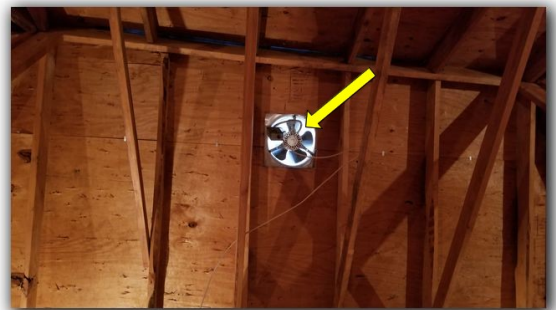
Power fan noted at north side of attic did not operate when activated and is in need of repair. South side attic fan noted as too high in attic to test.

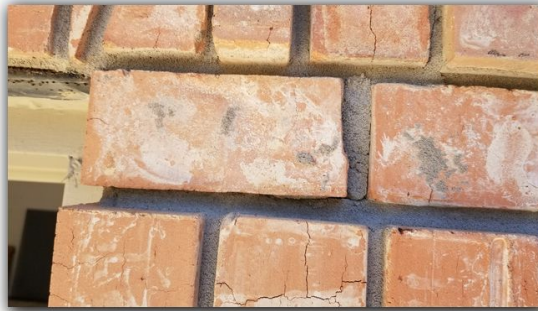
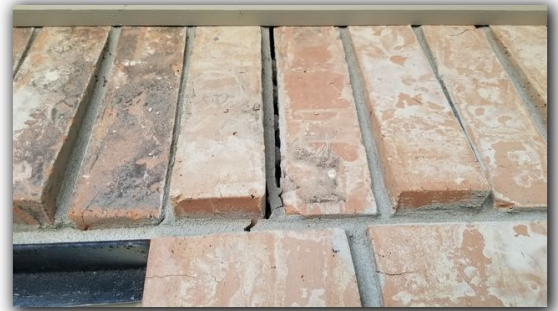
Mortar/stair step cracks and/or voids noted at multiple areas around brick exterior. These appear to be cosmetic and not structural in nature and can be repointed if buyer desires.

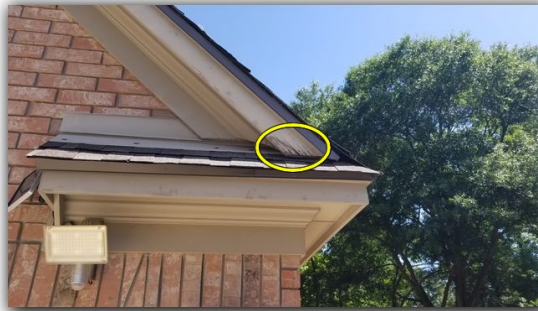
Area of minor deterioration is noted at south side of exterior trim/fascia. All deteriorated areas should be properly repaired and sealed, as needed, to prevent moisture penetration.

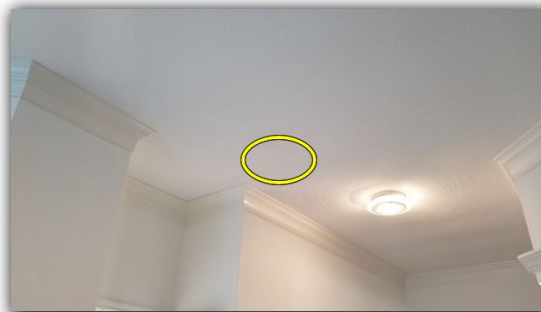
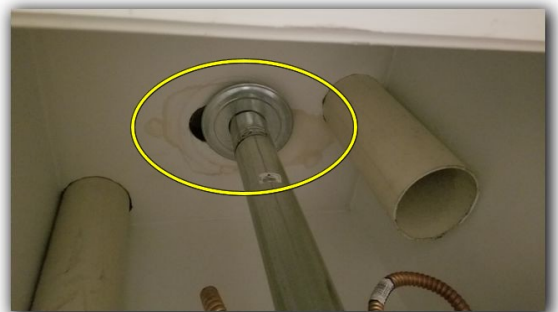
Water stains were noted at entry hall, mechanical closet, and master bedroom ceilings. These appear to be from previous roof/plumbing leaks and do not appear to be active. However buyer should routinely monitor these areas for worsening of staining or other changes until an active leak can be completely ruled out.

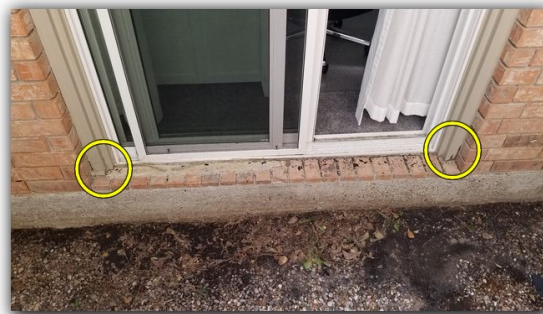
Wood deterioration noted at lower exterior jambs/trim at study exterior door. Door trims/jambs should be properly repaired to prevent moisture penetration and further deterioration.

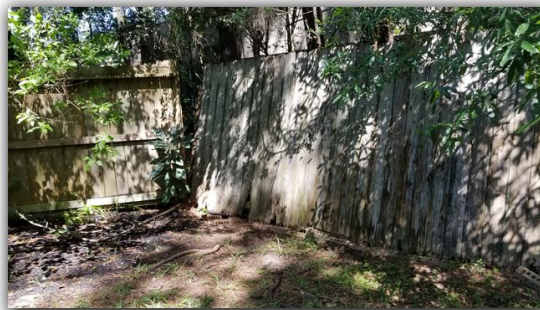
Multiple area of deterioration or damage noted at backyard perimeter wooden fence. Recommend replacing all deteriorated or damaged fence boards, structural members, posts, gate hardware...etc. The fence is not a structural component of the home.

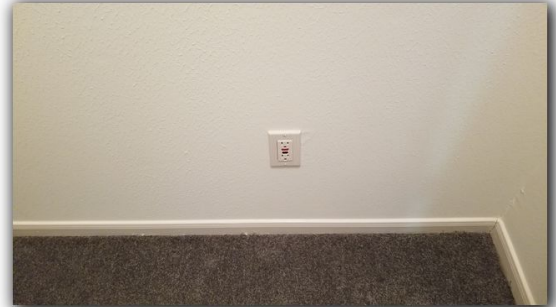
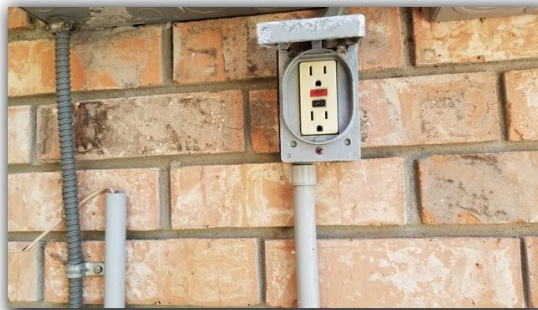
GFCI receptacle noted at north east exterior wall, master closet, and north exterior wall did not trip/reset when tested and is in need of proper replacement.

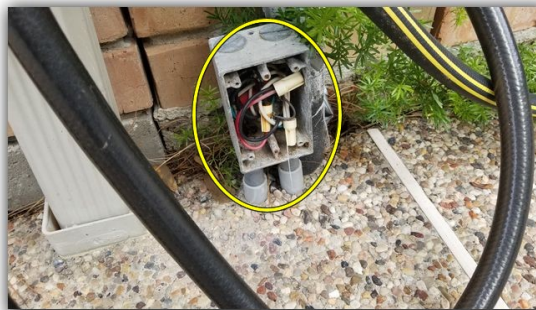
Open wire splices/ends are to be properly installed in approved J-box's and/or capped as needed at north east exterior wall.

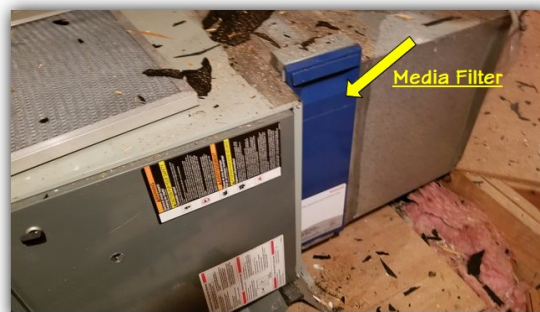
Double filtering (filters at returns and at media filter housing in attic) reduces airflow, reduces life and efficiency of compressor, as well as cooling of house and increases cost of operation. Recommend removing return grate filters throughout home or media filter at system in attic.

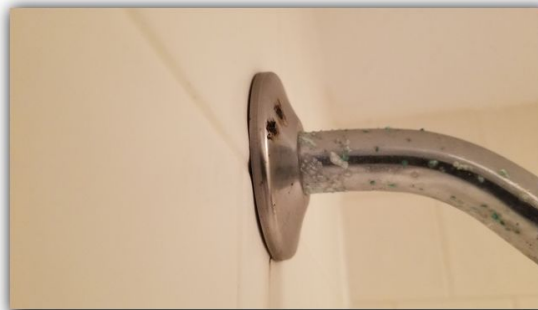
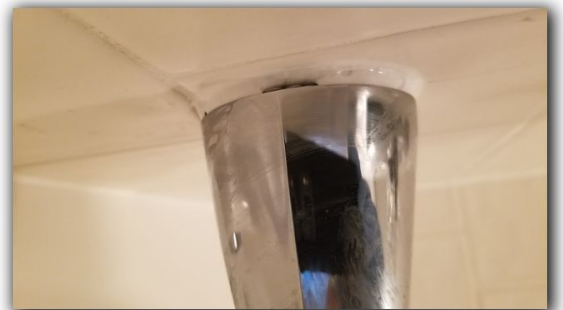
Non-sealed escutcheons at shower walls at all bathrooms should be caulk/sealed to prevent moisture penetration. Such as shower arm escutcheons, tub spouts, faucet controls..etc.

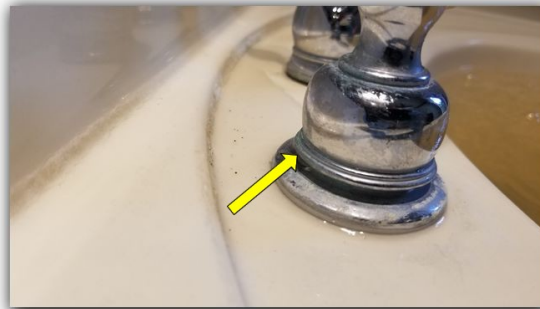
Hot knob at left sink in master bathroom is noted as leaking and is in need of repair.

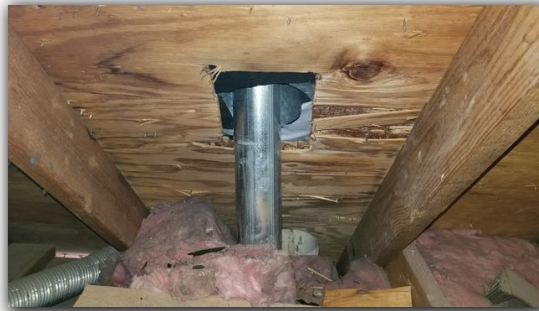
A B-type flue, with minimum 1" clearance to combustibles (decking) and strapped between rafters for stability, at roof jack in attic, run at least 1' above roof through roof jack with B-cap and collar should be installed with a minimum 5' length of flue from water heater to terminate above roof.

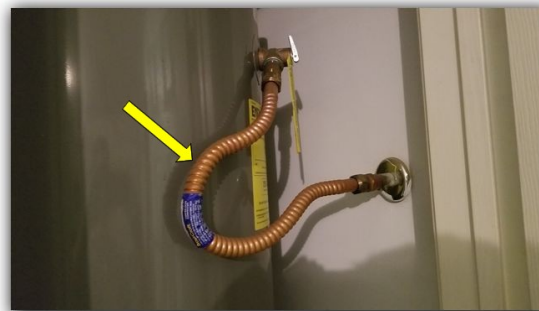
A flex line is improperly installed at temperature and pressure valve drain line. Properly reinstall 3/4" CPVC, copper, or other approved smooth material at temperature and pressure line from temperature and pressure valve removed through wall to exterior with a non-threaded elbow within 6" to 2' above grade or other approved termination.

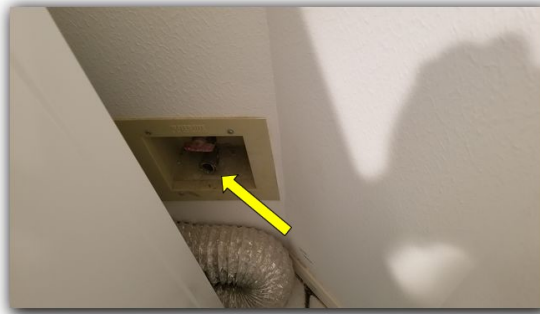
If gas clothes dryer is not used at utility room, gas valve should be properly capped/plugged for safety.

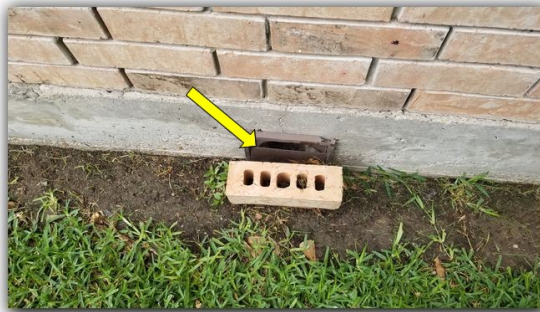
East exterior vent termination is noted as damaged and is in need of repair/replacement.

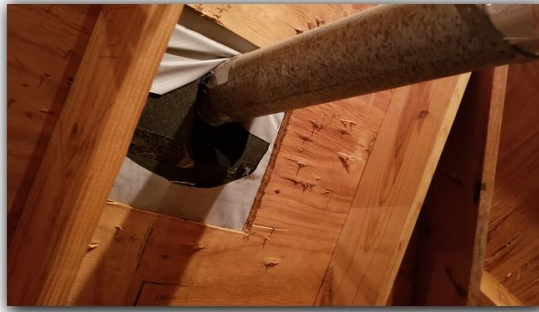
Recommend sealing flue at underside of roof penetration to prevent dryer lint from falling back into attic space. Due to proximity of gas fueled appliance, accumulation of dryer lint in attic space could result in possible fire hazard.

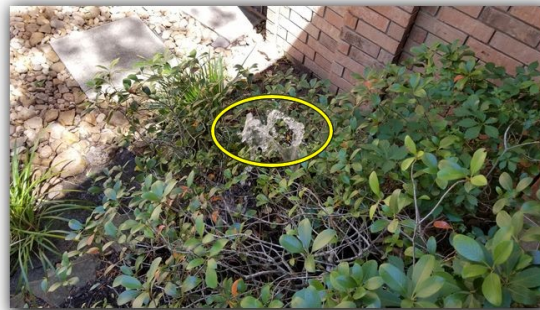
Missing and/or broken head noted at station 1.

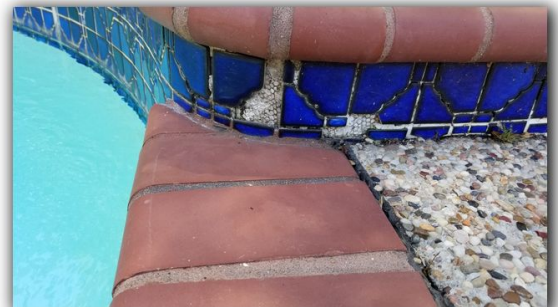
Recommend sealing all voids and cracks at exterior decking and/or pool coping/tile with grout, elastomeric caulk, or other approved material, as needed. Multiple locations noted as having broken or missing tile and are in need of repair. Uneven decking noted at north side of pool, which is recommended to be properly repaired to prevent tripping hazard.

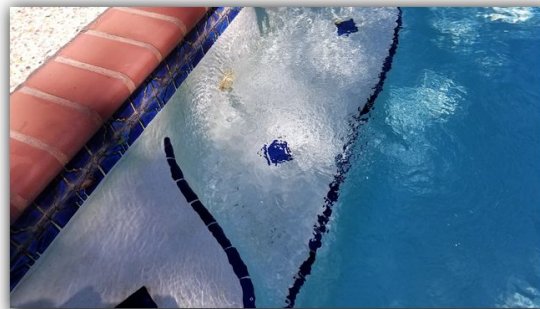
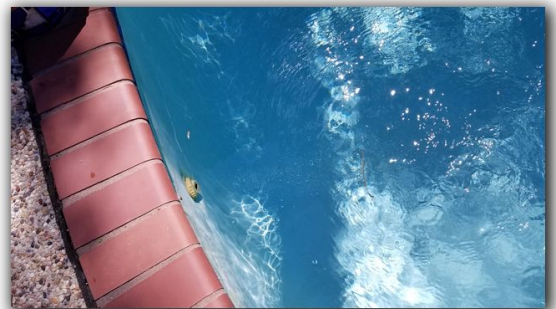
Bubbles noted coming from return jets at pool walls. This can indicate leak at plumbing and it is recommend having a professional pool maintenance/repair company evaluate and make repairs, as needed.
