1st Rate Inspections

Property Inspection Report

5907 Bridgegate Dr, Spring, TX 77373
Inspection prepared for: Anthony Echevarria
Real Estate Agent: -

Date of Inspection: 12/10/2019 Time: 1:30 PM
Age of Home: 1976 Size: 1380
Order ID: 13986

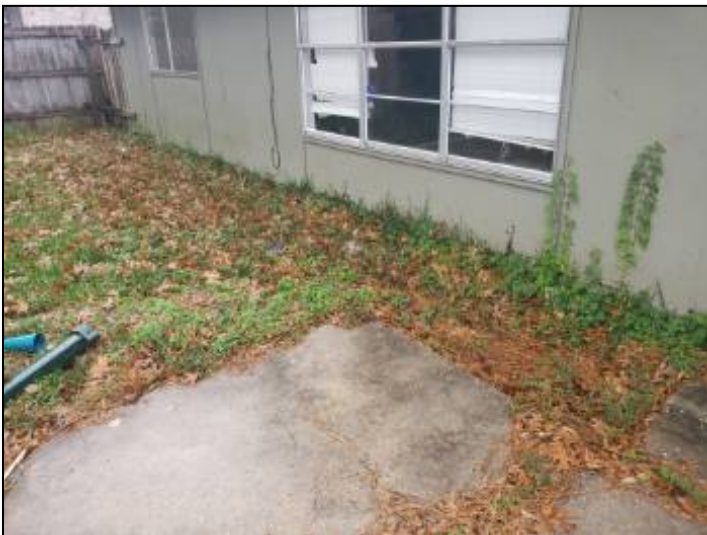
-The soil and or rock level around the home is higher than recommended or in contact with the siding materials. Recommend lowering the soil line to help prevent water penetration and/or damage to the structure. Mainly at - rear

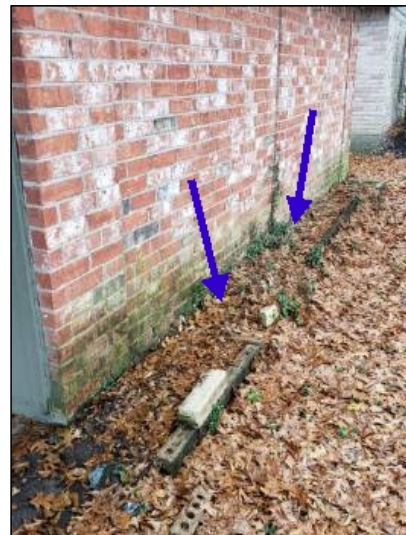
-The soil and or rock level around the home is higher than recommended or in contact with the siding materials. Recommend lowering the soil line to help prevent water penetration and/or damage to the structure. Mainly at - front

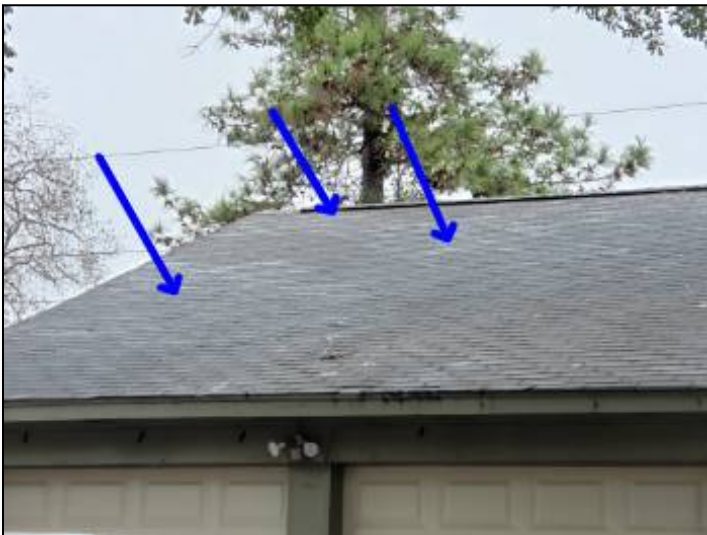
-Due to the excessive granular loss on the roof covering the roof may age prematurely. We recommend further review of the roof system for a better understanding of the present condition.

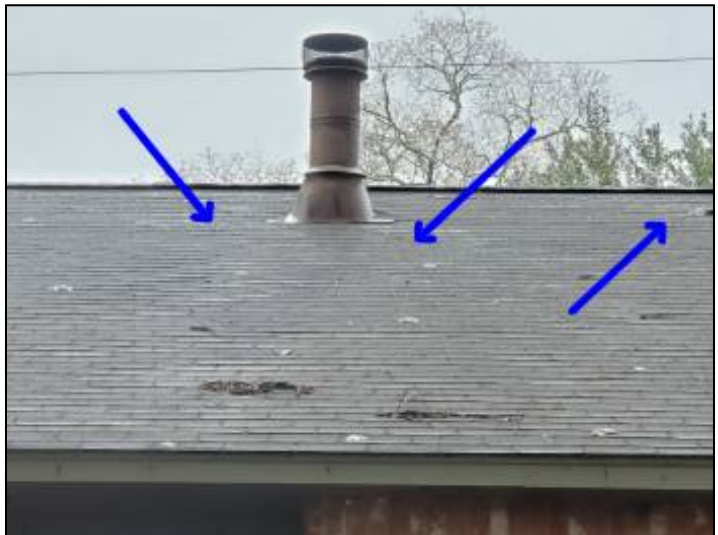
-Due to the excessive granular loss on the roof covering the roof may age prematurely. We recommend further review of the roof system for a better understanding of the present condition.

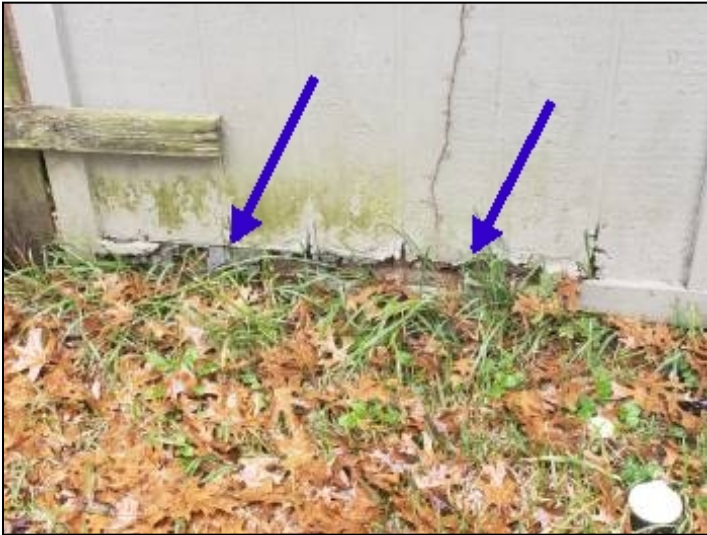
-Deterioration was noted at the siding, recommend replacing all deteriorated siding to help prevent further deterioration and water penetration. Unable to determine the condition of the underlying materials. Mainly at - rear

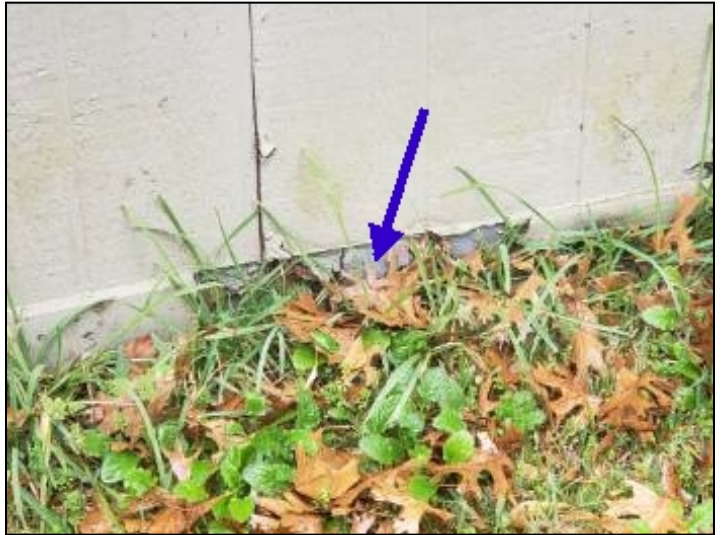
-Deterioration was noted at the siding, recommend replacing all deteriorated siding to help prevent further deterioration and water penetration. Unable to determine the condition of the underlying materials. Mainly at - rear

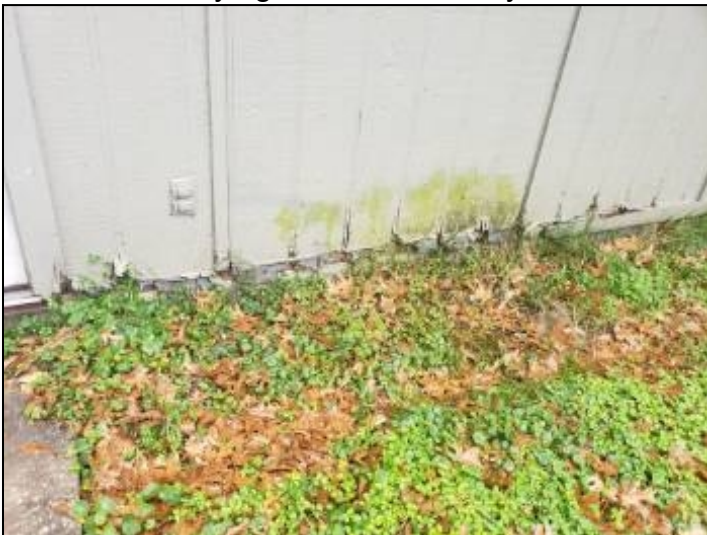
-Deterioration was noted at the siding, recommend replacing all deteriorated siding to help prevent further deterioration and water penetration. Unable to determine the condition of the underlying materials. Mainly at - rear

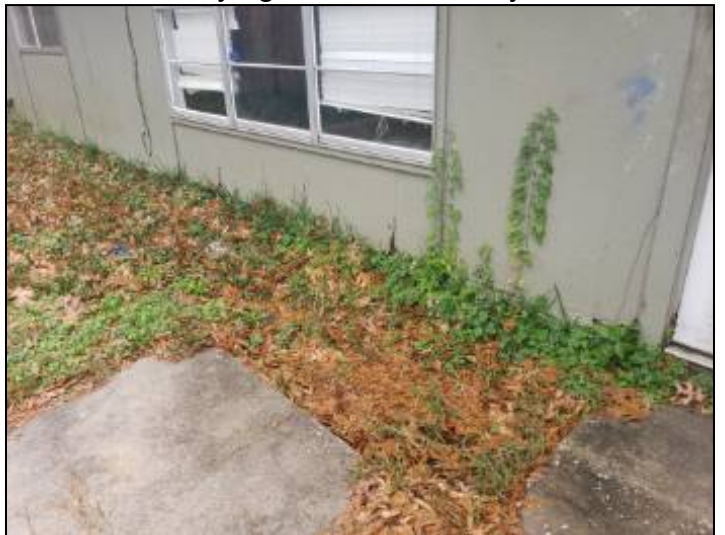
-Deterioration was noted at the siding, recommend replacing all deteriorated siding to help prevent further deterioration and water penetration. Unable to determine the condition of the underlying materials. Mainly at - rear

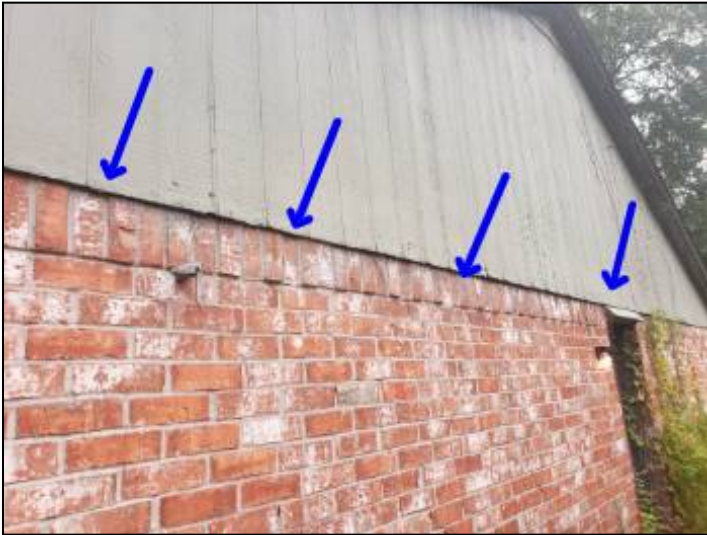
-Deterioration was noted at the siding, recommend replacing all deteriorated siding to help prevent further deterioration and water penetration. Unable to determine the condition of the underlying materials. Mainly at - left

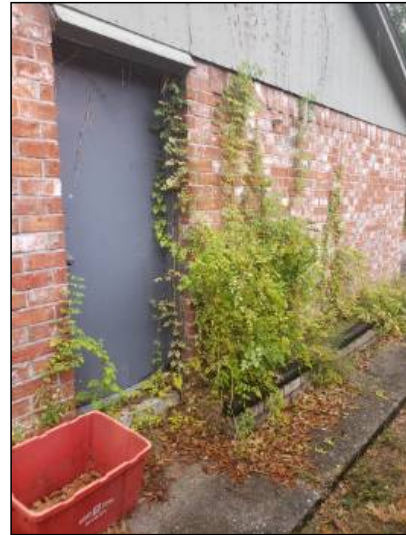
-Recommend trimming vegetation so that it is not in contact with the house. Vegetation in contact with the structure can hold moisture against the structure and promote damage to building materials and conducive conditions for wood destroying insects.

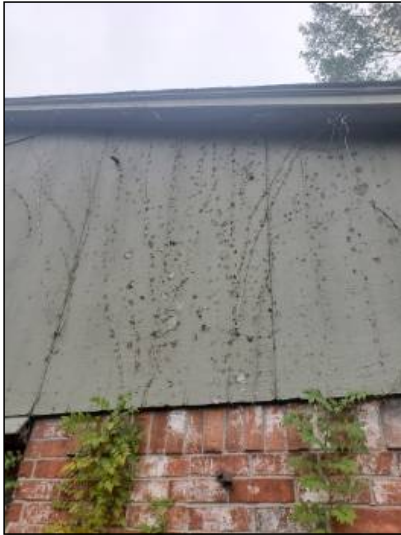
-There is some damage to the exterior siding, recommend repair or replacement to help prevent water penetration. Unable to determine the condition of the underlying materials. Mainly at - left

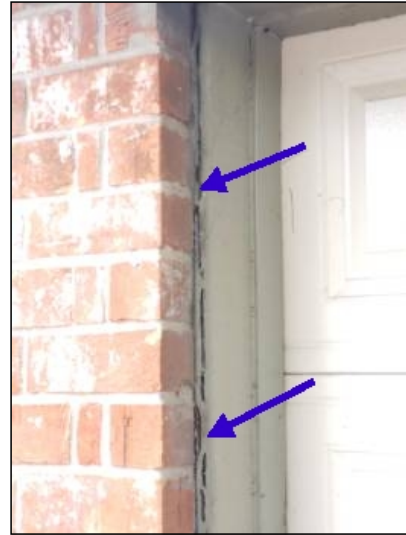
-Recommend sealing between the trim and brickwork to help prevent water penetration. Mainly at - garage

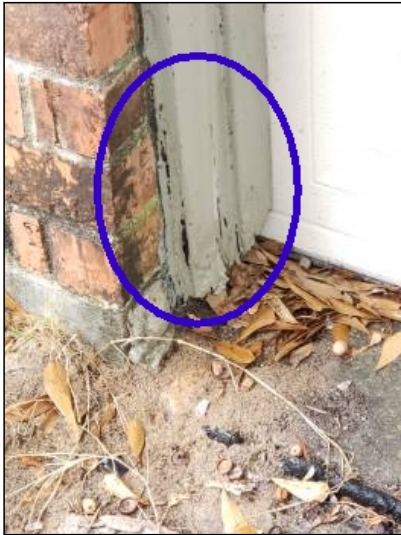
-Deterioration was noted at the trim, recommend replacing all deteriorated trim. Unable to determine the condition of the underlying materials. Mainly at - garage

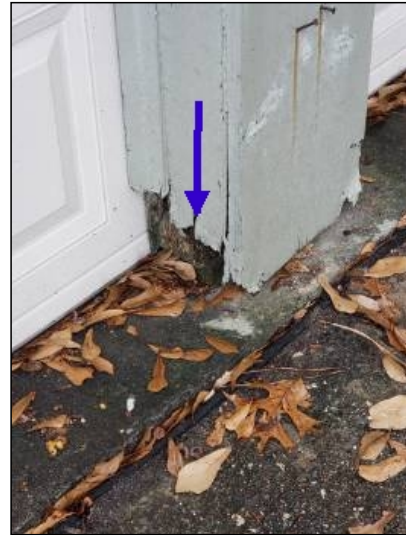
-Deterioration was noted at the trim, recommend replacing all deteriorated trim. Unable to determine the condition of the underlying materials. Mainly at - garage

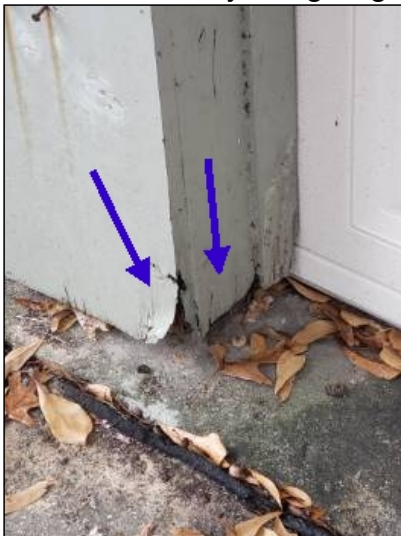
-Deterioration was noted at the trim, recommend replacing all deteriorated trim. Unable to determine the condition of the underlying materials. Mainly at - garage

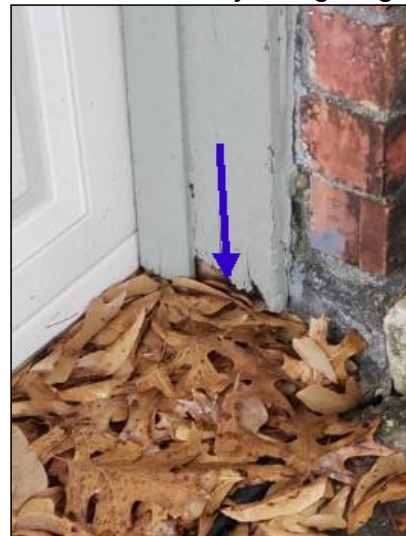
-Deterioration was noted at the trim, recommend replacing all deteriorated trim. Unable to determine the condition of the underlying materials. Mainly at - garage

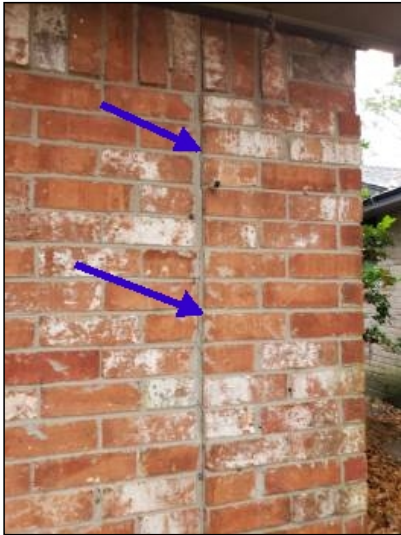
-Settlement cracks were noted in the brickwork. Mainly at - front right

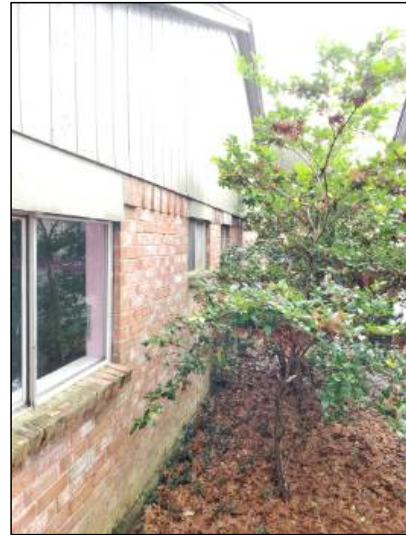
-Recommend trimming vegetation so that it is not in contact with the house. Vegetation in contact with the structure can hold moisture against the structure and promote damage to building materials and conducive conditions for wood destroying insects.

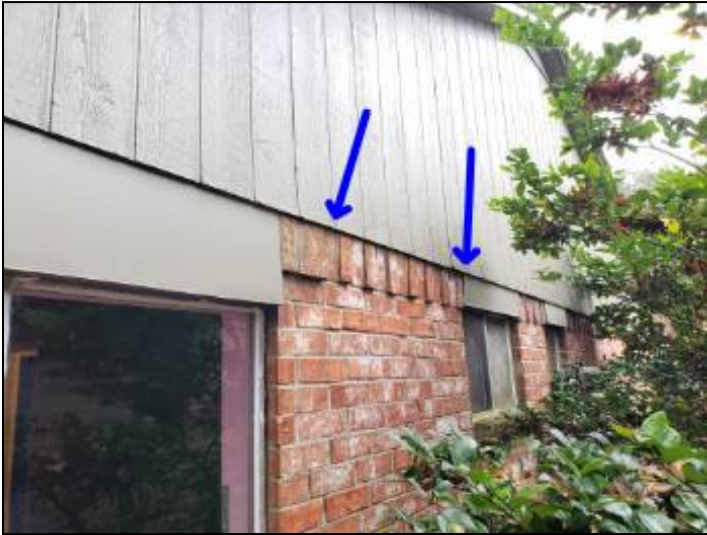
-Deterioration was noted at the siding, recommend replacing all deteriorated siding to help prevent further deterioration and water penetration. Unable to determine the condition of the underlying materials. Mainly at - right

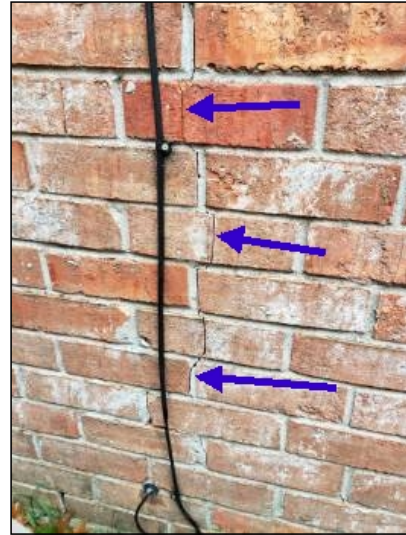
-Settlement cracks were noted in the brickwork. Mainly at - right

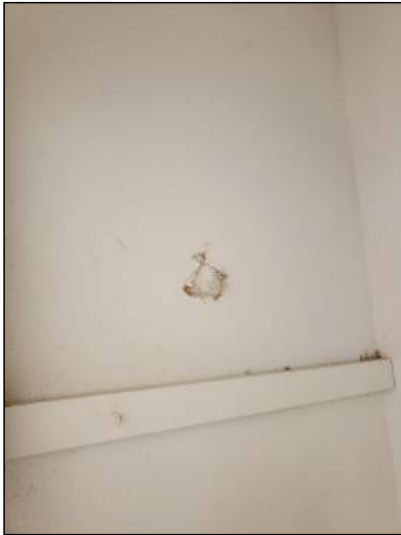
-There is damage to the drywall, recommend repairs as needed. Mainly at - throughout

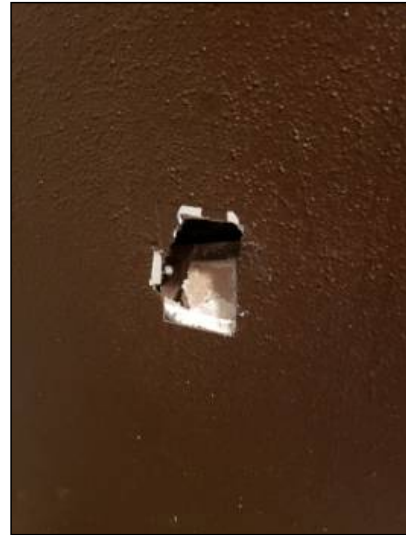
-There is damage to the drywall, recommend repairs as needed. Mainly at - throughout

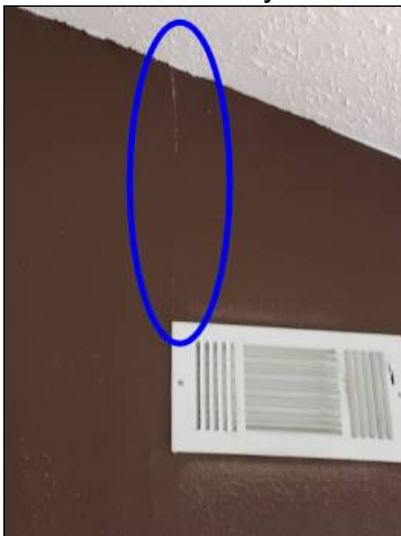
-Settlement cracks were noted in the drywall. Mainly at - living room

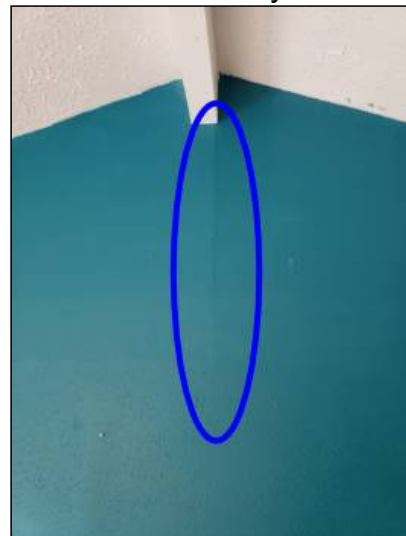
-Settlement cracks were noted in the drywall. Mainly at - living room

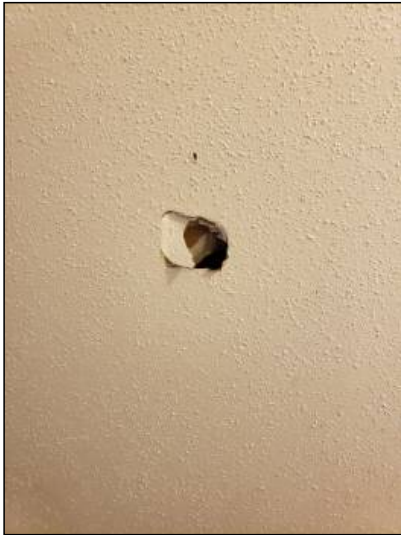
-There is damage to the drywall, recommend repairs as needed. Mainly at - throughout

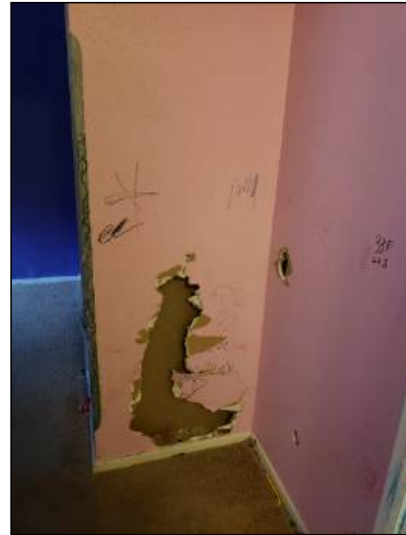
-There is damage to the drywall, recommend repairs as needed. Mainly at - throughout

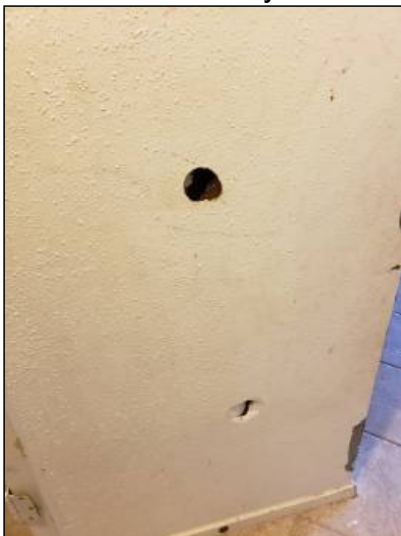
-There is damage to the drywall, recommend repairs as needed. Mainly at - throughout

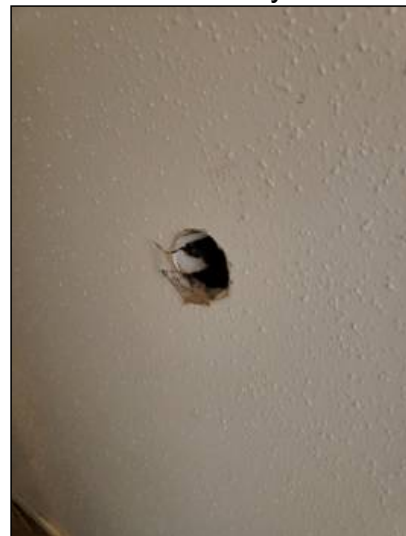
-There is damage to the drywall, recommend repairs as needed. Mainly at - throughout

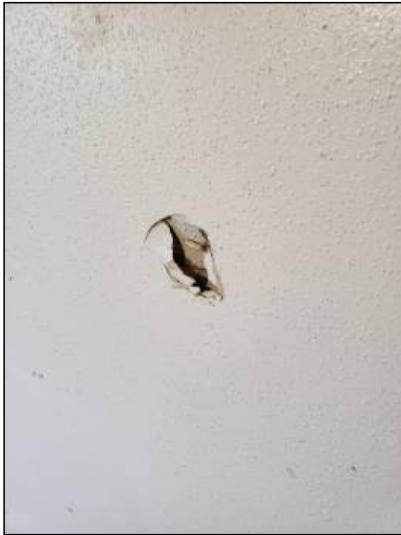
-There is damage to the drywall, recommend repairs as needed. Mainly at - throughout

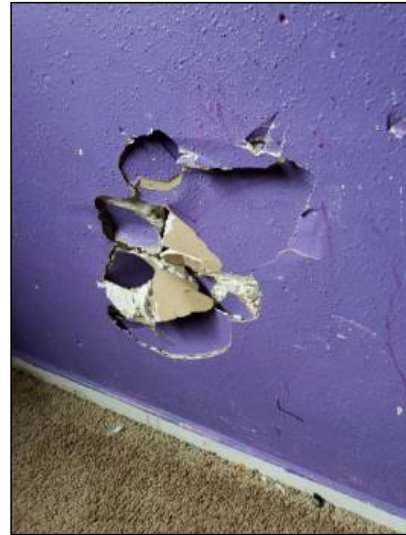
-There is damage to the drywall, recommend repairs as needed. Mainly at - throughout

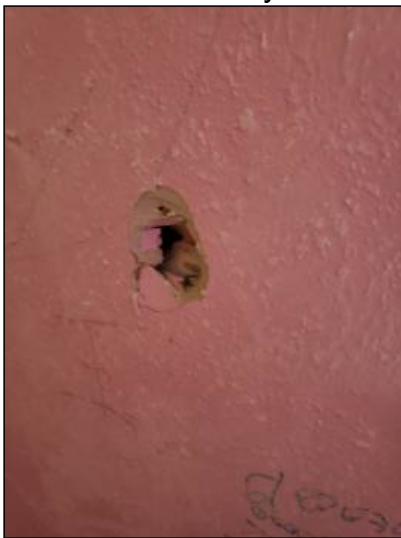
-There is damage to the drywall, recommend repairs as needed. Mainly at - throughout

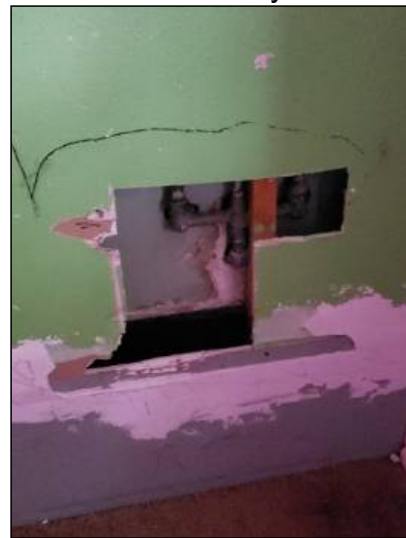
-There is damage to the drywall, recommend repairs as needed. Mainly at - throughout

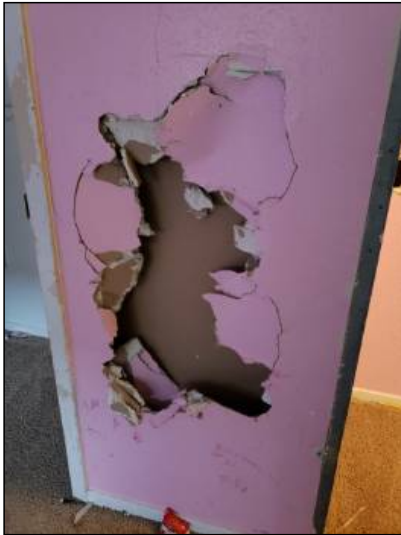
-There is damage to the drywall, recommend repairs as needed. Mainly at - throughout

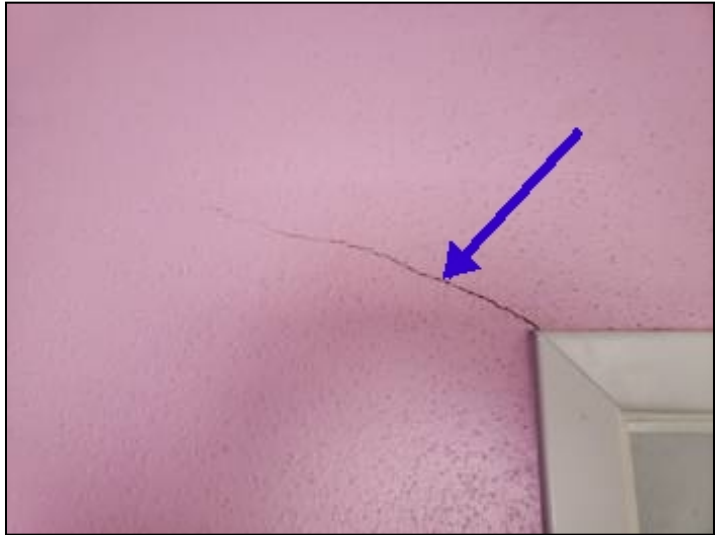
-Settlement cracks were noted in the drywall. Mainly at - front right bedroom

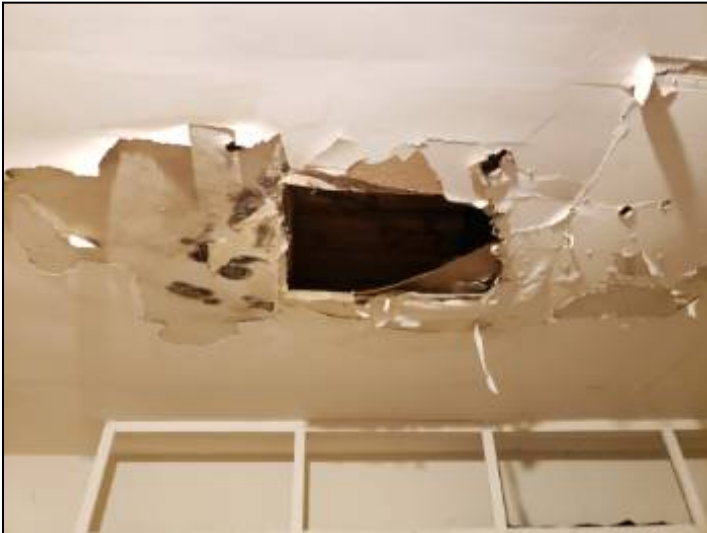
-There is at least one hole in the ceiling in the garage. All holes in the garage ceilings or wall against living areas should be patched to help keep the recommended fire barrier between the home and garage.

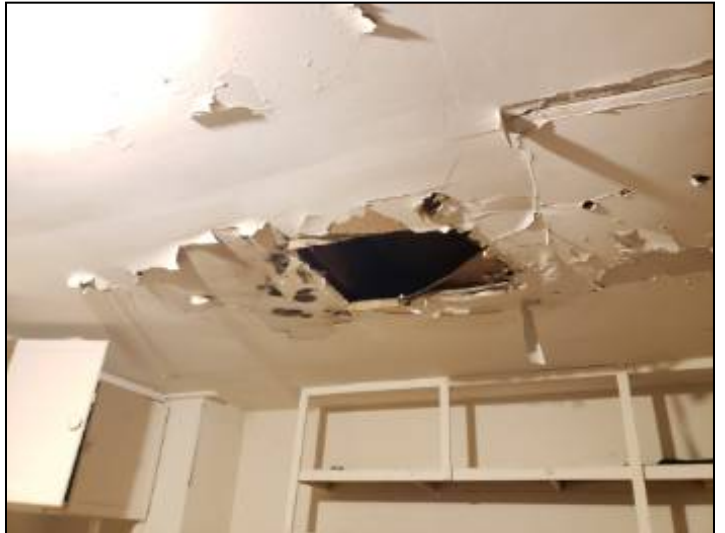
-Paint is peeling in the garage ceilings. This is a common occurrence due to high moisture of unconditioned garage space, recommend repainting to help prevent further deterioration.

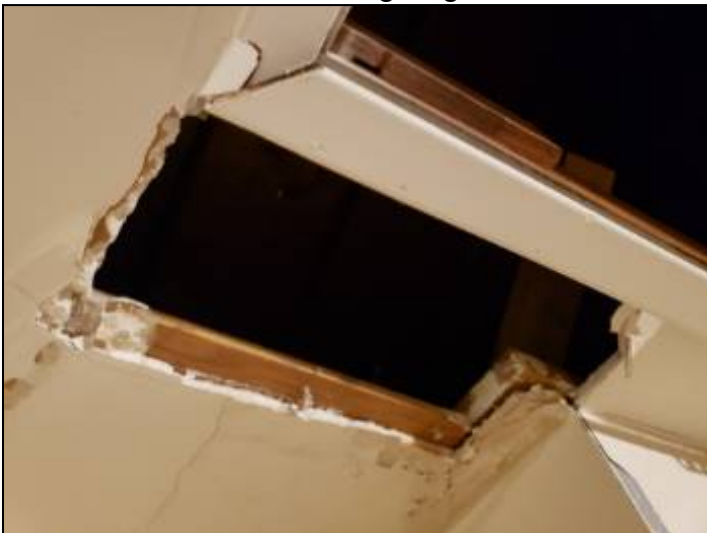
-There is at least one hole in the ceiling in the garage. All holes in the garage ceilings or wall against living areas should be patched to help keep the recommended fire barrier between the home and garage.

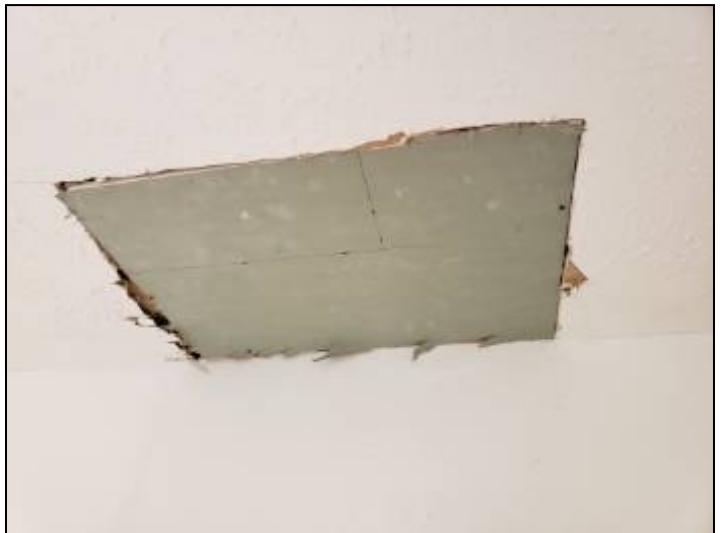
-Previous repairs were noted in the ceiling. Mainly at - breakfast nook

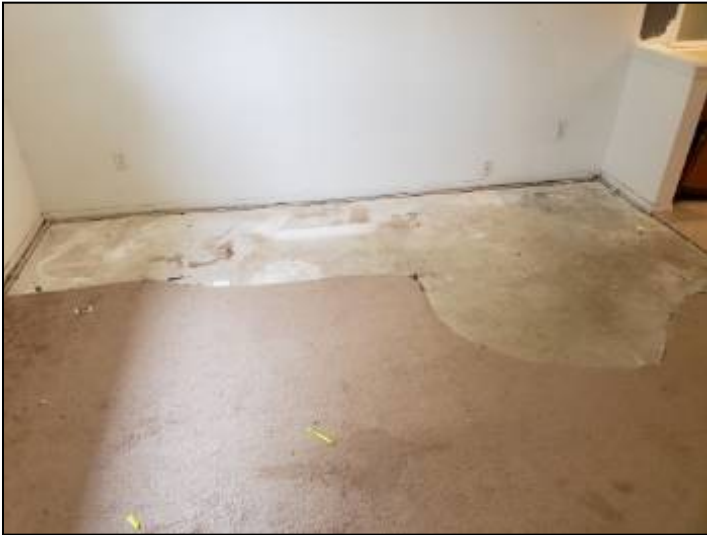
Carpet is damaged. Mainly at- master bedroom

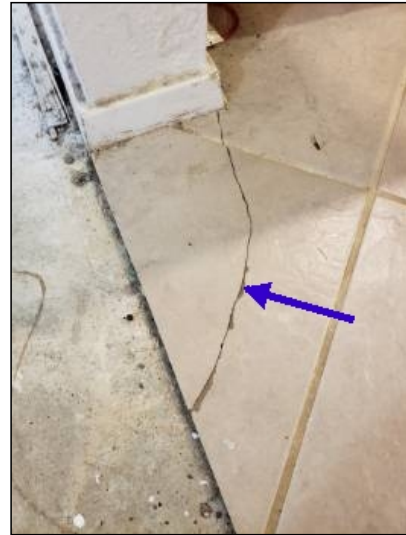
-Cracks were noted in the tile. Mainly at - master bath

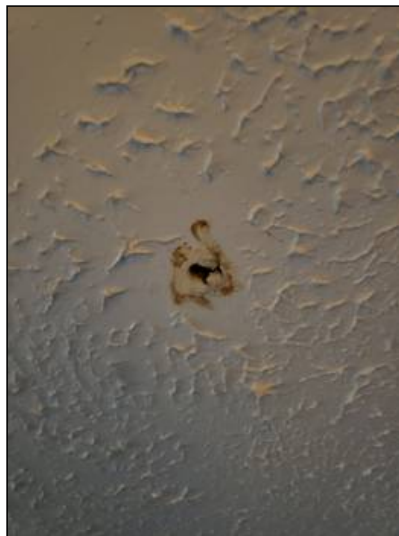
Hole in ceiling. Mainly at- front left bedroom

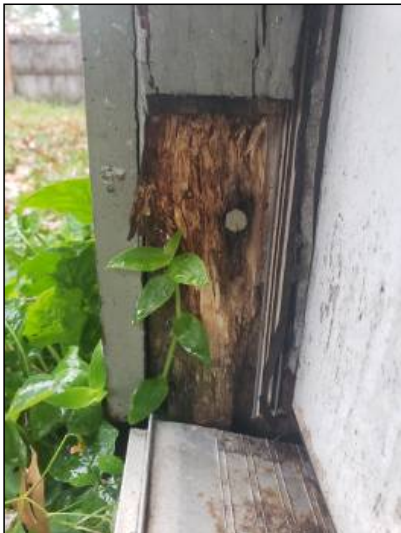
-Deterioration was noted mainly along the door jamb, recommend repair or replacement to help prevent water penetration. Unable to determine the condition of the underlying materials. Mainly at - back door

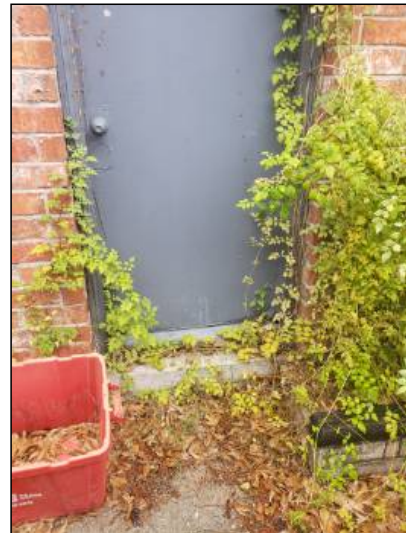
-Deterioration was noted mainly along the door jamb, recommend repair or replacement to help prevent water penetration. Unable to determine the condition of the underlying materials. Mainly at - garage exterior door

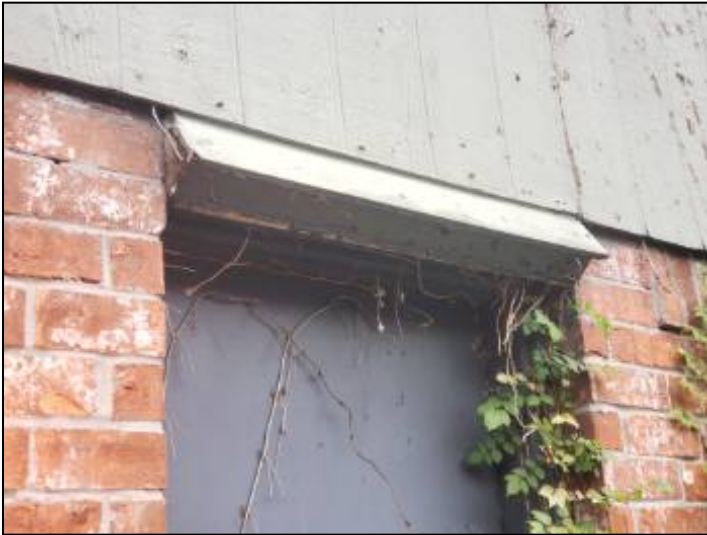
Door header is loose. Mainly at- garage exterior door

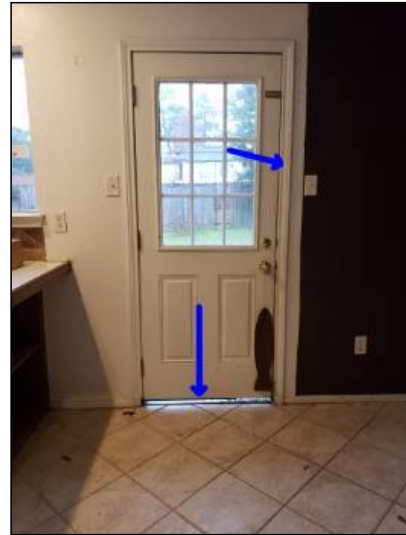
-There is visible light noted around the door. Mainly at - back door

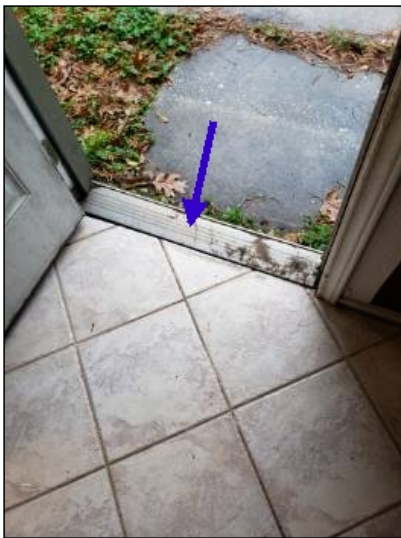
Threshold is sloped into the house. Threshold should slope toward the outside to shed water. Mainly at- back door

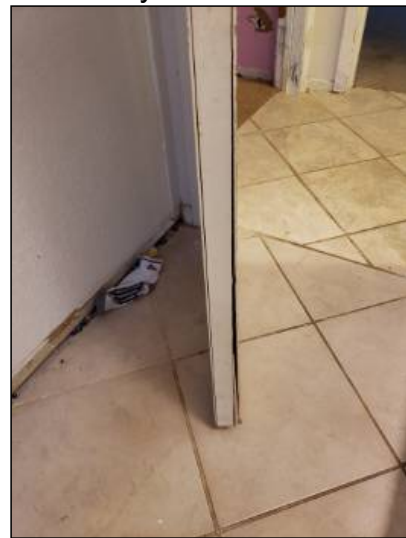
-The skin on the door is loose, recommend re-securing. Mainly at - hall bath

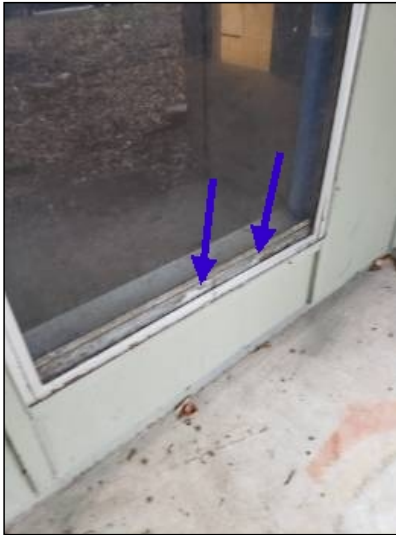
-Window screens were damaged or had holes in them and should be repaired to help prevent insects from entering. Mainly at - front porch

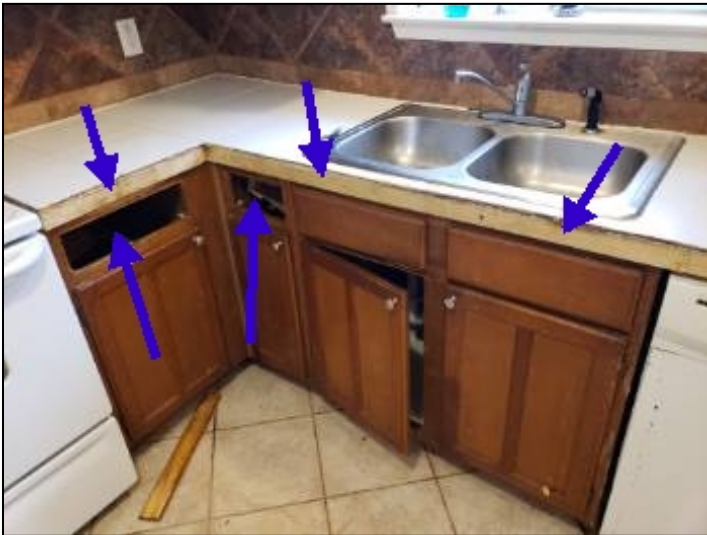
-Although cabinets are not inspected it was noted that cabinets are damaged throughout.

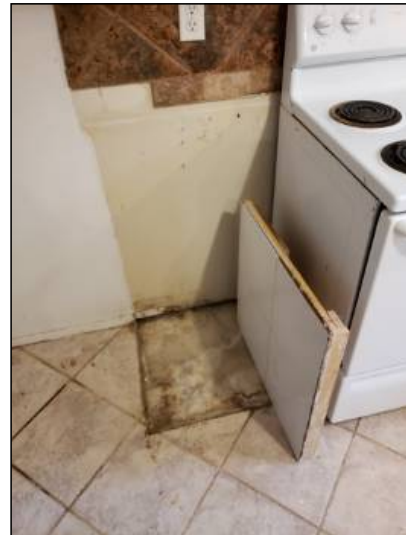
-Although cabinets are not inspected it was noted that cabinets are damaged throughout.

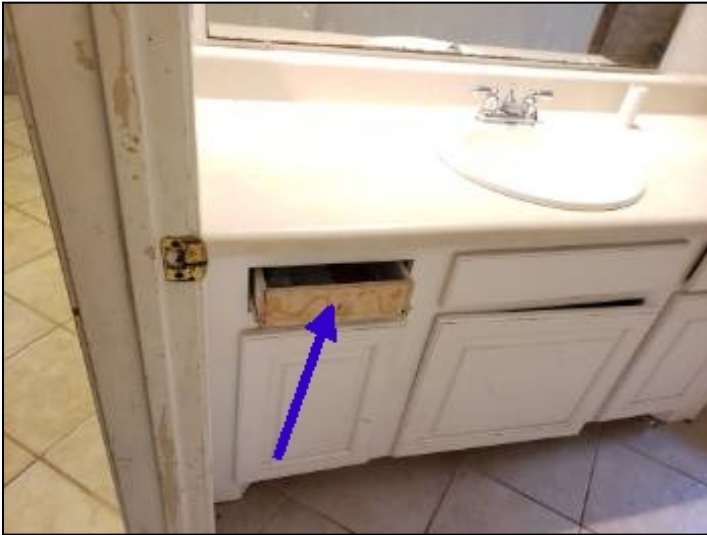
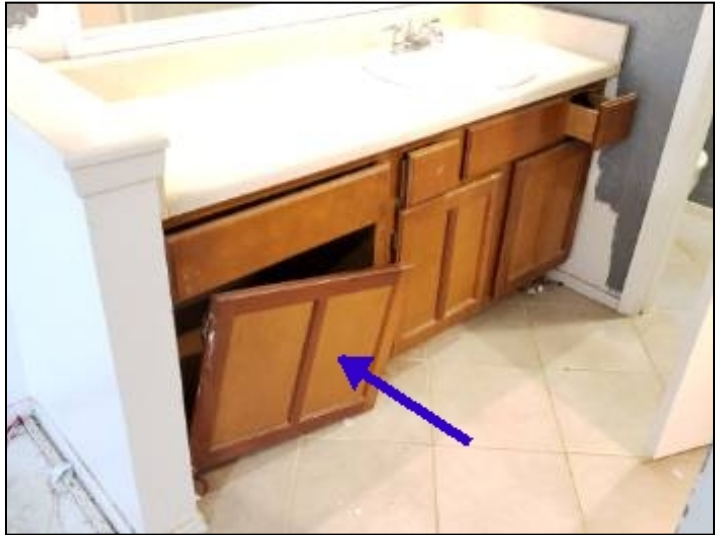
-Although cabinets are not inspected it was noted that cabinets are damaged throughout.

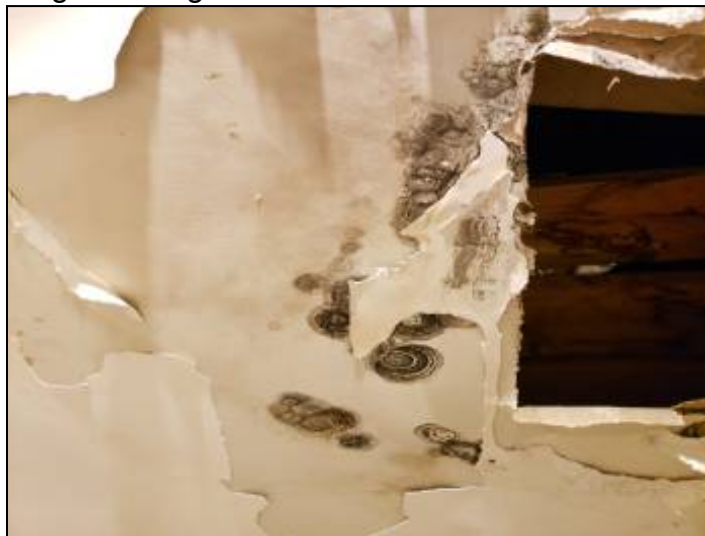
-Mold like stains are present, recommend remediation or cleanup as needed. Unable to determine condition of the underlying materials. Mainly at - garage ceiling

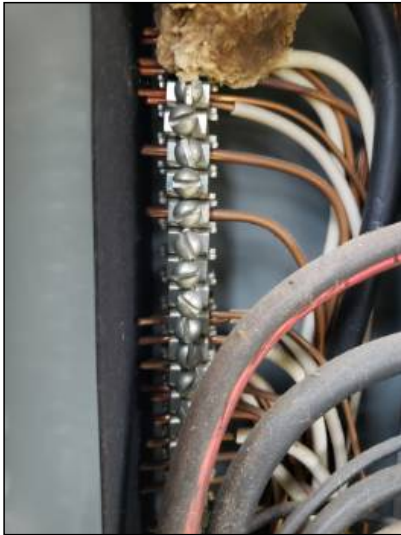
-There are more than one neutral wire located under the same screw. Neutral wires should be separated to individual screws.

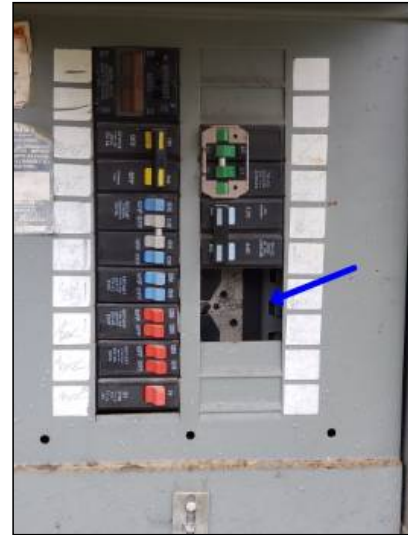
-There is at least one filler plate missing on the main electrical panel cover. Recommend adding missing filler plates to help prevent electrical shock.

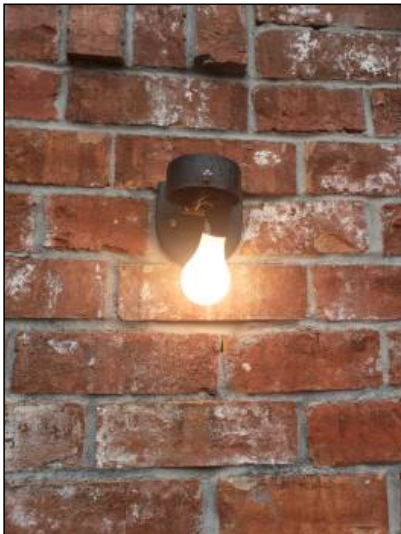
-Light fixture globe is missing or damaged. Mainly at - left exterior

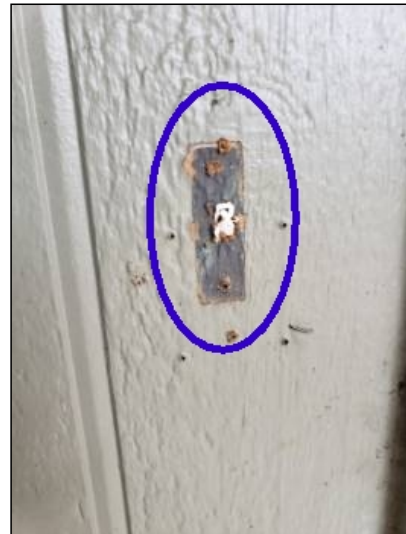
Doorbell button is missing.

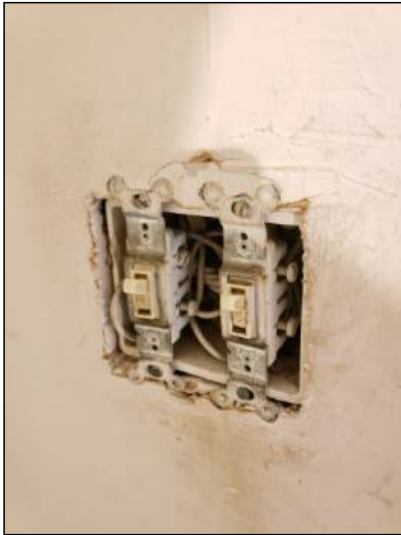
-Switch plate is broken or missing, recommend replacing covers to help prevent electrical shock. Mainly at - garage

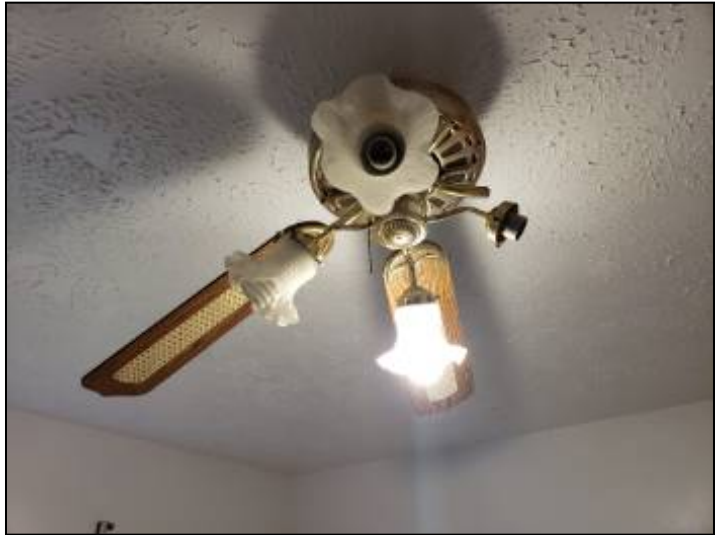
Light fixture is damaged. Mainly at- master bedroom

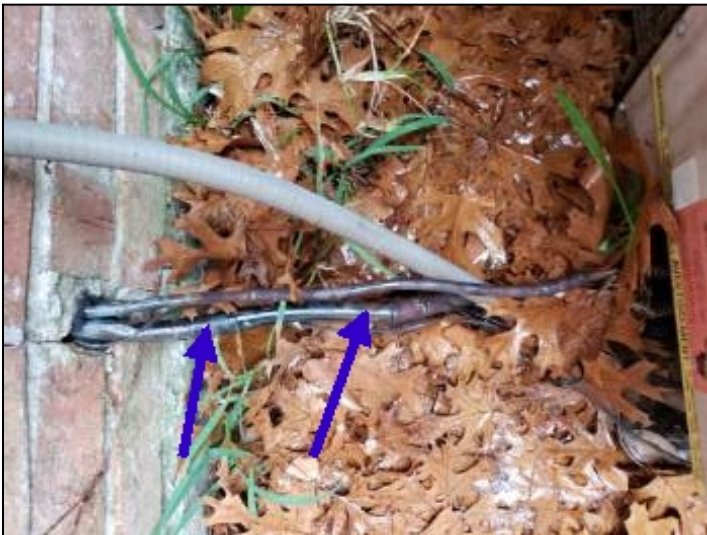
-The insulation is missing or damaged on the A/C suction line at the condensing unit. Recommend repair or replacement to prevent cooling loss from exterior temperatures.

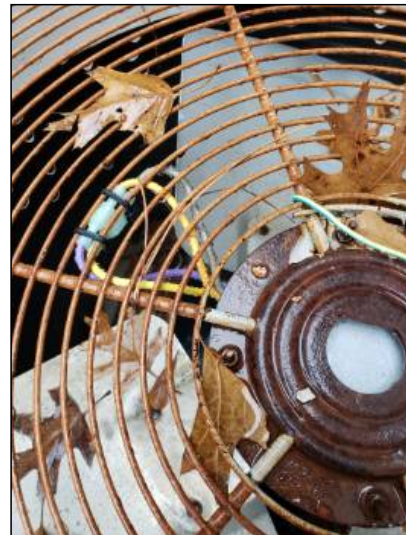
-There are electrical wires located outside of the cage of the fan on the outdoor condenser unit. This could pose a safety issue and these wires should be located inside unit.

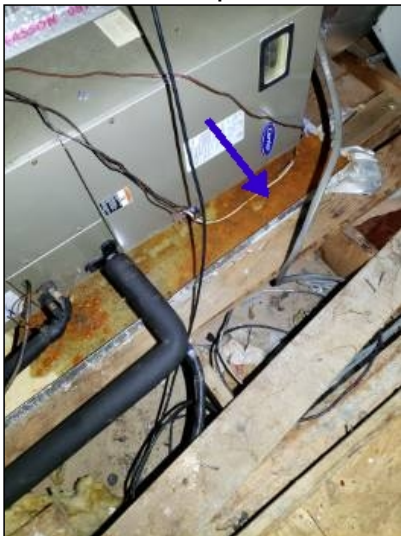
-There is water noted in the A/C pan. This is an indication that the main condensation line is clogged, recommend contacting an A/C specialist to remove clog and restore drain to normal operating procedure. It is also recommended to have the unit checked for proper operation and for cleanliness.

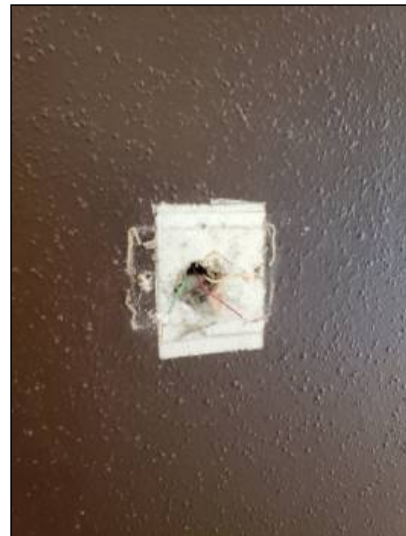
-The thermostat is missing. Recommend consulting an A/C and Heating specialist for further evaluation/repair and to check for other repairs that may be needed at that time.

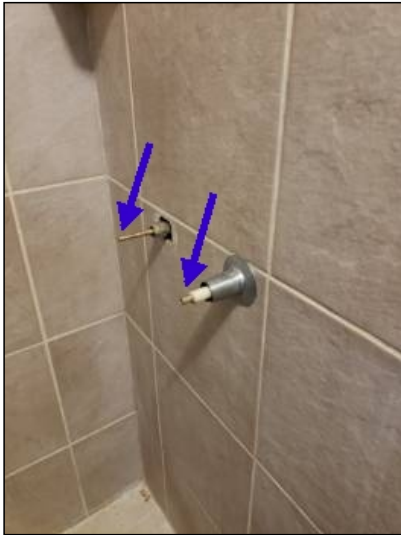
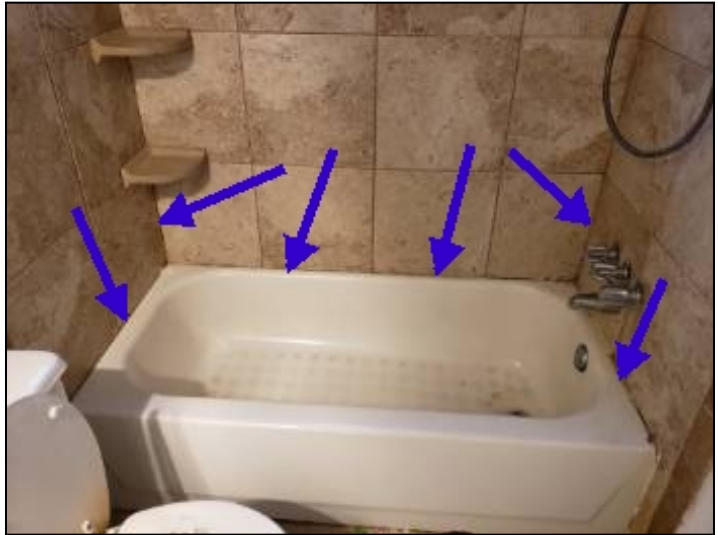
Shower faucet handles missing. Mainly at- master bath

-Recommend sealing the tub/shower surround to help prevent water penetration to underlying materials. Mainly at - hall bath

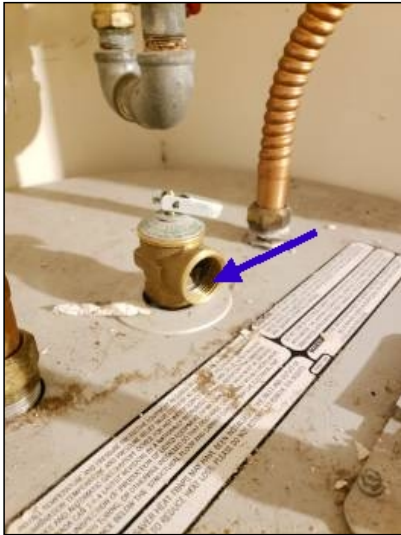
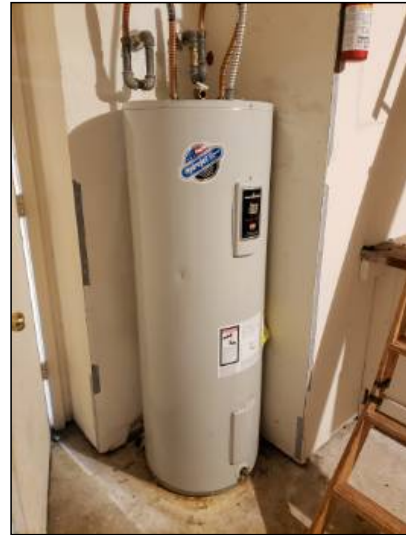
-There is no drain line for the water heater T&P (Pop-Off) valve.

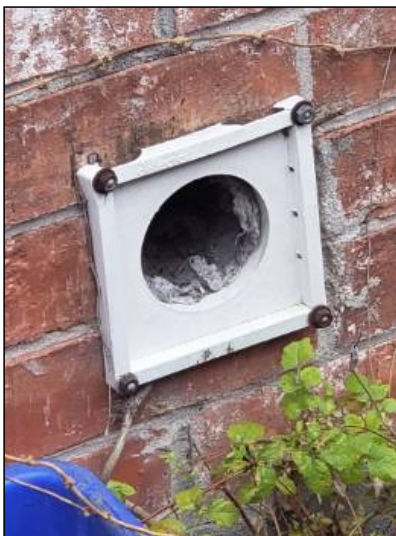
-The exterior dryer vent hood is damaged.
