RE: FOUNDATION INSPECTION

DATE: January 28, 2020

238 SCHLEY
Richwood, Texas 77531

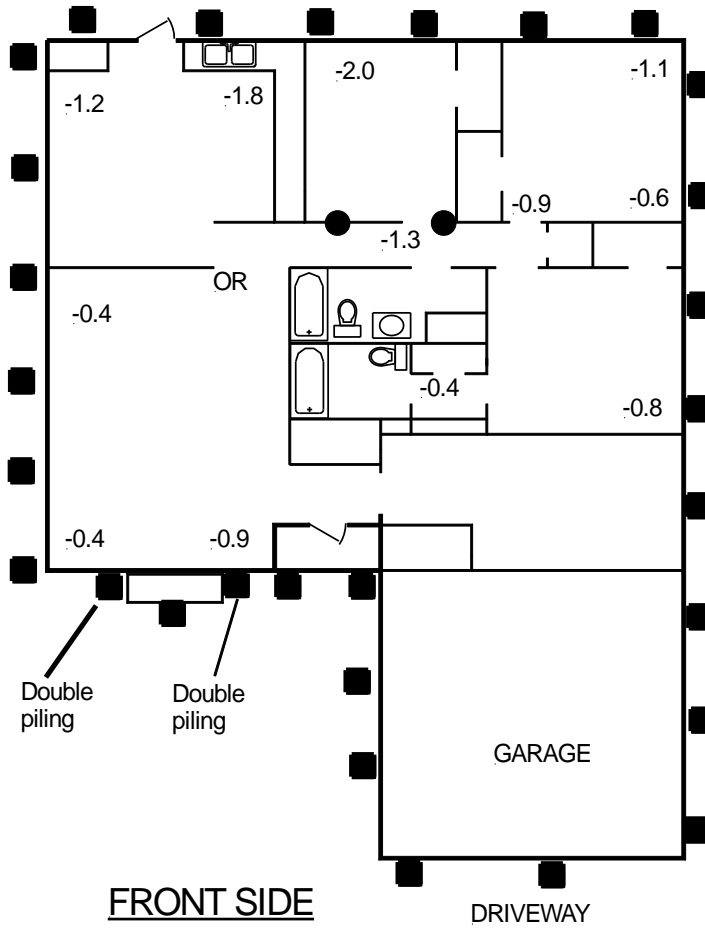
Attachment SK-1

From observations, the repairs inspected were provided by the selected Repair Contractor. In total, the work included the installation of perimeter exterior pilings and 2 interior pilings as summarized on the attached sketch, SK-1.

Included in the inspection was a random floor elevation survey, which was performed using a Compu level instrument, with the summary of this survey indicated on the attached sketch, SK-1. From these measurements the following was noted:

- 1) Elevations indicate proper floor levels have been provided.
