PREMIUM INSPECTIONS

519 Pedroso Dr, Crosby, TX

Date of Inspection: 12/1/2018 Time: 9:00 AM

Property Inspection Report

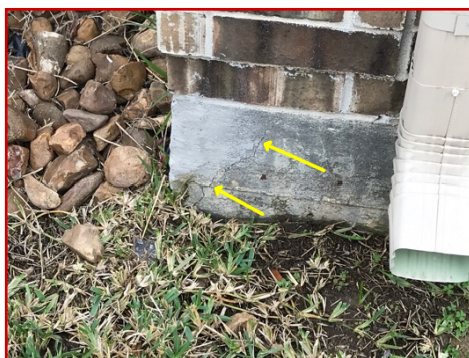
- At the time of the inspection, the Inspector observed no deficiencies in the condition of the visible portions of the concrete slab-on-grade foundation. Most of the slab was not directly visible due to floor coverings. The foundation is in satisfactory condition. This item is performing its intended function at the time of inspection and did not seem to need immediate leveling at this time.
- One or more corner cracks / spalling was observed. This is quite typical in all houses due to the fact it is difficult to reinforce that area. There is no reason for concern and there is no foundation issue causing it. This should be patched or repaired.

Common corner crack

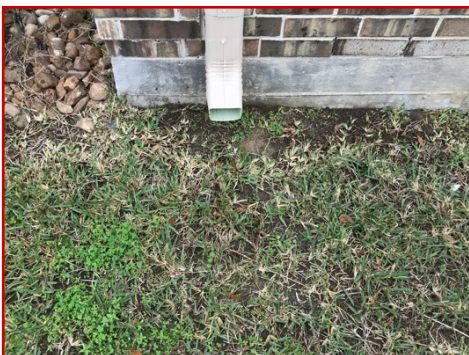
- One or more downspouts discharged roof drainage next to the foundation. This condition can effect the ability of the soil to support the weight of the structure above and can cause damage related to soil/foundation movement. The Inspector recommends the installation of downspout extensions to discharge roof drainage a minimum of 5 feet from the foundation.

Gutter discharges to foundation

- Recommend all downspouts, roof drains must discharge a minimum of 5' (five feet) from footing or too an approved drain system
- Lack of gutters in some areas has allowed rain run off to cut trenches by the foundation. Recommend addition of more gutters to prevent further damage.

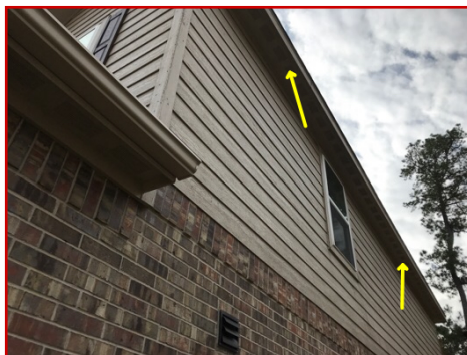
- The roof drainage system consisted of conventional gutters hung from the roof edges feeding downspouts.
- Only portions of the roof had gutters and downspouts installed. The Inspector recommends installation of a full gutter system to help protect the home structure and occupants.

Only partial gutters

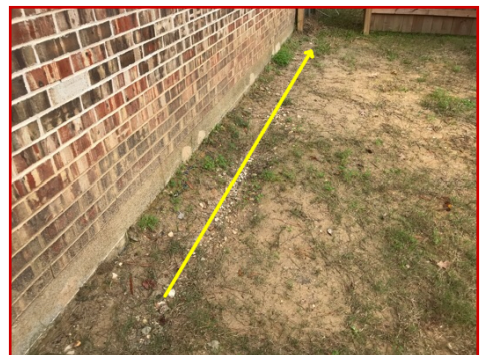
Rain draining from the roof is cutting a trench

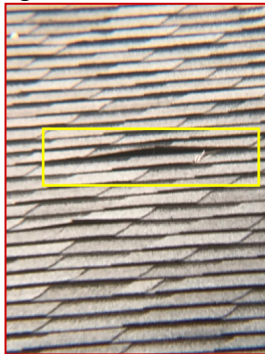
• Shingles are lifting away from the roof structure, caused by various reasons, allowing strong winds to penetrate and create further damage and greatly reducing the life expectancy which has been compromised. Recommend a licensed qualified roofing contractor to evaluate and repair or replace as needed.

Lifted shingle

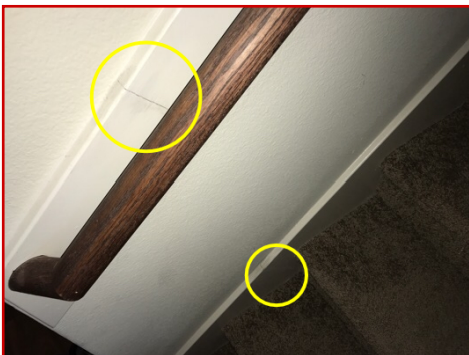
Separation in trim at stairs

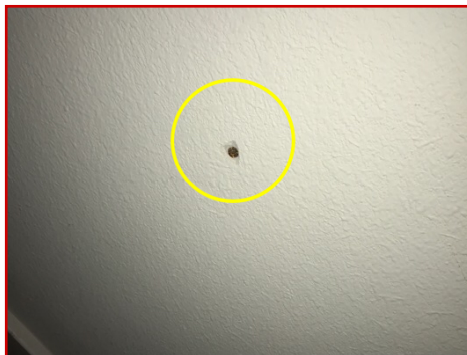
Nail pop in stairway wall

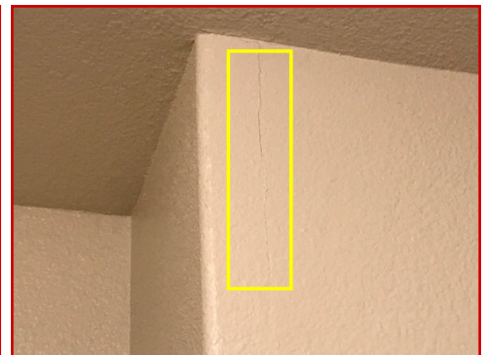
• Small cracks were observed on the walls. This is not a structural issue but appeared to most likely be a minor settling event of the structure and should not be a concern. Recommend patching to resolve the issue.

Minor drywall crack in upstairs bathroom

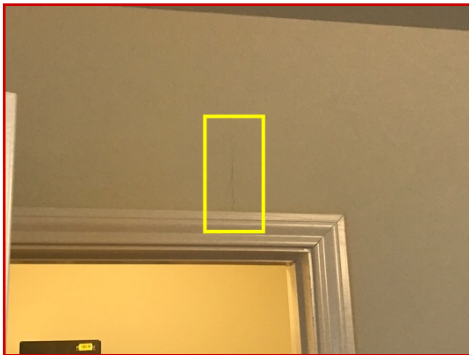
Minor crack above door in upstairs bedroom closet

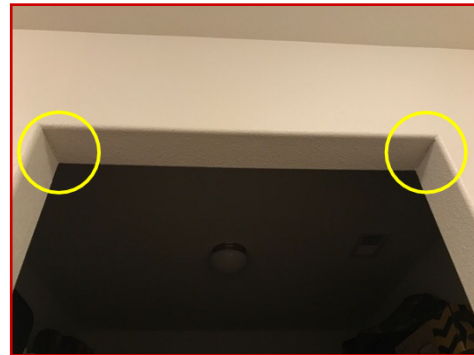
Minor cracking at master closet

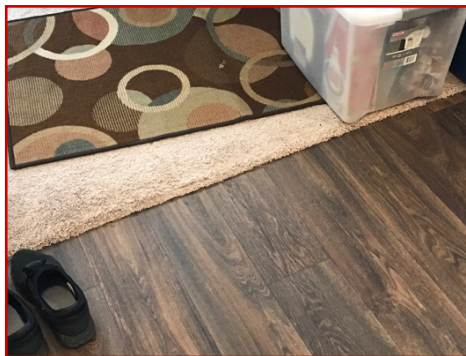
- At the time of the inspection, the Inspector observed no deficiencies in the condition of ceilings in the home.
- At the time of the inspection, the Inspector observed a few deficiencies of the floors in the home. Notable exceptions will be listed in the report.
- At the time of the inspection, the Inspector observed no deficiencies in the condition of vinyl floors in the home.
- Carpet tacks could be felt in the tack strip between the living room and dining room. You may wish to have this corrected by a qualified professional.

Carpet tacks can be felt in the seam between the living room and dining room

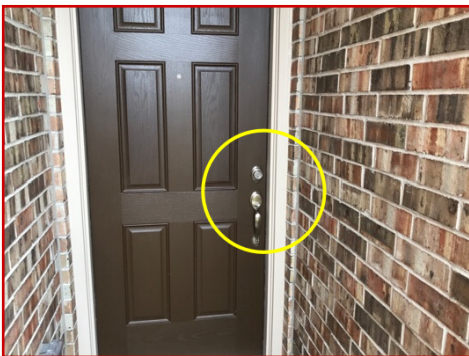
- Exterior doors rattled when closed and would benefit from having the strike plate trim tabs adjusted. The Inspector recommends adjustment by a qualified contractor.

Front door rattles when closed

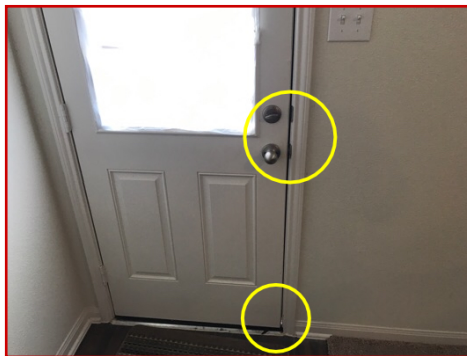
- Daylight visible around exterior doors was apparent at the time of the inspection. Methods used to prevent exterior leakage at doors typically can be resolved by adjusting the striker plate on the door jamb. Homes without effective seal against air leakage at doors will incur higher annual heating/cooling costs and occupants may experience lower comfort levels than with a similar home with doors effectively weather-sealed. The Inspector recommends repair as necessary by a qualified contractor.

Light visible at rear door and door rattles when closed

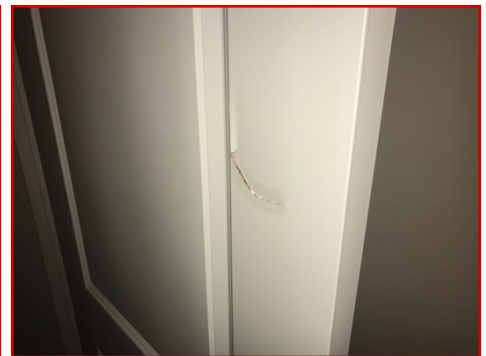
- Interior door in the upstairs bathroom of the home exhibited minor damage at inspection. Recommend repair by a qualified professional due to the possibility for moisture intrusion.

Minor damage to door in upstairs bathroom

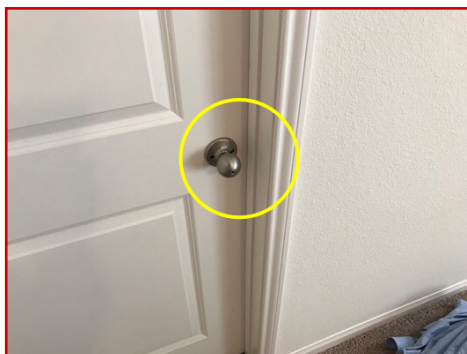
- The latch bolt of an interior door to the master bedroom did not align with the hole in the strike plate and did not hold the door closed. This door will need adjustment to operate properly. The Inspector recommends service by a qualified contractor.

Master bedroom door does not latch

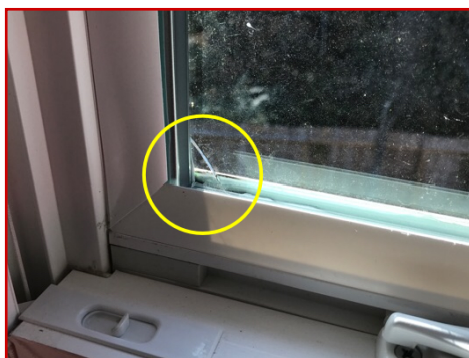
• A window in the upstairs living room of the home had a cracked or broken pane.

Cracked window pane in upstairs living room

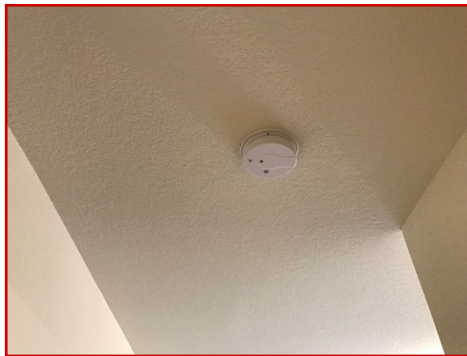
- One or more smoke detector are chirping. This item should be repaired as it poses a potential safety hazard.

Smoke detector in upstairs bedroom is chirping

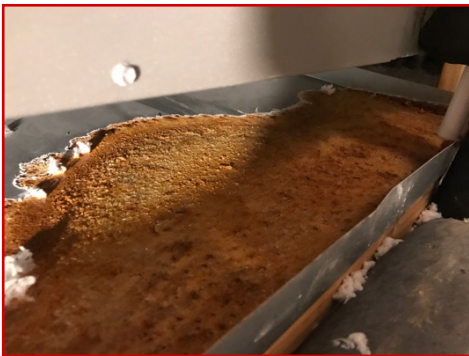
- **At the time of inspections, rust was observed in the catch pan under the A/C Air Handler unit in the attic and evidence showed that it leaked significantly to the exterior. There is no evidence of present moisture, the rust was most likely caused by a prior overflow from the secondary drain and allowed to sit. Recommendations would be to have a qualified licensed professional to further evaluate the unit to determine the cause of the moisture.**

Minor rust in catch pan, no moisture

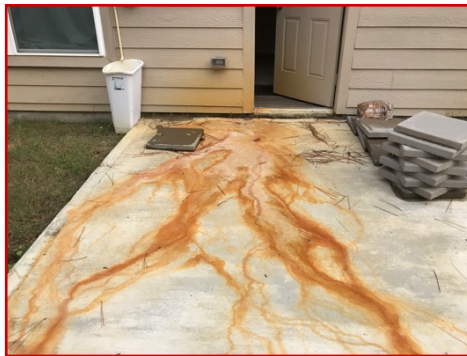
Rust stains from the AC secondary drain

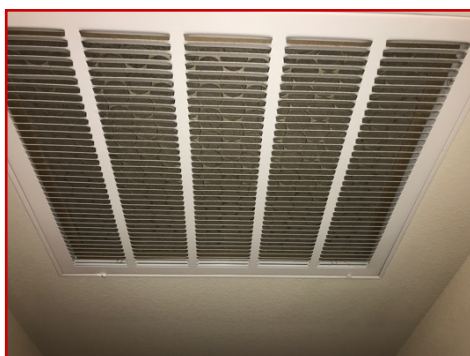
Upstairs return, dirty filter

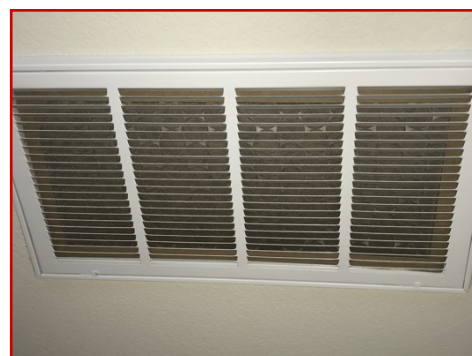
Down stairs return, dirty filter

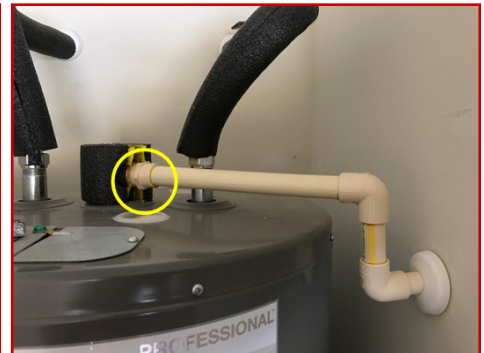
Coupler should be Metal
