**311 Summer Haven Court
League City TX 77573**

Client(s): Perez
Inspection Date: 4/7/2020
Inspector: Steve Fusselman , TREC 10405

Concerning: 311 Summer Haven Court, League City, TX 77573

By: Steve Fusselman TREC 10405 / BPG Inspection, LLC 4/7/2020

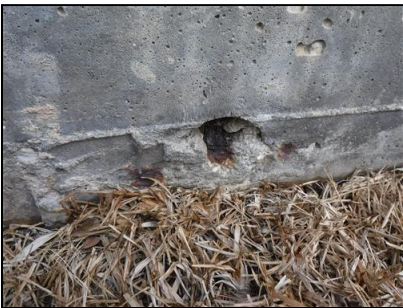
Right side

Rebar is protruding through foundation parging. This component will rust, allow water penetration behind parging causing it to de-laminate from foundation. Excess metal should be removed, sealed and additional parging applied.

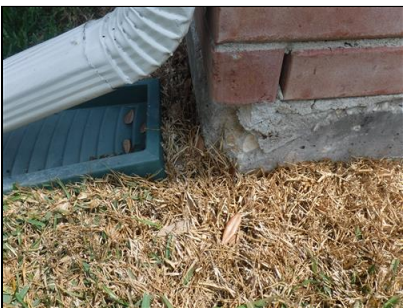
Right rear foundation corner missing. Recommend having corner sealed/re-formed as needed.

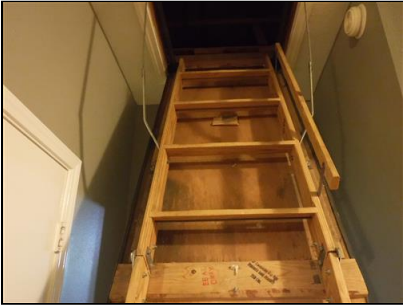
Observed the attic pull down ladder/hatch is not insulated completely, nor does it have weather stripping installed at edge of door that meets ceiling framing. Recommend fully insulating the attic stairway to keep the house more energy efficient. On average the insulation R-value for the entire attic area will drop approx. 27% when the attic stairs/hatch is not fully and properly insulated. The reason for this is that, although the attic stairs/hatch account for only 1% of the total attic area, the rate that heat flows through them by conduction (per square foot) is 38 times higher than in the insulated part of the attic.

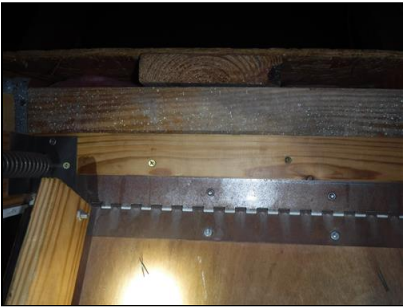
- 1. The attic pull down stairs are not properly fastened to the joists per the manufactures label (i.e. 16d nails or 1/4" lag bolts). I recommend updating to current standards.

The attic pull down stairs are not properly fastened to the joists per the manufactures label (i.e. 16d nails or 1/4" lag bolts). I recommend updating to current standards.

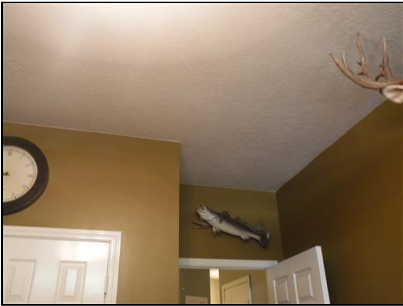
- 4. There are no bedroom smoke detectors installed. Today's standards now require smoke detectors in and directly outside of (hallways) all sleeping areas and on each level for multiple story structures. Additionally today's modern detectors are interconnected, so if one sounds they all sound.
- 5. There are no GFCI (Ground Fault Circuit Interrupt) protected outlets in locations called for by today's standards: island kitchen,. I recommend updating to current standards.

☒ There are no bedroom smoke detectors installed. Today's standards now require smoke detectors in and directly outside of (hallways) all sleeping areas and on each level for multiple story structures. Additionally today's modern detectors are interconnected, so if one sounds they all sound.

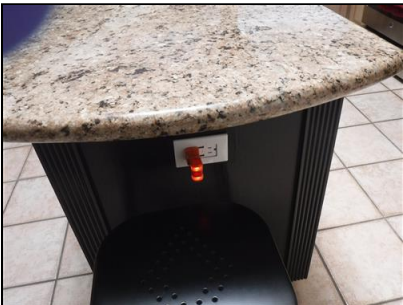
☒ There are no GFCI (Ground Fault Circuit Interrupt) protected outlets in locations called for by today's standards: island kitchen,. I recommend updating to current standards.

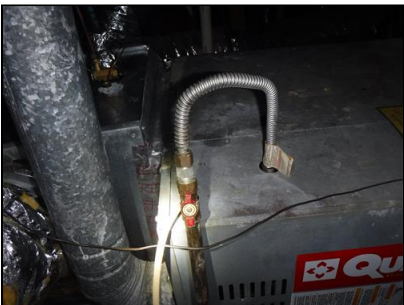
Gas supply to unit is missing a sediment trap, or drip leg as called for by current standards.

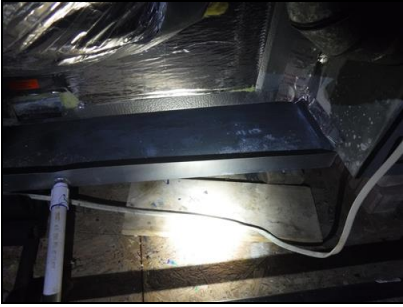
- 6. There is no emergency float electrical cutoff switch installed as called for by today's standards. These devices prevent condensate from overflowing into the interior house structure, and turn the unit off until service is performed to the unit. I recommend updating to current standards to prevent water incursion.

There is no emergency float electrical cutoff switch installed as called for by today's standards. These devices prevent condensate from overflowing into the interior house structure, and turn the unit off until service is performed to the unit. I recommend updating to current standards to prevent water incursion.

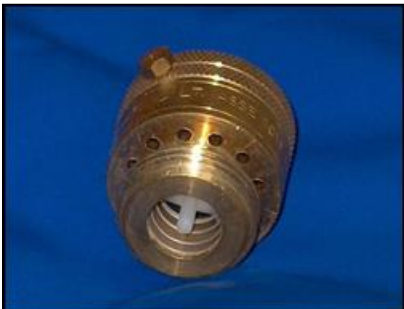
Some exterior hose bibs (faucets) are missing back-flow check valves as called for by today's standards

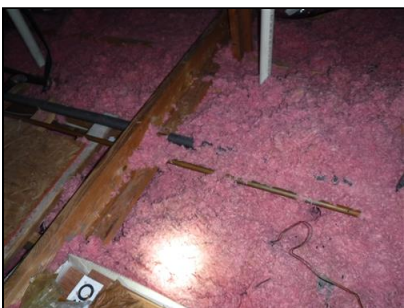
- 7. Supply pipes in in the attic space must be properly insulated. Current condition will not protect piping during hard freeze periods

Supply pipes in in the attic space must be properly insulated. Current condition will not protect piping during hard freeze periods

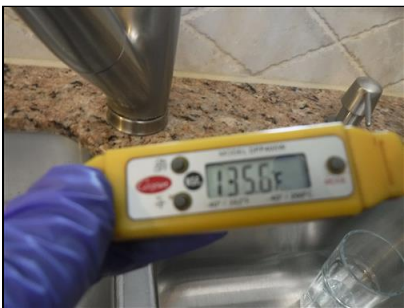
Temperature readings at sinks were measured at a higher than suggested setting. The U.S. Consumer Product Safety Commission (CPSC) urges all users to lower their water heaters to 120 degrees Fahrenheit. In addition to preventing accidents, this decrease in temperature will conserve energy and save money. Most adults will suffer third-degree burns if exposed to 150 degree water for two seconds. Burns will also occur with a six-second exposure to 140 degree water or with a thirty second exposure to 130 degree water. Even if the temperature is 120 degrees, a five minute exposure could result in third-degree burns. Consumers should consider lowering the thermostat to the lowest settings that will satisfy hot water needs for all clothing and dish washing machines.

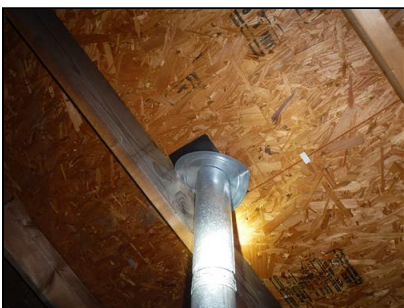
- 8. The flue from water heater as it terminates through roof is not strapped to rafters. Recommend properly securing flue to rafters with metal straps at rafters.

The flue from water heater as it terminates through roof is not strapped to rafters. Recommend properly securing flue to rafters with metal straps at rafters.

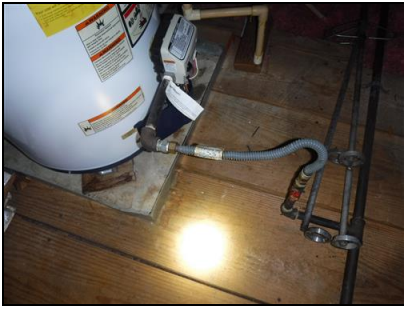
Gas supply to unit is missing a sediment trap, or drip leg as called for by current standards.

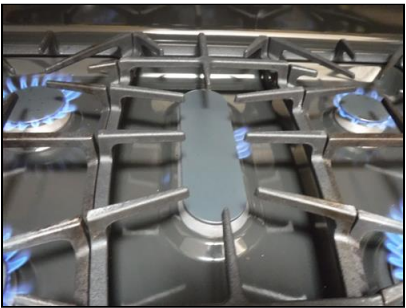
Noted that one burner will not ignite when tested. Most of the time, when a gas burner refuses to light or runs poorly when lit, the cause is dirt or grease. Fine particles of dirt or grease spatters can clog the flame openings on the burner, or could be electronic igniter failing. Recommend having appliance technician evaluate concern and repair or replace as needed.

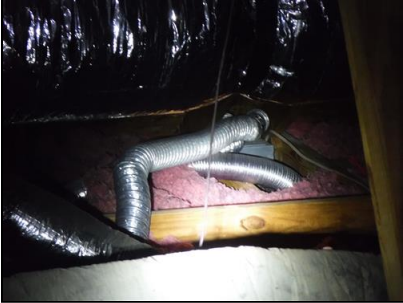
Bathroom exhaust fans vent to the attic. Today's standards now require bath exhaust to be directed to the exterior in bathrooms without opening windows

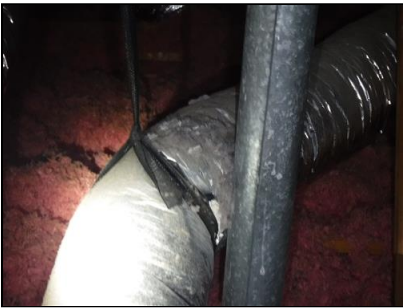
The dryer vent has excessive lint build-up and should be cleaned prior to use.
