PROPERTY INSPECTION REPORT

Concerning: 22502 Westbrook Cinco Ln., Katy, TX 77450
(Address or Other Identification of Inspected Property)

By: Rudolph Depena Lic. 5191 10- 12- 2016
(Name and License Number of Inspector) (Date of Inspection)

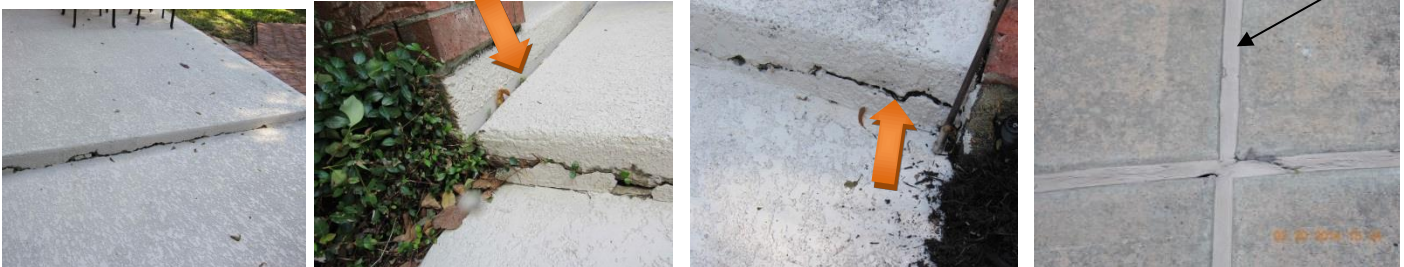
OBSERVATION: One of the concrete upper quadrants of the rear side appears to be sliding in an easterly direction. Visible gap between the concrete slab step transition is noted with fracture from one slab quadrant to the other, due to soil under-pressure with water traveling through soil capillaries under the concrete slab area from improper grading and drainage in this sloping area. It is the opinion of this inspectors to recommend implementation of proper grading and drainage within the surrounding terrain and others areas of the patio to prevent further movement (sliding) and/or lifting of this floating slabs quadrant around pool (see grading and drainage section for further comments). It is also recommended to fill the gap between the floating slab and step with self-leveling sealant.

Refill fractures and driveway expansion joints gaps between driveway floating concrete slab quadrants with self-leveling sealant (latex material), to avoid water penetration and deterioration. Keep these areas watertight to avoid the unnecessary excess of soil pressure underground.

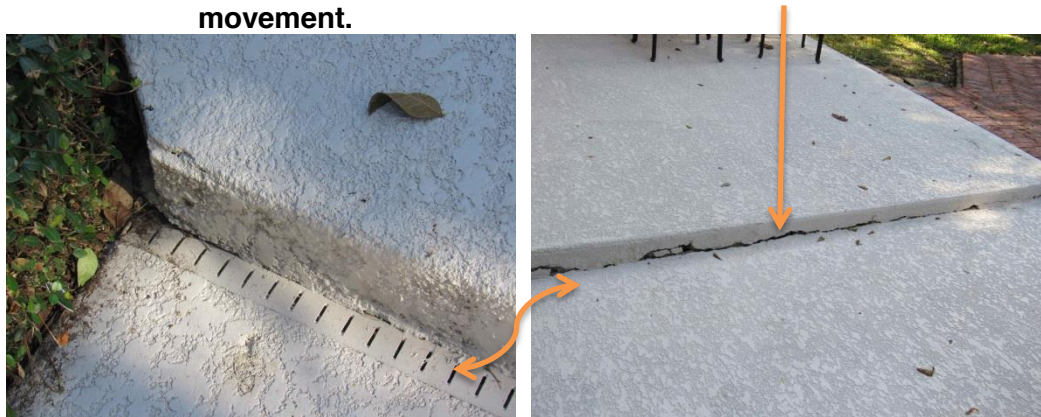
The concrete gutter in place between floating slab steps is recommended to be connected to a patio drain and clean periodically. An additional concrete gutter is recommended to be installed in the area of the step/concrete floating slab indicating lifting and with sliding movement.

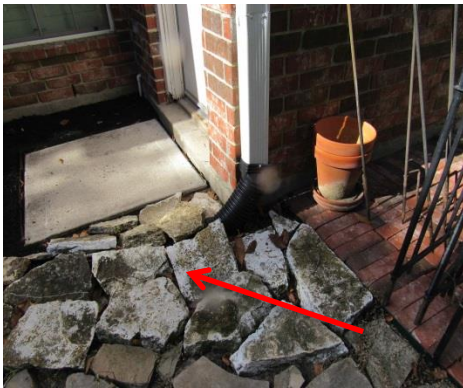
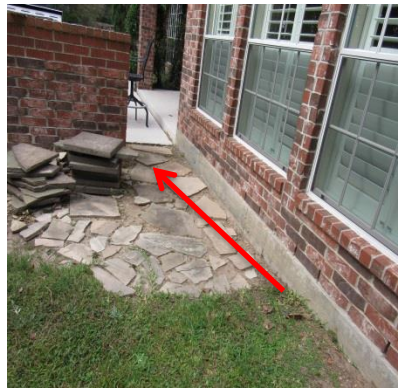
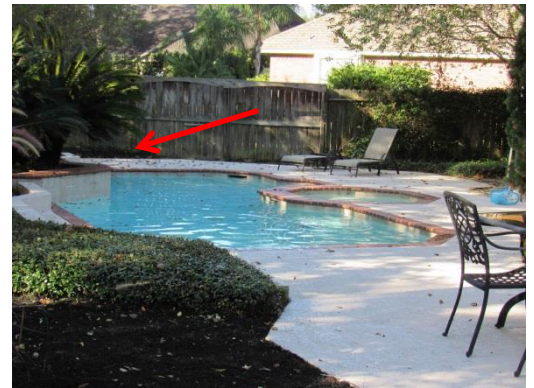
- D - Negative drainage is noted at the North front side toward the carport and towards the rear sun room area. The carport column is currently noted with settlement of the footing-foundation column element of the carport at the N.W. corner (as referred in the foundation section) and the exposed floating concrete slab quadrant of the rear.**
- Patio lowest point of the terrain (lot) is noted at the S.E. corner side close to the swimming pool. This area is not visible with adequate patio drain and may retain and pool/pond water during heavy rain.**

- Re-grade above mention areas with positive slope at top soil (avoid ponding of water), for storm waters to run away from the foundation. (part of a Foundation Maintenance). This may be aided by enhancing and adding to the drainage system as needed to exit as in this property towards the bayou area at the rear side.**

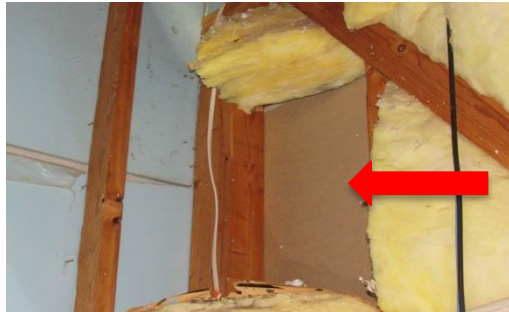
- Vertical Insulation fallen at the walk-in attic needs to be re-insulated.

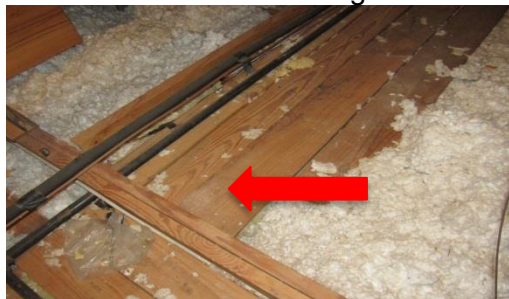
- Loose wood deck (catwalk) is noted between HVAC units at the upper attic.

Nail properly the wood deck to prevent tripping or prevent punching the sheetrock when walking the wood deck.

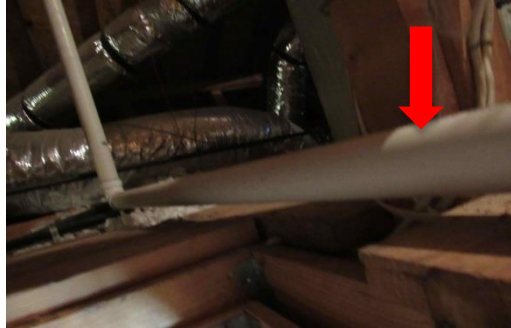
D - PVC plumbing vent stack pipe to the right side from the pull-down-stairway exhibits movement, and needs to be strap to the wood deck to prevent detachment or rotation. At roof line transition, the detached vent stack to be observed for leaks (water penetration).

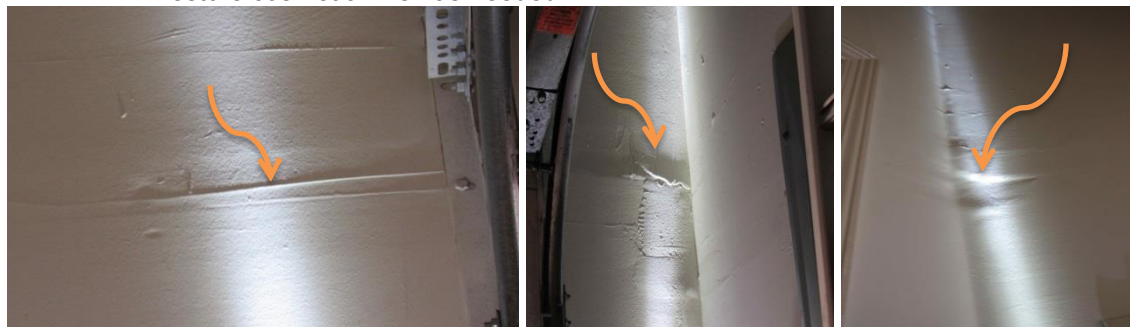
Note: Patching is noted to horizontal fractures at the west wall (next to the overhead garage door) of the garage and inside corner of the north wall. These may be part of rehab and from contraction and expansion of the wall wood framing. Restore cosmetic finish as needed.

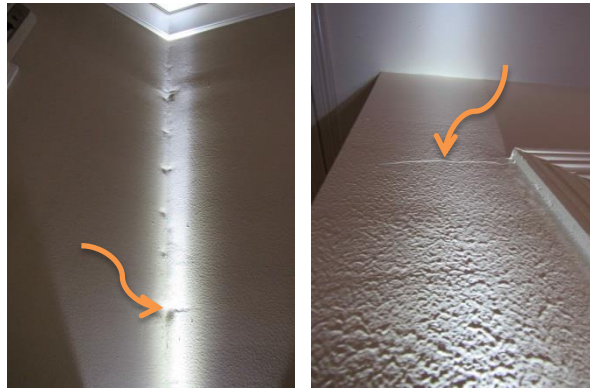
Patching repair is noted at the right inside corner wall of the study room and horizontal fracture at the right side to the closet trim element of the south bedroom (room where the pull down stairway is located). Restore cosmetic finishes as needed.

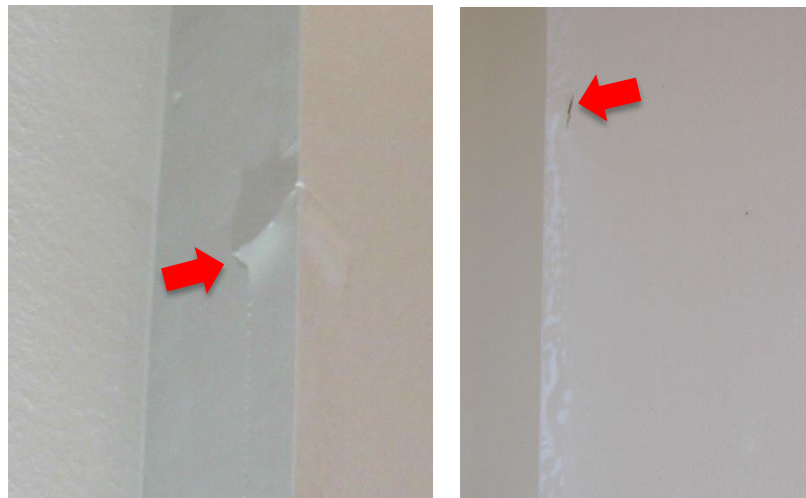
D - Stress and deflection is noted at the corner bead (metal wall edge) of the drywall at the left side of the fireplace. This may be attributed to workmanship and contraction and expansion of the wood framing. Restore as needed.

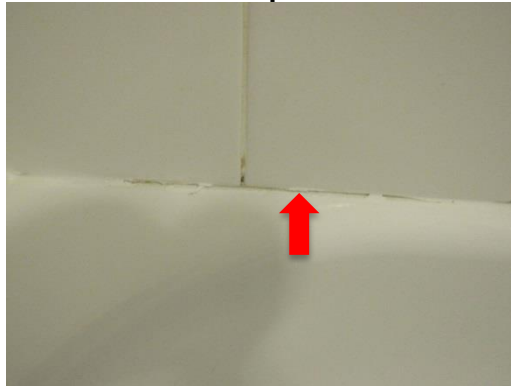
- D** - Recommend to seal properly the west wall transition of the ceramic tile surround and tub at the North bathroom. Prevent seepage of water to other components of the structure.

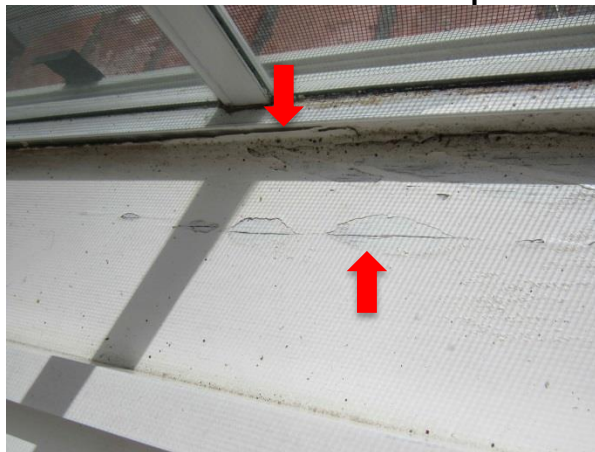
- Peeling paint to the window stool is noted at the master bedroom and other rooms in the dwelling. This is typically of a reaction of moisture accumulation. Restore window stool and recommend re-seal around the window frame to prevent moisture.

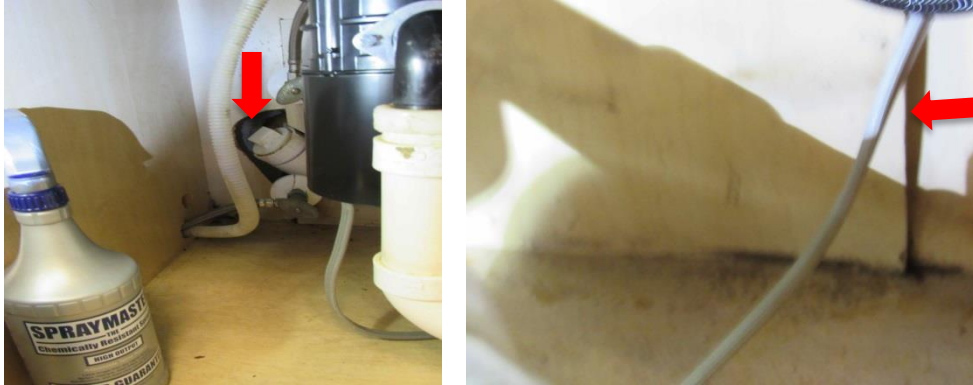
D - Seal the rear panel under the sink cabinet around the drain pipe with a gap and rear panel of the sink base cabinet detaching at the seam.

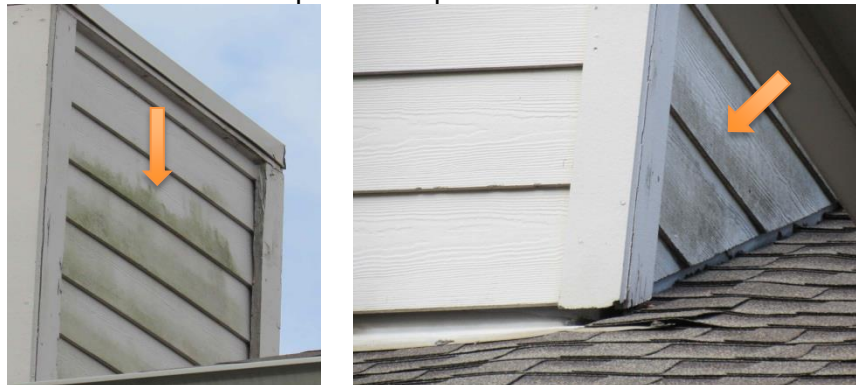
Siding at the rear dormer windows and chimney tower is indicative of needed wash. If after washing the siding mildew returns in a short time it is recommended to prime and paint.

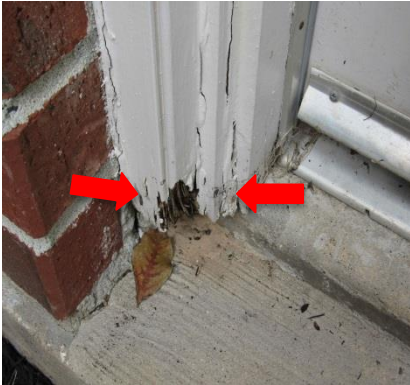
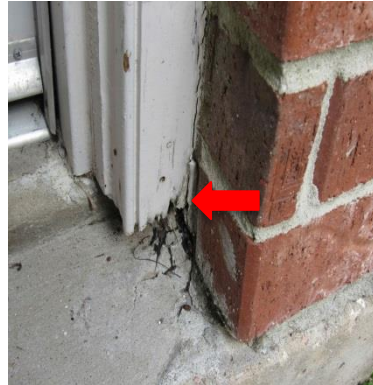
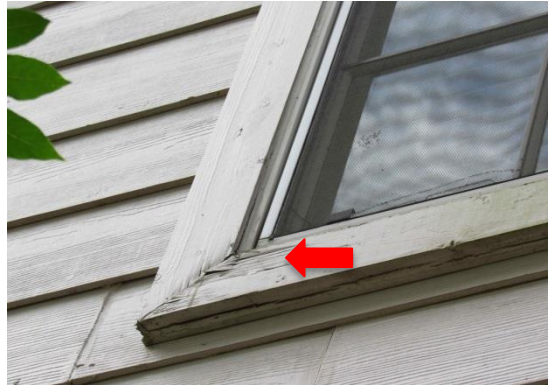
D - Rotted trim and jamb wood elements at the rear garage door and horizontal trim of the north window.

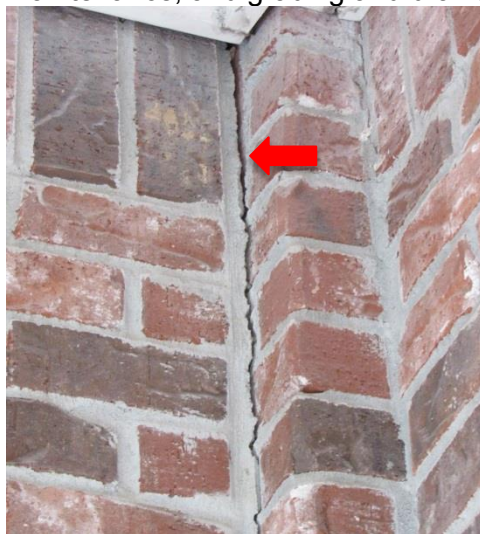
NOTE: A vertical fracture was noted at the inside corner of brick wall transition between the arch of the carport and the N.W. (front left) column. Indicating that, the independent concrete footing of this column appears to be affected by settlement/movement of footing-foundation from improper grading and drainage in the surrounding area. At this point it is these inspectors opinion, that this structural element those not need underpinning reinforcement. If after adequate drainage installed the columns deflects or settlement continuous a professional in the field should be consulted. See grading and drainage and exterior wall section for further comments.

- Re-Mortar brick veneer inside corner wall fractures at the N.W. corner of the carport with brick veneer column. At this point the fracture is indicating settlement of this column concrete footing. Observe after re-mortaring and re-grading for a period of 6-12 month. If crack reappear and are over 1/8" or deflects, consult a building professional. (See foundation for maintenance, and grading and drainage)

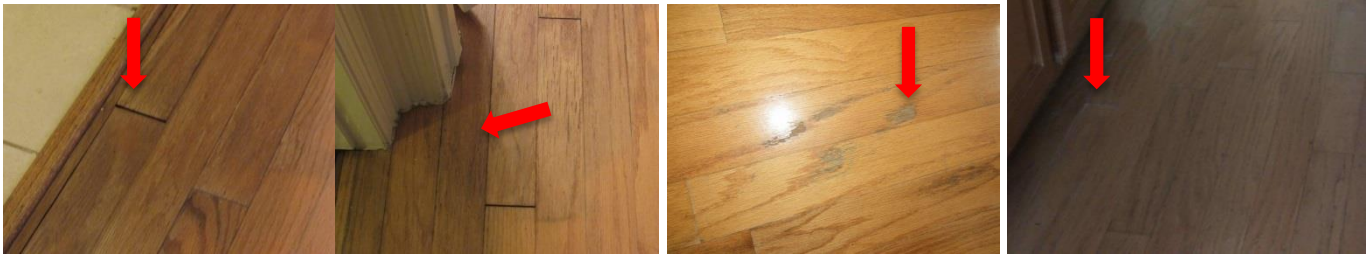
D - Damage Eng. Wood planks due to water penetration such as at the entrance to the Laundry room and some plank damages and/or buckled at the kitchen area and at the breakfast area.

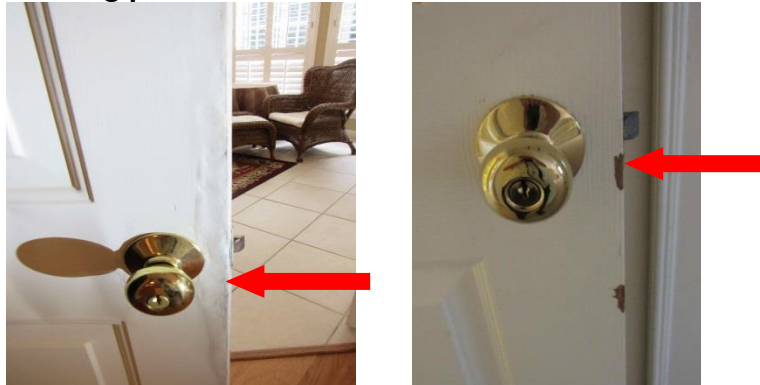
- Damage is noted to the slab veneer of the garage/house slab.
- Peeling paint veneer is noted at the N.E. bedroom door.

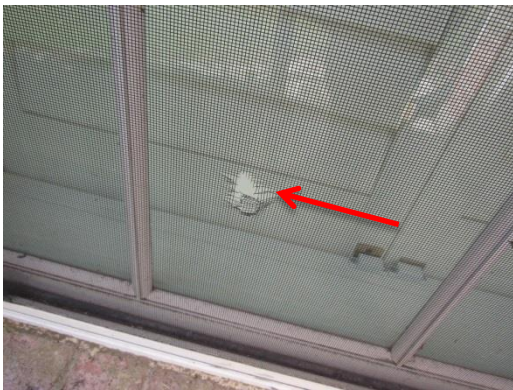
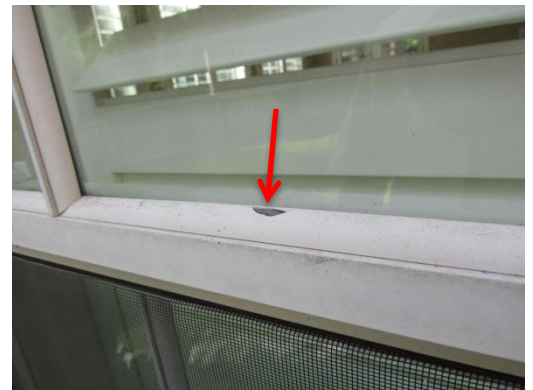
- D - One of the windows at the north wall has damage window screen.
- Seal around some of the window trim/brick veneer transition.
- Glazing bead in some of the windows are crack or broken. Replace to keep window pane in place and prevent HVAC air from leaking.

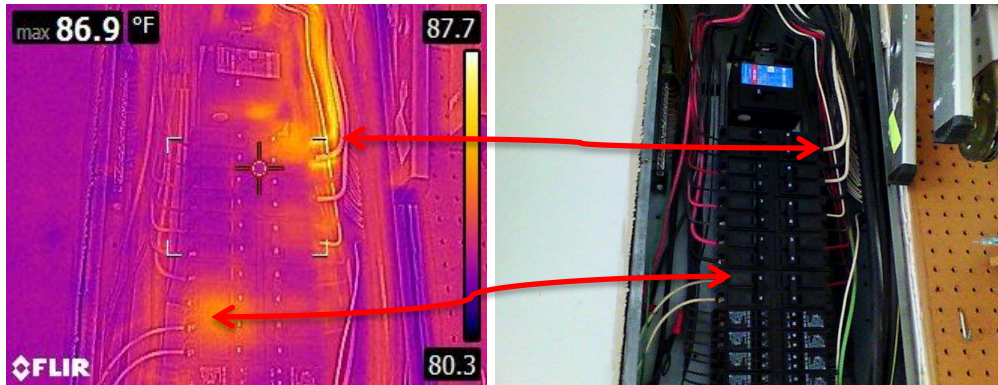
D - Main panel was tested for hot spots. Increase of temperature due to high resistance, noted with the infrared camera, to the connection of wiring to the top right 50 and left 20 amps double pole breakers. License electrician to check for loose wiring terminal or proper installation of multi-strand wire loose connection.

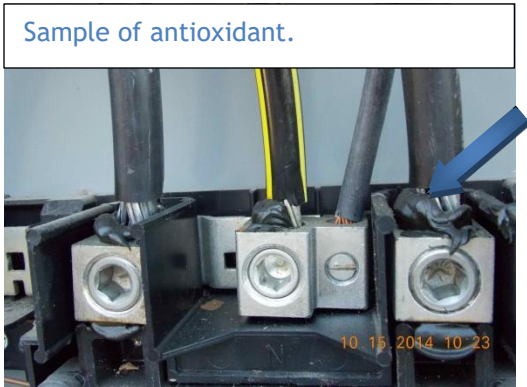
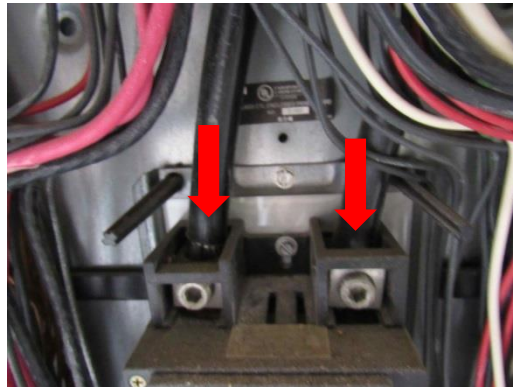
D - Antioxidant is needed for the AL (aluminum) conductors at the the service entrance wires with entrance lugs. This is to prevent overheating or corrosion.

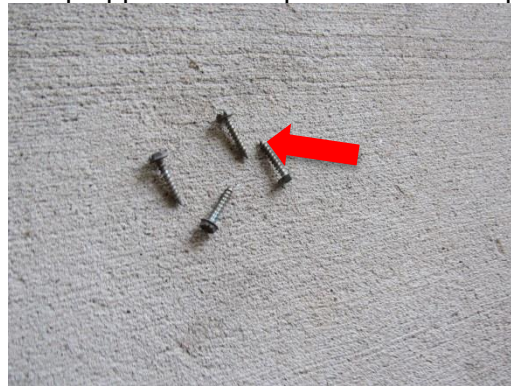
- The screws currently used for the interior cover of the 'CUTLER HAMMER' panel are sharp-tipped not to be used for electrical panels per NEC. Blunt tipped screws should be used. Avoid penetration of sharp-tipped into the protective envelope of wire.

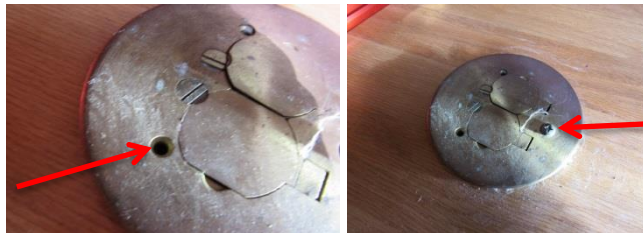
- Floor outlet of the living room is loose, not having all the screws to the top plate and one of the screws present is not intended for this use. Screws need to be flat headed.

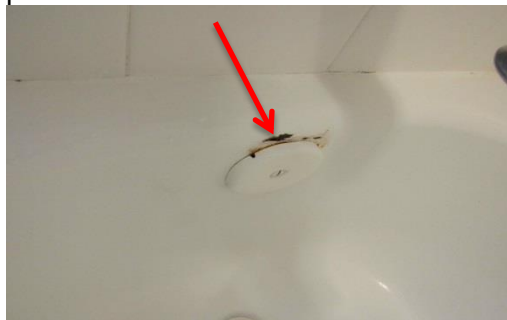
- Chips and corrosion above the blind plate to backflow pipe and edge of the tub at the north bathroom. Recommend refinishing to prevent further deterioration.
