## **PROPERTY INSPECTION REPORT**

**Concerning:** 806 Voyager Dr., Houston, TX 77062  
(Address or Other Identification of Inspected Property)

**By:** Michael Gann (TREC #7576) 05/08/2020  
(Name and License Number of Inspector) (Date)

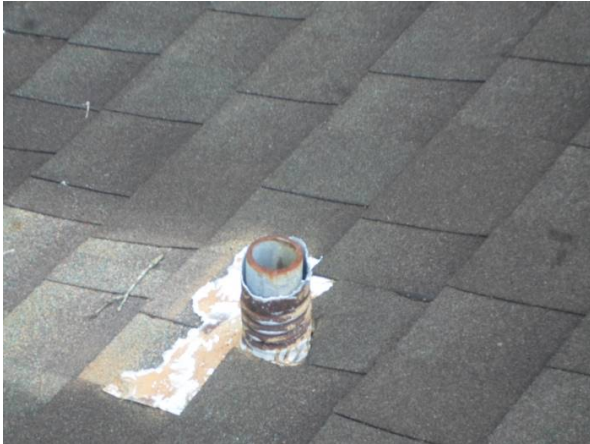
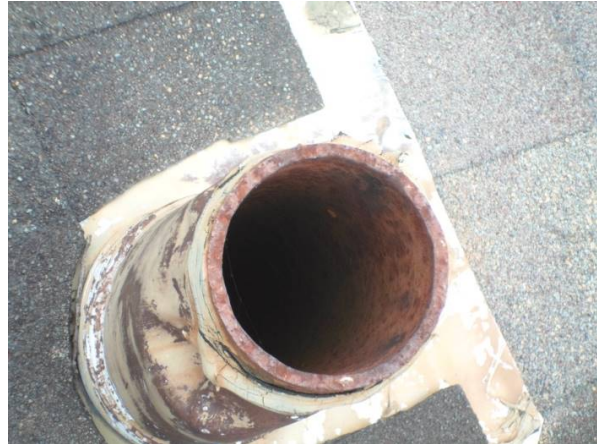
Three or more vent boot covers or roof jacks have squirrel damage on the left roof. This is common where squirrels are present. Replacement of the damaged roof jacks is needed to prevent roof leakage. Replacing with rubber boots is recommended when squirrels are present. If metal roof jacks are installed, they should be well painted to help prevent future squirrel damage. See photos below.

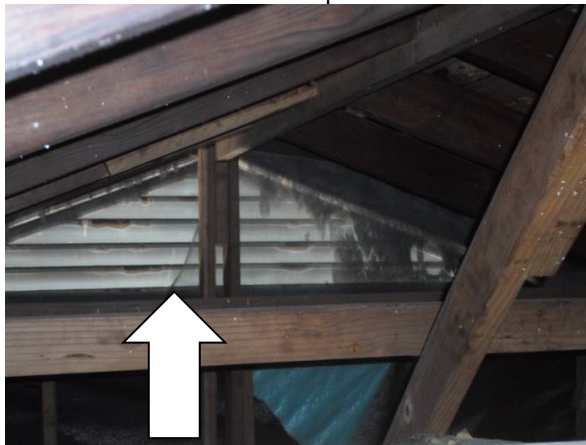
The roof or attic gable vents show to have damaged screens. The screens should be replaced to keep varmints out of the attic. See photo below.

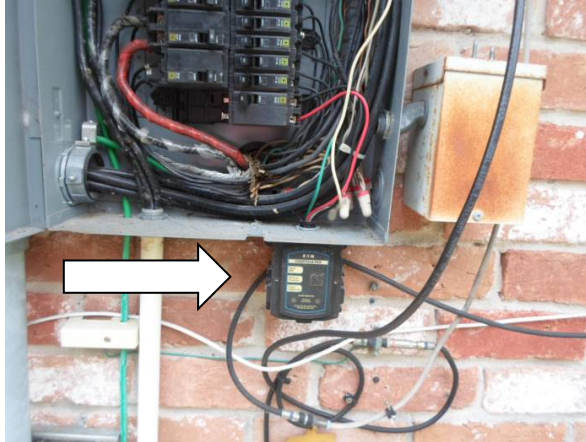
There is a whole house surge suppresser located underneath the breaker panel that is not functioning or spent. Replacement is recommended. See photo below.

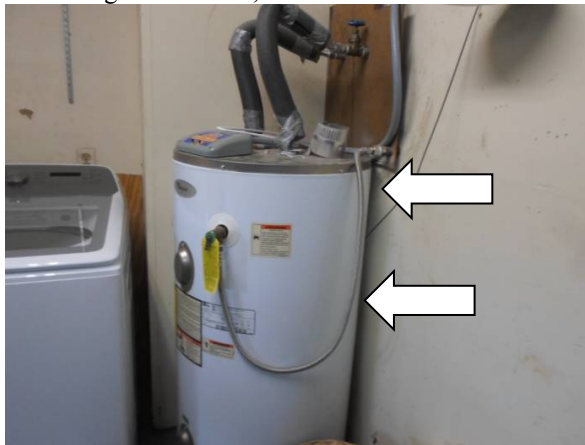
The T&P valve is piped with the discharge with an upward slope. The T&P line should always run down and never up. See photo below.

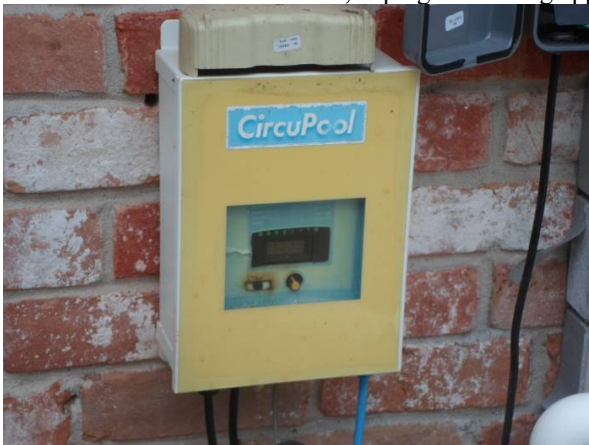
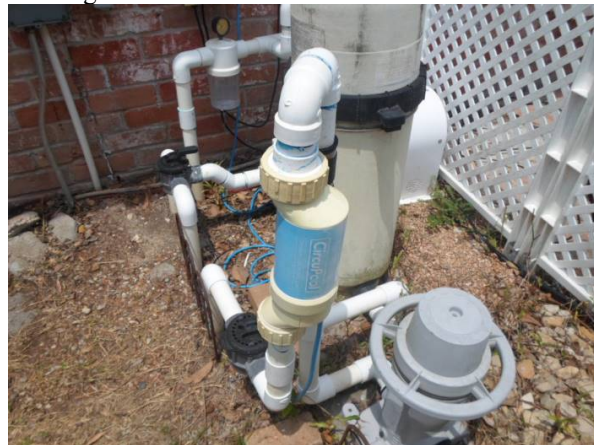
The chlorine generator appears to be in alarm state "Check Cell" and shows low salt. These components will need servicing or repair if the chlorine generator is utilized. At the time of the inspection, chlorine was being dispensed with floating dispensers. See photos below.
