PROPERTY INSPECTION REPORT

Concerning: 1003 East Camp Circle, La Marque, TX 77568

By: Bob Avery : TREC # 20559

08/16/2016

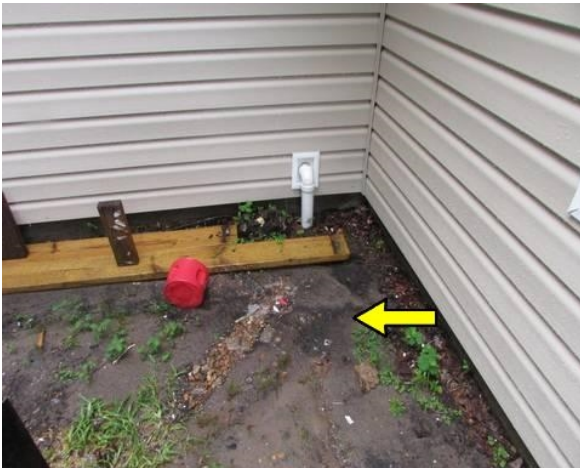
Erosion from rain runoff noted along at the Rt front of the home , add soil/backfill to all affected areas to promote intended water movement away from foundation areas.

Erosion

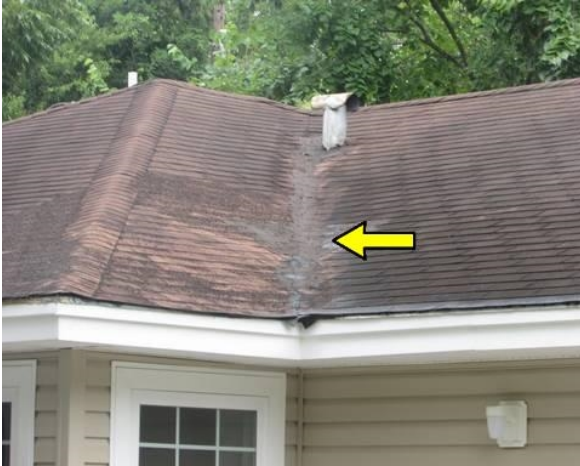
Repairs noted in roof valleys

Repaired

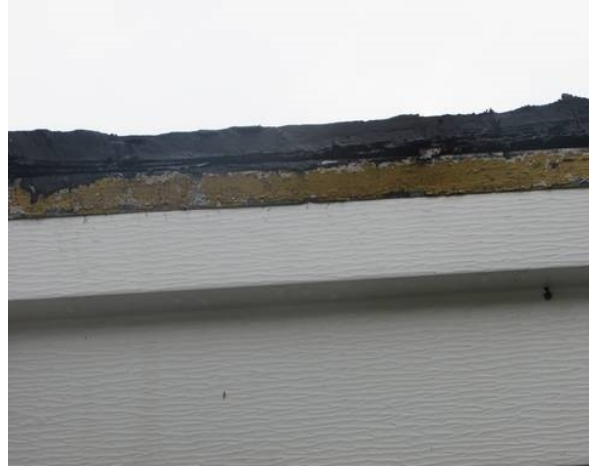
Drip edge is non-standard in practice; overhang does not visually appear to be adequate.
Damaged

Damaged drip edge and shingles - near side walk

Recommend having a qualified roofing contractor evaluate and rectify all affected areas as necessary to restored intended operation and function of roof covering.

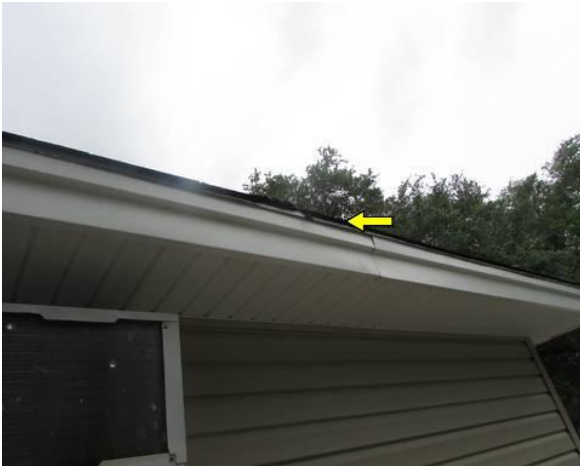
Shingles are damaged.

Damaged Shingle

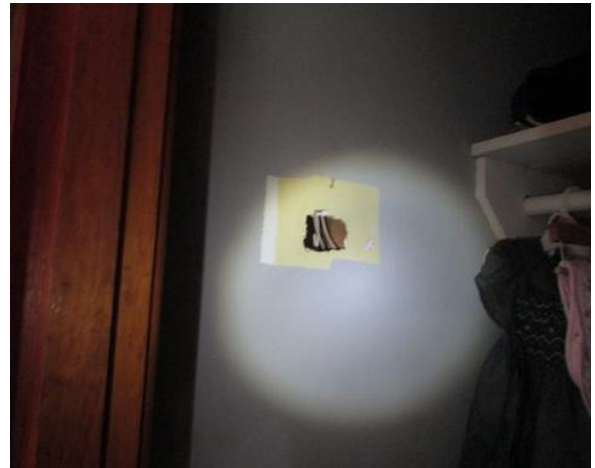
Closet

Whole in closet wall... repair

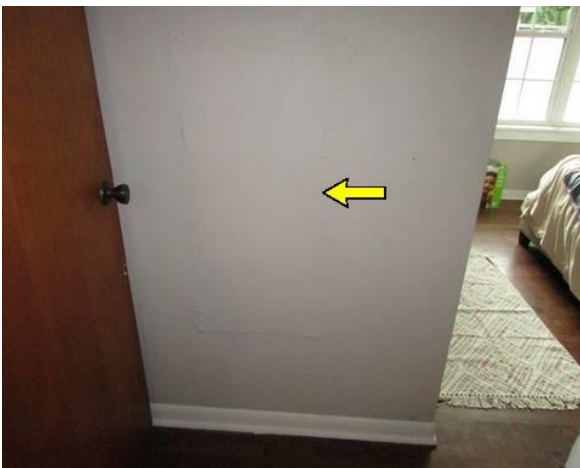
Repaired wall in hall

Wall repair

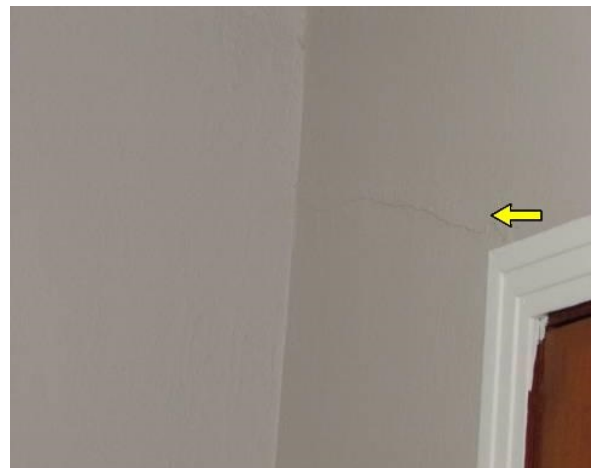
Wall crack in bedroom ... appears to be a settlement crack. Repair and monitor.

Wall crack

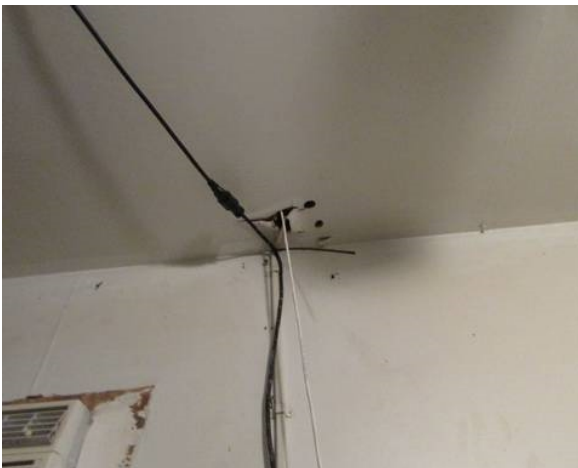
Hole in the garage - repair

Repair holes - garage

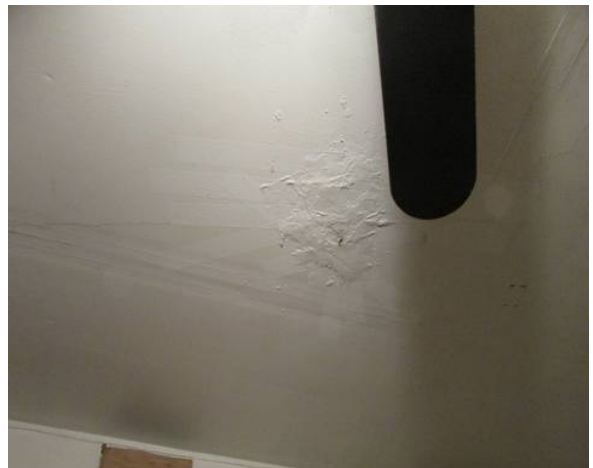
Repair noted in kitchen

Repair ceiling - kitchen

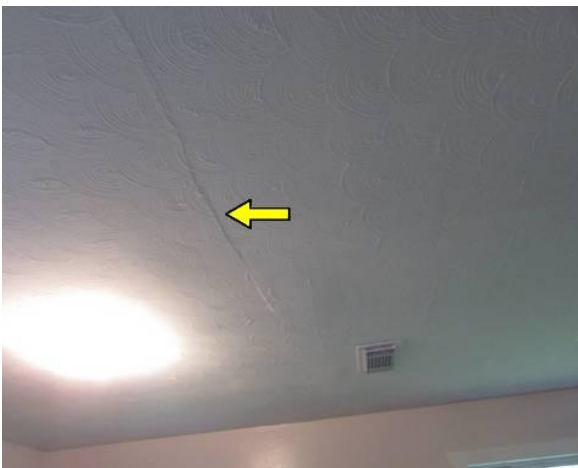
Settlement crack noted in living room.. repair and monitor

Crack - living room

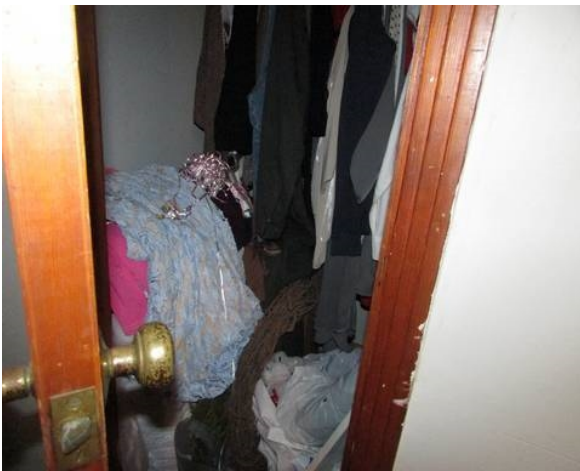
Does not latch

[Recommend qualified contractor make repairs](#)

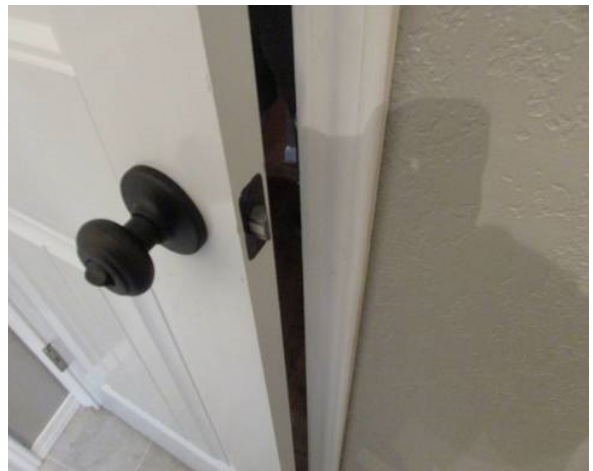
Does not latch

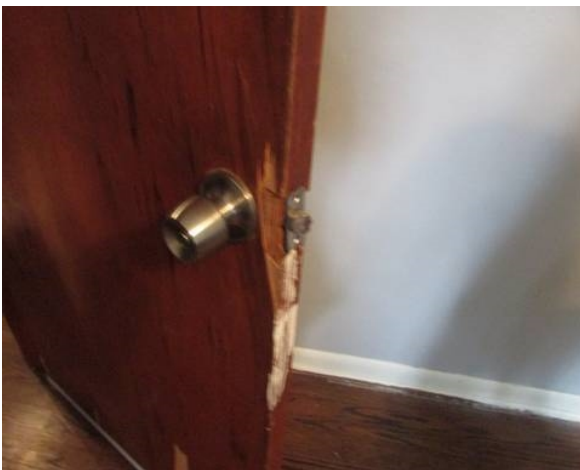
Damaged door

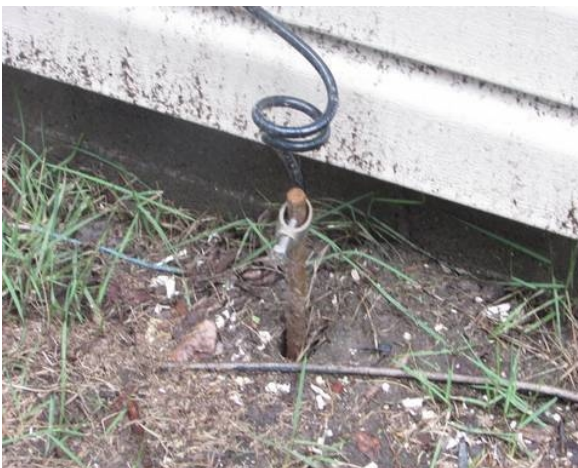
Grounding Rod connection

All bondings and groundings were not visible and could not be verified.

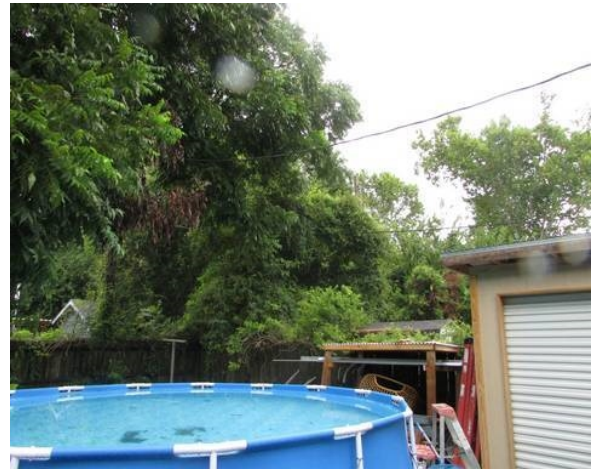
Feed wires are over a swimming pool. This is very dangerous. Recommending moving above ground pool to another location and away from Electrical wires

Wires over pool

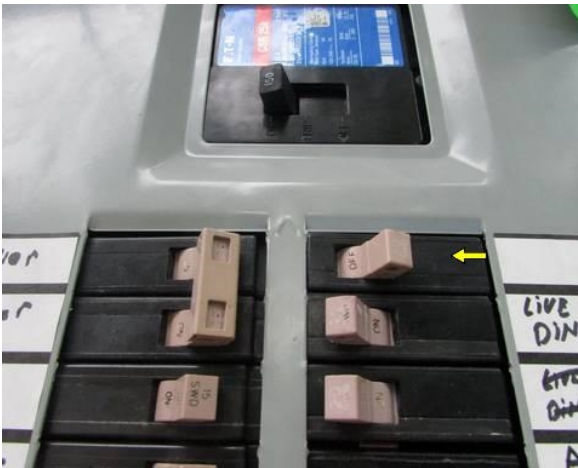
Breaker off

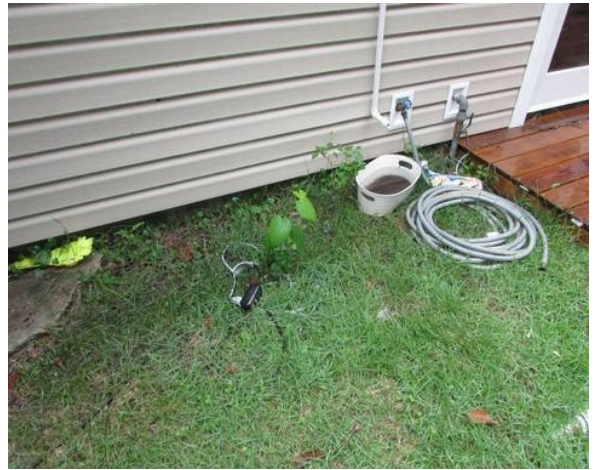
Extension cords being used to provide power for pool or as permanent wiring, this is non-standard practice. Recommend a licensed electrician install a dedicated type circuit to reduce possible electrical shock or fire hazard.

Extention cord

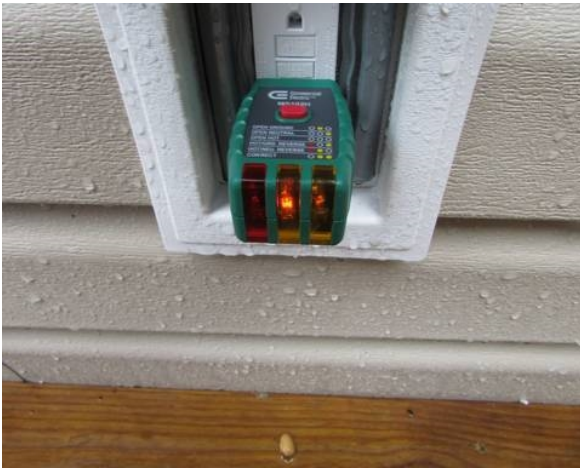
Open ground - exterior

Recommend licensed electrician make required repairs

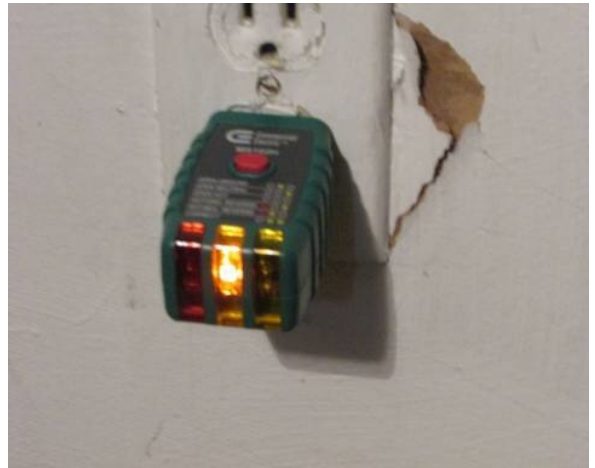
Open ground - interior

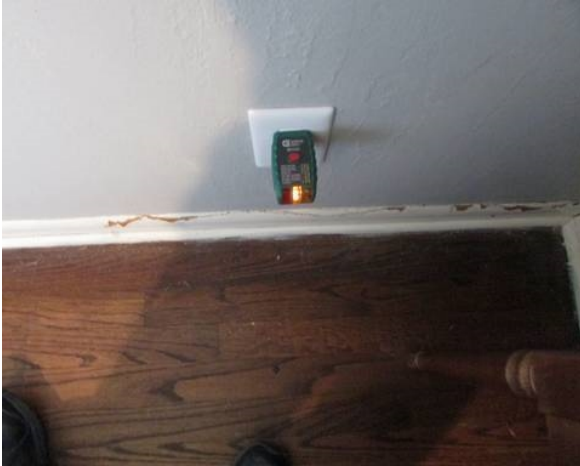
Open ground - interior

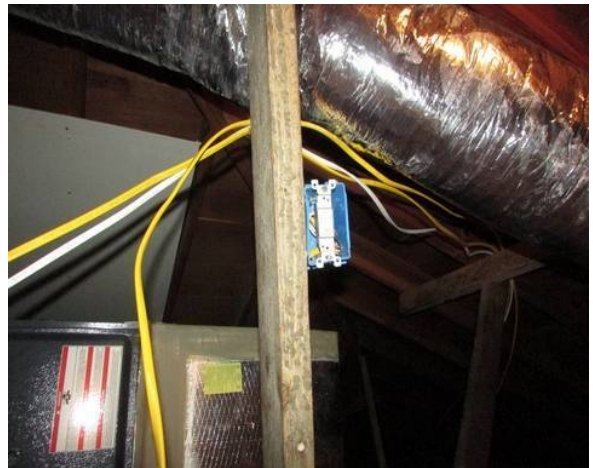
Junction box(s) in several locations are missing cover plates. New cover plates should be installed to reduce possible electrical shock or fire hazard.

Cover missing

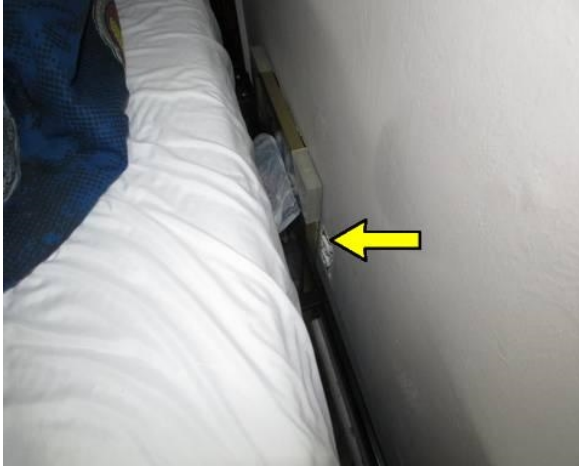
Cover missing

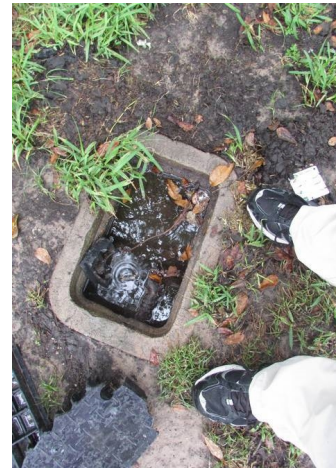
Meeter - call water company for new cover

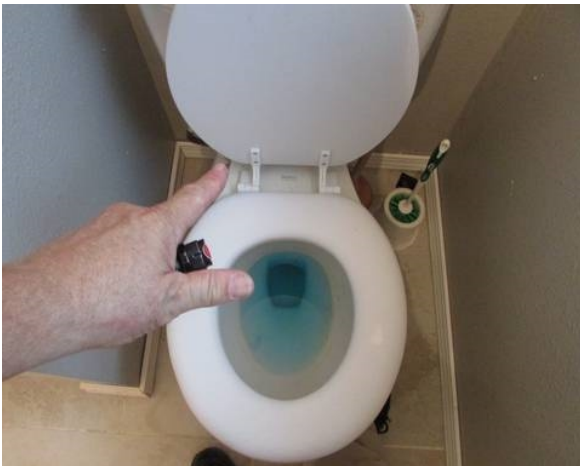
Close toilet

Toilet is loose and needs tightening.

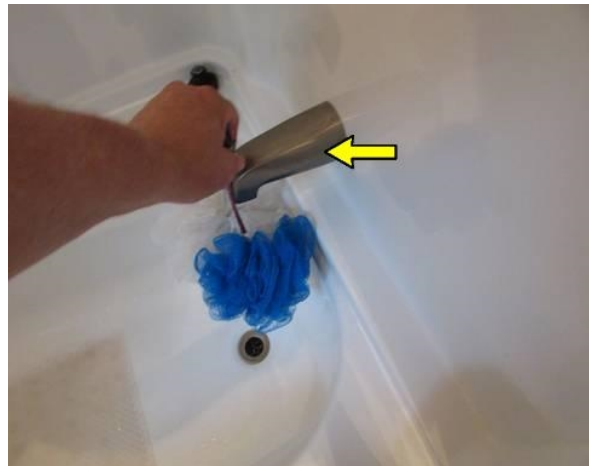
Lose faucet

Tub faucet is loose and needs tightening
