RESIDENTIAL INSPECTION REPORT

2506 Sand Bar Ct
Seabrook TX 77586

Jeremy Ellison
APRIL 18, 2020

PROPERTY INSPECTION REPORT

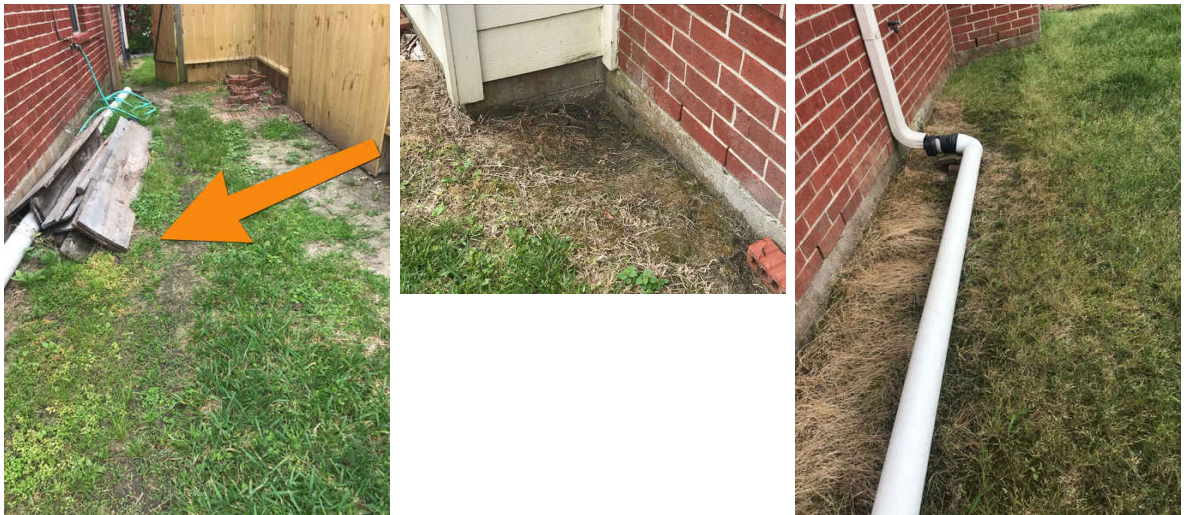
1: Grading & Drainage: Negative Grading

Grading was sloping towards the home in some areas. This can lead to water intrusion and foundation issues. Regrading by a qualified landscaping contractor or foundation contractor so that water flows away from the home is recommended.

Recommendation: Contact a qualified landscaping contractor

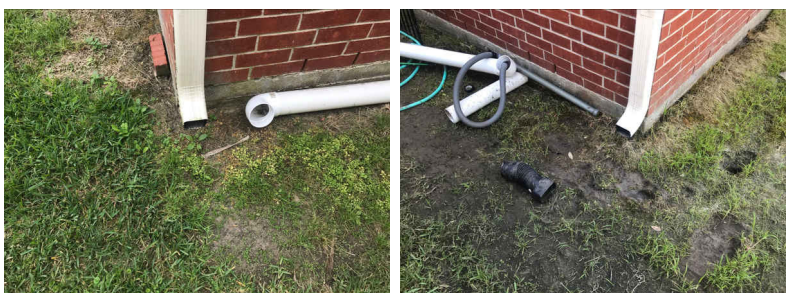
2: Gutters & Downspouts: Missing Splash Blocks

A splash block placed beneath the downspout elbow helps to disperse water away from the foundation and to prevent soil erosion. Remedy as needed.

Recommendation: Recommended DIY Project

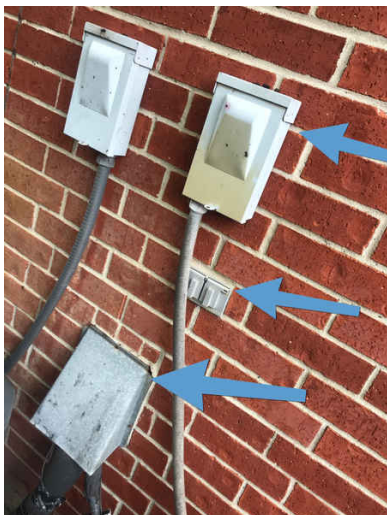
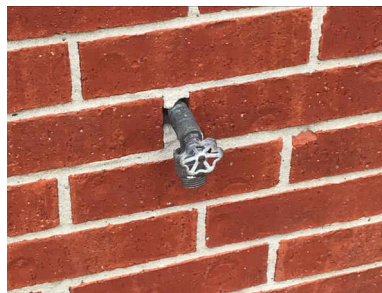
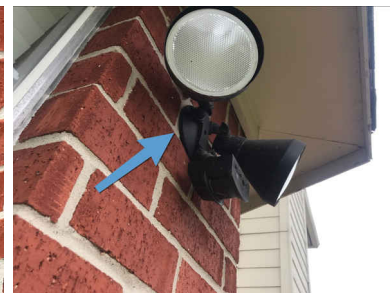
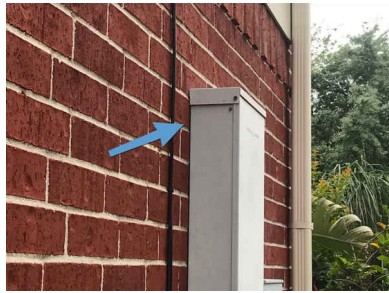
1: Exterior: Seal Wall Fixtures

All Exterior Wall Penetrations, Light Fixture(s), Electrical Distribution Panel(s), Service Panel(s), Vent Cover(s), A/C Disconnect Box(es), A/C return lines - Fixtures/Electrical boxes were not properly sealed. Remedy as needed.

Note: Modern building practices recommend sealing around components that are mounted on or pass through the exterior wall to limit moisture intrusion.

Recommendation: Recommended DIY Project

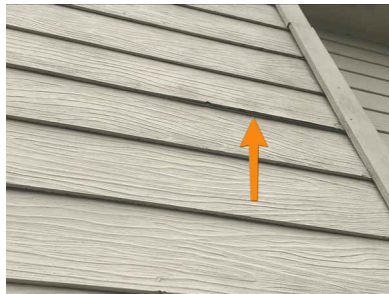
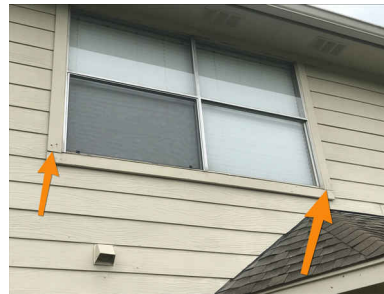
2: Exterior- Siding: Siding Damage

Chimney, rear

There was damage to exterior siding.

Recommendation: Contact a qualified professional.

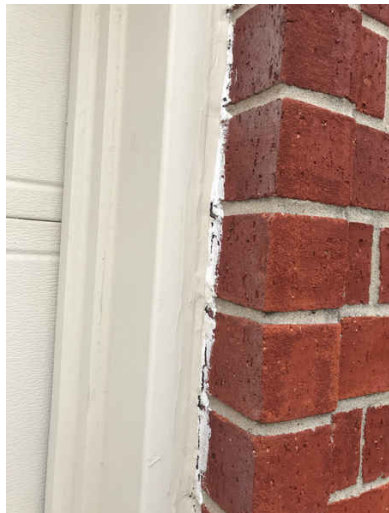
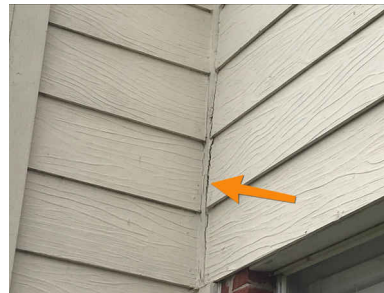
3: Exterior- Caulking: Deteriorated/Missing

Caulking around siding or trim was deteriorated or missing.

Recommendation: Contact a qualified professional.

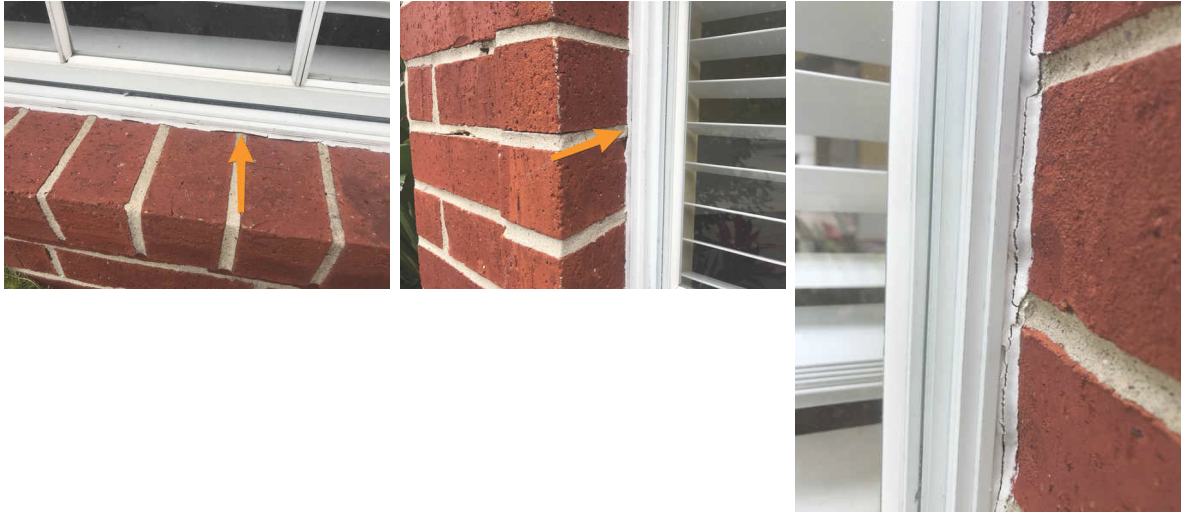
4: Exterior- Caulking: Missing/Deteriorated Around Window Frames

Multiple Locations

Recommendation: Contact a qualified professional.

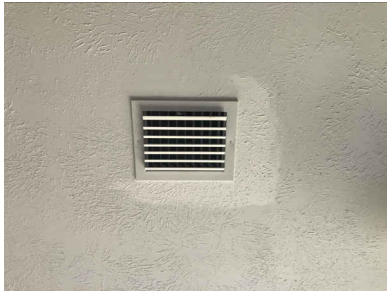
1: Note: Patched Ceilings

Second floor living room

Patched ceiling areas were observed at the time of inspection. Obtaining all previous work documentation is recommended.

Recommendation: Contact a qualified professional.

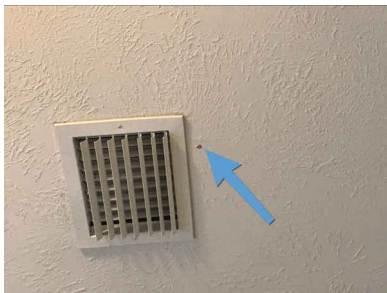
2: Ceiling: "Popped" Nails

2nd Floor Living Room

"Popped" (loose) drywall nails are observed on the ceiling. This condition is typically considered cosmetic. Re-seat and seal as needed.

Recommendation: Contact a handyman or DIY project

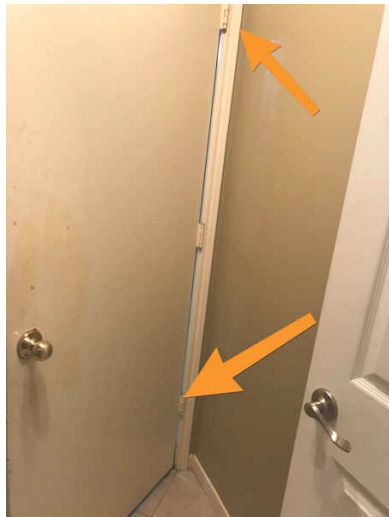
1: Garage Door into Living Space: Self-Closing Mechanism not Present/Operable

Entry door between the garage and living space should have a functioning self-closing mechanism.

Recommendation: Contact a qualified professional.

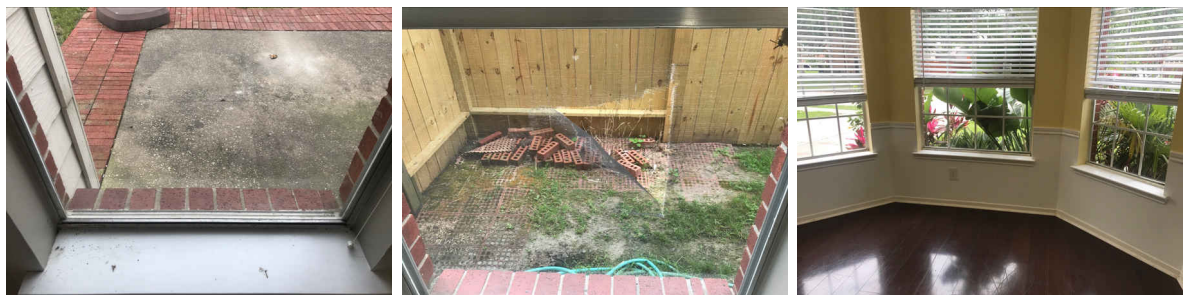
1: Missing/Damaged Screen(s)

One or more windows are missing a screen or had a damaged screen. Replacement of screens is recommended.

Recommendation: Contact a qualified window repair/installation contractor.

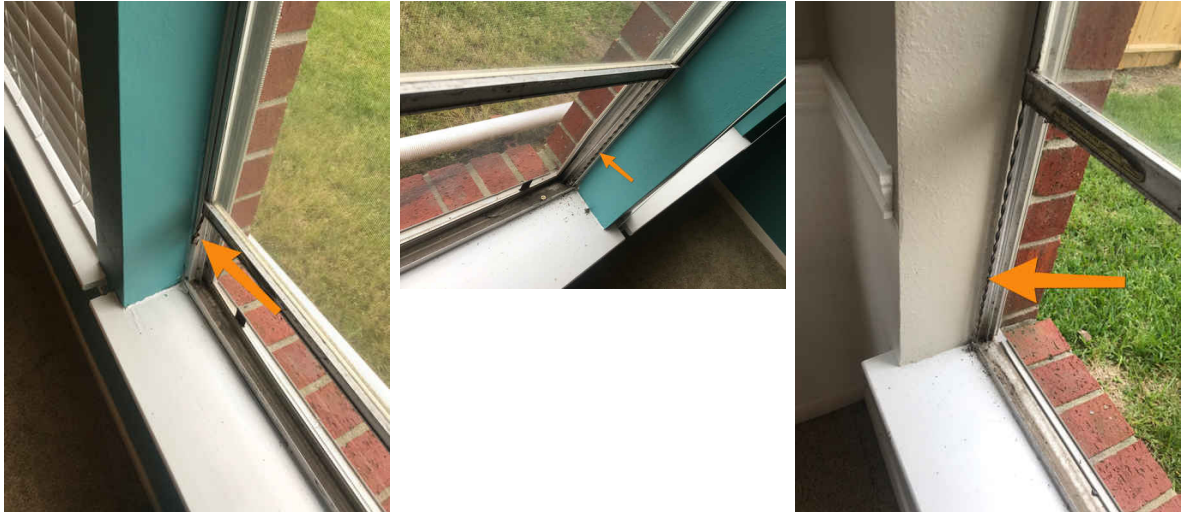
2: Window ballasts/springs are broken

Window ballasts (or guidesprings depending on the window style) were detached or damaged. These mechanisms serve to hold the window sash up, and if they are damaged the window may not stay open. Remedy as needed.

Recommendation: Contact a qualified window repair/installation contractor.

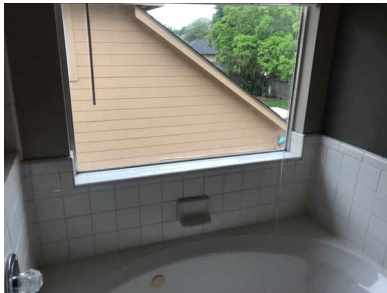
3: Safety Glass not Installed

Master Bathroom

within 60 inches of the floor of a tub or shower -

Safety glass with a tempered stamp should be installed in all hazardous locations, such as:

Recommendation: Contact a qualified professional.

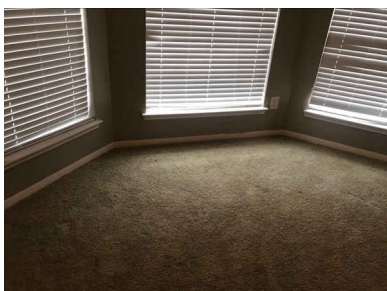
4: Sill Height: Too Low

2nd Floor Middle and Left Bedroom, Master Bedroom

Current building standards require any window with an exterior sill height of 72 inches or more to have a minimum interior sill height of 24 inches.

Recommendation: Contact a qualified professional.

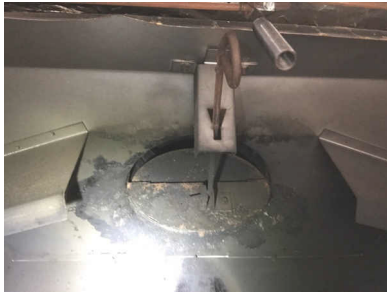
1: Damper: No clip

No apparent safety clip on the damper. Typically when gas logs are present, a safety clip must be installed on the damper to keep it from closing fully. Remedy as needed.

Recommendation: Contact a qualified professional.

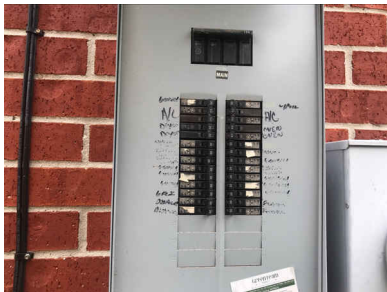
2: Circuits Not Labeled

Circuits in the distribution panel were not properly labeled. Remedy as needed.

Recommendation: Contact a qualified electrical contractor.

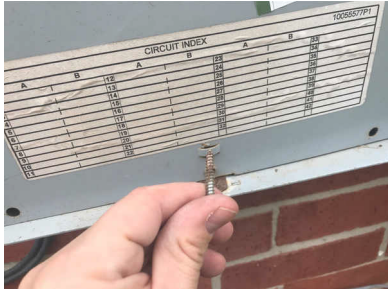
3: Pointed Screws Improper

Sharp tipped screws were used on the panel cover. Blunt tipped screws designed for this application are recommended to prevent puncturing electrical wiring insulation. Remedy as needed.

Recommendation: Contact a qualified electrical contractor.

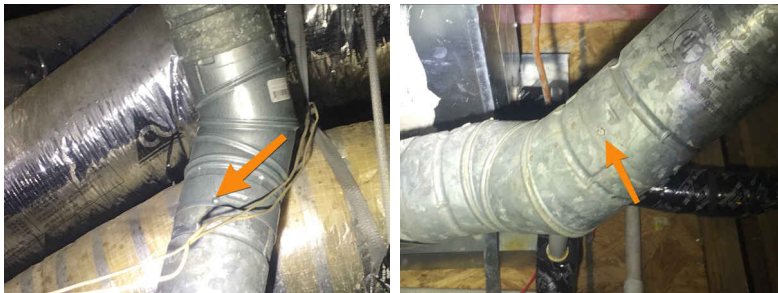
1: Venting: Sheet metal screws in pipe

Sheet metal screws were installed through the furnace vent pipe. Remedy as needed.

Recommendation: Contact a qualified professional.

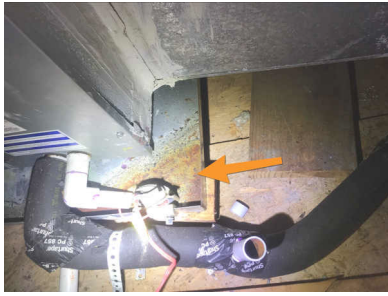
1: Condensate system: Rusted Emergency pan

Rear unit

The emergency overflow pan is rusted. Further evaluation by an HVAC professional is recommended.

Recommendation: Contact a qualified HVAC professional.

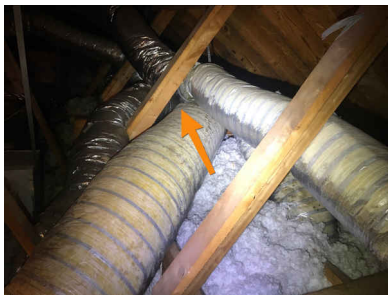
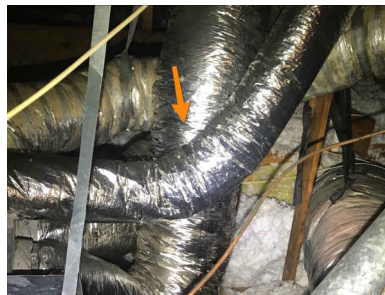
1: Ducts: Ducts resting on each other.

Ducts were resting on each other. This can result in condensation forming between the two sections of ductwork. Remedy as needed.

Recommendation: Contact a qualified professional.

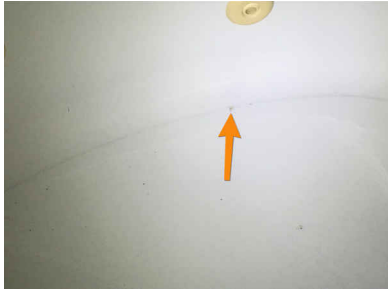
1: Tub: Surface Defects

Master Bathroom

Defects were observed on the tub surface. Remedy as needed.

Recommendation: Contact a qualified professional.

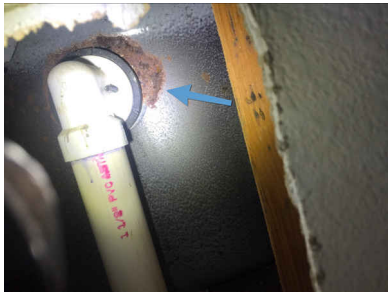
2: Tub: Rust at overflow (not leaking)

2nd Floor Hall Bathroom

Rust was observed at back of tub around overflow drain, but no leaks were observed. Monitor for future leaks or consult a plumber if further evaluation is desired.

Recommendation: Recommend monitoring.

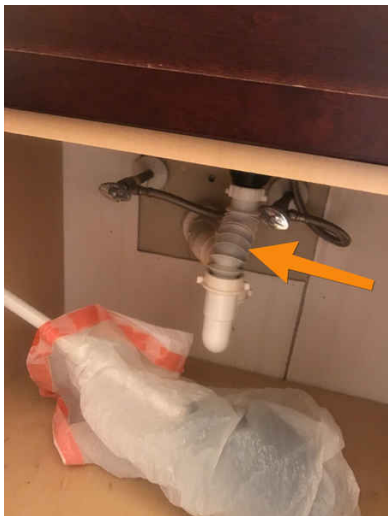
1: Drain Piping: Corrugated Line

1st Floor Bathroom

Current plumbing standards require all drains to have smooth interior surfaces. Corrugated materials are not approved.

Recommendation: Contact a qualified plumbing contractor.

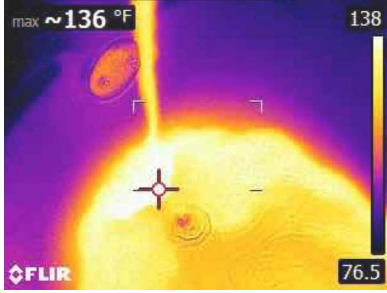
1: Hot Water Temperature Exceeds 125 Degrees F

The hot water temperature was measured and exceeds 125-Degrees F, which can cause burns from scalding. Refer to the Operating Instructions in the manual for this specific unit for detailed instructions on setting the proper water temperature for your needs. Contact a licensed plumber for further information.

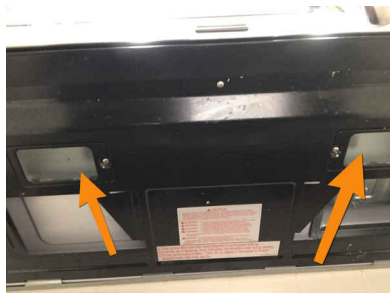
1: Exhaust Light Out

The light did not function at the kitchen exhaust. This may be the result of a bad bulb. Replace and test or remedy as needed.

Recommendation: Contact a qualified professional.

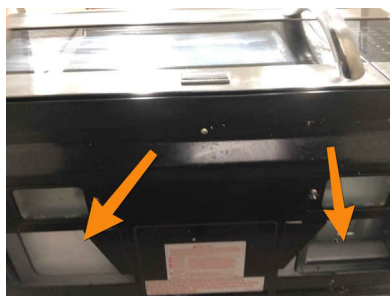
2: Missing Filter

The kitchen exhaust filter was missing. Replacement is recommended.

Recommendation: Contact a qualified professional.

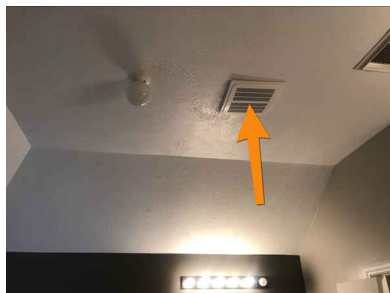
1: Bath Fan Inoperative

Master Bathroom

The exhaust fan was inoperable at time of inspection. Remedy as needed

Recommendation: Contact a qualified professional.
