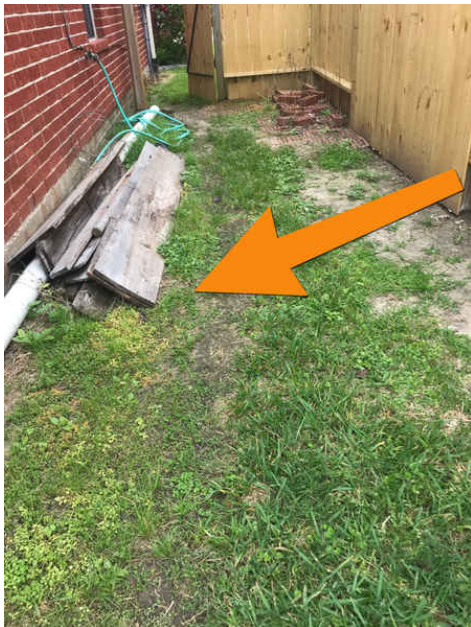
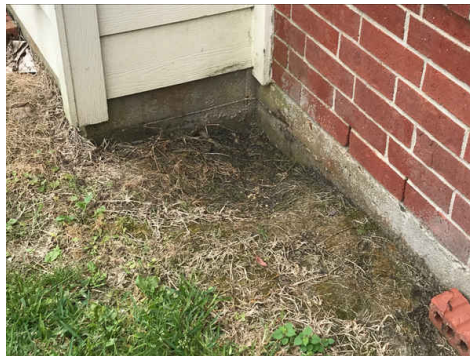
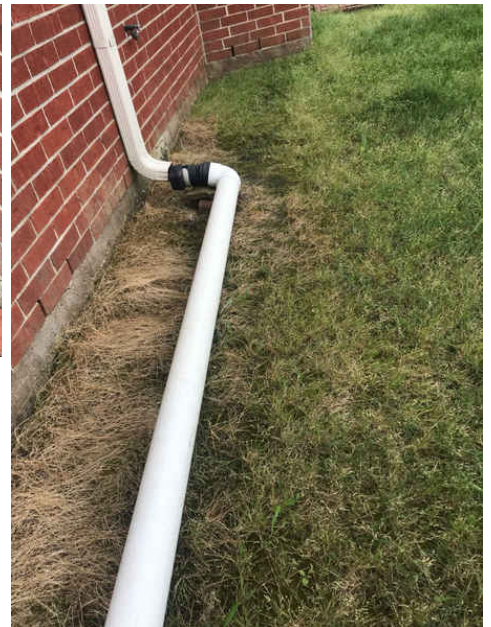
MULTIPLE LOCATIONS

GRADING & DRAINAGE: NEGATIVE GRADING

Grading was sloping towards the home in some areas. This can lead to water intrusion and foundation issues. Regrading by a qualified landscaping contractor or foundation contractor so that water flows away from the home is recommended.

Contact a qualified landscaping contractor

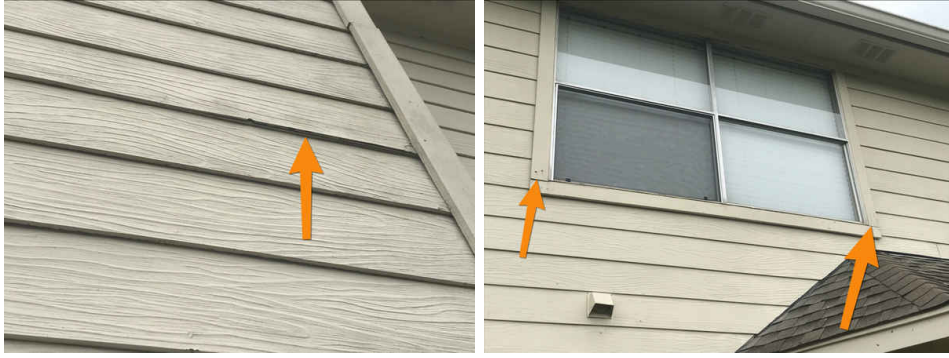
CHIMNEY, REAR

EXTERIOR- SIDING: SIDING DAMAGE

There was damage to exterior siding.

Recommendation
Contact a qualified professional.

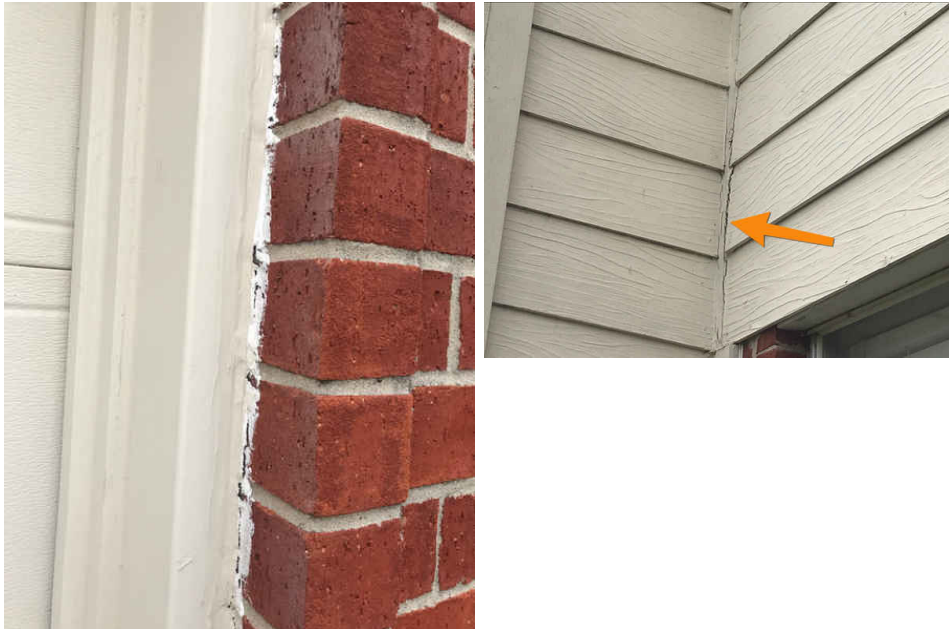
MULTIPLE LOCATIONS

EXTERIOR- CAULKING: DETERIORATED/MISSING

Caulking around siding or trim was deteriorated or missing.

Recommendation
Contact a qualified professional.

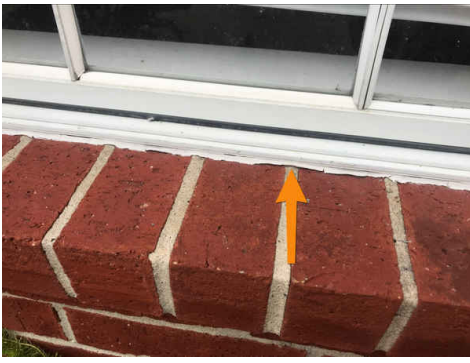
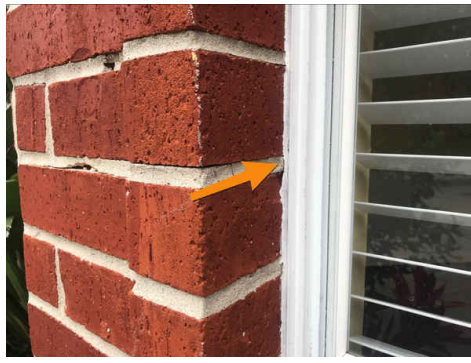
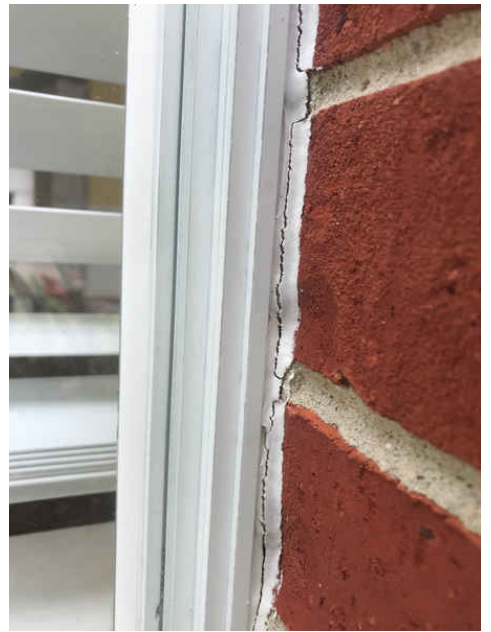
MULTIPLE LOCATIONS

EXTERIOR- CAULKING: MISSING/DETERIORATED AROUND WINDOW FRAMES

Recommendation
Contact a qualified professional.

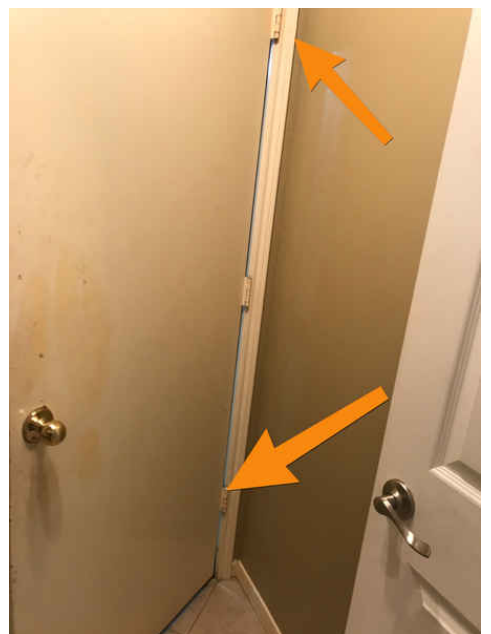
**GARAGE DOOR INTO LIVING SPACE:
SELF-CLOSING MECHANISM NOT
PRESENT/OPERABLE**

Entry door between the garage and living space should have a functioning self-closing mechanism.

Recommendation
Contact a qualified professional.

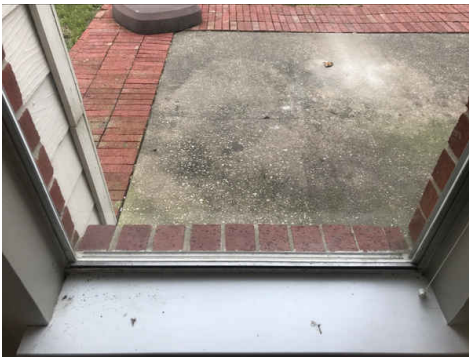
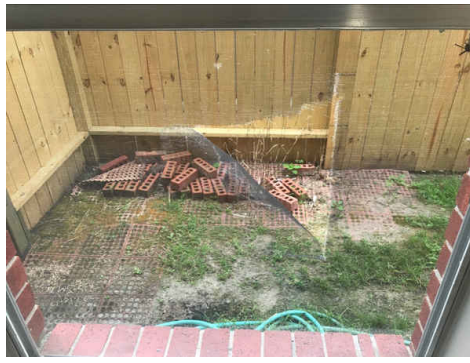
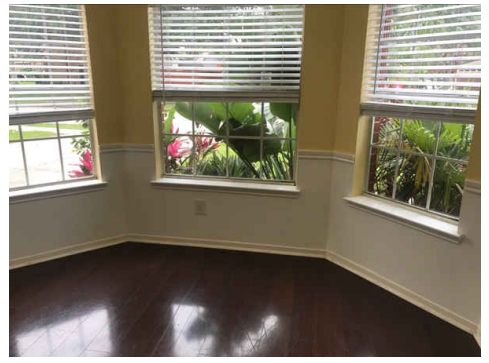
MISSING/DAMAGED SCREEN(S)

One or more windows are missing a screen or had a damaged screen. Replacement of screens is recommended.

Recommendation
Contact a qualified window repair/installation contractor.

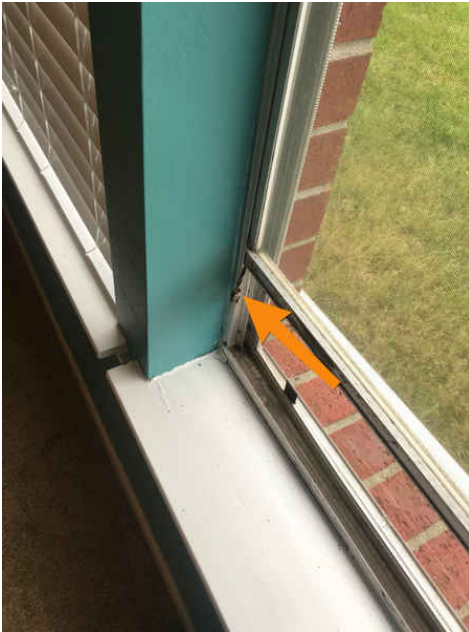
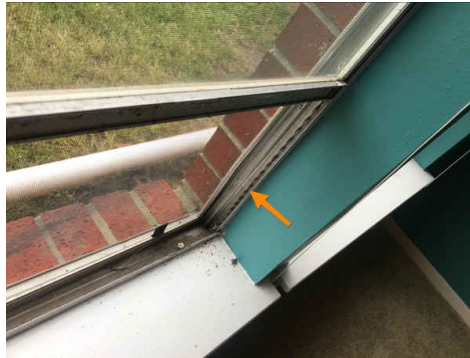
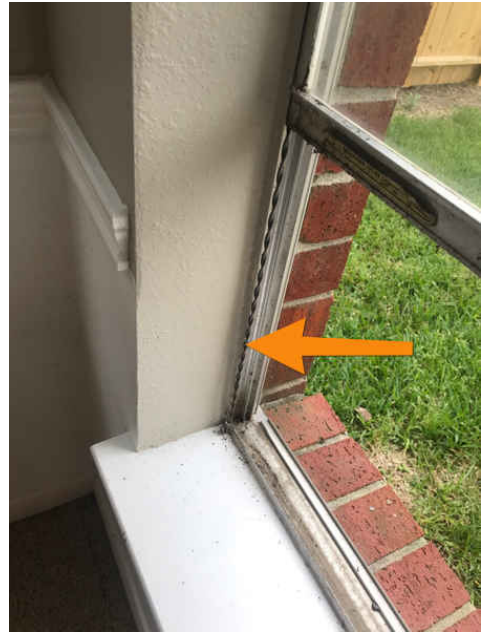
MULTIPLE LOCATIONS

WINDOW BALLASTS/SPRINGS ARE BROKEN

Window ballasts (or guidesprings depending on the window style) were detached or damaged. These mechanisms serve to hold the window sash up, and if they are damaged the window may not stay open. Remedy as needed.

Contact a qualified window repair/installation contractor.

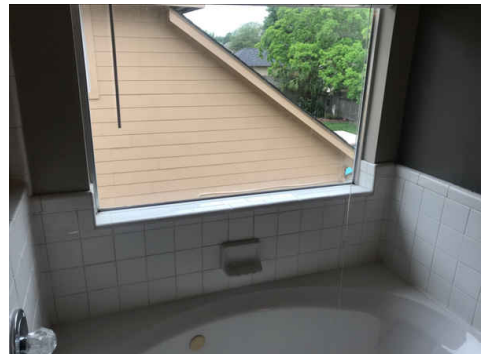
MASTER BATHROOM

SAFETY GLASS NOT INSTALLED

within 60 inches of the floor of a tub or shower

Safety glass with a tempered stamp should be installed in all hazardous locations, such as:

Contact a qualified professional.

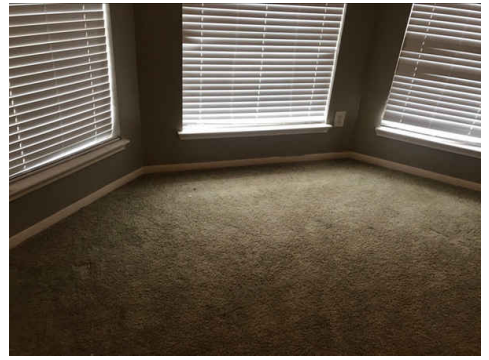
2ND FLOOR MIDDLE AND LEFT BEDROOM, MASTER BEDROOM

SILL HEIGHT: TOO LOW

Current building standards require any window with an exterior sill height of 72 inches or more to have a minimum interior sill height of 24 inches.

Contact a qualified professional.

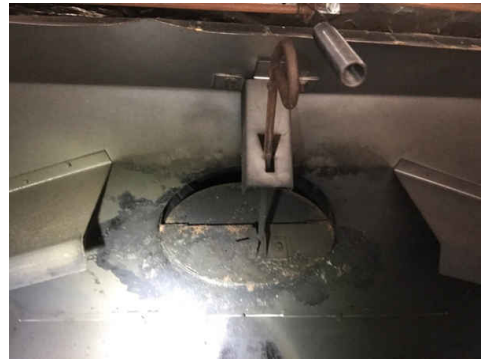
DAMPER: NO CLIP

No apparent safety clip on the damper. Typically when gas logs are present, a safety clip must be installed on the damper to keep it from closing fully. Remedy as needed.

Contact a qualified professional.

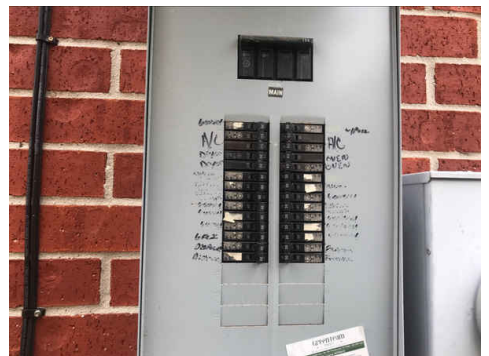
CIRCUITS NOT LABELED

Circuits in the distribution panel were not properly labeled. Remedy as needed.

Contact a qualified electrical contractor.

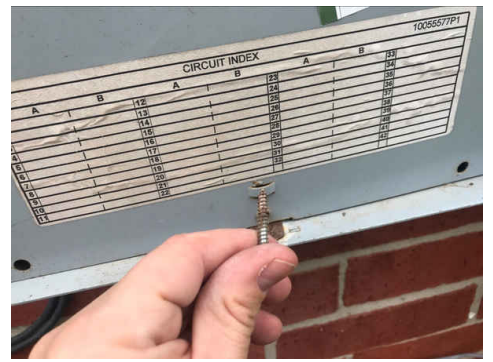
POINTED SCREWS IMPROPER

Sharp tipped screws were used on the panel cover. Blunt tipped screws designed for this application are recommended to prevent puncturing electrical wiring insulation. Remedy as needed.

Recommendation
Contact a qualified electrical contractor.

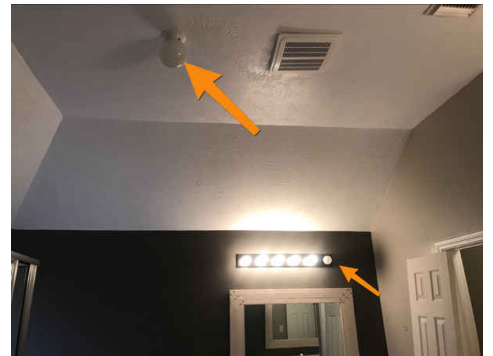
MASTER BATHROOM

LIGHT: INOPERABLE

One or more lights were not operating. New light bulb possibly needed. Remedy as needed.

Recommendation
Contact a qualified electrical contractor.

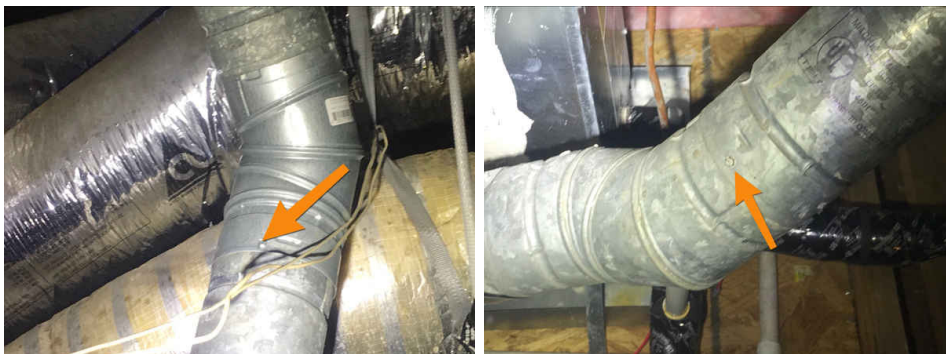
VENTING: SHEET METAL SCREWS IN PIPE

Sheet metal screws were installed through the furnace vent pipe. Remedy as needed.

Recommendation
Contact a qualified professional.

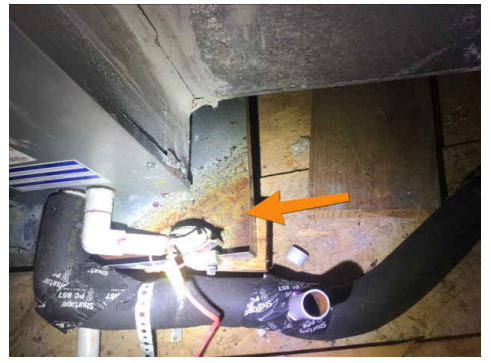
CONDENSATE SYSTEM: RUSTED EMERGENCY PAN

The emergency overflow pan is rusted. Further evaluation by an HVAC professional is recommended.

Contact a qualified HVAC professional.

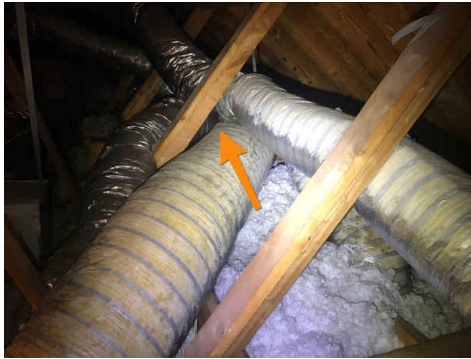
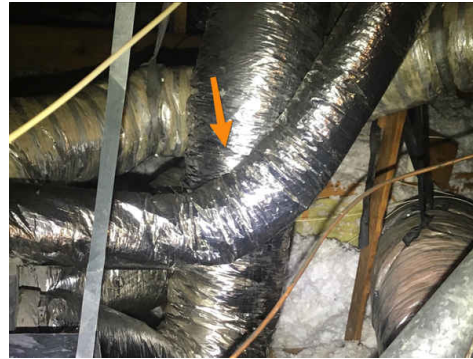
DUCTS: DUCTS RESTING ON EACH OTHER.

Ducts were resting on each other. This can result in condensation forming between the two sections of ductwork. Remedy as needed.

Contact a qualified professional.

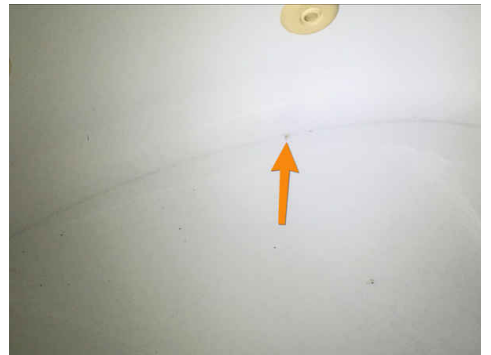
MASTER BATHROOM

TUB: SURFACE DEFECTS

Defects were observed on the tub surface. Remedy as needed.

Contact a qualified professional.

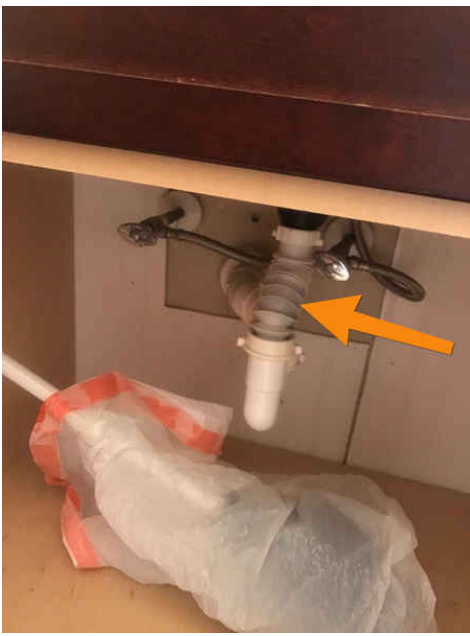
1ST FLOOR BATHROOM

DRAIN PIPING: CORRUGATED LINE

Current plumbing standards require all drains to have smooth interior surfaces. Corrugated materials are not approved.

Contact a qualified plumbing contractor.

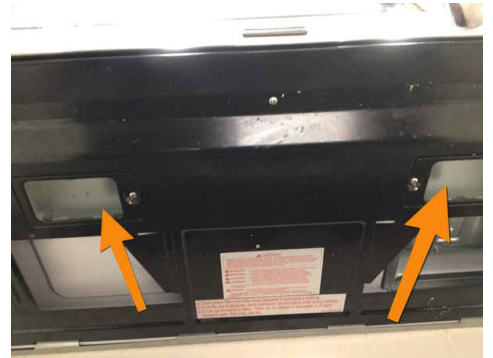
EXHAUST LIGHT OUT

The light did not function at the kitchen exhaust. This may be the result of a bad bulb. Replace and test or remedy as needed.

Contact a qualified professional.

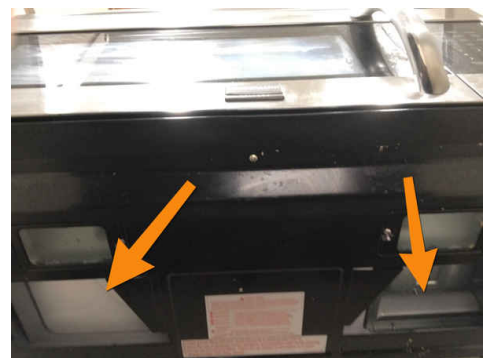
MISSING FILTER

The kitchen exhaust filter was missing. Replacement is recommended.

Contact a qualified professional.

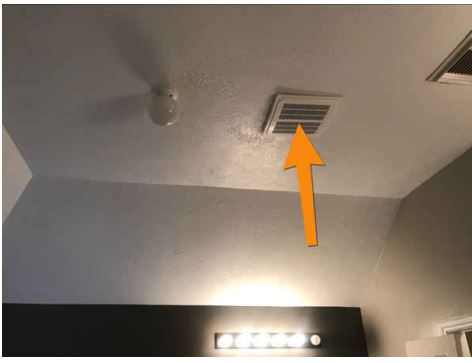
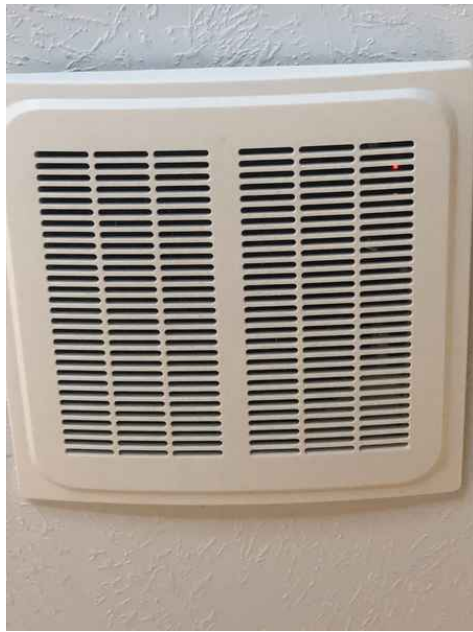
MASTER BATHROOM

BATH FAN INOPERATIVE

The exhaust fan was inoperable at time of inspection. Remedy as needed

Contact a qualified professional.
