Inspection Report

Property Address:
3111 Windmill St
Suagr Land Texas 77479

Texas HomeSpection Inc.

Date: 9/11/2017	Time: 11:30 AM	Report ID: 20170911-3111-Windmill
Property: 3111 Windmill St Suagr Land Texas 77479	Customer: Mr. Joseph Chen	Real Estate Professional:

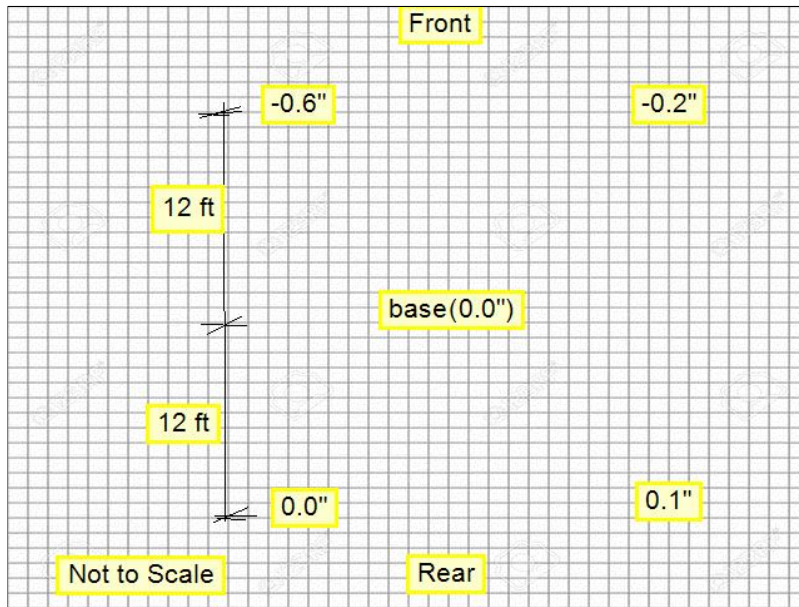
A. Item 1(Picture)

(1) The slab foundation was performing its intended function. No visible evidence of significant differential settlement was noted at interior and exterior of the house.

According to the rule of thumb, the acceptable foundation deflection is 1.5 inch within 20 feet. The maximum elevation differential reading using Smart Leveler is approximately 0.6 inches (see picture) and is within acceptable range.

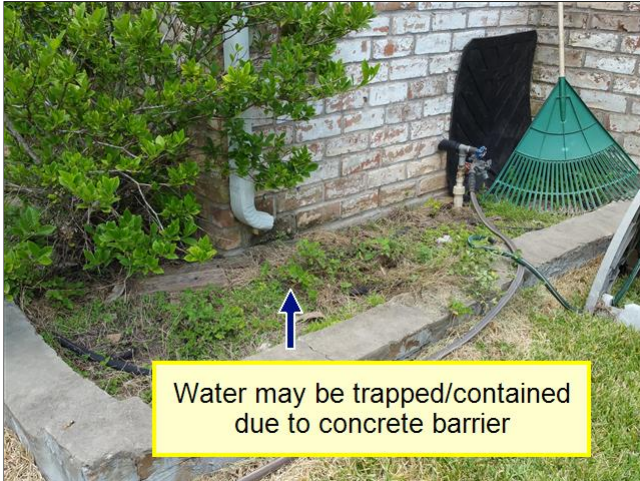
B. Item 1(Picture)

Concrete barrier may trap water from gutter downspout during heavy rain, which may penetrate into slab foundation and result in differential settlement of foundation. Recommend cut a 3-inch hole as outlet on the concrete barrier to discharge the water to prevent ponding.

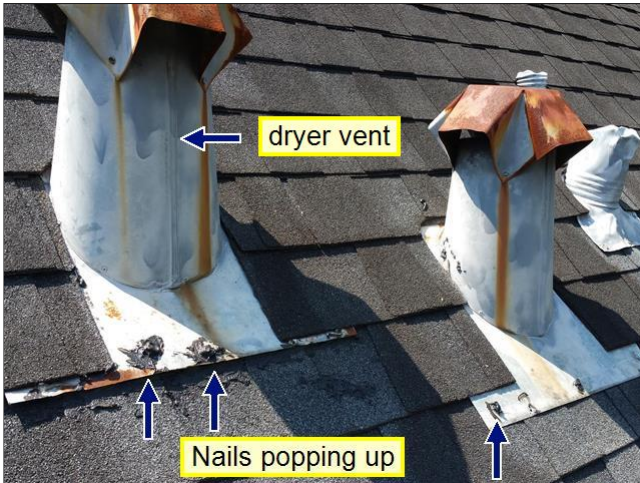
C. Item 1(Picture)

Nails popping up were noted at dryer vent on the rear roof. The coating (see pictures 1) using roof cement on the nailheads appear to be recent repairs.

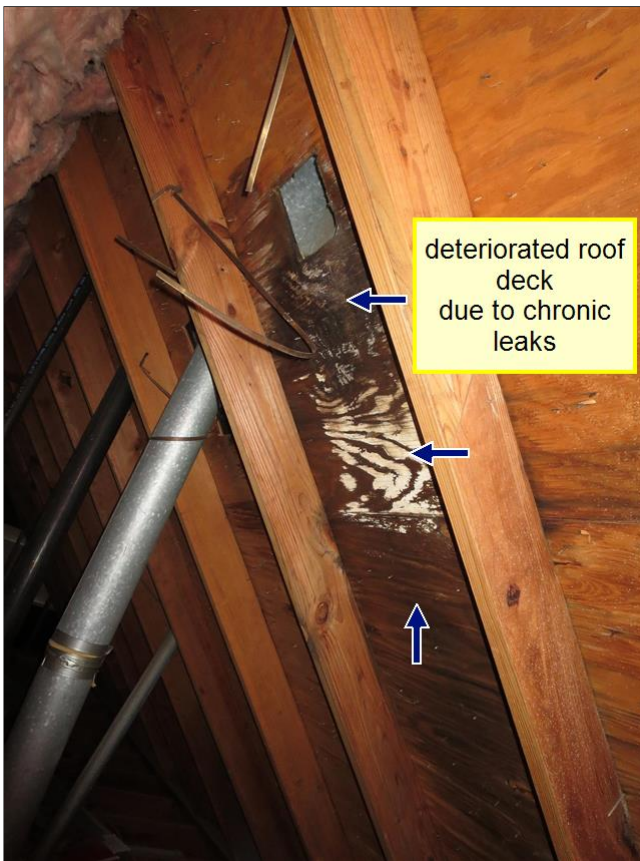
C. Item 2(Picture)

Chronic water penetration due through nail holes of dryer vent to the roof decks caused roof wood deterioration noted in the attic (see picture 2) . Water leaks all the way down to the attic floor sheetrock which is the ceiling of kitchen (see picture 3). The saturated sheetrock fell off during hurricane Harvey as shown in the picture.

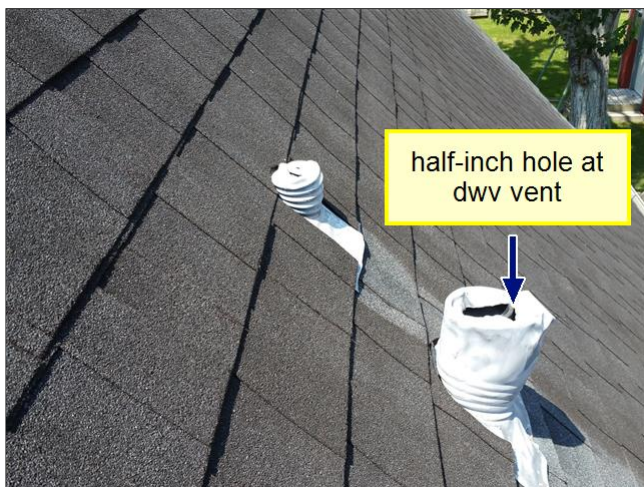
C. Item 4(Picture)

Half-inch gap space was noted between plastic DWV vent and aluminum flashing due to poor workmanship. Water may penetrate into the roof deck and cause wood rotten. Repair is needed.

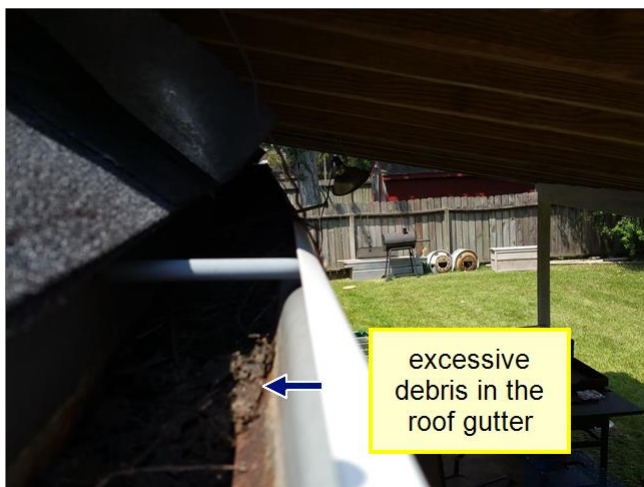
C. Item 5(Picture)

Excessive debris was observed in the gutter of rear patio roof and shall be cleaned up to prevent water overflow.

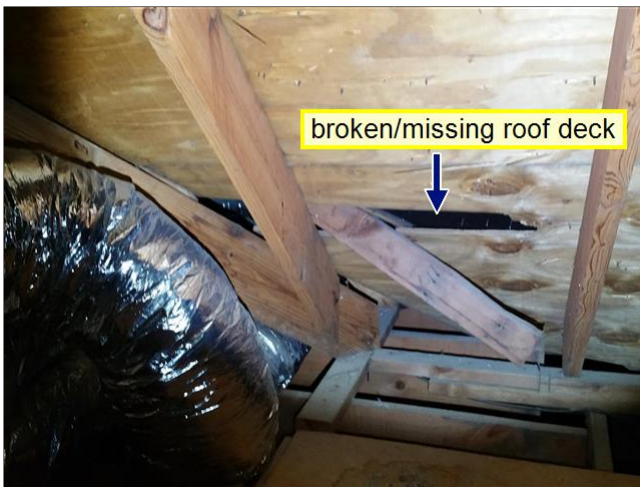
D. Item 1(Picture)

Missing/broken roof deck was found in the second attic (with evaporator and furnace) near A/C supply-air duct and shall be repaired.

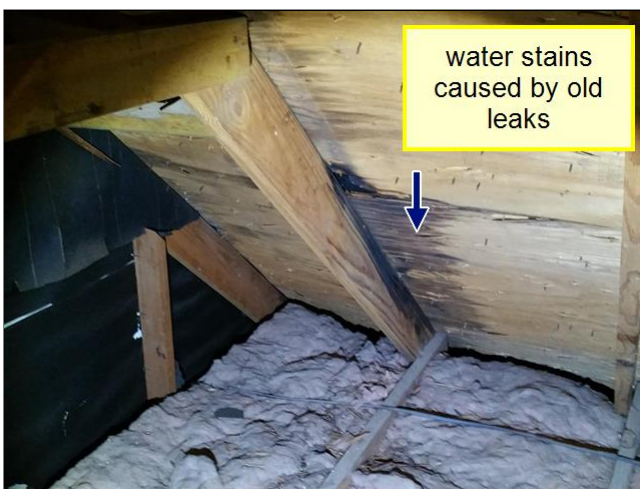
D. Item 2(Picture)

Water stains were noted in the front attic (see picture 2). The location shall be approximately under the roof dormer and may be caused by lifted step flashing around dormer base. Gap space (see picture 3) may cause water penetration into the roof and damage roof deck. Recommend contact a qualified roofer to repair the dormer flashing on the roof side.

The stain observed in the attic has been tested and identified using moisture meter. It appear more like natural tar in the wood ring instead of water stain. No repair shall be needed.

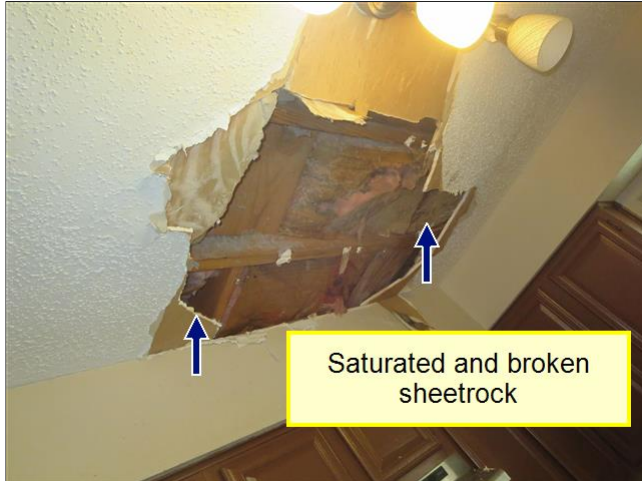
F. Item 1(Picture)

The sheetrock ceiling in the kitchen was saturated, broken, and fell off due to roof leaks during hurricane Harvey. Recommend contact a qualified roofer for repairs.

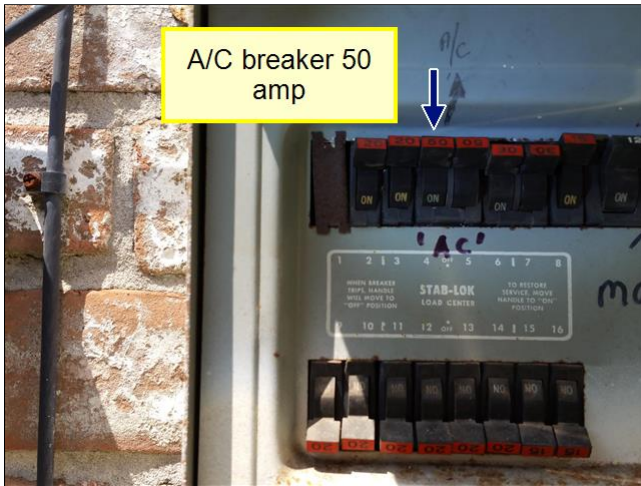
A. Item 1(Picture)

Panel A/C breaker of 50 amp is not compatible with the amp specified on the outdoor unit nameplate, min 35 and max 40 amps. Oversized breaker may not trip when overcurrent occur which may cause fire hazards. Recommend contact a qualified electrician to replace the A/C braker for safety purpose.

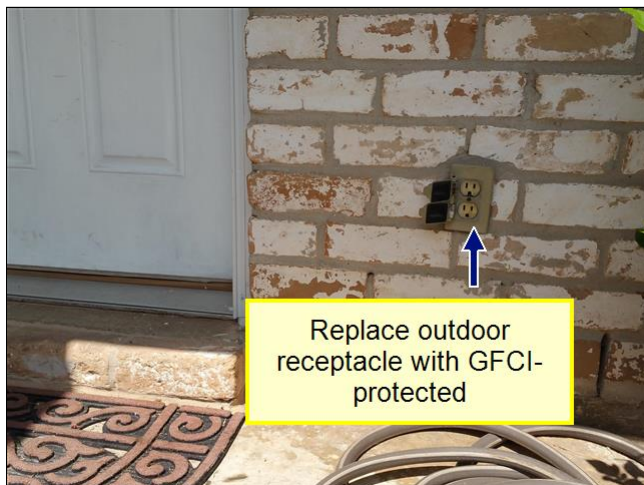
B. Item 1(Picture)

The outdoor receptacle outlet is not GFCI-protected and may cause short-circuit fire hazard in case water penetrates into the outlet.

Recommend contact a qualified electrician to replace with GFCI protected outlet.

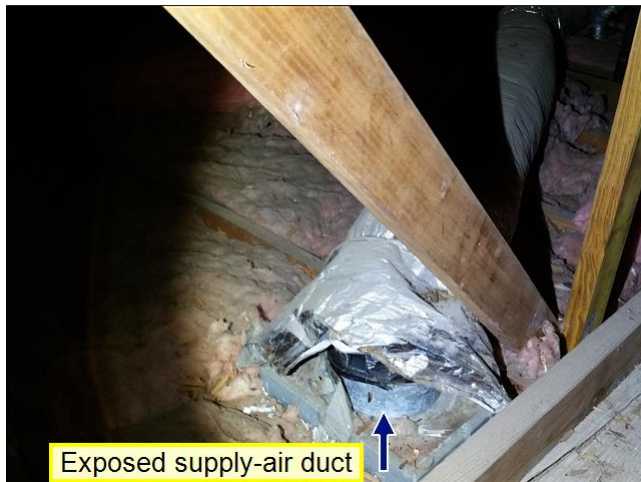
C. Item 1(Picture)

Exposed flex supply-air duct was noted in the attic. The metal duct shall be properly wrapped with fiber glass insulation and vapor barrier jacket to prevent energy loss. Missing insulation may also cause condensation dripping during hot and cold weather. Repair by a qualified HVAC technician is recommended.

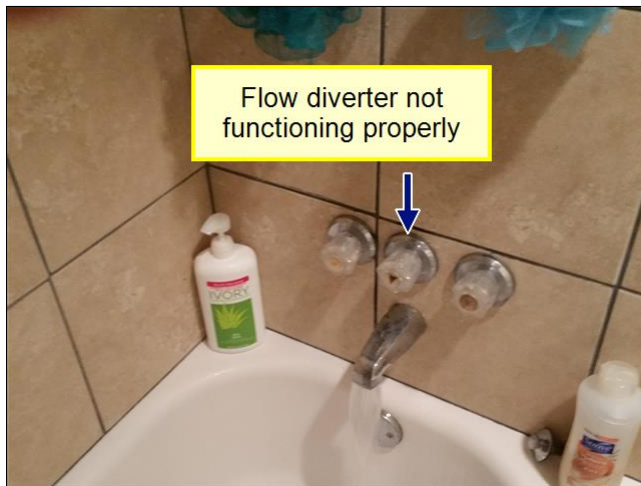
A. Item 1(Picture)

Flow diverter of master bath is not functioning properly. Water dripping/leaking was noted at showerhead when faucet nozzle was running water. Recommend repairs by a qualified plumber.

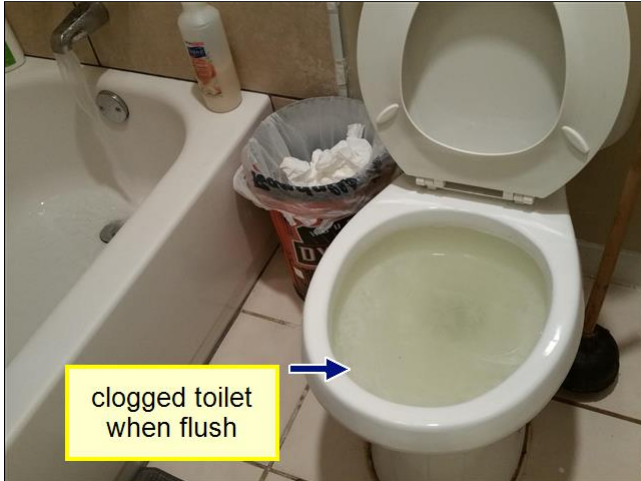
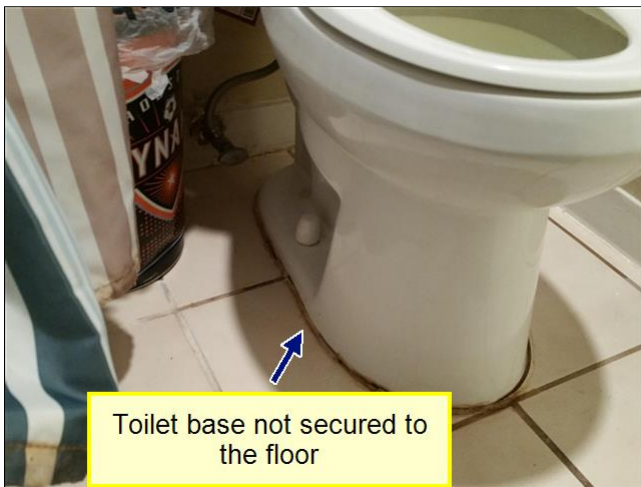
The toilet was clogged at toilet flush in the master bath. The toilet base was shakable and not secured to the floor and may damage the wax ring, causing sewage leaks. Recommend contact a qualified technician for repairs.

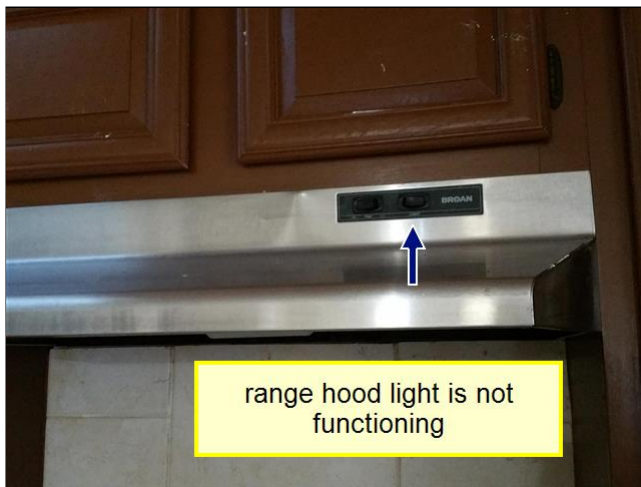
C. Item 1(Picture)

The range hood light over the cooktop is not functioning and shall be repaired.

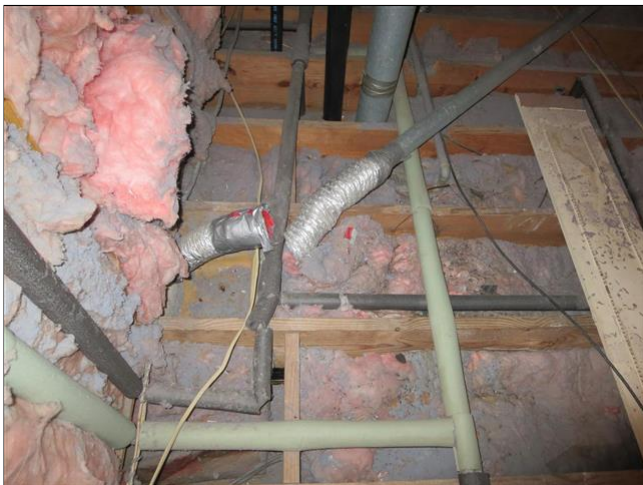
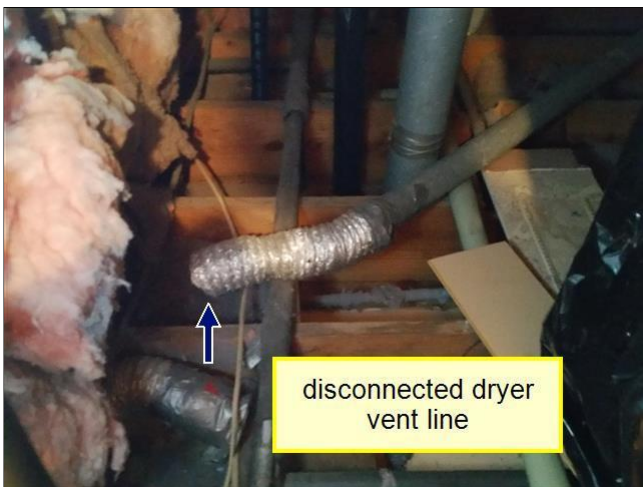
The dryer vent pipe is disconnected in the attic. The pipe exit to the roof vent was laying on the floor.

Exhaust streams from dryer pipe are full of moisture and hence have a high potential for condensation in the attic. Repair is needed.
