RESIDENTIAL INSPECTION REPORT

12463 Mooremeadow Ln
Houston TX 77024

Dayna Owens
APRIL 12, 2019

Jeff Marquardt

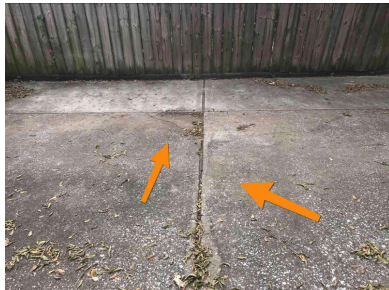
1: Grading & Drainage: Uneven/Cracked Driveway

Uneven or Cracked driveways can be a trip hazard.

Recommendation: Contact a qualified professional.

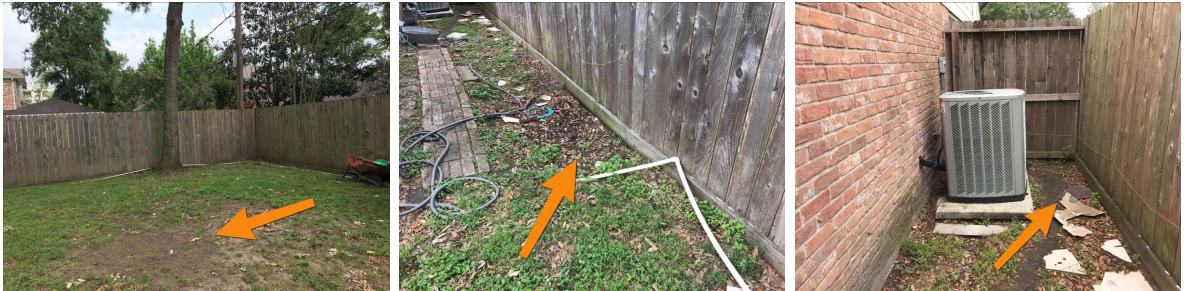
2: Grading & Drainage: Inadequate

Left Exterior

Low spots, ruts, and/or damaged sod were present at the time of inspection. Regrading by a qualified landscaping contractor or foundation contractor so that water flows away from the home is recommended.

Recommendation: Contact a qualified landscaping contractor

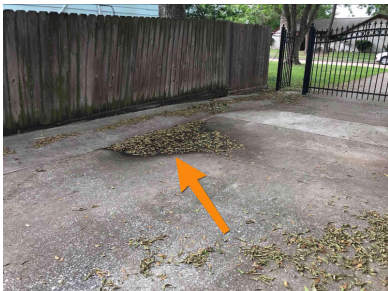
3: Grading & Drainage: Standing Water

Driveway

Standing water was observed which could indicate poor drainage and/or grading. Monitoring and/or having landscaping contractor remedy drainage/grading is recommended. Grading & Drainage:

Recommendation: Contact a qualified landscaping contractor

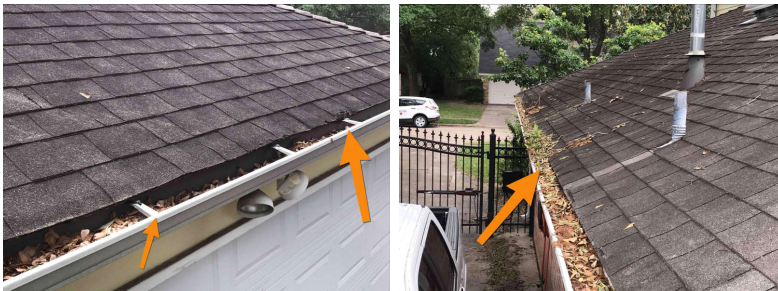
4: Gutters & Downspouts: Clogged

Multiple Locations

Clear gutters of debris to improve drainage. Badly clogged gutters can cause water to back up under the roof covering and cause damage.

Recommendation: Contact a qualified landscaping contractor

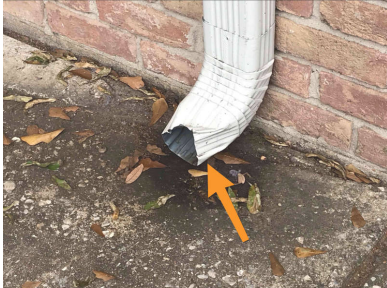
5: Gutters & Downspouts: Damaged

Right Side

Further evaluation of the gutter and drainage system is recommended.

Recommendation: Contact a qualified landscaping contractor

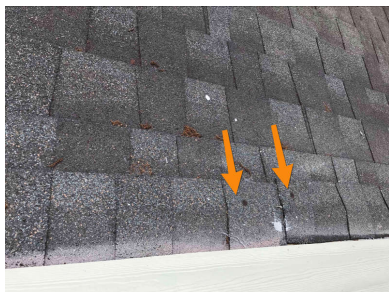
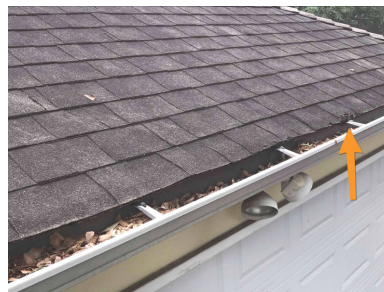
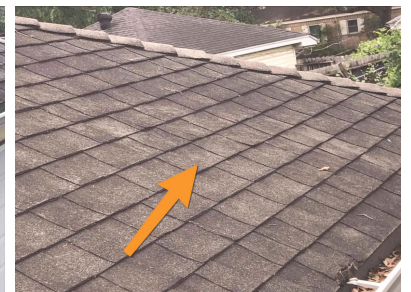
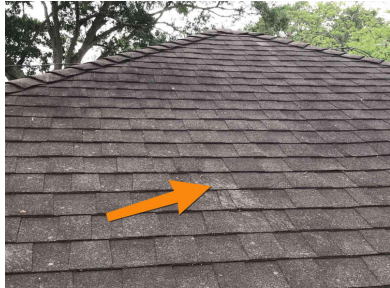
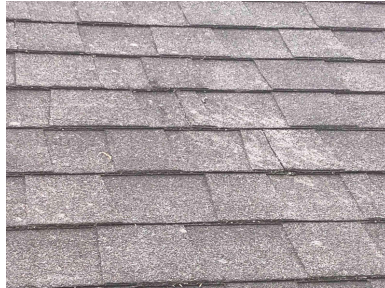
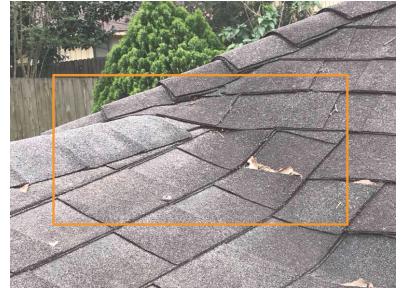
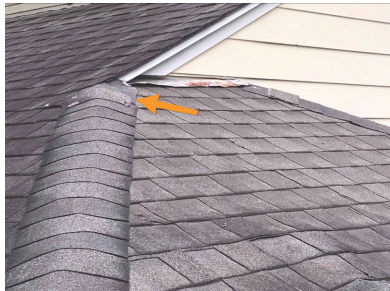
1: Multiple Roof Covering Defects Observed

Excessive Granule Loss, Exposed Fasteners, Damaged Shingles, Replaced Shingles -

Due to multiple deficiencies with the roof covering materials further evaluation by a qualified roofing professional is recommended.

Exposed Nails

Granule Loss

Recommendation: Contact a qualified roofing professional.

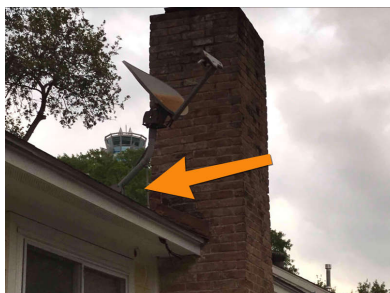
2: Satellite Dish(es) on Roof

Satellite dish(es) mounted to the roof. The inspector was unable to determine the condition of the roofing materials underneath. Remedy as needed.

Recommendation: Contact a qualified roofing professional.

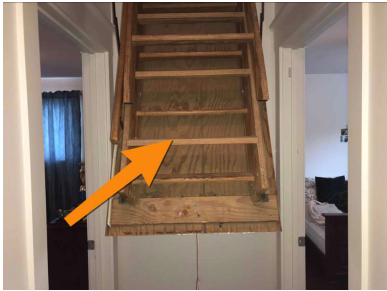
1: Pulldown stairs/ladder: Not insulated or weatherstripped

The ladder door was not insulated or weatherstripped. This can lead to increased energy loss. Remedy as needed.

Recommendation: Contact a qualified professional.

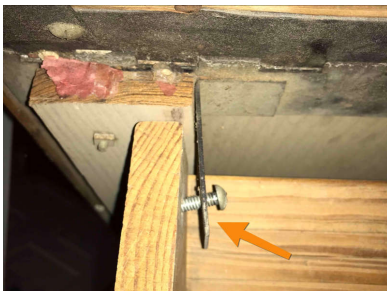
3: Pulldown stairs/ladder: Missing/loose nuts and bolts

Pulldown stairs/ladder was missing or had loose nuts or bolts. All missing/loose nuts and bolts on the attic access ladder should be tightened or replaced.

Recommendation: Contact a qualified professional.

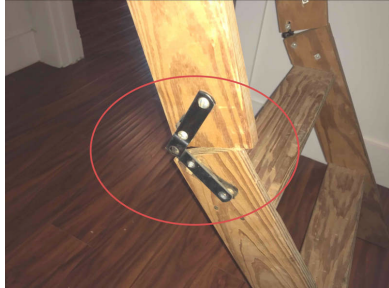
4: Pulldown stairs/ladder: Improper slope

Attic stairs were not properly cut at bottom giving improper slope. This puts improper stress on the side rails and hinges. Remedy as needed.

Recommendation: Contact a qualified professional.

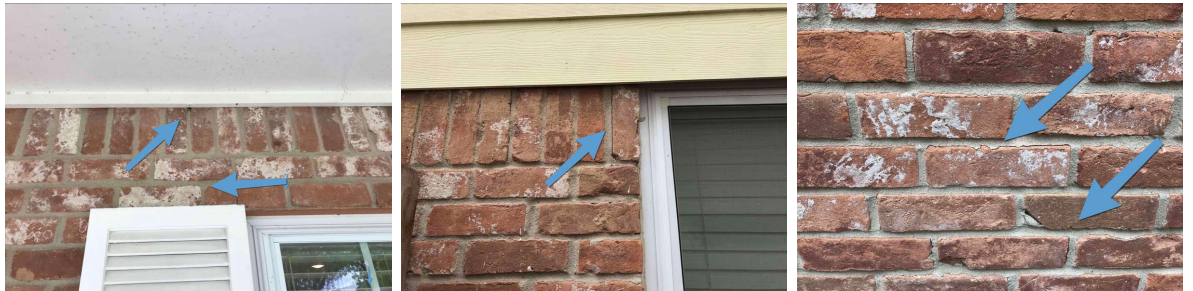
1: Exterior Masonry: Minor Brick Cracks

Multiple Locations Exterior

Cosmetic hairline cracks were observed in the masonry siding. Hairline cracks may be a result of thermal expansion of the veneer and/or normal structural movement. Monitoring is recommended.

Recommendation: Contact a qualified masonry professional.

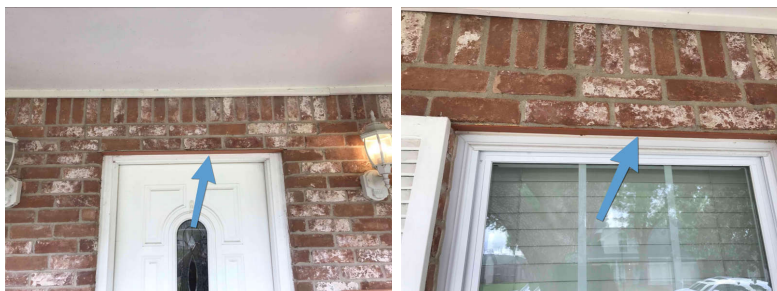
2: Exterior Masonry: Weep holes not present over openings

Multiple Locations Exterior

Weep holes were not installed in brick above steel lintels over windows and/or doors. Modern practices often utilize weep holes to prevent rusting of steel lintels supporting brick. If there is visible moisture damage to steel lintels or other building materials around these openings then this condition should be evaluated by a brick mason for possible correction. Otherwise the area should be monitored periodically.

Recommendation: Contact a qualified professional.

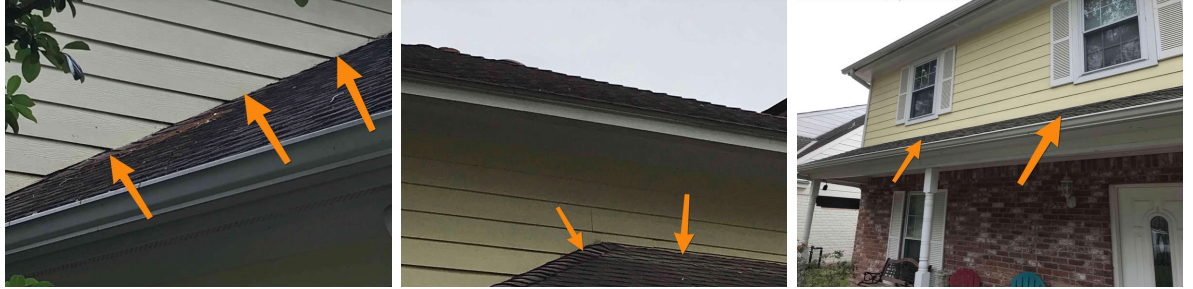
3: Exterior- Siding: Siding too close to roof surface

Multiple Locations 2nd Floor

The siding does not adequately clear the roof surface. Installation guidelines generally require 1-2 inches of clearance between the siding and the roof covering. Evaluate and remedy as needed.

Recommendation: Contact a qualified professional.

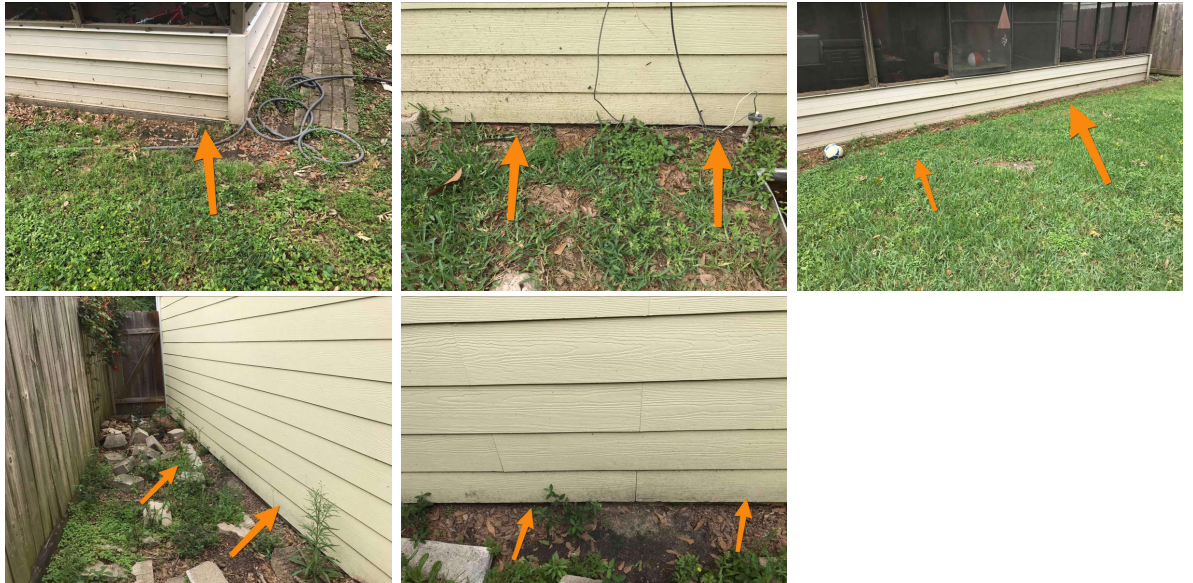
4: Exterior: Siding or brick is too close to grade

Multiple Locations Exterior

Siding should be a minimum of 6 inches above finished grade. Brick and stone should be a minimum of 4" above grade. Remedy as needed.

Recommendation: Contact a qualified professional.

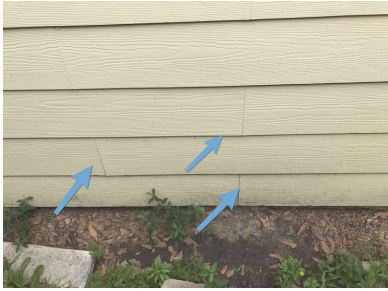
5: Exterior: Open end-to-end joints

Multiple Locations Exterior

Caulk or paint was missing at open end-to-end joints in the siding. Remedy as needed.

Recommendation: Contact a qualified painting contractor.

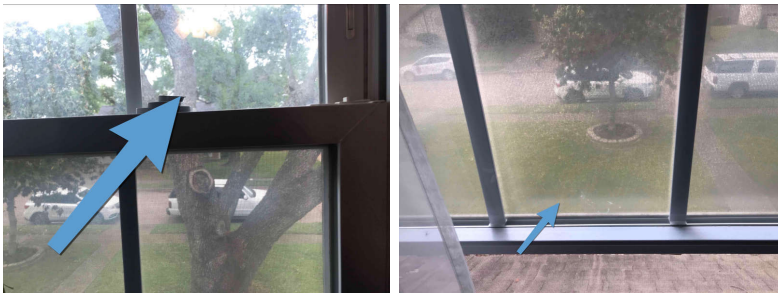
2: Low-e coating imperfections

2nd Floor Bedrooms

The low-e coating inside the window showed signs of imperfections.

Note: This condition primarily affects window clarity. It can appear as streaks on the glass or as bronze colored flecks and can (but not necessarily) be indicative of a failed seal.

Recommendation: Recommend monitoring.

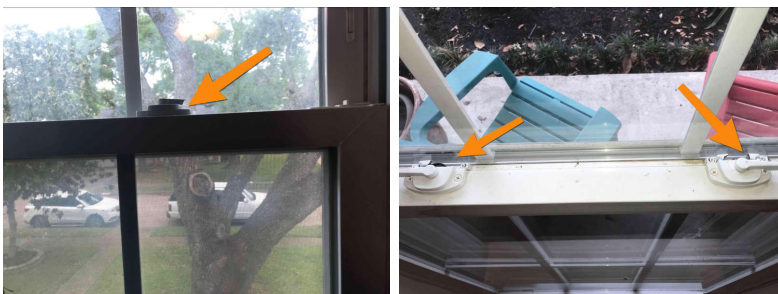
3: Hardware: Missing or Damaged

Multiple Locations, For Example: Dining Room, Master Bedroom, 2nd Floor Bedroom
Window hardware was missing or damaged. Remedy as needed.

Recommendation: Contact a qualified window repair/installation contractor.

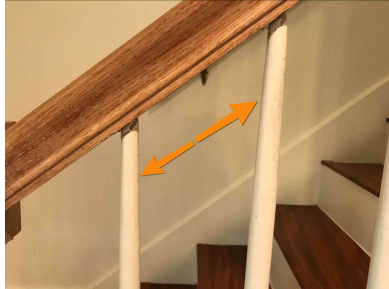
1: Handrail/Guardrails: Baluster Gap Too Wide

The baluster space was not up to modern safety standards. The space between balusters in a handrail should not allow passage of a 4 3/8-inch sphere for child safety. The space between balusters in a guardrail should not allow passage of a 4 inch sphere for child safety. Evaluation by a qualified professional is recommended. /Guardrails

Recommendation: Contact a qualified professional.

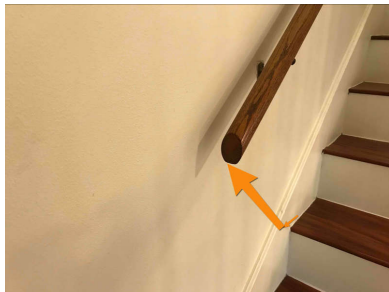
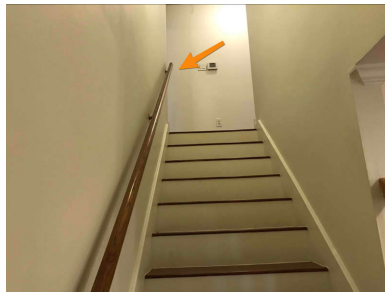
2: Handrails/Guardrails: Doesn't turn into wall

Stairway handrail does not turn in towards the wall at the upper end

Note: This is a safety measure to prevent an individual's clothing from getting caught on the open end of the handrail

Recommendation: Contact a qualified professional.

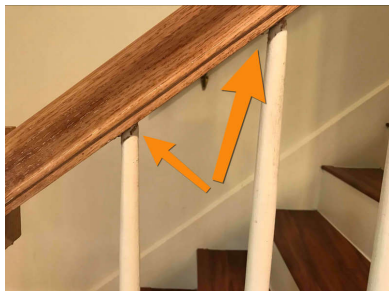
3: Handrail/Guardrails: Baluster/Spindle Loose

Handrail/Guardrails balusters were loose. This could pose a safety hazard. Evaluation and fastening by a qualified professional is recommended.

Recommendation: Contact a qualified professional.

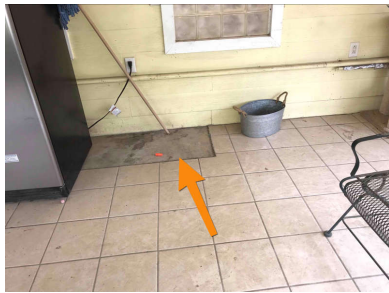
1: Tile Missing

Rear Porch

Recommendation: Contact a qualified professional.

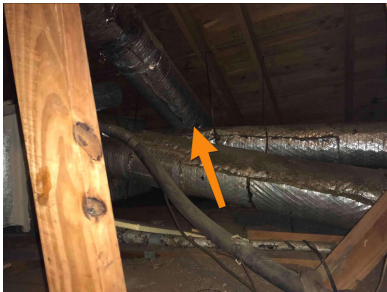
Ducts were resting on each other. This can result in condensation forming between the two sections of ductwork. Remedy as needed.

Recommendation: Contact a qualified professional.

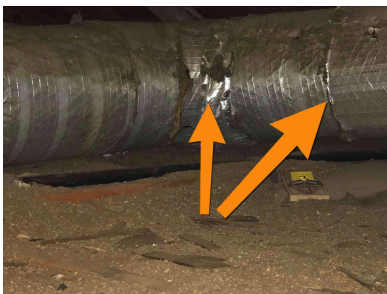
2: Ducts: Damaged

The air supply duct was damaged. Evaluation and remediation by a licensed HVAC contractor is recommended.

Recommendation: Contact a qualified HVAC professional.

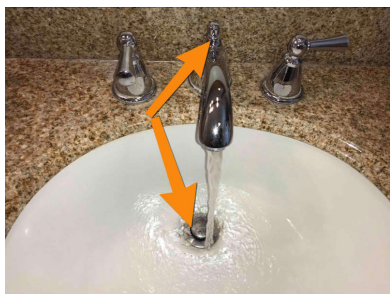
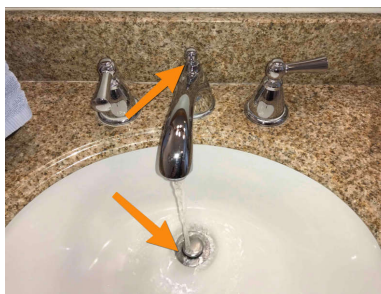
1: Fixture: Drain Stops Missing or Ineffective

Drain stops had issues that prevented them from working properly (holding water). Remedy as needed.

Recommendation: Contact a qualified plumbing contractor.

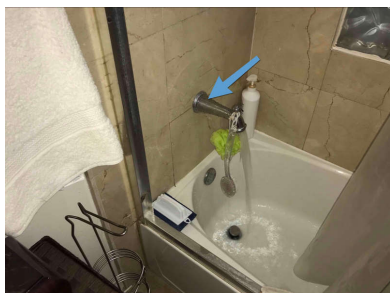
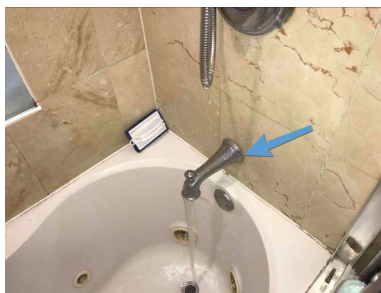
2: Fixtures: Not Sealed at Wall

The bathtub faucet was not sealed at the wall. Remedy as needed.

Recommendation: Contact a handyman or DIY project

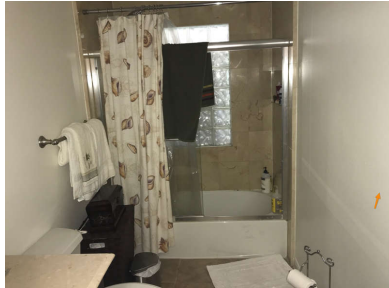
3: Shower: Door Missing

Shower door observed to be missing. Remedy as needed.

Recommendation: Contact a qualified professional.

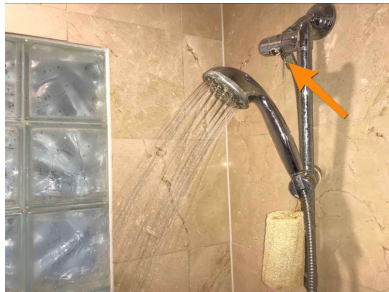
4: Shower: Showerhead leaks/sprays

Water leaked/sprayed around the showerhead during operation. Remedy as needed.

Recommendation: Contact a qualified plumbing contractor.

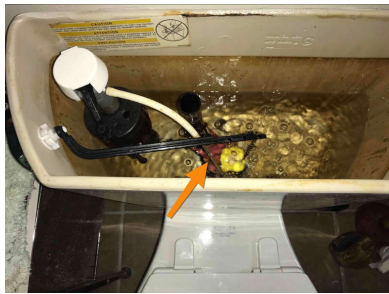
5: Toilet: Leaking fill valve

The fill valve inside the commode tank was leaking. Remedy as needed.

Recommendation: Contact a qualified plumbing contractor.
