# PROPERTY INSPECTION REPORT

Concerning: 2705 Beatty St., Houston 77023  
(Address or Other Identification of Inspected Property)

By: Ruben Santillan, Lic #5570 07/14/2020  
(Name and License Number of Inspector) (Date)

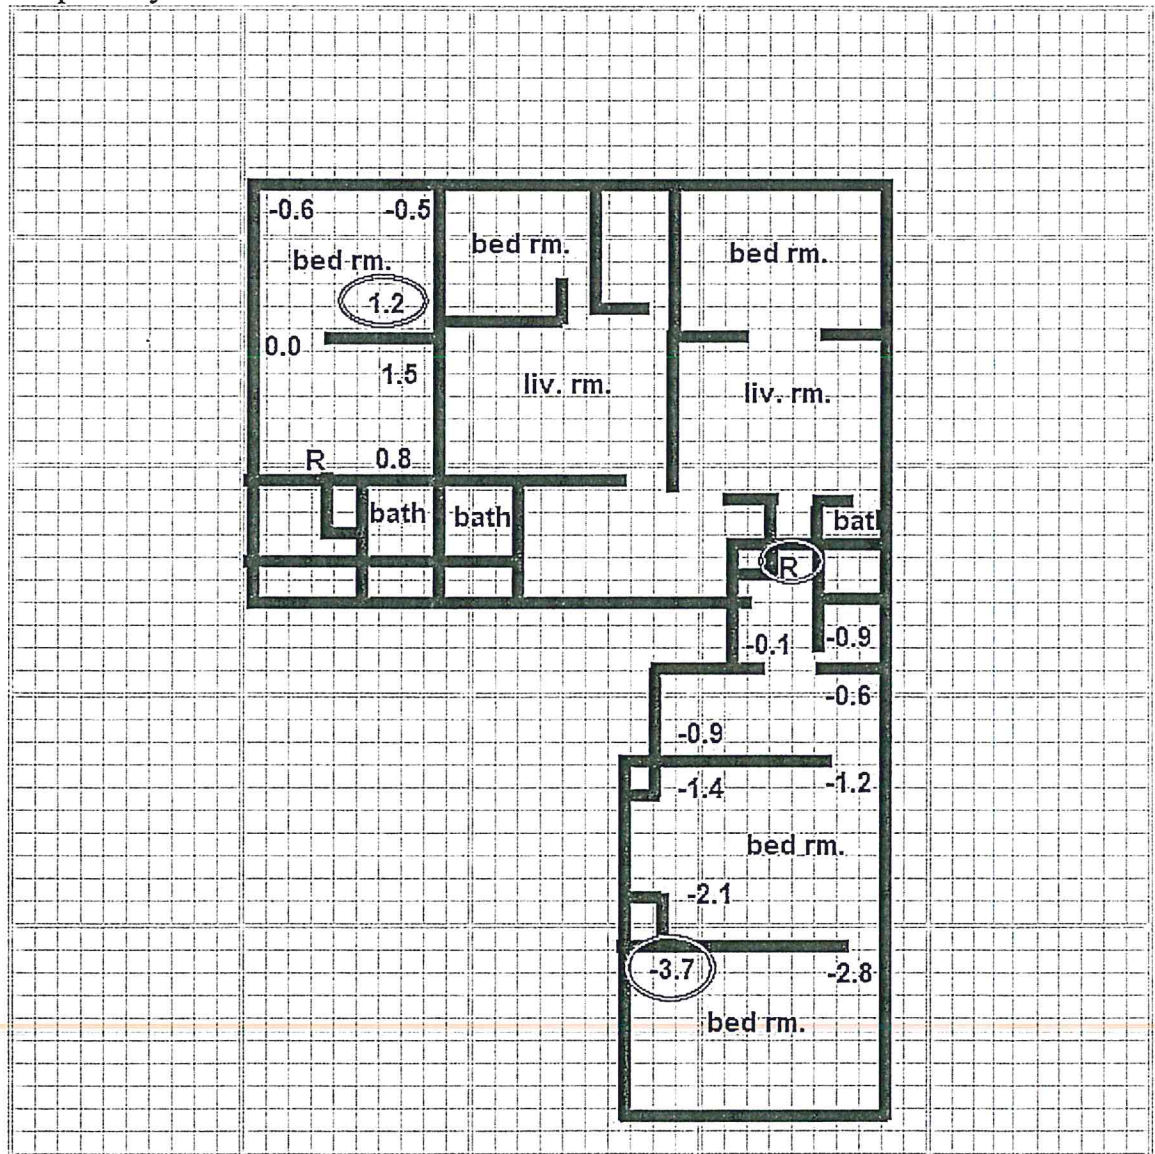
A foundation elevation survey was conducted during the inspection. The table below represents data gathered using a Zip Level or similar instrument and adjusting for floor covering height differences. i.e. differences between tile, carpet and wood flooring. Measurements are listed to the nearest .1". Measurements were taken along the respective walls listed below-North, East South, West, etc. Greatest variance was possibly over 4 inches.

Note: numerous areas could not be measured due to excessive storage/furniture and locked rooms. The numbers that were observed were larger than considered typical. The flooring on unit D also feels hollow or elevated. Recommend having the entire structure further evaluated by a foundation repair company or structure engineer.

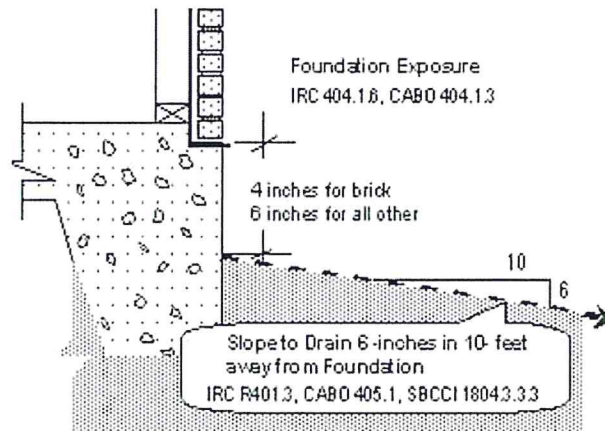
Soil grade and drainage patterns around some areas of house do not appear to properly direct water away from foundation to aid in controlling runoff water and could cause differential movement of the foundation or water penetration during heavy rains.

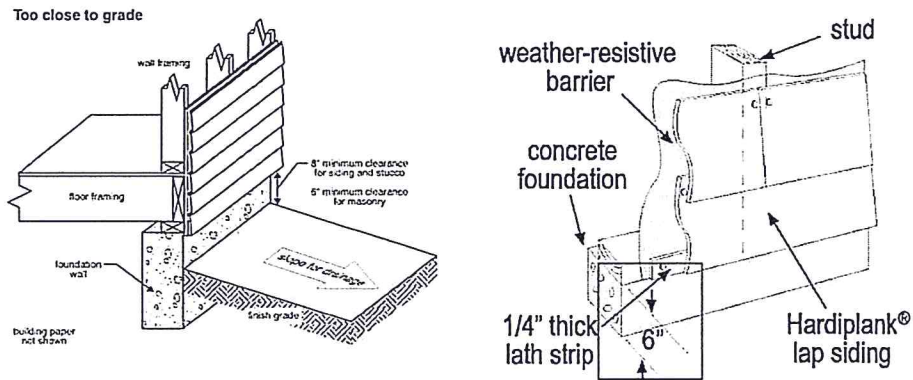
Soil level too high around areas with brick siding at west side. Common industry practice requires a clearance of at least 4 inches from bottom of brick veneer to soil. High soil level near brick siding promotes wood rot and is considered a conducive condition to termite activity and water penetration.

Soil level too high, or close to Hardi plank siding, promotes wood rot and is considered a conducive condition to termite activity at one or more locations around house/garage

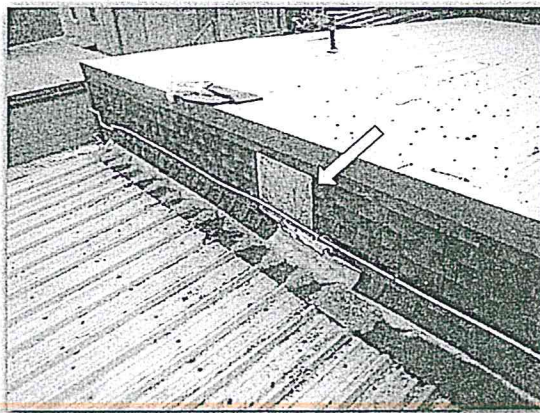
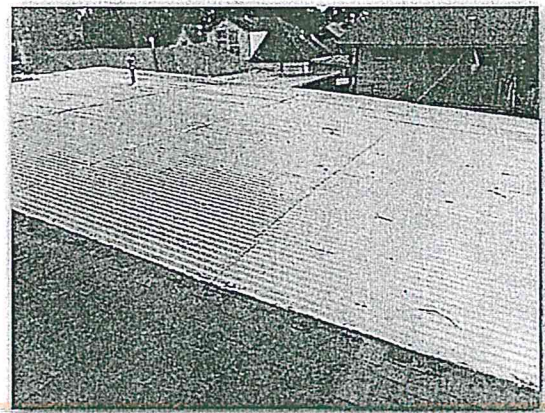
**Exposed roof/wall deck observed without covering, this will allow the exposed wood to deteriorate and allow water penetration.**

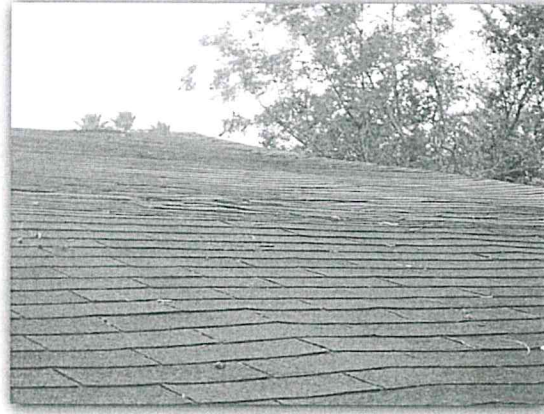
**It appears that either the roof structure, or roof decking is inadequate. The roofing material has sags between the roof structure supports. The decking feels spongy or bouncy indications that the roof decking may be too thin (1/4 thick). The cause and remedy should be investigated and corrected as necessary.**

Possible improper use of roofing material on low sloped roof. Composition shingles on low slope roof have a tendency to allow wind driven rain to penetrate below shingles.

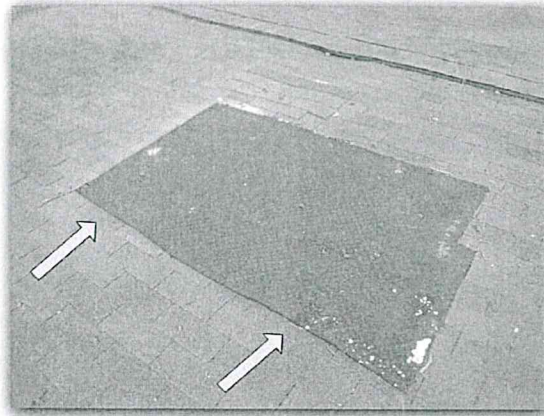
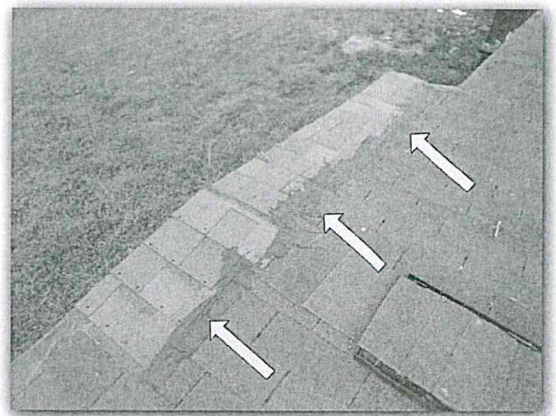
**Observed amateurish patching roof patching jobs at numerous locations. Some of the patching is not properly inter woven with existing roofing material where the edges are exposed. A plastic mat also observed being used to patch the roof. This inspection firm recommend roof replacement.**

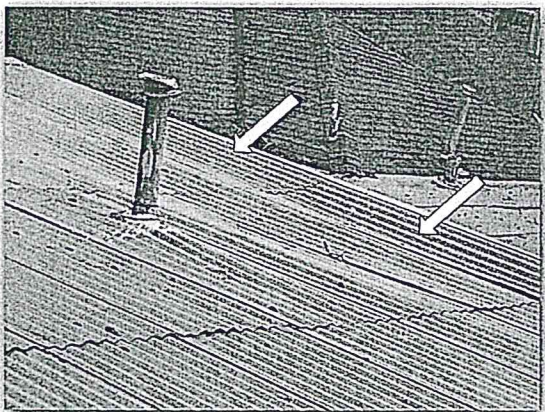
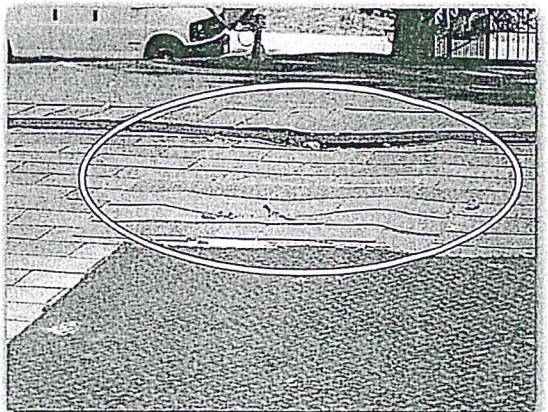
**Area(s) of soft/spongy and/or rotted roof decking observed while walking on roof.  
The extent of any damage is beyond the scope of this inspection.**

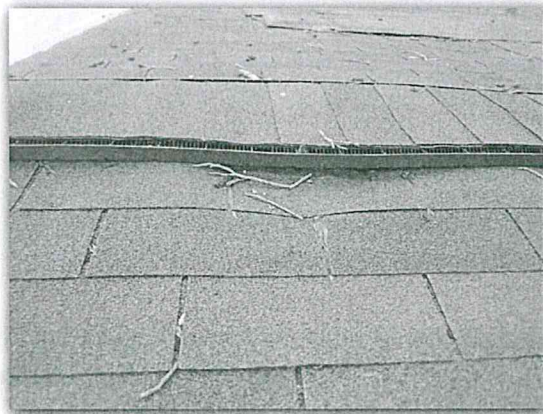
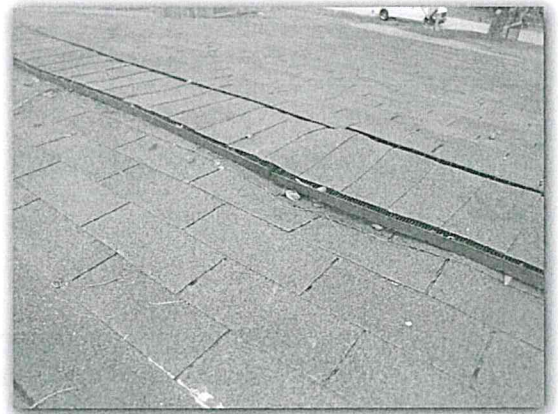
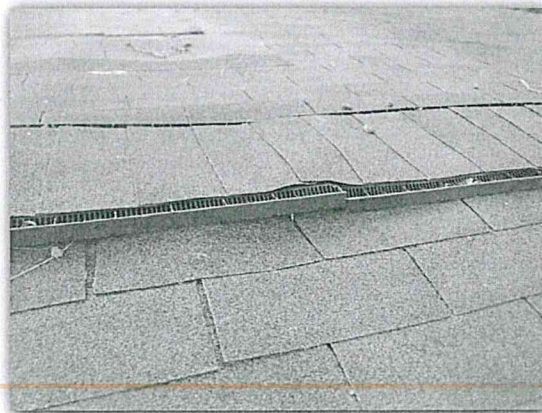
The ridge vents appear to be damaged. Typically these vents are installed in higher sloped roofs. The vents should not be stepped on to prevent the vents from collapsing. All sections of the vents appears to be pressed on damaging the vents.

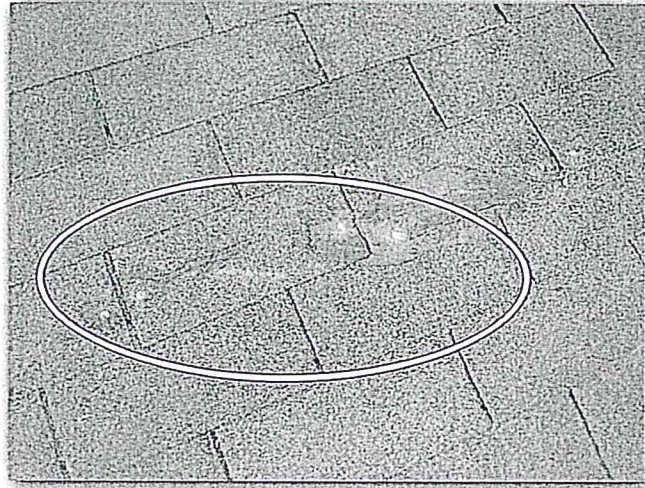
One or more areas of raised shingle tabs from fasteners not secured down properly or nail heads popping up through shingles.

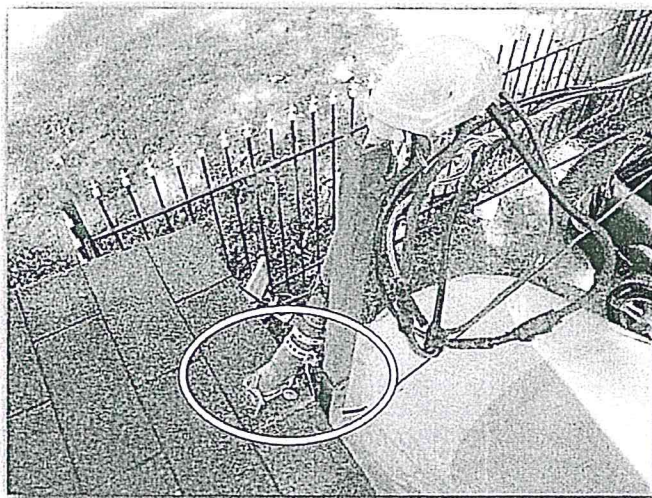
**Flashing for the electrical service drop observed to be missing, this condition could and will allow water penetration.**

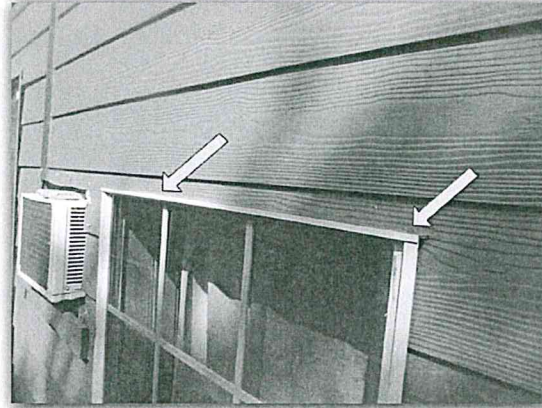
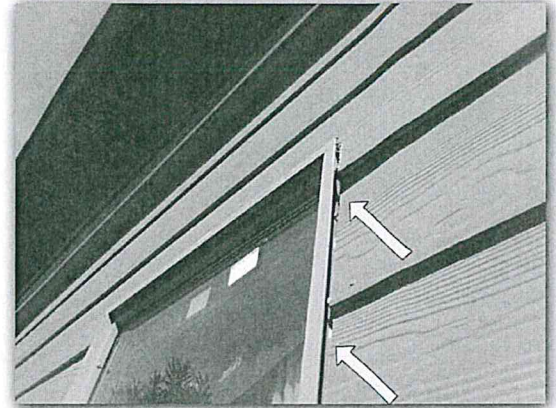
**Multiple windows observed to be missing flashing to help prevent water penetration. The top and sides edges of the windows are exposed.**

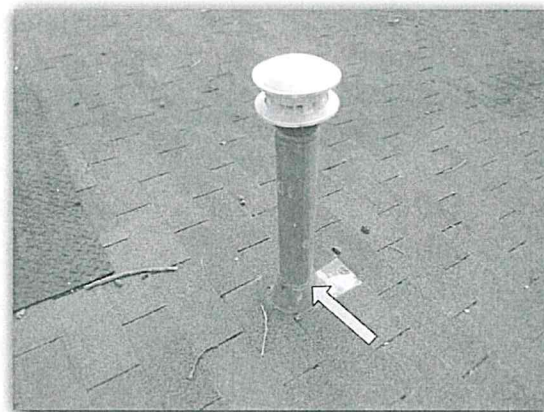
Storm collar missing.(south unit water heater)

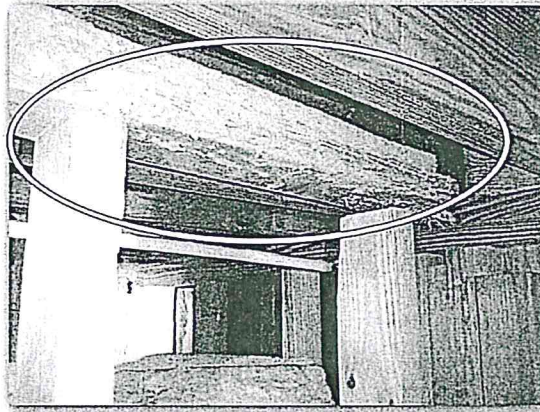
**Termite damage to the roof structure observed from the front attic hatch.**

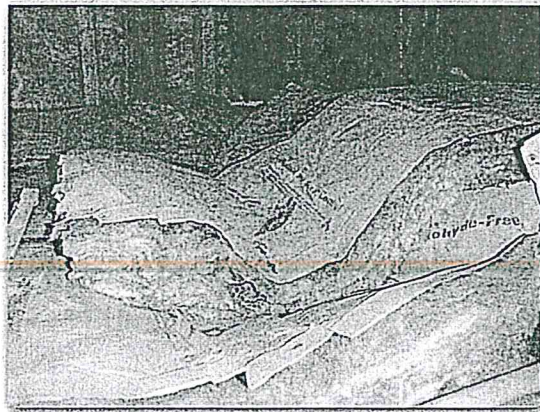
**Insulation improperly installed. Vapor barrier not on "warm on winter" side.**

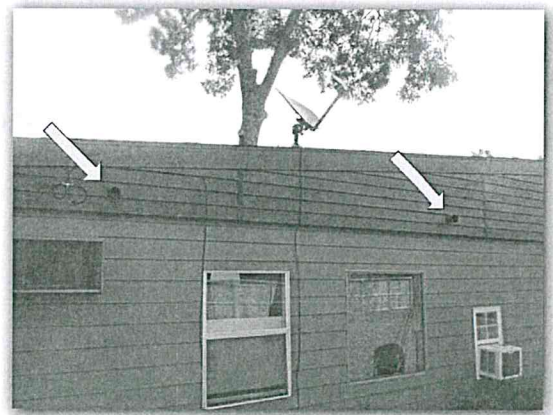
Types and locations of vents

**Inadequate amount of soffit or roof venting to allow proper ventilation of attic, owner incurs larger utility bills as well as shortened roof life with poor attic ventilation. Only a few pipes sticking out of the structure observed on the south side. This method is adequate and improper. The pipes are opened, not properly flashed and could allow water penetration.**

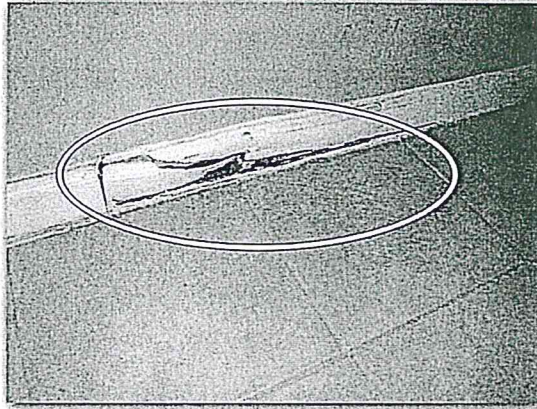
Wood deterioration due to water damage or wood destroying insect damaged observed at unit D back bedroom or east edge.

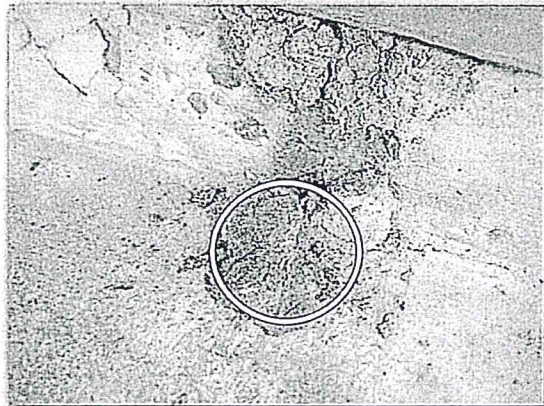
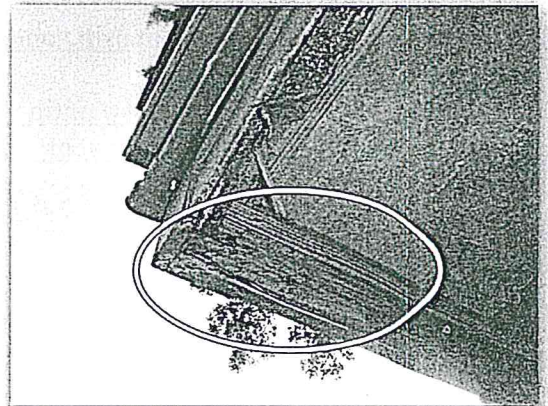
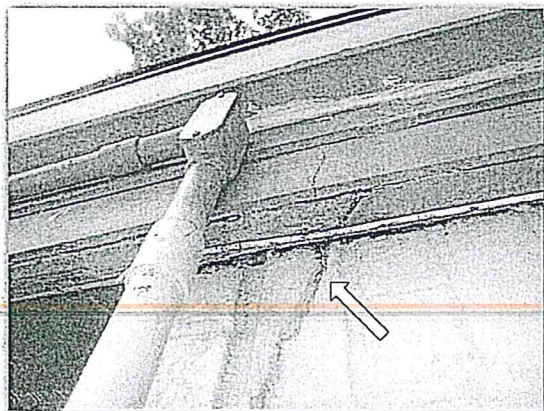
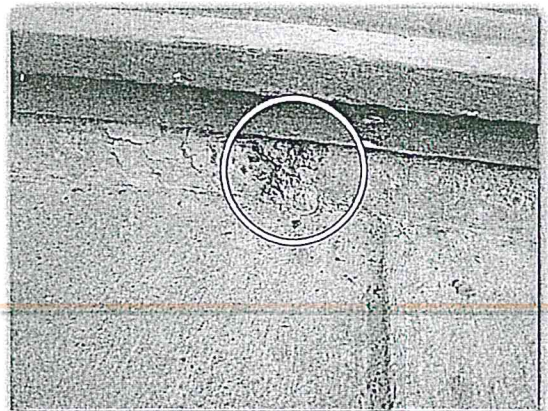
Wood destroying insect activity observed at front unit. ; **Final determination of structurally significant damage to wood members cannot be determined without removal of wall covering {interior sheetrock or exterior siding}.**

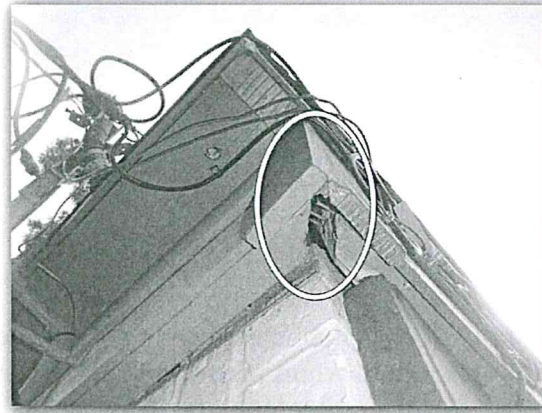
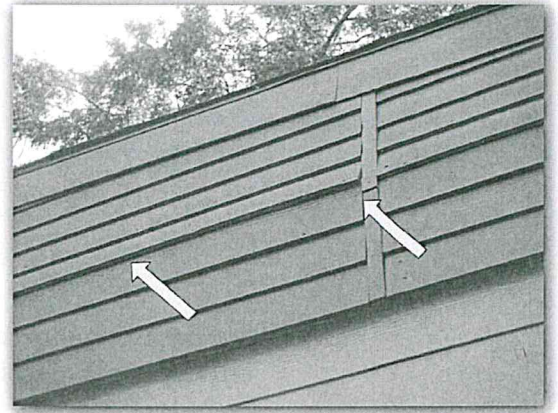
Freeze board separation at one or more corners of house. Indication of foundation movement. Recommend sealing to prevent insect entry into the attic.

Vener observed to be loose, or bowing out on the south side of the structure. The cause and remedy should be investigated and corrected as necessary.

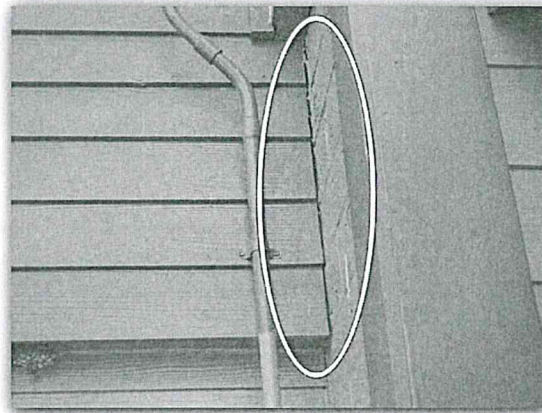
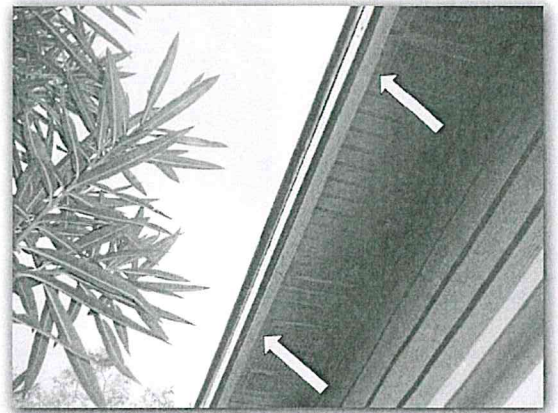
Caulking missing and/or deficient around vertical trim boards may allow wind driven rain entry.

Recommend painting any exposed wood such as at the fascia board around the structure to help prevent wood deterioration.

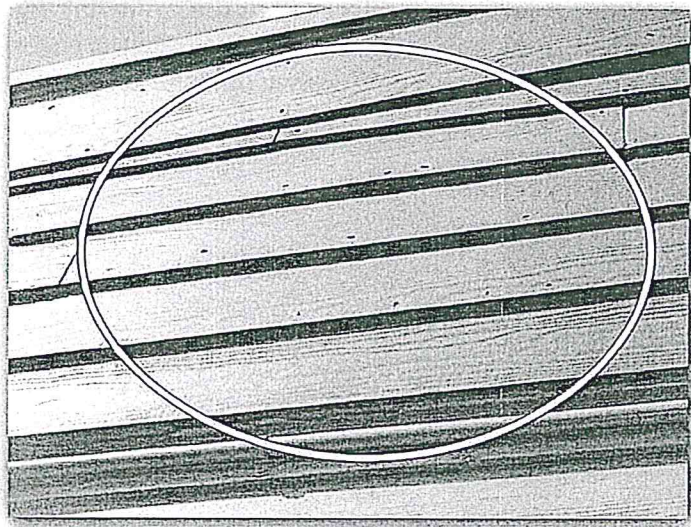
Recommend sealing veneer vertical joints to help prevent possible moisture penetration at one or more locations.

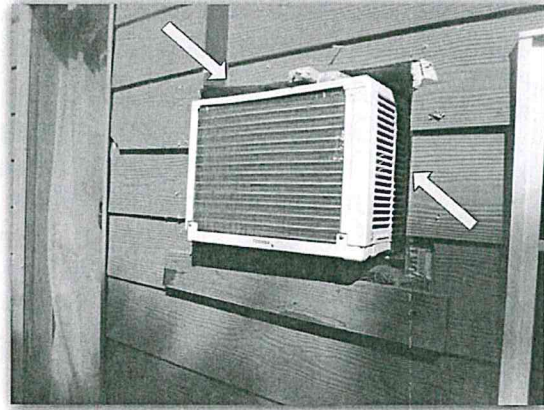
Large gaps at one or more wall units observed that are not properly sealed to help prevent water penetration.

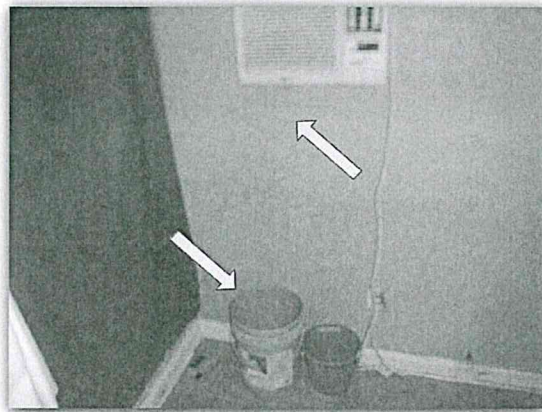
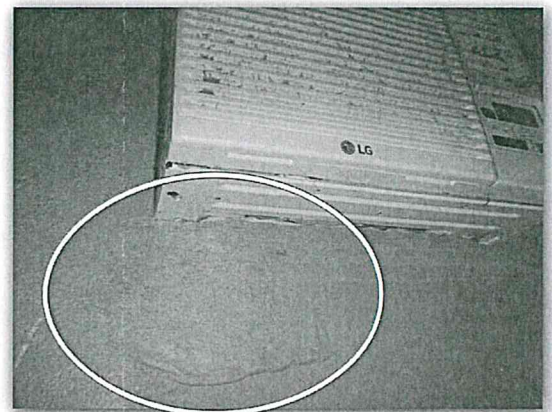
**Water penetration observed at the following location(s): Moisture damage observed at unit D back room from water entering the wall void from the AC wall unit. Extent of damage is beyond the scope of this inspection.**

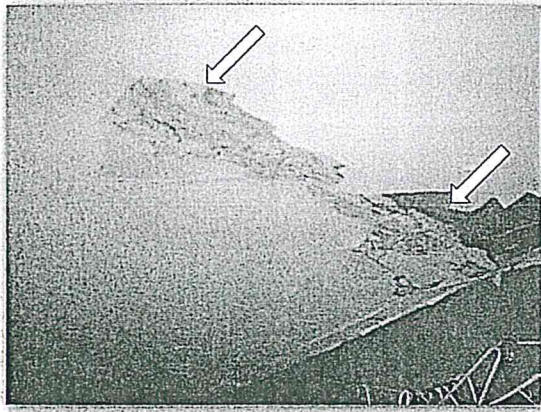
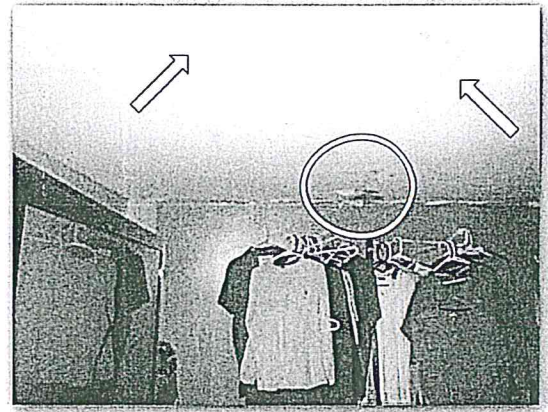
Wood destroying insect activity observed at front unit at the front bedroom ceiling.. ;  
**Final determination of structurally significant damage to wood members cannot be determined without removal of wall covering {interior sheetrock or exterior siding}.**

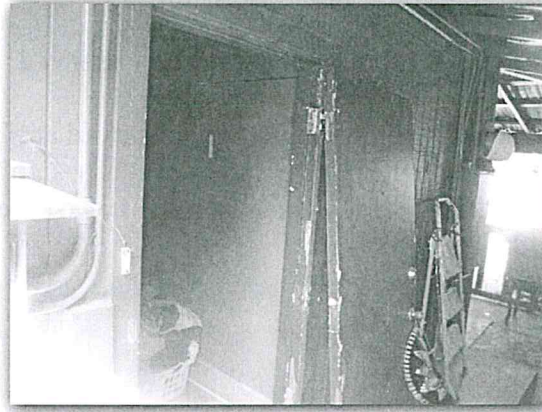
*Prudent buyers replace/rekey exterior locks upon taking possession of property.*  
Weather stripping torn/damaged and/or missing on one or more exterior door(s).  
Security consideration, exterior "hollow core" door. (one or more)  
One or more doors inside and out observed to be missing or not installed.

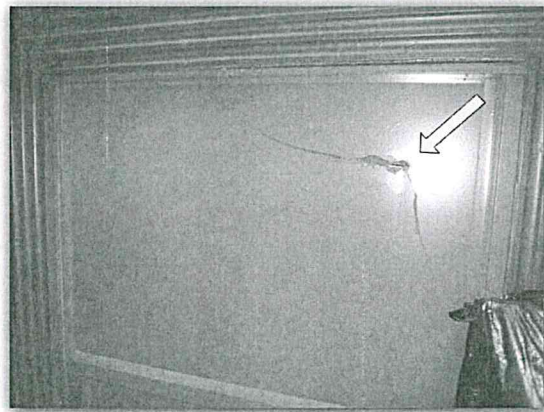
One or more windows had cracked / broken glass pane(s).(storage window)

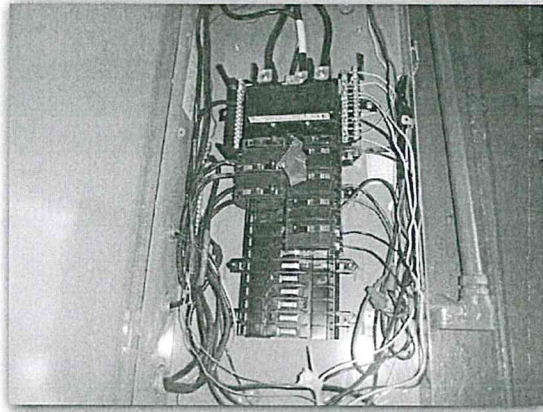
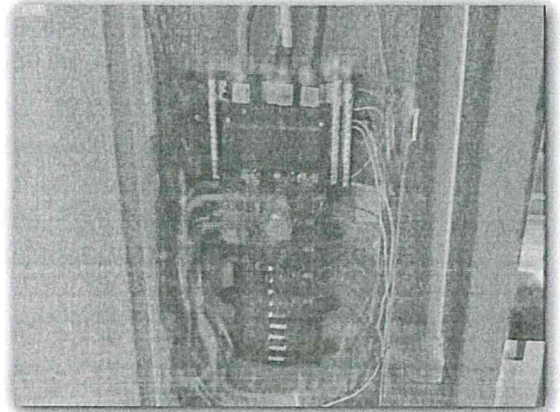
150 AMP ELECTRICAL SERVICE PANEL LOCATED AT NORTH EXTERIOR

Dead front missing one or more securing screws. Need to ensure screws used do not have sharp / pointed ends that can penetrate live electrical wiring behind dead front and cause shock, fire, serious injury.

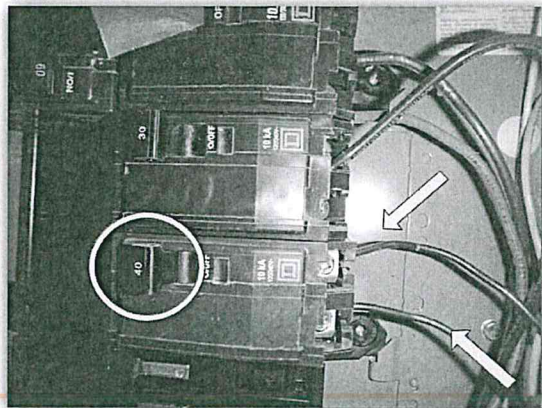
**One or more breakers appear oversized for wiring used. A 40 amp breaker connected with 12 gauge wiring. 12 gauge wiring is listed or labeled to be used with a 20 amp circuit only. The breaker will not trip if a surge exist on this circuit.**

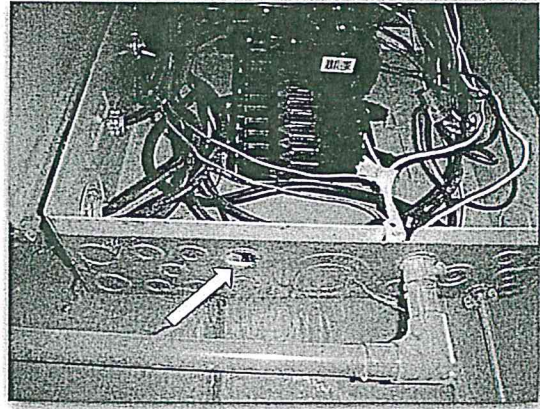
Panel exterior circular knock out(s) need to be sealed to prevent wasp / bee infestation.

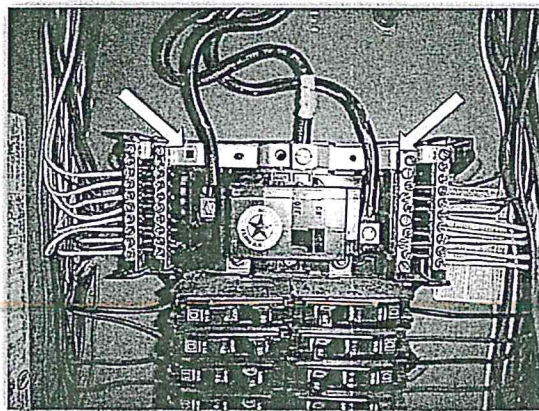
Improper connection at sub-panel, need to remove bonding jumper from ground bus bar to isolate ground from neutral.

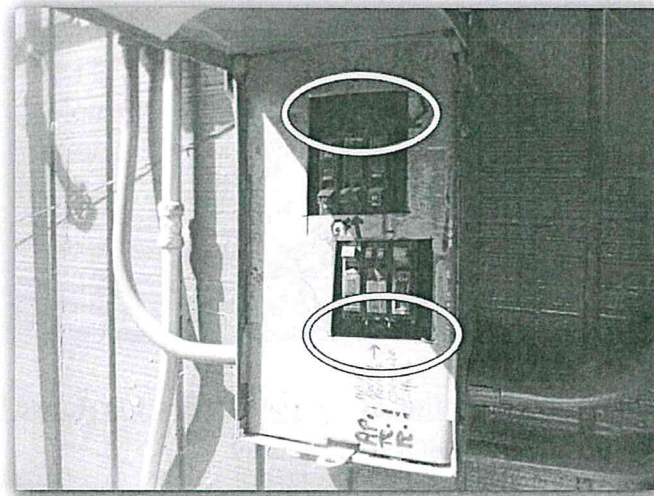
Improper or homemade dead front cover observed, the cover is not adequate and large gaps can be seen exposing the interior of the panel box.

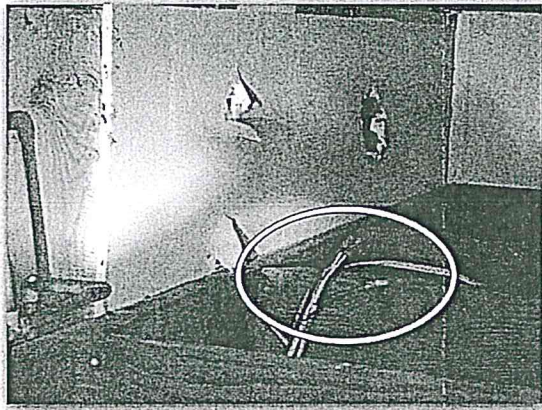
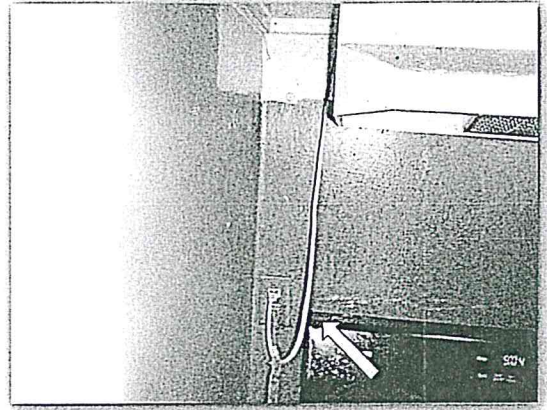
Lamp cord and/or extension cord wiring used improperly as permanent wiring; servicing the hood vent for unit A.

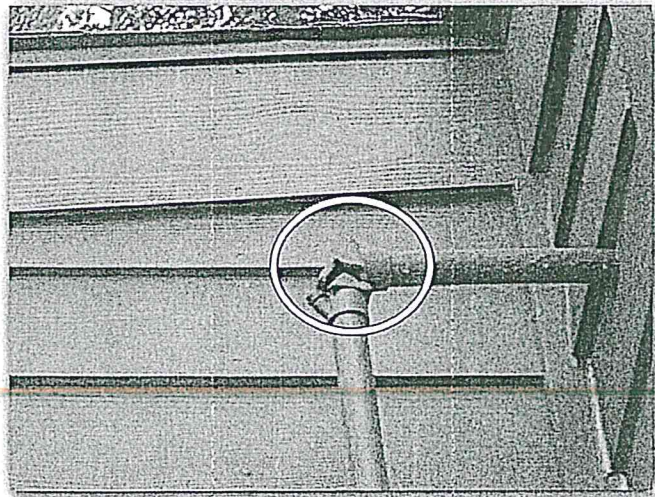
Conduit elbow observed to be damaged on the south side exposing the wiring to the outside elements and possibly allowing water intrusion within the conduit.

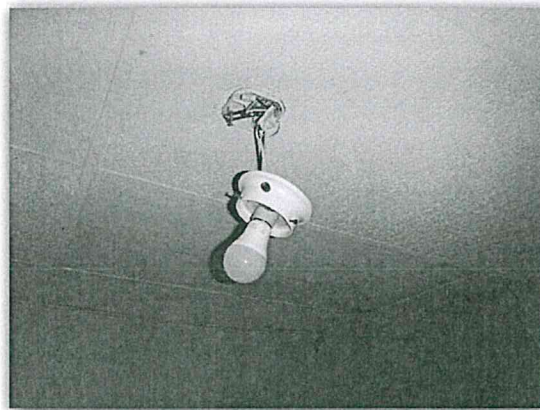
Light not secured, unit D.

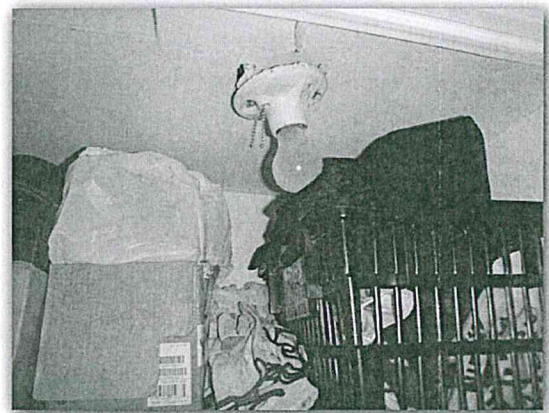
One or more of the closet light fixture(s) appear to be mounted to close to combustible material. Safety precautions should be taken around these light fixtures.

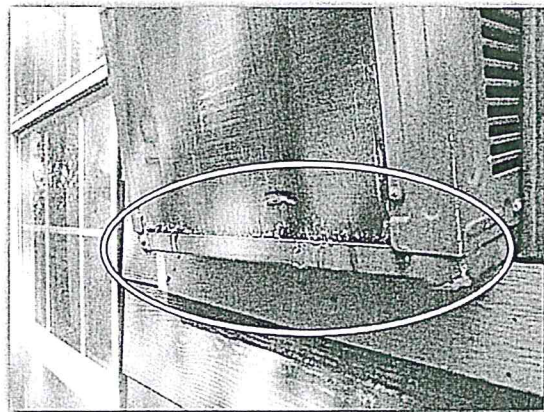
**One of the wall units in apartment A was not functioning at the time of this inspection.**

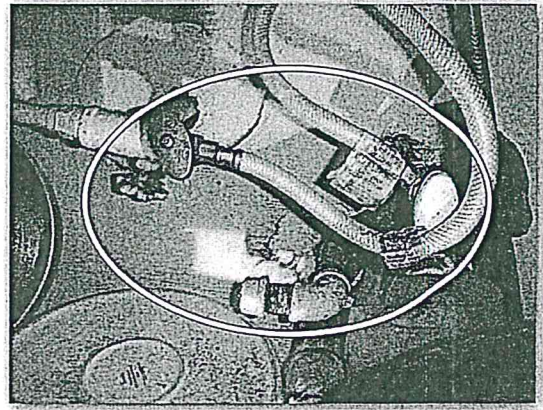
*Water supply piping observed to be predominantly galvanized.*

rusting of galvanized pipe can greatly reduce water pressure and will eventually cause leaks as rust creates holes in the pipe wall:

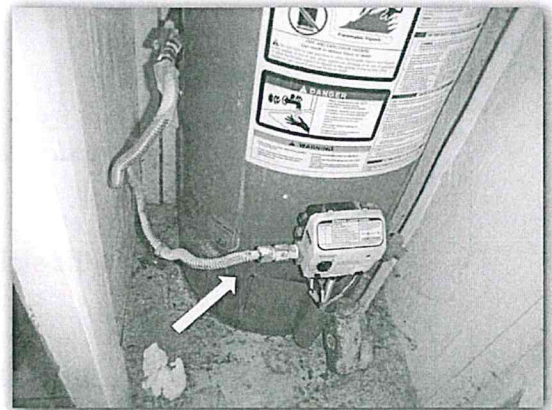
*Did not observe gas line drip leg(s) on gas house heater and/or gas water heaters which is called for in the manufactures installation instructions.*

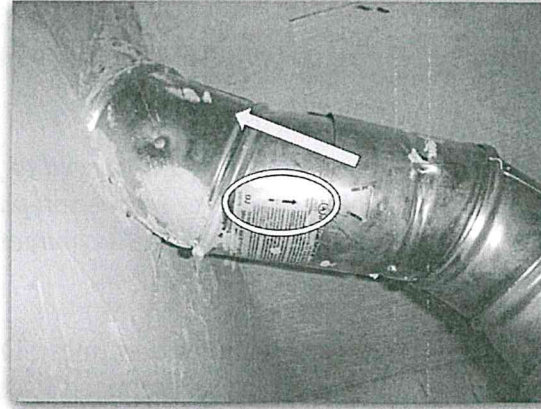
**Vent pipe connection(s) improper, inside out / upside down, does not fully contain products of combustion in duct; south unit.**

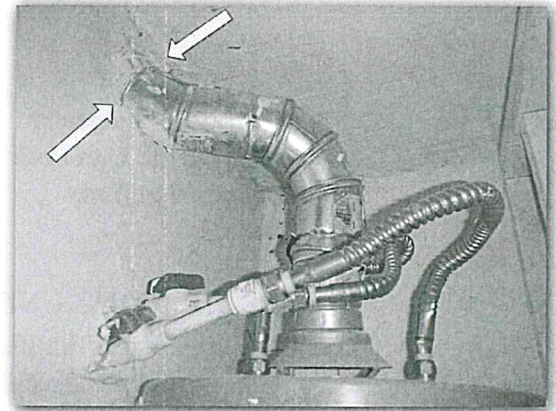
Exhaust vent pipe is in contact or does not have required minimum 1" clearance from combustible material, [wood roof decking].

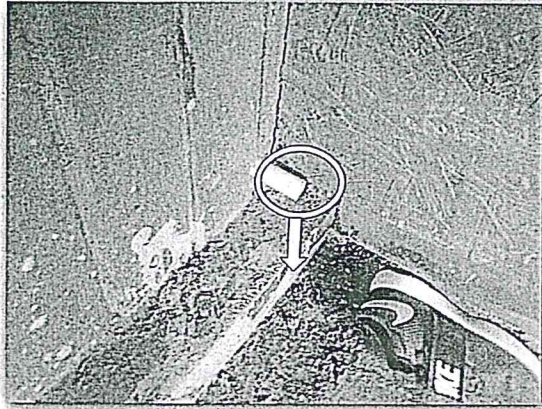
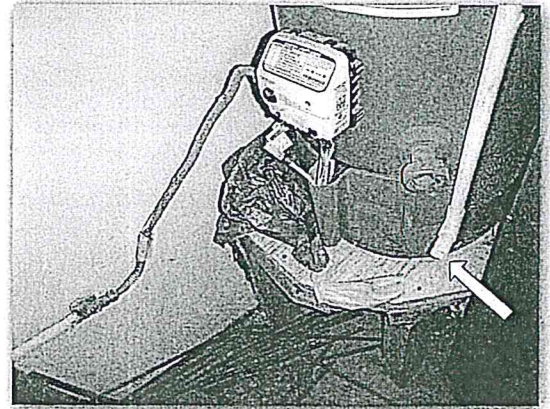
End of drain line missing 90 degree fitting to direct discharge downward.

**The TPR drain line should terminate to the exterior of the structure and terminate within 6 inches of the ground.**

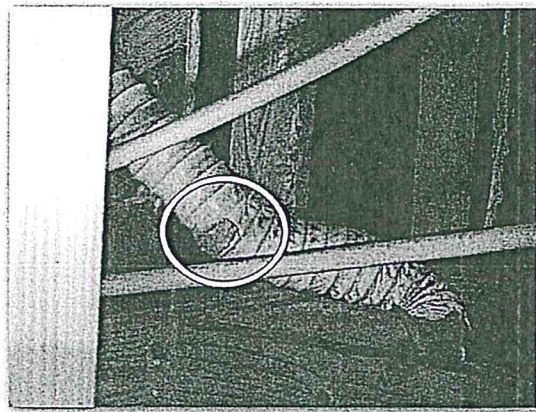
Improperly vents into attic. Should vent to exterior.(not all to the exterior) The only one that had evidence of terminating to the exterior was for the front unit. This motor was not functional and the plastic vent is not rated to be used in the attic. The vent is also damaged probably by rodents.
