21 November 2017

Re: Post-Flood Mitigation Moisture Inspection
100-192 Litchfield Lane, Houston, Texas 77024
Building 12, Unit 233

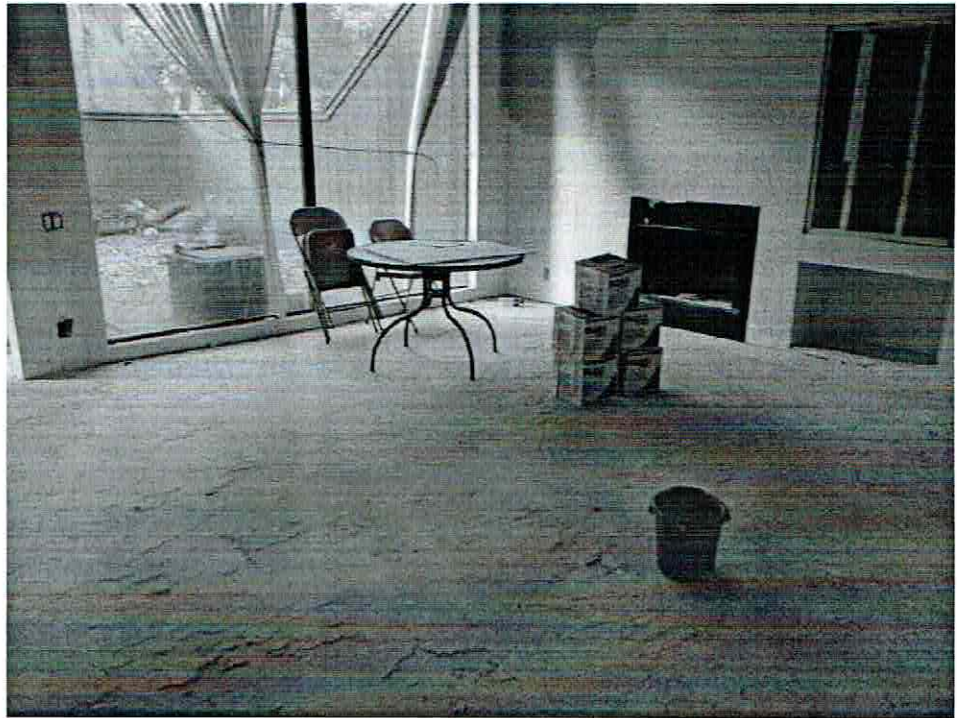
Photo No.:	Date:
1	11/21/17

Build back observed throughout the residence.

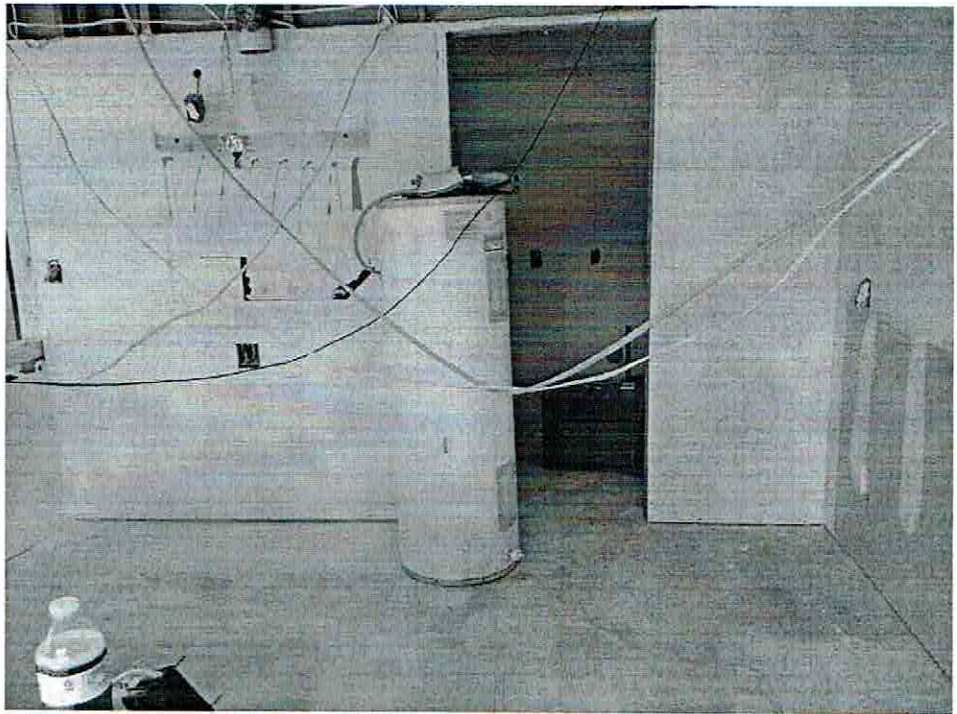
Photo No.:	Date:
2	11/21/17

Build back observed throughout the residence.

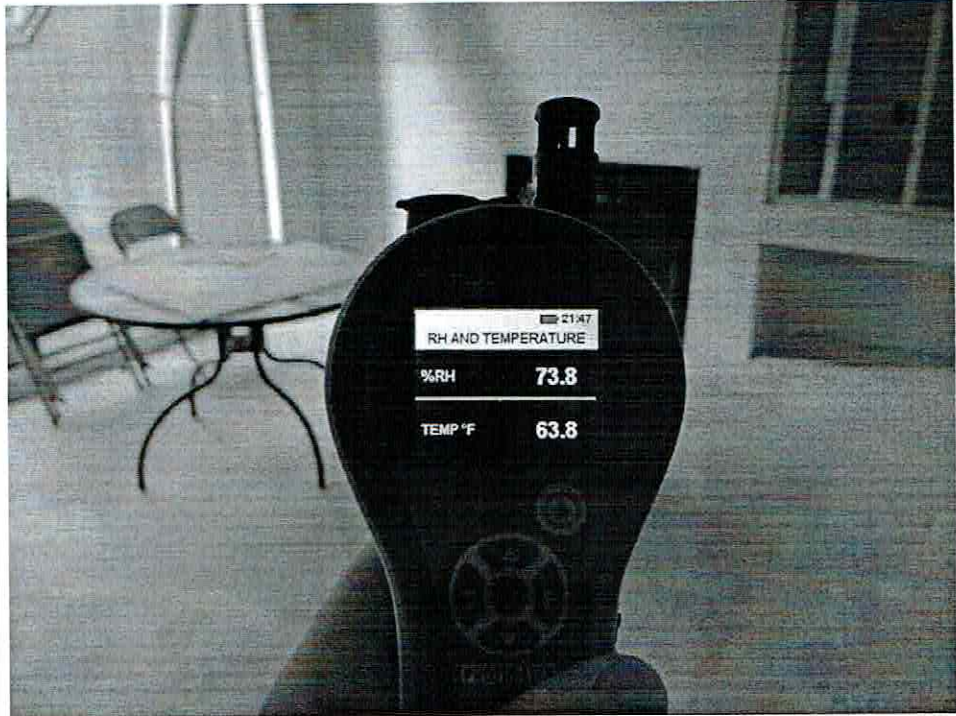
3

Humidity levels at the time of the inspection.

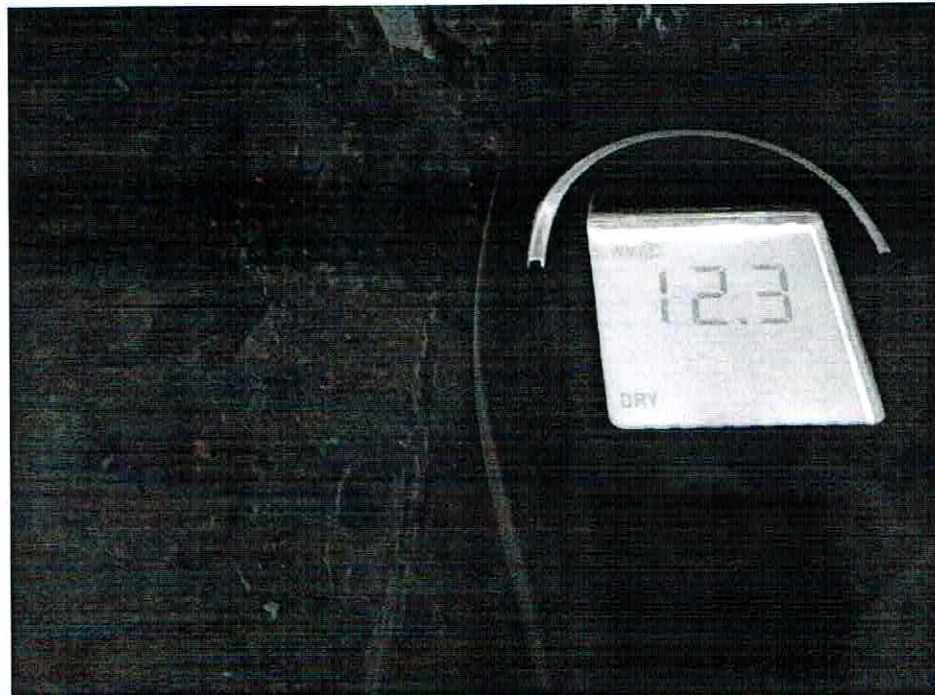
4

Moisture Reading:

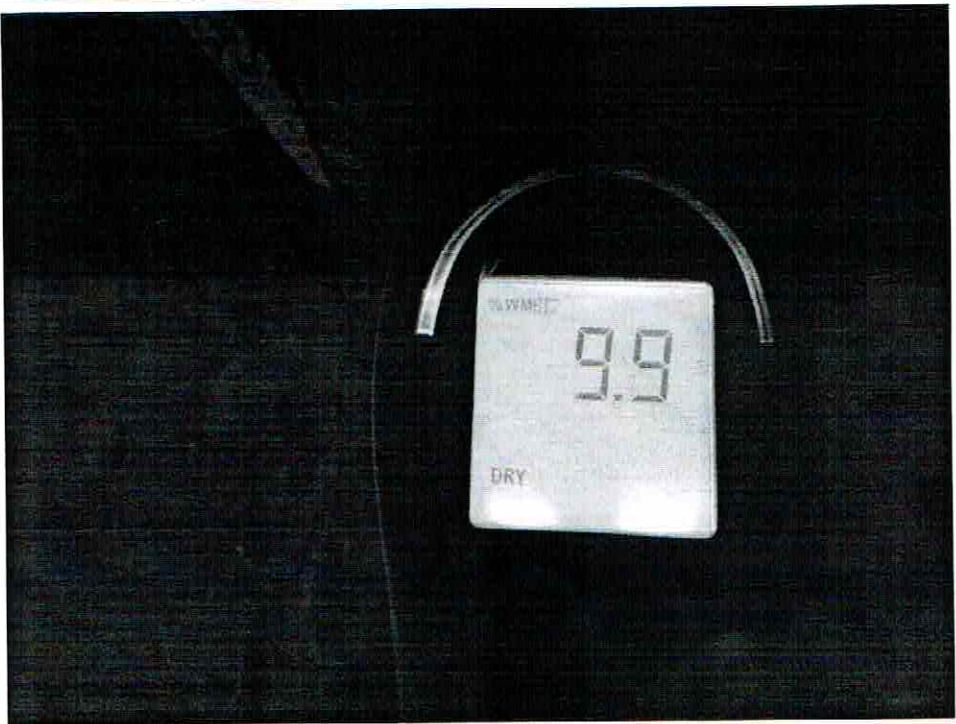
Photo No.: 5	Date: 11/21/17
Moisture Reading:

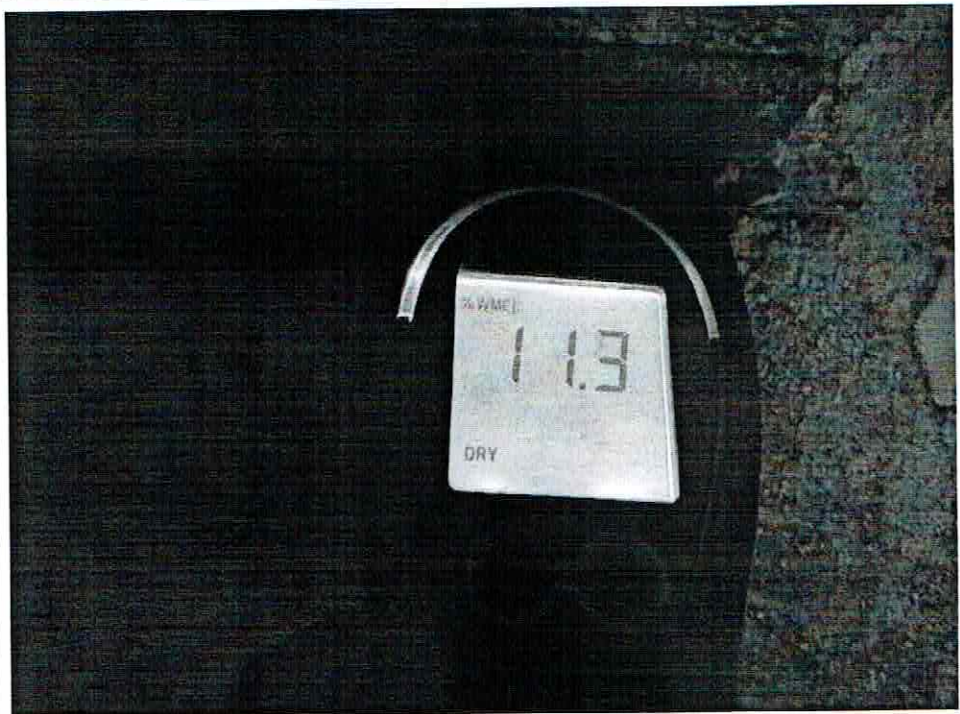
Photo No.: 6	Date: 11/21/17
Moisture Reading:

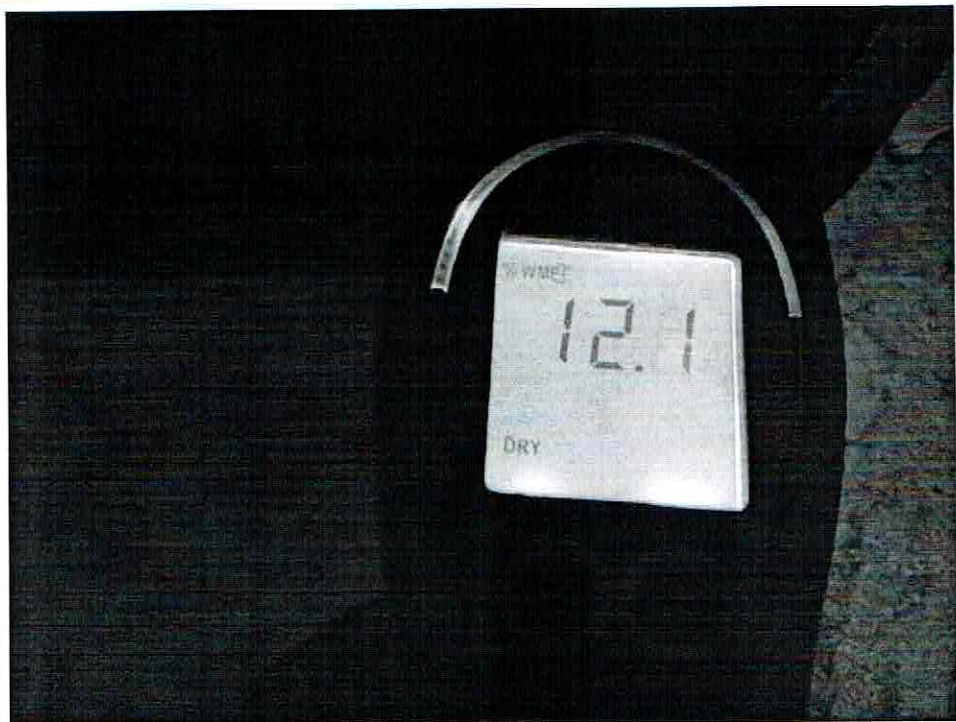
Photo No.:	Date:
7	11/21/17

Moisture Reading:

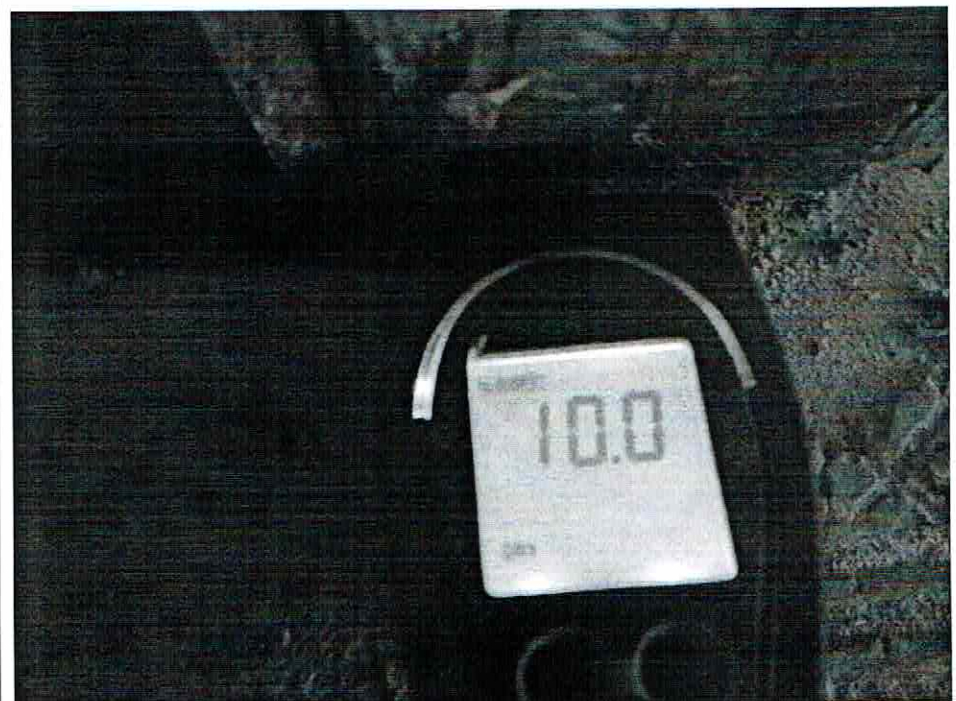
Photo No.:	Date:
8	11/21/17

Moisture Reading:
