HOME INSPECTION REPORT

Prepared For:	Miguel Valdez	
	(Name of Client)	
Concerning:	17114 Ross Lake Ct, Humble, TX, 77346	
	(Address or Other Identification of Inspected Property)	
By:	Charles Rowden 22155 David Jones 22116	5-6-2020
	(Name and License Number of Inspector)	(Date)
	(Name, License Number of Sponsoring Inspector)

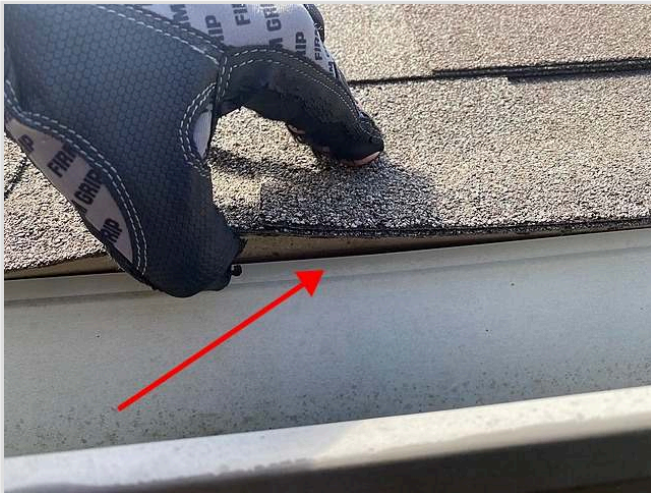
The gutters on the upper section of the roof were installed in front of the drip edge flashing. Common industry standard calls for the drip edge flashing to “drop” into the gutter trough.

Installed in front of the drip edge

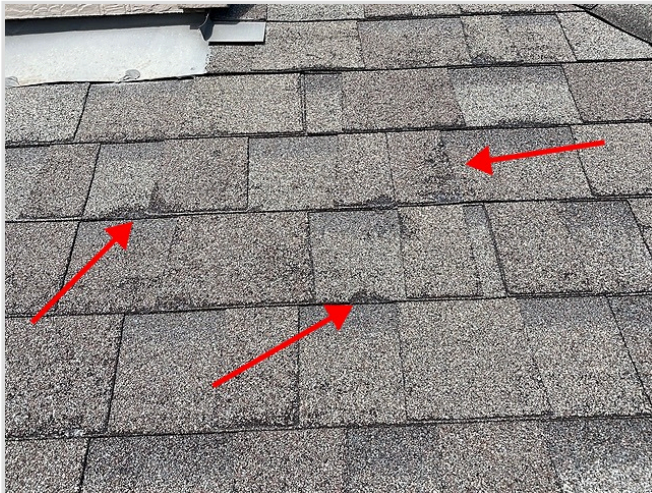
The asphalt-fiberglass shingle roof was moderately worn with areas of significant wear.

Areas of accelerated granule loss

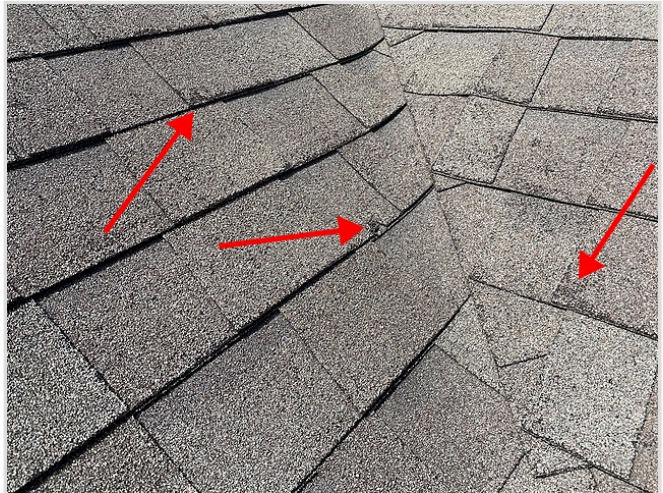
Some of the shingles were damaged.

Damaged shingles

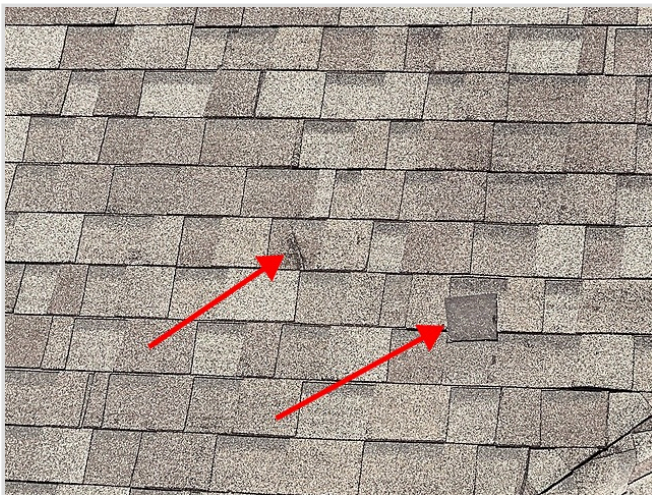
Damaged shingles

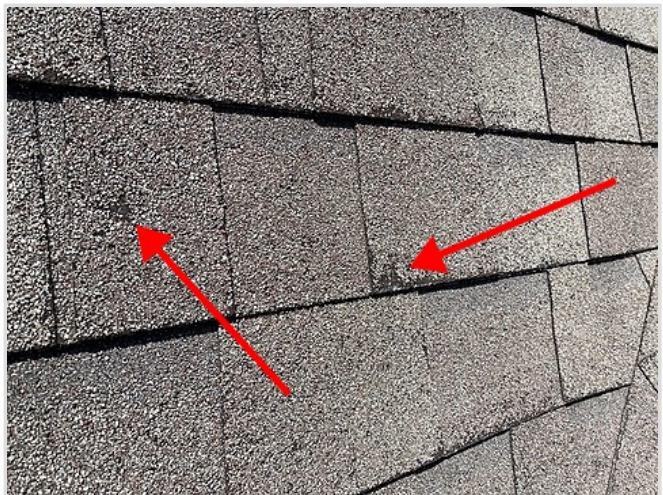
Damaged shingles

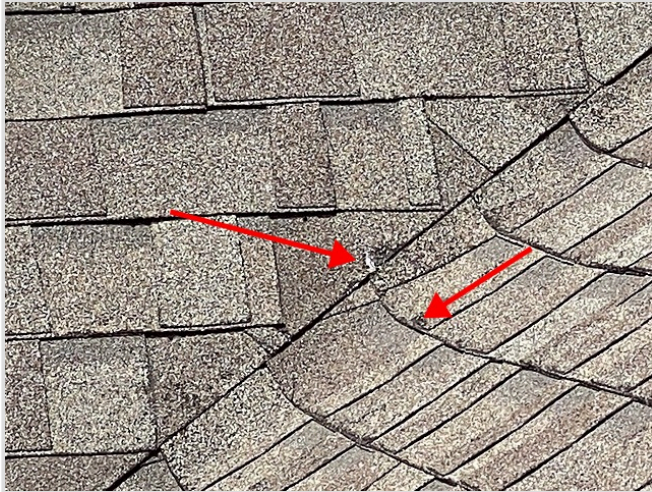
Damaged shingles

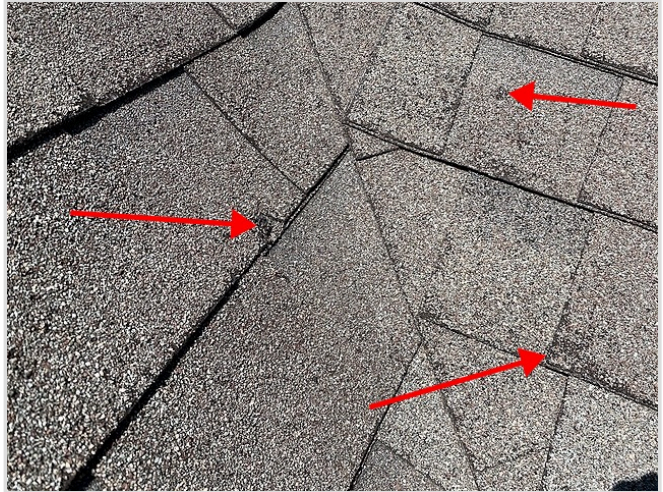
Damaged shingles

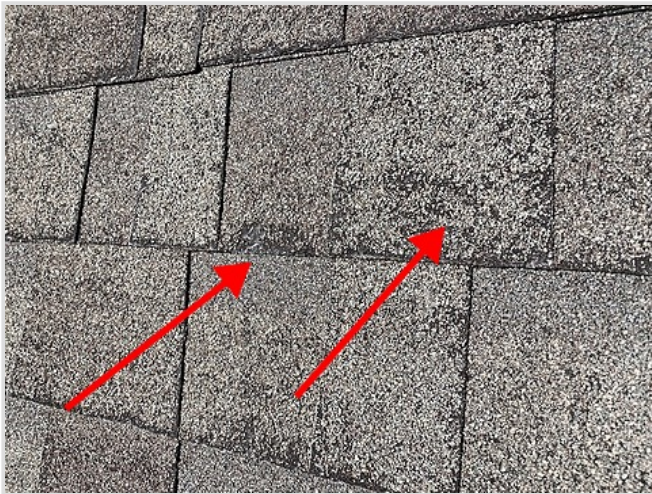
Damaged shingles

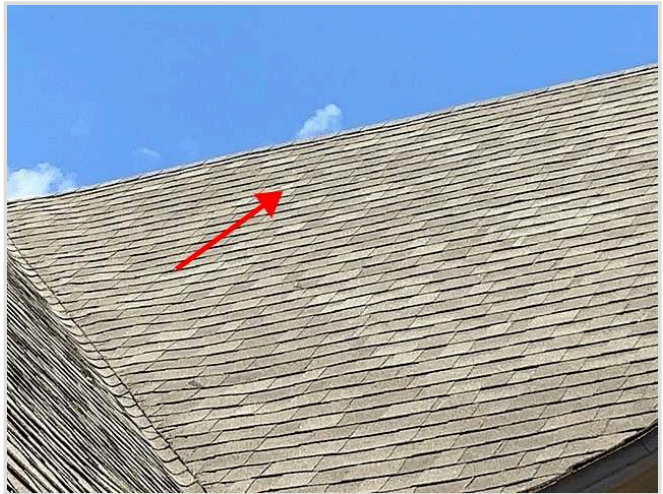
Damaged shingle

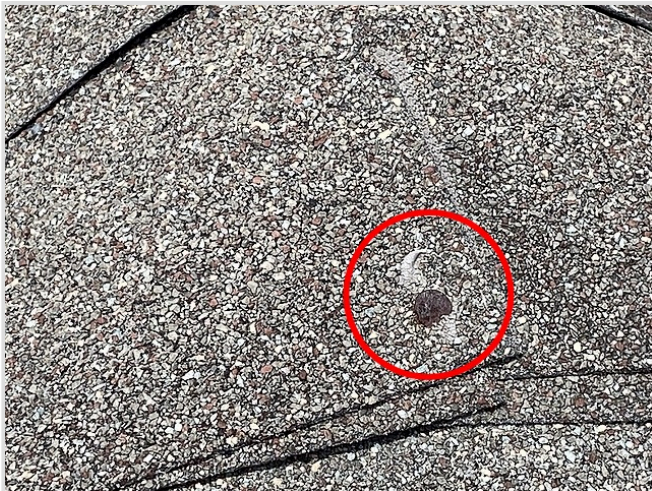
Exposed nails were observed in one or more locations. Common industry standards call for nails that are exposed to the elements to be caulked/sealed to help prevent rust corrosion, which can lead to leaks.

Exposed nail

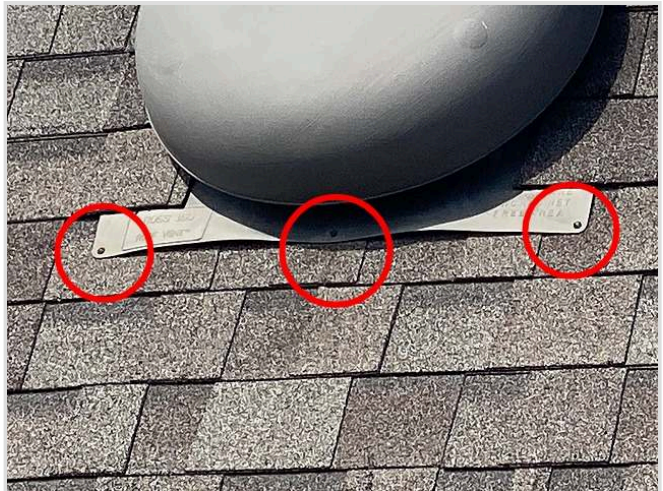
Exposed nails

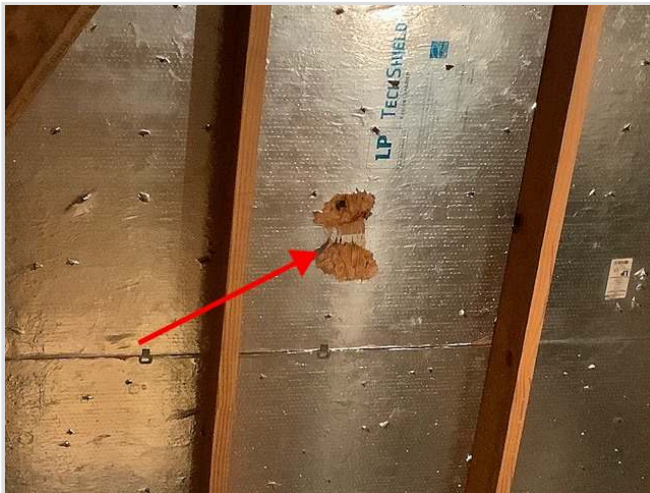
A portion of the roof decking/radiant barrier was damaged

Damaged

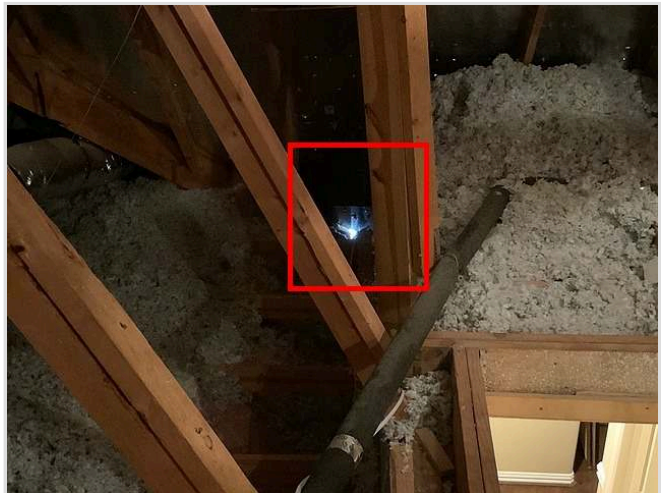
There was a gap in the roof structure on the front side (conducive condition for rodent/pest entry).

Gap in the roof structure (front side)

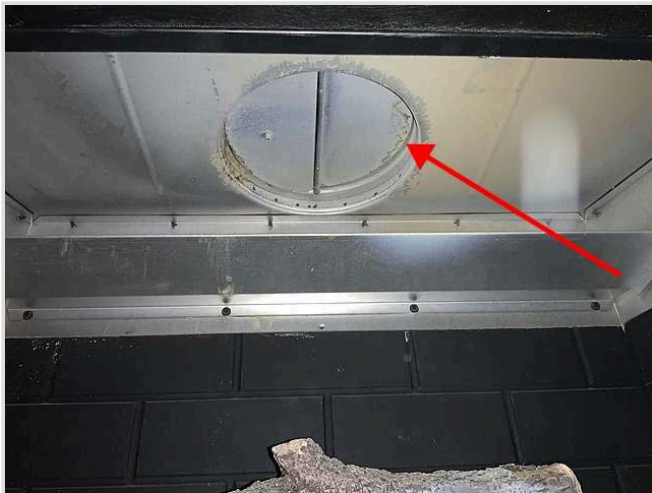
Units were performing as intended at the time of inspection.
An artificial gas log insert was installed in the firebox and no damper clamp present. Having a properly installed damper clamp will prevent carbon monoxide from a pilot light or other sources, from exiting into the room where the fireplace is located.

No damper clamp present

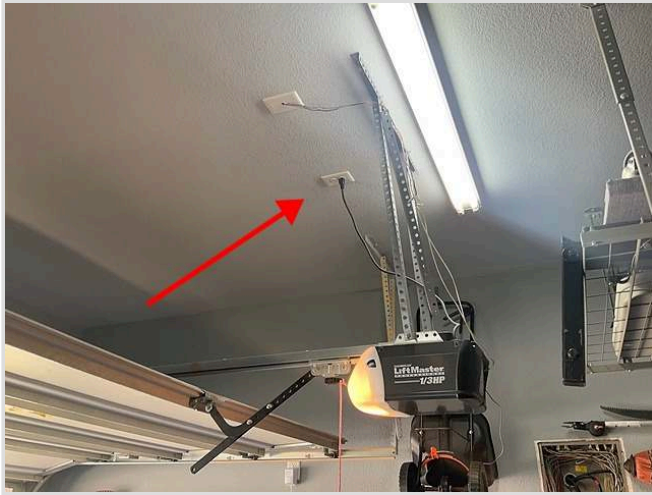
Ceiling receptacles in the garage were not on GFCI (ground fault circuit interrupter). The Texas Real Estate Commission (TREC) considers this to be a deficiency according to the standards of practice (SOP).

Not on GFCI

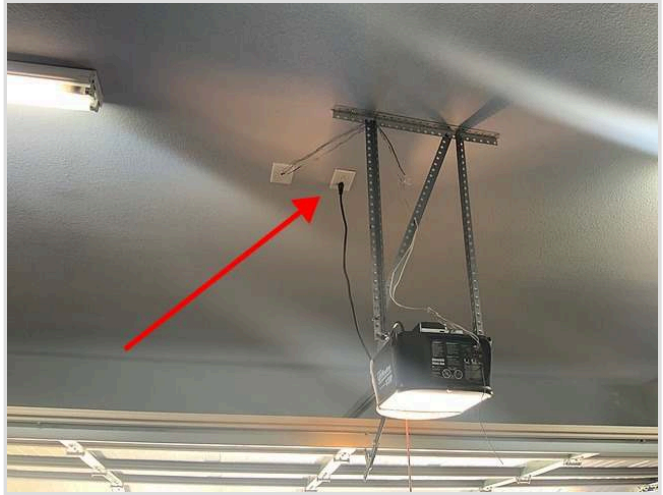
Not on GFCI

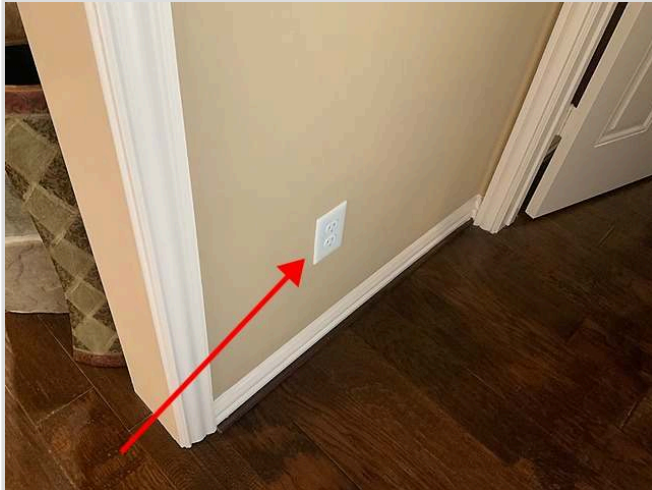
Several receptacles were not properly installed in the gang box (loose).

Loose (master bedroom hallway)

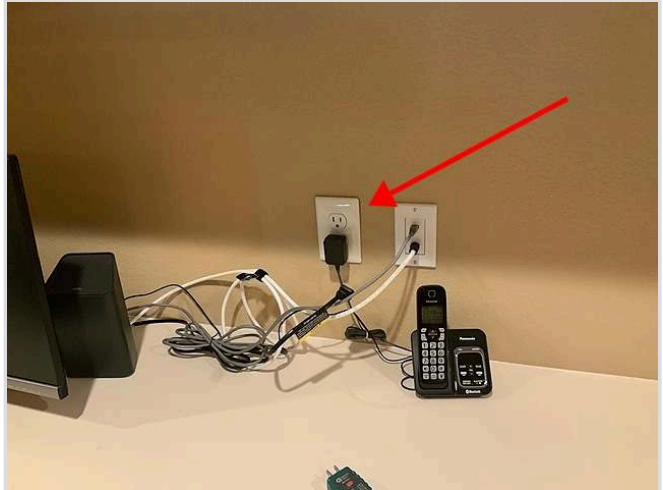
Loose (second floor hall-office area)

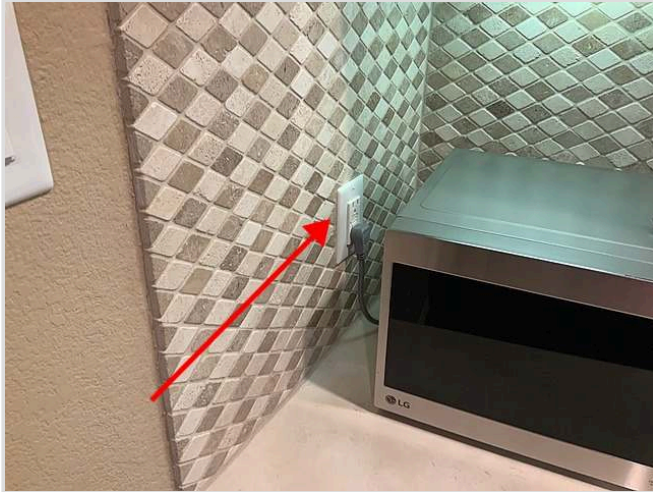
Loose (wet bar on second floor)

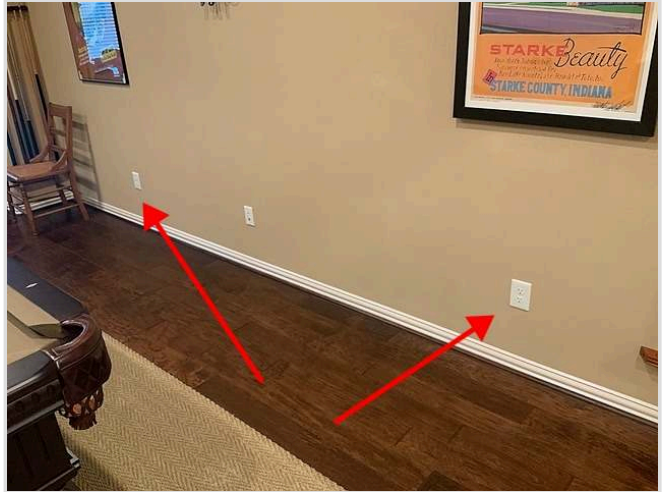
Loose (game room)

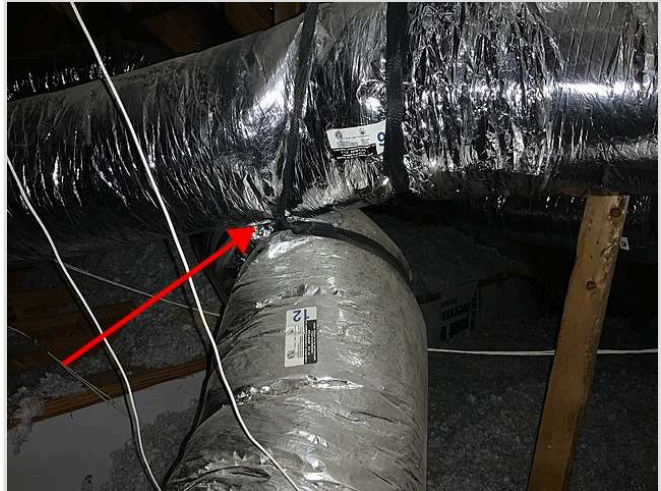
Ducts in the attic space were in contact with refrigerant lines and other ducts. Points of contact between these items has been known to create condensation (sweating) in the attic space. Common industry standard calls for supply ducts to be elevated over insulation, not in contact with refrigerant lines/other flex ducts and/or HVAC units in the attic space.

Ducts in contact with other ducts

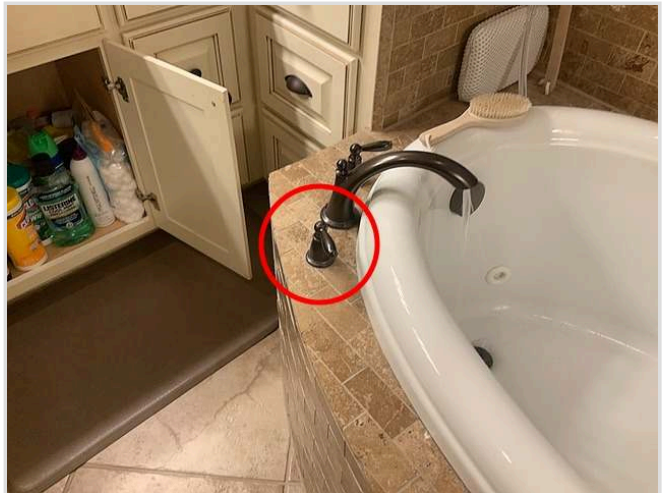
Hot water faucet for the bathtub in the master bathroom was improperly installed (loose).

Loose (master bathtub)

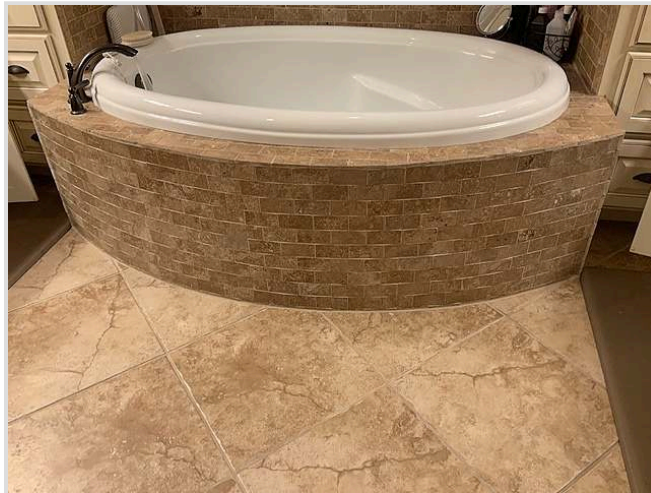
Unit was encased in a permanent structure that prevented the visual inspection of, and access to the system's pump. There should be access to the pumping system and it's electrical components to include the GFCI receptacle.

Encased in permanent structure

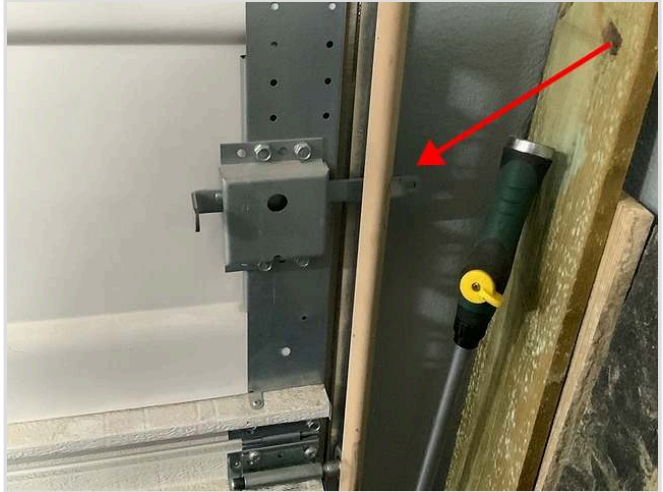
The manual door lock for the left operator had not been disabled. Not disabling the door lock for the garage has the potential of operating the door opener while locked, which can lead to damaging the door and connected components.

Door lock not disabled

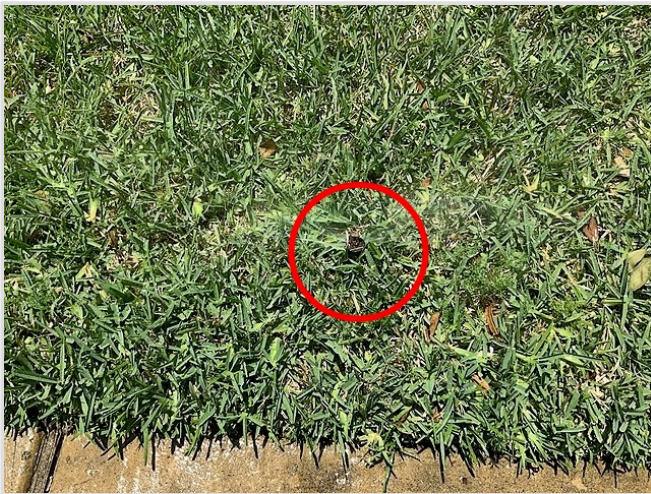
Several spray heads had improper spray patterns and were in need of adjustment.

Needed adjustment

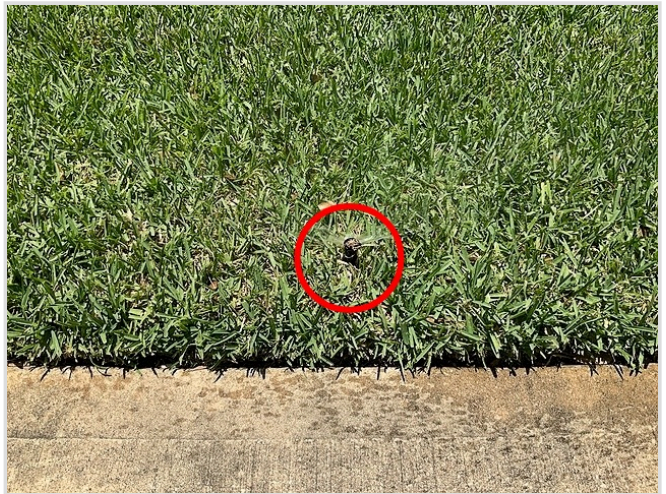
Needed adjustment

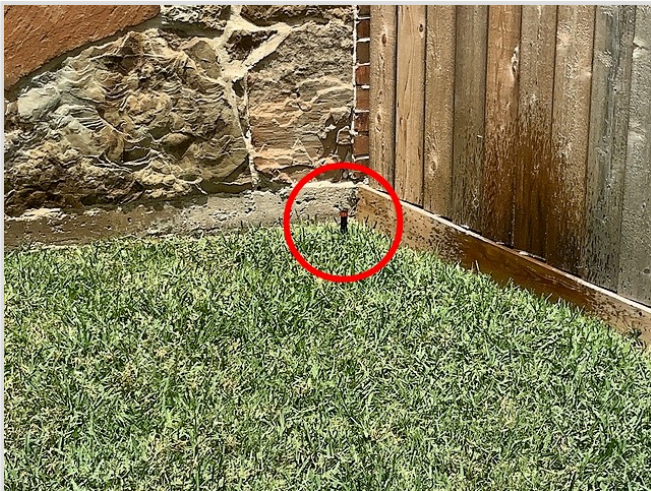
Improper spray pattern

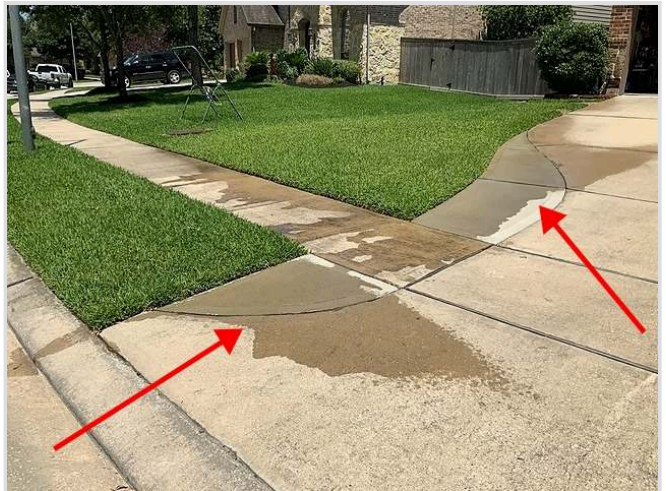
Improper spray patterns
