Structural Engineering Foundation Performance Evaluation For
Client: William Adams
property located at
2103 Seven Maples Drive
Kingwood, Texas

Date: Tuesday, June 16, 2020

PROJECT DESCRIPTION

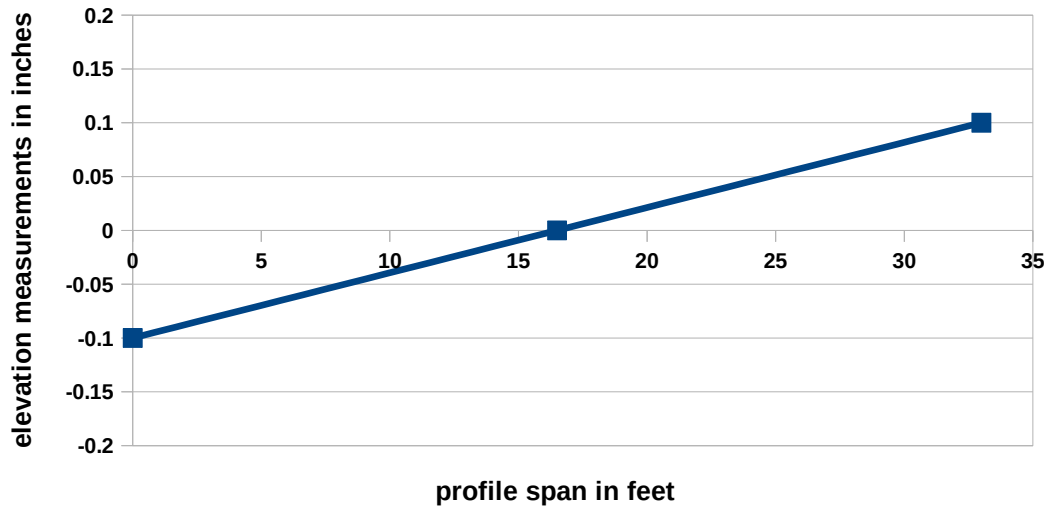
Front (door) To Rear Estimated Deflection/Tilt Profile

profile span (feet)	deflection (inches)	deflection ratio (over 360)	tilt (%)
33	0	0.00	<1%

**dominant distortion mode:
no deflection – normal tilt only**

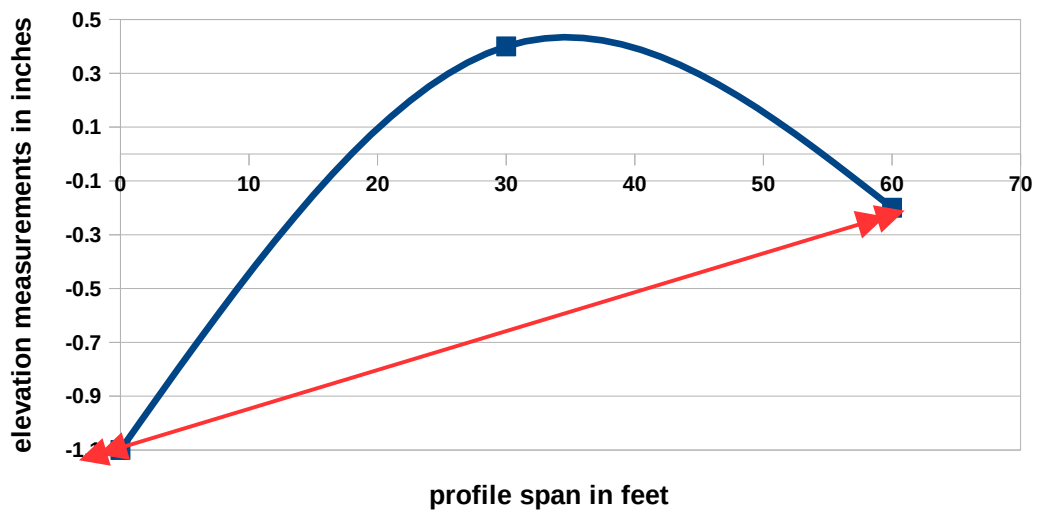
Left Side To Right Side Estimated Deflection/Tilt Profile

profile span (feet)	deflection (inches)	deflection ratio (over 360)	tilt (%)
60	0.9	0.45	<1%

**dominant distortion mode:
moderate normal center-lift with
normal tilt**
