PROPERTY INSPECTION REPORT

Prepared For: Lauren & Scott Kastner
(Name of Client)

Concerning: 2127 Stacy Glen, Houston, TX 77008
(Address or Other Identification of Inspected Property)

By: Tommy Thompson TREC # 2714 3/30/2017
(Name and License Number of Inspector) (Date)

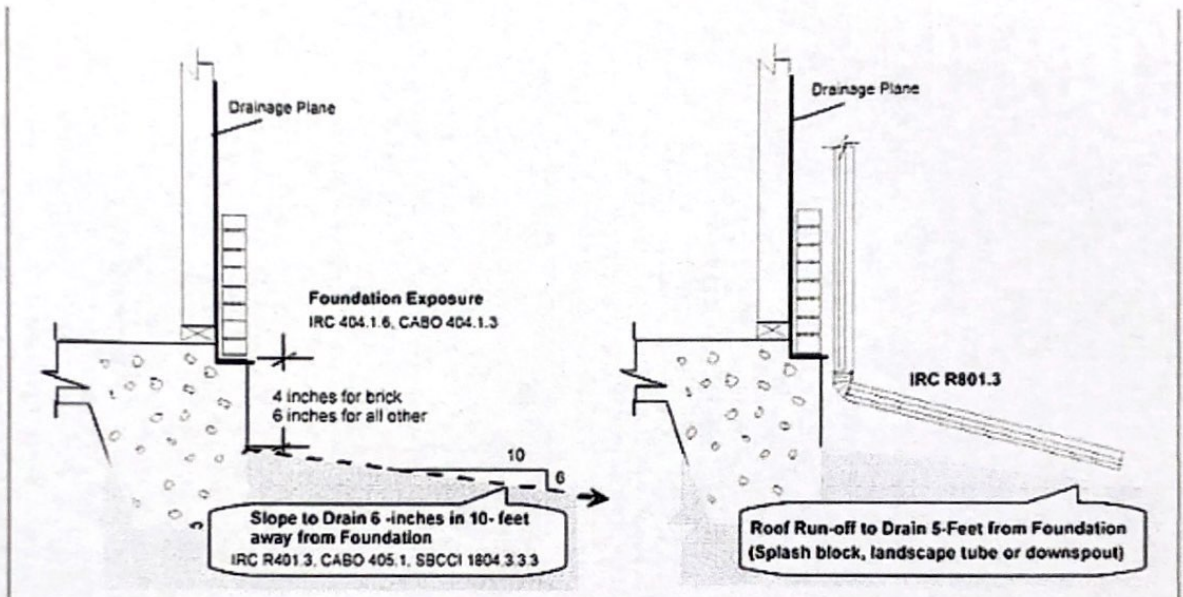
- The splash pads or irrigation pipes were missing from the bottom of the downspouts at some locations next to the grade beams. Discharging water next to the slab can create adverse conditions and settling in the future.
- High surface levels (soil) were viewed at the grade beam. These levels should be lowered at least two to three inches from the top of the foundation to prevent possible moisture and insect penetration.

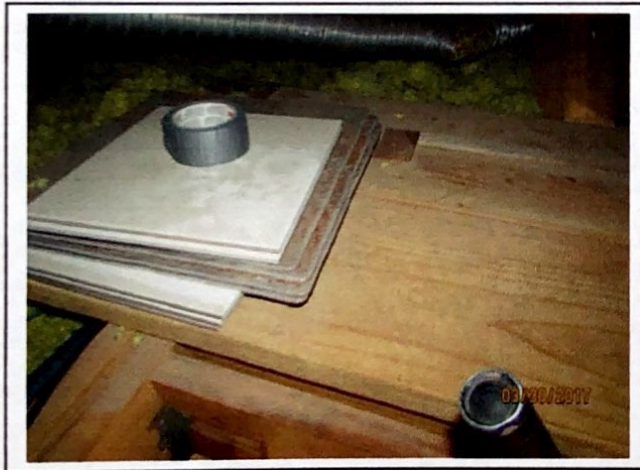
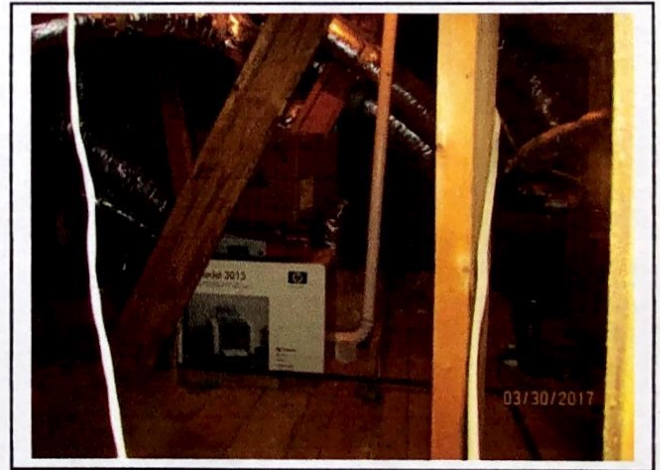
- **The attic area needs to be cleaned from all product boxes, wood pieces, garbage and debris from the walkway and insulation areas. All remaining tile, grout products, and carpet pieces should be moved to a remote area in the attic – not in the front pathways.**

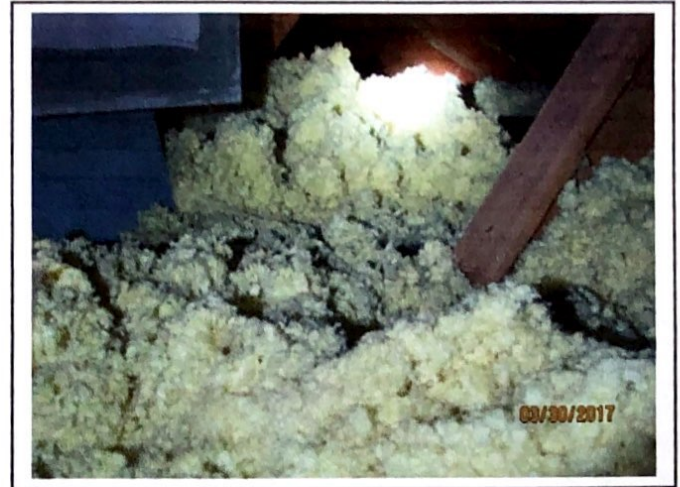
- The attic insulation in some areas is considered to be sub-standard and needs to be re-installed and evened out where it has been *but not limited to*: disturbed by service personnel and compressed by stored items and debris. The minimum insulation value of R-30 (10 to 12 inches) is needed for the minimum performance of the insulation.

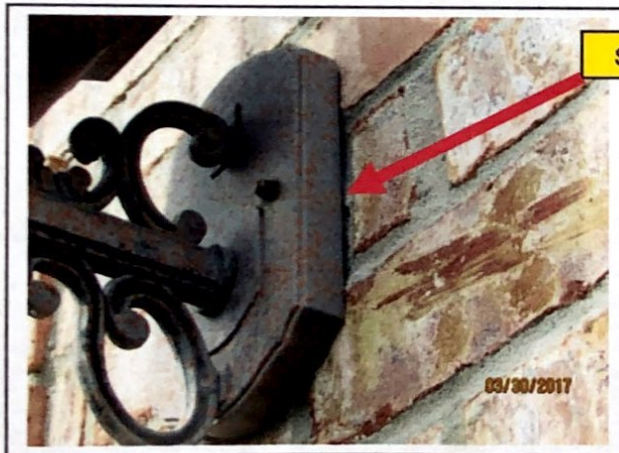
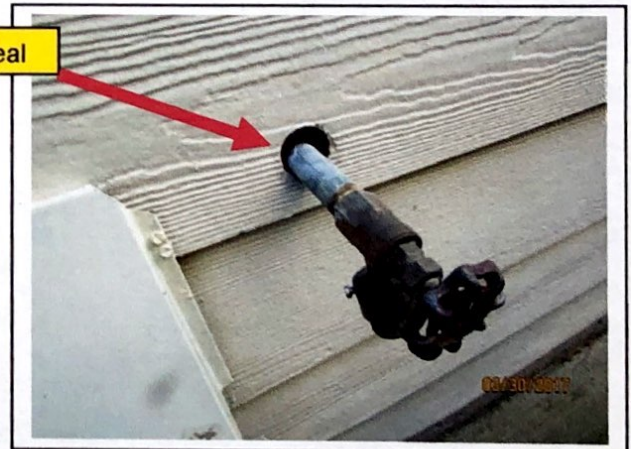
- All exterior wall penetrations need to be properly sealed at the wall coverings. Cracks, gaps, and separations allow water to "wick" along the penetrations back into the interior structural portion of the wall. Minor sealant repairs should be performed around all lights, electric boxes, pipes, vent caps, and any other unsealed wall penetration.

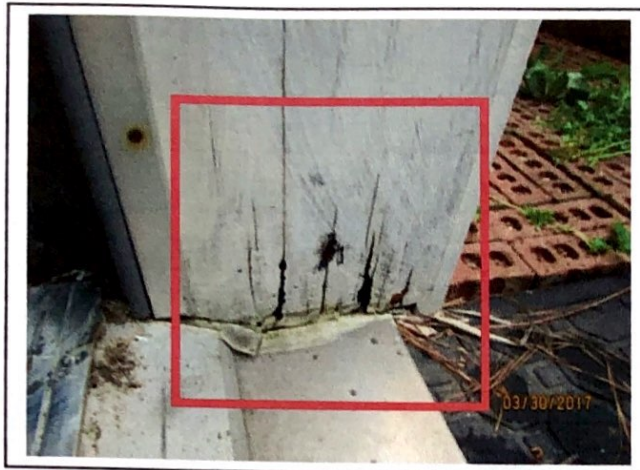
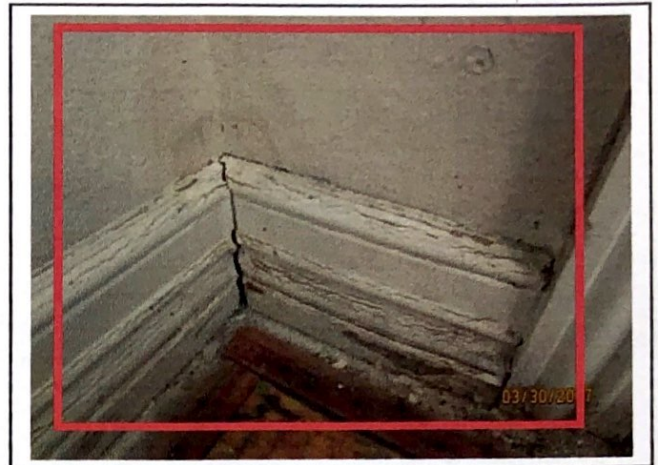
- Deteriorated/weathered wood areas were viewed at *but not limited to*: rear exit door jambs. All deteriorated wood areas should be replaced and not just covered with wood filler, caulk, and/or paint. Other areas of deterioration may be hidden under painted, sealed, or non-accessible or viewable surfaces.
- Water staining and minor damages on the walls were noted in *but not limited to*: the rear exit door in the bedroom. All discolored areas need to have the stain source located, investigated, and properly sealed if necessary.

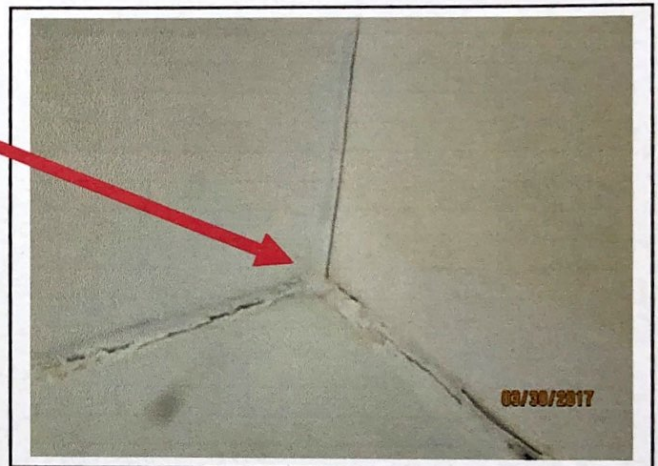
- The wall cracks and separations in the bathtub and/or shower joint areas need to be re-sealed with a flexible sealant to prevent water penetration into the subwall area.

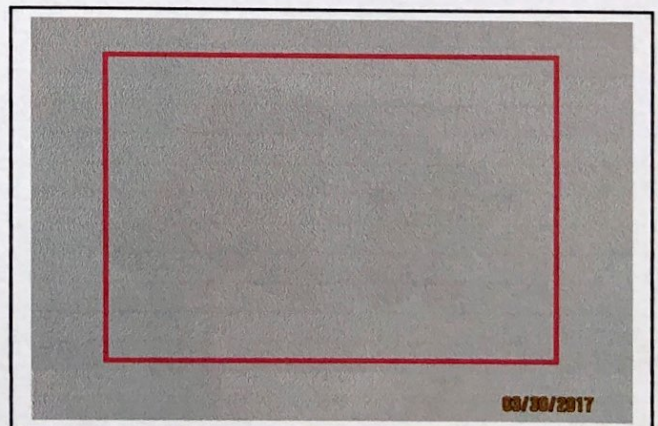
- Readily visible stains were viewed on the ceilings located in *but not limited to:* the garage. All discolored areas need to have the stain source located, investigated, and properly sealed if necessary.

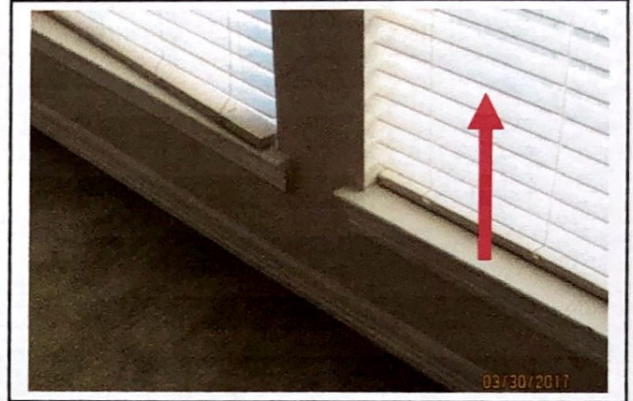
- In dwelling units, where the opening of an operable 2nd floor window is located more than 72 inches above the finished outside grade or surface below, the lowest part of the clear opening of the window shall be a minimum of 24 inches above the finished floor of the room in which the window is located. (R-612.2 Window sills.) This violation was found in *but not limited to*: upstairs bedrooms.

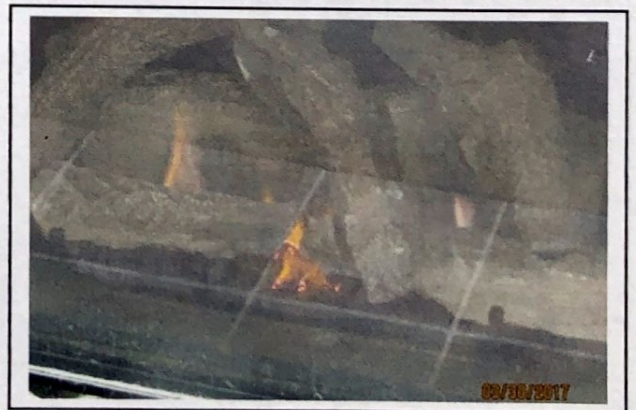
- The remote control box was not operational during the inspection.

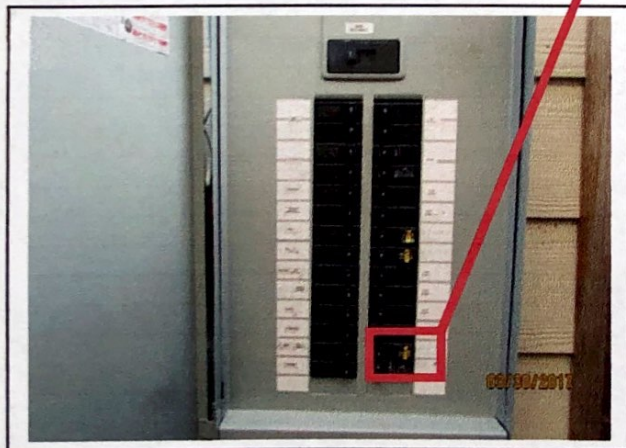
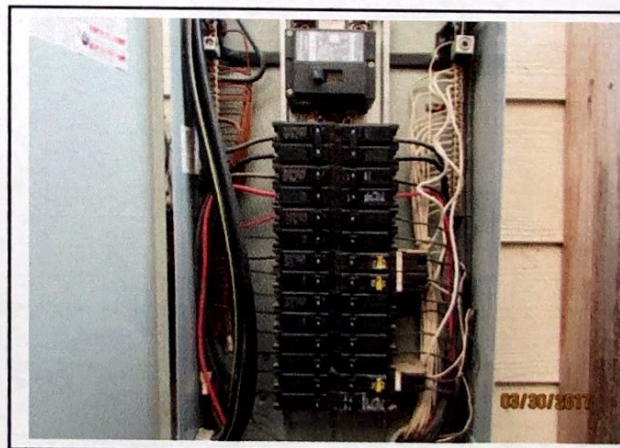
- AS OF SEPTEMBER 1, 2015 the Texas Real Estate Commission has determined that the lack of a properly-bonded gas system in a house is a hazardous deficiency. The gas meter piping system was not viewed as being properly bonded/grounded to today's current requirements. (See TREC FORM OP-1 or the bottom of page two of this report)
- Improper ground clamps were used on the ground wire connection points to the ground rods. This type clamp is only designed for pipe applications – not ground rods. An "acorn" type exterior clamp should be installed on the ground rod. (Ref: NEC 110.3(B))
- The AFCI device in the lower panel does not "trip" at the test button or plugs and lights in the bedroom. This device is not operational or improperly wired. Replacement is needed.

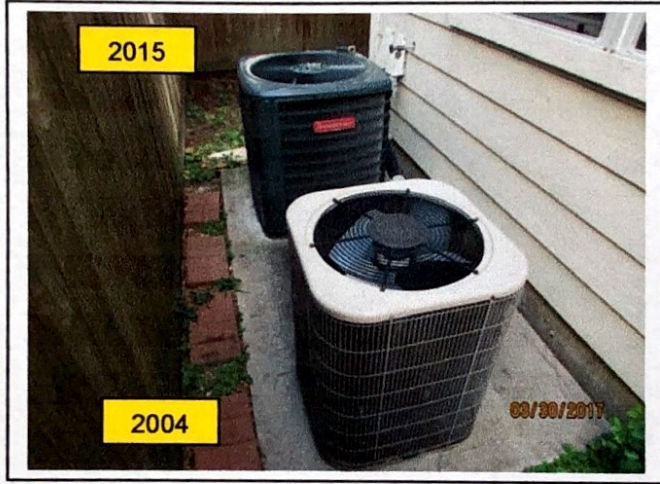
Upper Zone - 7 degrees. Deficient

- The temperature drop measured across the evaporator coil of the *upper-zoned* air conditioning system is lower than considered typical. The allowable operating range is between 15 to 22 degrees. This condition usually indicates that servicing is needed. A qualified heating and cooling technician should be consulted to further evaluate this condition and the remedies available for correction.

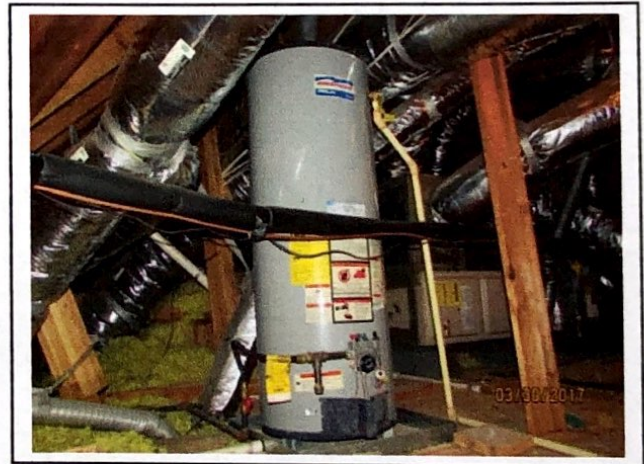
- The temperature/pressure relief valve (T&P valve) was found to be seized up and not operational. Valve replacement should be performed.
