REDSTAR RESIDENTIAL INSPECTION

13819 Duran Falls Ct
Houston TX 77044

PROPERTY INSPECTION REPORT

Concerning: 13819 Duran Falls Ct, Houston TX 77044

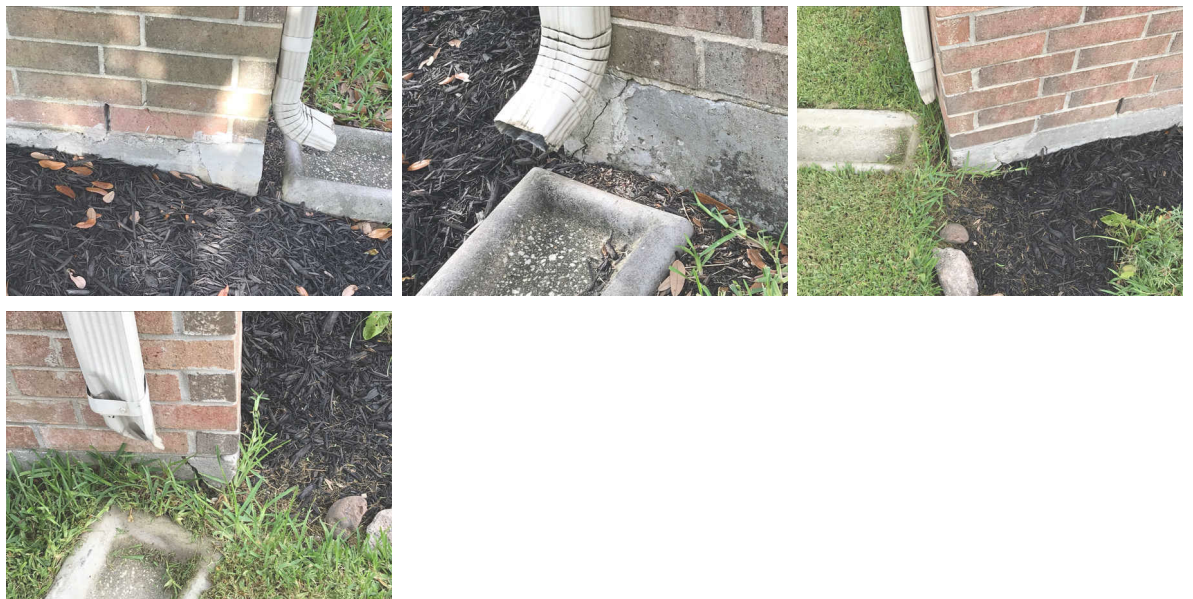
1: Slab: Corner Pops

Right front, left front

Cracks were noted at the corners of the foundation walls. Referred to as a "corner pop", these are very common and not a structural issue at this time. They should however be properly sealed to prevent further deterioration.

Recommendation: Contact a qualified concrete contractor.

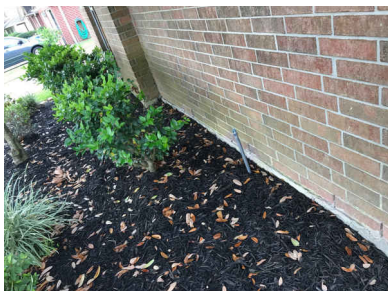
1: Landscaping: High Soil

High soil conditions observed at the various locations around the structure. The soil level should be reduced to allow for a minimum of 2-4" of foundation exposure, while still providing positive drainage away from the home. Recommend correction.

Recommendation: Contact a qualified landscaping contractor

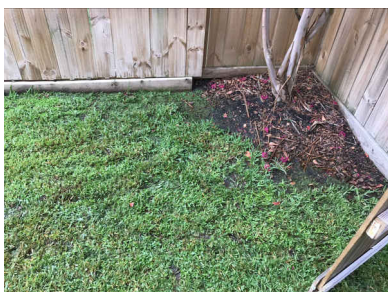
2: Grading and Drainage: Low spots/Standing water

Locations were observed around the property that were low or improperly sloped and likely holding water. Low spots in the grade should be properly repaired to ensure proper drainage and avoid a potential hazard.

Recommendation: Contact a qualified landscaping contractor

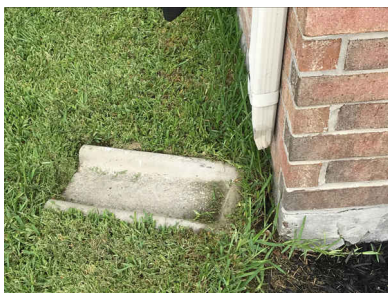
3: Gutters: Minor damage/wear

Minor damage from typical wear and tear was observed on the gutter system at some locations. This damage does not appear to be affecting the performance of the gutter, but I recommend correction to prevent further deterioration.

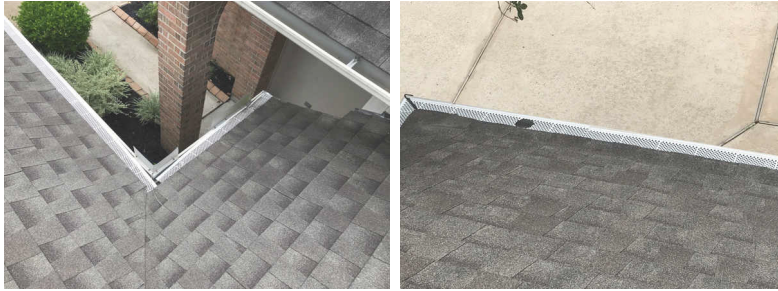
4: Leaf guard

There are gaps in the leaf guard on the gutters. I recommend repairs.

Recommendation: Contact a qualified professional.

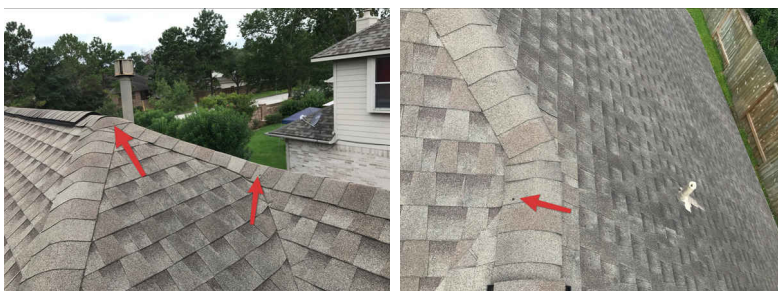
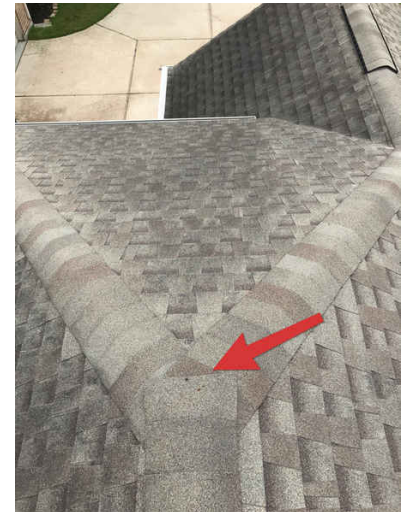
1: Exposed Nails

Several locations where the nail heads are exposed and need sealed. These locations include around vent jacks, flashings, and hip and ridge caps. Recommend correction as needed to prevent moisture penetration over time.

Recommendation: Contact a qualified roofing professional.

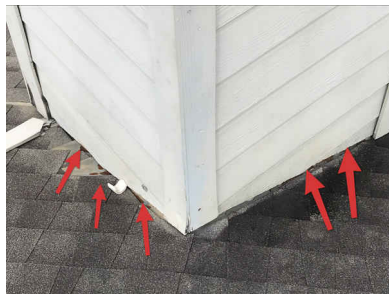
2: Rusted Flashings

Sections of the exposed flashing and/or other areas were observed to be displaying rust. This condition can result in failure of the covering/flashing and I recommend further evaluation and correction as needed to prevent further deterioration or potential moisture penetration.

Recommendation: Contact a qualified roofing professional.

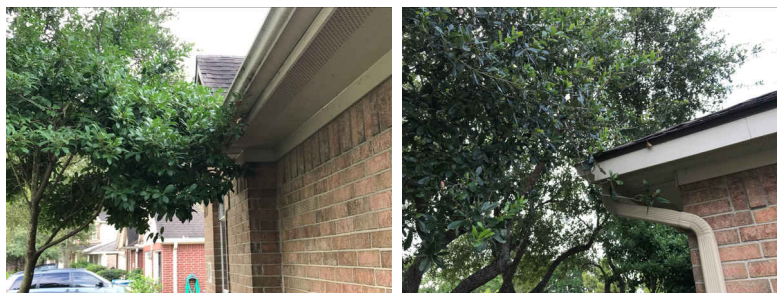
3: Trees/Foliage in contact

Trees or heavy foliage were observed to be in contact with the roof covering at the time of inspection. These conditions can result in damage to the covering, and I recommend all areas be trimmed back and the roof covering evaluated for damage. Recommend further evaluation by a qualified contractor.

Recommendation: Contact a qualified professional.

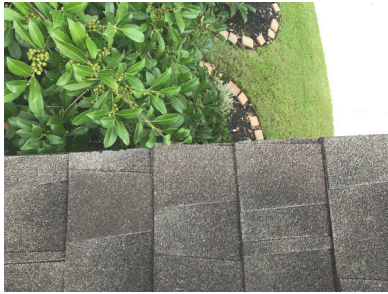
4: Shingles: Damaged/Missing

Damaged/missing shingles were observed on the roof covering. These conditions can compromise the

integrity of the roof covering, and I recommend further evaluation by qualified contractor to determine the extent of needed repairs.

Recommendation: Contact a qualified roofing professional.

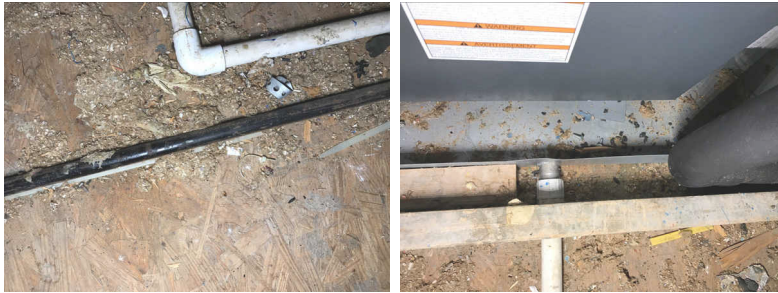
1: Note: Rodent Activity

There was evidence of possible rodent activity in the attic. While this is not uncommon, a qualified

pest control company should be contacted if remediation or exclusion is desired.

Recommendation: Contact a qualified professional.

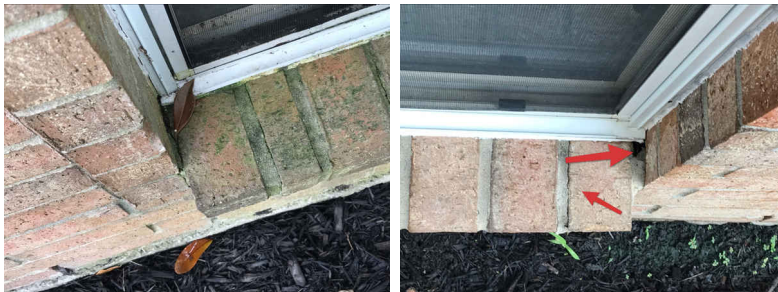
1: Masonry: Minor cracks/Maintenance Recommended

Minor cracks were observed in the masonry walls and/or mortar lines around the home. These conditions appear related to typical or normal settlement. Recommend you consider correction to avoid further deterioration and for cosmetic reasons.

Recommendation: Contact a qualified masonry professional.

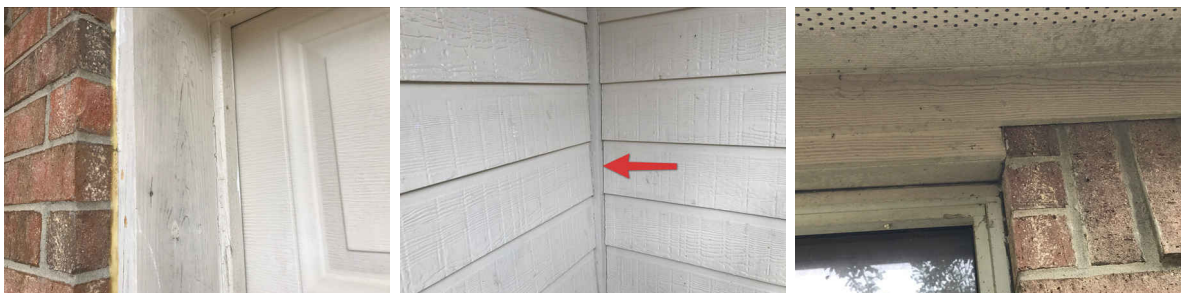
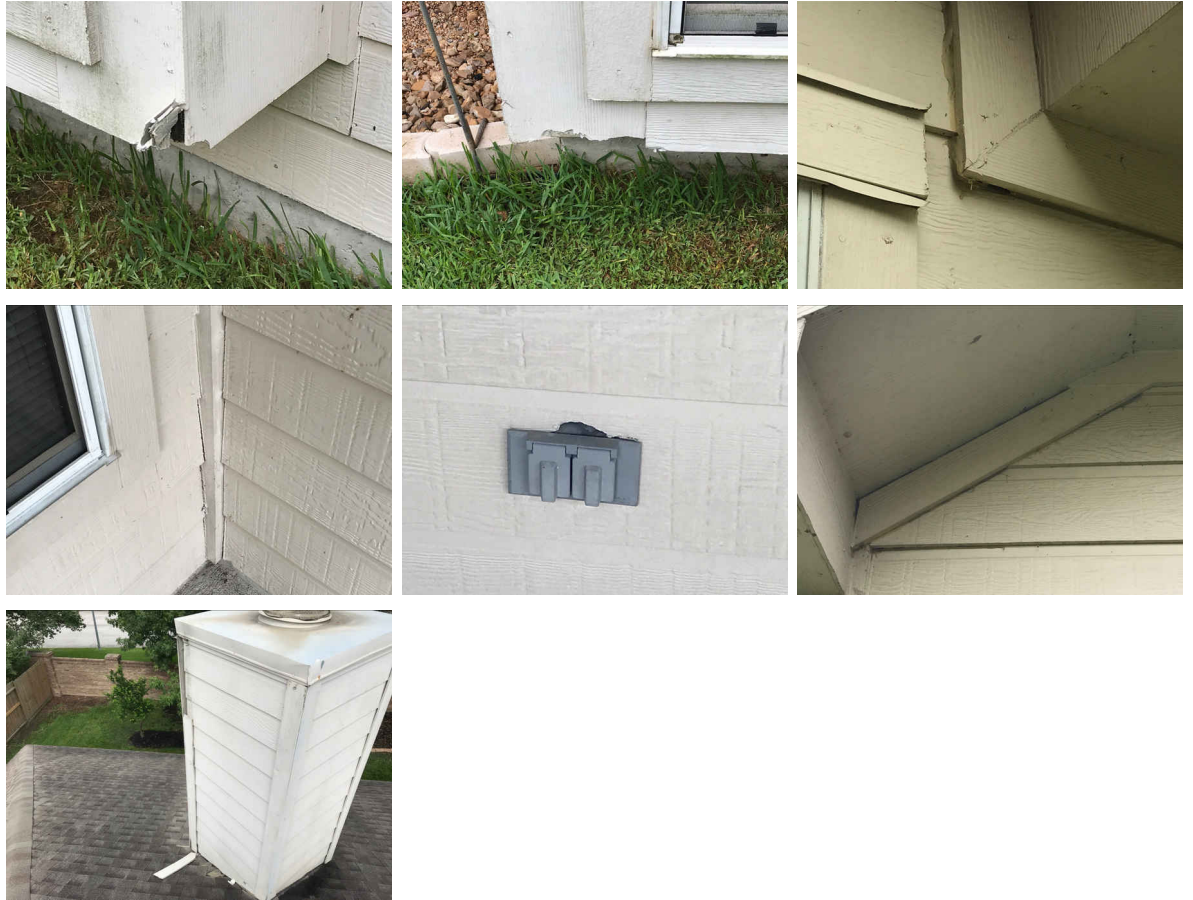
2: Siding: Minor Damage/Maintenance Recommended

The siding displayed sections with minor damage or maintenance issues. Common maintenance items include: minor damage, separation at joints and trim, finishes that are worn, etc. While these conditions do not appear to be contributing to any larger issues, I recommend you consider correction to avoid further deterioration and as part of normal maintenance.

Recommendation: Contact a qualified handyman.

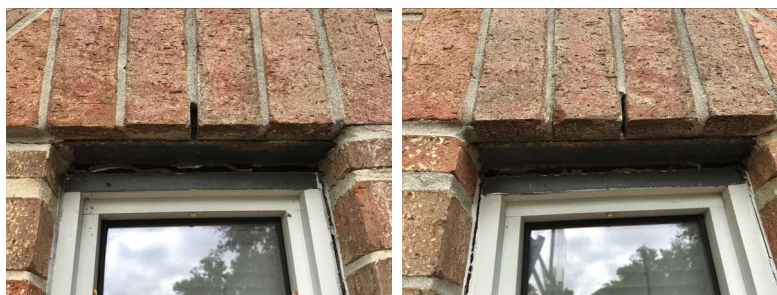
3: Masonry: Lintels Rusted/Maintenance needed

Steel lintels above the windows and doors were observed to be unpainted or the paint finish displayed rusting/corrosion.. Recommend properly painting/sealing to prevent deterioration.

Recommendation: Contact a qualified painting contractor.

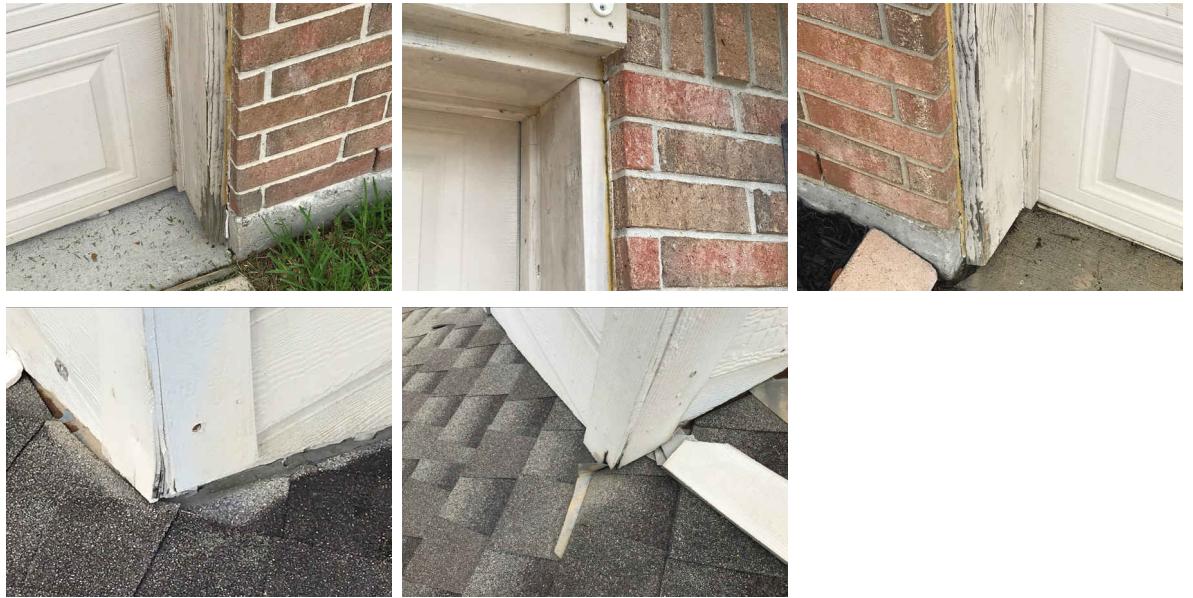
4: Siding: Wood Rot/Moisture Issues

Moisture penetration was observed to the wooden trim, fascia boards and siding at multiple locations around the home. Repair as needed to prevent further deterioration.

Recommendation: Contact a qualified professional.

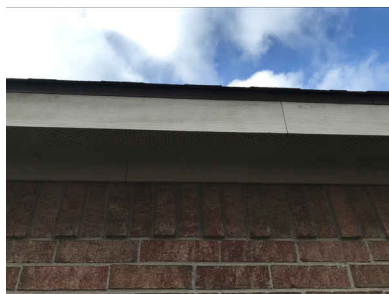
5: Siding: Caulking Missing at Buttress Joints

The inspector observed caulking deteriorated or missing at the joints where the siding butt up against each other. Recommend to caulk all joints to prevent moisture damage.

Recommendation: Contact a handyman or DIY project

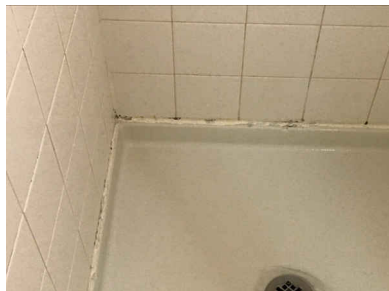
6: Shower enclosure

There are some gaps in the caulking in the master shower. I recommend repairs.

Recommendation: Contact a qualified professional.

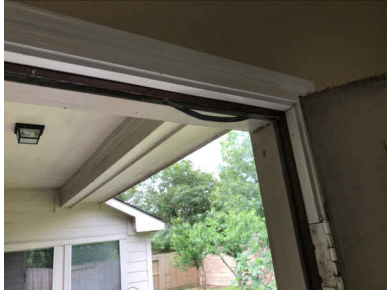
1: Exterior Door: Gaps in Weather Seals

Gaps were observed in the weather seal around the exterior doors. Repair as needed to prevent moisture, pest, and air intrusion.

Recommendation: Contact a qualified professional.

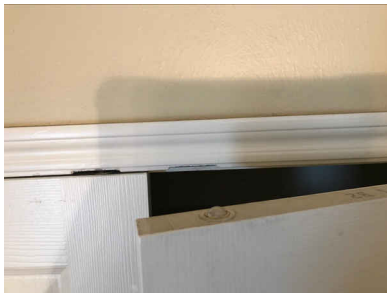
2: Interior Door Hardware: Ball Catch Does not Engage

Right side front bedroom

The ball hardware for the door does not engage on strike plate. Adjustment to the ball catch is recommended to allow it to close.

Recommendation: Contact a qualified professional.

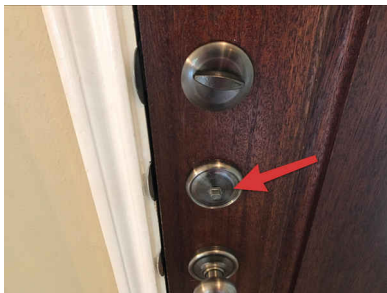
3: Deadbolt lock

One of the locks at the front door is missing the thumb turn. I recommend repairs.

Recommendation: Contact a qualified professional.

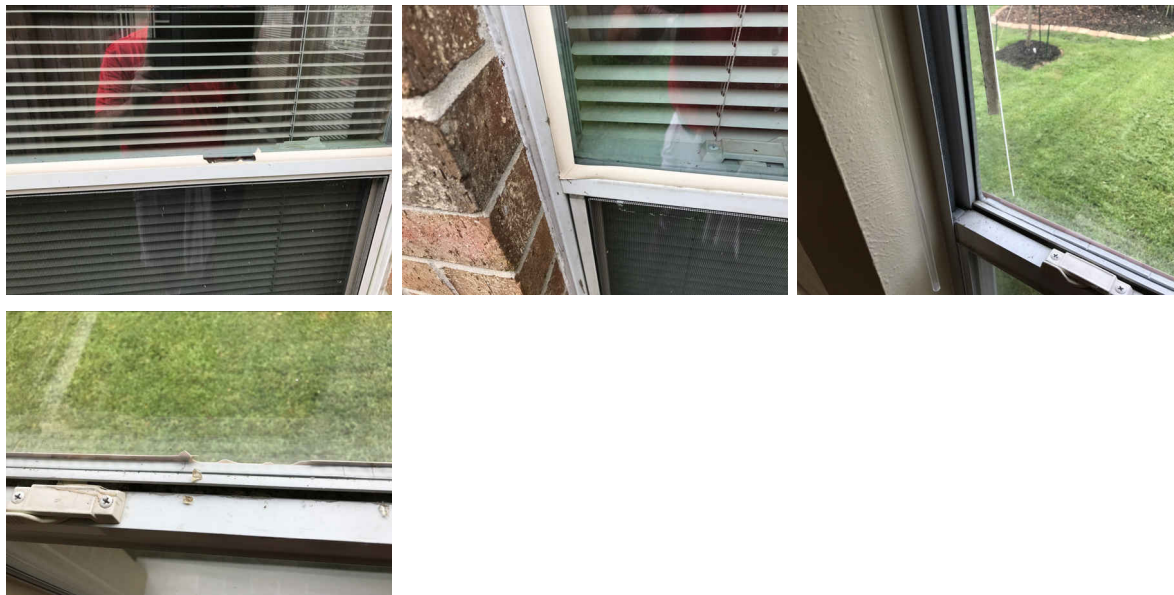
1: Glazings: Damaged

Master bedroom, breakfast area

The glazings at the exterior of the window panes at multiple locations around the home show damage or displacement. Recommend correction as needed to prevent further deterioration or moisture penetration.

Recommendation: Contact a qualified professional.

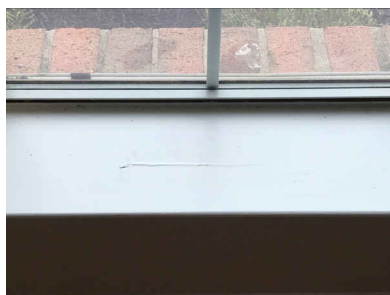
2: Condensation Damage

Office

Some minor moisture damage observed at the jambs and sills around the interior of windows at various locations. This is likely as a result of the aluminum window frame condensing. Recommend monitoring and repairing as needed.

Recommendation: Contact a qualified professional.

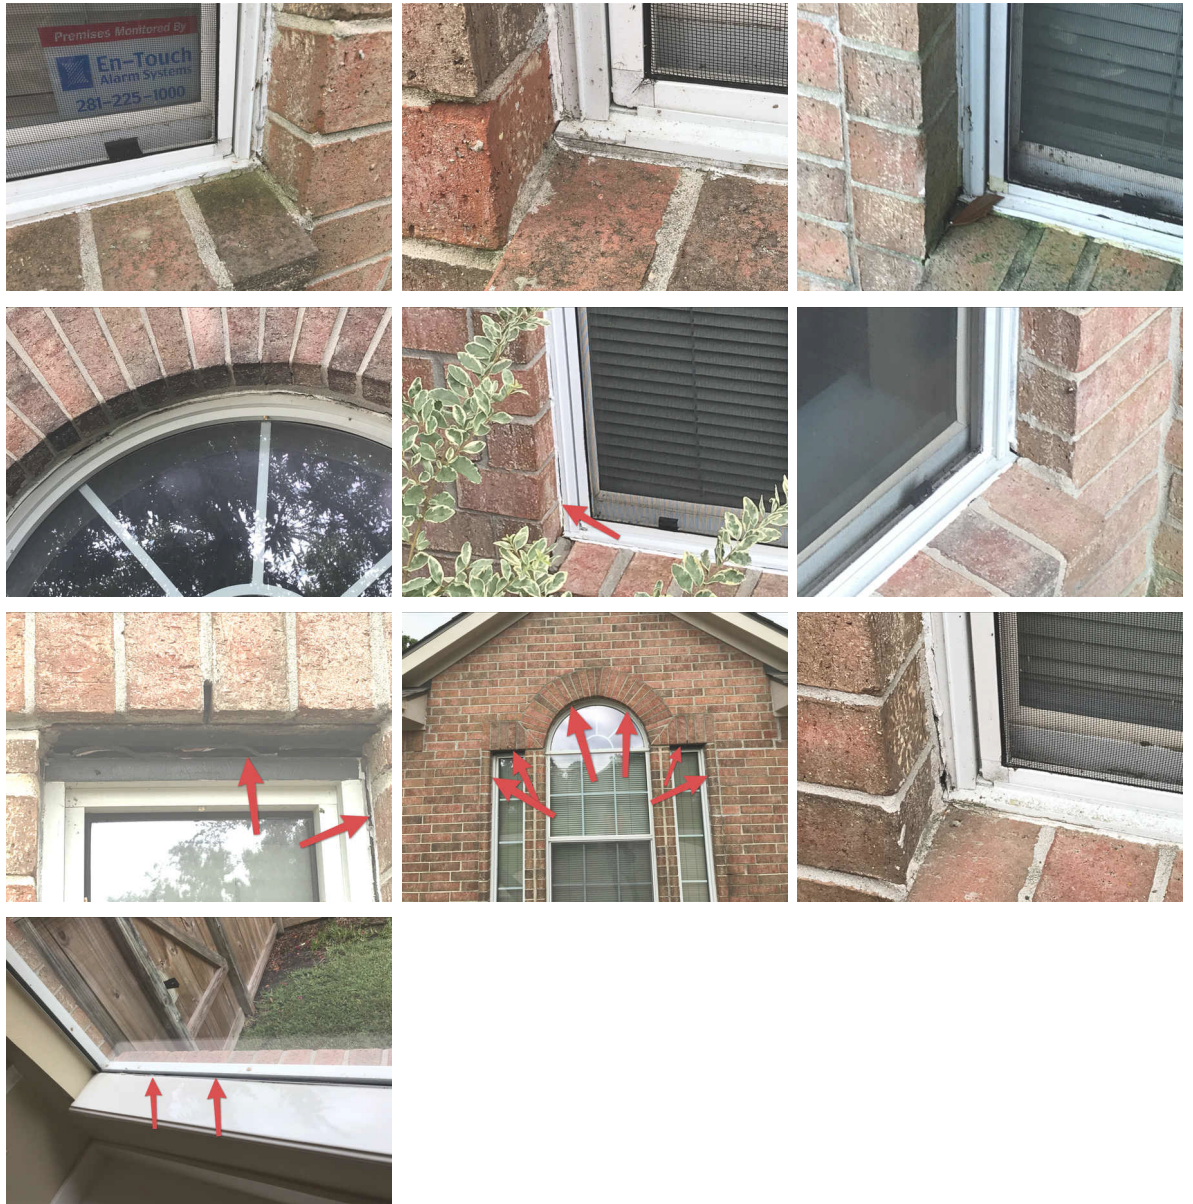
3: Missing/Deteriorated Caulking Exterior/Interior Frames

Caulking is missing/deteriorated on the exterior frame. Remedy as needed.

Recommendation: Contact a qualified professional.

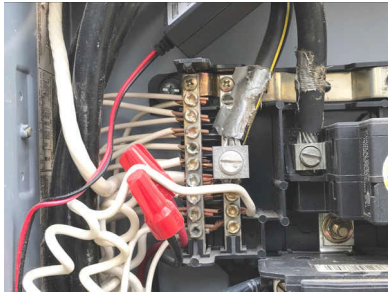
1: Double Lugged Neutral Wires

Double lugged neutral wires were on the neutral bus bar inside the distribution panel. One neutral wire per lug is recommended. Remedy as needed.

Recommendation: Contact a qualified electrical contractor.

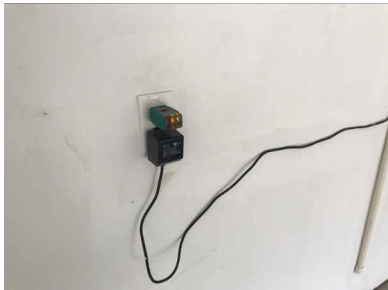
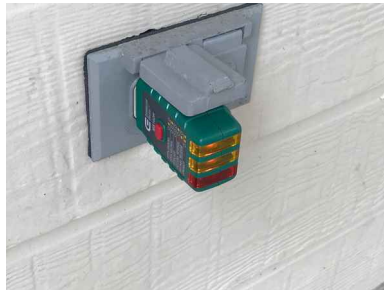
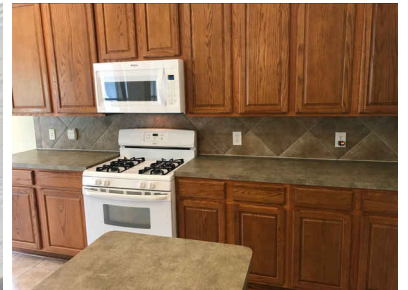
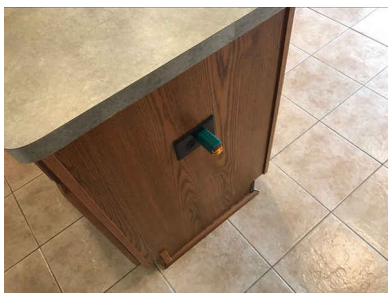
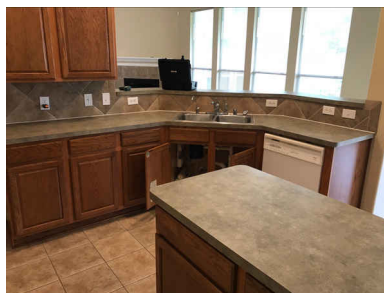
1: Outlets: GFCI Protection Inadequate/Missing

Garage, Exterior, All Kitchen Countertop -

Recommendation: Contact a qualified professional.

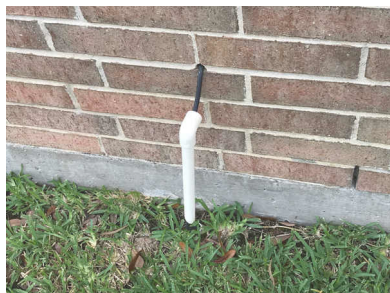
2: Damaged conduit

Right side

The sprinkler control wires are in PVC conduit which has been damaged by lawn equipment. I recommend repairs.

Recommendation: Contact a qualified professional.

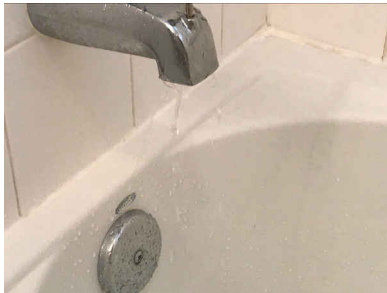
1: Fixture: Diverter not Functioning Properly

The tub diverter is not operating properly. Recommend further evaluation by a plumbing contractor.

Recommendation: Contact a qualified plumbing contractor.

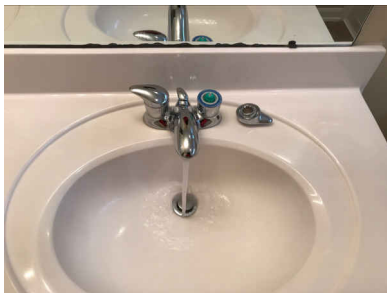
2: Fixture Handle: Loose

Hall bathroom

Observed fixture not secured to sink. Remedy as needed.

Recommendation: Contact a handyman or DIY project

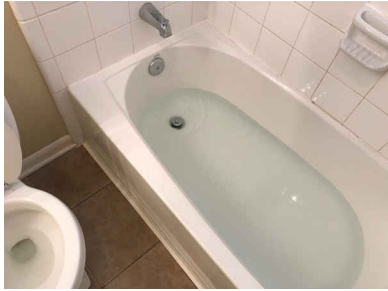
1: Drain Piping: Poor/Slow Drainage

Hall bathroom

Poor/slow drainage was observed at time of inspection. Recommend a qualified plumber evaluate and repair.

Recommendation: Contact a qualified plumbing contractor.

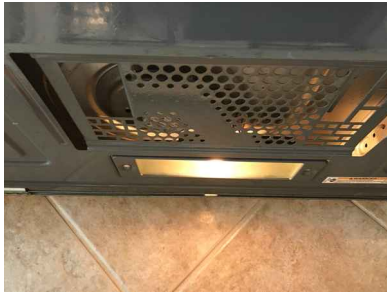
It does not vent to the exterior but filters the air and vents back into kitchen. The filter is missing. I recommend replacement.

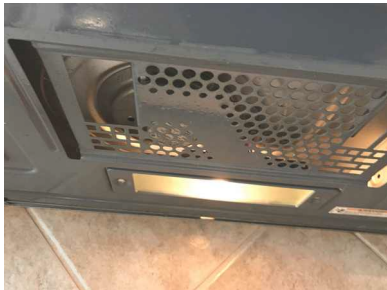
1: Missing Filter

Exhaust filter is missing. Remedy as needed.

Recommendation: Contact a qualified professional.

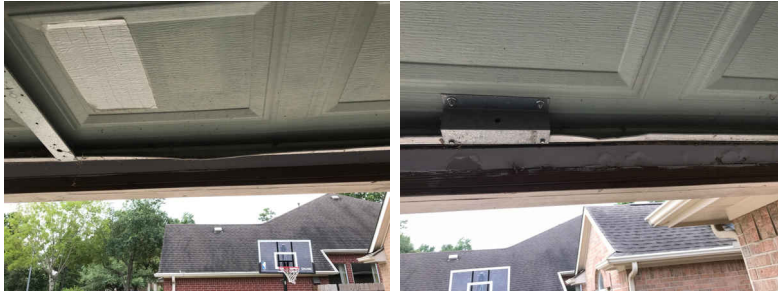
1: Garage Door: Damage

The garage door panels show damage. Recommend further evaluation to determine extent of necessary repairs.

Recommendation: Contact a qualified professional.

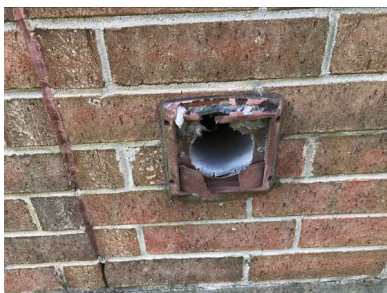
1: Damaged Cover

Exterior dryer vent cover was damaged. Remedy as needed.

Recommendation: Contact a qualified professional.
