PROPERTY INSPECTION REPORT

Concerning: 2122 Avenue K, Galveston, TX 77550
(Address or Other Identification of Inspected Property)

By: Danny Marlow Lic.#: 23187 01/05/2021
(Name and License Number of Inspector) (Date)

Home Inspection Report

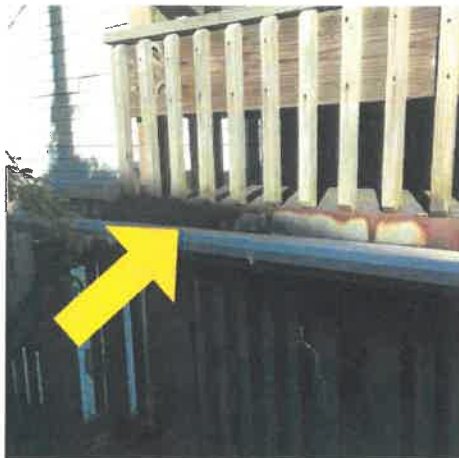
- Asphalt shingles.
- Inspected from ground level with binoculars and from ladder at eaves.
- Drip edge flashing was showing heavy rusting at garage/apartment.

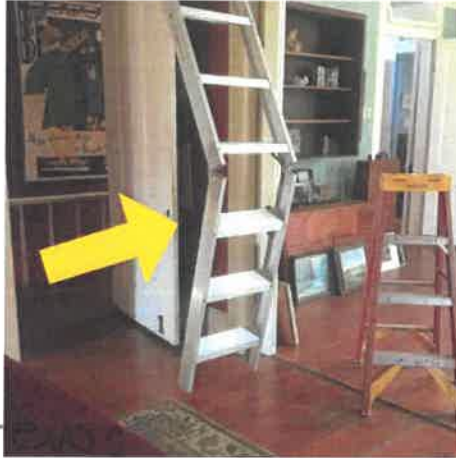
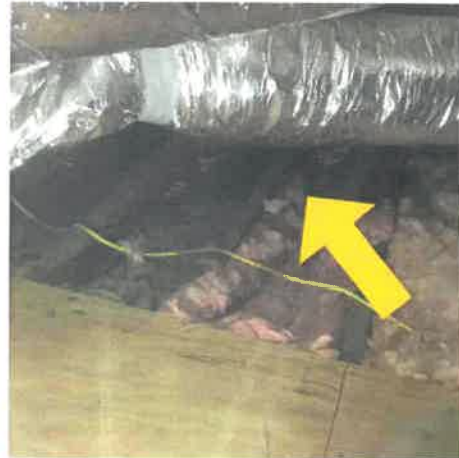
- Attic was entered for inspection (insulation was approximately 8-10 inches thick at time of inspection (batt insulation)).
- Insulation is low and missing in some areas of the attic. Recommend adding more insulation to reduce energy costs and provide added comfort.
- Attic pull down ladder was noted as not being correct length to reach the floor. Recommend having proper length pull down ladder installed for safety.

This ladder
has two
2x4 extension
pieces with
wing nut + scr
connections.
~~stop~~

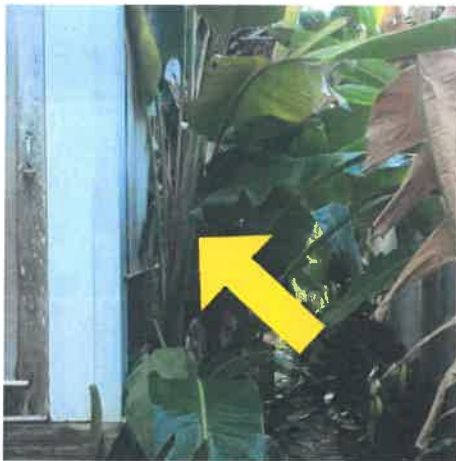
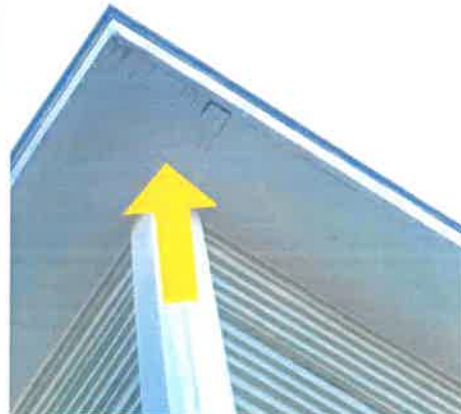
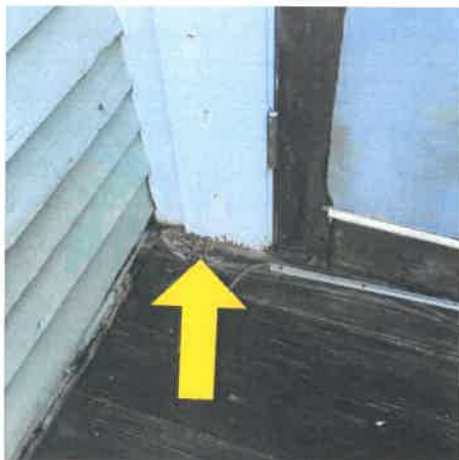
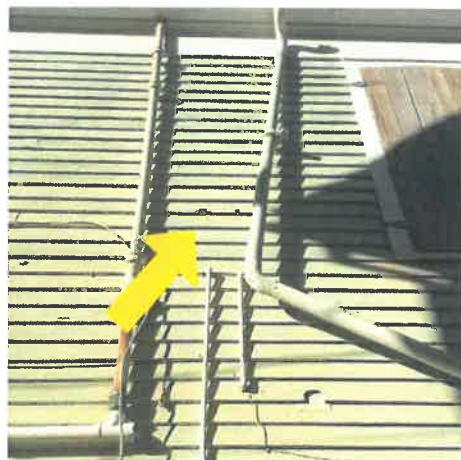
- Wood and asbestos siding with wood trim (exterior). Drywall with wood trim trim (interior).
- There were multiple areas where siding was showing wood rot and various other damages. Recommend having qualified contractor evaluate the extent of damages and repair as needed for to prevent further deterioration and damages.

- There was wood rot noted at miscellaneous trim and soffit areas. Recommend having qualified contractor evaluate the extent of damages and repair as needed to prevent further deterioration and damages.

- There was sheetrock damage noted at wall in garage apartment.
- There were minor stress cracks noted at various windows (typically associated with settlement).

- Trim/maintain/ trees in close proximity to structure to reduce moisture related damages and premature wear of finishing materials
- There was sheetrock damage noted under multiple windows (possibly due to older windows/no weatherstripping).

These plants almost have all died so have been removed.

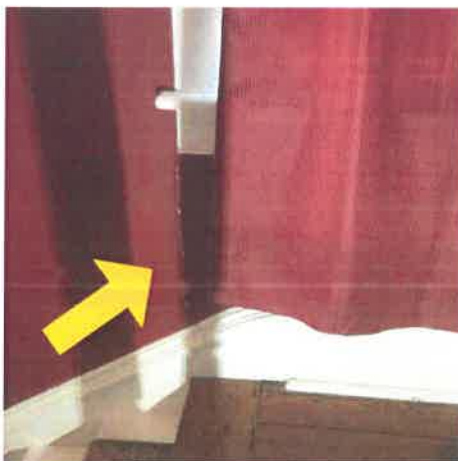
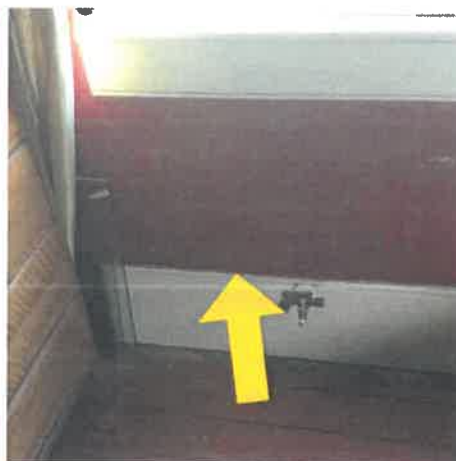
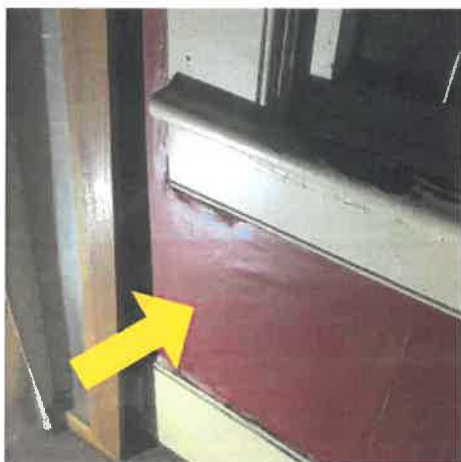
old water damage
that has been
fixed on the
outside, just
not on the
inside

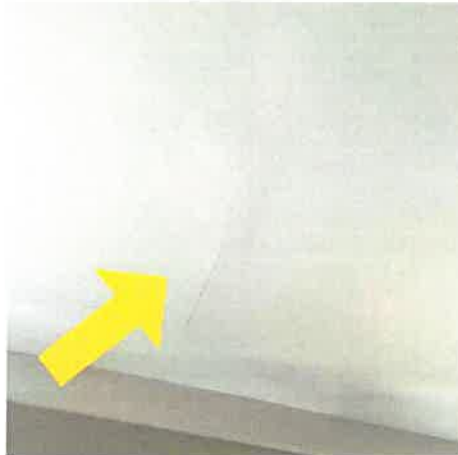
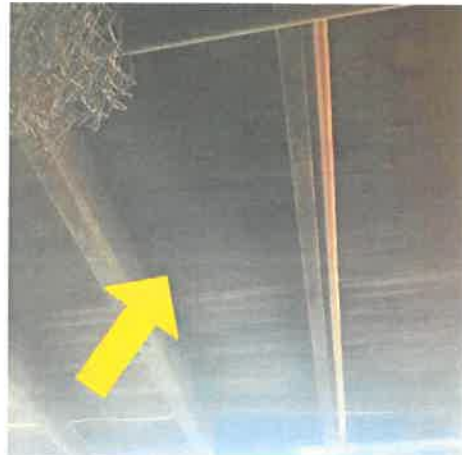
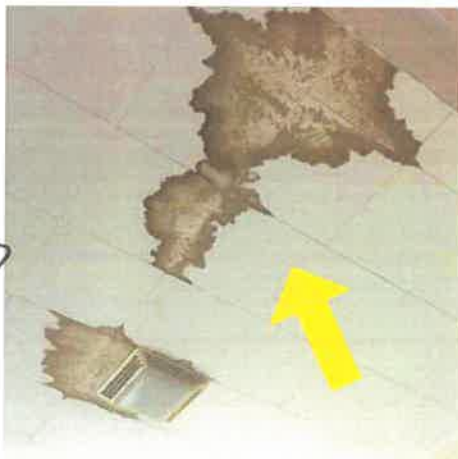
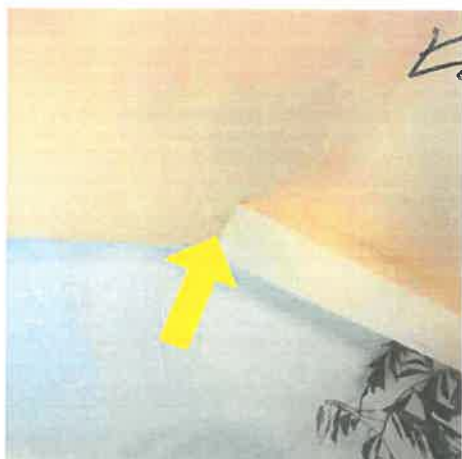
- There were multiple areas where ceilings had signs of previous staining/water damage. No moisture was detected at time of inspection with moisture meter.
- Garage ceiling does not provide adequate fire separation between the garage and the attic. A minimum of 1/2 inch gypsum board/5/8 inch type X gypsum board is recommended to be installed on the garage ceiling between the garage and the attic/all habitable rooms above the garage.

This is old water damage from a leak in the roof. The roof above was fixed after Hurricane Harvey w/ new flashing above in needed area and any water damage in that ~~expose~~ area was removed + repaired. This ceiling ~~was~~ has not been repaired.

aug 2017

Hurricane Harvey - ~~the above~~ the flashing was fixed on the above roof.

← this water damage was caused by rain from

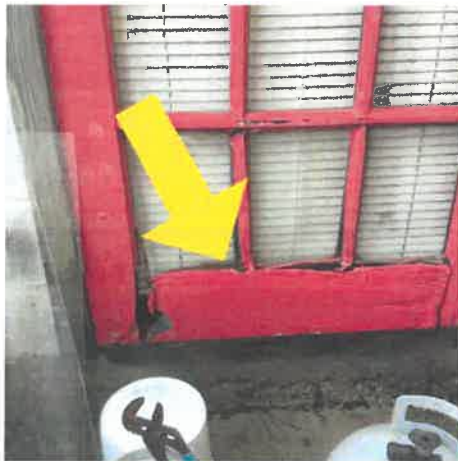
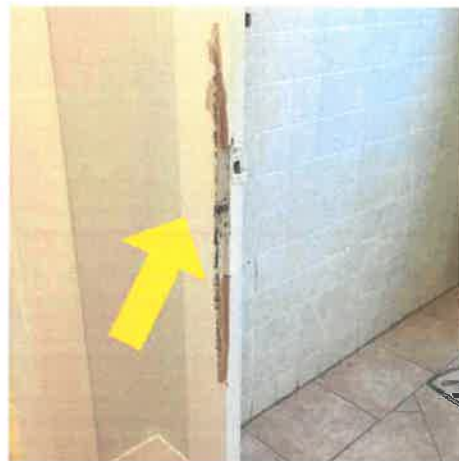
- Most doors were noted as being older type wood panel and in various states of repair.
- Side exterior door to garage was noted as being heavily damaged/wood rot. Recommend replacement to prevent further deterioration and damages.
- Front door to garage apartment was noted to be dragging on the floor when opened. Recommend adjustments for proper operation.
- There was door frame damage noted at bathroom door in garage apartment.
- Glass was noted as being broken in two side doors at main house. Recommend having qualified contractor repair as needed.
- French doors at dining area were showing wood rot/damage. Recommend repairs for proper operation and sealing.

this has been replaced

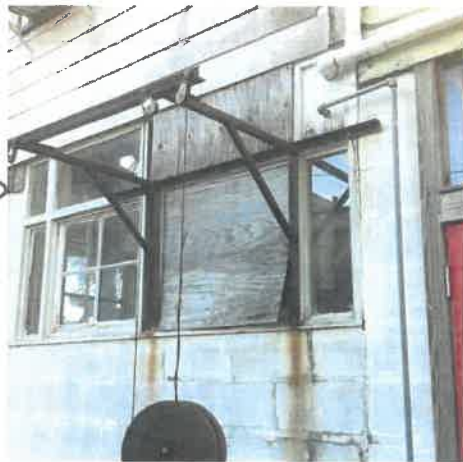
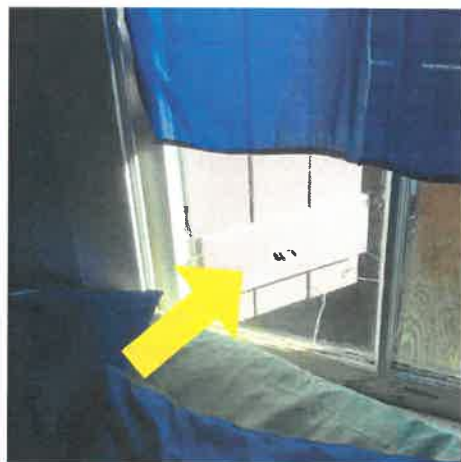
- Windows are old and in various states of repair (missing weatherstripping, not opening, missing hardware). Budget for replacement in the near future.
- There were windows at garage that were noted as being broken out and boarded up.
- There was a broken window noted in upstairs back bedroom.

This metal structure will be removed as it is used for our ceramic kiln.

The plywood can be removed. There is glass windows in place behind.

It was covered up because to ~~be~~ protect the glass from the heat of the kiln. which will also be removed with sale of house.

this is replaced.

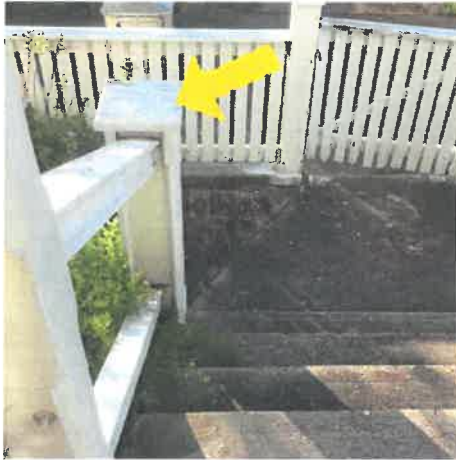
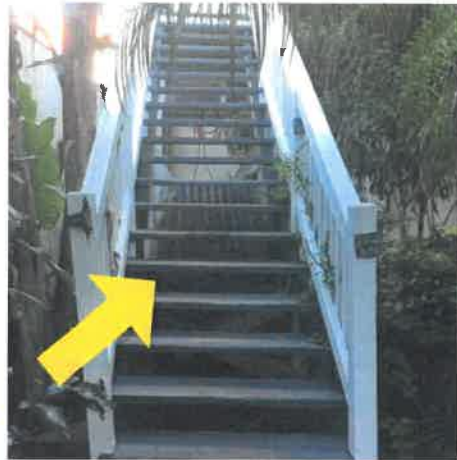
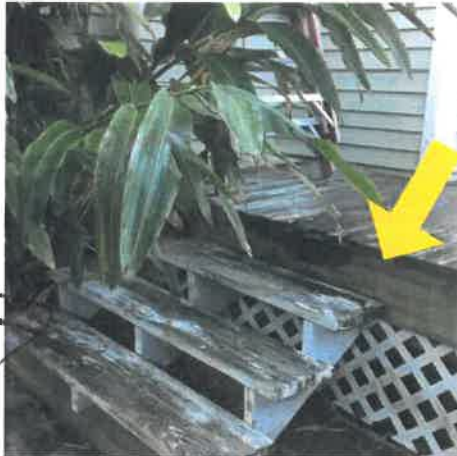
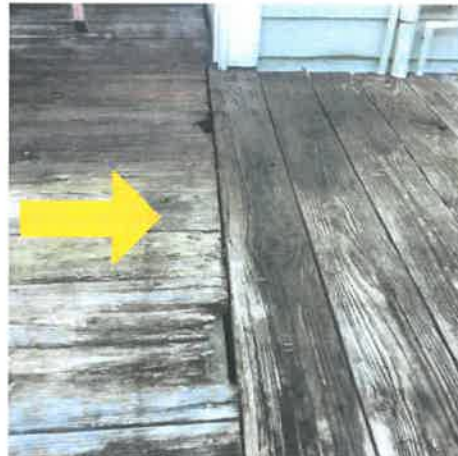
- Stairways were noted to be missing the required graspable type handrails. Recommend installing graspable type handrails for safety.
- Handrails should be at least 1 1/2 inches out from the wall so that you can get your hand around it, and the part that you grab should be roughly 1 1/2 inches across the top surface.
- Stairways to garage apartment was noted to be leaning/not level. Recommend having qualified contractor evaluate condition and repair as needed for safety.

Stairs
have been
fixed.

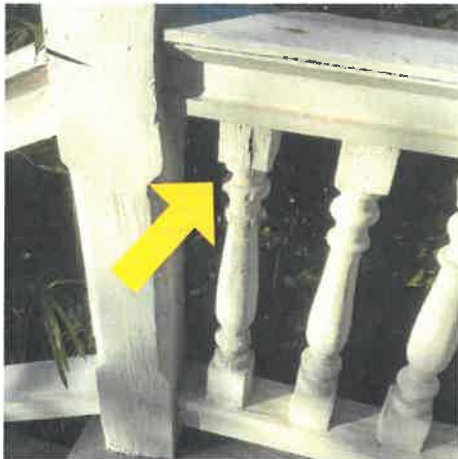
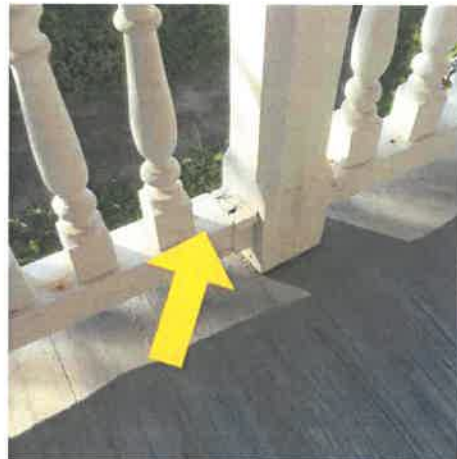
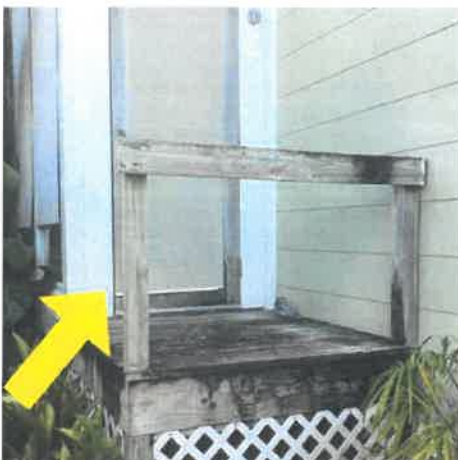
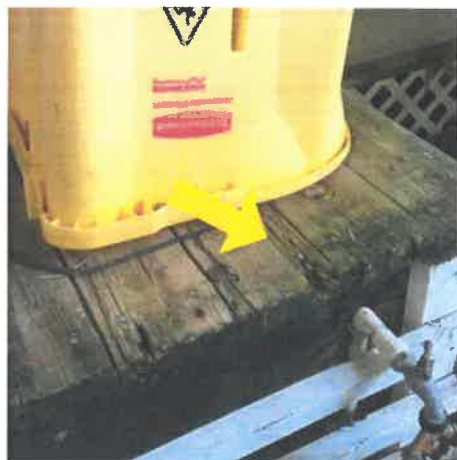
- Decks were showing moderate wear and deterioration. There were miscellaneous areas where deck handrails and deck boards were showing wood rot/damage. Recommend having qualified contractor evaluate the extent of damages and repair as needed for safety.
- End guardrails at upper balcony at front of home were loose not secured properly. Recommend immediate repairs for safety.
- Guardrail height at front upper balcony was measured at 32". Minimum height for guardrails should be 36". This is a safety hazard and should be corrected for safety.
- Side deck was noted as not having guardrails. Recommend installing guardrails for safety.

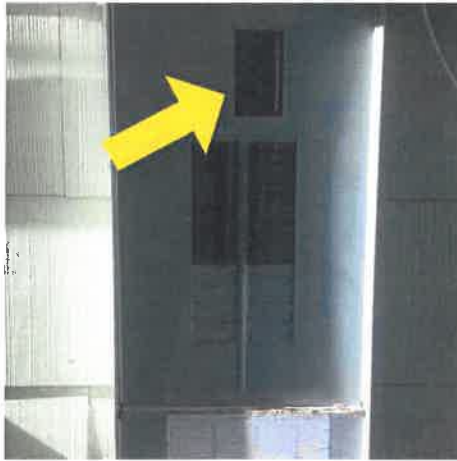
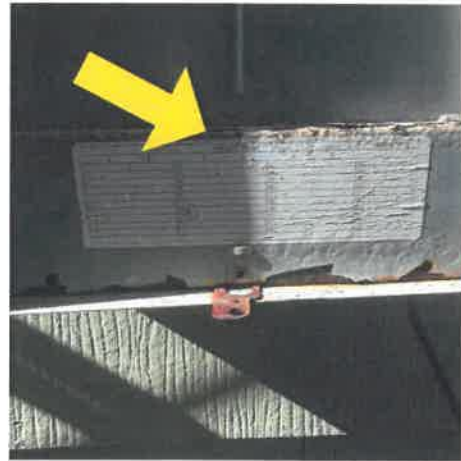
- 120/240 volt, 200 amp service.
- Grounding is through grounding rod to earth.
- Main disconnect is located in service panel on right exterior of home.
- Breaker panel not properly labeled. Recommend having permanent labeling to promote breaker identification

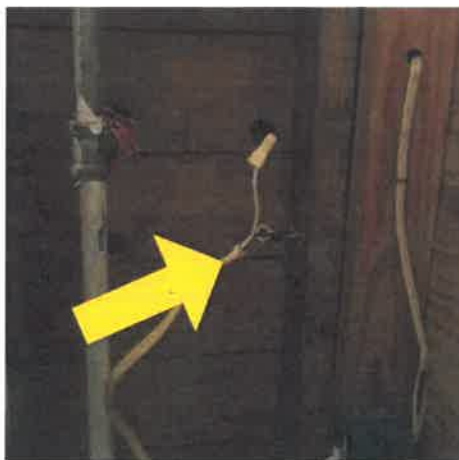
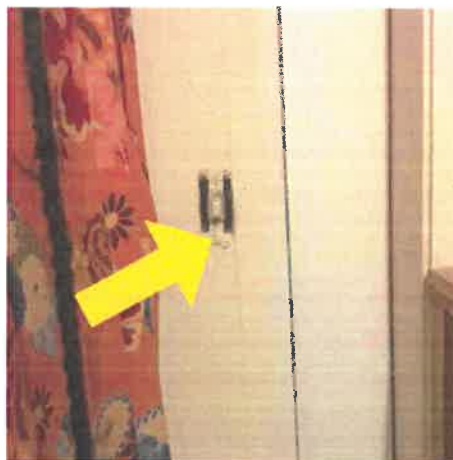
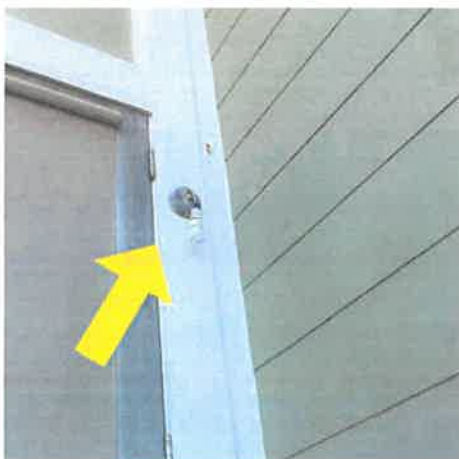
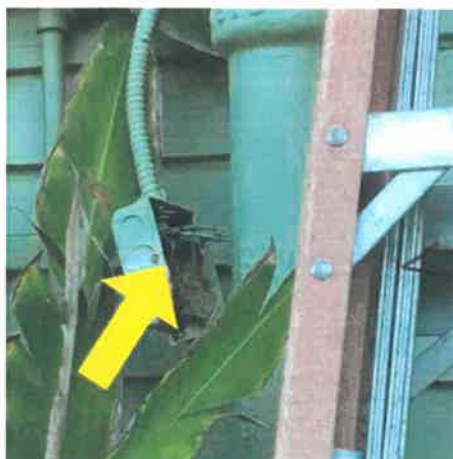
- All wiring appears to be copper and in good condition.
- Further evaluation is required to determine the presence and full extent of concealed knob and tube wiring throughout house and the associated cost of removal. Knob and tube removal may be required by your insurance company.

- Smoke detectors were operating as designed but were not found in all required areas. Smoke detectors are required in all sleeping rooms in areas just outside of sleeping rooms and in living area of each floor. Recommend installing smoke detectors in all required areas for safety.

- There were miscellaneous open wire splices noted. Wire splices should be made in a closed junction boxes. Recommend having licensed electrician evaluate and repair as needed for safety.

The house was completely rewired in 2008 (Fall of) after Hurricane Ike.

this has been removed.

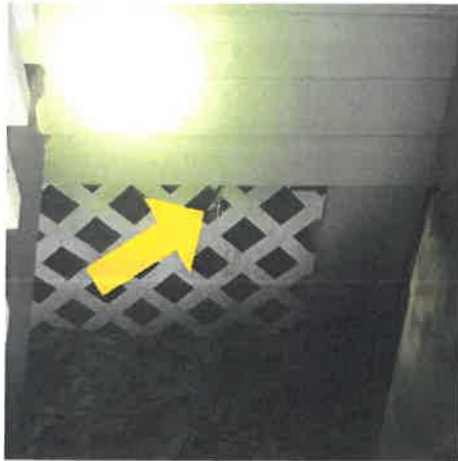
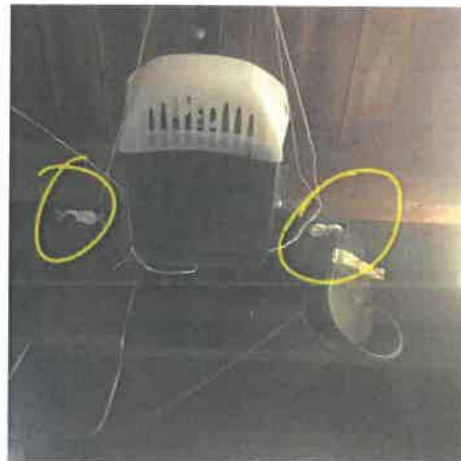
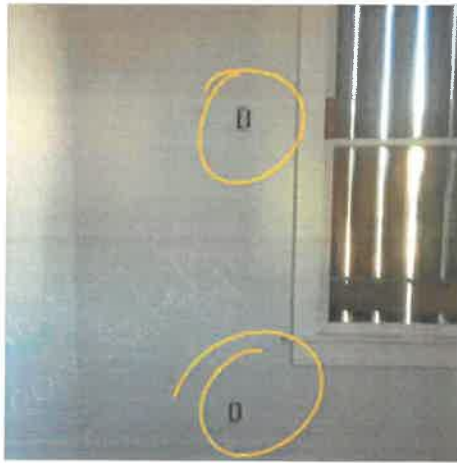
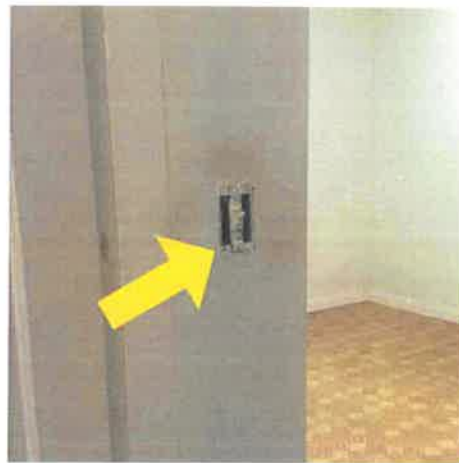
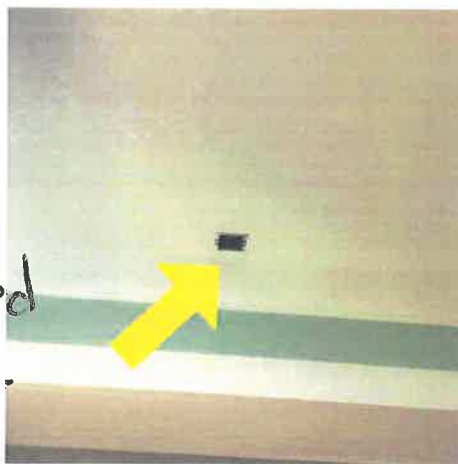
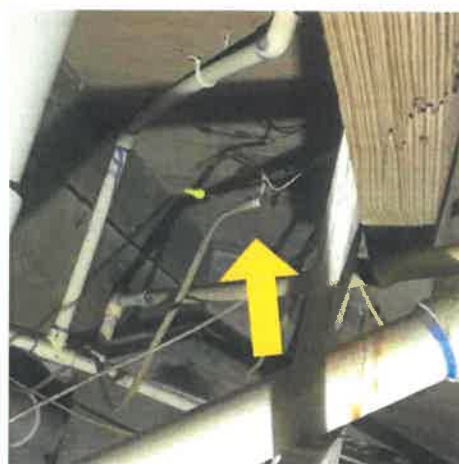
- There were multiple missing cover plates at receptacles and light switches. Recommend replacing missing cover plates for receptacles and light switches for safety.

This is not connected to anything. It was

never covered after Hurricane Ike's (2008) repairs.

All light switch plates have been added where needed.

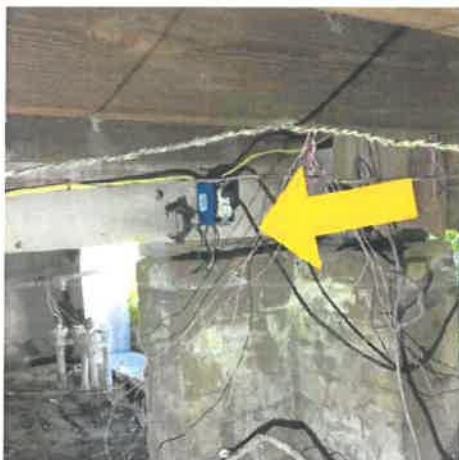
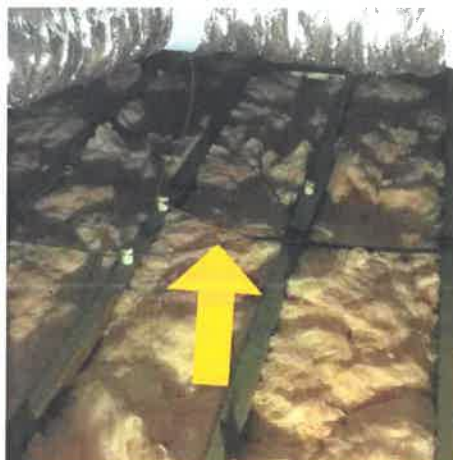
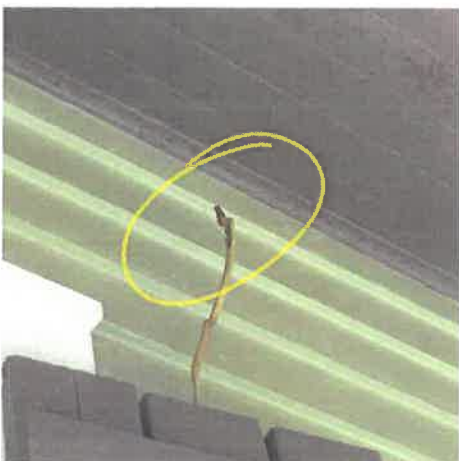
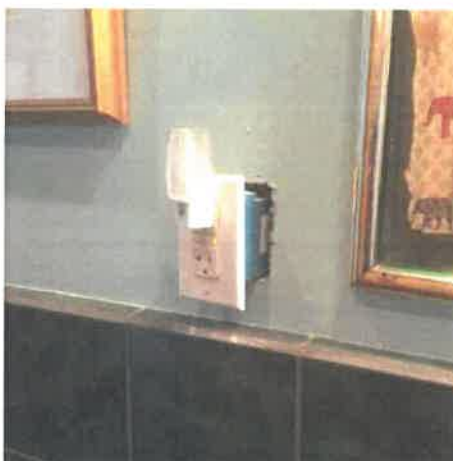
- Receptacle in upstairs bathroom was noted as being loose in the wall. Recommend securing properly for proper operation and safety.
- Multiple receptacles are not GFCI protected in required areas. Receptacles in wet areas, outside and in garage are required to be GFCI protected to reduce the risk of electrical shock(kitchens and garage).

This wife has been removed

This has been fixed

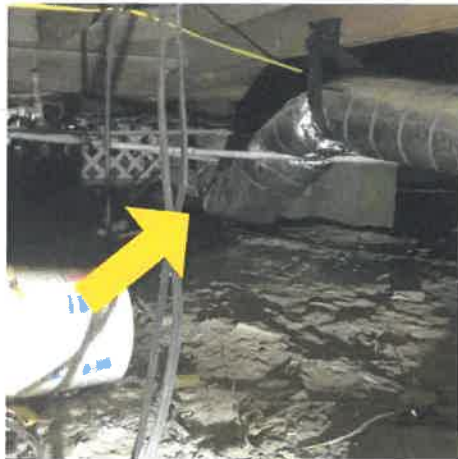
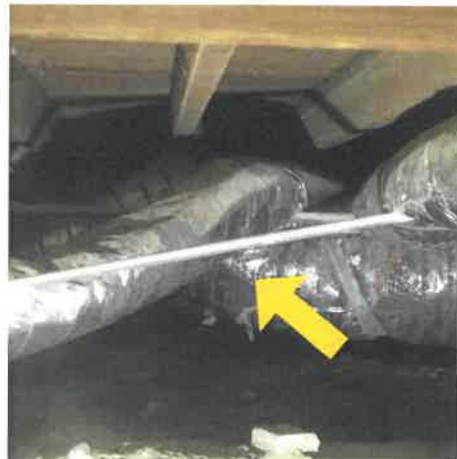
- There was miscellaneous duct work noted as not being hung properly under home. Recommend having licensed HVAC technician evaluate and repair as needed for proper air flow to registers.

This has all been lifted off the ground and secured properly.

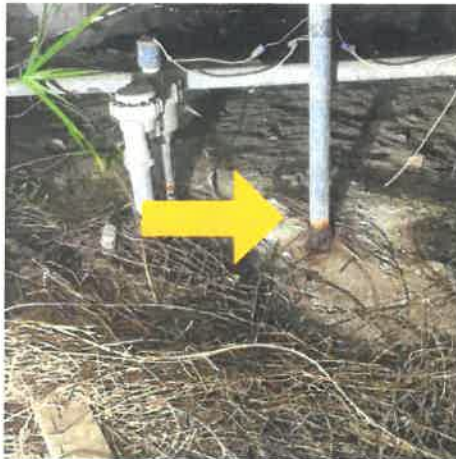
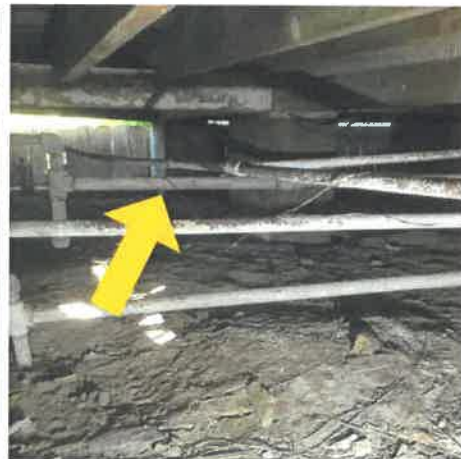
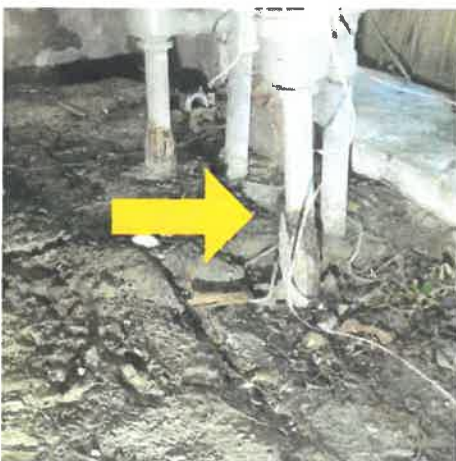
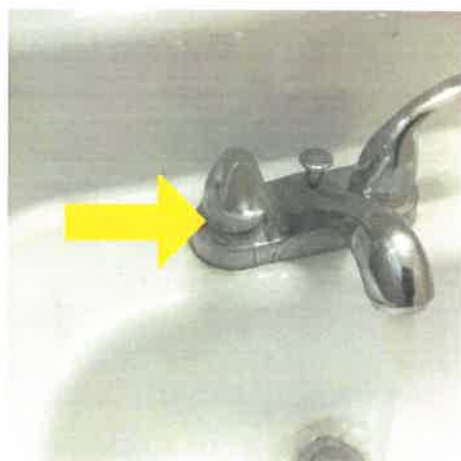
- Water meter is located in back at alley.
- Main water cut off was not located, recommend asking seller for location.
- Static water pressure was 60 psi. at time of inspection. Normal water pressures should be between 40 and 80 psi.
- There were miscellaneous galvanized water and gas lines under home that were showing moderate to heavy rusting. Recommend having licensed plumber evaluate and repair as needed for proper operation.
- There were miscellaneous water and gas lines that were noted as not being properly supported. Recommend having licensed plumber evaluate and repair as needed.
- Faucet at garage apartment bathroom was leaking when used. Recommend repairs to prevent further damages.

This is fixed.

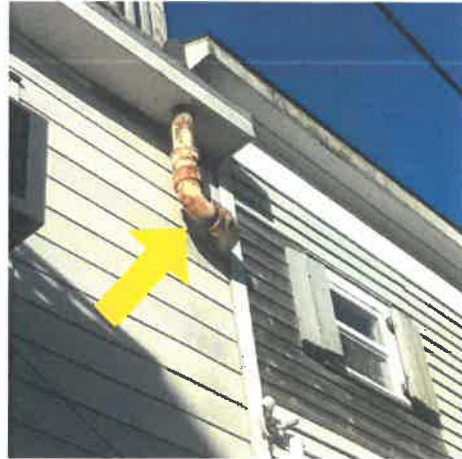
- There were damaged cast iron pipes noted on exterior. Recommend having licensed plumber evaluate and repair as needed for proper operation.
- Drain line under toilet in garage apartment was leaking when flushed. Recommend having licensed plumber evaluate and repair as needed.

this pipe is not being used

This has been fixed.

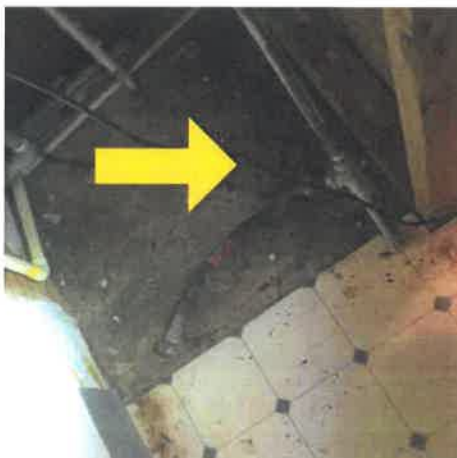
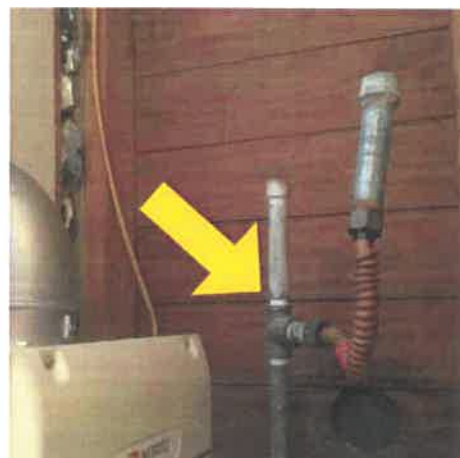
- There were what appeared to be abandoned gas lines noted at tankless water heater area. Recommend having licensed plumber evaluate and repair/remove as needed.

yes,
they
are
abandoned
gas lines

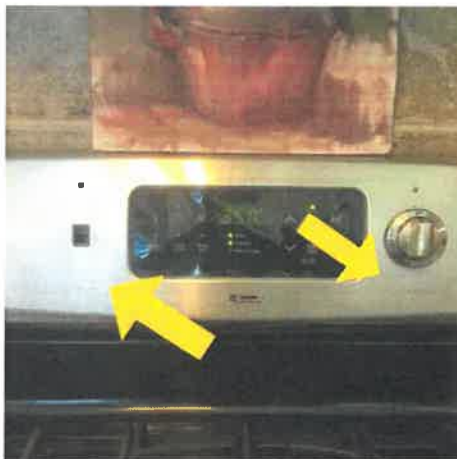
- Oven and cook tops we're operating as designed at the time of inspection(Main house).
- Control labeling on oven was noted as being worn and unreadable. Recommend repairs for proper operation.
- Oven anti - tip device is missing or disconnected. This is a safety hazard and should be corrected.
- Oven cook tops were not functioning properly (garage apartment). Recommend having qualified contractor evaluate and repair as needed for proper operation.
- Oven anti - tip device is missing or disconnected. This is a safety hazard and should be corrected.
