Your Inspection Report

1112 13th St
Galveston, TX 77550

PROPERTY INSPECTION REPORT

Concerning: 1112 13th St, Galveston, TX
(Address or Other Identification of Inspected Property)

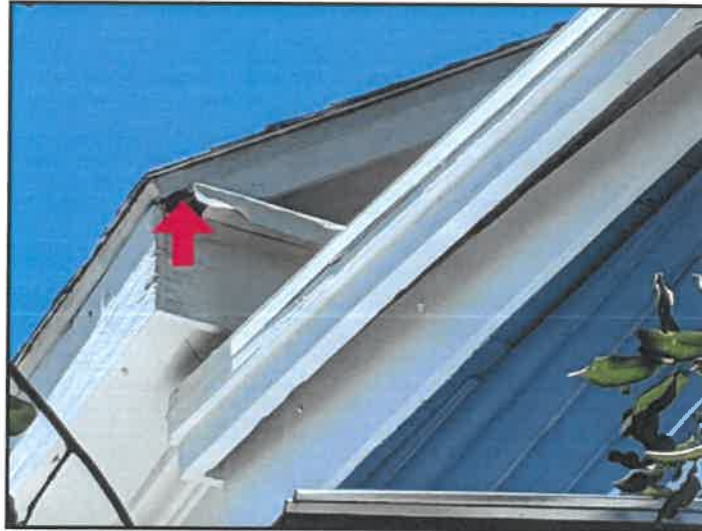
4. Loose, damaged, patched, open seams

4. Condition: • [Loose, damaged, patched, open seams](#)

Implication(s): Chance of water damage to contents, finishes and/or structure

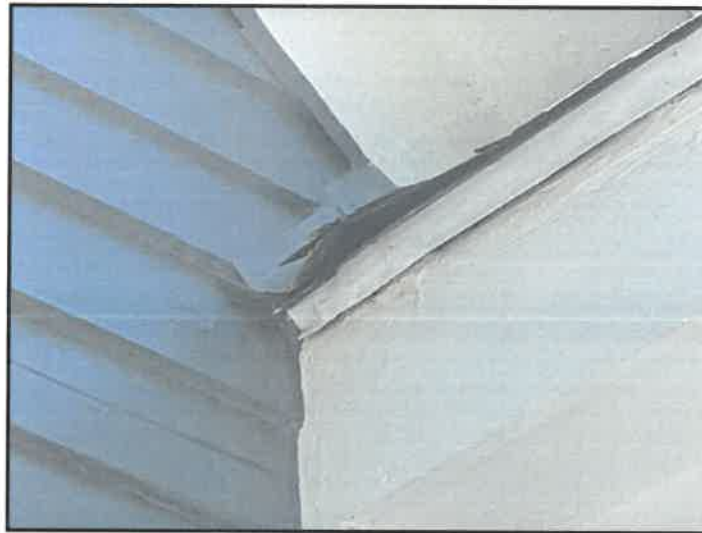
5. Kickout flashing - missing

5. Condition: • [Kickout flashing - missing](#)

Implication(s): Chance of water damage to contents, finishes and/or structure

Location: Various

Task: Replace

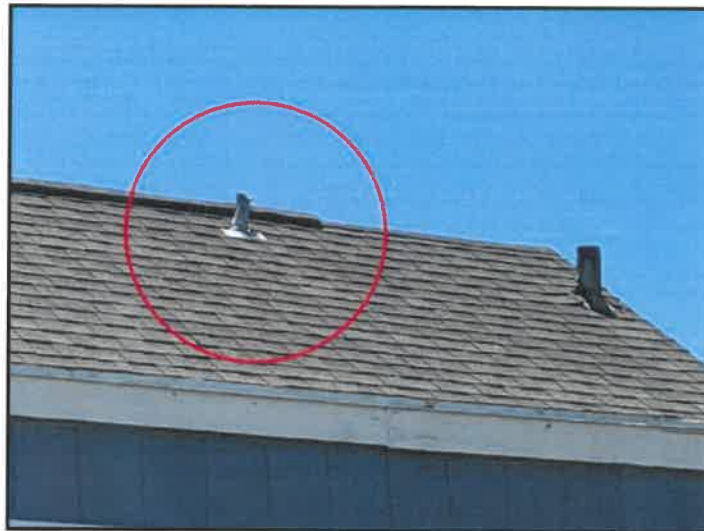
6. Damage

6. Condition: • [Damage](#)

Implication(s): Chance of water damage to contents, finishes and/or structure

Location: Rear Middle Roof

Recommendation: Replace pipe/roof jacks with new installations to prevent any water damage or leaking.

Task: Replace

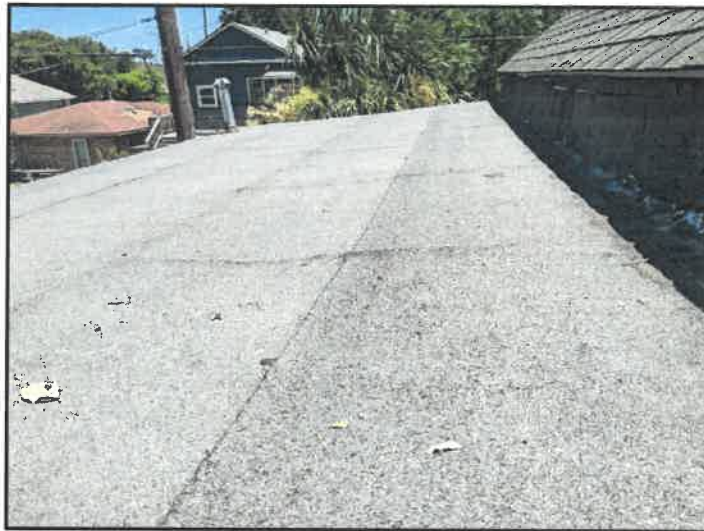
8. Aging

8. Condition: • Aging

Location: Rear Left Side Roof

Task: Repair or replace

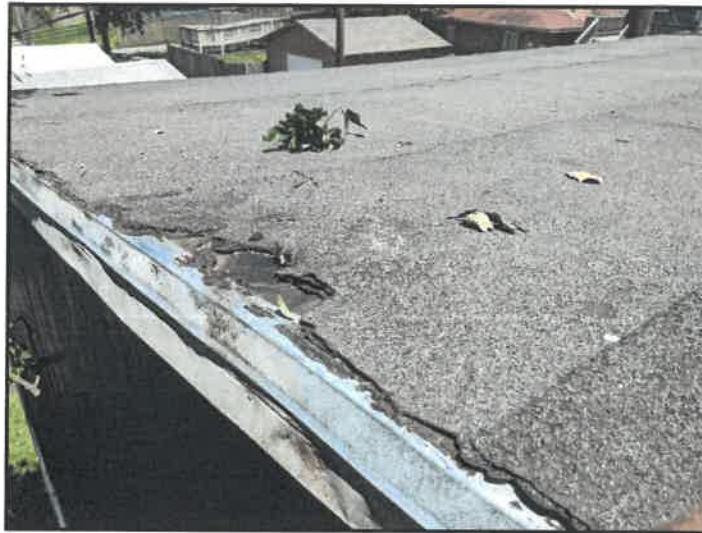
9. Damage, punctures, tears

Modified bitumen: **Damage, punctures, tears** Location(s): **Rear Left Side Roof**

9. Condition: • [Damage, punctures, tears](#)

Implication(s): Chance of water damage to contents, finishes and/or structure

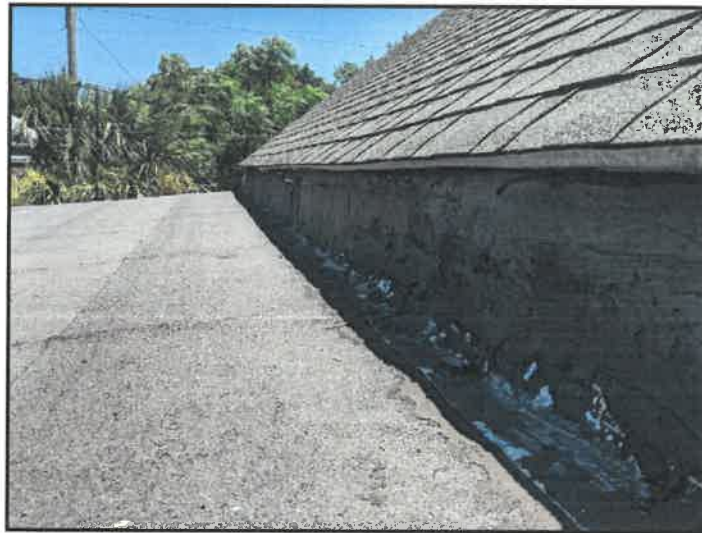
10. Patched

10. Condition: • [Patched](#)

Implication(s): Chance of water damage to contents, finishes and/or structure

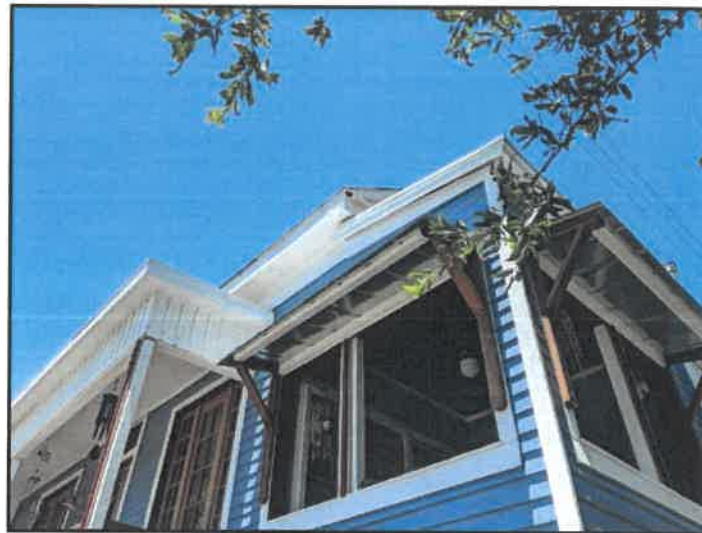
14. Missing

Gutters and Downspouts: **Missing** Location(s): **Throughout**

Location: Throughout

Task: Provide

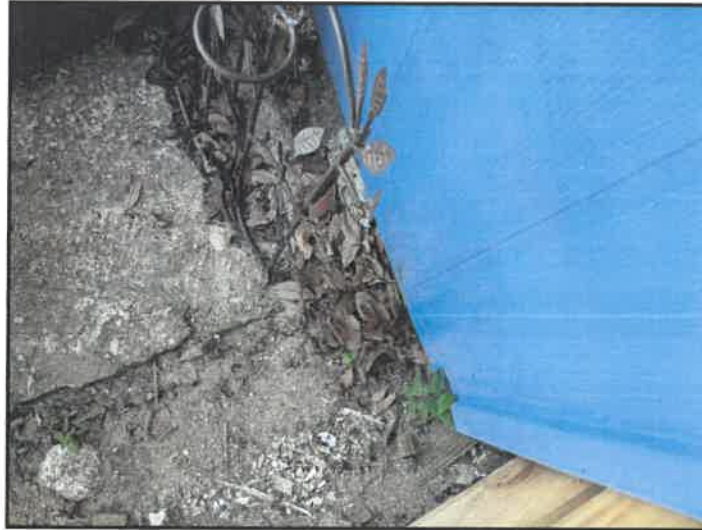
16. Too close to grade

16. Condition: • [Too close to grade](#)

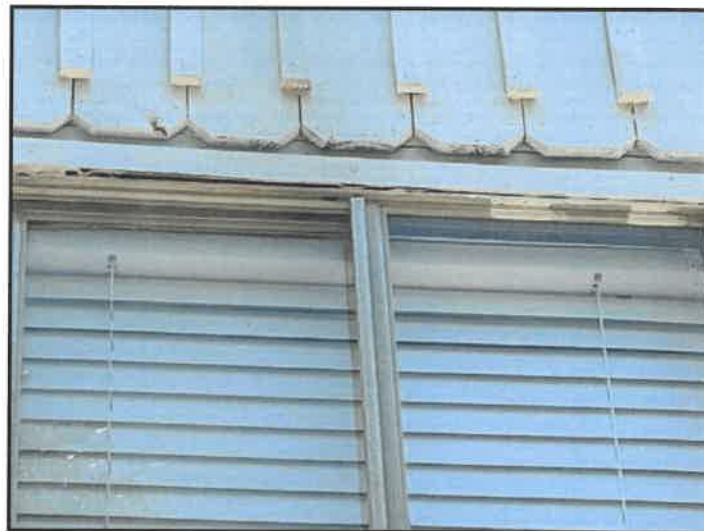
20. Paint and Caulking - deteriorated / missing

Location: Various Exterior Wall

Task: Improve

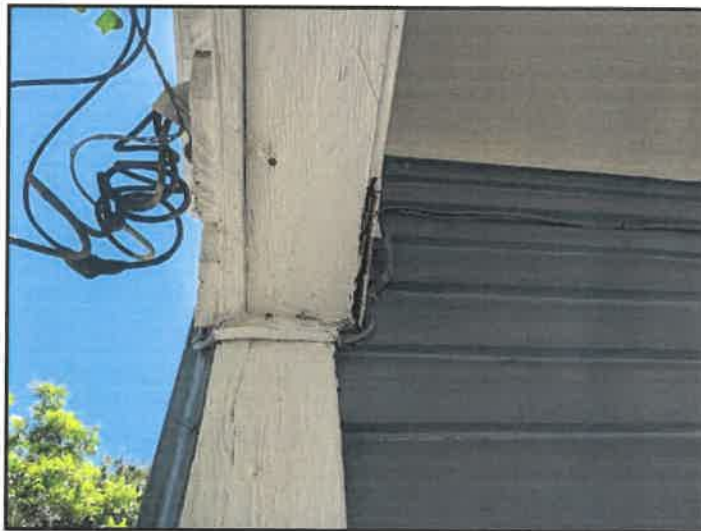
27. Rot or insect damage

Beams: **Rot or insect damage** Location(s): **Front Left Side Porch**

Location: Front Left Side Porch

Task: Repair or replace Monitor

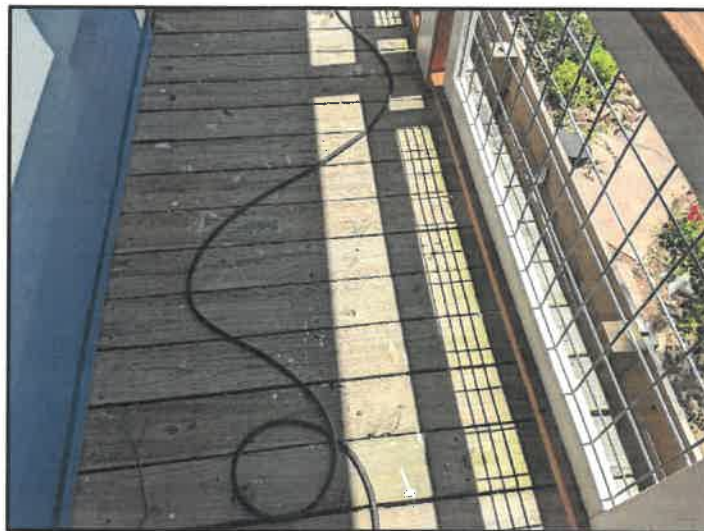
33. Paint or stain needed

Floors: **Paint or stain needed** Location(s): **Front Porch**

Location: Front Porch

Task: Improve

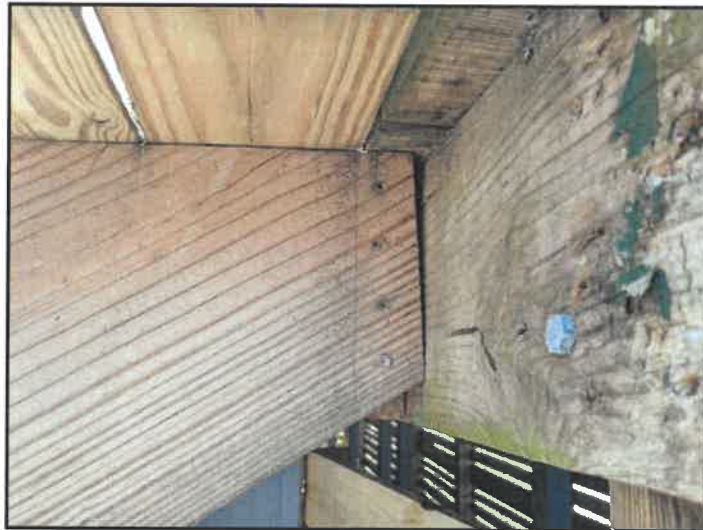
43. Inadequately secured to header

Joists: **Damage** Location(s): **Left Side Exterior Staircase**

Location: Left Side Exterior Staircase

Task: Repair

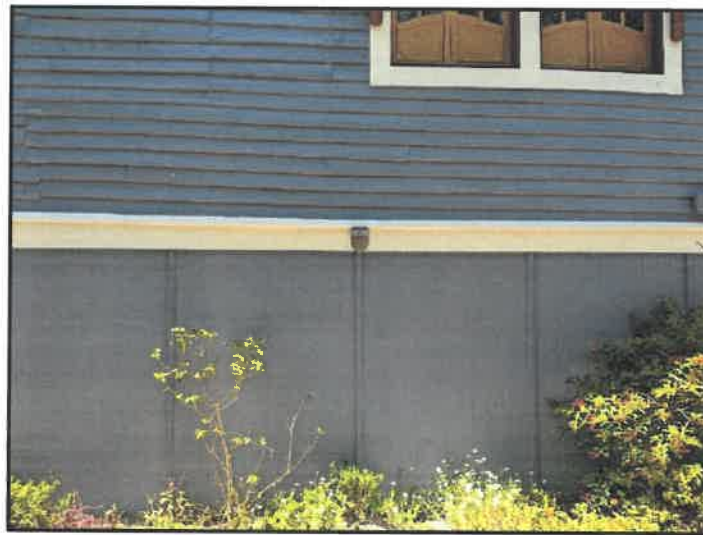
44. Bowed, bulging or leaning

General notes: **Bowed, bulging or leaning** Notes: **Missing garage column may cause settlement.** Location(s): **Right Side Middle**

Location: Right Side Middle

Overview: **Recommendation: Monitor for settlement or consult with a licensed engineer about a missed column within the garage space.** *replaced column*

Task: Further evaluation Monitor

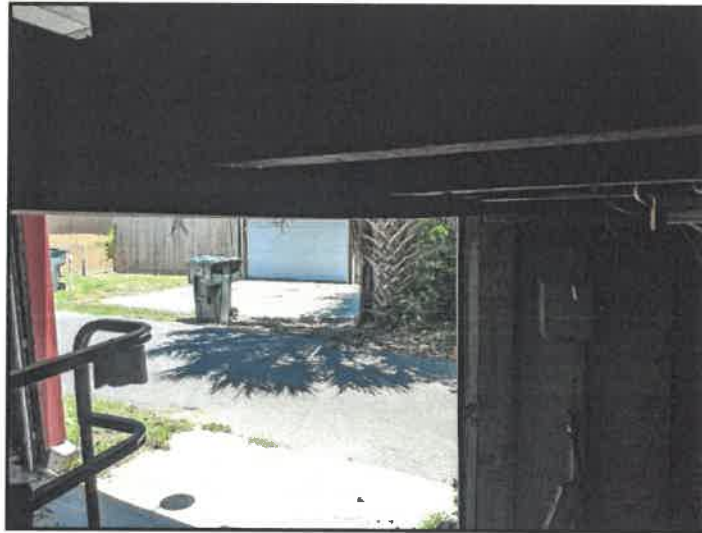
45. Missing

Columns or piers: **Missing** Location(s): **Front Middle Garage**

Location: Front Middle Garage

Task: Replace

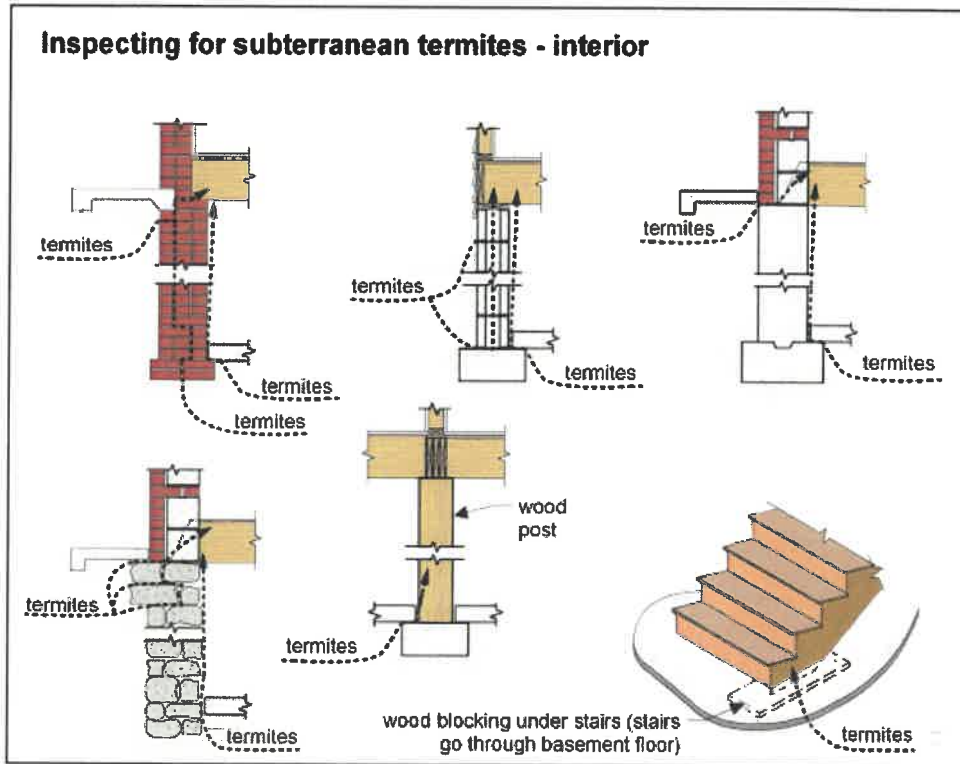
Columns or piers: **Insect damage** Location(s): **Front Left Side Garage**

40. Condition: • [Insect damage](#)
Implication(s): Weakened structure
Location: Front Left Side Garage
Task: Monitor

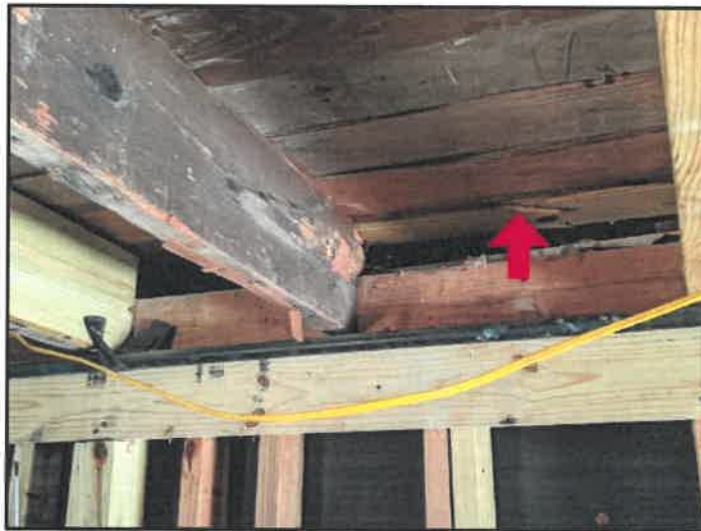
47. Buckled

Location: Middle Garage

Task: Replace Monitor

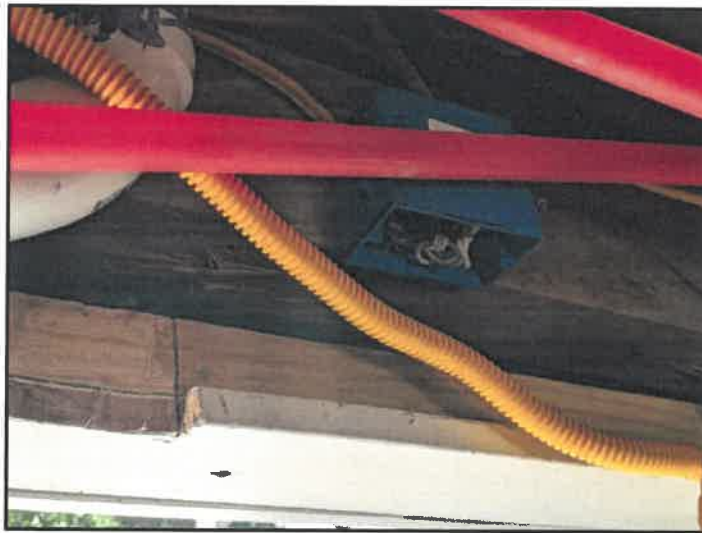
60. Cover loose or missing

Junction boxes: **Cover loose or missing** Location(s): **Various Garage**

Location: Various Garage

Task: Replace

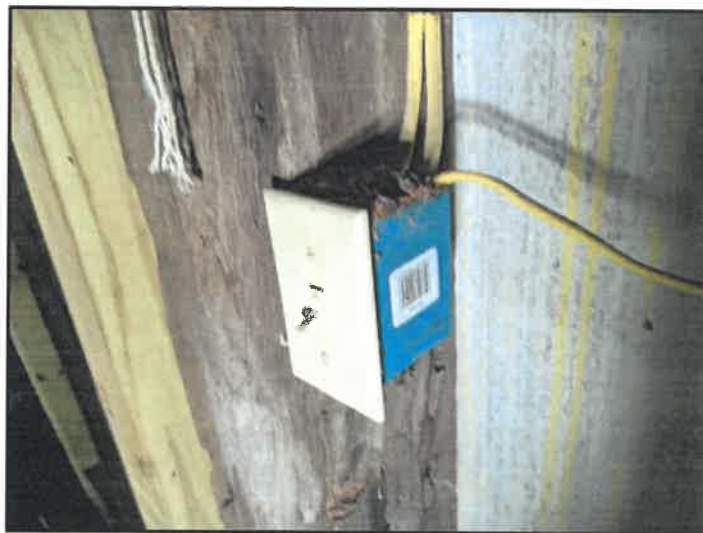
64. Faulty

Location: Garage

Task: Replace

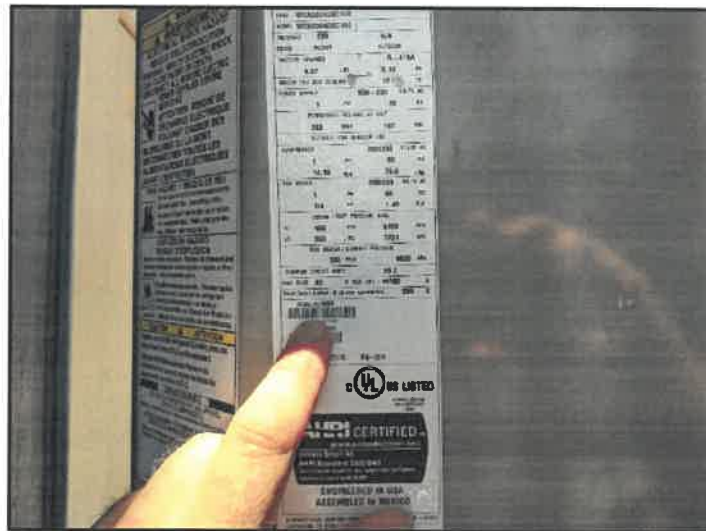
72. Excess electric current draw

Excess electrical current draw (beyond standards)

Recommendation: Make sure amperage for AC correlates to breaker size.

Task: Replace Improve

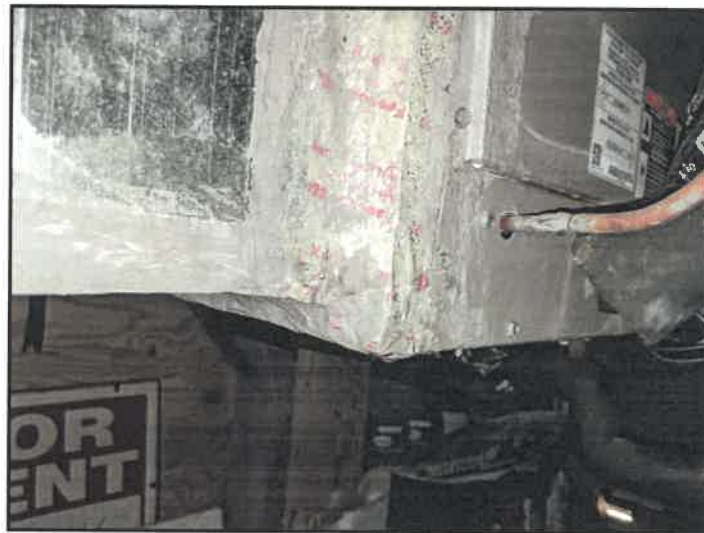
74. Blocked or crimped

Condensate system: Pan leaking Location(s): Garage

Location: Garage

Recommendation: Clean and re-plumb condensate lines for primary and secondary evaporator coil.

Task: Further evaluation

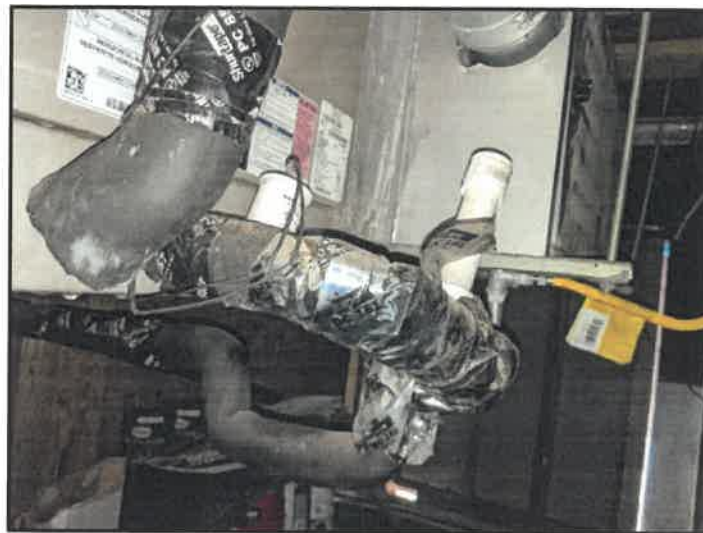
75. Blocked or crimped

Location: Garage

Task: Further evaluation Clean

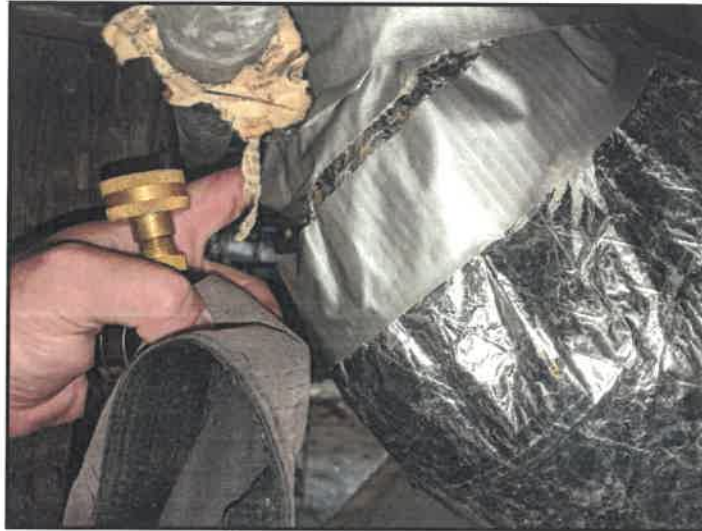
76. *Disconnected or leaking*

Ducts, registers and grilles: Disconnected or leaking

Overview: Recommendation: Repair and replace disconnected and leaking ducting under the home.

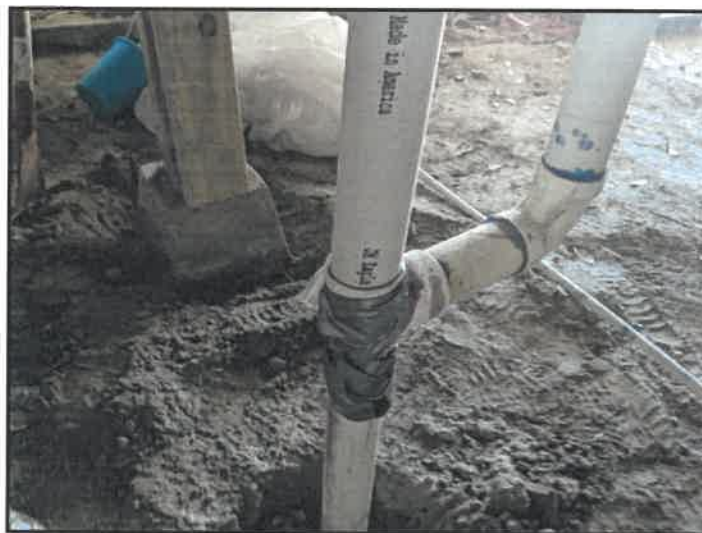
87. Poor manifolding of drain pipe

Location: Garage

Task: Repair or replace

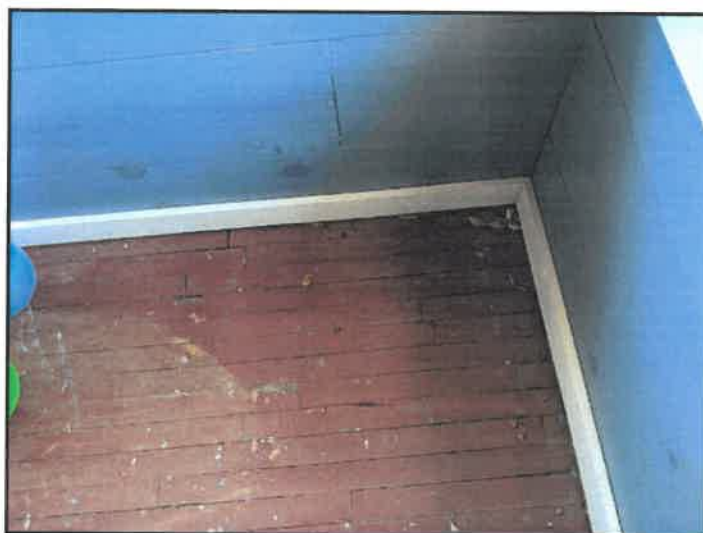
94. Stained

Location: Front Right Porch

Task: Service annually

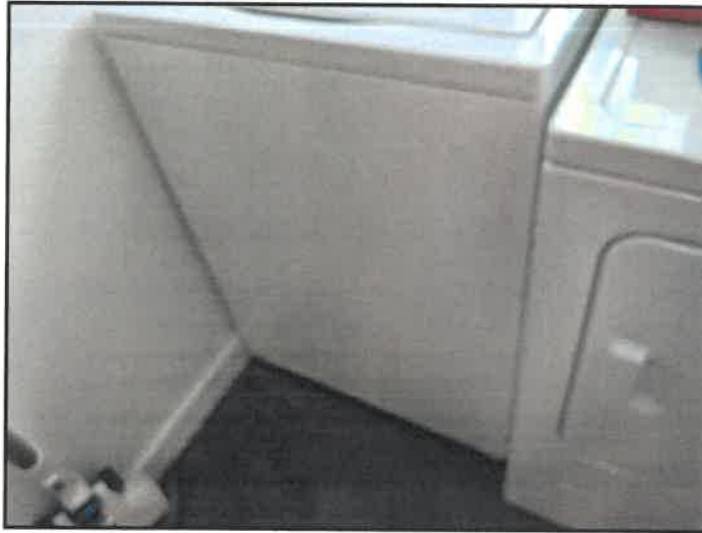
98. *Drip pan missing*

Washing machine: Drip pan missing Location(s): Laundry Area

Location: Laundry Area

Task: Provide
