1st Rate Inspections

Property Inspection Report

10086 Ash Fork Dr, Houston, TX 77064

Date of Inspection: 8/8/2020 Time: 1:30 PM

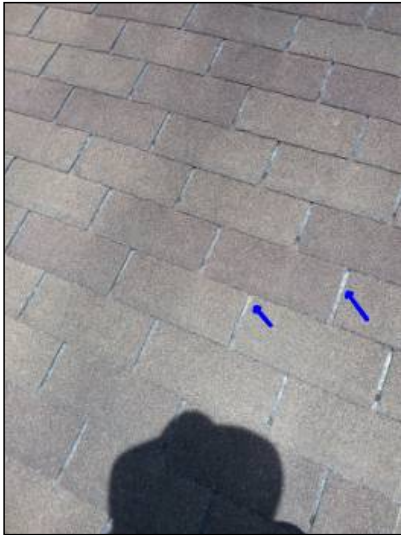
C.8. -Due to the excessive granular loss on the roof covering the roof may age prematurely. We recommend further review of the roof system for a better understanding of the present condition.

-Due to the excessive granular loss on the roof covering the roof may age prematurely. We recommend further review of the roof system for a better understanding of the present condition.

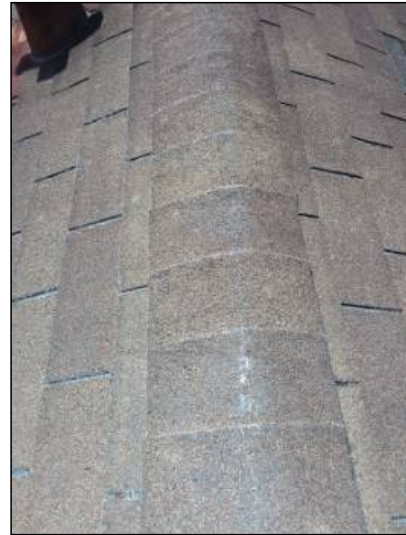
C.7. -Due to granular loss on portions of the ridge shingles these portions of the roof covering materials may age prematurely. May want to replace worn ridge shingles to help prolong the life of the roof. This is often due to normal wear due to the age of the roof.

-Due to granular loss on portions of the ridge shingles these portions of the roof covering materials may age prematurely. May want to replace worn ridge shingles to help prolong the life of the roof. This is often due to normal wear due to the age of the roof.

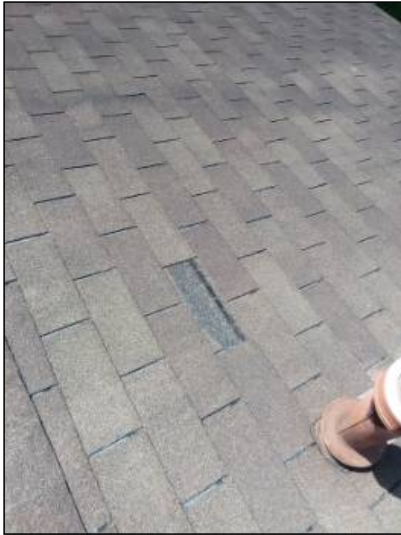
-The roof is missing shingles, recommend replacement of missing shingles. Mainly at - front left

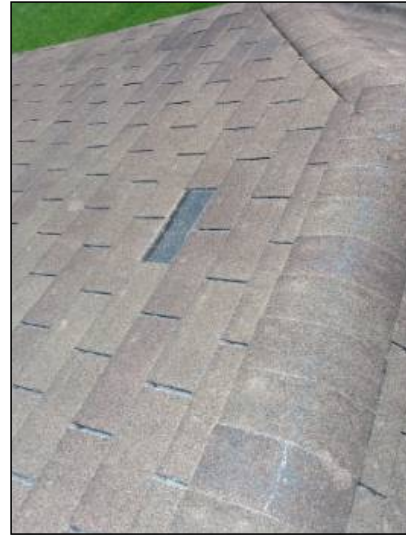
-The roof is missing shingles, recommend replacement of missing shingles. Mainly at - front right

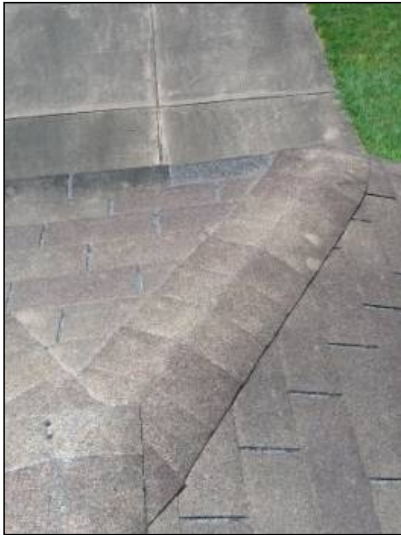
-The roof is missing shingles, recommend replacement of missing shingles. Mainly at - front left

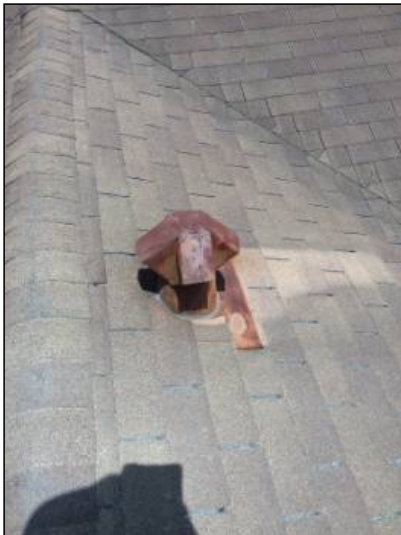
C.3. -Recommend painting all unpainted vents and flashings to help prevent damage due to UV rays or rust.

-Recommend painting all unpainted vents and flashings to help prevent damage due to UV rays or rust.

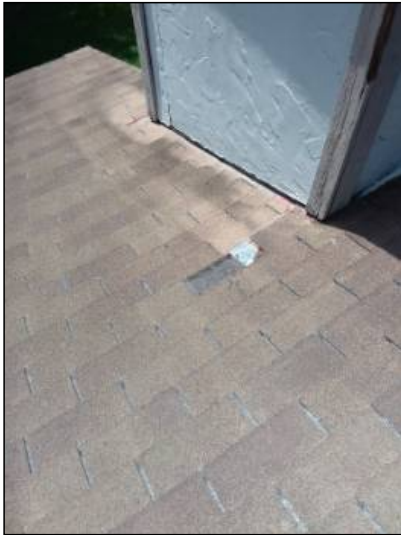
-The roof is missing shingles, recommend replacement of missing shingles. Mainly at front left

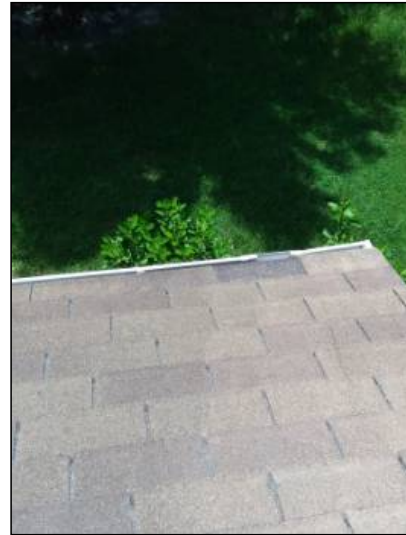
-The roof is missing shingles, recommend replacement of missing shingles. Mainly at - front right

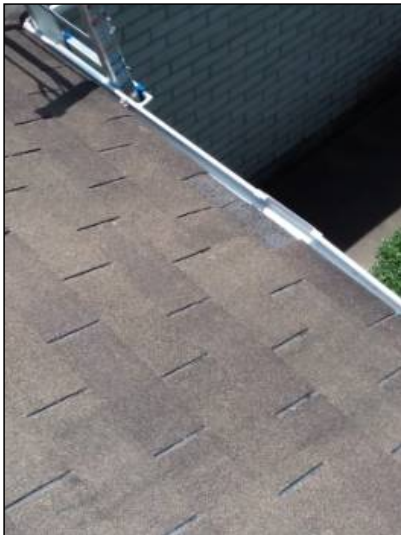
-The roof is missing shingles, recommend replacement of missing shingles. Mainly at - front right

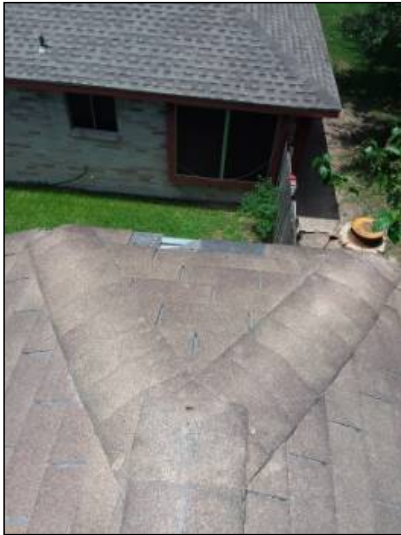
-The roof is missing shingles, recommend replacement of missing shingles. Mainly at - front left

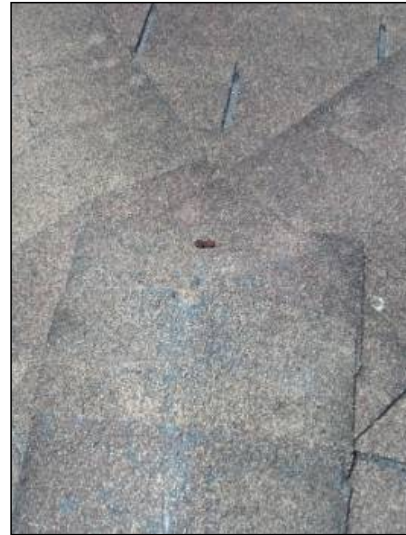
-All exposed nails and fasteners on roof should be sealed at all penetrations, ridges and roof to wall connections.

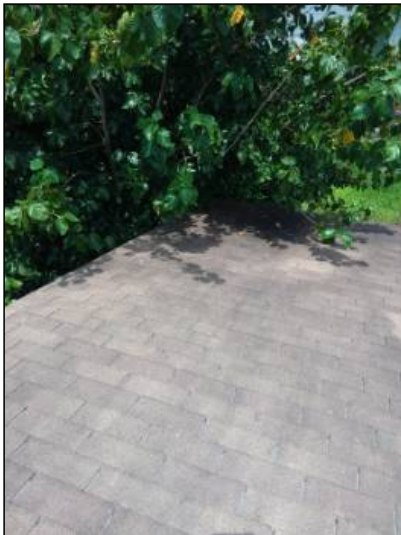
C.1. -Tree limbs should be kept trimmed at least 5' from roof to help prevent damage to the roof during windy conditions.

-Tree limbs should be kept trimmed at least 5' from roof to help prevent damage to the roof during windy conditions.

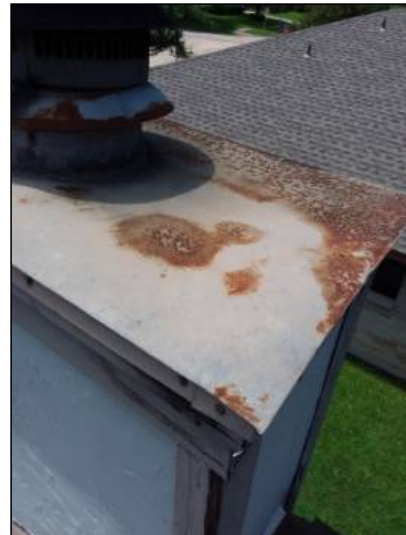
C.4. -There are signs of rusted flashings on the rooftop. We recommend painting or replacing all rusted or deteriorated flashings as needed.

-There are signs of rusted flashings on the rooftop. We recommend painting or replacing all rusted or deteriorated flashings as needed.

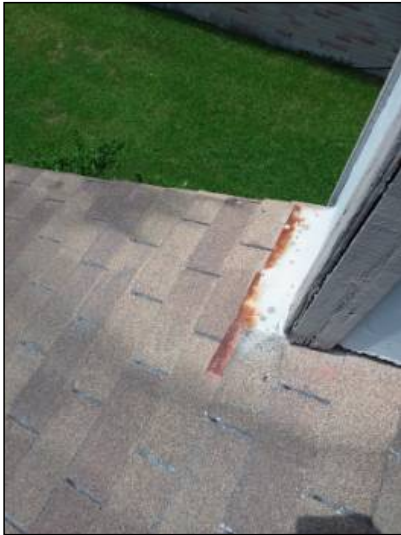
-There are signs of rusted flashings on the rooftop. We recommend painting or replacing all rusted or deteriorated flashings as needed.

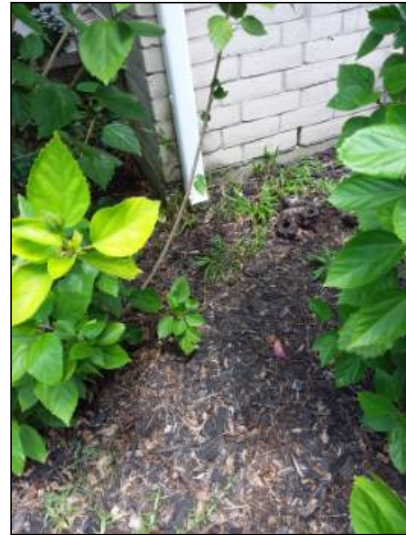
C.10. -Splash blocks or downspout extensions should be installed to direct water away from foundation.

-Splash blocks or downspout extensions should be installed to direct water away from foundation.

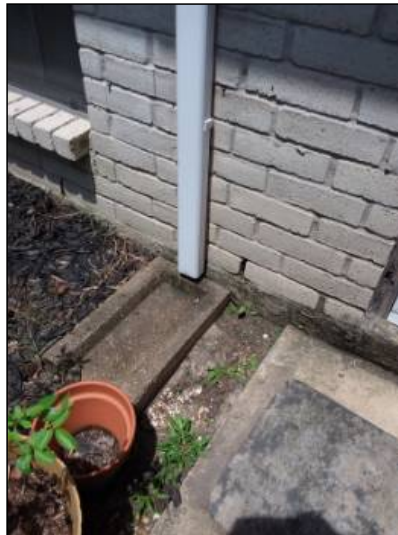
C.11. -The downspout is missing the 90 degree elbow to direct water away from foundation. Mainly at - front

-The downspout is missing the 90 degree elbow to direct water away from foundation. Mainly at - front

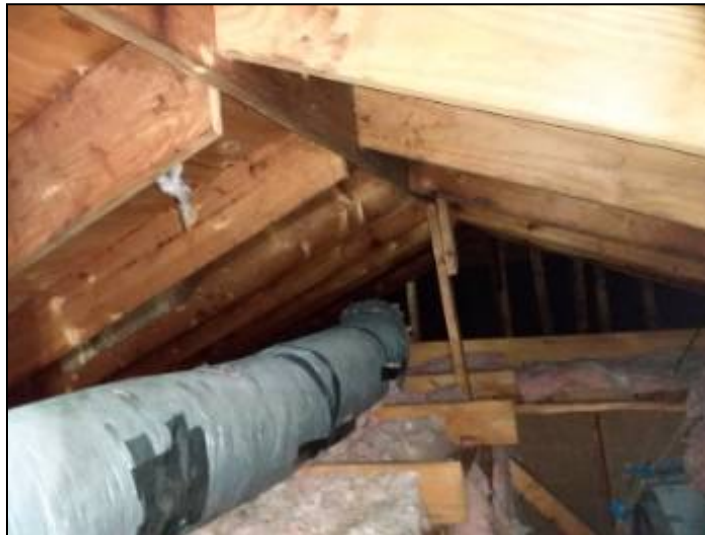
D.3. -Missing collar ties to hold ridge together.

-Missing collar ties to hold ridge together.

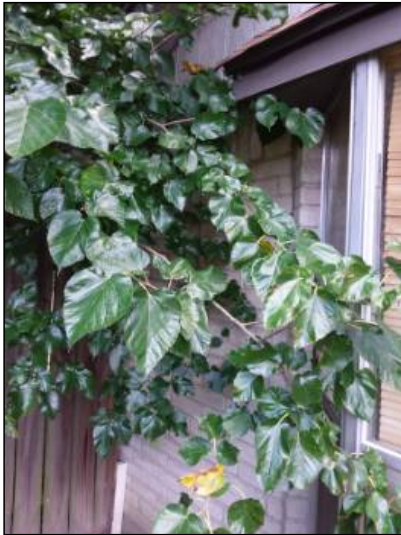
E.2. -Recommend trimming vegetation so that it is not in contact with the house. Vegetation in contact with the structure can hold moisture against the structure and promote damage of building materials.

-Recommend trimming vegetation so that it is not in contact with the house. Vegetation in contact with the structure can hold moisture against the structure and promote damage of building materials.

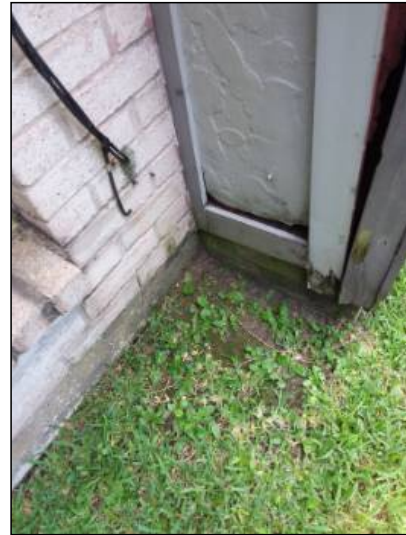
E.3. -Deterioration was noted at the trim, recommend replacing all deteriorated trim. Unable to determine the condition of the underlying materials. Mainly at - left side

-Deterioration was noted at the trim, recommend replacing all deteriorated trim. Unable to determine the condition of the underlying materials. Mainly at - left side

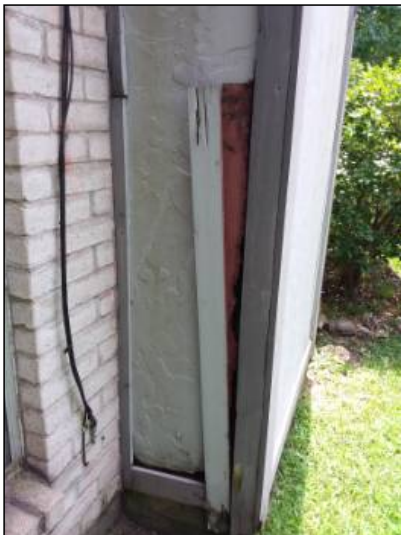
-Deterioration was noted at the trim, recommend replacing all deteriorated trim. Unable to determine the condition of the underlying materials. Mainly at - left side

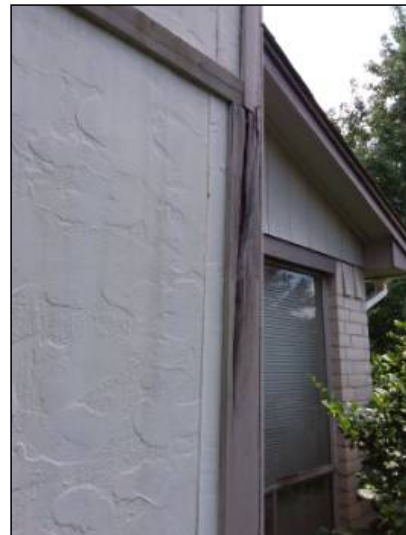
-Deterioration was noted at the trim, recommend replacing all deteriorated trim. Unable to determine the condition of the underlying materials. Mainly at - left side

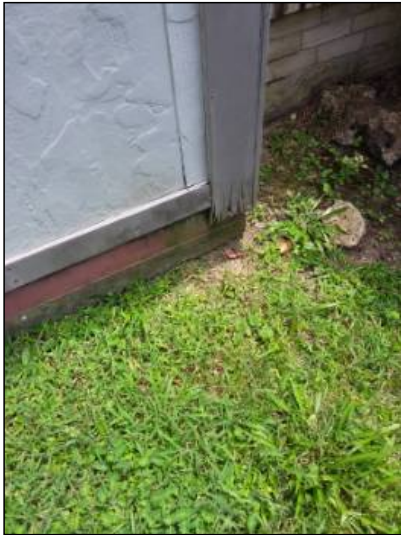
-Deterioration was noted at the trim, recommend replacing all deteriorated trim. Unable to determine the condition of the underlying materials. Mainly at - left side

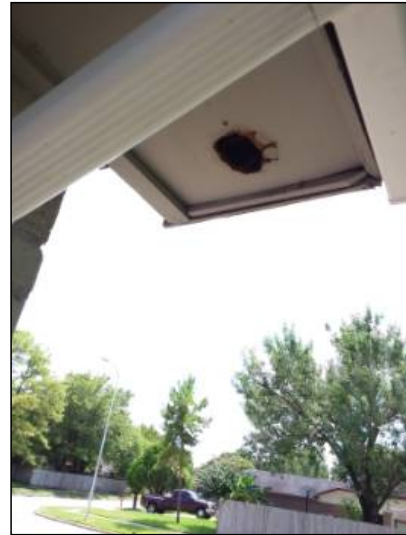
-Seal gaps and holes in soffit to help prevent water penetration or rodent intrusion. Mainly at - front

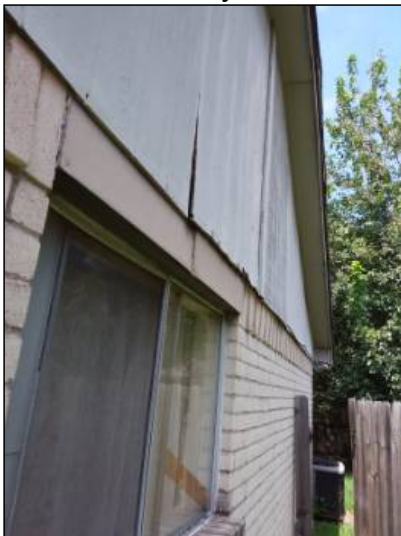
E.7. -Deterioration was noted at the siding, recommend replacing all deteriorated siding to help prevent further deterioration and water penetration. Unable to determine the condition of the underlying materials. Mainly at - left side, right side

-Deterioration was noted at the siding, recommend replacing all deteriorated siding to help prevent further deterioration and water penetration. Unable to determine the condition of the underlying materials. Mainly at - right side

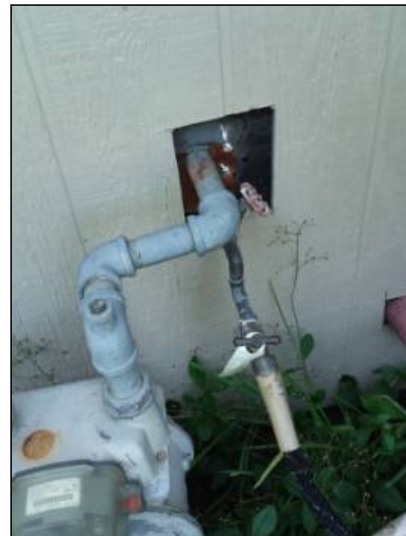
-Seal gaps and holes in siding to help prevent water penetration. Mainly at - rear

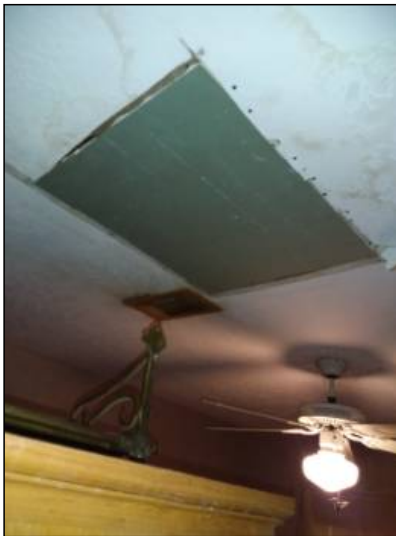
F.1. -Previous repairs were noted in the ceiling. Mainly at - left rear bedroom

-Previous repairs were noted in the ceiling. Mainly at - left rear bedroom

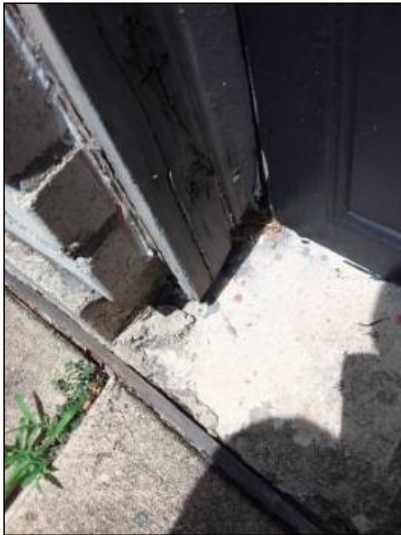
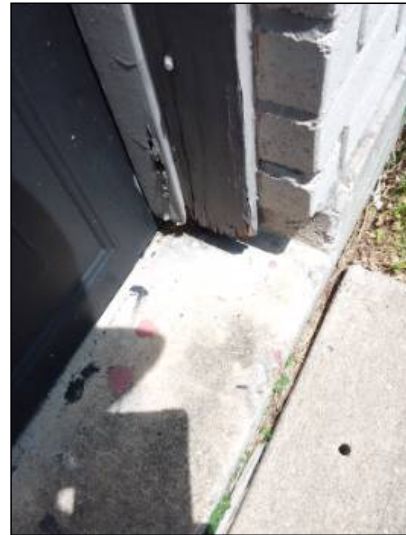
G.2. -Deterioration was noted mainly along the door jamb, recommend repair or replacement to help prevent water penetration. Unable to determine the condition of the underlying materials. Mainly at - garage

-Deterioration was noted mainly along the door jamb, recommend repair or replacement to help prevent water penetration. Unable to determine the condition of the underlying materials. Mainly at - garage

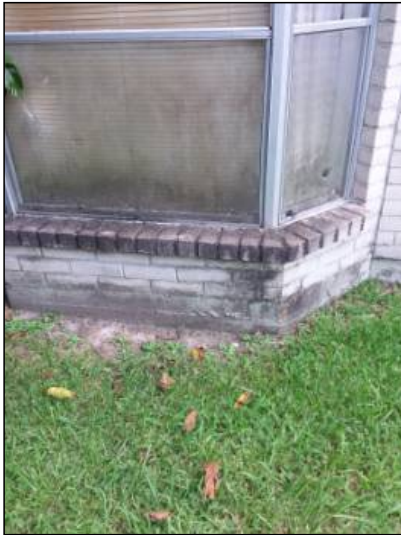
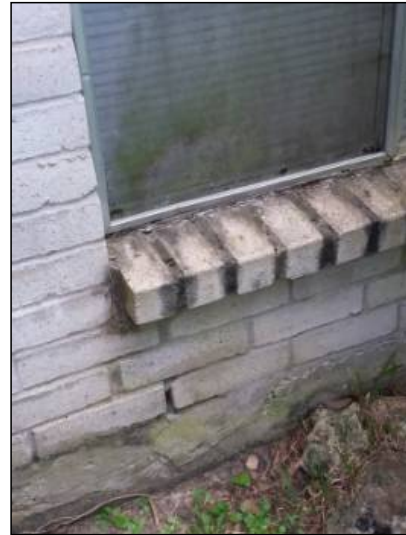
H.1. -Window screens were damaged or had holes in them and should be repaired to help prevent insects from entering. Mainly at - 2) left side, rear

-Window screens were damaged or had holes in them and should be repaired to help prevent insects from entering. Mainly at - 3) left side

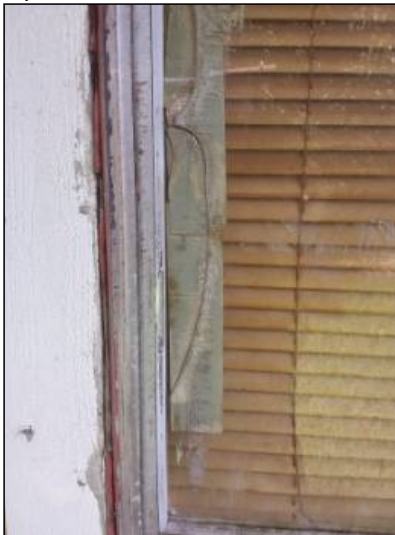
H.2. -Cracked windowpane(s) were noted. Mainly at - rear

-Cracked windowpane(s) were noted. Mainly at - rear

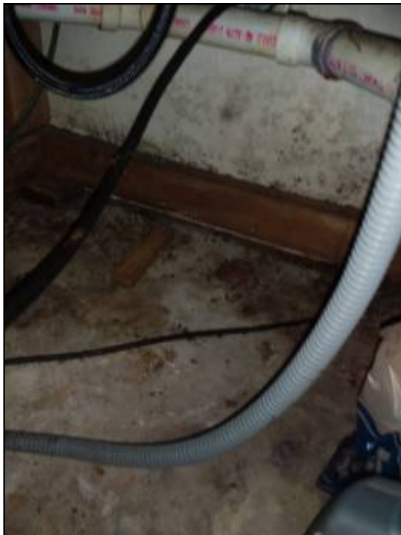
L.1. -Mold like stains are present, recommend remediation or cleanup as needed. Unable to determine condition of the underlying materials. Mainly at -underneath kitchen sink.

-Mold like stains are present, recommend remediation or cleanup as needed. Unable to determine condition of the underlying materials. Mainly at -underneath kitchen sink.

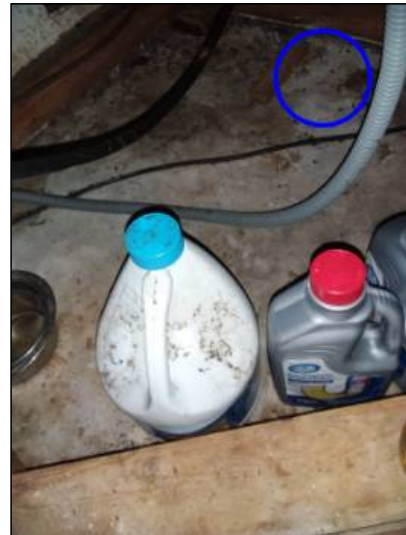
Indications are there there are animal droppings beneath the sink. Recommend pest control specialist

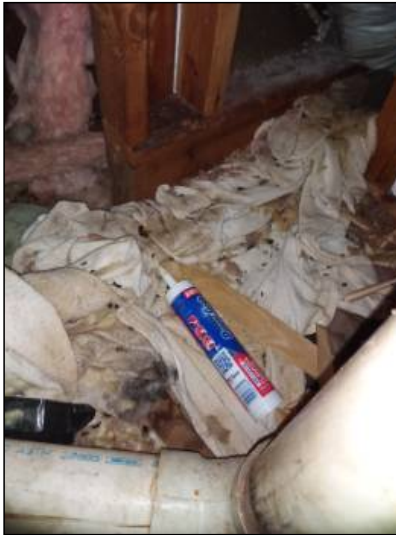
L.2. Indications are there there are animal droppings beneath the sink, and in the attic. Recommend pest control specialist

Indications are there there are animal droppings beneath the sink, and in the attic. Recommend pest control specialist

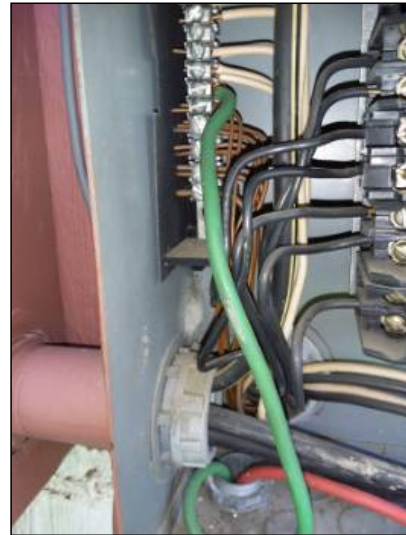
A.2. -There are more than one neutral wire located under the same screw. Neutral wires should be separated to individual screws.

-There are more than one neutral wire located under the same screw. Neutral wires should be separated to individual screws.

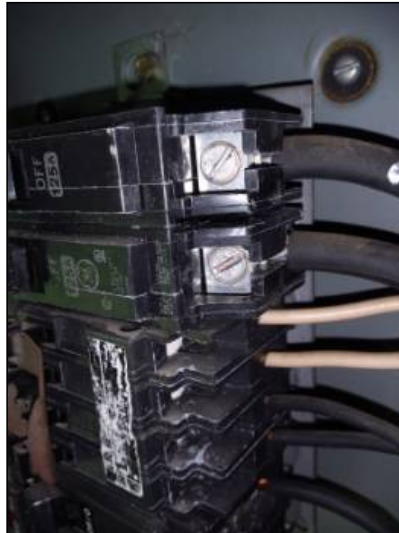
-There is no antioxidant on main aluminum feeds to the panel box. This should be used to help prevent overheating.

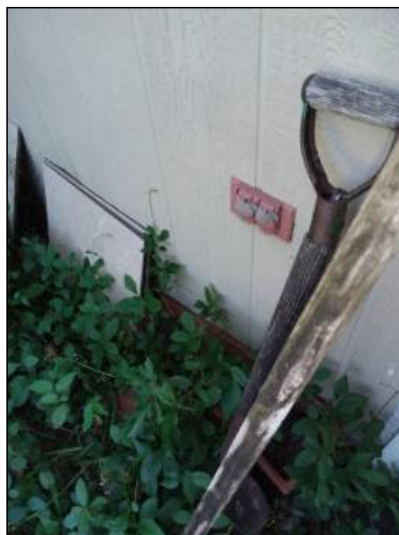
B.2. -Recommend replacing all wet area exterior receptacle covers with the code approved bubble style cover.

-Recommend replacing all wet area exterior receptacle covers with the code approved bubble style cover.

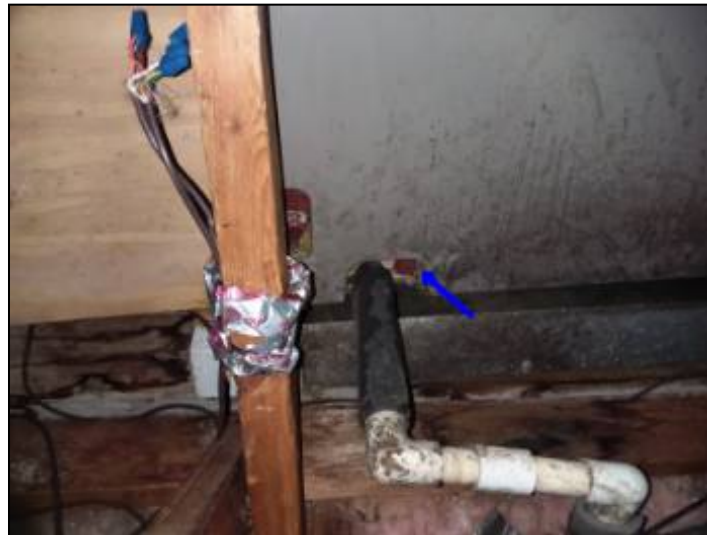
B.2. -The evaporator is missing the secondary drain line to the exterior or to the pan incase main condensation line becomes clogged, recommend adding a secondary drain or high water shutoff to drain line to help prevent water damage to ceilings.

-The evaporator is missing the secondary drain line to the exterior or to the pan incase main condensation line becomes clogged, recommend adding a secondary drain or high water shutoff to drain line to help prevent water damage to ceilings.

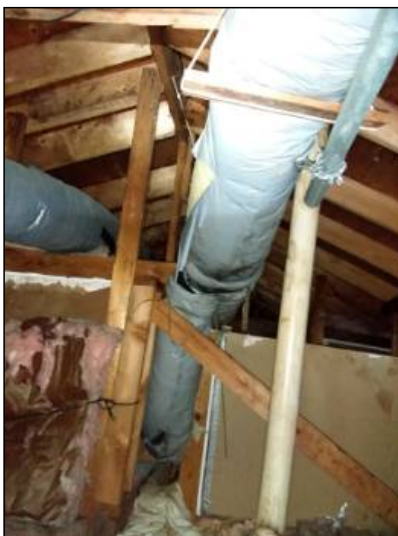
C.2. -The gray plastic covering on the A/C & Heating ducts are known for having issues with deterioration. Some of the ducts in the attic is beginning to deteriorate, recommend an evaluation by a licensed A/C and heating specialist for repair or replacement needs of all ducts. Further deterioration may happen over time.

-The gray plastic covering on the A/C & Heating ducts are known for having issues with deterioration. Some of the ducts in the attic is beginning to deteriorate, recommend an evaluation by a licensed A/C and heating specialist for repair or replacement needs of all ducts. Further deterioration may happen over time.

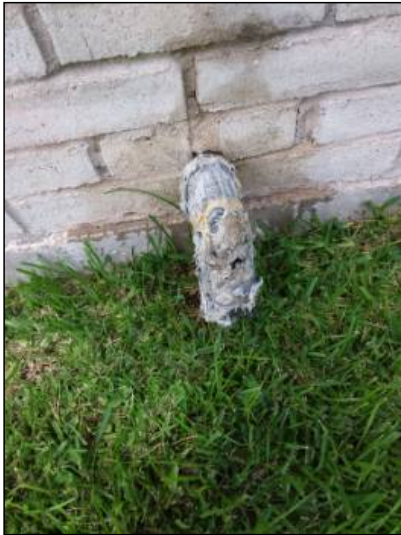
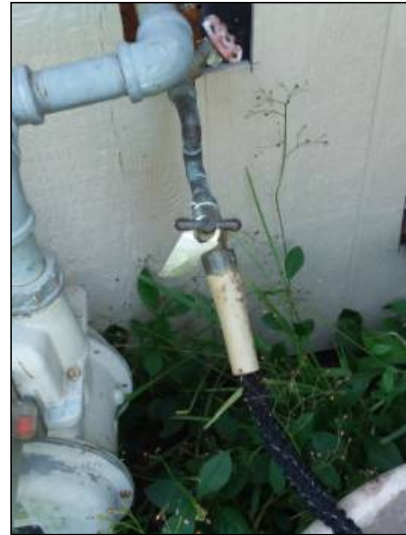
A.7. -Insulate all damaged or uninsulated exterior water lines to help prevent damage to the pipes in freezing weather. Mainly at - right side

-Insulate all damaged or uninsulated exterior water lines to help prevent damage to the pipes in freezing weather. Mainly at - right side

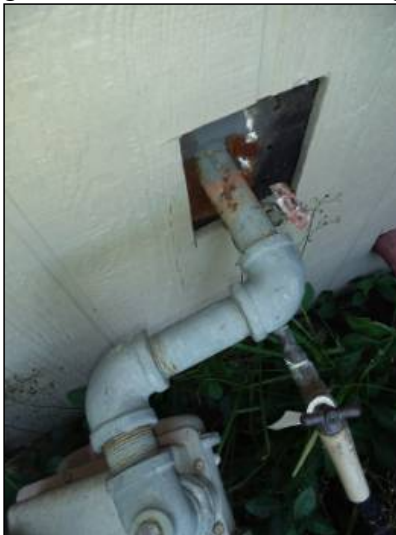
A.8. -Paint pipe at gas meter to help prevent premature deterioration.

-Paint pipe at gas meter to help prevent premature deterioration.

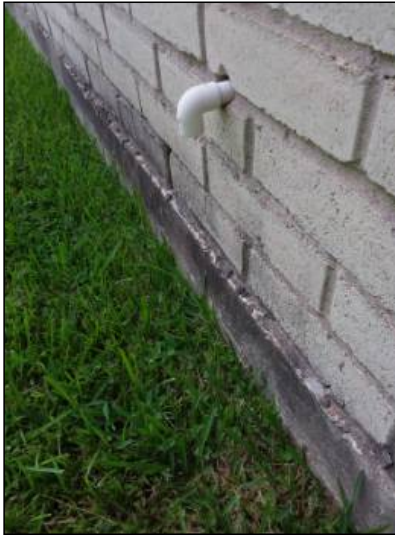
C.3. -The water heater T&P (Temperature and Pressure Relief Valve) drain ends more than 6" from ground. Recommend adding pipe to the 90's so that they exit within 6" of the ground. Also recommend painting to prevent premature deterioration from UV rays.

-The water heater T&P (Temperature and Pressure Relief Valve) drain ends more than 6" from ground. Recommend adding pipe to the 90's so that they exit within 6" of the ground. Also recommend painting to prevent premature deterioration from UV rays.

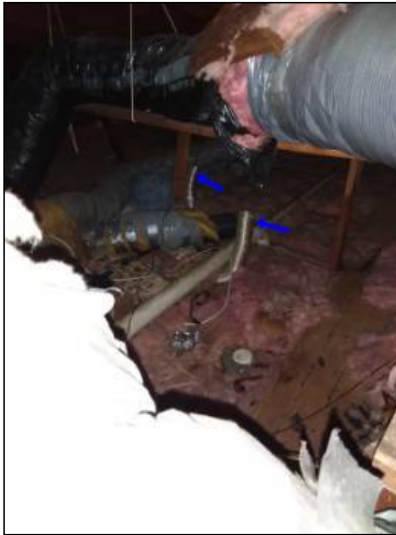
F.3. -Bath or laundry exhaust vents terminate in attic, recommend all exhaust vents terminate to the exterior.

-Bath or laundry exhaust vents terminate in attic, recommend all exhaust vents terminate to the exterior.
