# Inspection Report

**Property Address:**  
7278 Avocet Ln  
Houston TX 77040

# PROPERTY INSPECTION REPORT

**By:** Anthony Byrd 21925 / Byrd's Eye Inspection 8/3/2020

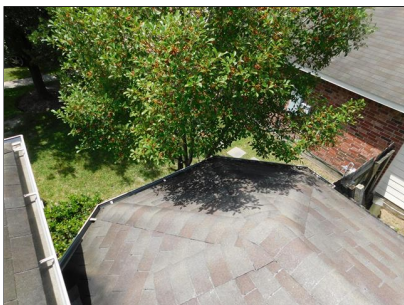
C. Item 3(Picture)

(3) Tree limbs that are in contact with roof or hanging near roof should be trimmed back 3-5' to prevent any damage to the roof covering.

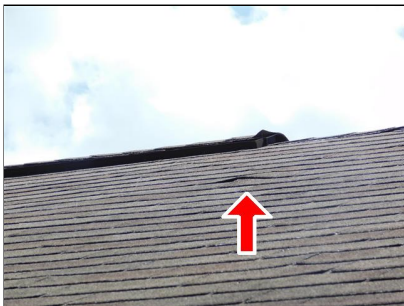
C. Item 4(Picture)

(4) The shingles are worn with significant granular loss in various areas. A roofer should perform a maintenance check on the covering for needed repairs, patching or replacement of worn shingles.

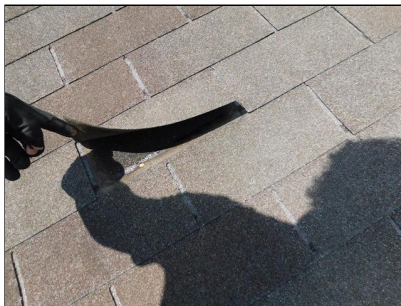
C. Item 5(Picture)

(5) The shingles are lifting in various areas throughout the roof. These can become further damaged during storms or high winds. Recommend qualified roofer to reseal and apply roofing adhesive to lifted areas of shingles.

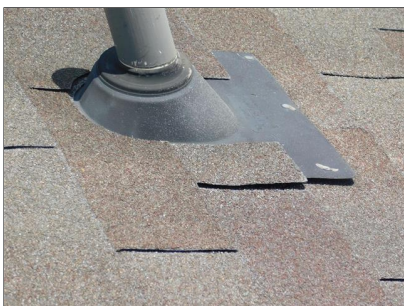
C. Item 7(Picture)

(6) There were vent, counter or step flashings observed to be raised and improperly sealed. A qualified roofer should reseal and seal these roofing components as needed to prevent any future water penetration.

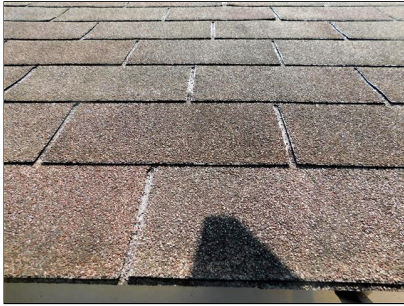
C. Item 9(Picture)

(7) The shingles are damaged/ worn with granular loss in various areas. A roofer should perform a maintenance check on the covering for needed repairs, patching or replacement of worn shingles.

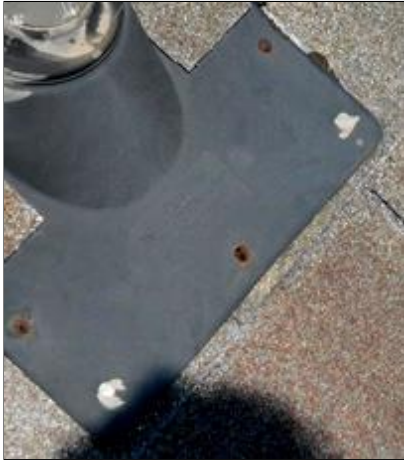
C. Item 17(Picture)

(8) There were several roofing fasteners observed to be improperly sealed or exposed. Left unsealed the

fastener penetrations could present a point of water penetration into the roof structure. Seal (caulk) all exposed roofing fasteners (i.e. plumbing vents, flue pipe roof jacks, flashings, and ridges lines).

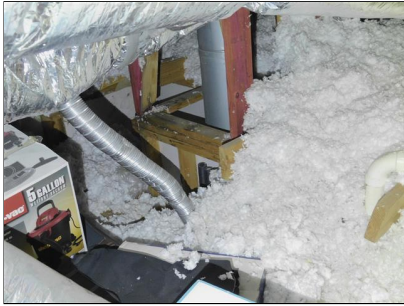
D. Item 2(Picture)

- (4) The chimney flue could not be accessed. 2 inches of clearance between flue pipe and insulation/building materials is required. Recommend installing shield and/or pulling insulation away from direct contact with flue pipe if in contact.

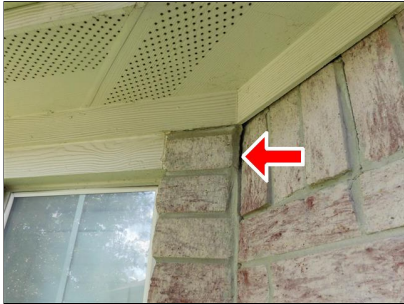
E. Item 1(Picture)

- (2) There are joint cracks on the walls in various locations. These cracks appear to be typical settlement/shifting joint cracks with no other visible displacement. Recommend sealing (mortar) crack to prevent moisture incursion and monitor for further settlement/separation

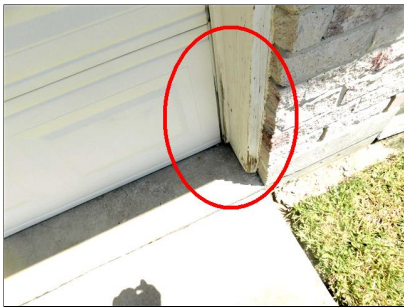
E. Item 2(Picture)

(3) Seal (paint) all exposed wood surfaces around the exterior of the home to include any bare wood, joints in siding and trim, etc.

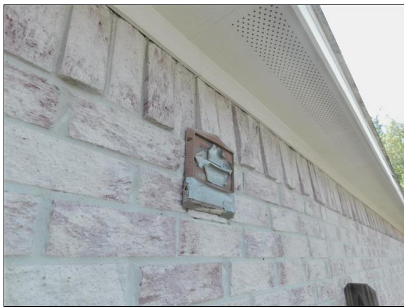
E. Item 3(Picture)

(4) There is an unknown vent cover at the side of the home taped up. Recommend query owner of usage.

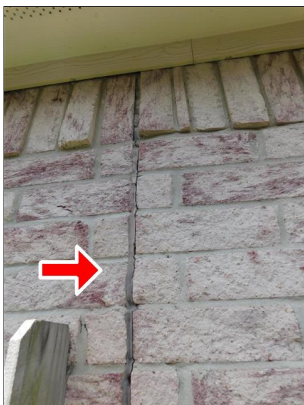
E. Item 4(Picture)

(5) Control joints require added joint compound to prevent water incursion into wall space.

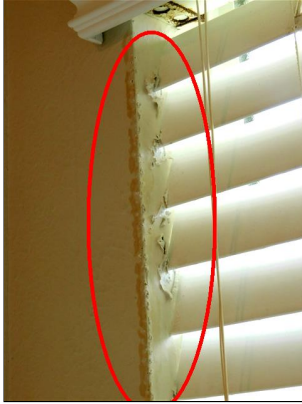
F. Item 3(Picture)

- (3) The bath room wall has several areas of paint peeling conditions. Typical for due to moisture or humid exposure.

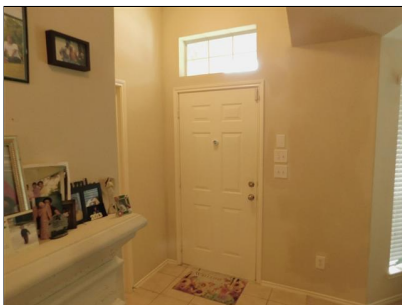
G. Item 2(Picture)

- (3) Doors at do not close properly, bind in frames. Recommend carpenter to make adjustments.

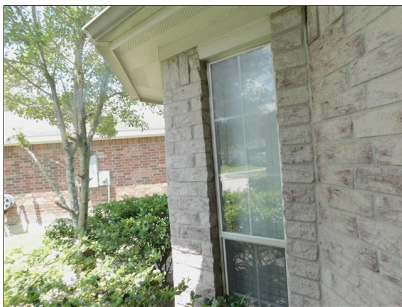
H. Item 1(Picture)

(3) The glazing between glass panes are failing at some windows (condensation/fogging between panes). Double-pane windows have a layer of gas -- usually, argon or air -- trapped between the two panes of glass and should be insulated enough to prevent the accumulation of condensation. If this type of window appears misty or foggy, it means that its seal has failed and the window needs to be replaced.

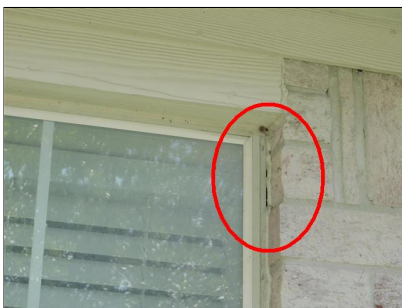
H. Item 2(Picture)

(4) Fresh sealant/caulk applications recommended on exterior window frames at walls. This is an ongoing maintenance item that should be performed on a regular basis to prevent the entry and subsequent damage from water/moisture.

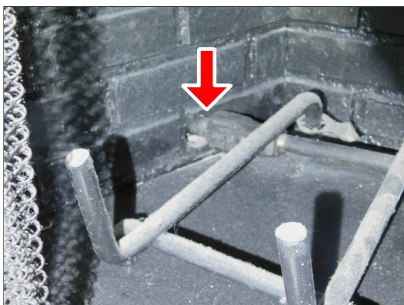
J. Item 2(Picture)

(2) Sealant (fire-rated/high temp caulk) is needed around the gas log starter line at cabinet knock-out penetration.

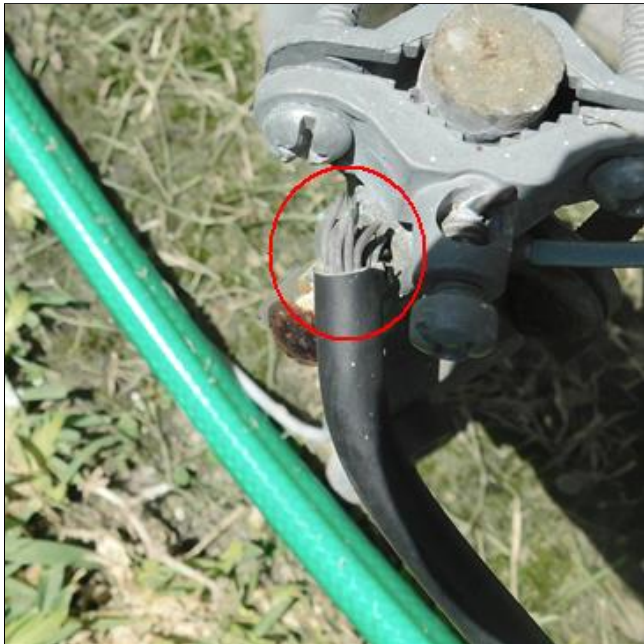
A. Item 3(Picture)

(2) At least one of the service conductors has been damaged/cut. This essentially reduces the gauge and amperage rating of the conductor. Though a common occurrence it is technically incorrect, and should be corrected .

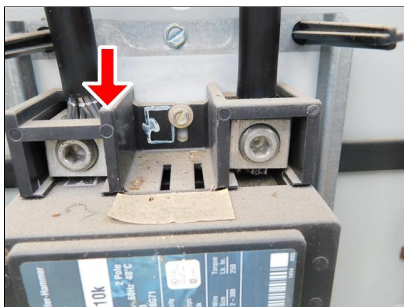
A. Item 4(Picture)

(3) The aluminium service wires should be coated with anti-oxidation grease where they are stripped back to be connected to the mains, main or branch circuit breakers.

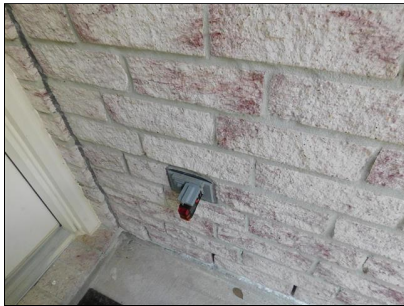
B. Item 1(Picture)

(1) There was an outlet found to be non-functional in the exterior. There may be a GFCI outlet in the home that was not found or not operation. I recommend further evaluation/diagnosis and repair by a licensed electrician if needed.

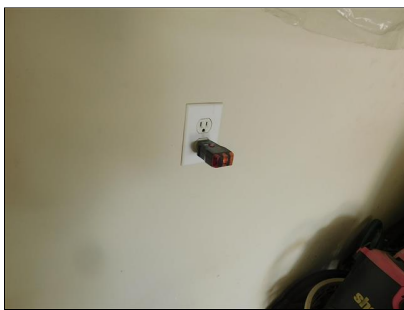
B. Item 2(Picture)

(2) There are no GFCI (Ground Fault Circuit Interrupt) protected outlets in locations called for by today's standards (all non dedicated garage below 6', laundry outlets). I recommend updating to current standards.

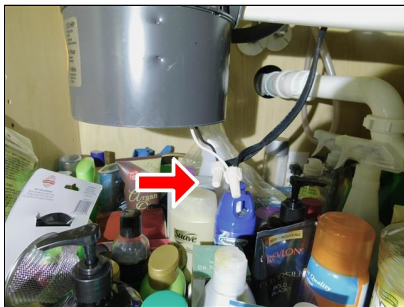
B. Item 3(Picture)

(3) There were exposed connections, open boxes observed in the kitchen. Secure, enclose in rated enclosures to prevent hazards.

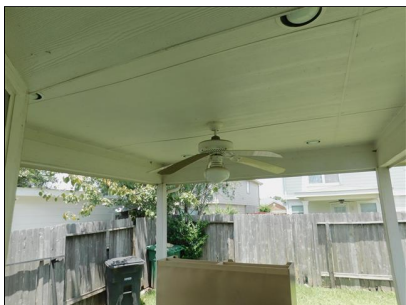
B. Item 4(Picture)

(4) Patio/deck ceiling fan does not appear to be rated for exterior use.

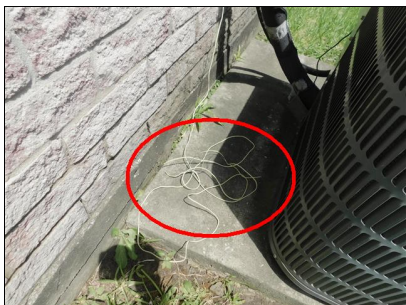
B. Item 5(Picture)

(5) There is an unknown wire at the a/c unit on the floor. It may not be in use. Remove if not needed.

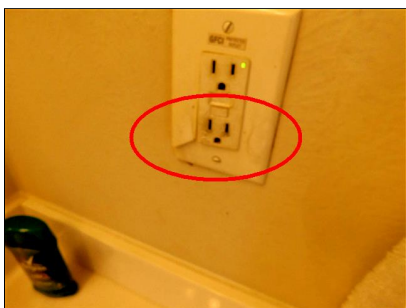
B. Item 6(Picture)

(6) There are possible burn marks around the terminals in the master bath outlet. It may be just dirty. Loose wire will make for a bad connection and cause an unusual amount of heat buildup. Loose connections can also cause sparking in the junction box that can result in arcing. This should be further evaluated by a qualified electrician

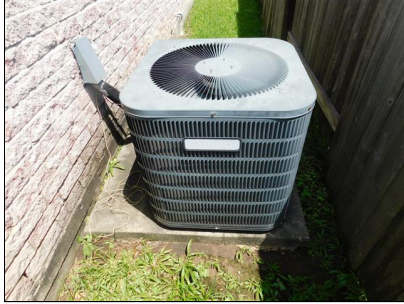
B. Item 4(Picture)

(3) The condenser outside (AC unit) is older and may last a few years more, but maybe not. I have seen units fail shortly after a home inspection during the seasonal change from mild to hot weather. I cannot determine how long your AC will last before a replacement is necessary. Average life span is 13 to 15 years.

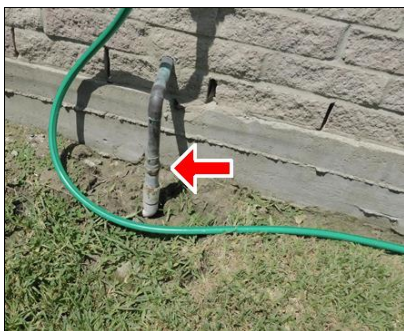
A. Item 3(Picture)

(3) Supply pipes must be properly insulated.

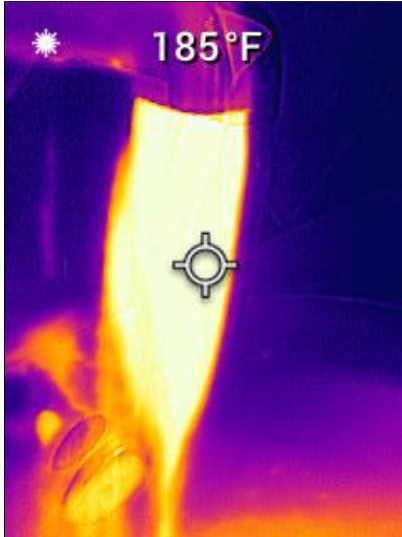
A. Item 4(Picture)

(4) Temperature is extremely high. Recommend lowering temperature to prevent possible burns.

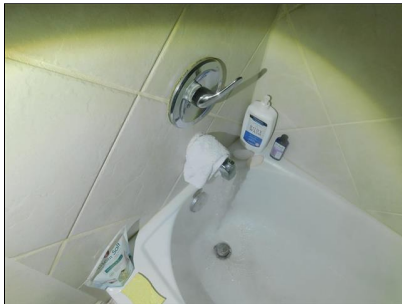
A. Item 5(Picture)

(5) The guest bath plumbing is making a humming/vibration noise. A common cause for the noise made by your shower is the build-up of water pressure in the pipes, either caused by sediment in the pipes or friction created when the water flows through curves in the pipe. Recommend that a plumber evaluate and make necessary repairs.

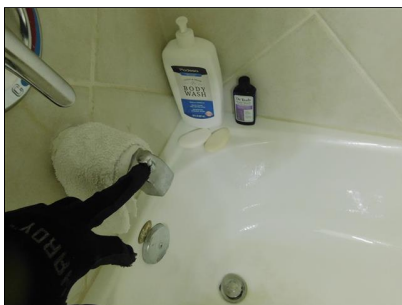
A. Item 6(Picture)

(6) Shower valve did not function.

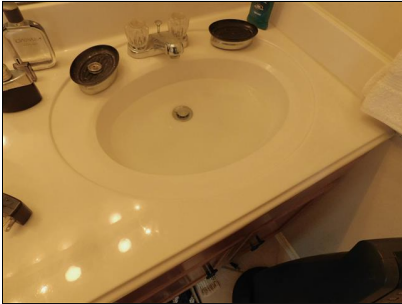
B. Item 1(Picture)

(1) The drain was slow, and may be clogged in the master bath sink. I recommend repair by a plumber.

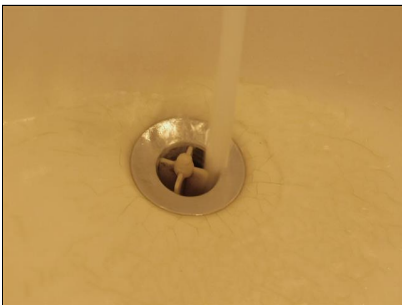
B. Item 2(Picture)

(2) Drain stops were missing.

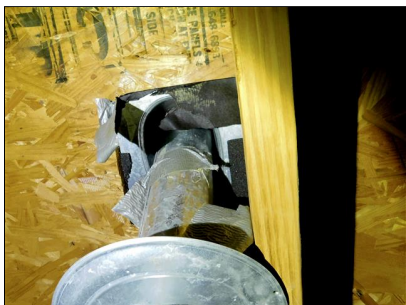
C. Item 2(Picture)

(3) Flue vents not properly secured at elbows with sheet metal screws. Tape is currently being used, which can become a source of combustion. Remove tape and properly secure vents with sheet metal screws.

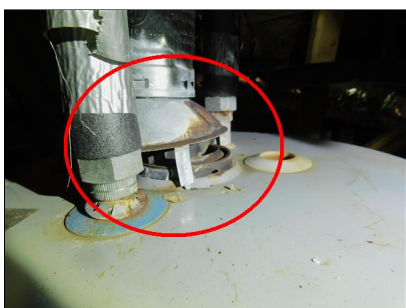
C. Item 3(Picture)

(4) The water heater flue and bonnet are not centered to the combustible draft port. This is a safety hazard as noxious gases are not properly vented from interior. Immediate repair required.

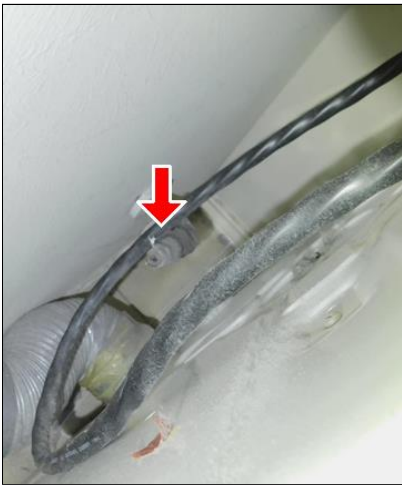
E. Item 1(Picture)

Unused gas lines must be capped to prevent accidental discharge.
