HOUSECHECK REAL ESTATE INSPECTIONS

PROPERTY INSPECTION REPORT

Concerning: 9118 Petersham Drive
(Address or Other Identification of Inspected Property)

By: George Szontagh, TREC Lic. #2212 12/5/2018
(Name and License Number of Inspector) (Date)

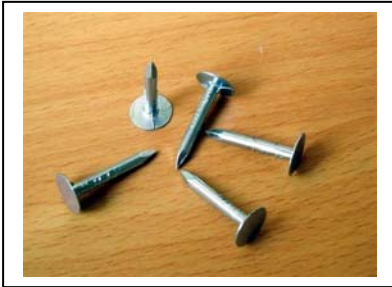
←Roof shingles at this location have self-seal strips, which are designed to melt in the sun after shingles are applied, and which seal down the shingles to help resist high winds and water penetration. A random sampling of shingles revealed that shingles are well-sealed, and prying up the exposed sections of shingle to examine nailing pattern would break the seals, potentially affect single performance, and void the shingle warranty.

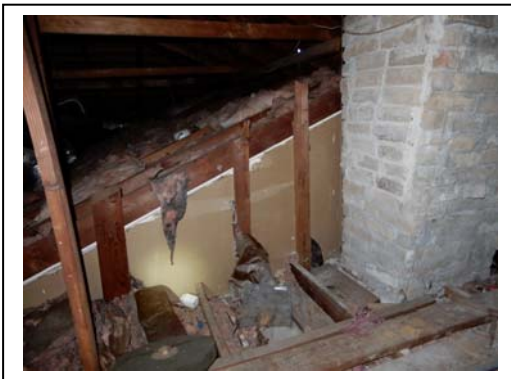
←Missing attic insulation at a few places, such as at the den raised ceiling vertical walls.

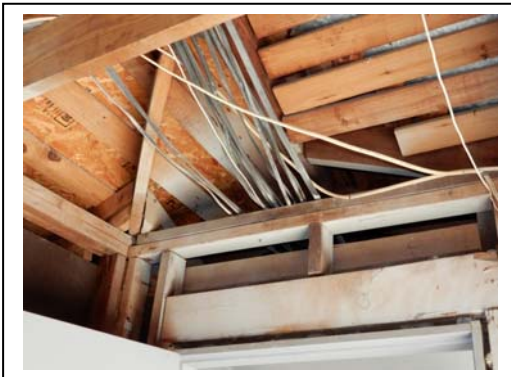
←Garage lacks adequate firestopping to the breezeway attic. Opening must be sealed properly, such as with drywall or 2x wood. This is to help stop a fire that starts in the garage from spreading to the main house structure.

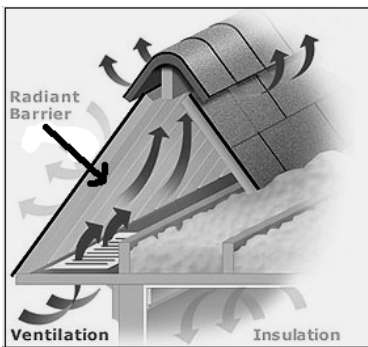
←Attic ventilation appears to be adequate, however it is unclear what performance will be like in the summer. Partial hip-roof attics of this type are difficult to vent adequately. If attic temperatures go over 110 deg F in summer, recommend adding more exhaust ventilation.

Also recommend adding intake (soffit) vents at the front of the house.

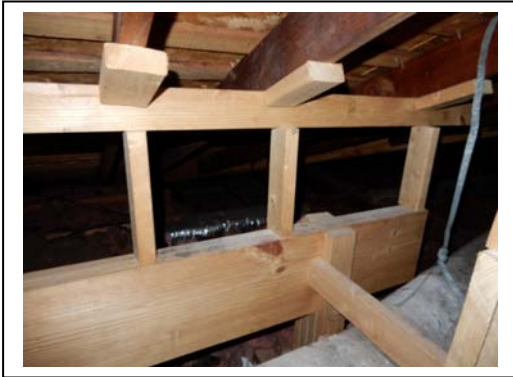
←As the furnace is in the way of purlin bracing over the front rooms, an extra beam was added behind the furnace. This work appears to be performing.

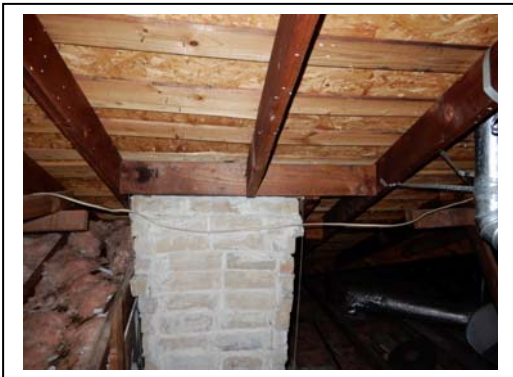
←Rafters at the chimney roof penetration were not properly doubled up as would be done today.

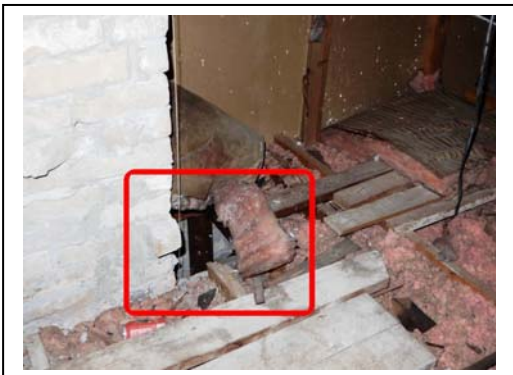
← There is no visible fireblocking material installed around the fireplace chimney in the attic. The space between the chimney and all floors and ceilings through which a chimney passes should be fireblocked with noncombustible material. (IRC 602.8,1001.16)

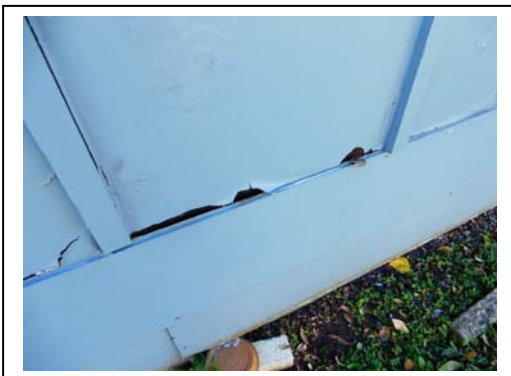
←**Water-damaged panel siding at the back of the garage.**

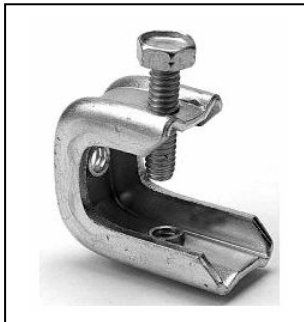
←**With a gas log installation, damper must be held fully open with a device called a damper stop or clamp. Stop here is missing. The stop is required to keep flue gases from venting into the dwelling and harming occupants.**

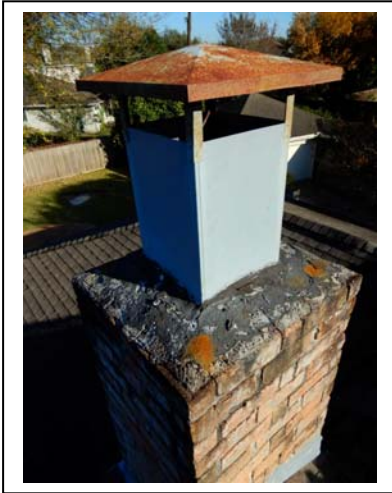
←Metal chimney cap should be primed and painted.

This system should not be used for fuel-burning purposes until it has been examined and repaired as needed by a chimney specialist.

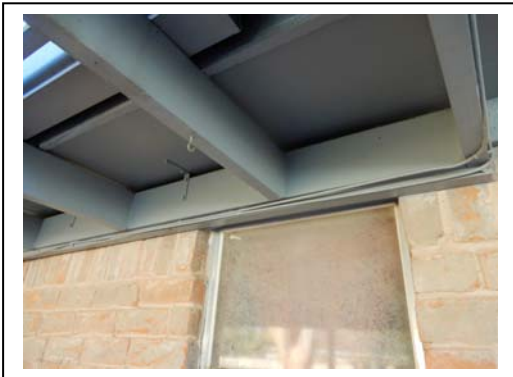
←Its unclear how the back pergola structure was attached to the house. Failure under load could occur.

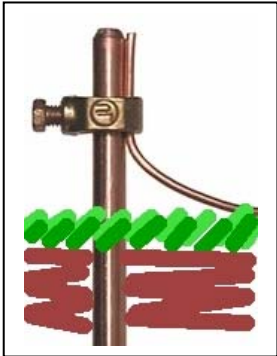
←Note that NEC 250.56 also requires a second grounding electrode unless testing shows <25 ohms resistance at existing electrode. Such testing is seldom done, and the installation requirement of a second electrode in our area is rarely enforced in residential settings. During extended dry weather periods, the effectiveness of a single grounding electrode could be affected.

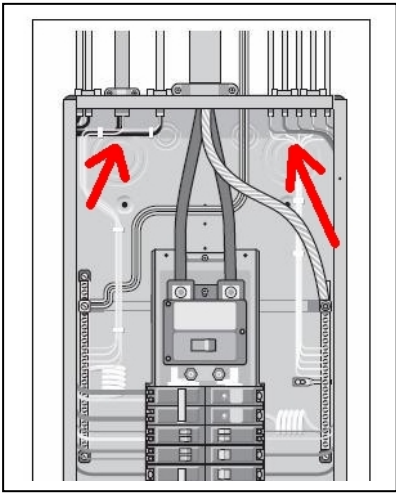
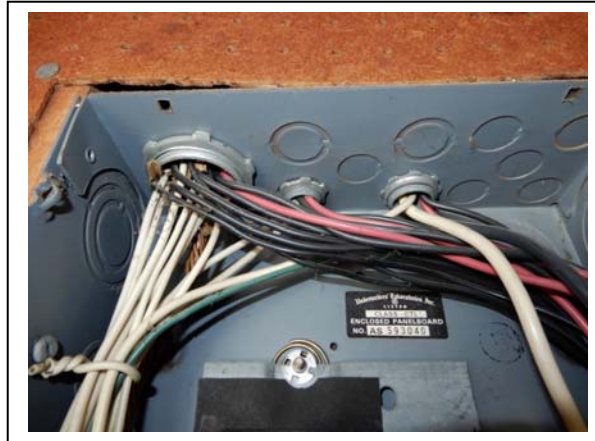
↑ **Most Romex cables where entering the panel are not secured properly as per NEC Section 312.5 (C), which states that “each cable shall be secured to the cabinet, cutout box, or socket enclosure.” Grouping many cables together through one opening as was done here was a very common practice until recently, with municipal authorities approving such installations in many cases. While most installers and inspectors apparently have avoided dealing with this situation, the client should be aware that this was not a correct installation as per the NEC. Diagram shows correct installation.**

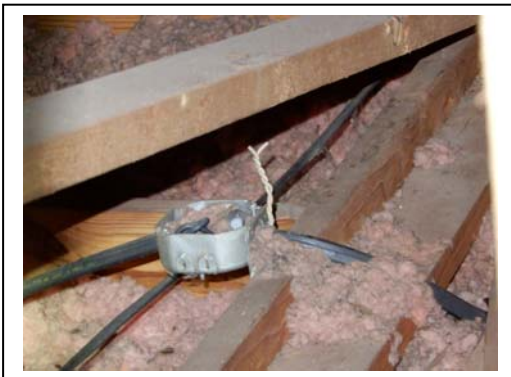
←Open junction box in the attic above the front BRs.

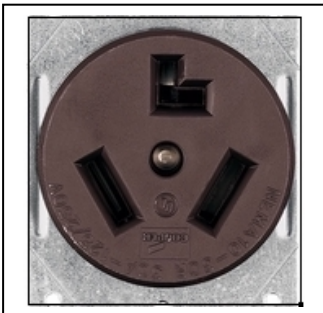
← **Client should be aware that the 240v clothes dryer receptacle is the older 3-prong type, and that newer 4-prong dryer cords will not work with this receptacle. Conversion by an appliance specialist or electrician may be needed. The 3-wire configuration was upgraded for safety in the mid-1990s to a 4-wire circuit. Upgrading at this point at this dwelling would require new wiring to be run from the breaker panel.**

← **Note also that with 3-wire dryer cabling, the neutral is also the ground; and as the neutral is typically carrying some current (from the 120v dryer motor), the metal dryer cabinet is not properly grounded, by modern standards. The**

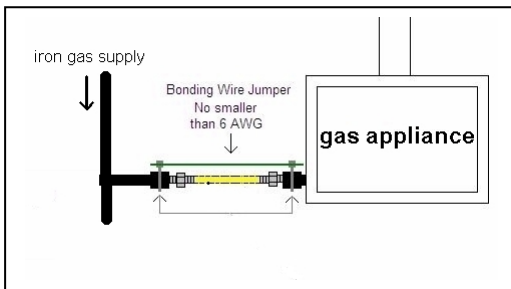
←Inspector recommends bonding across flex gas lines at the furnace and water heater, to reduce likelihood of lightning-induced damage to flex lines.

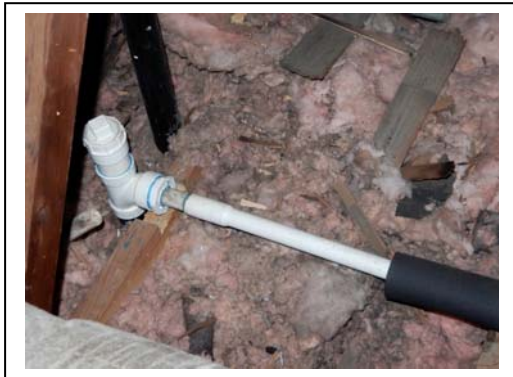
←Primary condensate drain runs directly to a DWV (sewer) stack at the hall bathroom, presumably with its own trap in the wall. This arrangement is controversial and no longer permitted, as it can allow sewer gases to enter into the HVAC system if the trap dries out. Ideally drain should be run to an active trap, such as at a tub or lavatory, or to the outside.

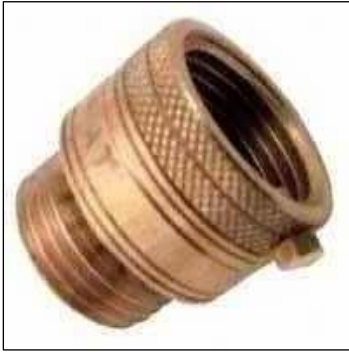
←**Hose bibs lack proper backflow preventers.** These are inexpensive screw-on products, which prevent contaminated water from being siphoned back into the potable water lines during city water pressure outages.

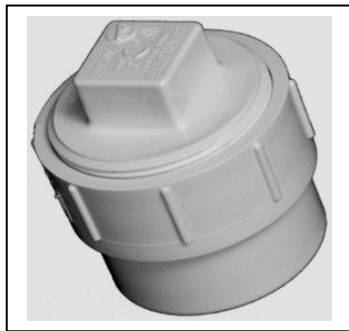
Inspector was not able to readily locate a main sewer cleanout, in the yard. There may be one concealed below grade or behind vegetation or other cover. Recommend the cleanout be located. A cleanout is a capped access point in a drain system that allows snaking and cleaning of the lines. If a main dwelling sanitary cleanout is not located, recommend that one be installed. Cleanouts are an important aspect of the sanitary drain system and are very useful for testing purposes, and for when drains become clogged. The time to install a cleanout is not when the main sewer line backs up.

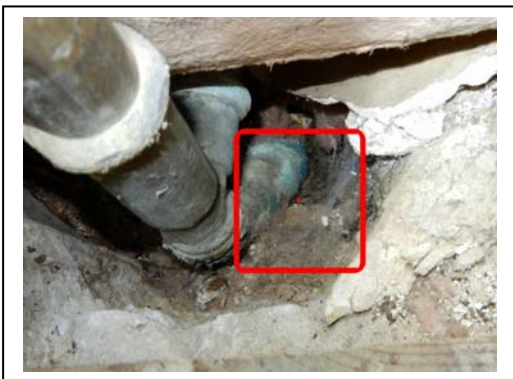
←Tub drain leaking under house.

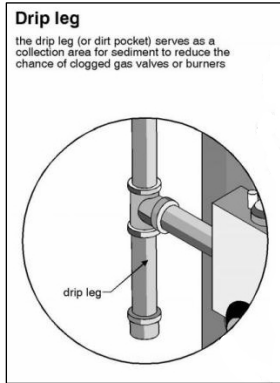
←**Gas supply lacks a sediment trap/ drip leg at the unit. Installing one has been specified by manufacturers for many years. Absence of a drip leg can result in problems with warranty claims. See manufacturer's installation instructions.**

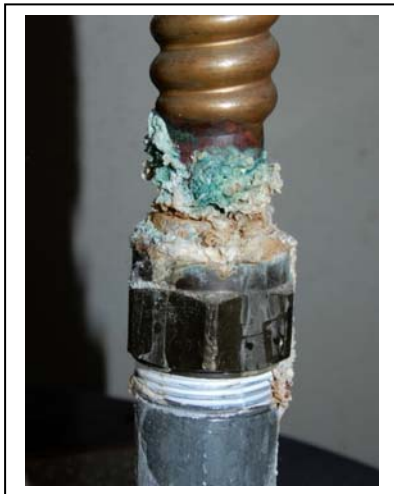
←**Corrosion at water connection.**

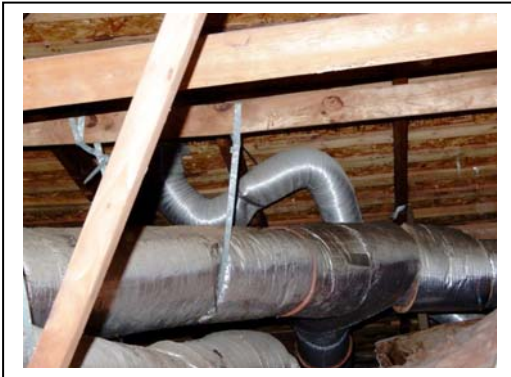
←Vent pipe in the attic is metal, but is a corrugated product, not smoothwall pipe. Fire hazard.

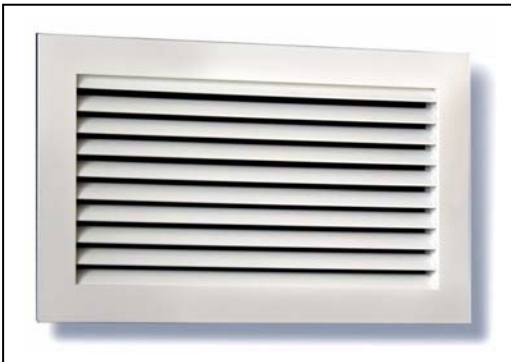
← **Room must have makeup air supply. This can be provided by adding louvers etc.**

← In some new construction applications, builders will add a fixed louver grille on each side of an interior studwall, to create proper makeup air.
