Home Inspection Report

9934 Valley Mill Ct
Houston, TX 77078

PROPERTY INSPECTION REPORT

Inspection Date: 07/28/2020

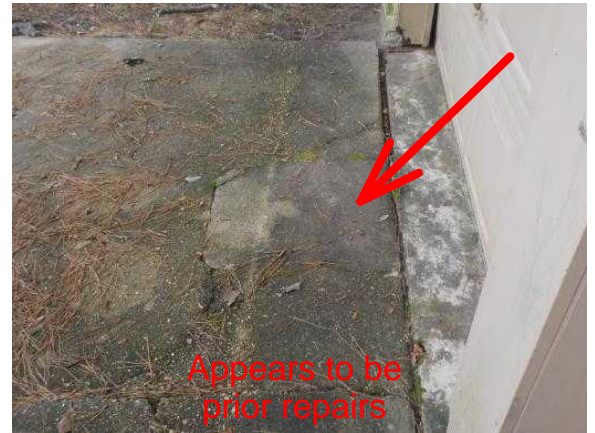
Observed prior foundation repairs at the driveway. Recommend gathering as much information as possible on who did the repairs and what was the extent of the repairs. Also inquire as to whether the warranty is transferable.

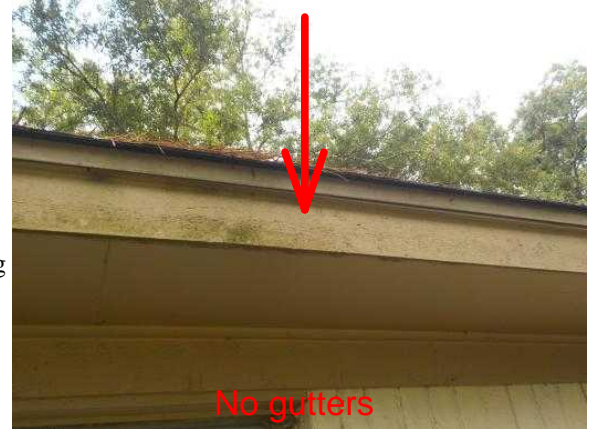
This structure has no guttering system. Recommend installing a full gutter system. The gutter system is designed to expedite the drainage of water away from the property. Splash plates located under the downspouts can help direct water away from the foundation and reduce soil erosion which can reduce the effectiveness of the termite chemicals placed in the soil. A properly installed gutter system is an important tool in maintaining even moisture content in the surrounding soil.

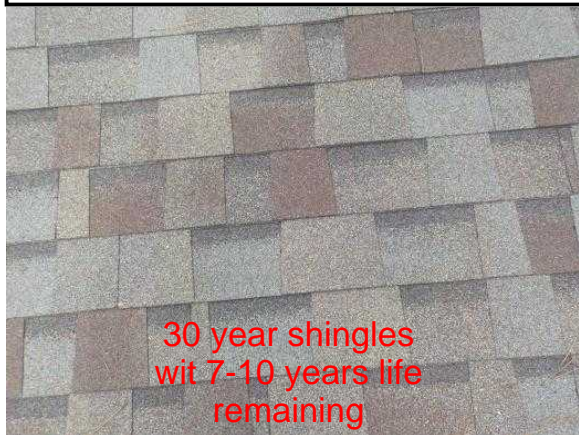
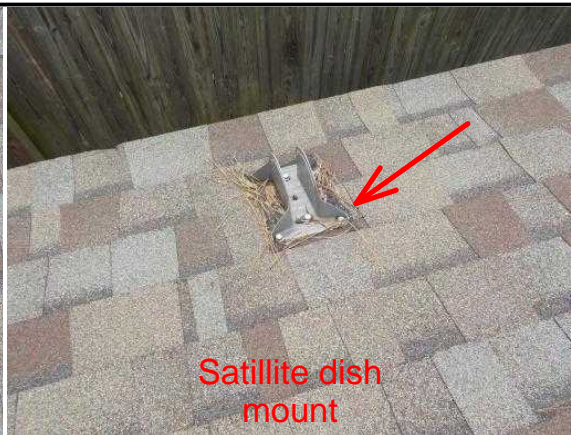
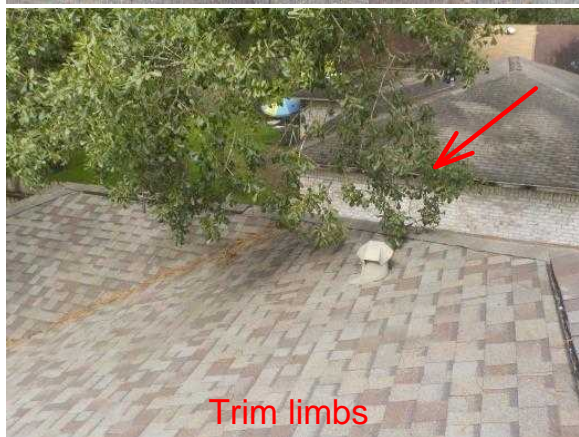
A roof mounted satellite dish is installed. These are known to be problematic over time. It should be noted that often, removing the satellite dish is more conducive to water entry than leaving the dish installed. Many owners choose to leave the dish in place until the roof is replaced, at which time they will remove the dish.

Observed impinging tree limbs at the front. Recommend trimming all limbs back at least 5 feet from roof.

Observed impinging tree limbs at the front. Recommend trimming all limbs back at least 5 feet from roof. Types(s) of Roof Covering: Architectural (30 year shingle) Viewed From: Walked roof

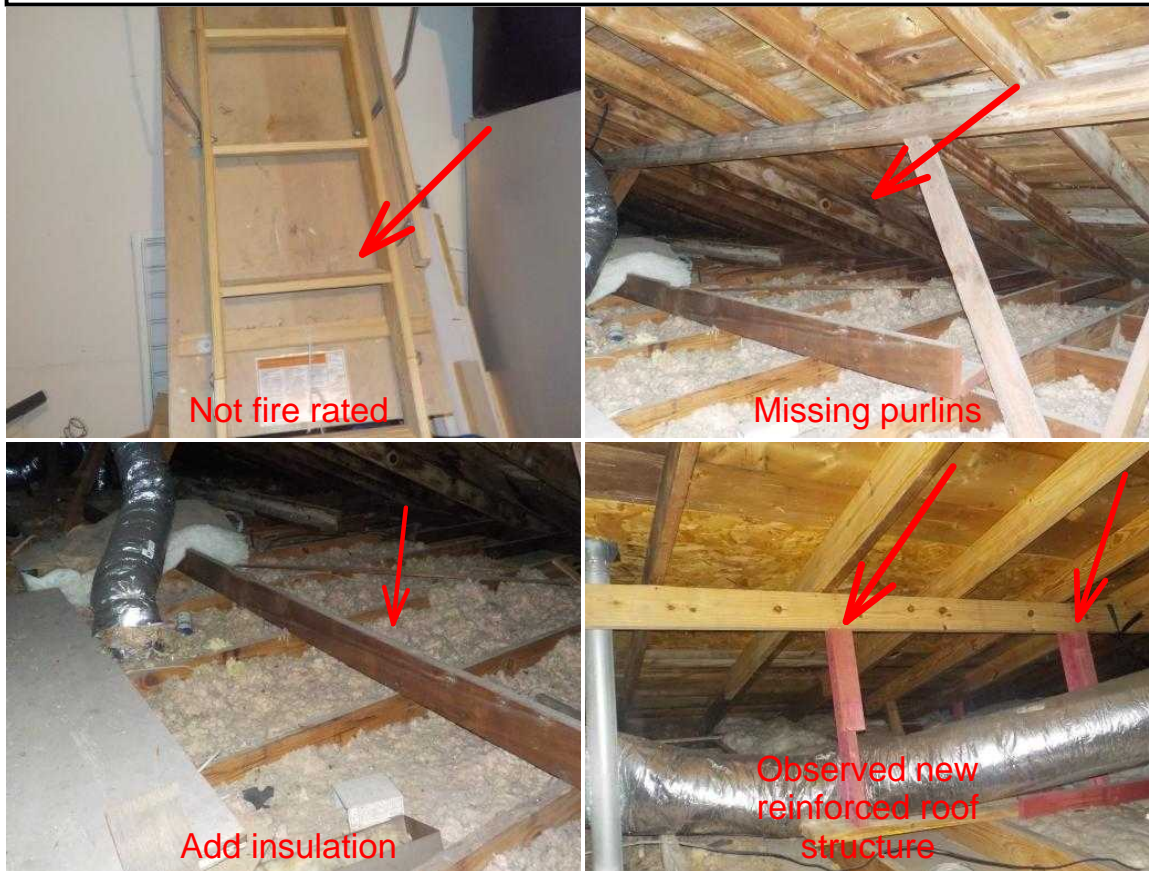
Attic insulation is missing in one or more locations and is required to be a minimum thickness throughout the attic of at least R-26 or 8.75" (IRC Table n1102.1).

Installed attic ladder does not appear to be fire rated. Since garages frequently house flammable materials, attached garages are required to have fire walls installed at walls and ceilings. Attic stairs must comply with this requirement.

Purlins shall be sized no less than the required size of the rafters that they support. Purlins shall be continuous and shall be supported by 2-inch by 4-inch (51 mm by 102 mm) braces installed to bearing walls at a slope not less than 45 degrees from the horizontal. The braces shall be spaced not more than 4 feet.

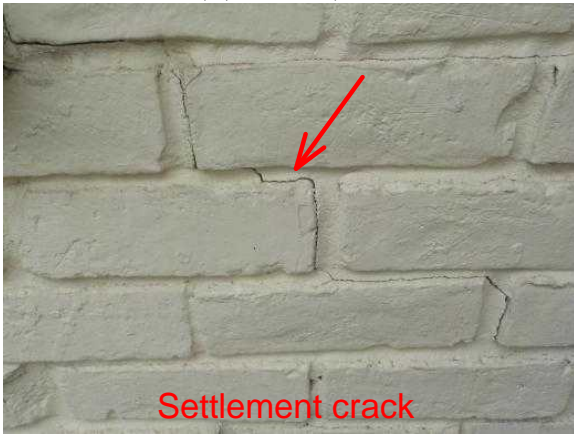
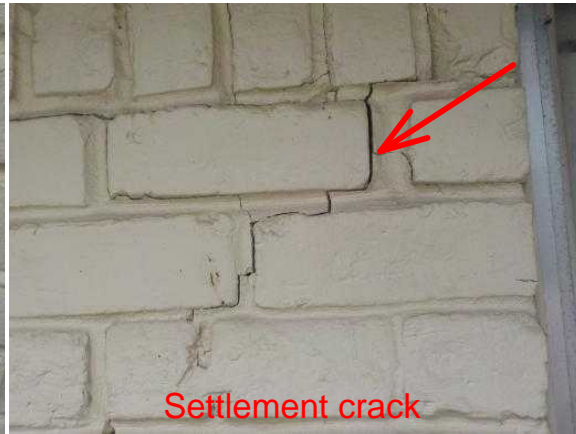
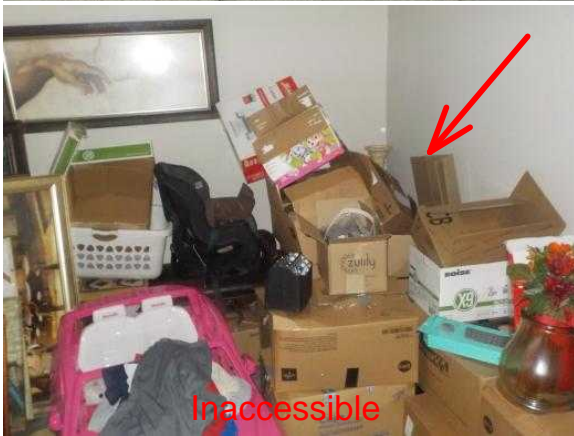
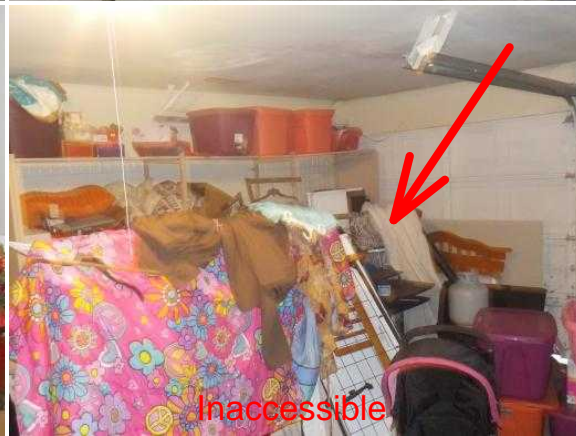
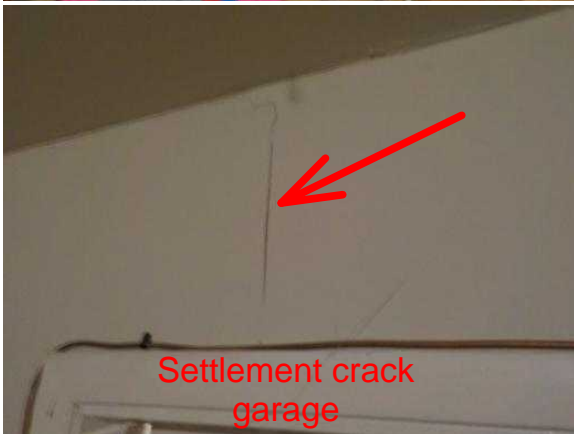
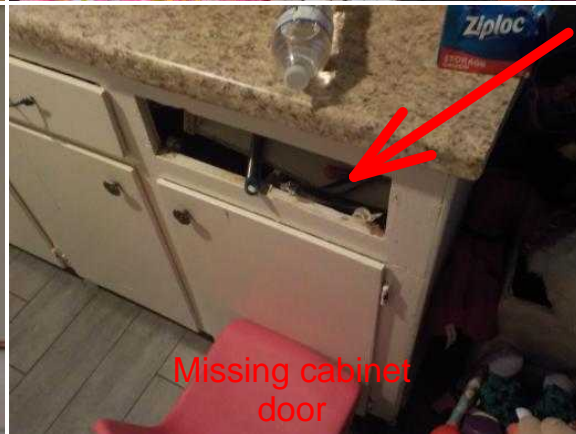
Observed settlement cracks in the brick veneer at the right side of home.

Common cracks up to 1/8" were noted in the interior gypsum wallboard. Cracks near the interior windows and doors are usually indications that there is some degree of movement occurring in the structure. (in any structure some degree of movement is normal and should not be of concern) the severity of the cracks can be an indication of the amount of movement in a structure. Photos are representative of the issue and may not include all instances of the issue.

Observed missing door at the kitchen cabinet.

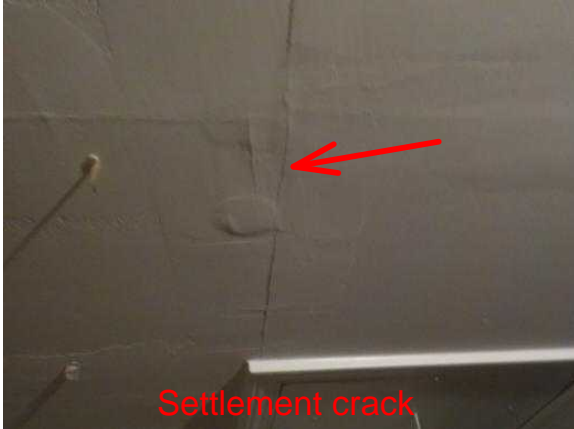
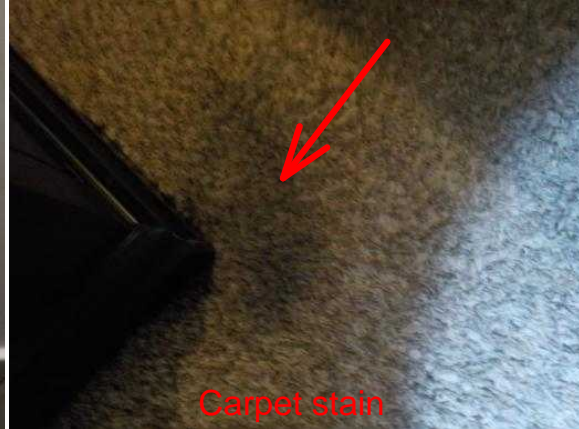
Common cracks up to 1/8" were noted in the interior gypsum ceiling board. Cracks in the ceiling are usually indications that there is some degree of movement occurring in the structure. (in any structure some degree of movement is normal and should not be of concern) the severity of the cracks can be an indication of the amount of movement in a structure. Photos are representative of the issue and may not include all instances of the issue.

Observed carpet stains.

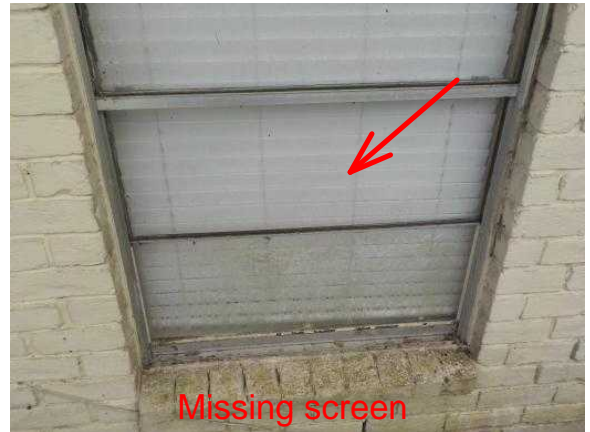
Observed missing screens at various locations. This is a known safety hazard.

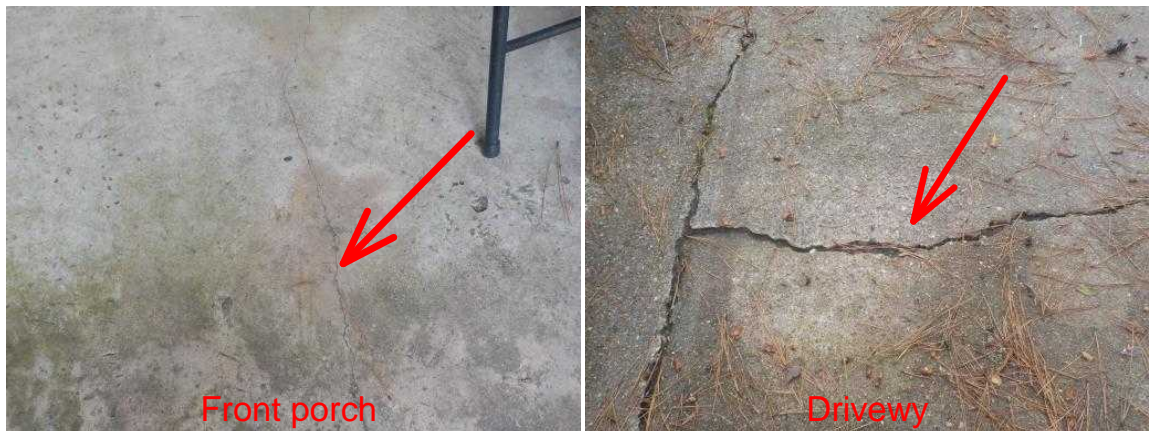
There are hairline cracks on the sidewalks, driveway and porches. These cracks are common in this area with this type of foundation. Recommend starting a good moisture program around the slab area. This will help reduce the amount of these types of cracks. Recommend also that these cracks be monitored periodically to see if they increase in size. If they do, consult with a licensed structural engineer.

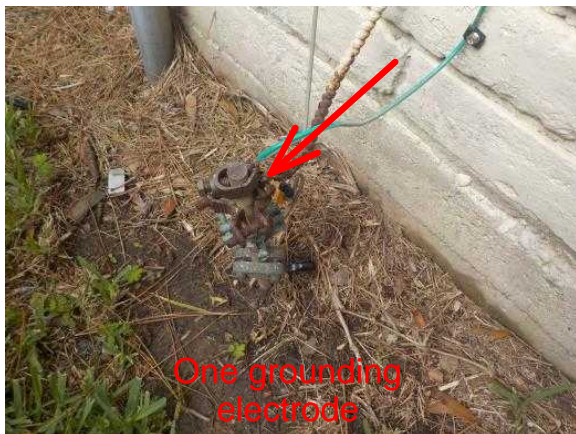
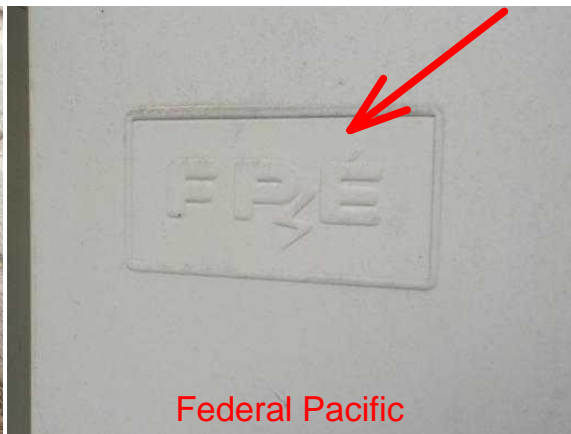
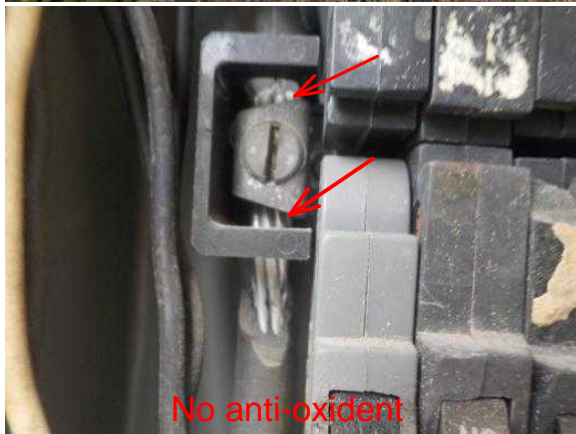
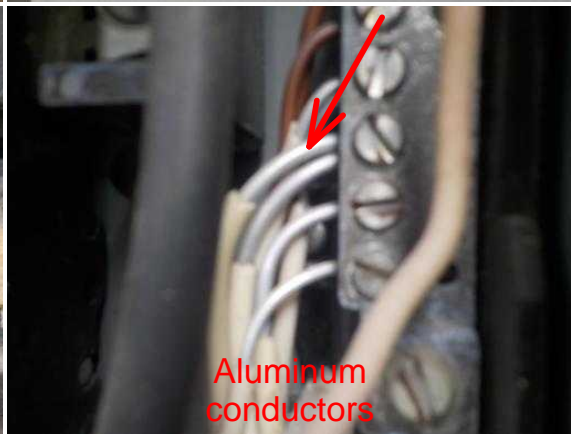
Observed one grounding electrode. Current standards require two.

The circuit breakers are not identified and labeled. Proper labeling of circuit breakers can be crucial during an emergency situation.

*** Safety Warning*** Observed a Federal Pacific Electric "Stab-Lok" service panel in the house. This panel may be a latent fire hazard: this brand of circuit breakers may fail to trip in response to an overcurrent or a short circuit. Failure of a circuit breaker to trip can result in a fire, property damage, or personal injury. A circuit breaker that may not trip does not afford the protection that is intended and required. Simply replacing the circuit breakers may not a reliable repair. The buyer is advised to contact a licensed electrician for an expert opinion on this panel. Additional information about the fire and shock hazards associated with this equipment can be read on the internet at <http://www.inspect-ny.com/fpe/fpepanel.htm>.

Breaker box did not have a main cut-off (disconnect) breaker. It is considered a hazard if it takes more than six motions of the hand to shut off the electricity of the main structure. The box should not be locked or obstructed in any way. Be aware of where the breaker box is located.

Aluminum wiring was not terminated properly. Aluminum wiring is acceptable if the terminations are of the correct type. In most cases, this is co/alr type fixtures and breakers. Sometimes the wires are "pigtailed" or pressure fitted to copper wire for termination. This is called "cop/alum pigtails". The expansion rate of aluminum wiring and copper wire rated fixtures are different. Co/alr fixtures are made to compensate for this. The Texas Real Estate Commission has determined that this is an item in need of repair; a qualified technician should service the electrical system.

Observed a missing dead front. This is a safety issue.

Observed the absence of anti-oxidants on the aluminum service conductors. This is a recognized safety hazard and should be repaired by a licensed electrician.

Aluminum wiring was not terminated properly. Aluminum wiring is acceptable if the terminations are of the correct type. In most cases, this is co/alr type fixtures and breakers. Sometimes the wires are "pigtailed" or pressure fitted to copper wire for termination. This is called "cop/alr pigtails". The expansion rate of aluminum wiring and copper wire rated fixtures are different. Co/alr fixtures are made to compensate for this. The Texas Real Estate Commission has determined that this is an item in need of repair; a qualified technician should service the electrical system.

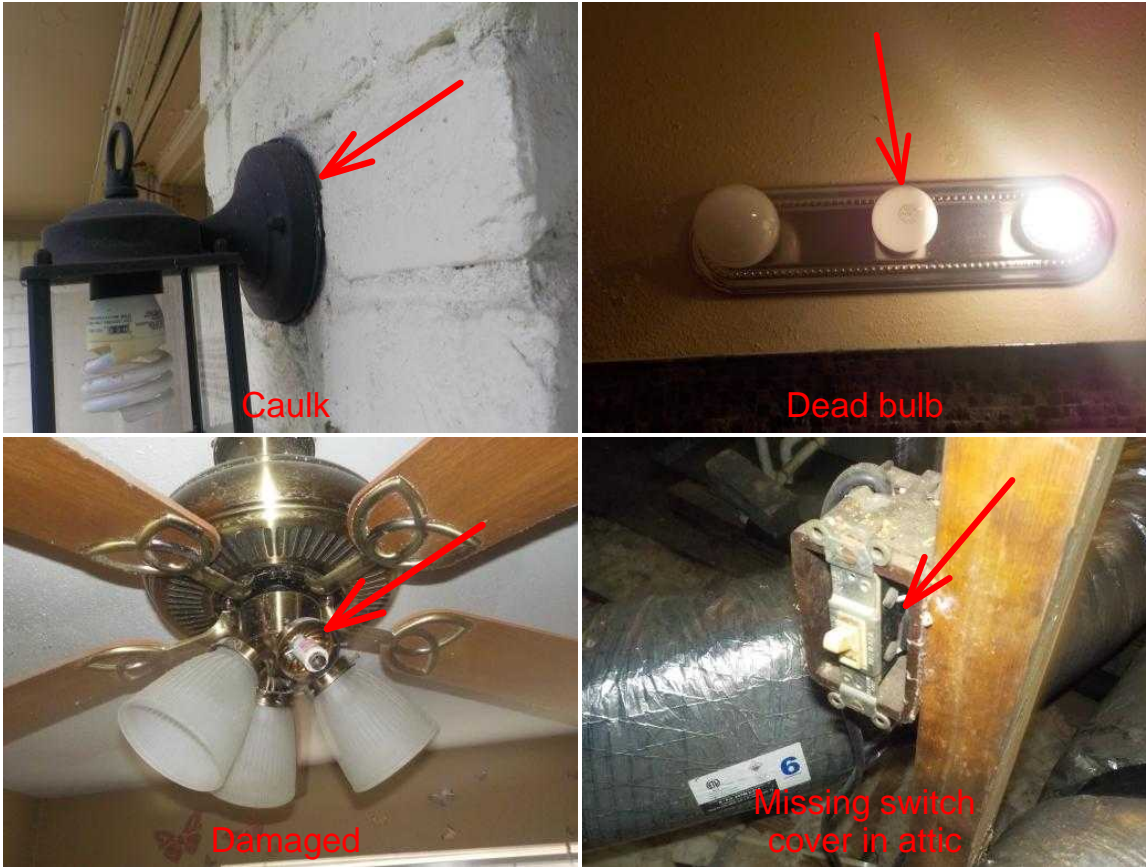
Observed an absence of smoke or fire detectors in required locations. Smoke detectors are required in each bedroom and adjoining hallway, and at least one on each level of the home. Add/replace smoke detectors as needed.

Some lights did not function when tested. Light bulbs should be replaced and fixture operation verified to ensure an underlying electrical problem does not exist.

Observed no outlets in the bathroom.

Observed some damaged ceiling fan lights.

Recommend caulking and sealing exterior light fixtures. This will help prevent possible insect infestation and moisture penetration to the structure.

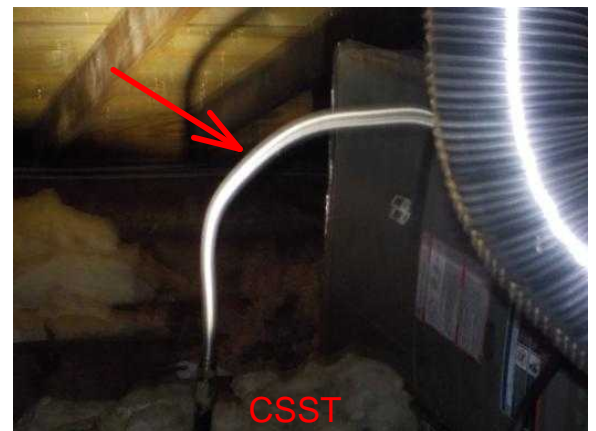
Observed CSST gas line connector at furnace that is not bonded.

Observed CSST gas line connector at furnace that is not bonded. Type of System: Forced Air Energy Source: Natural gas

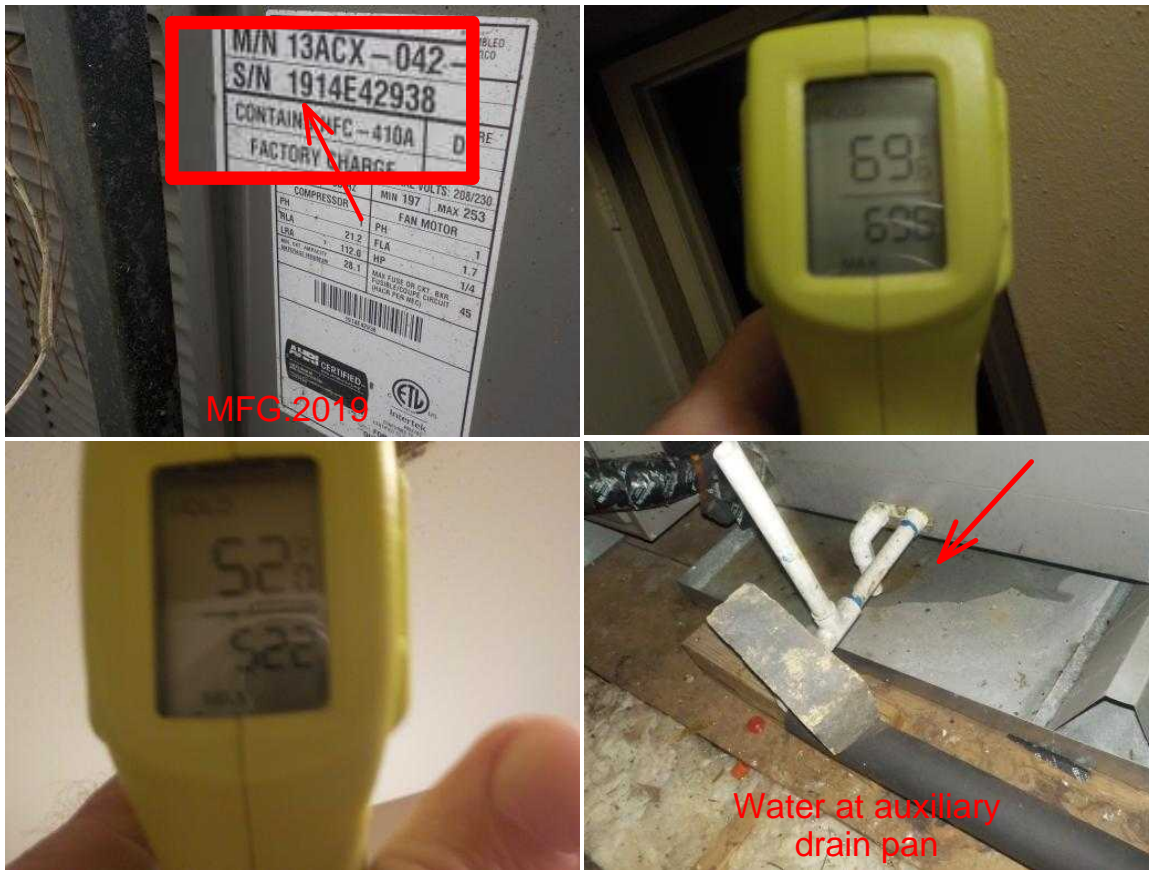
Observed water at the auxiliary drain pan. This is usually a sign the primary drain is clogged. Recommend service by an HVAC technician.

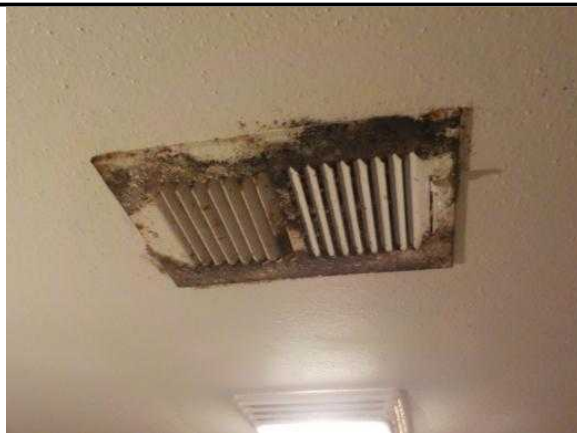
Observed moisture and organic growth at the supply vents.

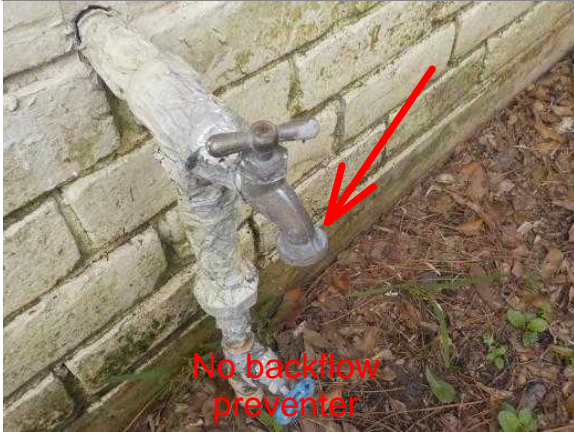
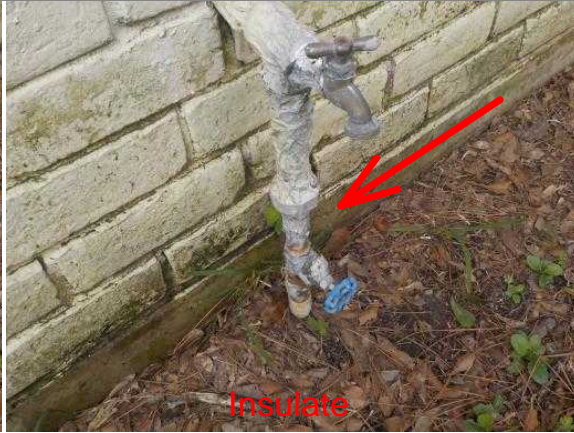
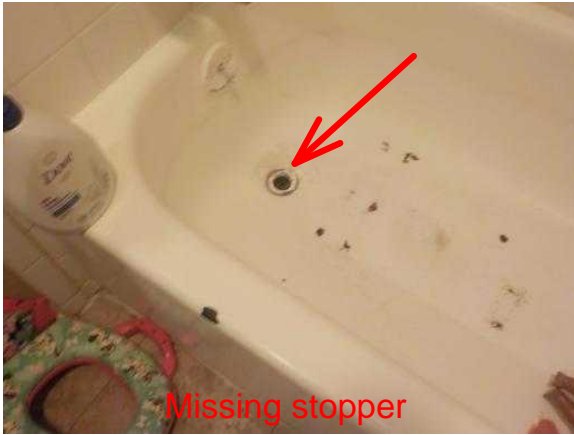
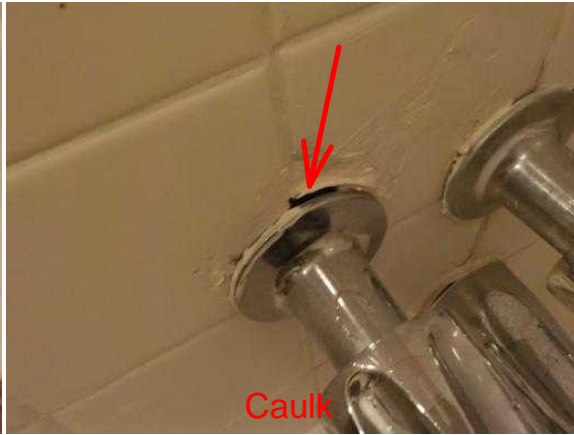
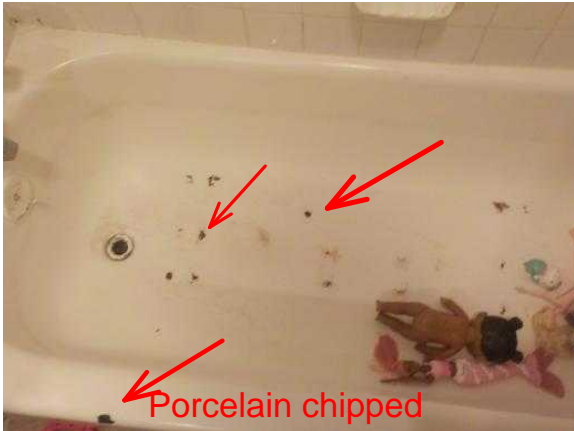
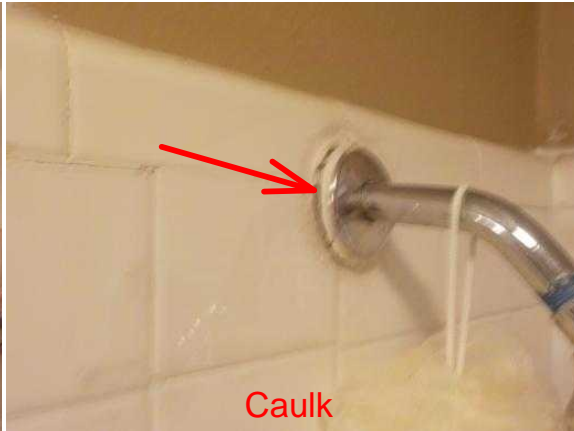
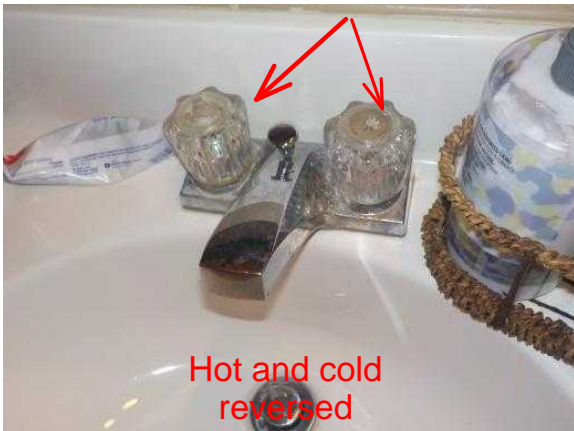
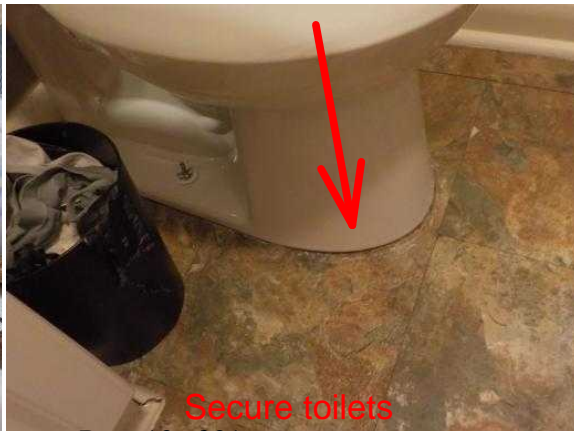
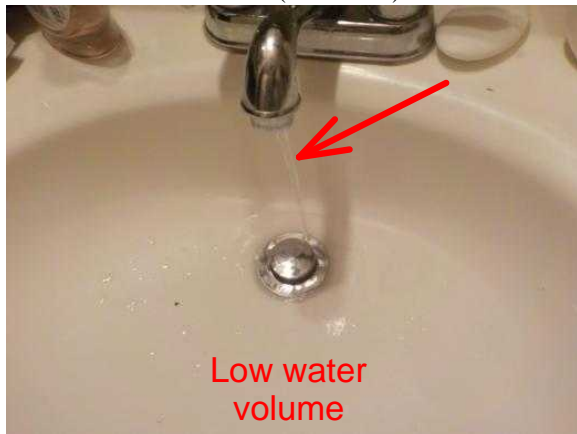
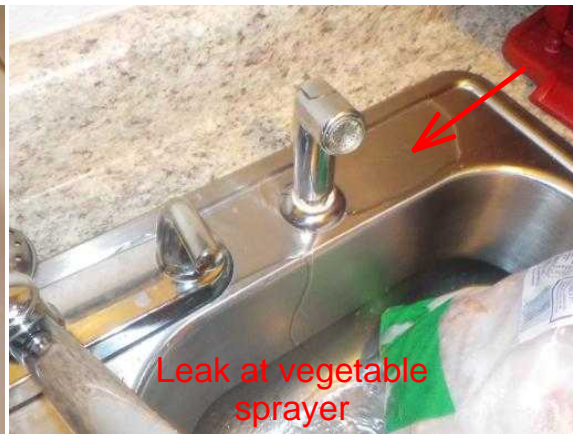
Backflow preventers were not installed at all exterior hose bibs. Recommend installing at all hose bibs to meet required standards. These are inexpensive screw-on products, which prevent contaminated water from being siphoned back into the potable water lines during city water pressure outages.

Observed exterior water piping material that should be insulated.

Shower/tub needs caulking. Caulk any gaps that may appear between the hardware and tile of the fixtures or shower enclosures. Most tile surfaces will have gaps in the grout that can also allow for water penetration past the tile work. A leak in any one of these areas can cause concealed structural damage that would not be obvious in a visual inspection.

Observed a leak at the vegetable spray when the water is turned on.

Observed loose toilets. Recommend securing all loose toilets.

Observed missing tub stoppers.

Observed the hot and cold is reversed at the hall bathroom sink.

Observed the stopper adjuster is frozen open at the hall bathroom sink.

Observed the kitchen plumbing is noisy when turned on.

Observed low water volume at the master bathroom sink.

Observed damaged porcelain at the bathtub.

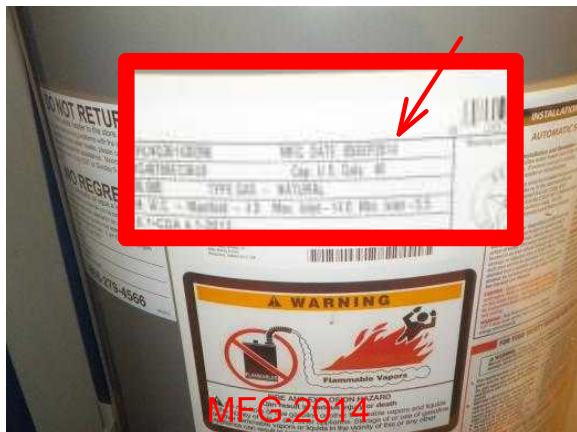
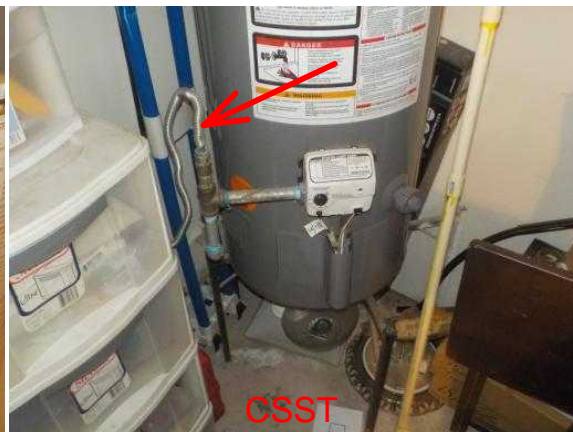
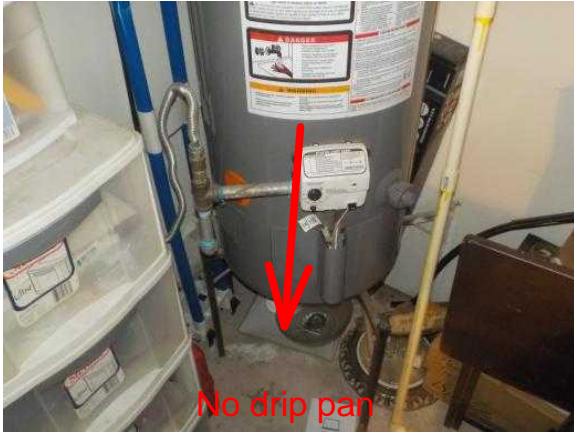
Observed CSST gas line connector at water heater that is not bonded.

Observed no drip pan under water heater.

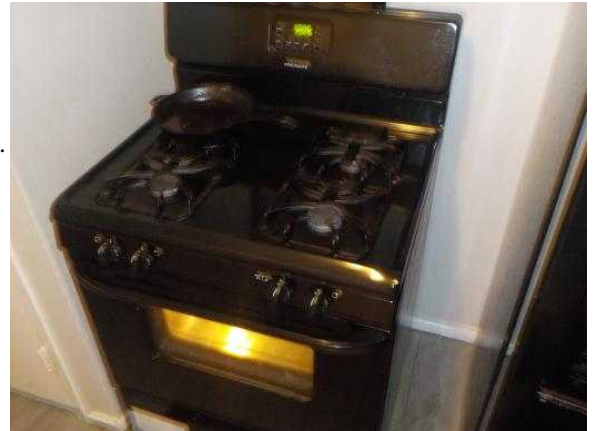
Install anti-tip device as required.

Kitchen stove anti-tip bracket is a single or two piece device, supplied by the stove manufacturer, that must be installed at the base / behind the stove. It prevents the stove from tipping over or tilting while somebody applies pressure to the open oven door.
