PROPERTY INSPECTION REPORT

Concerning: 113 Dolphin Ave, Galveston TX 77550
(Address or Other Identification of Inspected Property)

By: Neal Harris - TREC #23748 11/19/2020 9:00 am
(Name and License Number of Inspector) (Date)

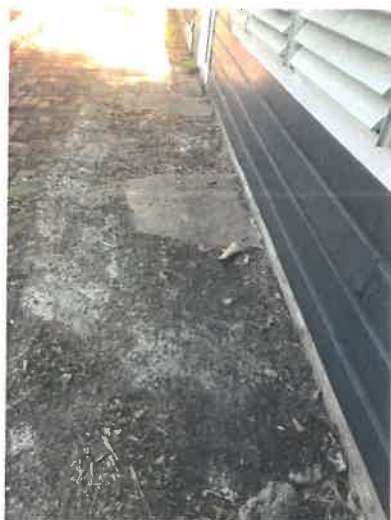
1: Slab: Cracks

Cracking was noted at the foundation. This is typically consistent with soil movement and could lead to serious damage to structural components, foundation and/or slabs. Evaluation and recommendation of a course of action/remedy by a licensed structural engineer is recommended.

Recommendation: Contact a qualified structural engineer.

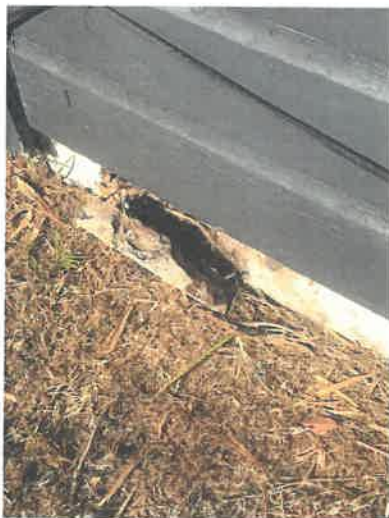
2: Trees Too Close

Root systems of large trees planted too close to the foundation can cause foundation problems.

Recommendation: Contact a qualified professional.

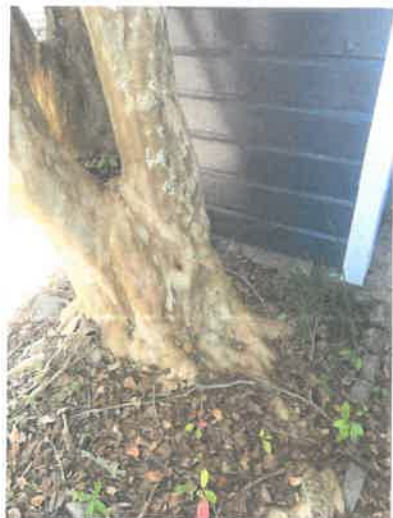
1: Grading & Drainage: Inadequate

Low spots, ruts, and/or damaged sod were present at the time of inspection. Regrading by a qualified landscaping contractor or foundation contractor so that water flows away from the home is recommended.

Recommendation: Contact a qualified landscaping contractor

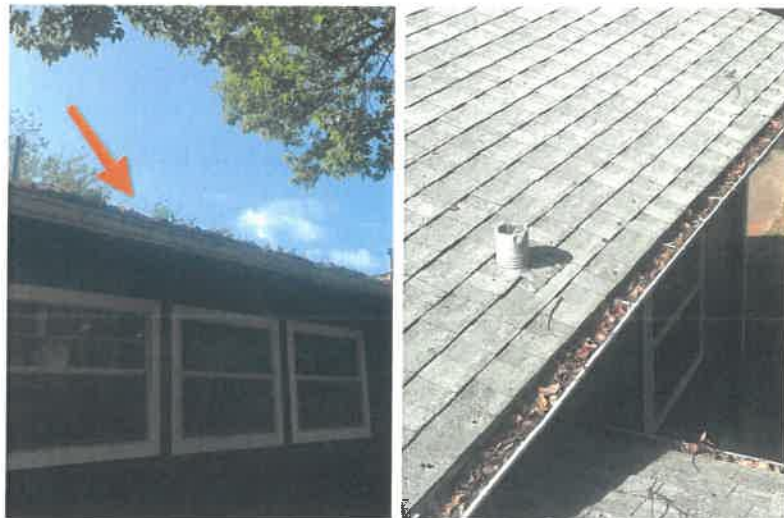
3: Gutters & Downspouts: Damaged

Further evaluation of the gutter and drainage system is recommended.

Recommendation: Contact a qualified landscaping contractor

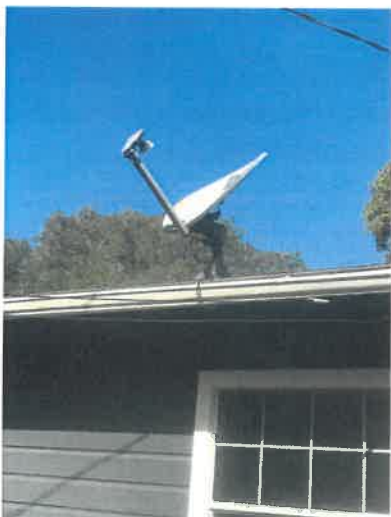
2: Tree limbs on/near roof

Tree limbs that are in contact with roof or hanging near roof should be trimmed to prevent damage to the roofing materials.

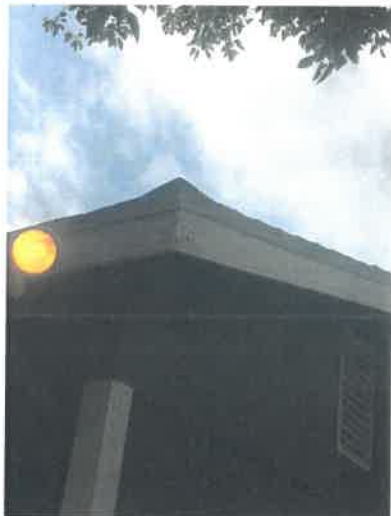
5: Drip Edge: Loose, Damaged, or Not Continuous

Sections of drip edge were loose, damaged, or not continuous.

Recommendation: Contact a qualified roofing professional.

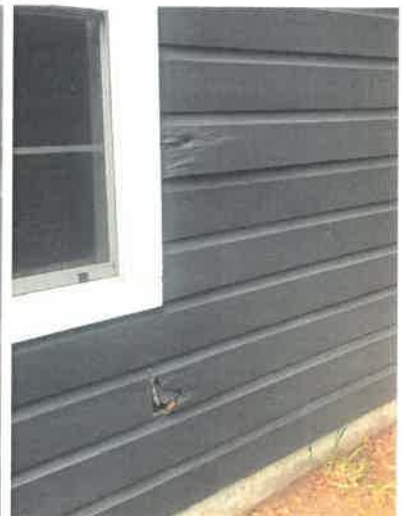
2: Exterior- Siding: Siding Damage

There was damage to exterior siding.

Recommendation: Contact a qualified professional.

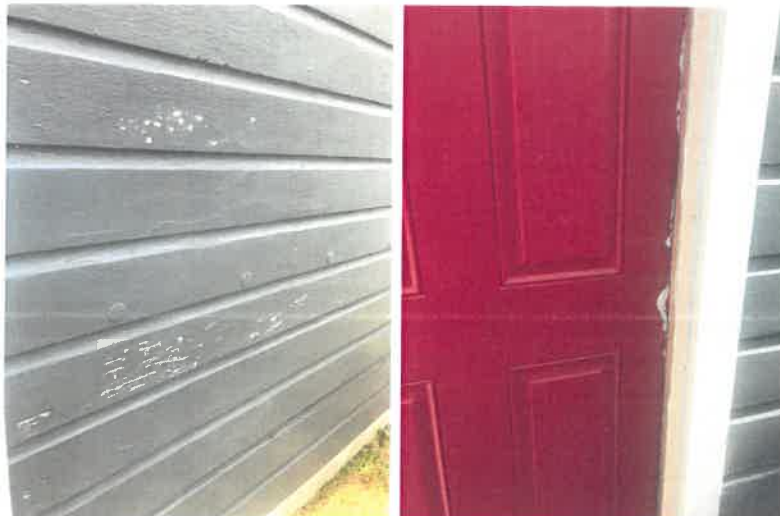
6: Exterior: Siding or brick is too close to grade

Siding should be a minimum of 6 inches above finished grade. Brick and stone should be a minimum of 4" above grade. Remedy as needed.

Recommendation: Contact a qualified professional.

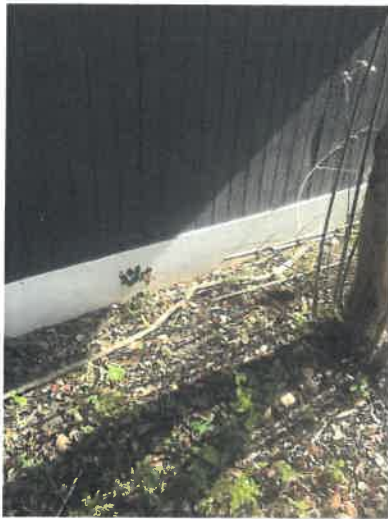
A high soil level was observed. The foundation should have at least 4 inches of exposure. Remedy as needed.

Recommendation: Contact a qualified landscaping contractor

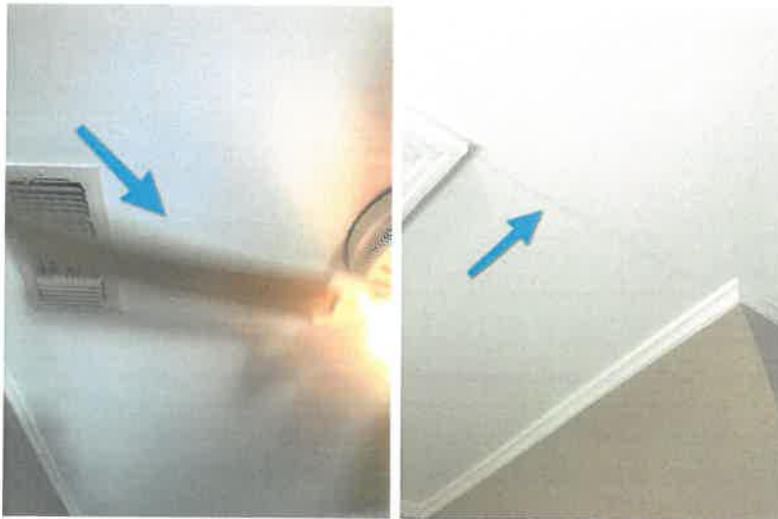
1: Ceiling: Texture Cracks

Texturing cracks were observed in vaulted ceiling joints and appear cosmetic in nature. These are not typically caused by structural defects.

Recommendation: Contact a handyman or DIY project

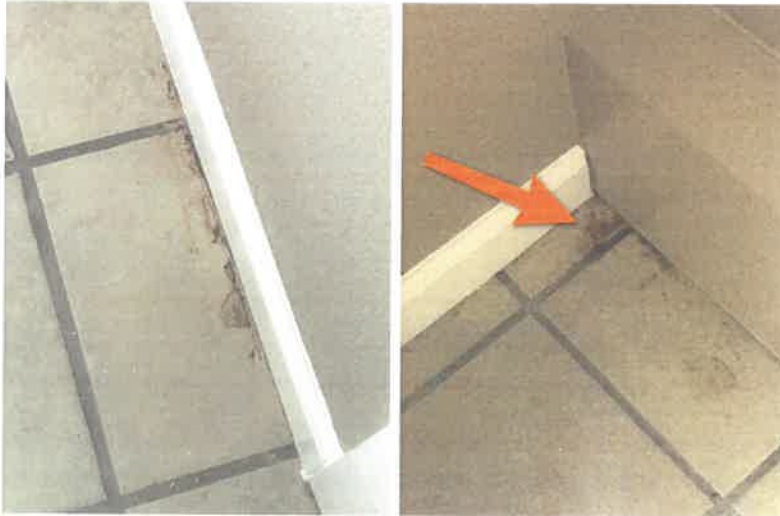
3: Flooring: Damaged

Flooring had damage visible at the time of the inspection. Evaluation by a qualified flooring contractor is recommended.

Recommendation: Contact a qualified professional.

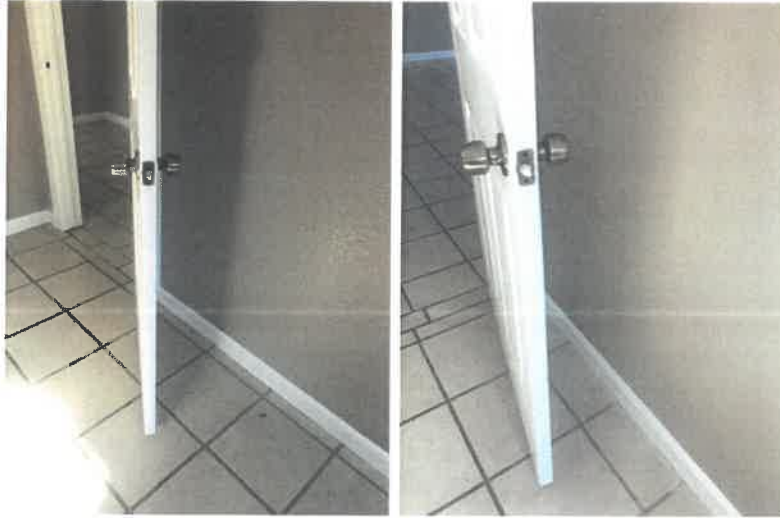
7: Door Hardware: Doorknob Loose

Loose doorknobs were observed. Loose doorknobs can cause door to stick or eventually fall out of place. Remedy as needed.

Recommendation: Recommended DIY Project

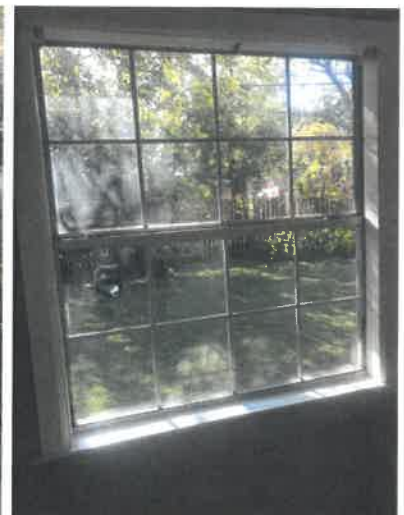
1: Missing/Damaged Screen(s)

One or more windows are missing a screen or had a damaged screen. Replacement of screens is recommended.

Recommendation: Contact a qualified window repair/installation contractor.

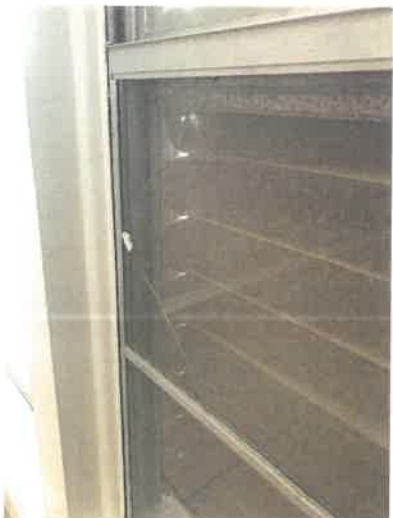
2: Cracked/Broken Glass Panes

Cracked or broken glass panes were present. Remedy as needed.

Recommendation: Contact a qualified window repair/installation contractor.

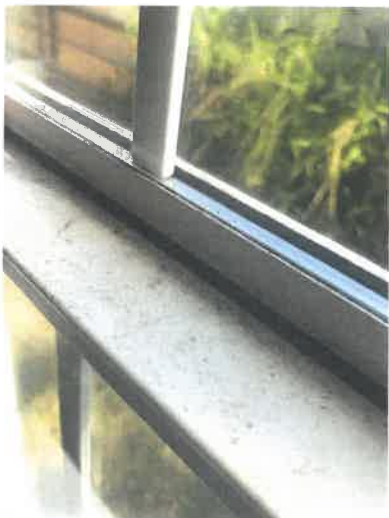
3: Possible microbial growth

For Example: Left Rear Bedroom

Recommendation: Contact a qualified professional.

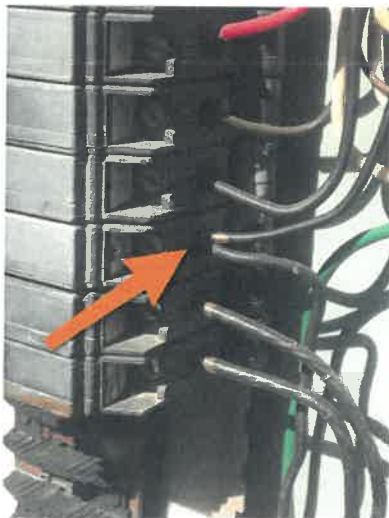
Two or more wires are attached to a single breaker. Most terminals are not designed for two wires, and is a poor installation practice. Further evaluation by a licensed electrician is recommended.

Recommendation: Contact a qualified electrical contractor.

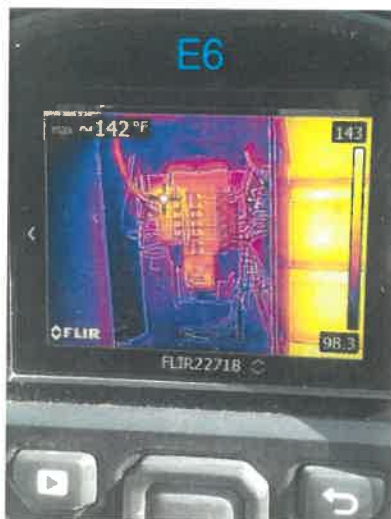
**3: IR: Breaker Too Hot**

Inspection of the distribution panel with an infrared camera revealed one or more breakers that were excessively hot. The temperatures could cause injury to a potential user if the surface or handle of the breaker is touched. Evaluation and/or remediation by a licensed electrician is recommended.

Recommendation: Contact a qualified professional.

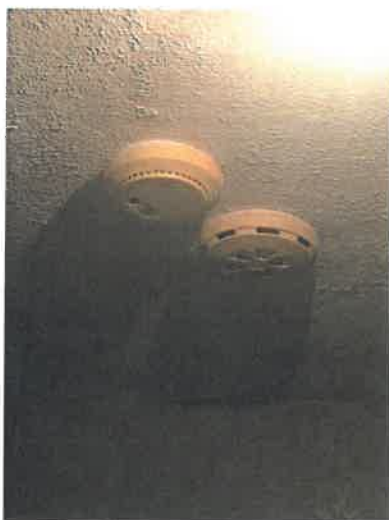
2: Smoke Detector Defective

Note: The inspector does not disassemble devices to check for expiration dates.

Recommendation: Contact a qualified professional.

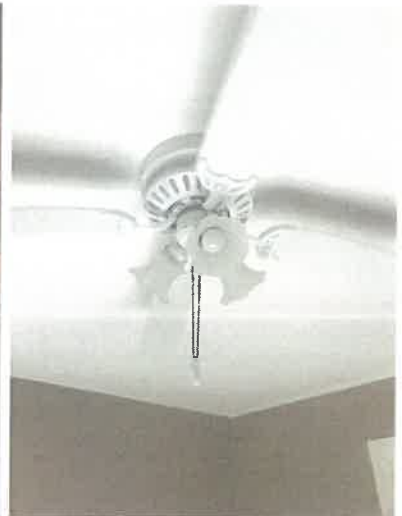
3: Ceiling Fan Defects

Light out, Inoperative -
Further evaluation is recommended.

Recommendation: Contact a qualified professional.
