Inspection Report

PROPERTY INSPECTION REPORT

Concerning: 1223 Watermoon, Richmond, TX 77469
(Address or Other Identification of Inspected Property)

By: Paul Ashlock - TREC#20340 03/28/2018
(Name and License Number of Inspector) (Date)

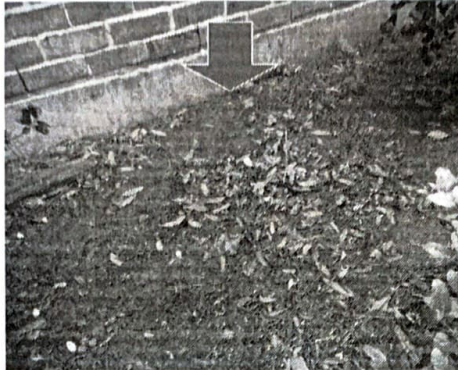
Front of the home

Yard area(s) next to the home's foundation appear to drain slowly- (standing water/grass not growing/moss growing) - This condition may cause the homes foundation to move and/or fail.

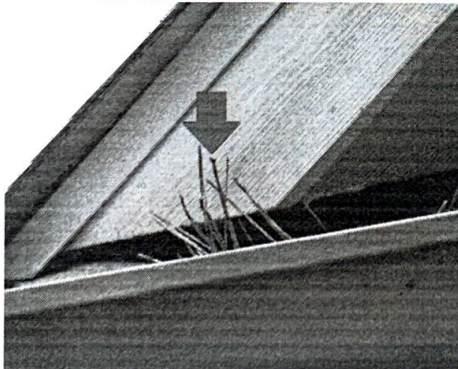
Gutters full of debris: Around the home.

- Fixed

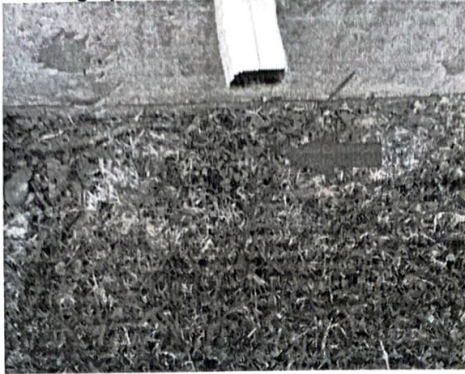
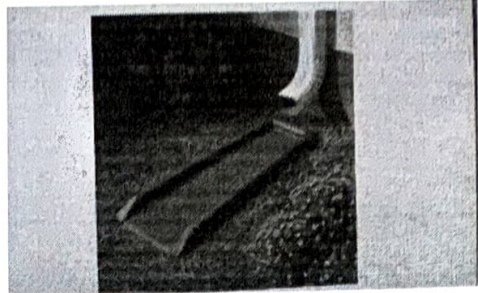
Missing splash blocks: Around the home.

Fixer

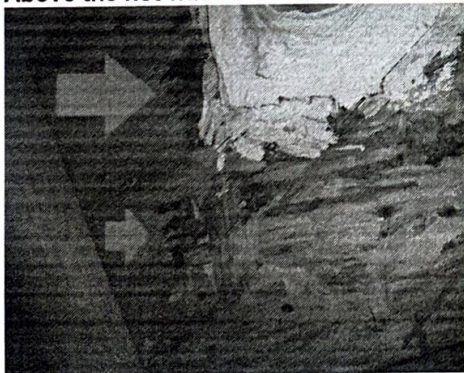
Above the hot water heater

Water stain present - Stain was dry at the time of inspection, get with seller on what repairs were made.

replaced H2O heater 2020

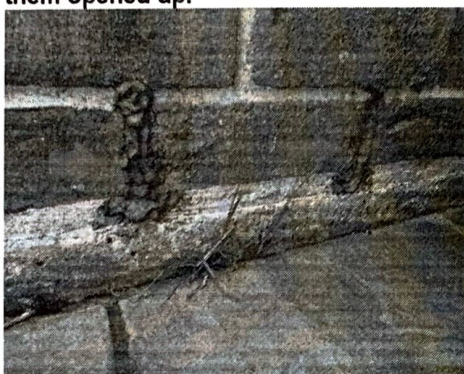
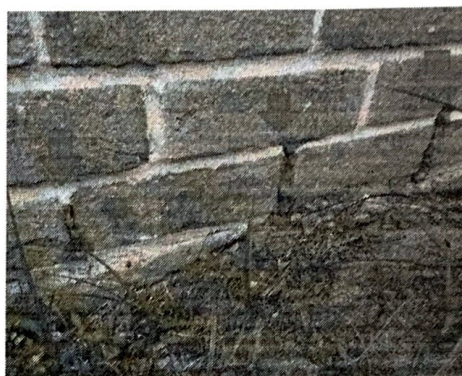
Weep holes blocked rear of the home - Get with seller on why these were sealed up and have them opened up.

Fixed

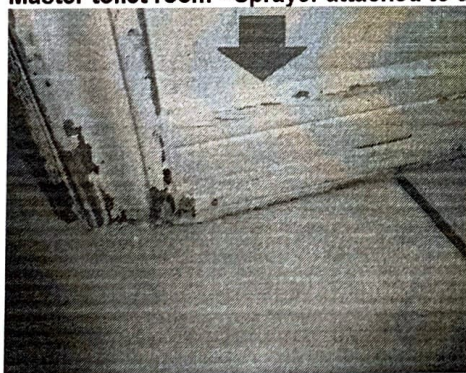
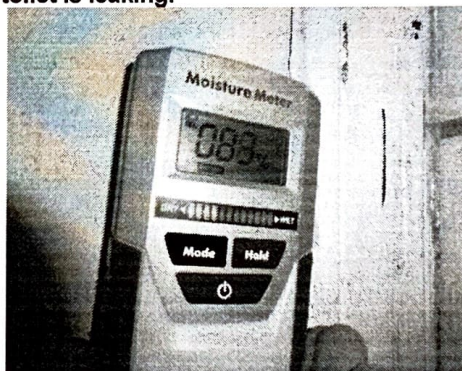
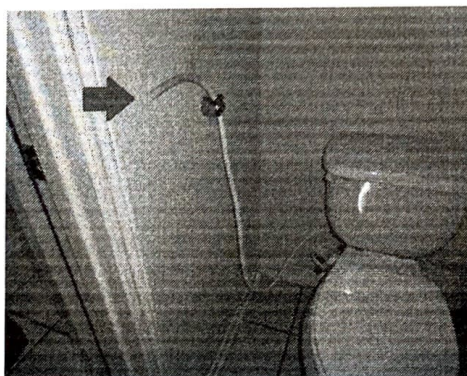
There were moisture stains on the interior walls at the time of the inspection, positive readings on a moisture meter (83% readings on meter). Further evaluation is needed.

Master toilet room - Sprayer attached to the toilet is leaking.

Fixed

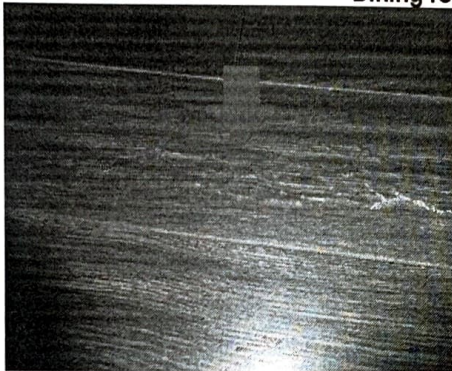
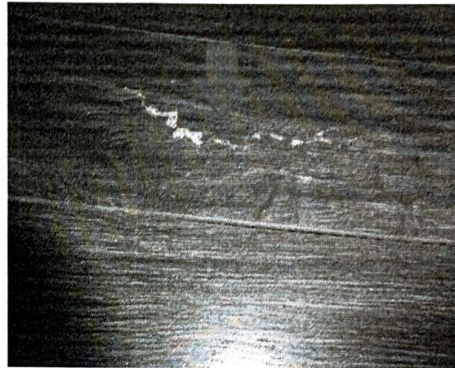
Dining room floor

Water stains present:

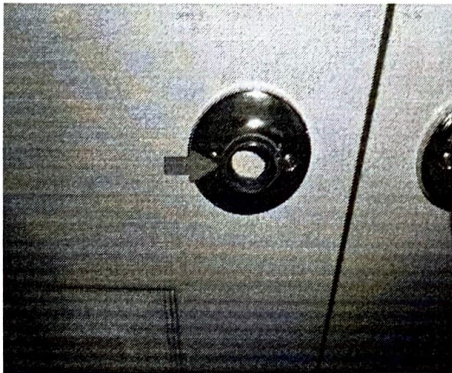
Middle bedroom closet

Missing door knobs:

all new doors
knobs
fixed

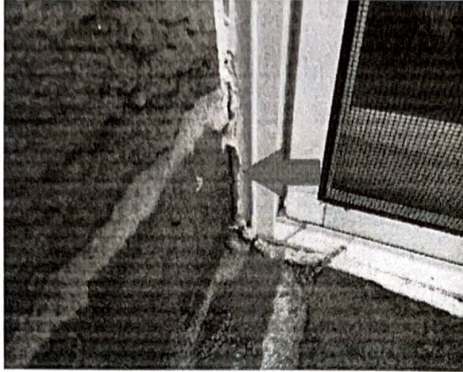
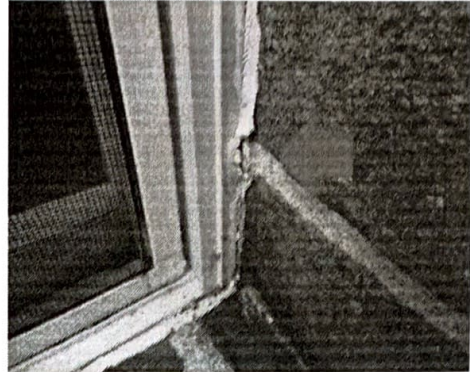
The caulking compound was deteriorated at windows around the home at the time of the inspection.

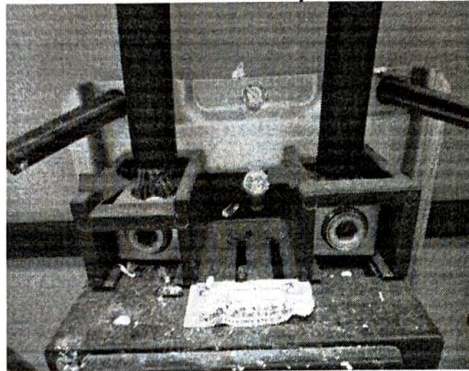
There was no antioxidant paste visible on the aluminum wire connections.

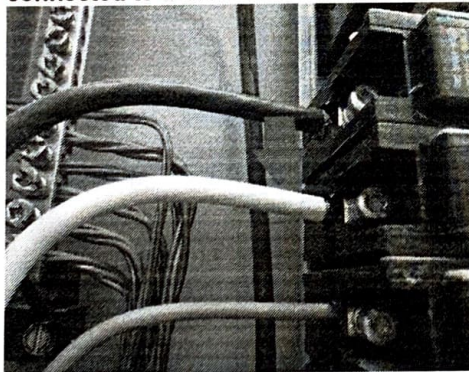
The white A/C wire was not tagged with black tape or paint as required when a white wire is connected to a breaker.

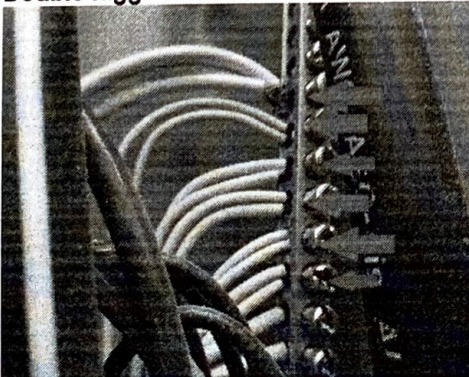
Double lugged neutral bus bar

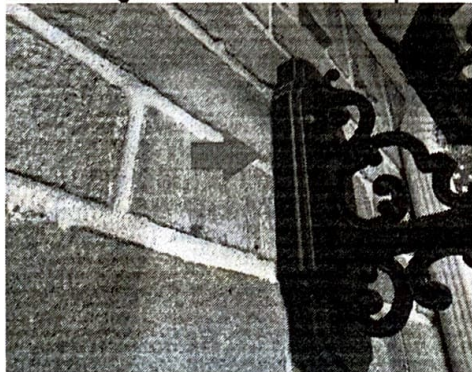
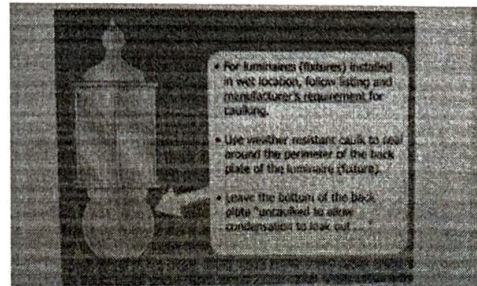
Exterior lights need to be sealed up.

Fixed

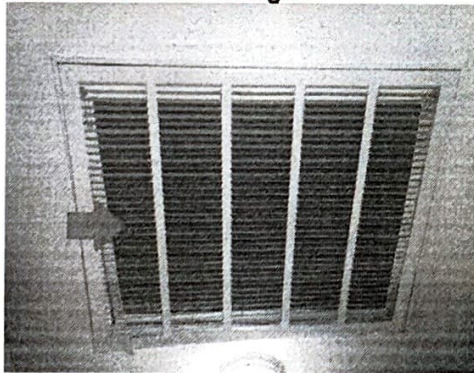
Filter needs to be changed.

Fixed

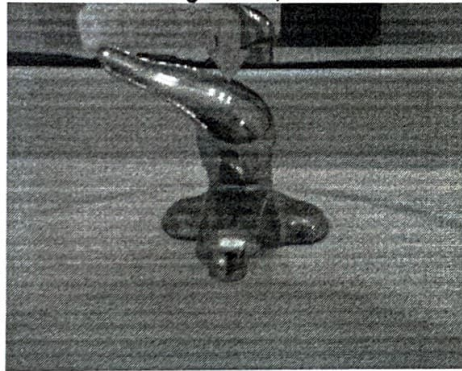
Faucets not operating properly - Further evaluation and repair is needed.

Master bath - Right sink, hot water side is not operational

Fixed & replaced all bathroom faucets

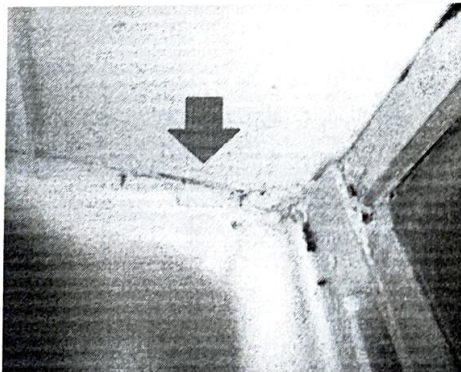
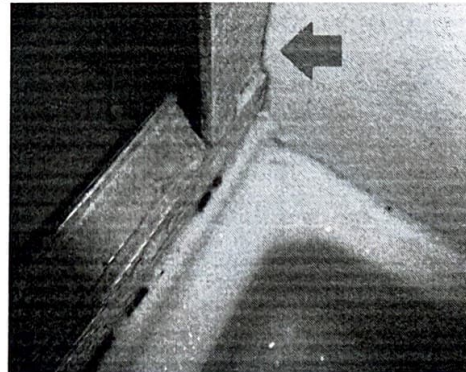
Master shower

Caulk/Grout needed:

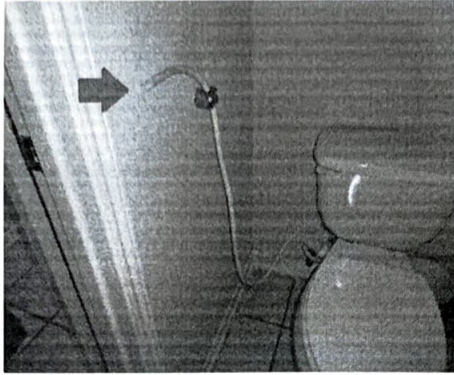
Sprayer attached to the master toilet appears to be leaking - Further evaluation and repairs are needed.

removed /
Fixed
replaced
toilet

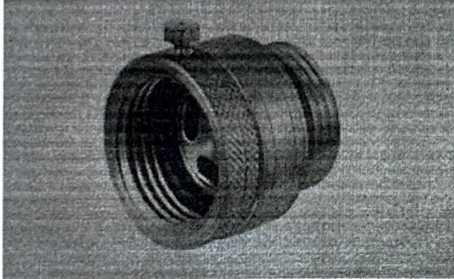
Exterior hose spigot(s) do not have code approved anti-back flow devices installed.

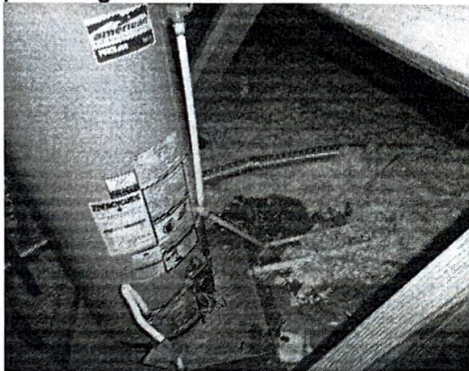
Issues:
Water heater is noisy making popping sounds - Further evaluation is needed by a licensed plumbing contractor.

*replaced
2020*

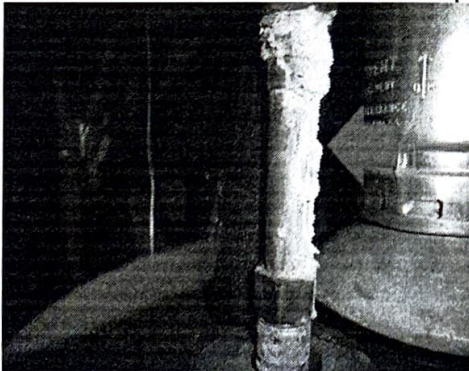
The water heater had rust/corrosion on pipes and valves at the time of the inspection.

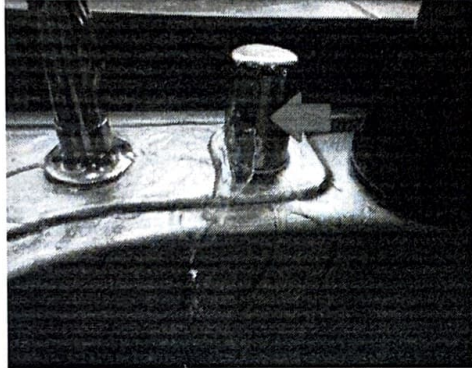
Dishwasher leaks from the overflow on the sink - Further evaluation and repair is needed.

Fixed

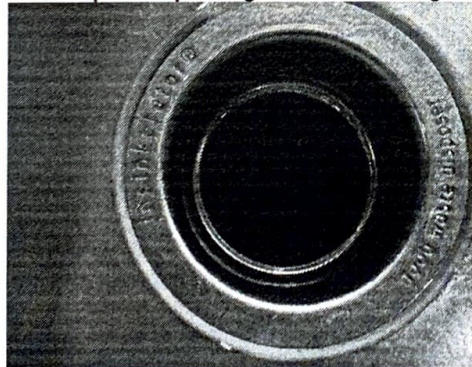
The disposal splash guard was damaged or missing at the time of the inspection.

Fixed

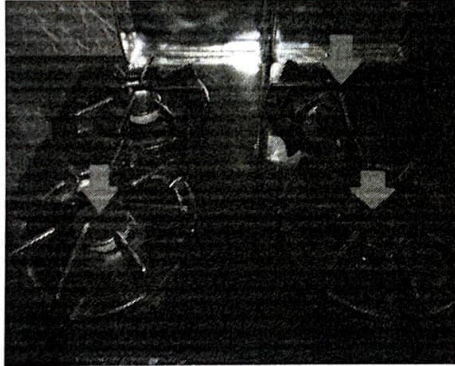
The burner on the separate Cook Top did not operate at the time of the inspection. Further evaluation and repair is needed.

all work
