PROPERTY INSPECTION REPORT

Concerning: 5300 Silverbelle Ln, Richmond, TX 77406
(Address or Other Identification of Inspected Property)

By: Chris Blanks, Lic #23710 04/22/2021
(Name and License Number of Inspector) (Date)

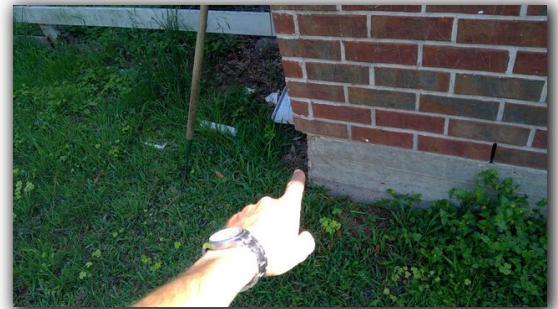
● Shear cracking "corner pops" were observed at the corners of the foundation. These are generally considered cosmetic and do not typically affect the performance of the foundation.

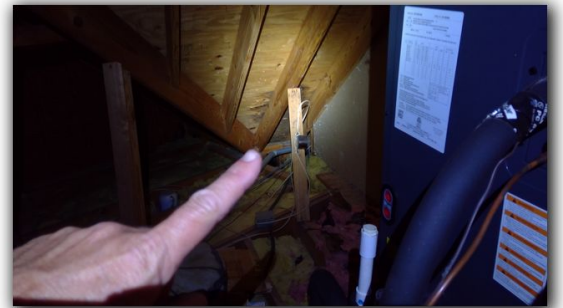
- Water damaged roof decking is present in the attic. It does not appear to be wet at the moment.

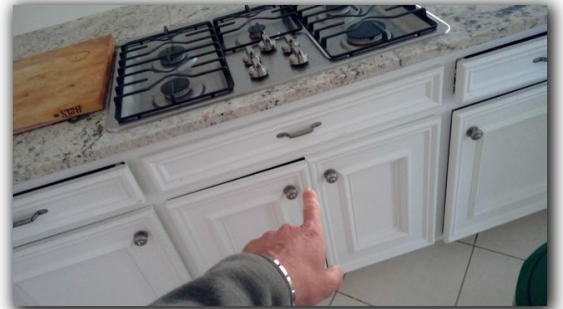
- Cabinet doors rub and need adjustment.

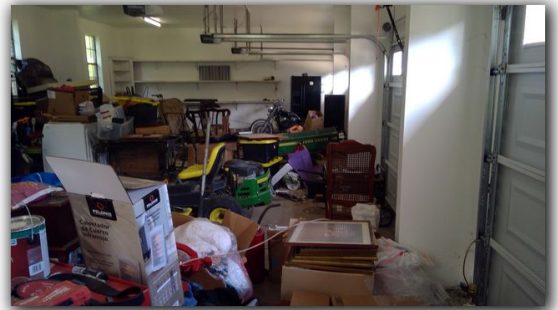
- Storage prevented the evaluation of many areas.

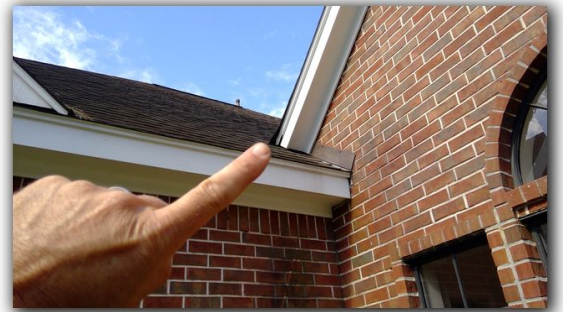
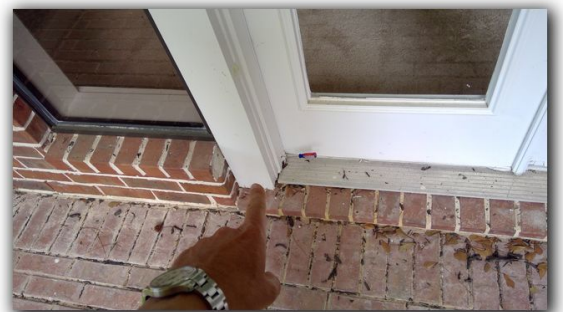
- Trim boards are present that are showing signs of deterioration/rot and are in need of replacement.

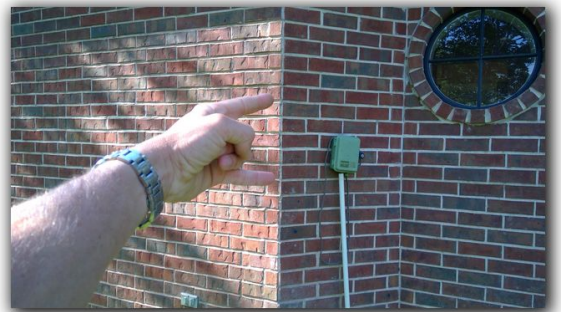
- Cracking was identified within the brick/mortar on exterior walls.

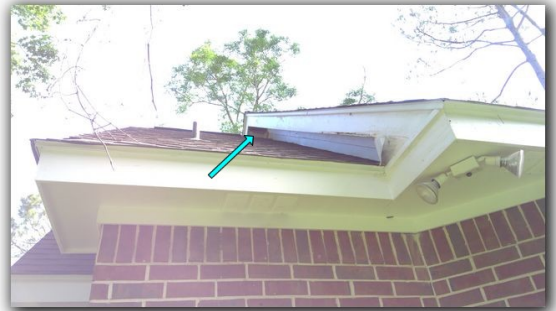
● Soffit boards were observed to have large holes in them in areas. This was likely caused by animals..

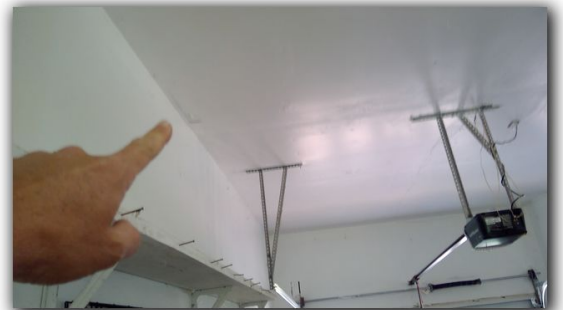
- Damage to the ceilings was observed.

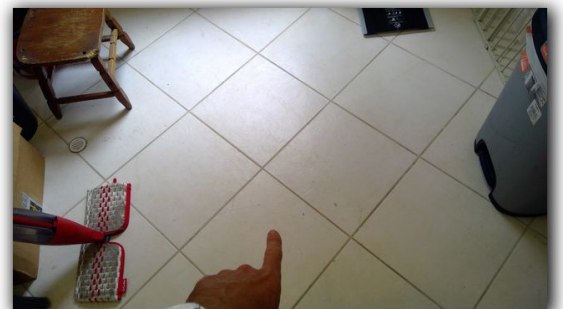
- Floor tiles were observed to be cracked or damaged.

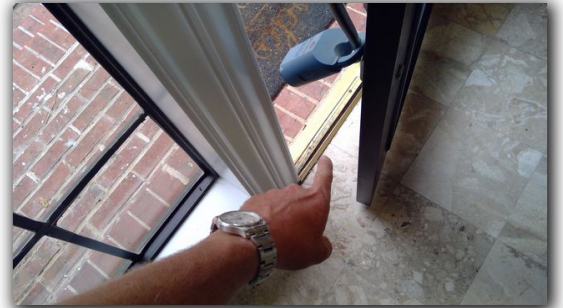
- Exterior doors were observed to be physically damaged on the house.

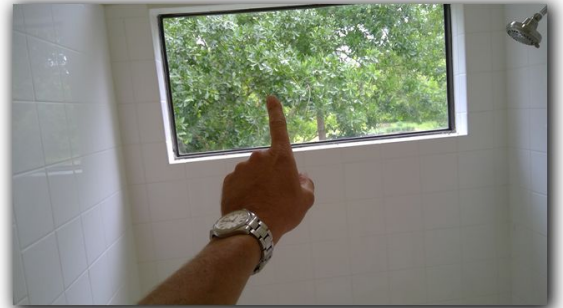
- A glass panel is loose in its frame.

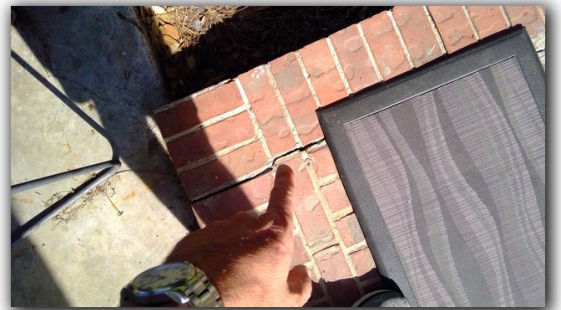
- The side entry steps are leaning and cracked through.

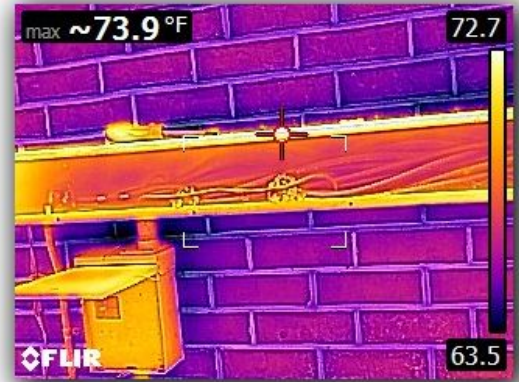
Service Entry Cable Tray

- The cable tray is badly rusted in areas.

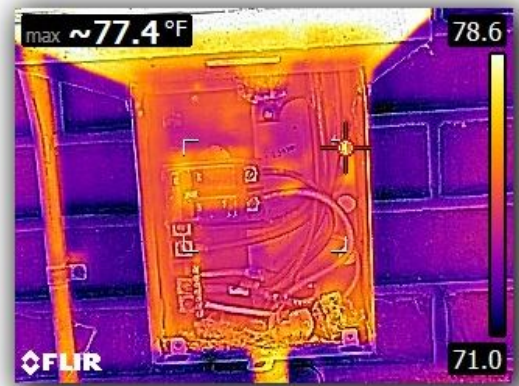
- Significant debris was observed inside the panel. Panels should be kept clean and free of debris.

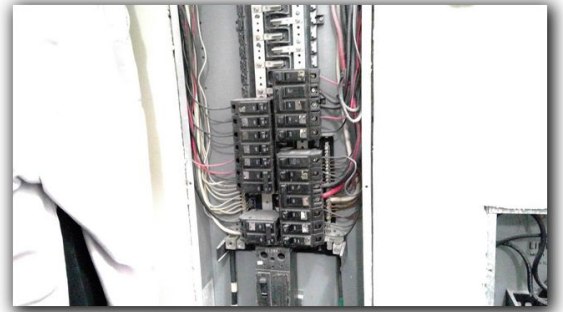
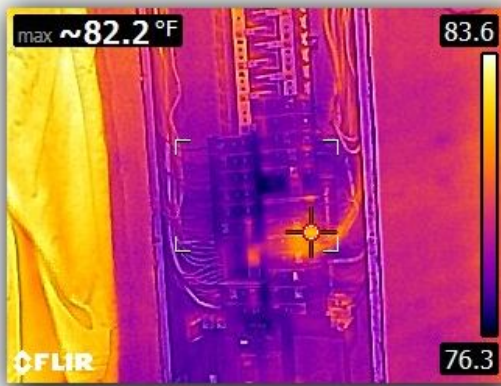
- Panel is located in an improper location. Panels may not be located in closets or bathrooms due to the potential fire hazard it may create, nor may they be located above stairs.

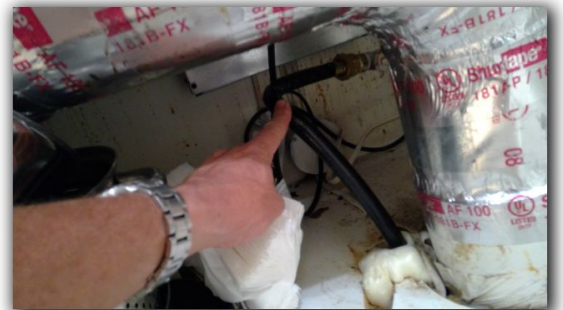
- Corrugated Stainless Steel Tubing (CSST) is used for gas distribution in the home. Bonding of the CSST to the home's electrical system could not be confirmed. It is important that CSST be bonded to the home's electrical system because runs of CSST that are not bonded are prone to significant damage and leakage should the home be exposed to a lightning strike. The resulting damage/leakage could cause a fire. An electrician should evaluate the CSST in this home and bond it to the home's electrical system if not already bonded.

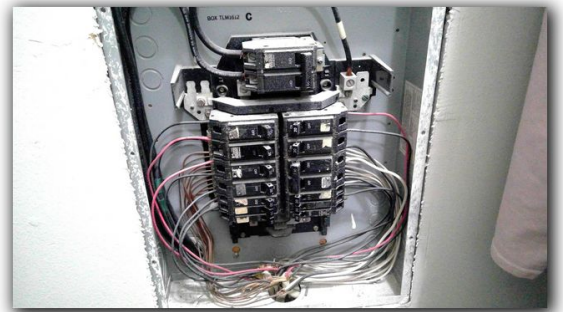
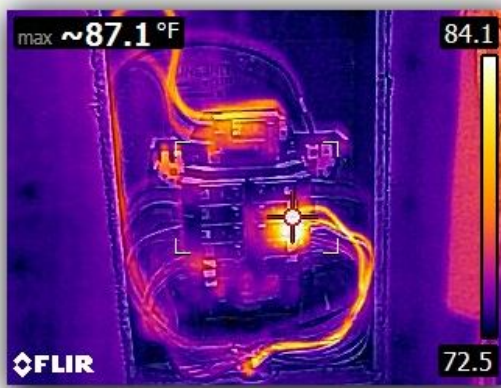
- Panel is located in an improper location. Panels may not be located in closets or bathrooms due to the potential fire hazard it may create, nor may they be located above stairs.

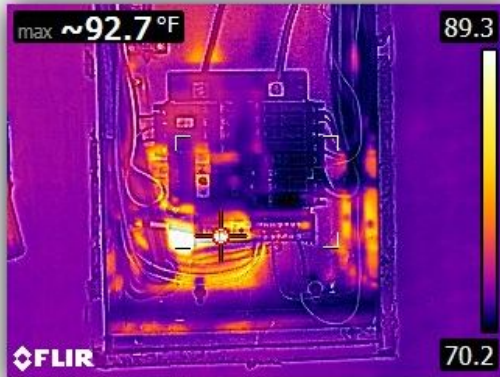
- The electrical panel is not fully labeled.

- Breakers were found in the off position upon inspection. With no knowledge as to why the breakers were off, the breakers were not engaged. Engaging a fault tripped breaker can potentially cause damage to the circuit or devices plugged into the circuit. This should be evaluated by a licensed electrician.

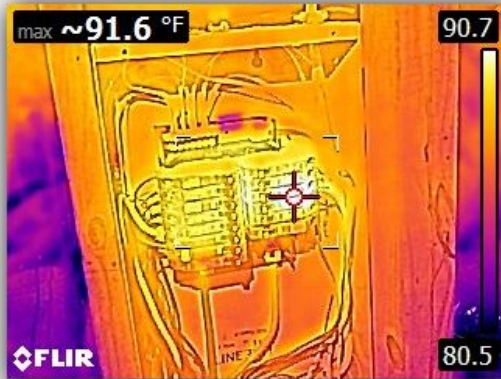
- The electrical panel is not fully labeled.

- One or more knockouts are missing, allowing for unsafe access into internal portions of the electrical panel.

- The dead front panel is missing a screw or screws.

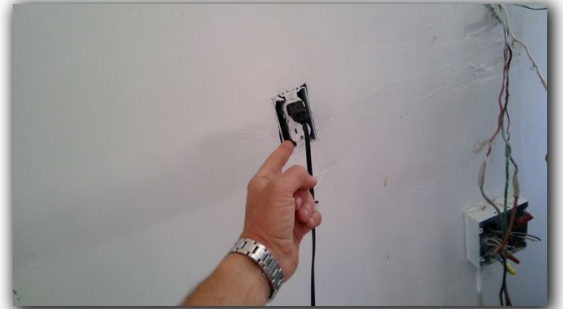
- Missing face plates were observed on receptacles/switches.

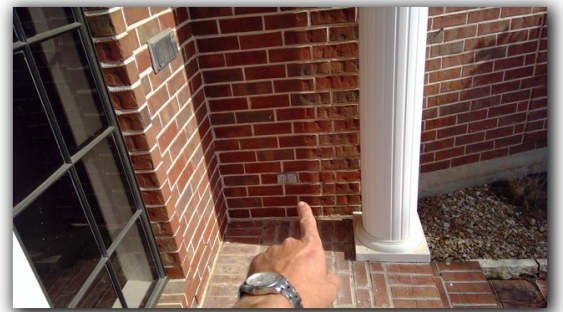
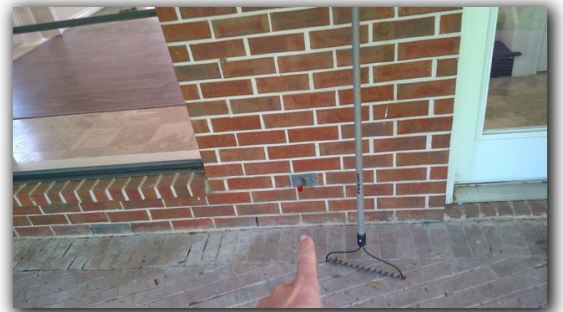
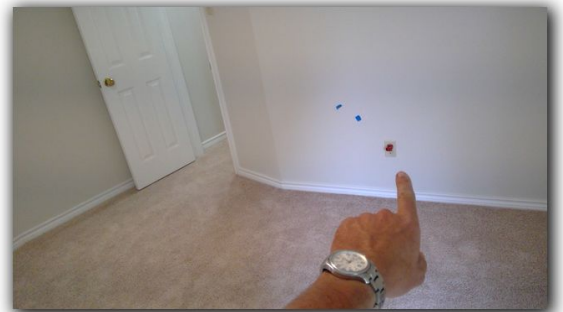
- Receptacles were observed to be inoperable.

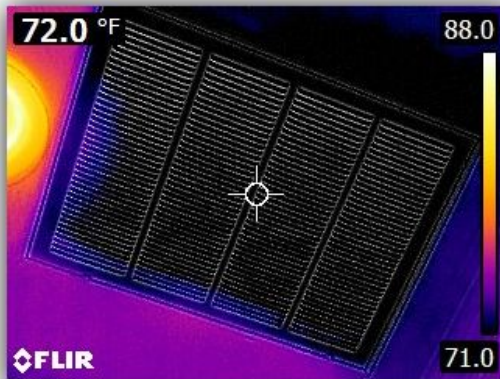
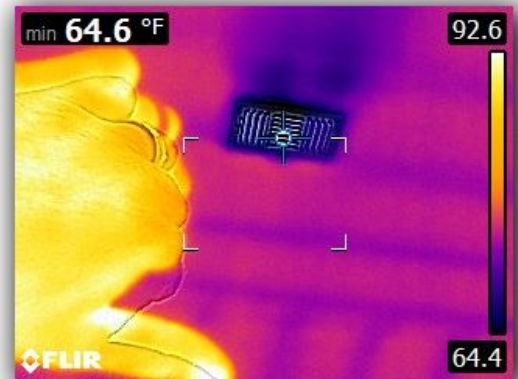
● The temperature differential between the supply and return registers is not within recommended range of 15-20 degrees Fahrenheit. A licensed HVAC technician should evaluate the system.

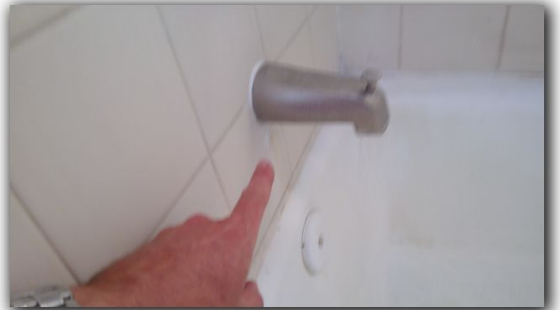
- The spiqot in a bath tub/shower leaks during operation.

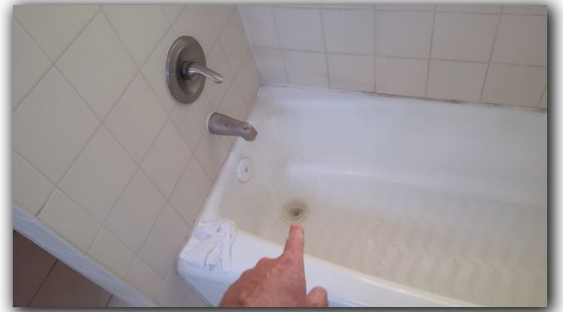
- The enamel surface of the tub/shower is chipped or damaged.

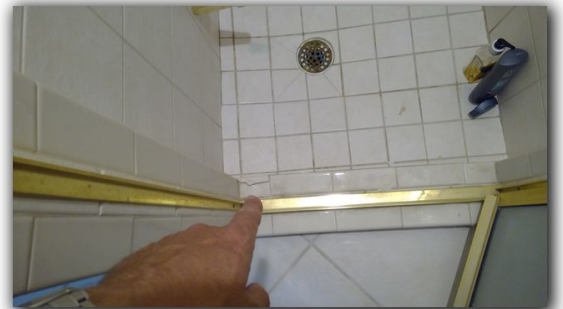
- Damaged shower tile was noted.
