**A Town Home Inspection Report On
11568 S. Kirkwood, Stafford, TX
Sold by Sandra McClusky, Listed By**

Monday, January 27, 2020

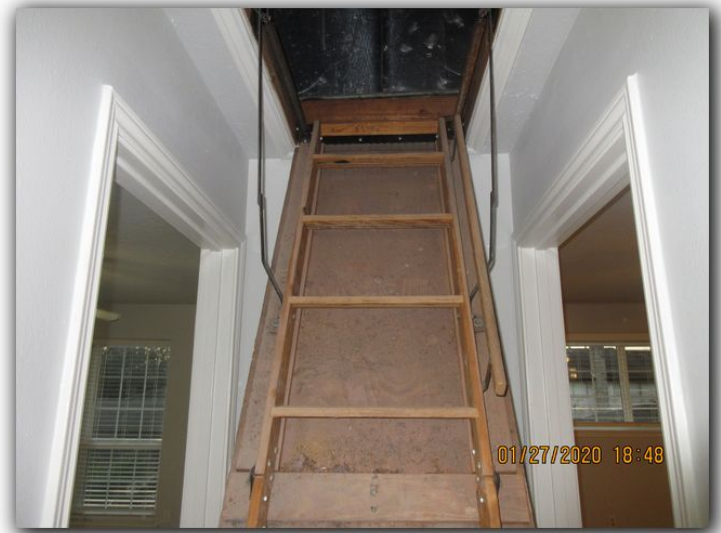
11. The attic ladder is missing insulation as required by code.

Subject property on the right and it is correct on the left side

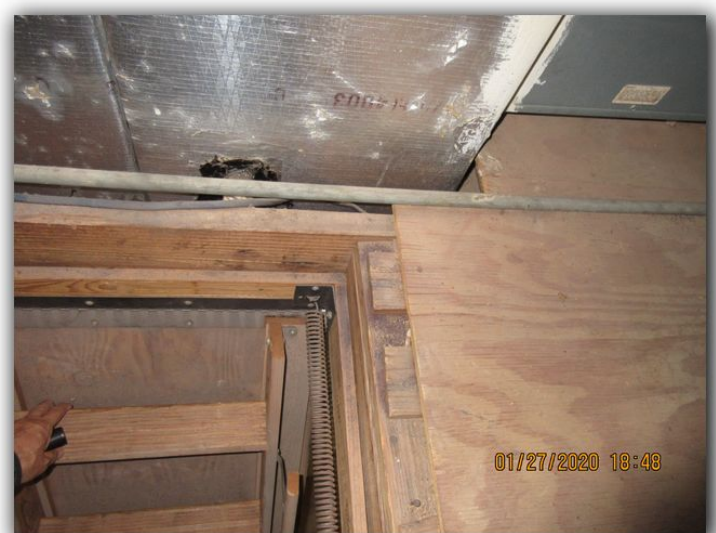
14. Missing foam insulation at the perimeter of the attic ladder frame as per code.
15. N1102.1.10 Air leakage. All joints, seams, penetrations, window and door assemblies and their respective jambs and framing; and other sources of air leakage (infiltration and exfiltration) through the building thermal envelope shall be caulked, gasketed, weather stripped, wrapped, or otherwise sealed to limit uncontrolled air movement (see photo below)

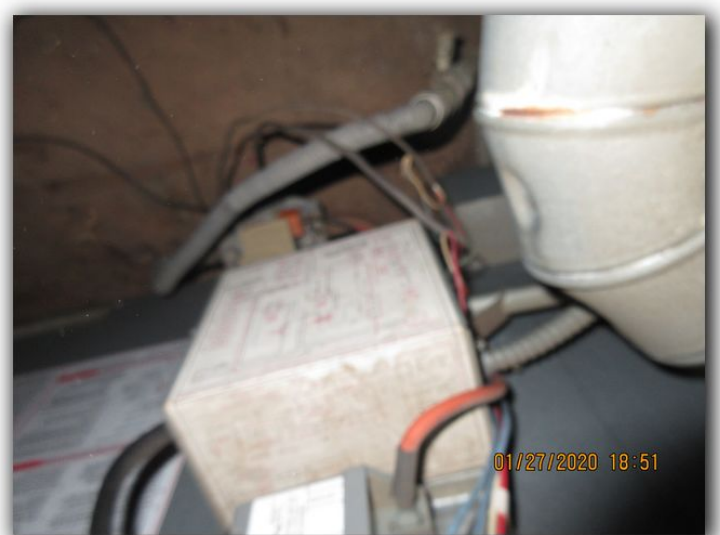
18. Improper decking methods, attic decking must be solid plywood with no obstructions in front of the furnace as per code and as seen on the left lower photo below.

19. One of the furnaces is installed backwards and has no work space.

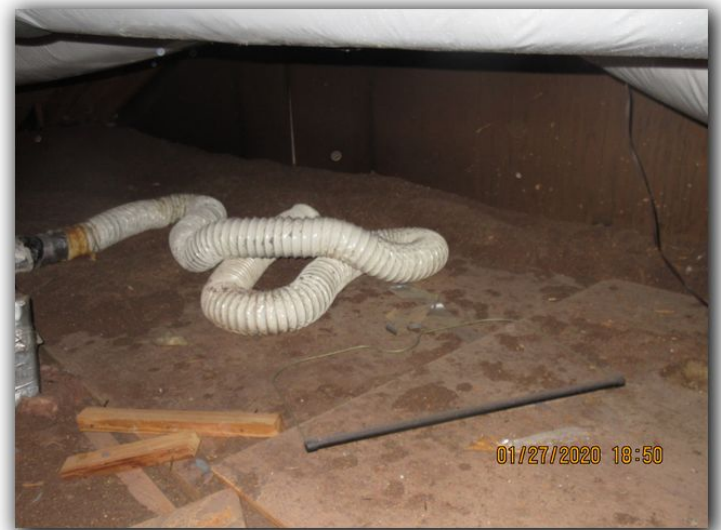
22. The insulation meets code R-38 or at least ten inches as per code.

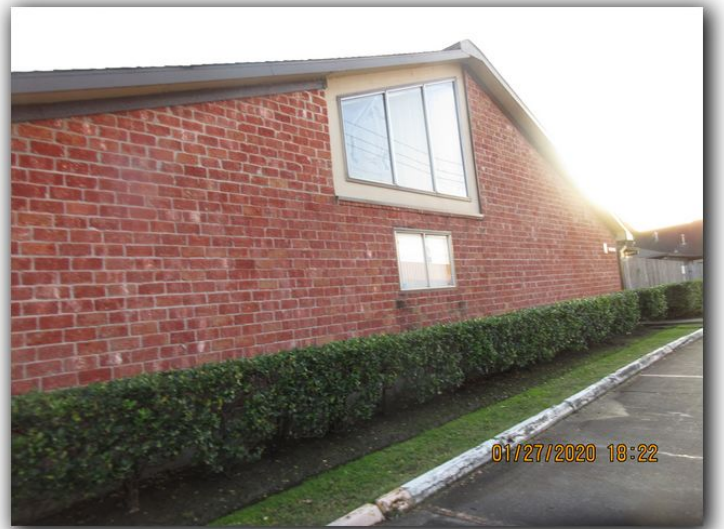
36. The siding is in generally good condition.

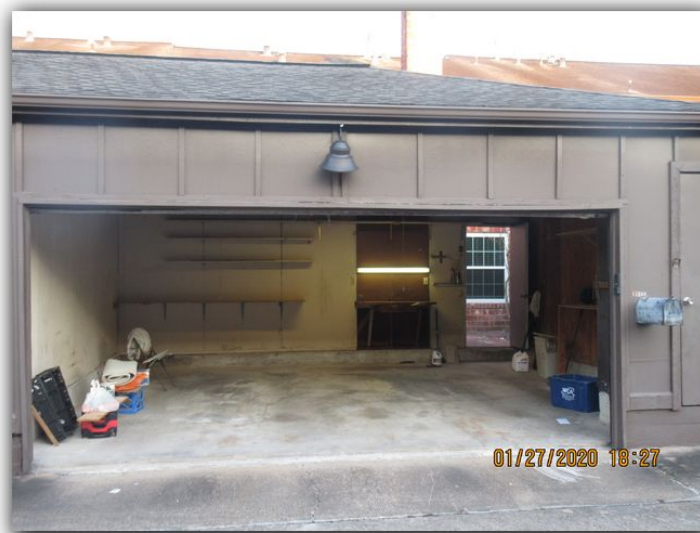
1. Garage door frame wood trim is too close to the ground, must be cut 45 degrees, painted at the base (sealed) and be two inches above the concrete floor to avoid water rot;

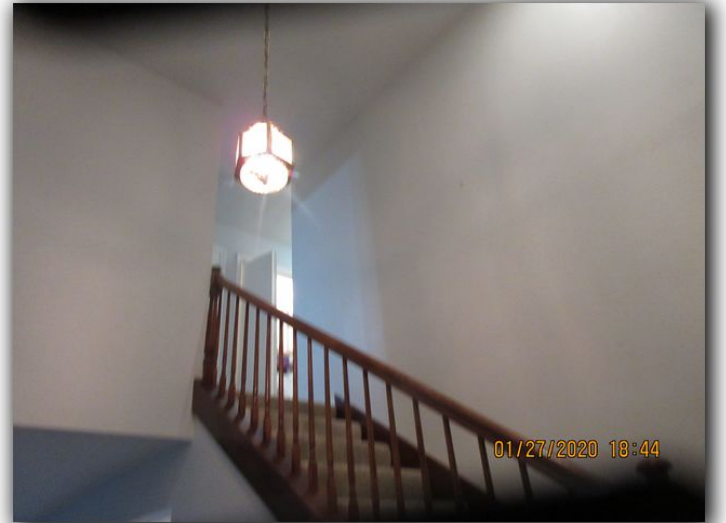
- The home has a stairway that is in good condition.
- The stair way has a proper three way switch, one on the bottom and a second on the top of the stairs as per code.

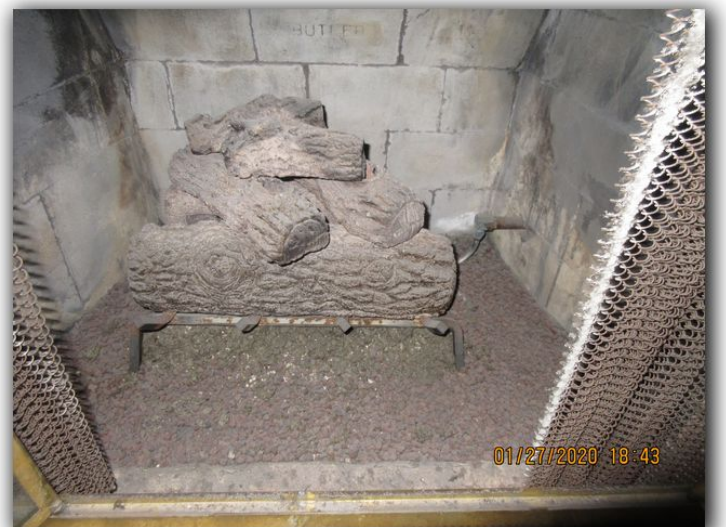
10. Fireplace and chimney must be serviced prior to use.

11. Missing a c-clamp, c-clamp on the damper keeps it open for carbon monoxide venting, however when the fireplace is not in use such as in the summer, the vent should be closed.

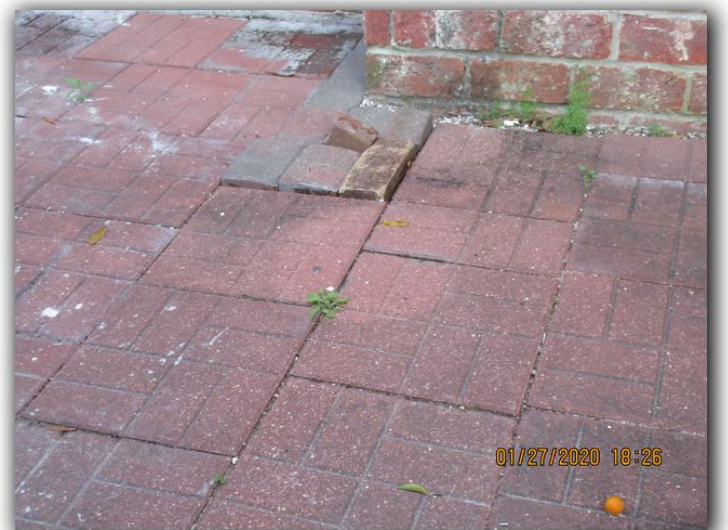
14. The patio has loose pavers and some that are in need of repair, a trip hazard.

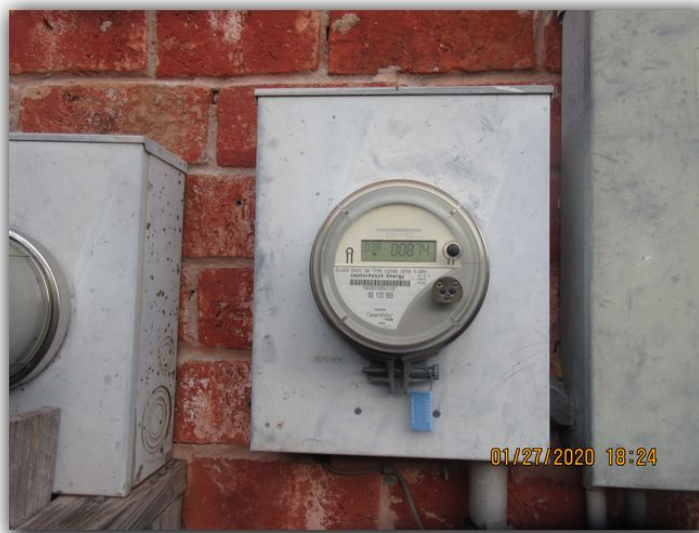
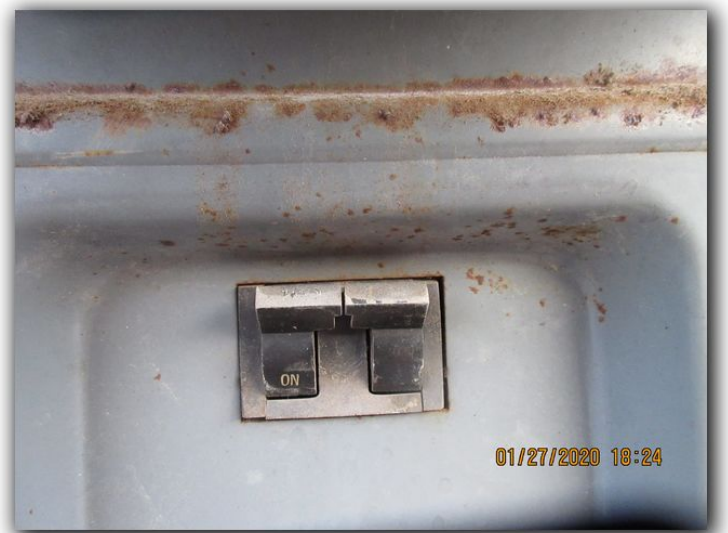
25. The main breaker and service is 100 amps which is adequate for the connected load.

26. Improper ground rod, it is extremely too short, it must be at least six feet made of copper bonded steel rod. [Press Here to see one at ACE.](#)

27. At this time there is no ground rod protection.

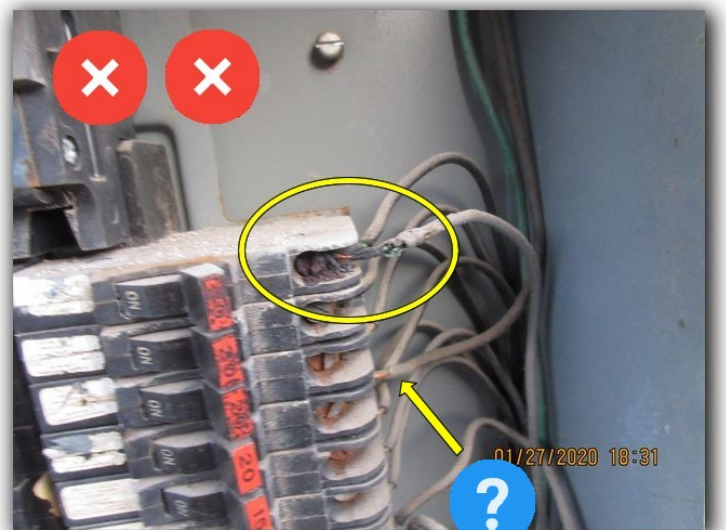
- 31. Improper wiring methods, there is one double lugged breaker and what appears to be an over heated wire on the top right bank as seen below, it needs immediate repair.
- 32. There is a damaged white wire on the left bank as seen below on the left side, needs repair.
- 33. An electrician should make further assessment to confirm that the main panel was not damaged due to an over current resulting from a defective ground rod.

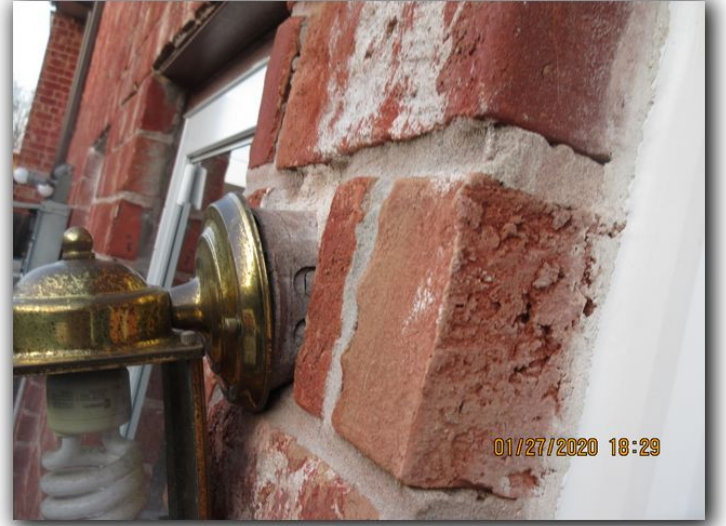
46. Rear lamp at the brick wall is not properly installed.

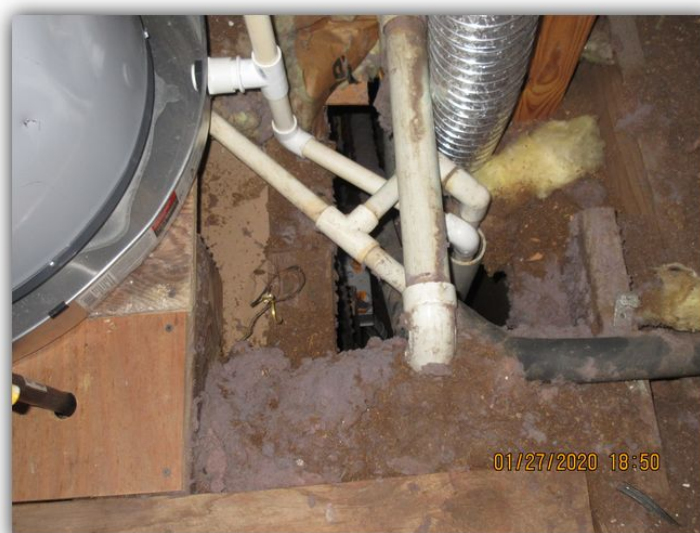
4. Both of the drain lines are terminating to the plumbing drain system to avoid foundation settlement and attracting termites when dripping next to the foundation.

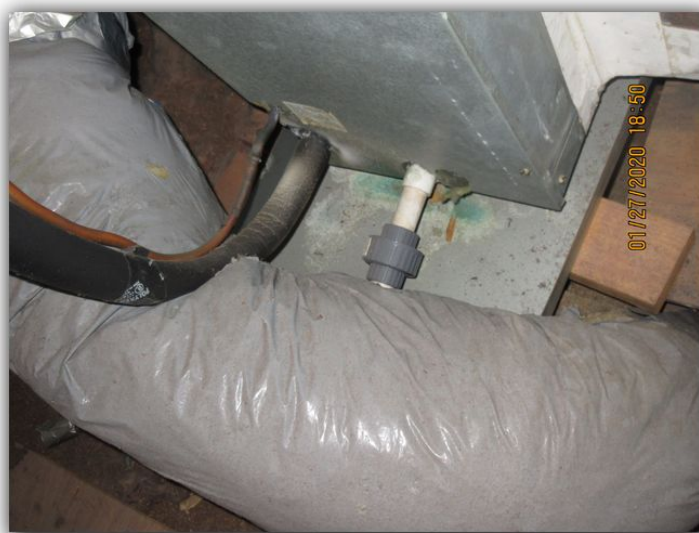
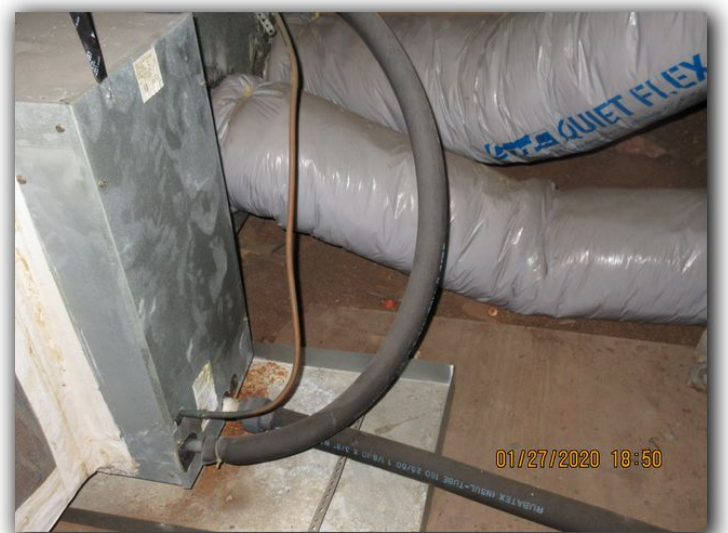
- 8. Both of the drain pans in the attic were clear.
- 9. One drain pan has minor rust spot.
- 10. The drain pan has a secondary drain line connected, termination not confirmed.

- 11. Both of the secondary drain lines were viewed at the soffit as per code.

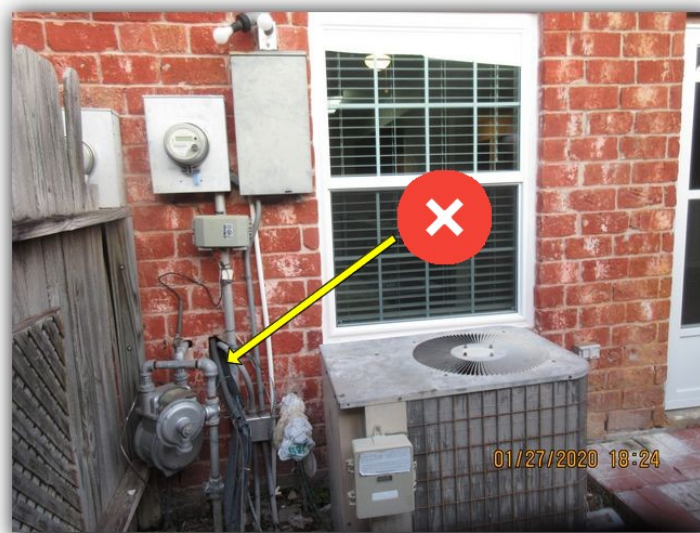
22. The gas meter should not be located under the main panel or next to the a/c condenser.

23. Gas meter was not bonded as required by code

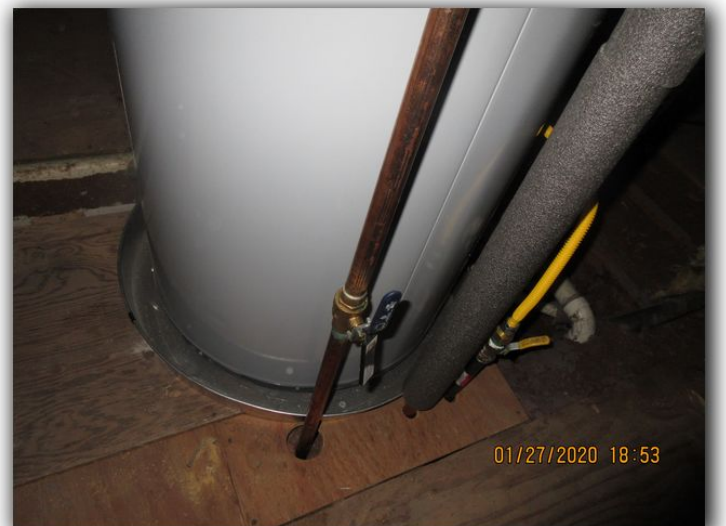
32. The copper water lines on the water heater are not insulated.

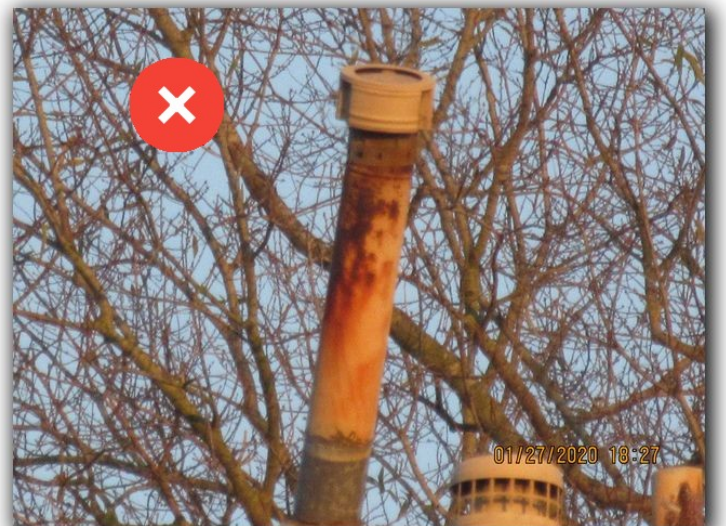
11. The vent pipe at the roof level is rusty and it may be due to a blockage that has caused over heating, the vent pipe and cap need to be replaced.

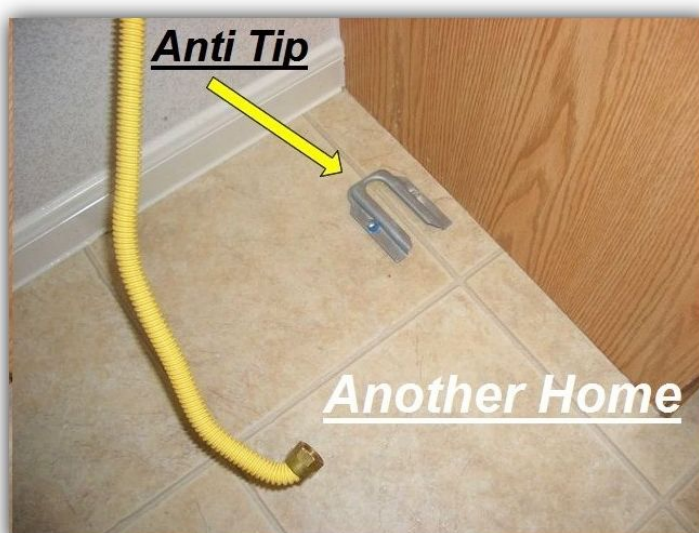
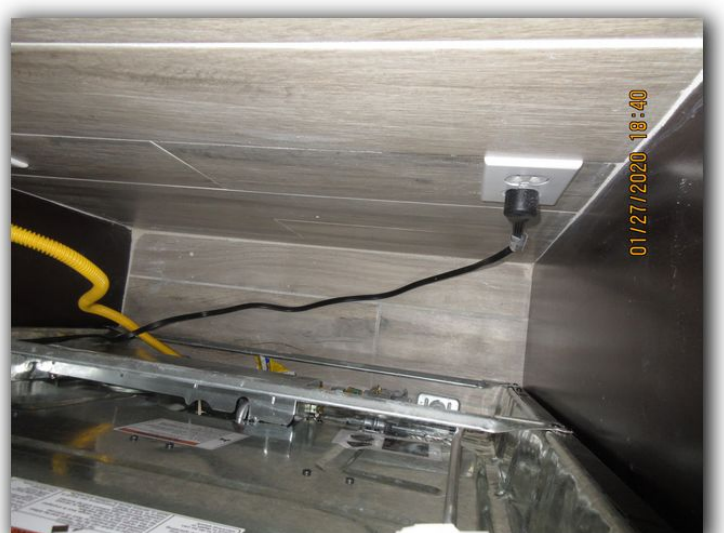
45. The stove was not working at the time of the inspection.

46. Stove is missing an anti tip device as required by code.

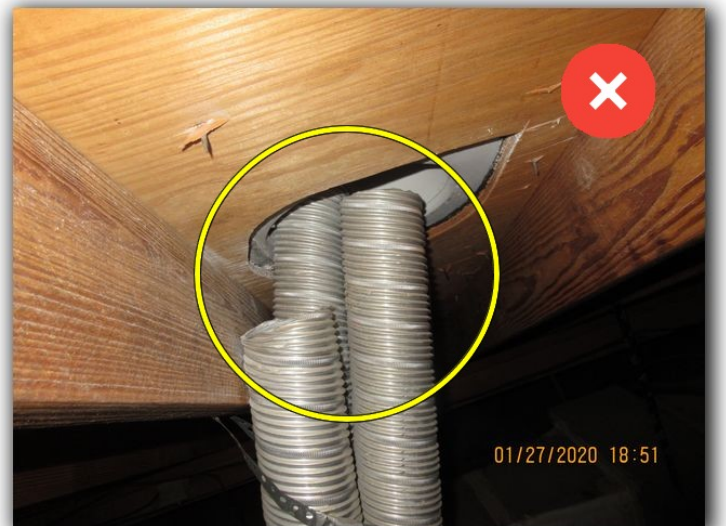
54. Improperly terminating flex vents into the attic, they must be properly fitted into the roof jack so they can terminate to the exterior as per code.
