PROPERTY INSPECTION REPORT

Concerning: 17506 Memorial Ridge Dr., Spring, TX 77379

By: Ronald Wood, Lic #7350

08/05/2017

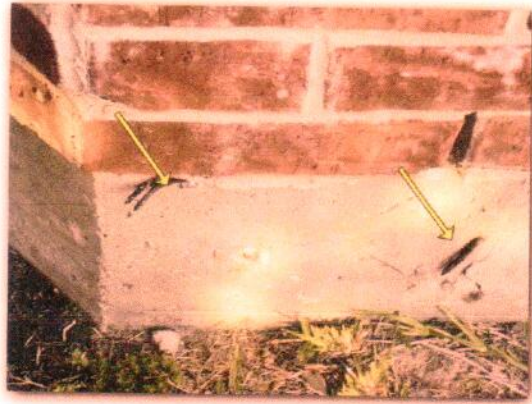
- Brick veneer and/or mortar stress cracks noted at one or more locations.
- Some uneven and/or sloped floor areas noted at one or more locations.
- Stress crack(s) and/or curing crack(s) noted in the garage floor.
- Stress crack(s) noted in the interior gypsum wallboard above one or more doors and/or windows.
- Stress crack(s) noted in the interior gypsum wallboard at one or more ceiling areas.
- There was an exposed foundation form board nail noted at rear corner of the home's foundations - **SAFETY HAZARD. Needs to be removed.**

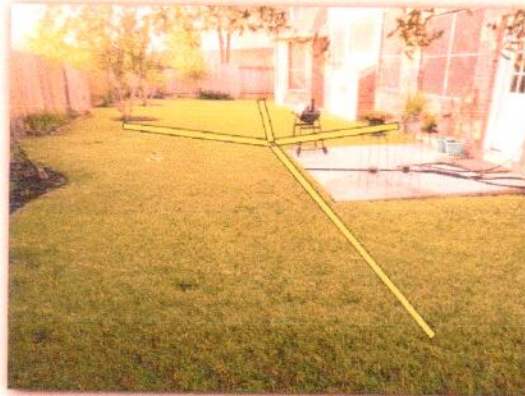
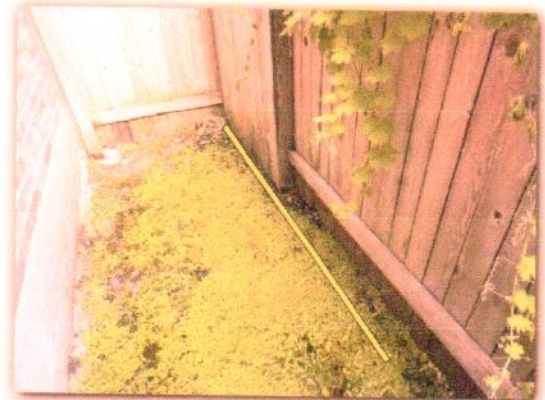
- Some low lying/improperly graded soil areas were noted along the foundation at one or more locations. These areas are prone to ponding when exposed to water/rain - Insure water drains away from the house in these areas. front rear left right.
- The swale on the rear, right and left yard areas needs to be improved to direct water away from the house, yard and fence areas and prevent ponding.

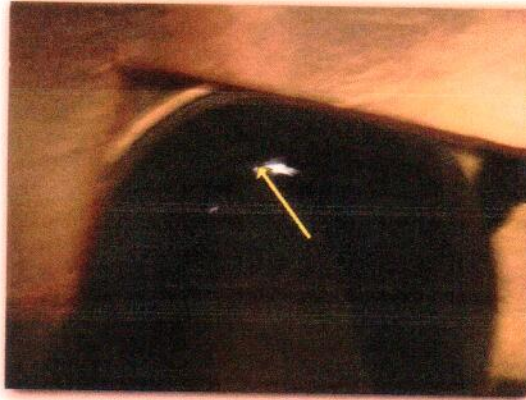
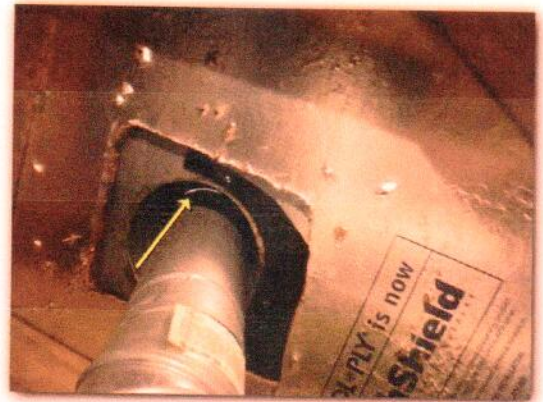
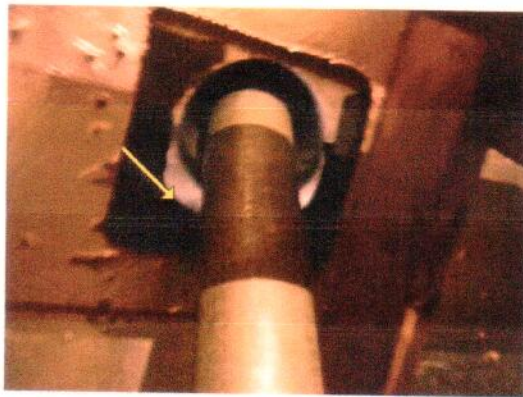
- Some roof wave noted at one or more locations. (common)
- Weather ring/collar, cap and/or roof jack for the right hot water heater and both of the furnace/heater's flue pipe appears not to be properly secured and/or sealed. I was able to view some daylight at this point in the attic area of the home.

NOTE: Recommended that repairs of all deficiencies listed below be obtained from/by a Certified Roofing Company prior to the end of the option period. (Refer to comments below for additional information about the roof/roof covering.)

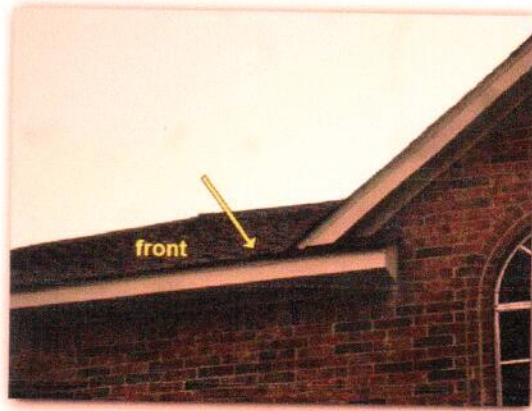
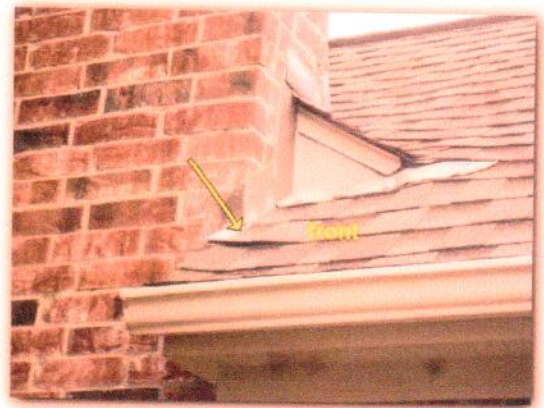
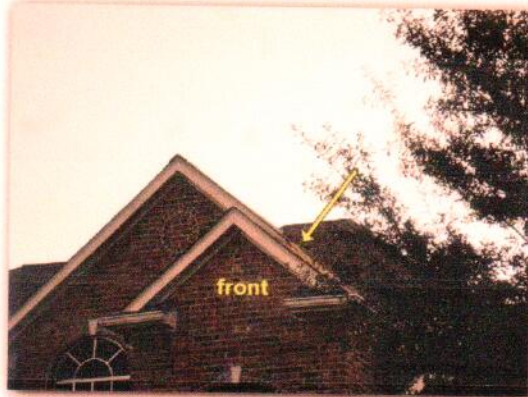
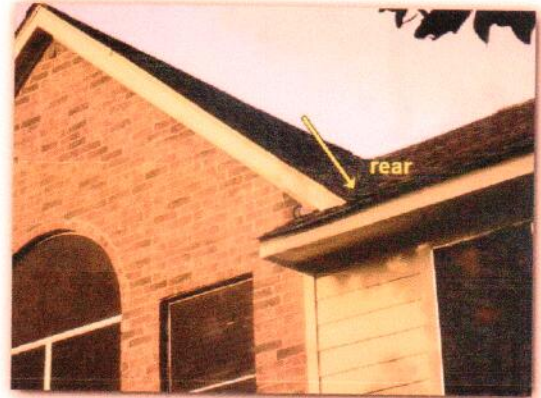
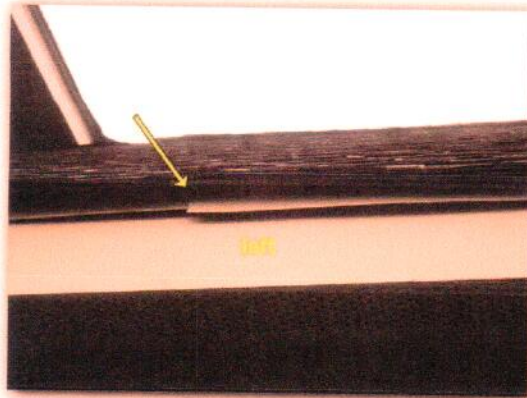
- Loose nails/nail pops appear they may have pushed up (fish mouth) the roof shingles and/or roof flashing at one or more roof locations. This may also be due to the shingle not being properly bonded. front rear left

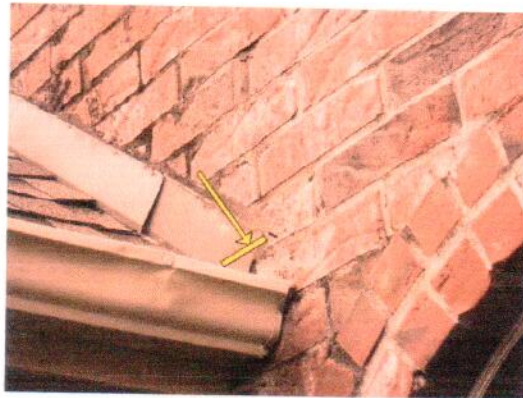
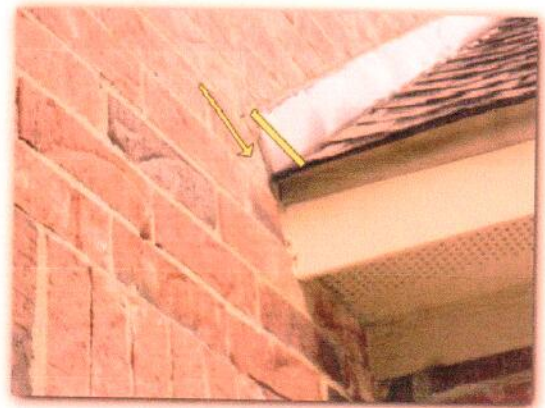
There was no rain diverting roof/wall flashing installed at several rear locations. (Keeps excessive water run-off off the exterior walls of the home.) front

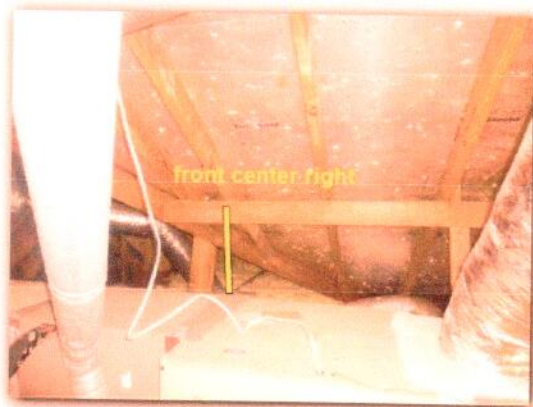
Missing vertical purlin brace/support noted. front right center

- Missing purlin and vertical purlin braces/supports noted at the attic area above the garage. This may or may not be part of the engineered design. (Engineer and engineered plans not present)

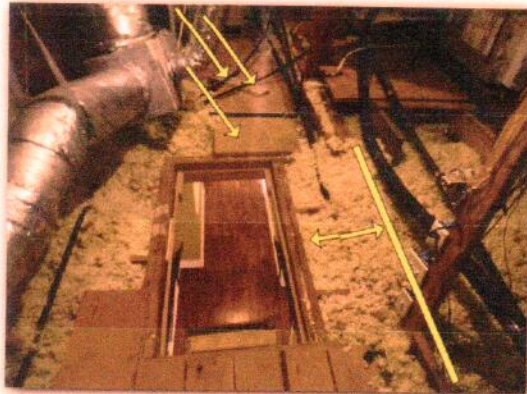
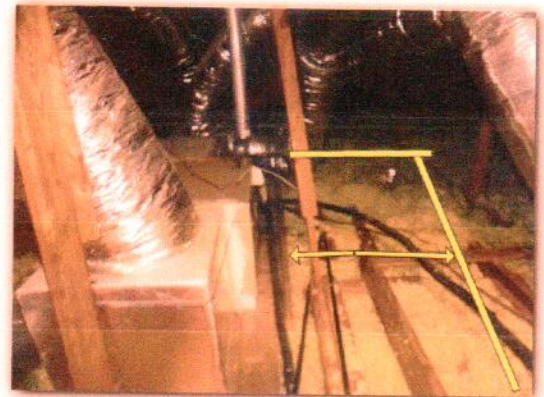
The service walkway from the attic stairs/access opening and/or service access area in front of both the HVAC systems was obstructed, missing in some areas, had some gapes and/or was not the proper size - **SAFETY HAZARD.** (Service walk minimum 24 inches wide from attic access opening and minimum 30 X 30 in front of the system.) Also may be more costly when servicing and/or replacing the system.

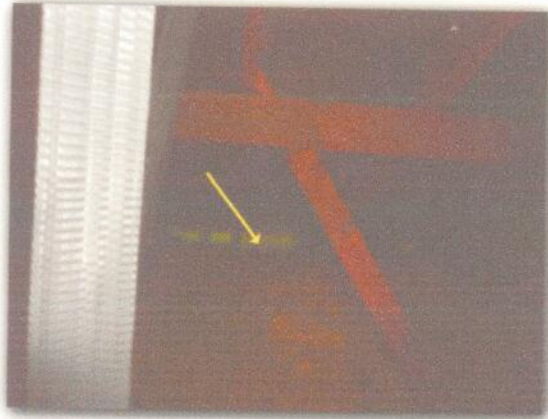
The attic ventilation/insulation baffles are missing at one or more eave/soffit vent locations.

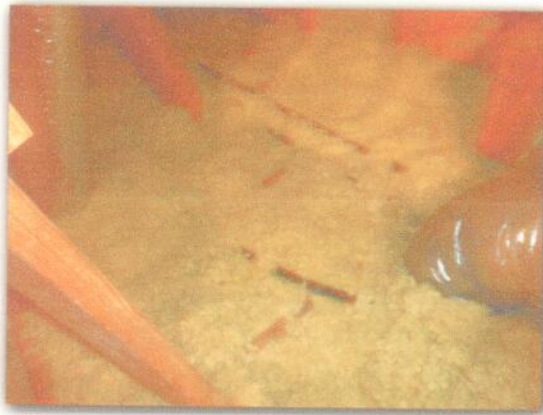
- Type:** Batt Loose Fill Radiant Cool-Ply/Tech Shield Decking Barrier
 Insulation is missing or less in spots, leaving uneven coverage.

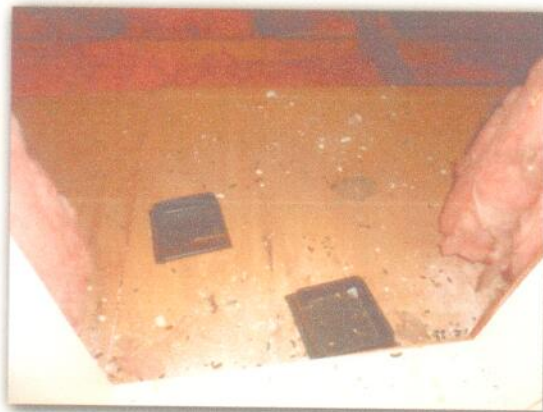
- There were signs of rodent and/or rodent trapping devices in the attic area of the home.
Recommend further information from the seller should be obtained and all possible exterior attic penetration points have been properly sealed.

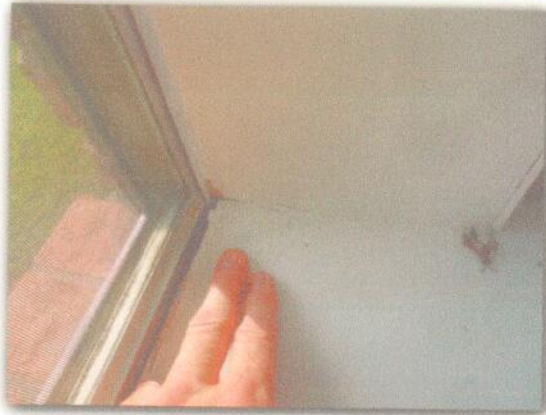
- Stress crack(s) noted in the interior gypsum wallboard above one or more doors and/or windows.
- There appeared to be some undetermined, possibly cosmetic in nature, wall and/or trim damage noted at one or more wall areas in the home and garage.
- Interior wood window sill/stool and/or gypsum wallboard have some damage and stains at multiple window locations throughout the home. Randomly tested these areas with a moisture meter. No moisture was present at the time of inspection. This is usually caused by condensation (coke can effect) from the interior areas on windows/glass dripping down onto the sill and is fairly common. These areas should be repaired, caulked and painted to prevent further damage and should be maintained (painted/caulked).

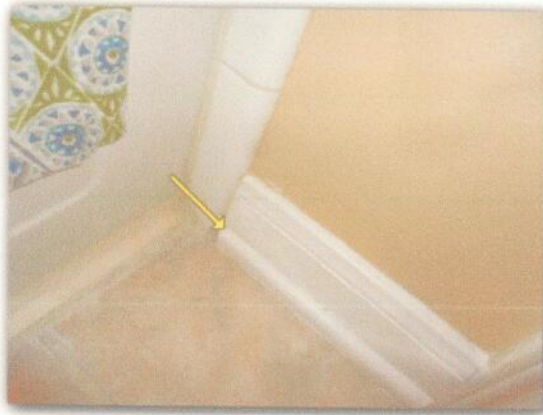
- Undetermined stained and/or damage areas were noted on the wall and/or trim areas next to second floor bathroom tubs. This damage areas are usually caused by moisture escaping the tub area during operation/use. Randomly tested these wall areas with a moisture meter. Moisture did not appear to be present at these areas at the time of inspection.

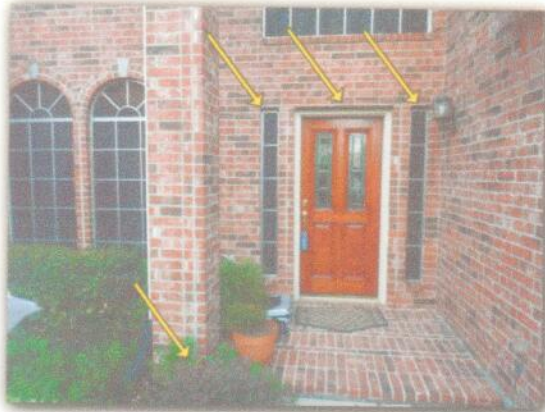
- The weep holes are missing at the bottom area of the brick veneer wall area above one or more window and/or doors and bottom of front column of the home.

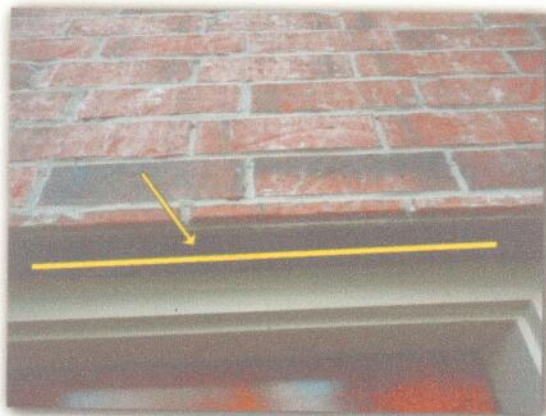
- Some rusting of the metal lintels were noted above one or more windows and/or doors. (The metal lintels, which support the brick veneer, should be sealed and painted to prevent damage to lintel and/or brick veneer.)

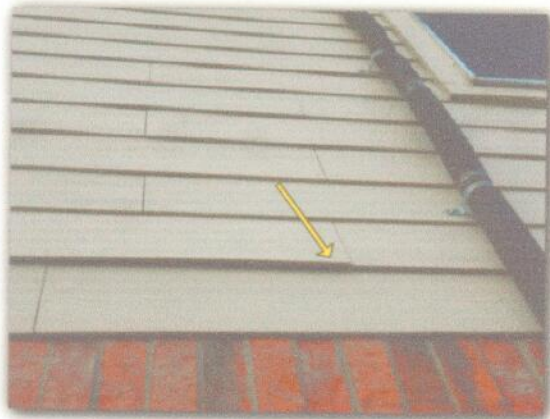
- The siding and/or trim material appear to be loose and/or damaged at one or more locations.

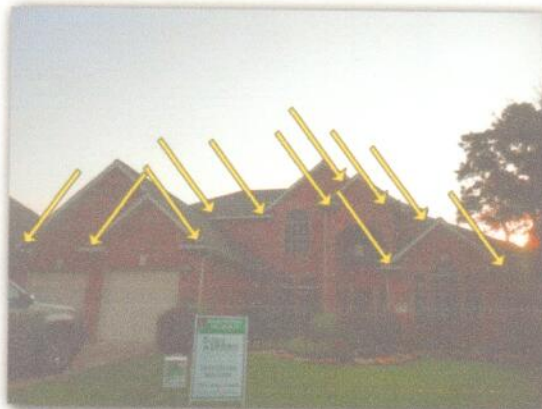
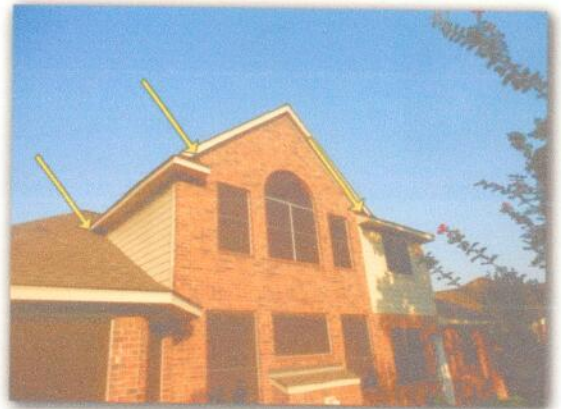
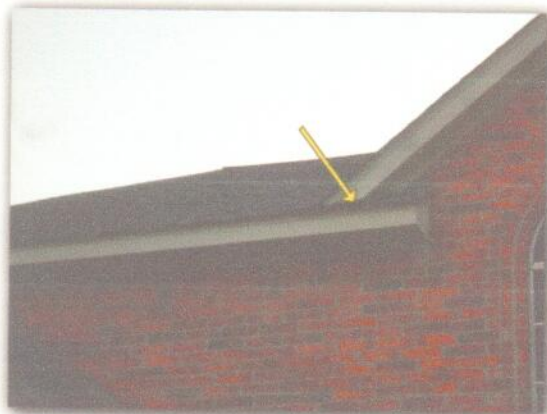
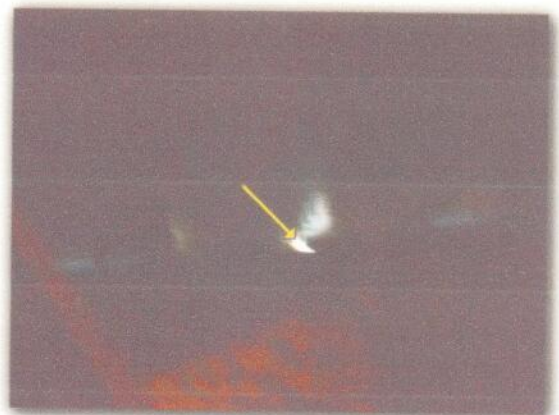
- The eave/soffit areas did not appear to be properly flashed and/or sealed where they butt up to the lower split level roof areas of the home. front rear left I was able to view daylight in some of these areas in the attic. These areas are commonly not properly sealed. (Should be properly sealed and/or flashed to prevent small animals/rodents from possibly entering the eave and possibly the attic area.)

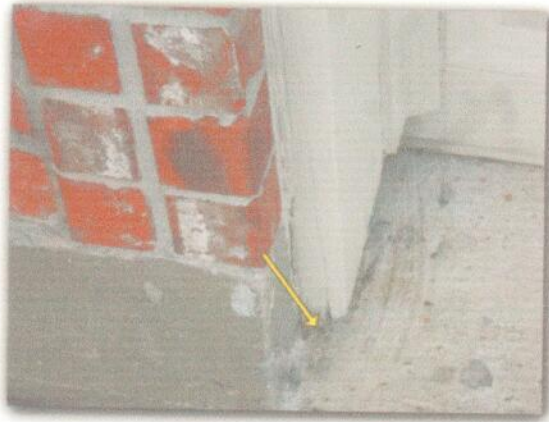
- There appeared to be some moisture damaged wood trim noted at one or more home locations. front/garage door area These conditions can be conducive to hidden damage and wood destroying insects.

NOTE: Recommend repairs of deficiencies listed above by a qualified and reputable company.

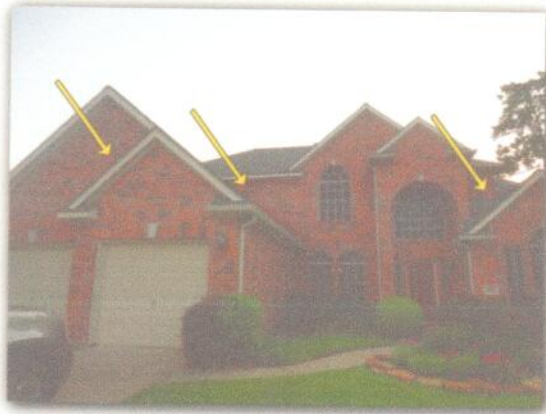
NOTE: Brick veneer and/or stone appears to be supported by the roof framing. front These areas may be more prone to have settlement cracks in the brick veneer, but this is a common installation if properly supported. (Unable to inspect all supports/framing due to limited access.)

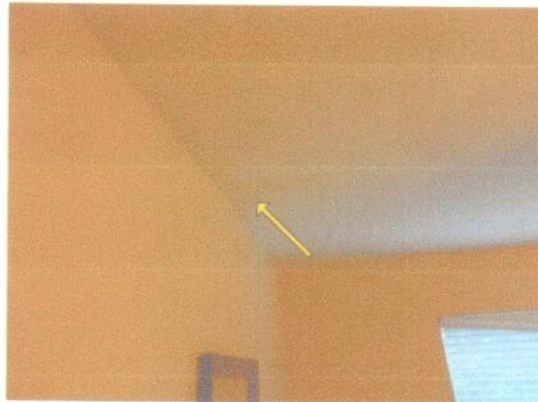
- Stress crack(s) noted in the interior gypsum wallboard at one or more ceiling areas.
- There appeared to be some undetermined, possibly cosmetic in nature, ceiling damage noted at one or more wall areas in the home and garage.
- Nail pops noted at one or more wall and/or ceiling locations.
- There appeared to be some undetermined stained and/or discolored ceiling areas noted in the rear second floor bedroom. Randomly tested this area with a moisture meter. Moisture did not appear to be present at the time of inspection. **It is highly recommended that you, the buyer, obtain further information from the seller about these areas prior to the end of the option period.**

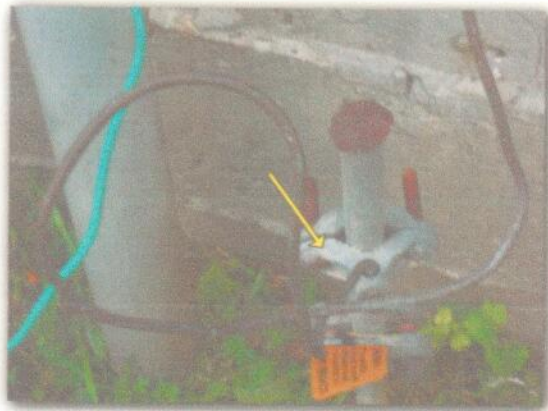
Ground wire is not properly secured to the grounding rod with the approved clamp (acorn clamp).

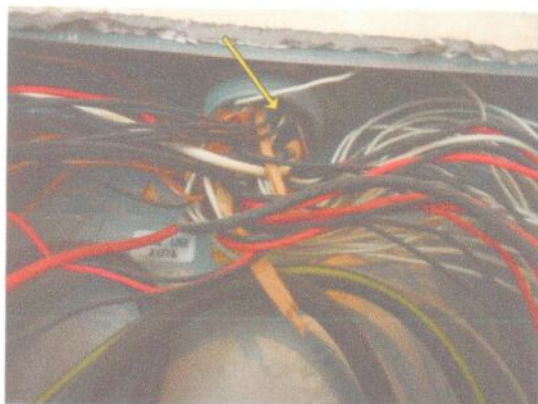
- The breaker size exceeds the manufacturer's guidelines for one of the A/C condensers. (On a 40 or 60 amp breaker should be on a 35 max amp breaker.)
- Wire bundling noted at the panel. (Typical of older home installations.)

NOTE: Recommend repairs of all deficiencies listed above be performed by a licensed electrician.

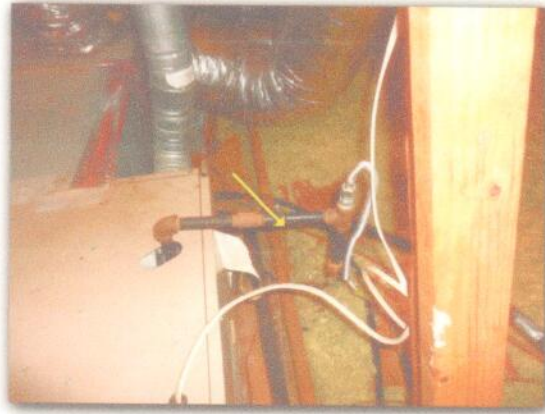
- The gas valve/line assembly is obstructing the heater's service access panel.

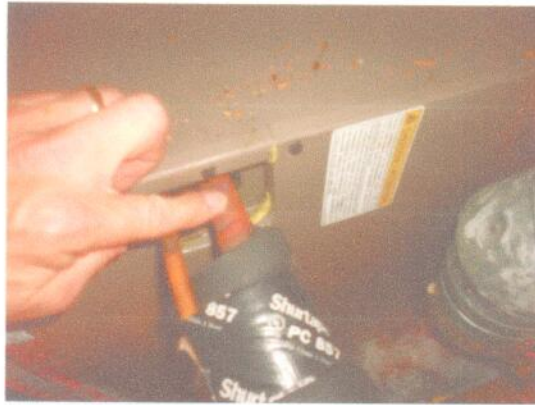
- Temperature differential is within range of 15-20 degrees Fahrenheit.
- The cooling system appeared to be cooling within the required temperature differential at the time of inspection.
- The HVAC system in the attic area of the home appears it may in aged condition (10+ years). (Should be monitored and have annual inspection/servicing.)
- Suction lines have some damaged/missing insulation at one or more locations at the unit in the attic area.

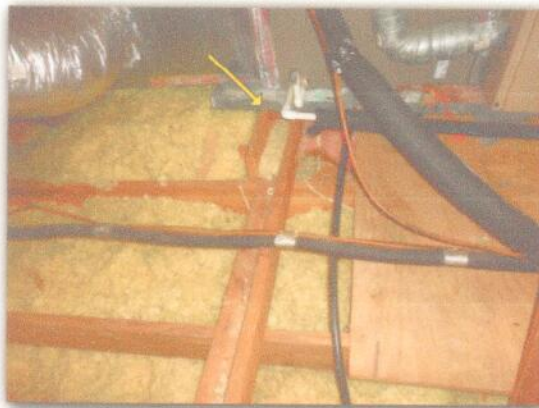
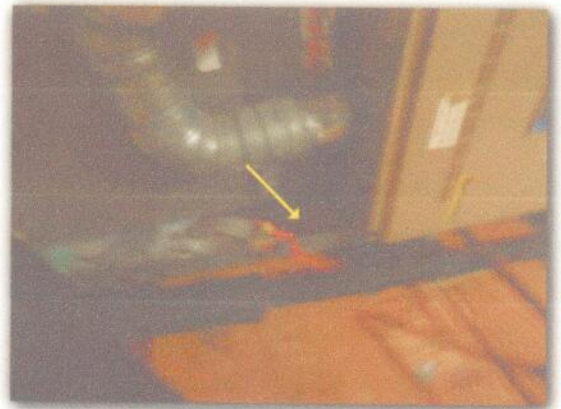
- The evaporator coil housing was sealed and not inspected.
- The safety drain pan is dirty, rust, has signs of previous moisture and does not appear to slope toward the safety drain line.

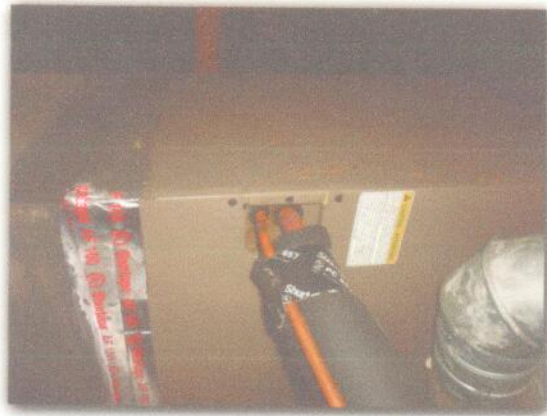
Air leaks at the evaporator housing.

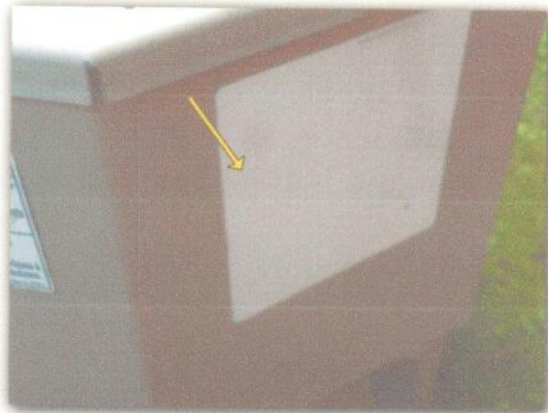
I was unable to determine the unit's size, age and correct electrical breaker size in the panel box due to the informational label on the exterior compressor unit being faded out and/or missing.

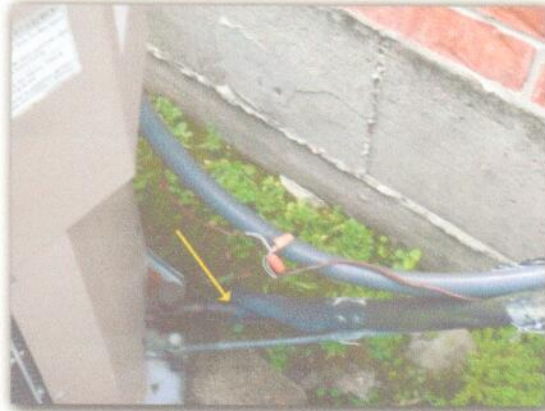
- Temperature differential is within range of 15-20 degrees Fahrenheit.
- The cooling system appeared to be cooling within the required temperature differential at the time of inspection.
- The HVAC cooling system appears it may in aged condition (10+ years). (Should be monitored and have annual inspection/servicing.)
- The compressor/condenser unit appeared to be in aged condition (10 + years) coils are slightly dirty. Should be monitored and have annual inspection/servicing.)
- Suction lines have some damaged/missing insulation at one or more locations on the exterior at the compressor/condenser unit and in the attic area.

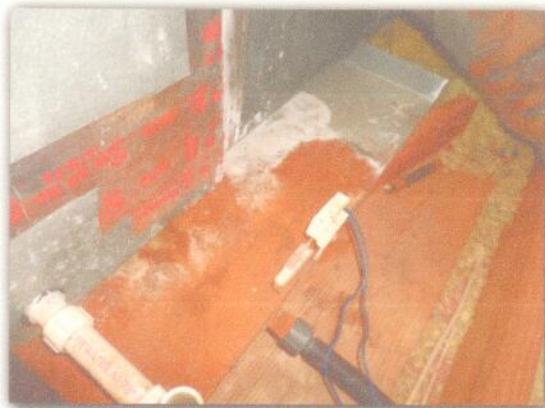
- The evaporator coil housing was sealed and not inspected.
- The safety drain pan is dirty, rusted and has signs of previous moisture.

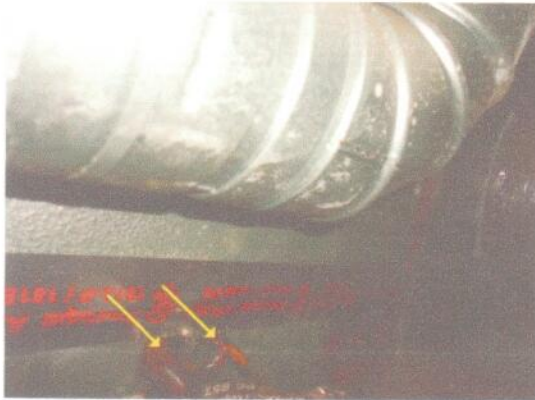
Air leaks at the evaporator housing.

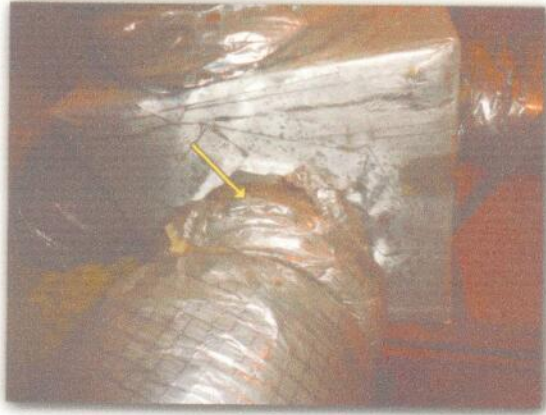
- Air leaks noted at one or more duct transitions and/or duct connections.

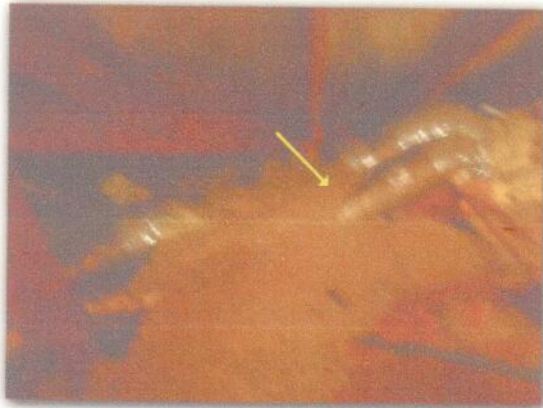
- Ducts touch each other or lay on the attic insulation at one or more locations. Ducts should not touch each other or lay directly on the insulation due to moisture/condensation.

NOTE: Recommended that all deficiencies listed above be repaired by a licensed HVAC specialist to ensure maximum efficiency.

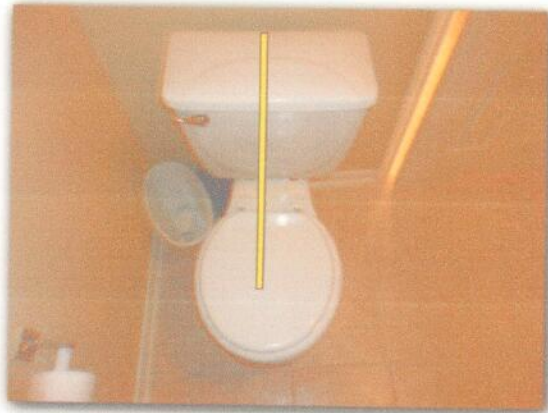
- The toilet tank(s) water levels need adjustment (too high). half second floor
- The toilet appeared to be installed at an angle. front second floor

NOTE: Recommended that repairs of all deficiencies listed above be performed by a licensed plumber.

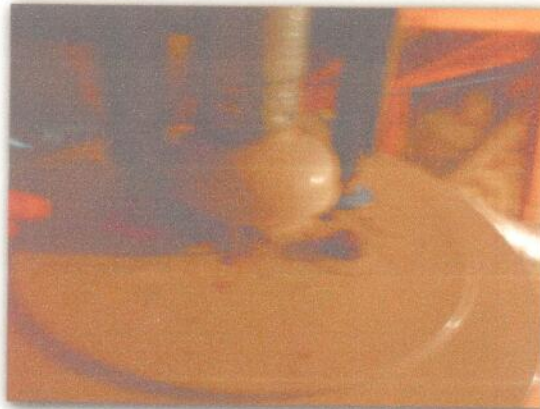
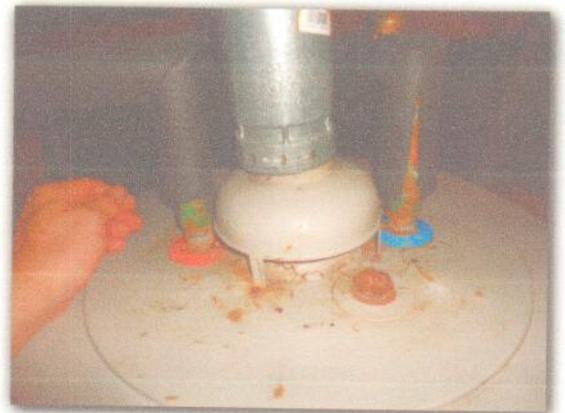
The hot water heating unit appeared to be in aged condition (10 + years), has some rust, is noisy when heating and has rust in the burner compartment that appears to be starting to effect the flame/burner operation - **SAFETY HAZARD**. May be at or nearing the end of its functional life. **Further information from a licensed plumber prior to the end of the option period.**

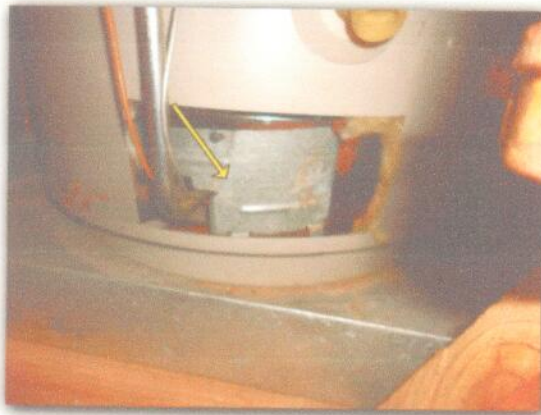
- ☑ The interior burner access cover was not properly secured - **SAFETY HAZARD.**

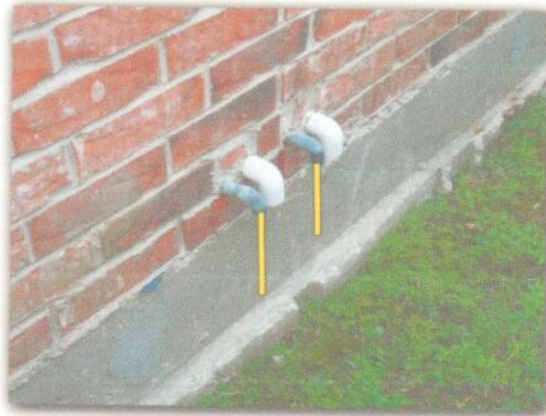
- ☑ Rusted/corroded water supply plumbing connections were noted above the unit.
- ☑ The temperature pressure relieve valve should be replaced every 3 to 4 years as per manufacturer recommendation.
- ☑ The temperature pressure relieve valve drain line is more than 6 inches from the ground - **SAFETY HAZARD.**

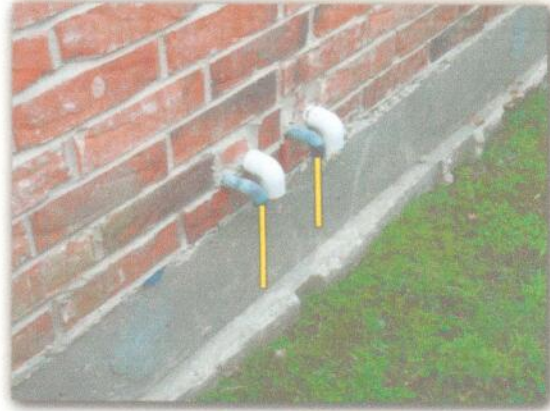
- The interior burner access cover was not properly secured - **SAFETY HAZARD.**
- Rusted/corroded water supply plumbing connections were noted above the unit.
- The temperature pressure relieve valve should be replaced every 3 to 4 years as per manufacturer recommendation.
- The temperature pressure relieve valve drain line is more than 6 inches from the ground - **SAFETY HAZARD.**

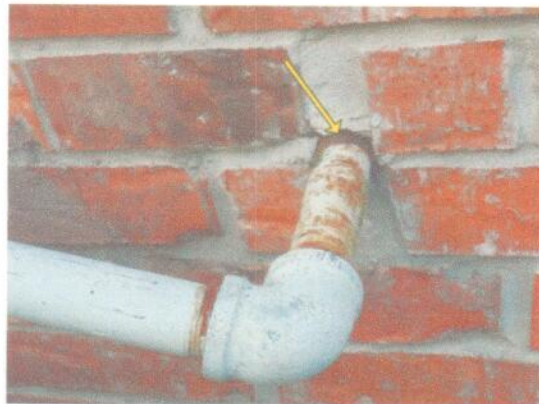
- The gas line from the meter to the home did not appear to be wrapped and/or sleeved where it penetrates the brick veneer wall of the home and has some rust. **Should remove rust, be properly painted, wrapped and wrapped and/or sleeved at the brick veneer.**

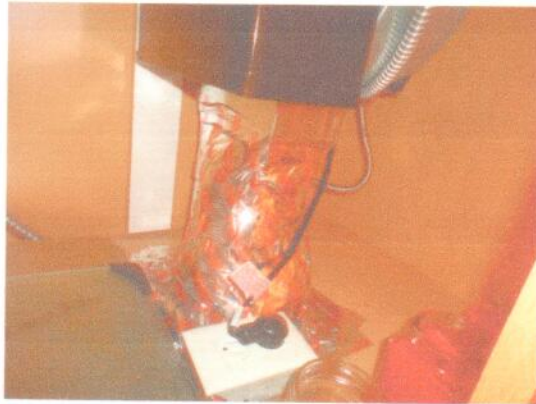
- The vent pipe is not properly sealed at one or more locations in the cabinet area below the unit.

NOTE: Recommend repairs of deficiencies listed above by a qualified and reputable company.

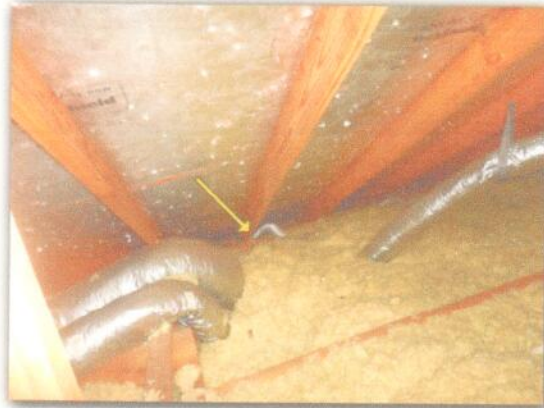
- One or more exhaust fan systems appear to terminate/vent out at one or more eave/soffit areas. The soffit vents allow air flow in and out of the attic area.

NOTE: Recommend repairs of deficiencies listed above by a qualified and reputable company.

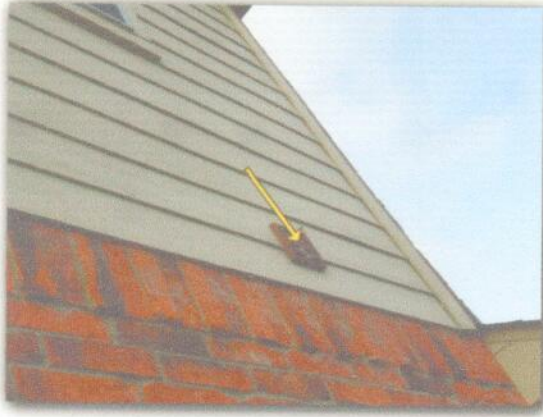
- The exterior wall dryer vent cover appears to be dirty and stuck in the open position. (Should seal when system is not in service to prevent moisture penetration or small animals and/or rodents from entering.)

NOTE: Recommend repairs of deficiencies listed above by a qualified and reputable company.
