Inspection Report

Property Address:
55 Blush Hill Drive
Conroe Texas 77304

PROPERTY INSPECTION REPORT

By: Tod Law TREC# 22123 / House To Home Inspection 3/27/2017
(Name and License Number of Inspector) (Date)

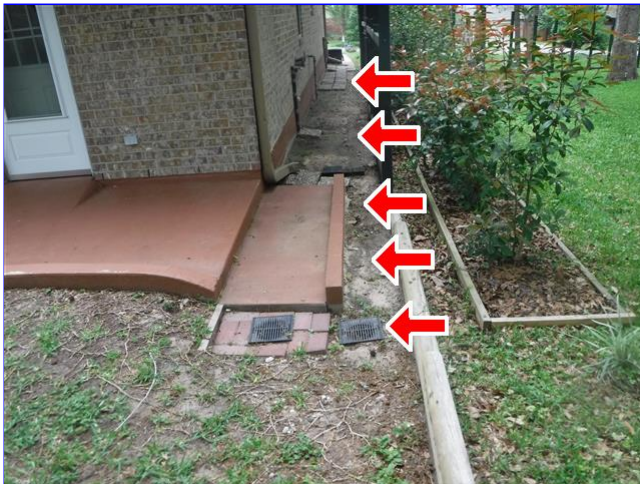
(2) There is a washed out area on the left side of the house where a majority of the water flows from the back of the property. I recommend adding bull rock down the entire length to prevent erosion damage to the foundation.

B. Item 1(Picture) Washed out area here

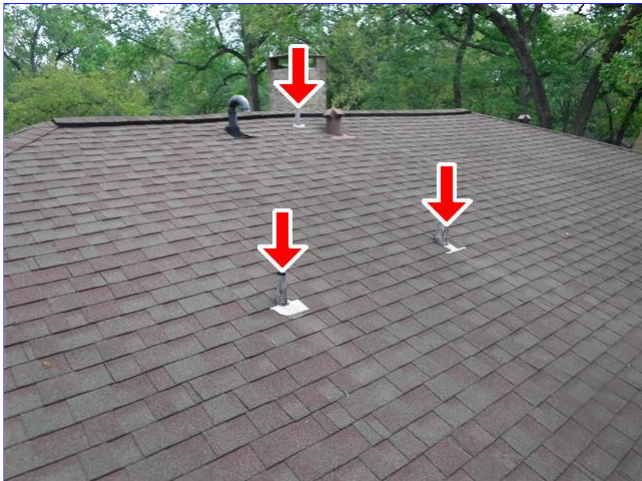
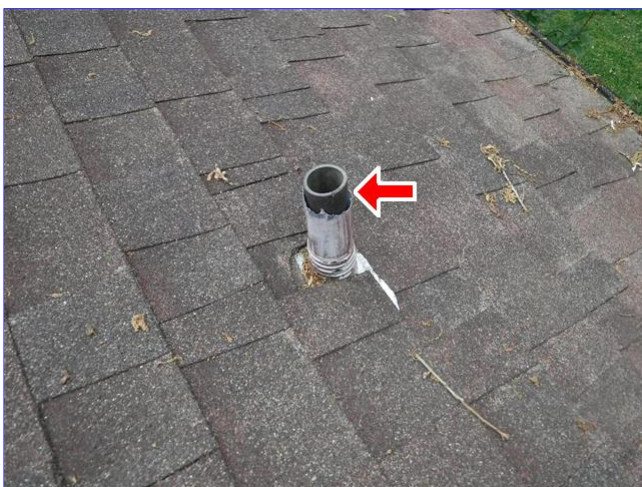
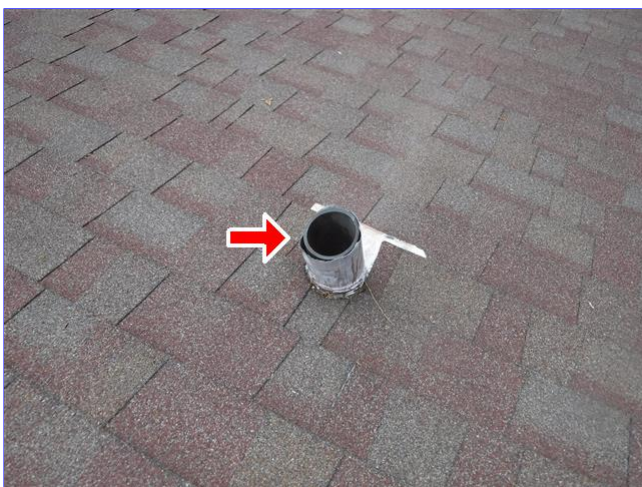
(2) The plumbing vent pipe penetration flashing throughout the roof of the house is damaged and not properly sealed over the vent pipe. I did not detect any moisture in this area during the inspection of the roof or attic space. I recommend having a qualified roofing professional evaluate and repair as needed.

C. Item 5(Picture) Damaged vent seals here

C. Item 6(Picture) Damaged vent seal here

C. Item 7(Picture) Damaged vent seal here

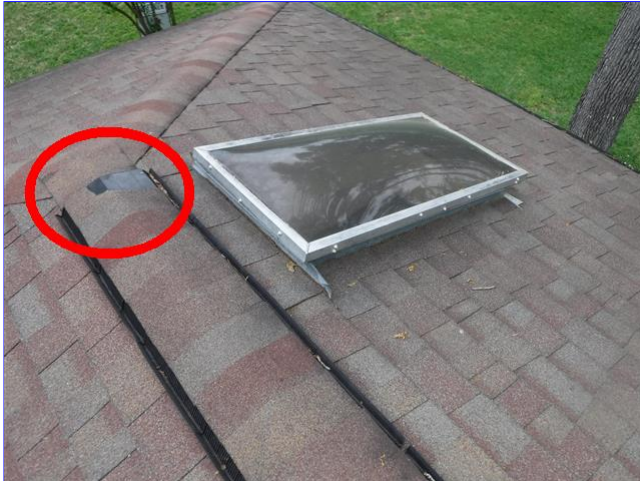
(3) There is a missing/damaged shingle on the ridge vent at the back of the house. I recommend having a qualified roofing professional evaluate and repair as needed.

C. Item 8(Picture) Damaged shingle here

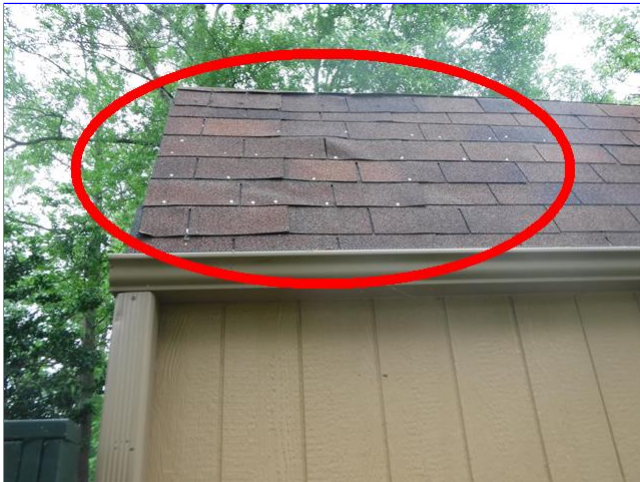
(4) There are exposed nail heads on the outbuilding. I recommend sealing the nail heads to prevent the nail heads from rusting and failing allowing roof covering damage to occur. The pictures shown are not all inclusive of every exposed nail.

C. Item 9(Picture) Exposed nail heads here

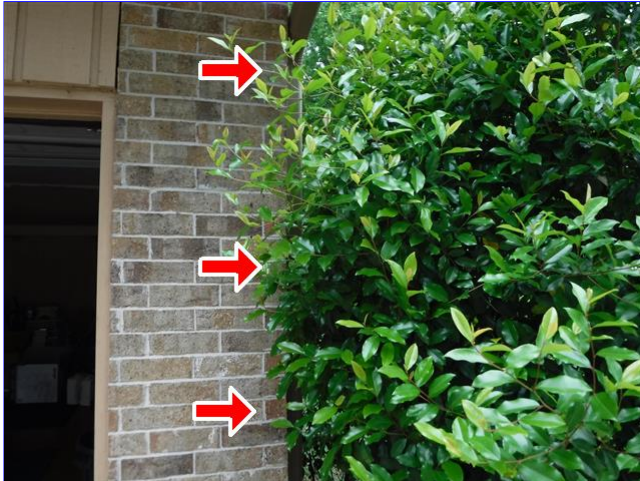
E. Item 1(Picture) Excess vegetation needs to be trimmed back

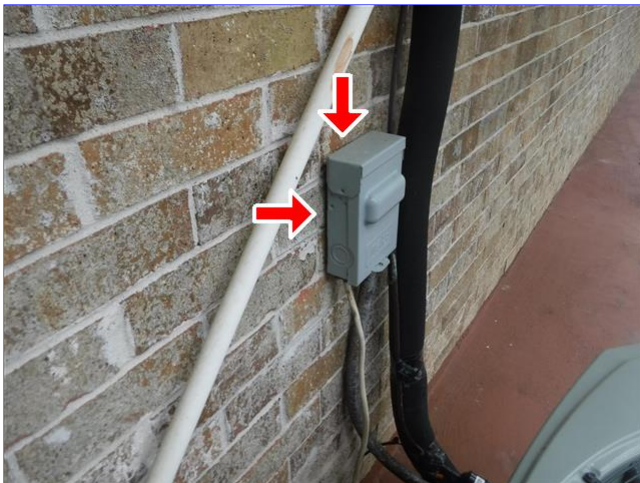
(3) The cooling condenser service disconnect is not sealed to the wall. I recommend sealing the disconnect to prevent moisture intrusion into the wall.

E. Item 2(Picture) This area needs to be sealed to the wall to prevent moisture and pest intrusion into the wall.

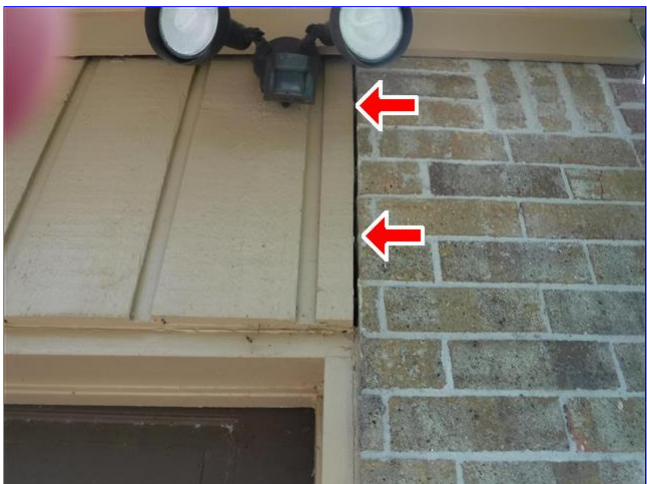
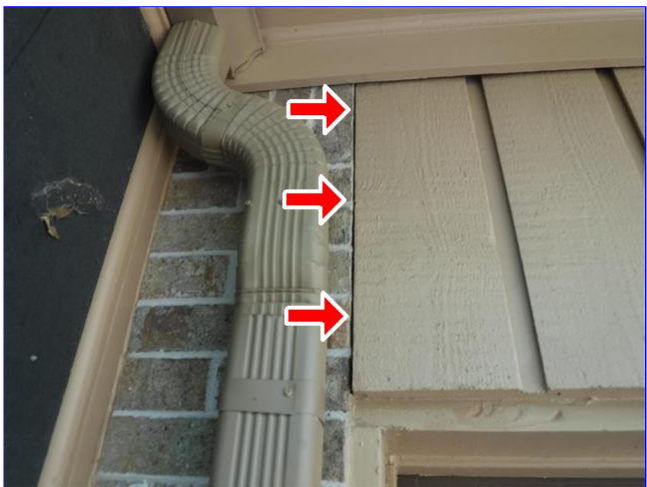
(4) There is an excessive open area in the siding on the upper right and left side of the garage door opening. I recommend sealing this area to prevent moisture and pest intrusion.

E. Item 3(Picture) This area needs to be sealed to prevent moisture and insect intrusion

E. Item 4(Picture) This area needs to be sealed to prevent moisture and insect intrusion

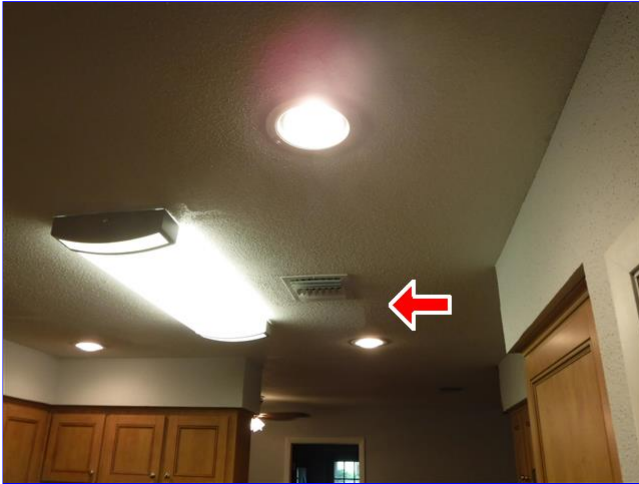
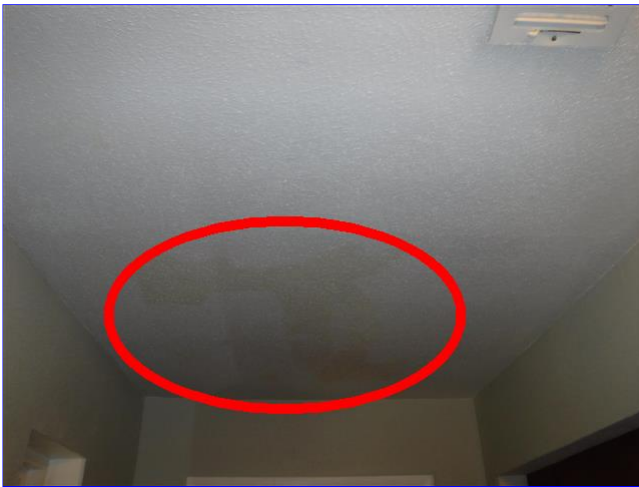
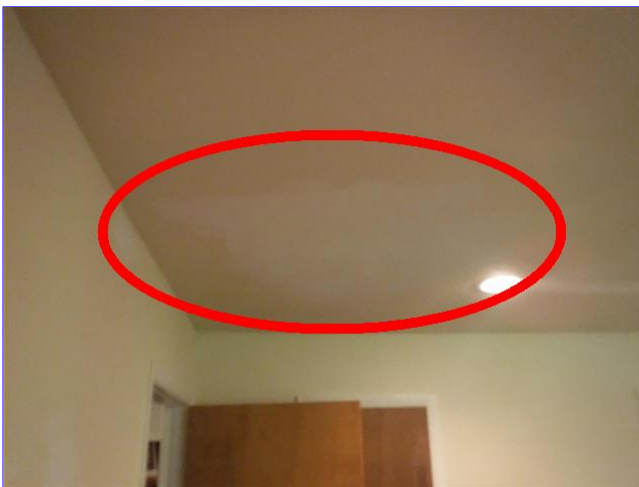
(2) There is evidence of ceiling repair in the kitchen, foyer, and master bedroom ceiling. I did not detect a defect in this area from either side of the ceiling at the time of the inspection. I recommend asking the current owners for details concerning the repaired area.

F. Item 1(Picture) Previous repair here

F. Item 2(Picture) Previous repair here

F. Item 3(Picture) Previous repair here

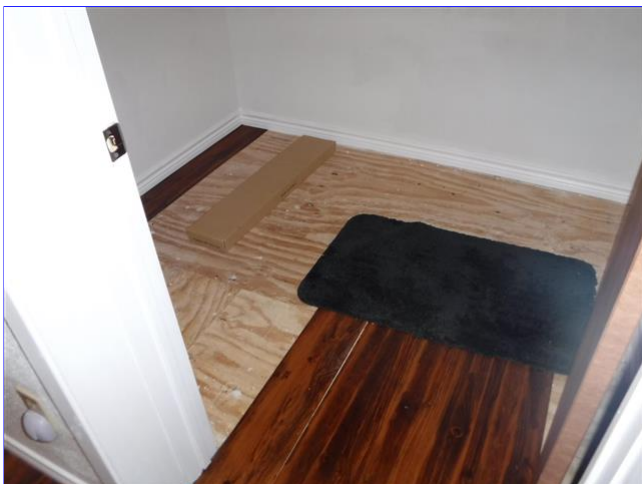
(3) The flooring is incomplete in the master bedroom closet. Repair as needed.

F. Item 4(Picture) Incomplete flooring here

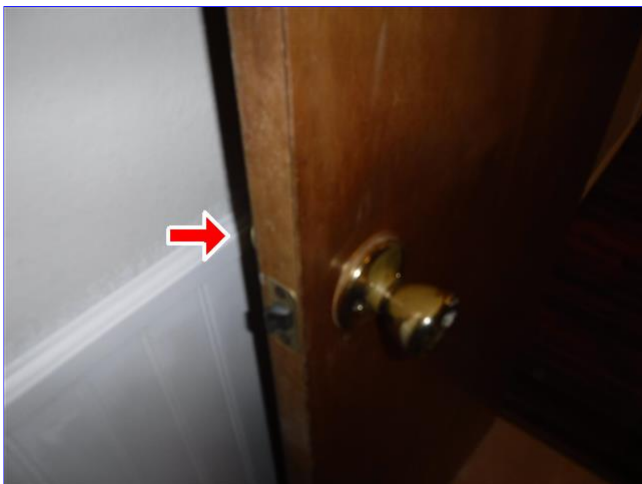
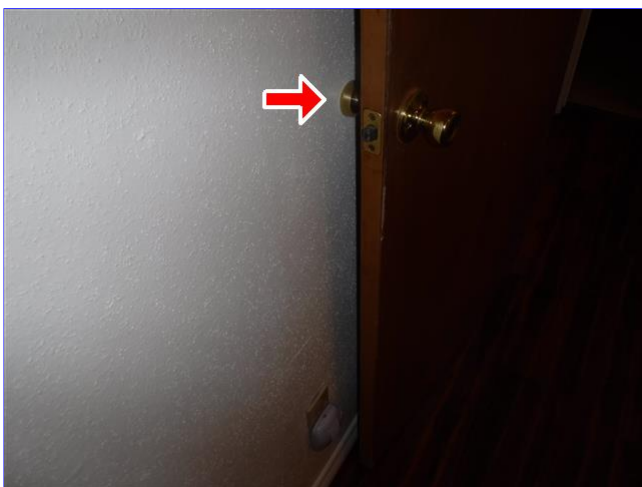
(2) There are missing/defective/non-functioning door stops throughout the house. I recommend installing door stops to prevent drywall and door damage. The pictures shown are not all inclusive of every missing/defective/non-functioning door stop.

G. Item 1(Picture) Missing door stop here

G. Item 2(Picture) Missing door stop here

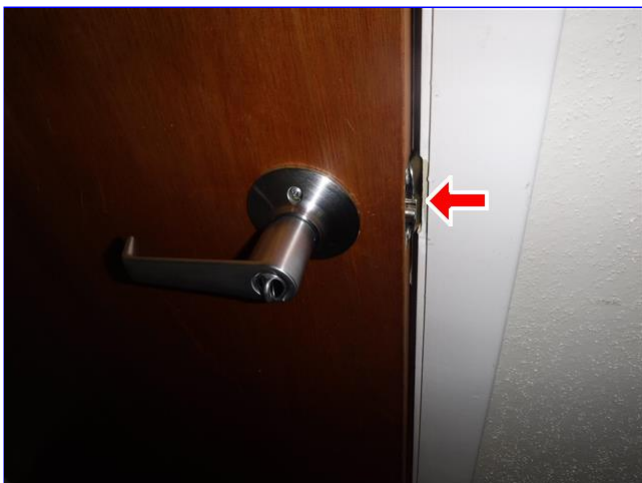
(3) The front right side bedroom does not latch into the striker plate. I recommend adjusting the door or striker plate as needed to properly secure the door in the closed position.

G. Item 3(Picture) Damaged striker plate here

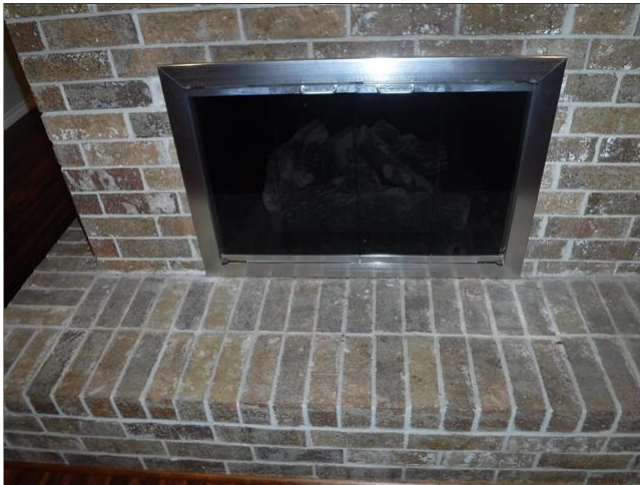
The fireplace did not function at the time of the inspection. The fireplace would not lite with remote activation or manually. I recommend further evaluation by a qualified fireplace technician.

J. Item 1(Picture) View of the fireplace (inactive)

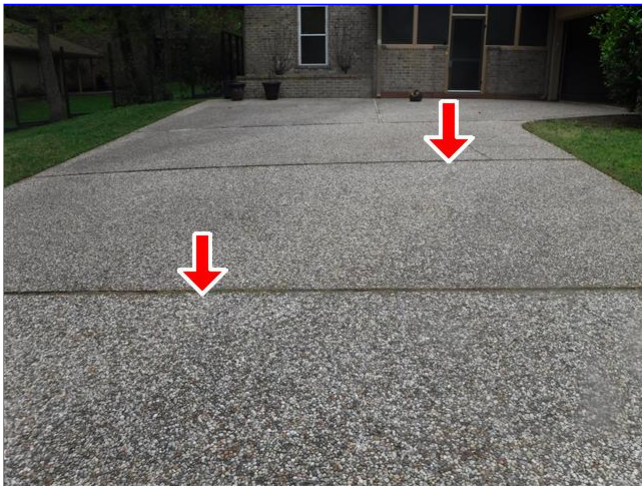
The expansion joints in the driveway are open. Open expansion joints can allow water to get under the concrete surface and expand the soil causing lifting in the concrete. I recommend filling the expansion joints with an approved expansion joint material.

L. Item 1(Picture) Open expansion joints here

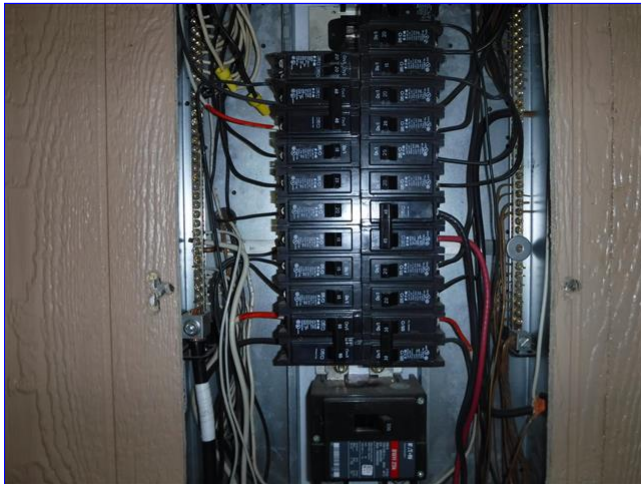
(2) There are no Arc Fault Circuit Interrupts (AFCI) breakers present in the breaker panel box. Current standards require all habitable spaces in the house be AFCI protected. NOTE: AFCI breakers requirements for all habitable spaces was not the building standard at the time this house was constructed.

A. Item 2(Picture) View of the breaker panel open for inspection (No AFCI)

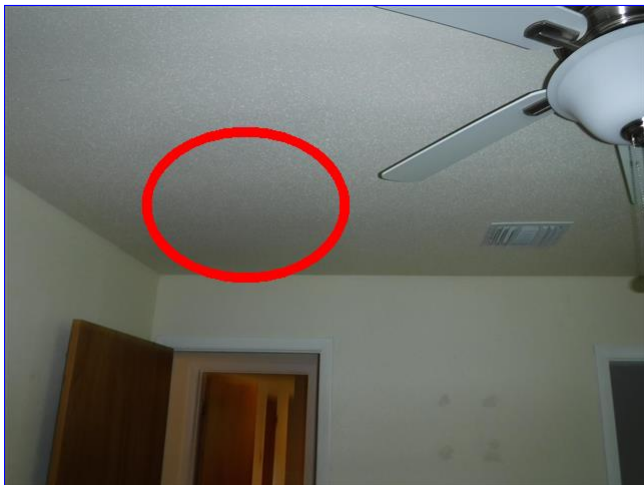
(2) There are no smoke detectors present in the bedrooms that meet current standards. To meet current standards I recommend installing smoke detectors in all bedrooms, all sleeping areas and in the immediate

vicinity of all bedrooms. The smoke alarms should be interconnected if one smoke alarm sounds they should all sound. The smoke alarms should also have a battery back up in the case of power failure.

B. Item 1(Picture) No smoke alarms (bedrooms)

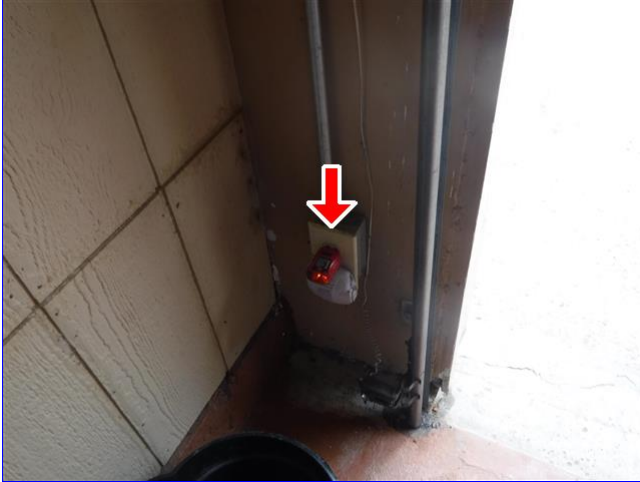
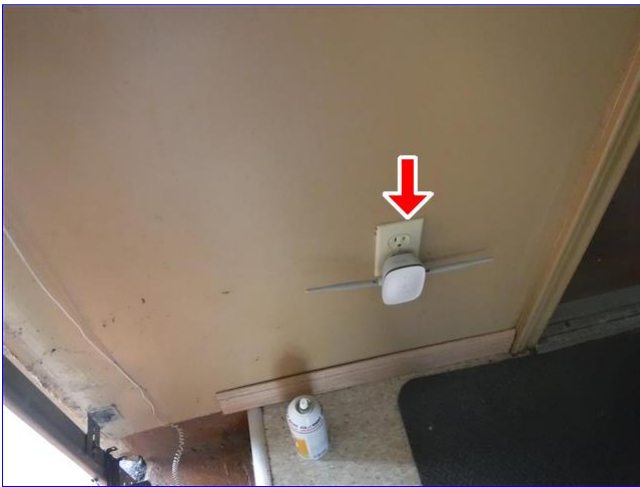
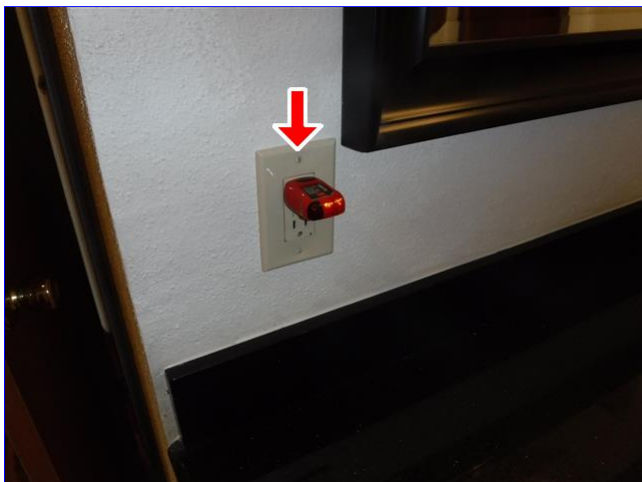
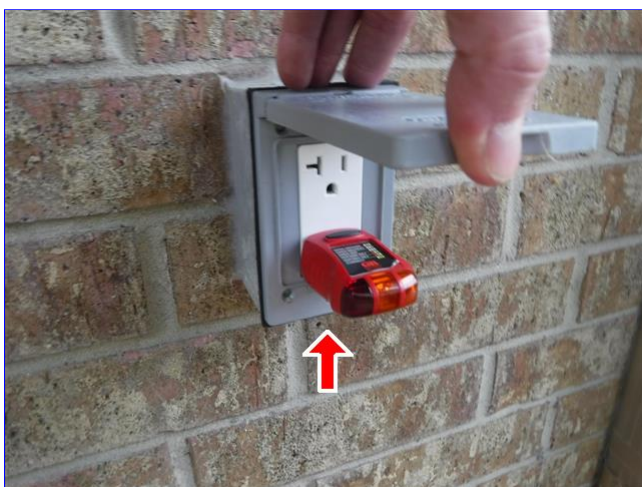
(4) Not all electrical circuits as required per the current standards are ground fault circuit interrupt (GFCI) protected . GFCI outlets should be present in any power outlet that is within a 6 foot radius of a water source inside the house and at all kitchen, kitchen islands and bathroom countertop areas. As well as all exterior power outlets and all power outlets in the garage should be GFCI protected. At the time of construction of this house all GFCI protected areas may not have been the standard. I recommend having a licensed electrician evaluate and install GFCI circuits as needed.

B. Item 2(Picture) No GFCI protection (garage)

B. Item 3(Picture) No GFCI protection (garage)

B. Item 4(Picture) No GFCI protection (master bathroom)

B. Item 5(Picture) No GFCI protection (exterior)

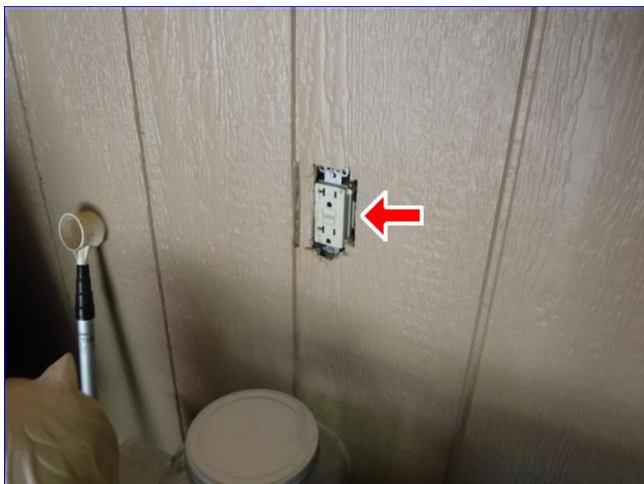
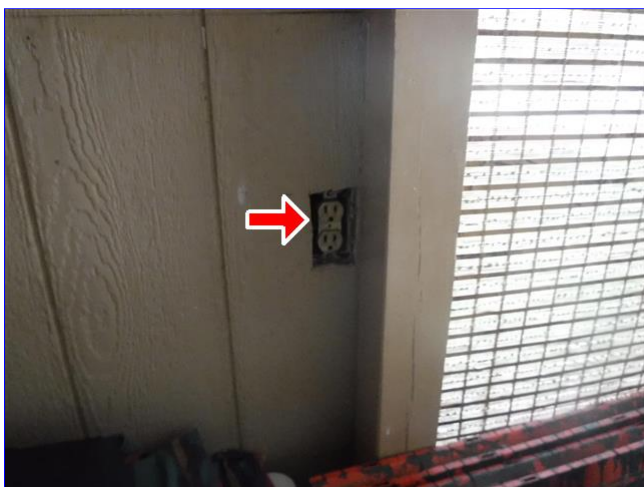
(5) There are missing outlet covers in the garage area. I recommend replacing all damaged covers giving access to electrical connections to prevent accidental shock.

B. Item 6(Picture) Missing outlet cover here

B. Item 7(Picture) Missing outlet cover here

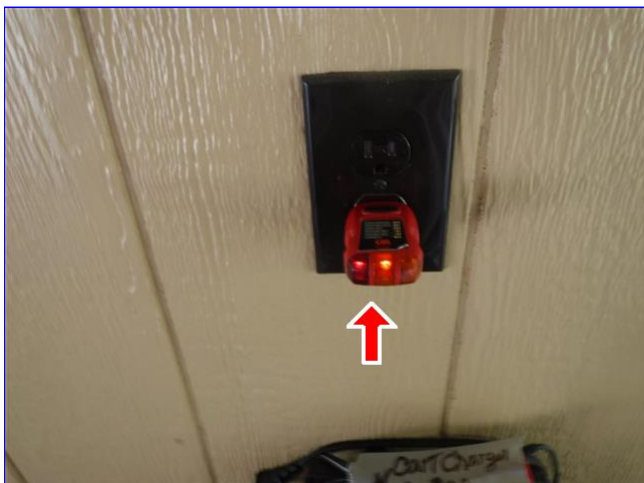
(6) There is a power outlet in the garage that has the power and neutral reversed (Reverse Polarity). I recommend having a licensed electrician evaluate further and repair as needed.

B. Item 8(Picture) Reverse polarity (garage)

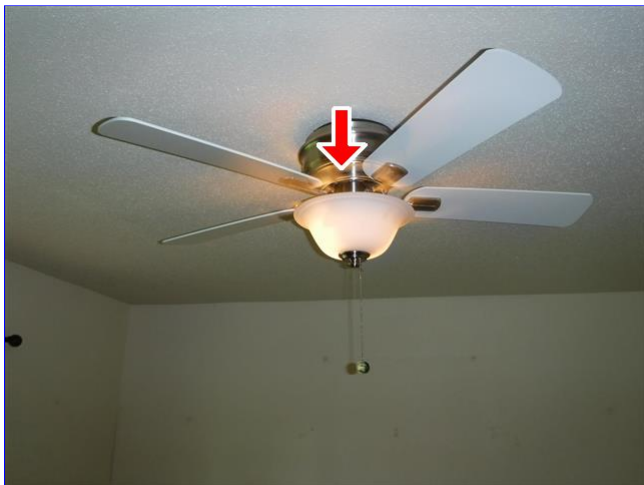
(7) The ceiling fan blades are rubbing on the top cover plate in the front bedroom. I recommend repairing the fan to prevent premature ware of the fan.

B. Item 9(Picture) Fan blades rubbing here

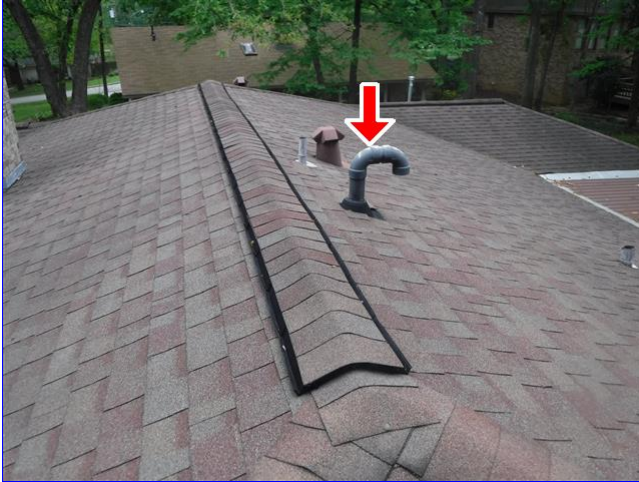
(2) The furnace vent is not an approved b-vent type exit stack. I recommend having a qualified HVAC professional evaluate and replace as needed.

A. Item 1(Picture) Wrong type of exhaust vent here

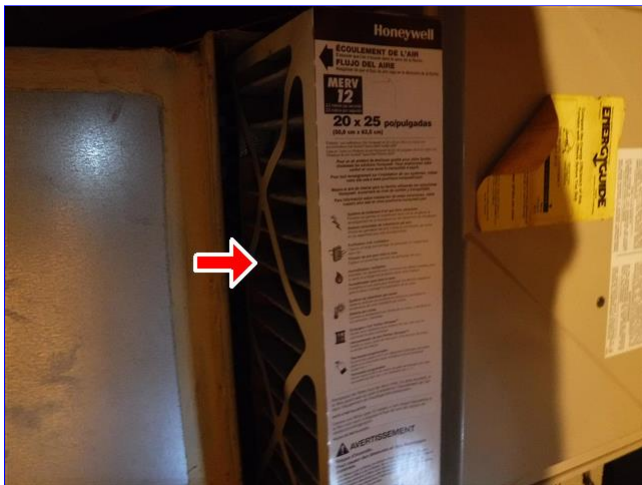
(1) This house is equipped with a whole house filter. The filter is dirty and in need of replacement. I recommend checking the filter once a month and changing the air filters per the manufactures requirements in order to enhance the efficiency of the heating and cooling systems.

C. Item 1(Picture) Dirty filter here

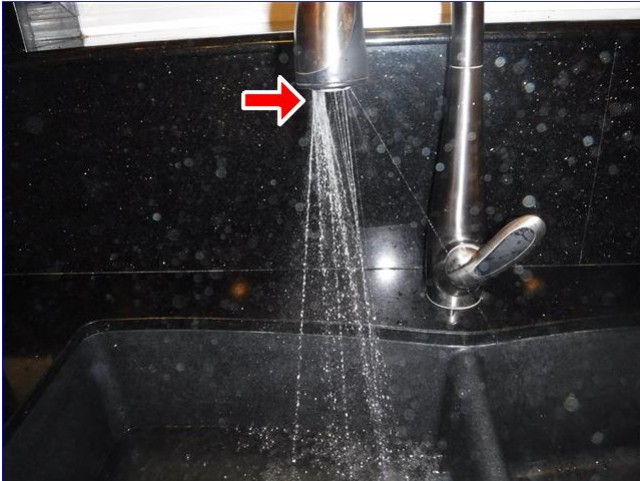
A. Item 3(Picture) Irregular spray pattern here

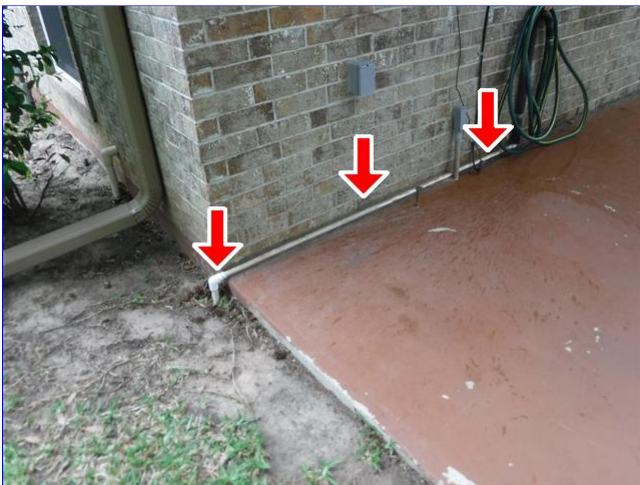
(4) The exterior plumbing around the house needs to be insulated to prevent freezing. I recommend insulating all exterior plumbing to prevent possible freezing and damage caused from freezing.

A. Item 4(Picture) This area needs to be insulated.

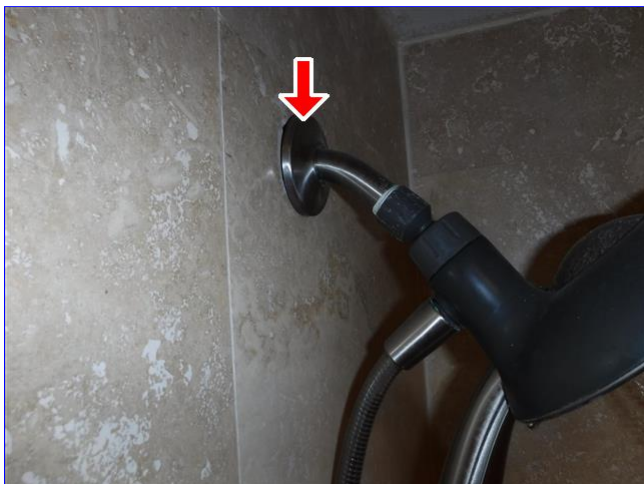
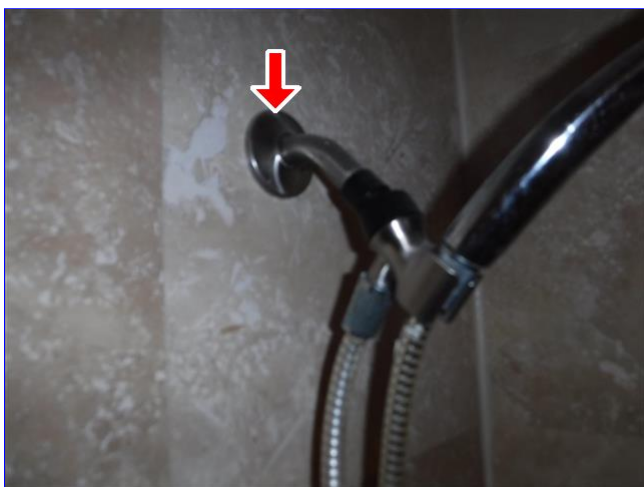
(5) The shower stems are loose and unsealed at the base in the guest and master bathrooms. I recommend having a licensed plumber evaluate and repair as needed.

A. Item 5(Picture) Loose stem here

A. Item 6(Picture) Loose stem here

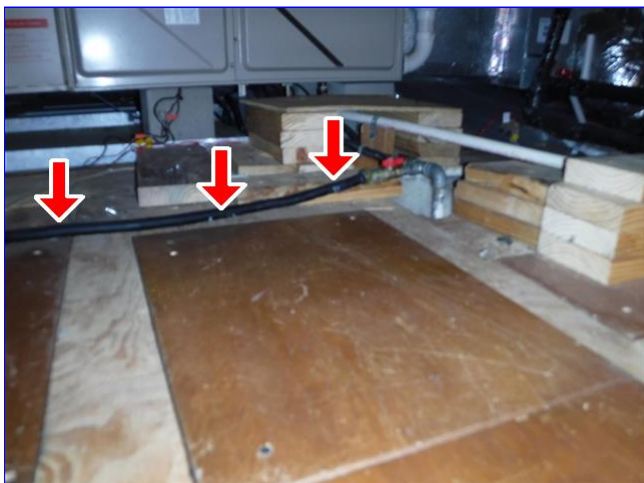
(6) The gas line running to the fireplace is flex hose and not an approved black pipe gas line. I recommend having a licensed plumber evaluate and repair as needed.

A. Item 7(Picture) Flex line here

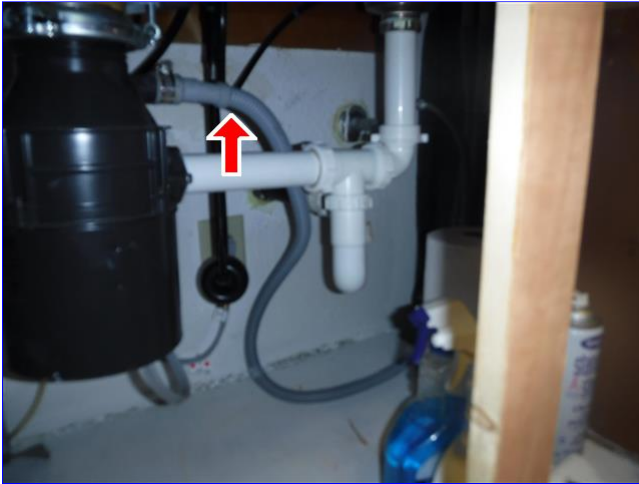
(2) There is no dishwasher high loop or vent present in the dishwasher drain line. The dishwasher drain line should run up from the garbage disposer and then back down to the dishwasher or up to a drain line vent. Having a high loop drain line or vent line style type of routing of the dishwasher drain line will help prevent clogging of the drain line and will help keep the disposer waste from the waste disposer from backing up into the dishwasher drain line causing a clog. I recommend installing a high loop or vent into the dishwasher drain line to help prevent clogging of the dishwasher drain line.

B. Item 1(Picture) Any drain line entering a food waste disposer should enter the disposer in a downward direction to prevent clogging.

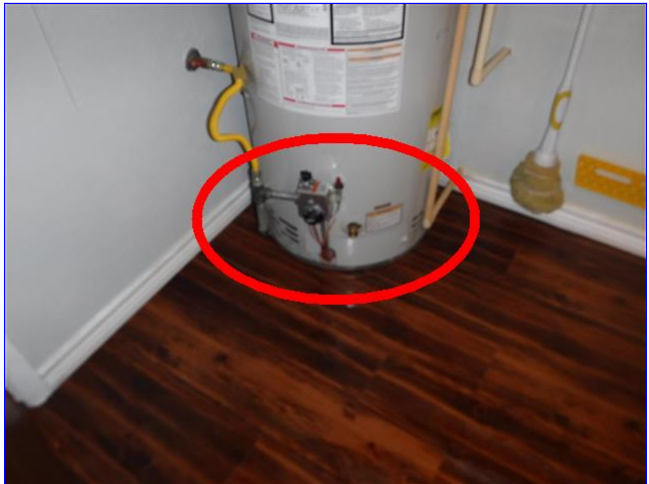
(2) There is no water heater safety drain pan installed beneath the water heater. The current water heater location can cause drywall damage if the water heater was to leak. I recommend installing a water heater safety drain pan and routing the drain line to an area that will not cause dry wall damage if used.

C. Item 2(Picture) Missing drain pan here

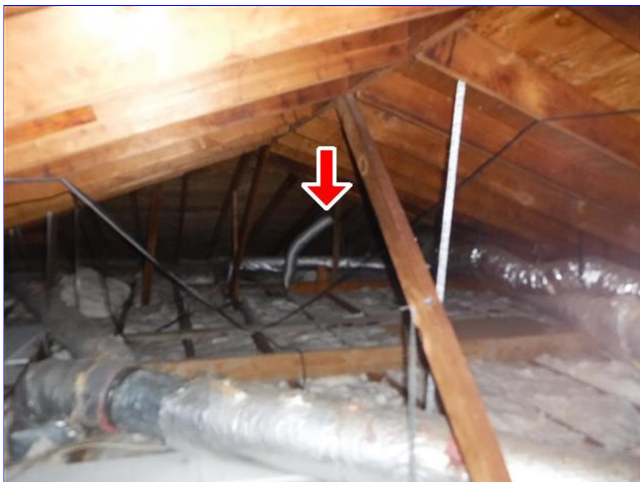
(2) The range exhaust vent hood is vented into the attic space. The current standards is to vent the range exhaust to the exterior of the house. I recommend venting the range exhaust to the exterior of the house.

C. Item 1(Picture) Vent does not exit attic space here

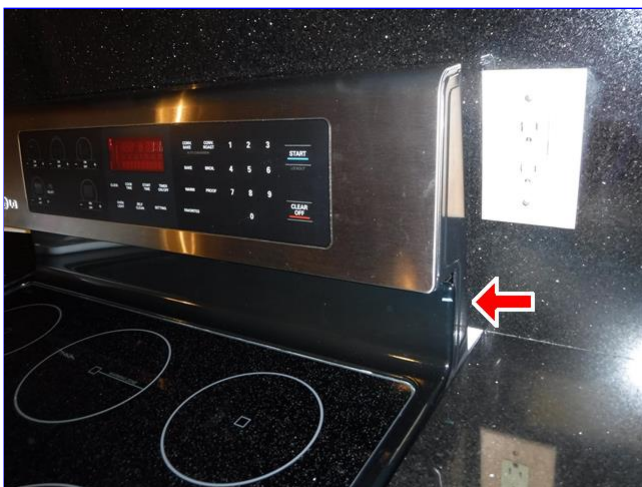
(2) The oven was not equipped with a anti-tip device. The anti tip device will prevent the oven from tipping forward in the event too much weight is applied to the oven door or front of the oven. This is a safety feature that should be installed on all stand alone ovens.

D. Item 2(Picture) No anti-tip device here
