PROPERTY INSPECTION REPORT

Concerning: 2823 Allyson Lane , Spring, TX 77373
(Address or Other Identification of Inspected Property)

By: Marcus Brandt Lic.#: TREC # 22244 07/02/2020
(Name and License Number of Inspector) (Date)

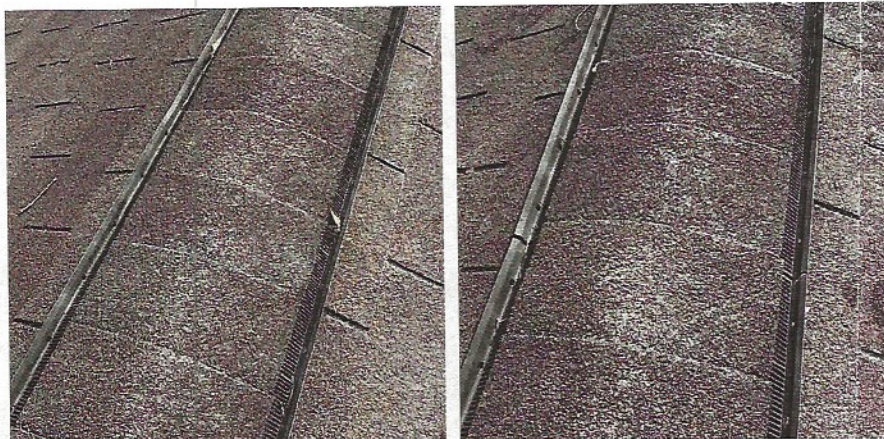
- 1. Granular erosion observed on shingles, indicating shingles may have exceeded their useful life expectancy (see photo) Recommend further review by a qualified roofing contractor to determine if repairs can be made or if removal and replacement of shingles is needed.

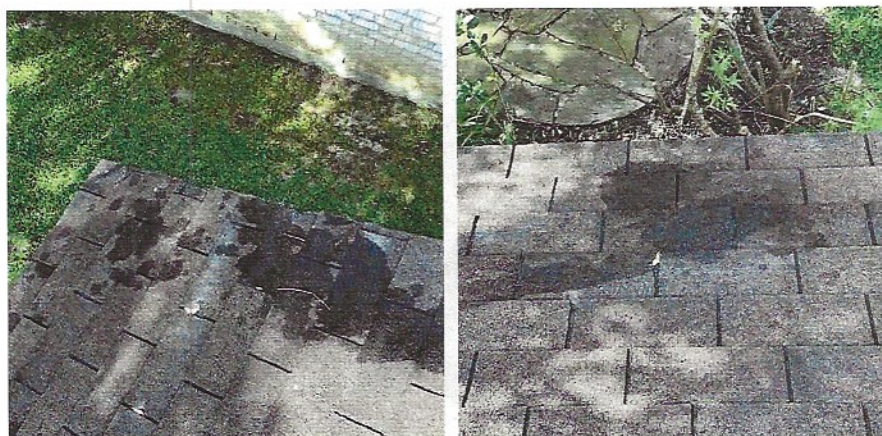
- 2. Damaged shingles were observed in one or more locations on the surface of the roof (see photos). Recommend consulting with a qualified roofer regarding this condition.

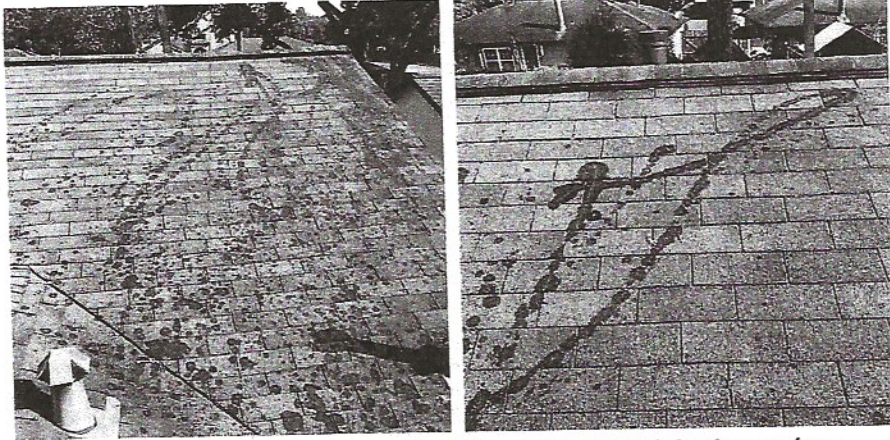
- 3. Unusual staining was observed on the surface of the roof (see photos). The cause of this staining was not determined at the time of inspection. Recommend consulting with a qualified roofer regarding this condition.

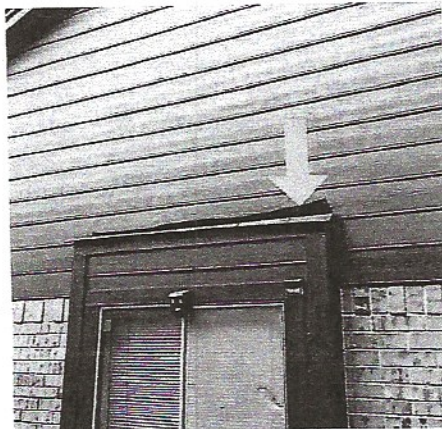
- 4. Lifted flashing was observed at the right side of the home (see photo). Recommend consulting with a qualified contractor regarding this condition.

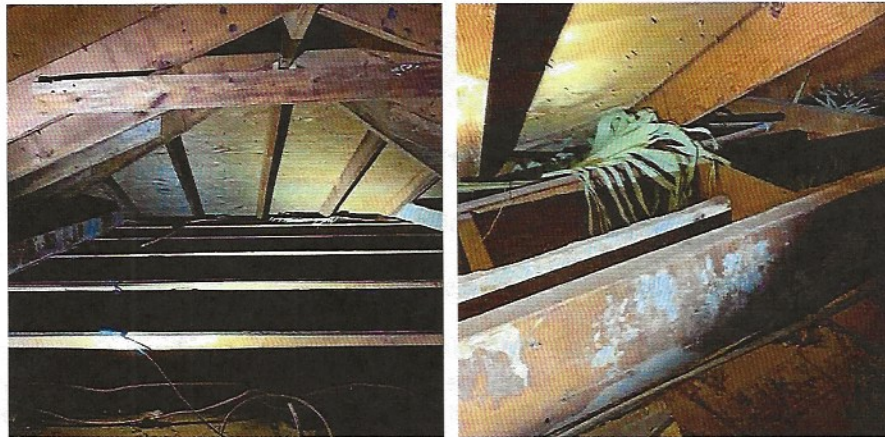
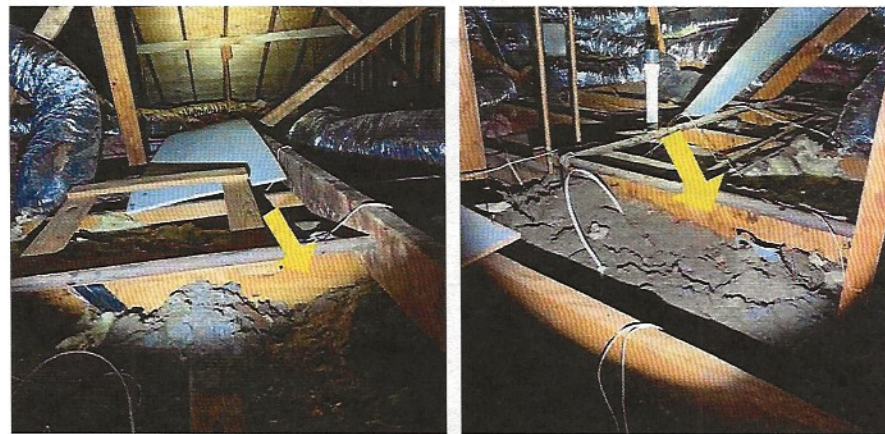
- **1. Insulation was observed to be of inadequate depth in the attic space (see photo). Typically insulation in the attic space should be even with, if not above, joists. Suggest adding insulation in attic space. Recommend consulting with a qualified contractor regarding this condition.**

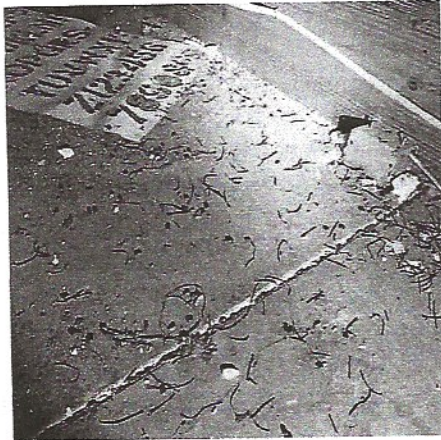
- 2. Potential rodent droppings were observed in the attic space at the time of inspection (see photo). Recommend consulting with a qualified contractor regarding this condition.

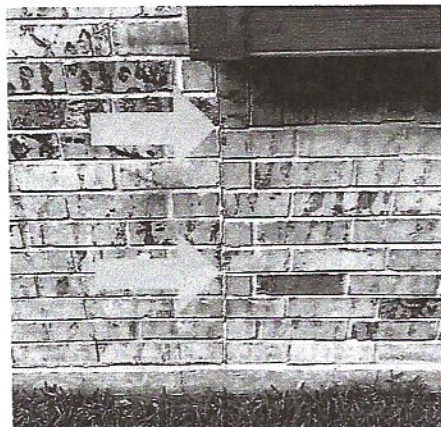
- 1. Expansion joints in masonry veneer are not sealed (see photo). Recommend sealing all expansion joints with good, exterior grade sealant to prevent moisture and pest intrusion at expansion joint.

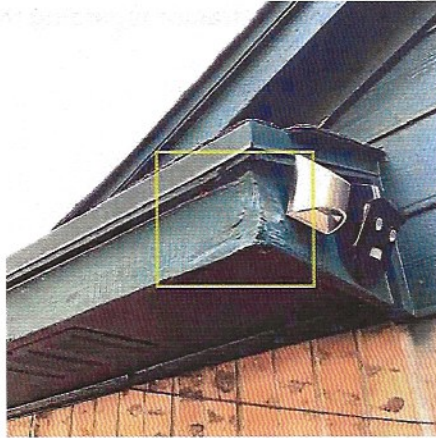
- 2. Wood rot was observed at fascia trim on the left side of the home (see photo). Recommend consulting with a qualified contractor regarding this condition.

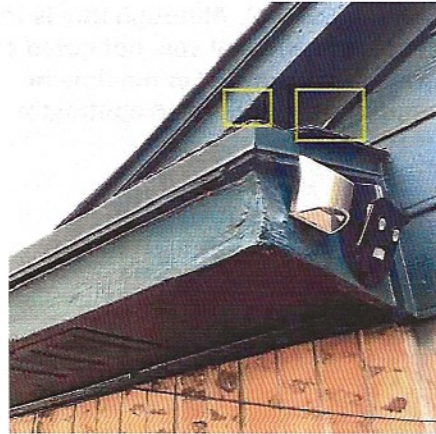
- 3. Signs of rodent damage was observed at fascia trim on the left side of the home (see photo). Recommend consulting with a qualified contractor regarding this condition.

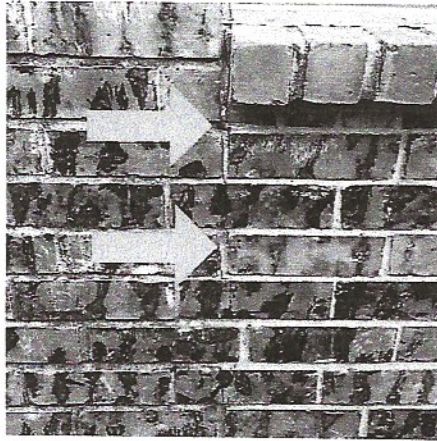
- 4. Settlement cracks were observed in the brickwork on the left side of the home (see photo). Although this is indicative of foundation movement, excessive movement was not noted and the foundation appears to be performing as intended at the time of inspection. Recommend consulting with a qualified contractor regarding this condition.

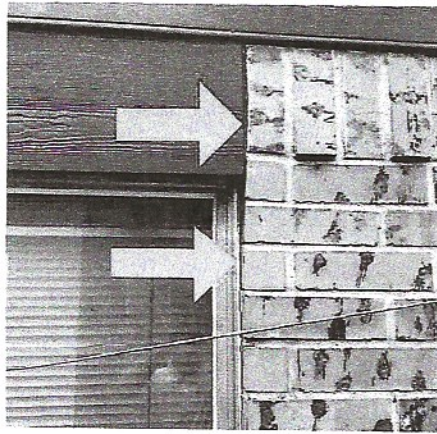
- 5. Separation was observed between the window frame and the brick wall on the left side of the home (see photo). Although this is indicative of foundation movement, excessive movement was not noted and the foundation appears to be operating as intended at the time of inspection. Recommend consulting with a qualified contractor regarding this condition.

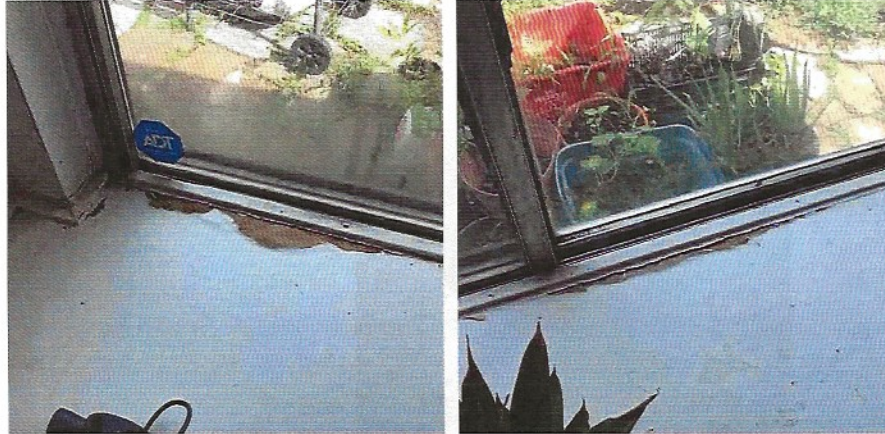
- 6. Signs of minor moisture intrusion were observed at the window sill in the dining room (see photos). This is a common occurrence with single pane windows. Recommend consulting with a qualified contractor regarding this condition.

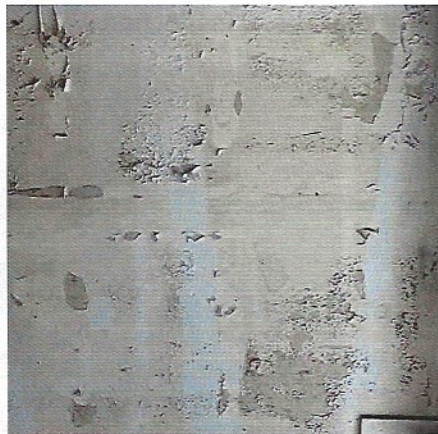
- 7. The painted walls in the garage are peeling (see photo). This is likely caused by high humidity or improper installation. Recommend consulting with a qualified contractor regarding this condition.

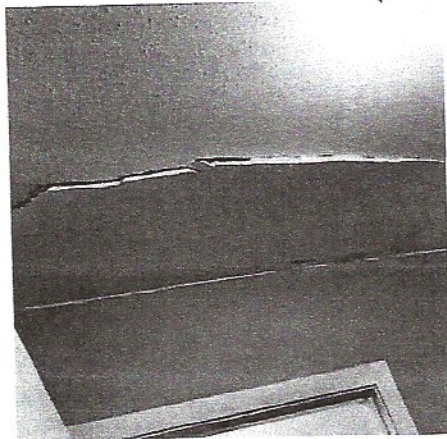
- 1. Damage to the ceiling was observed in the laundry room (see photo). This was likely caused by someone stepping through the ceiling from the attic space. Recommend consulting with a qualified contractor regarding this condition.

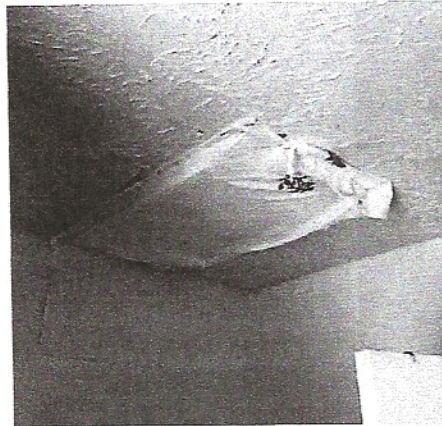
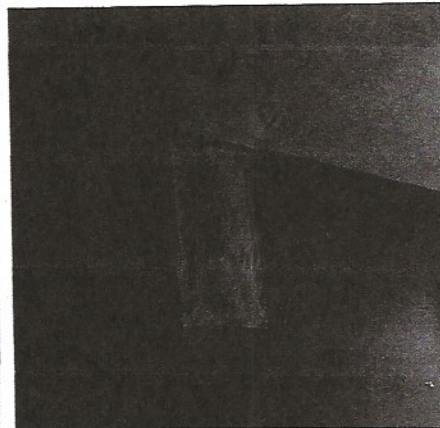
- 2. Coverings were observed at the ceiling in three different locations in the master bathroom and bedroom (see photos). The need for these coverings was not determined at the time of inspection.

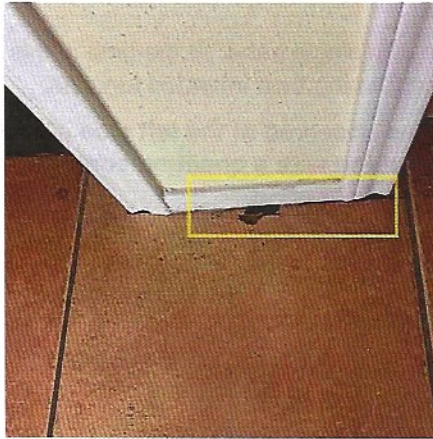
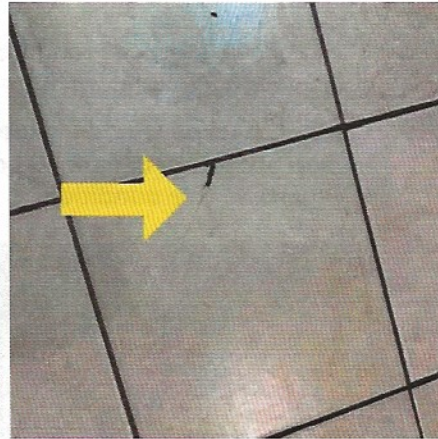
• 3. Cracked or damaged tiles were observed in one or more locations around the home (see photos). Recommend consulting with a qualified contractor regarding this condition.

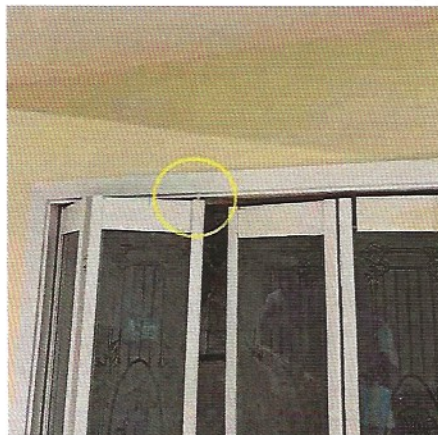
• 1. The left door to the study is off the tracks and does not close as intended (see photo). Recommend consulting with a qualified contractor regarding this condition.

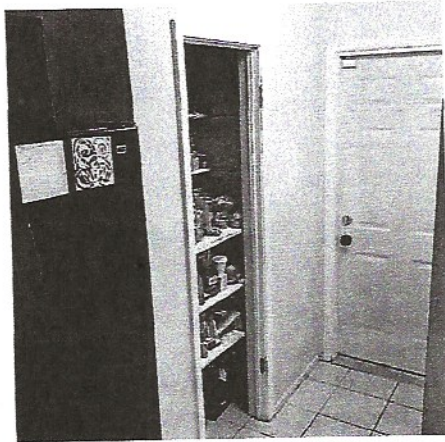
- 2. The door to the kitchen pantry is missing (see photo). Recommend consulting with a qualified contractor regarding this condition.

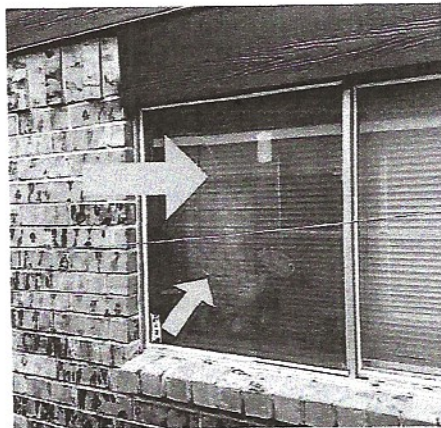
- Windows are aluminum frame with single pane. At the time of this inspection, the windows were performing their intended function.
- 1. A cracked window pane was observed at the left side of the home (see photo). Recommend consulting with a qualified contractor regarding this condition.

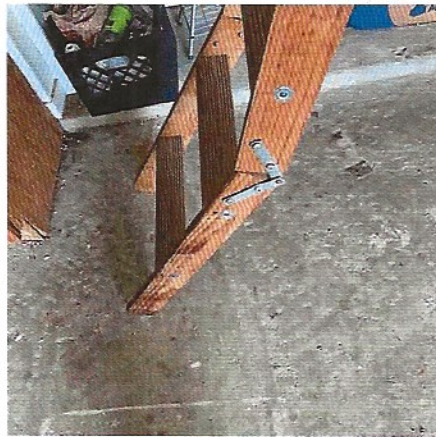
- 1. The stairs were observed to be weak when opened (see photo). This is considered a safety hazard. Recommend consulting with a qualified contractor regarding this condition.

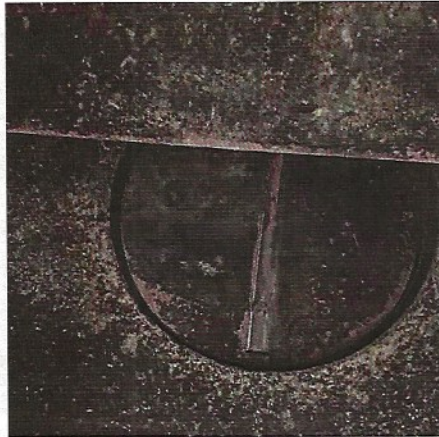
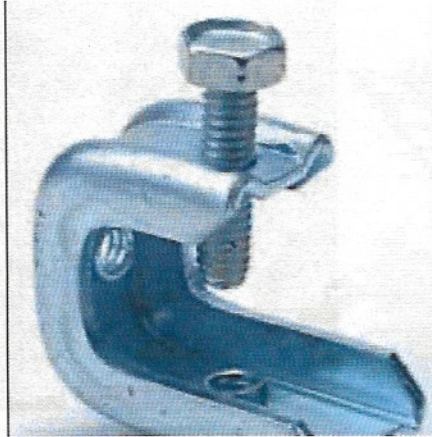
- 1. Damper Clamp missing in fireplace. Where gas logs are installed in an existing fireplace, the fireplace damper must be permanently opened or removed so that the exhaust can go up the chimney. A damper clamp is required by code when artificial gas logs are present in an open fireplace. When gas logs are in use, the fuel (whether natural gas or propane) is going through the combustion process. The by-product from combustion is carbon monoxide. Remember that carbon monoxide is a poisonous and odorless gas. Recommend adding damper clamp, as required by code.

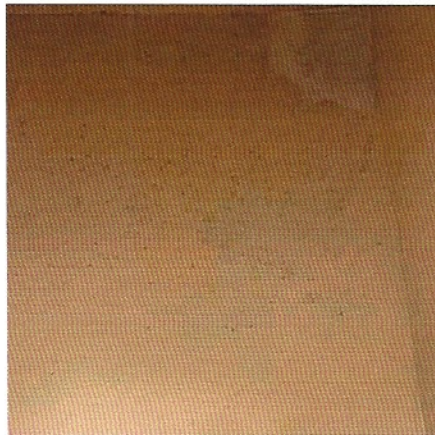
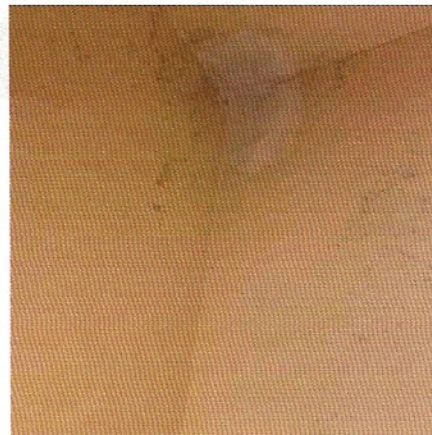
- 1. Possible mold-like growth was observed in the hall bathroom closet (see photos). Recommend consulting with a qualified contractor regarding this condition.

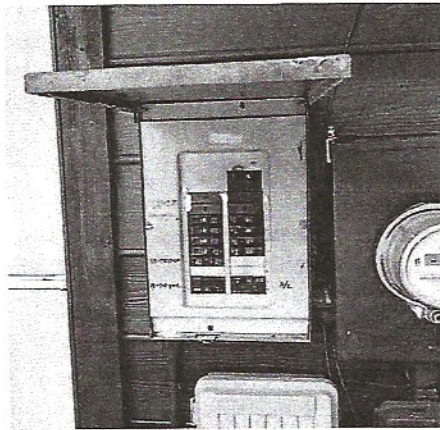
- 1. Panel was not labeled properly at time of inspection (see photo). Recommend labeling by a qualified person or electrician.

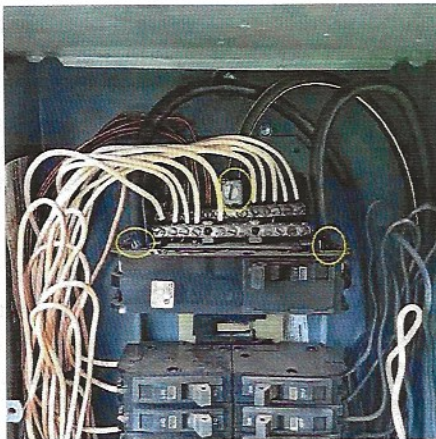
- 2. Anti-oxidant paste missing at main aluminum conductor terminals in panel (see photo). Wires should be fully dipped in anti-oxidant paste to prevent oxidation from occurring. Recommend having a qualified electrician apply paste properly, as needed.

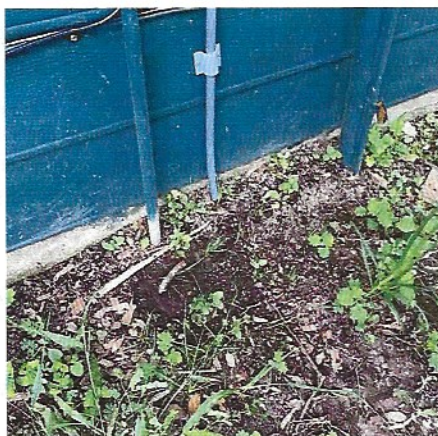
- 3. A visible and verifiable ground rod was not observed at the time of inspection (see photo). Recommend consulting with a licensed electrician regarding this condition.

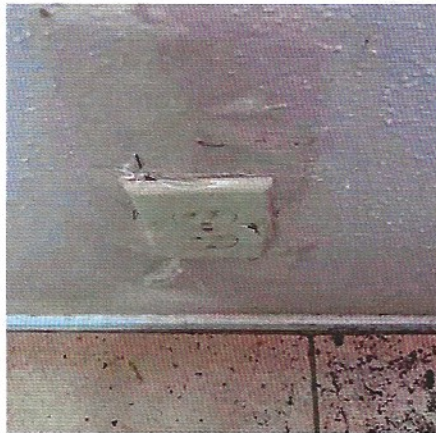
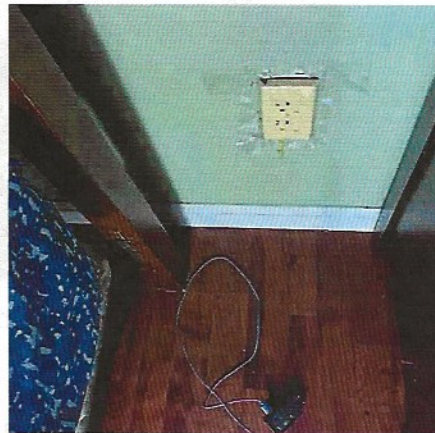
- **1. Several receptacles throughout the home were covered in tape (see photos). The reason for this was not determined at the time of inspection.**

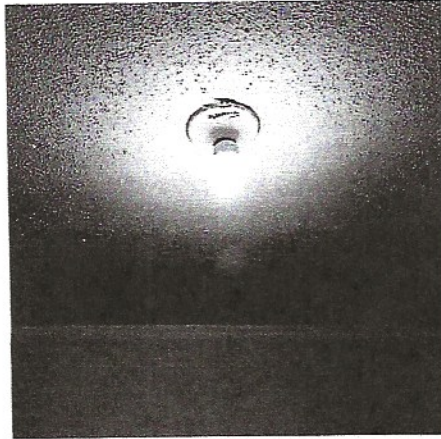
- 2. Where light bulbs are present in clothes closets, globes are needed over them (see photo). This is considered a fire hazard. Recommend installing globes.

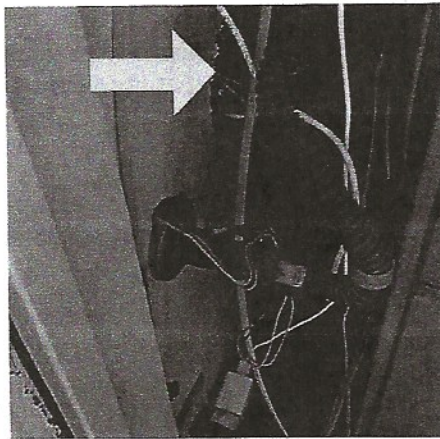
- 3. Proper coverplates observed missing at junction boxes in AC closet (see photo). Recommend installing coverplates, as needed.

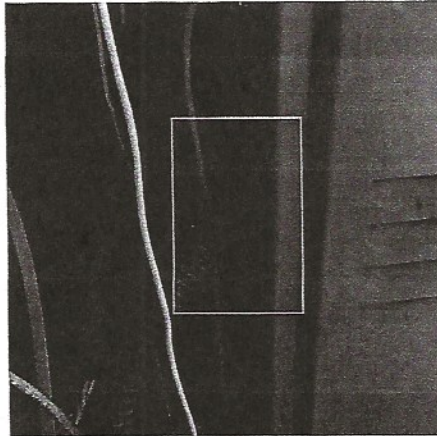
- 1. The gas line entering the furnace compartment is flex pipe and should be hard pipe (see photo). This is a potential safety hazard. Recommend consulting with a qualified contractor regarding this condition.

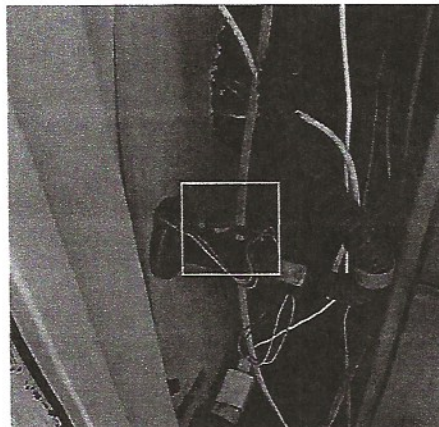
- 2. An unapproved gas valve was observed at the gas line feeding the gas furnace (see photo). Recommend consulting with a qualified contractor regarding this condition.

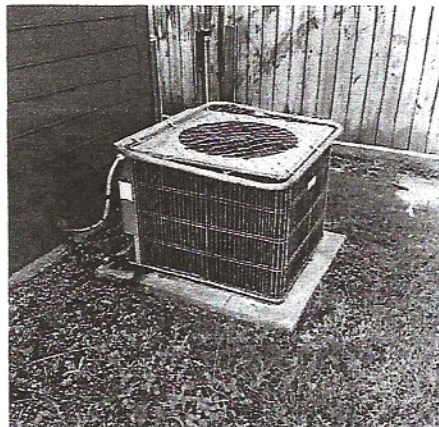
- 1. The condensing unit cage is rusted excessively (see photo). This is an indication of old age. Recommend consulting with a qualified contractor regarding this condition.

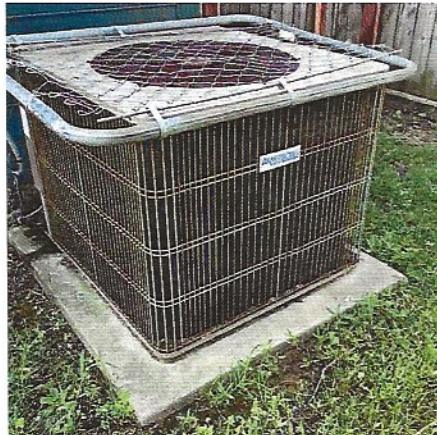
- 2. The gate on top of the condensing unit should be removed (see photo). This could potentially impede operation. Recommend removing.

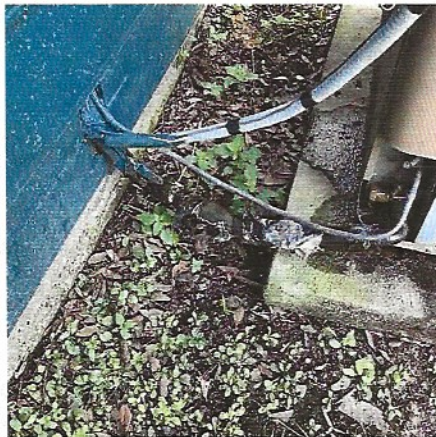
- 3. Refrigerant pressure lines at exterior condenser observed with damaged or missing insulation (see photo). Recommend replacement of insulation, as needed.

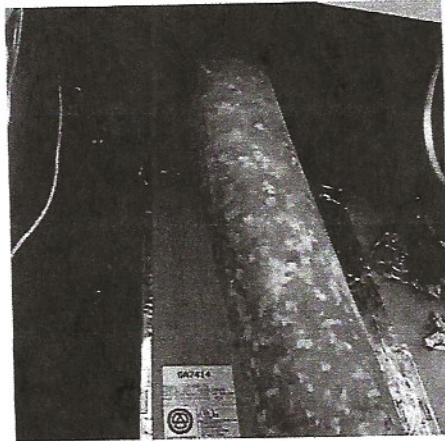
- 1. The return chase is not sealed with fire-blocking (see photo). Recommend consulting with a qualified contractor regarding this condition.

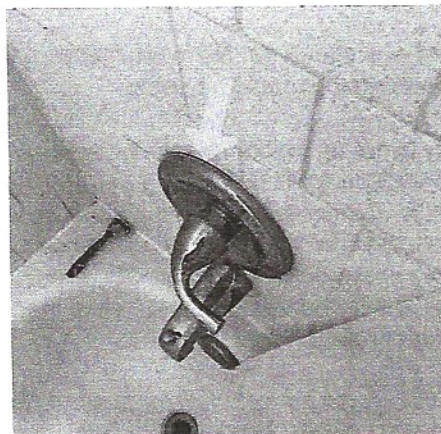
- 1. Inside tub and shower enclosures, handles and faucets should be sealed to the wall (see photo). Recommend consulting with a qualified contractor regarding this condition.

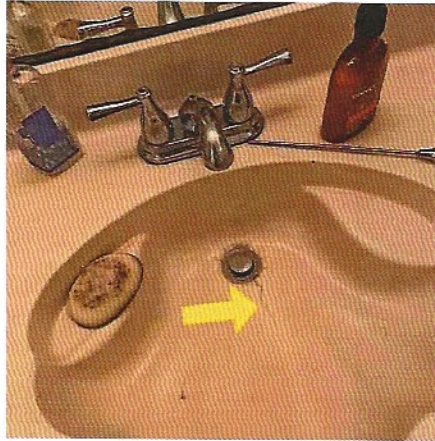
- 2. Spider cracks were observed in the hall bathroom sink (see photo). Recommend consulting with a qualified contractor regarding this condition.

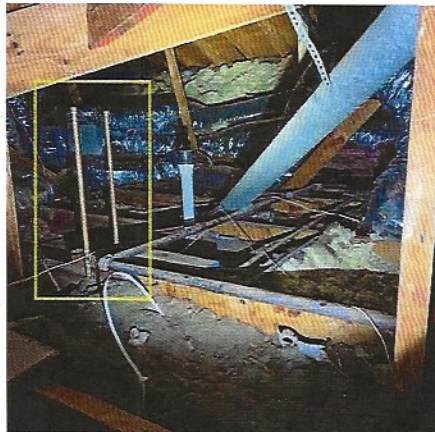
- 3. Visible portions of water distribution piping observed in attic areas were not insulated and could be a potential problem if a hard freeze were to occur (see photo). Recommend insulating exposed piping in attic areas.

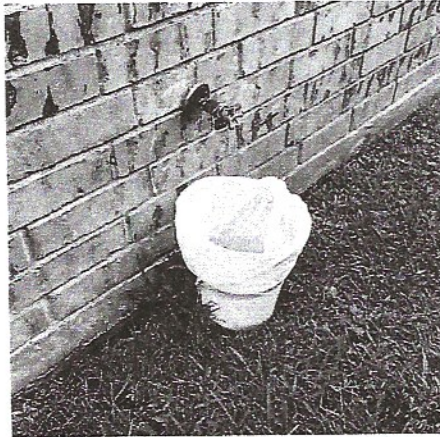
- 4. One dripping faucet was observed at the left side of the home (see photo). Repair or replacement is needed. Recommend consulting with a qualified contractor regarding this condition.

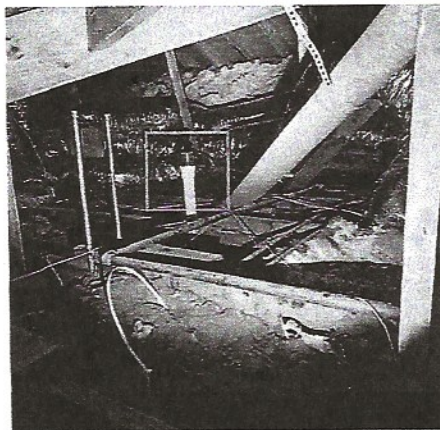
- 1. PVC drain waste piping in the attic space was observed venting directly in the attic space (see photo). This is improper practice. Recommend consulting with a qualified contractor regarding this condition.

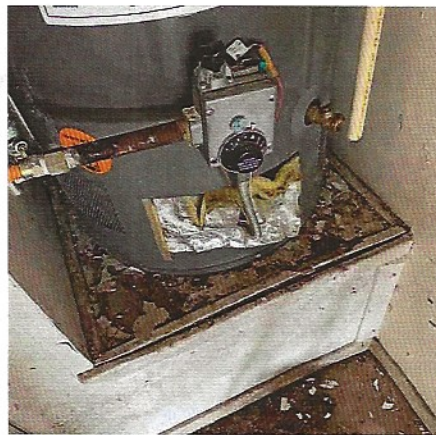
- 1. A drain pan is missing underneath the water heater (see photo). Recommend adding a safety pan.

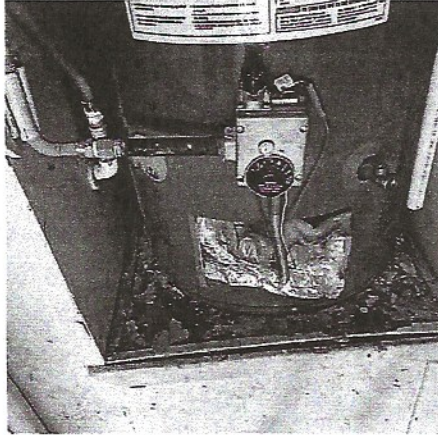
- 2. There was no gas drip leg at or near gas connection to water heater (see photo). Recommend further review by a qualified plumbing contractor to install gas drip legs at water heater connection.

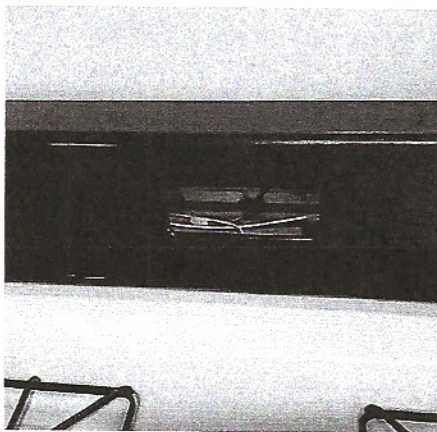
- 1. The control board is missing (see photo). Recommend consulting with a qualified contractor regarding this condition.
