RESIDENTIAL INSPECTION REPORT

6624 Merry Ln
Houston TX 77023

Juan Chavero
AUGUST 26, 2020

PROPERTY INSPECTION REPORT

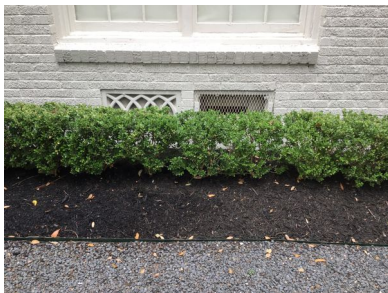
1: Trees Too Close

Root systems of large trees planted too close to the foundation can cause foundation problems.

Recommendation: Contact a qualified professional.

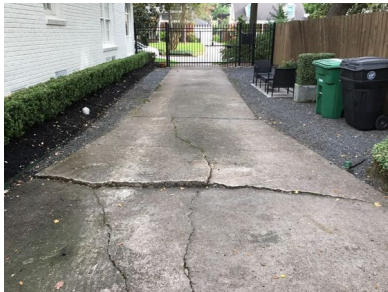
1: Grading & Drainage: Uneven/Cracked Driveway

Uneven or Cracked driveways can be a trip hazard.

Recommendation: Contact a qualified professional.

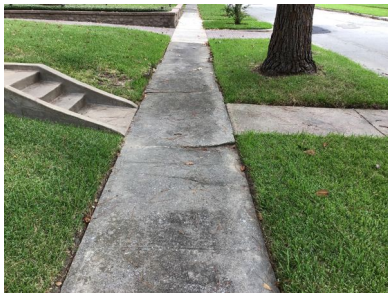
2: Grading & Drainage: Uneven/Cracked Sidewalk

Uneven or Cracked sidewalks can be a trip hazard.

Recommendation: Contact a qualified professional.

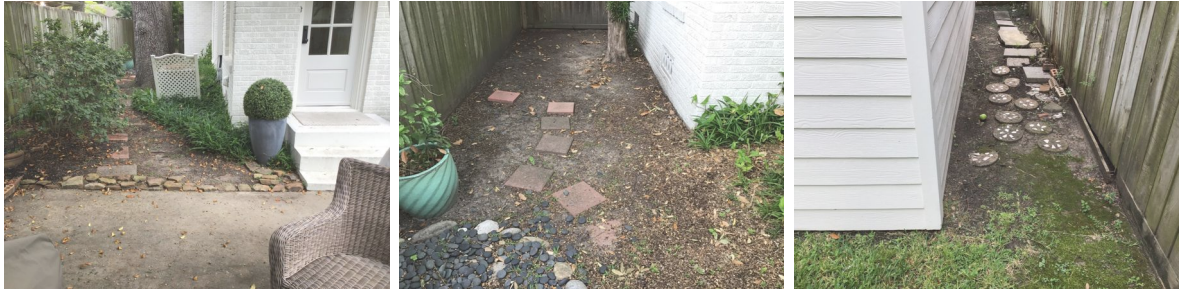
3: Grading & Drainage: Inadequate

Low spots, ruts, and/or damaged sod were present at the time of inspection. Regrading by a qualified landscaping contractor or foundation contractor so that water flows away from the home is recommended.

Recommendation: Contact a qualified landscaping contractor

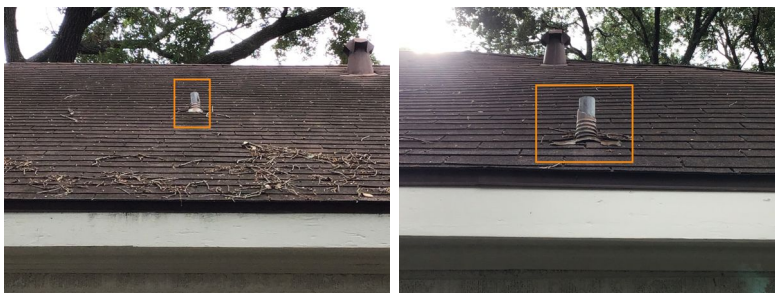
2: Flashing: Lead Jacks Damaged

The lead vent jack was damaged. Remedy as needed.

Recommendation: Contact a qualified roofing professional.

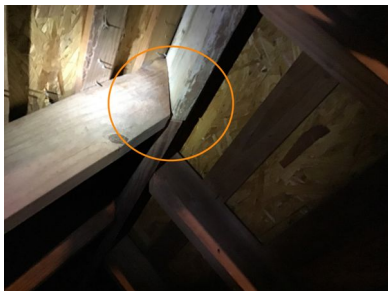
3: Framing: Ridge prop missing

No ridge prop (support board) was installed. Installation is recommended to ensure proper load support of the ridge framing. Evaluate and remedy as needed

Recommendation: Contact a qualified professional.

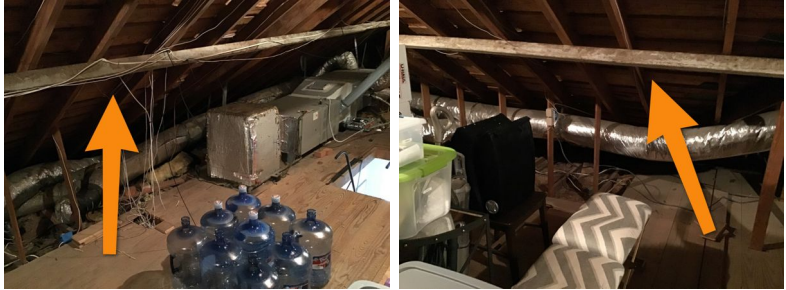
4: Framing: Missing Purlin Supports

Current building standards require purlin bracing every 4 ft.

Recommendation: Contact a qualified professional.

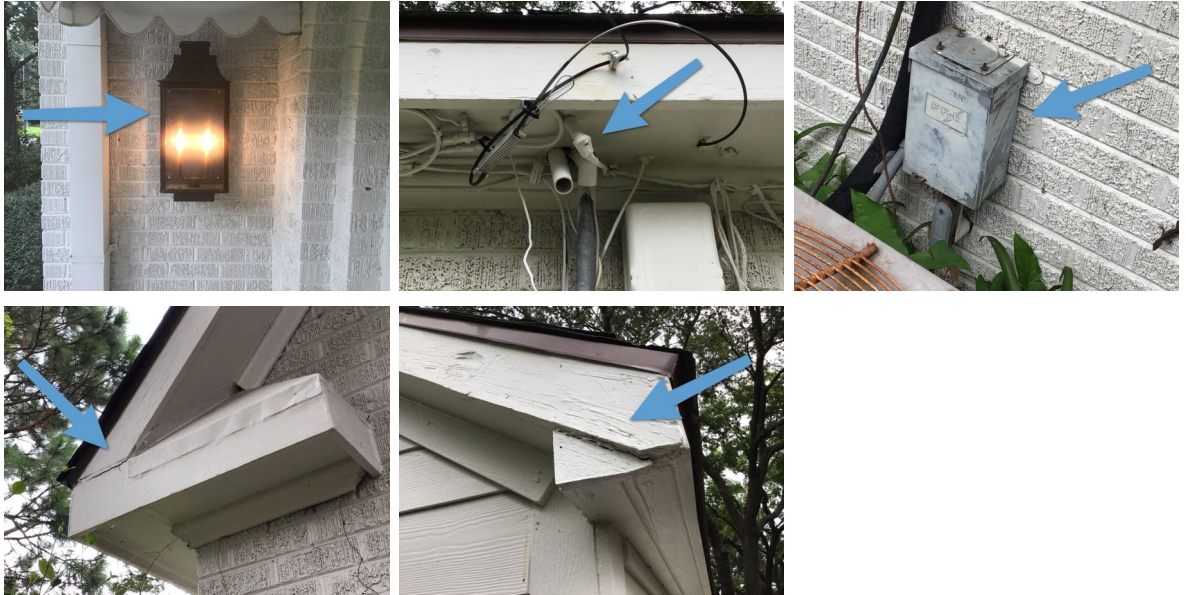
1: Exterior: Seal Wall Fixtures

Note: Modern building practices recommend sealing around components that are mounted on or pass through the exterior wall to limit moisture intrusion.

Recommendation: Recommended DIY Project

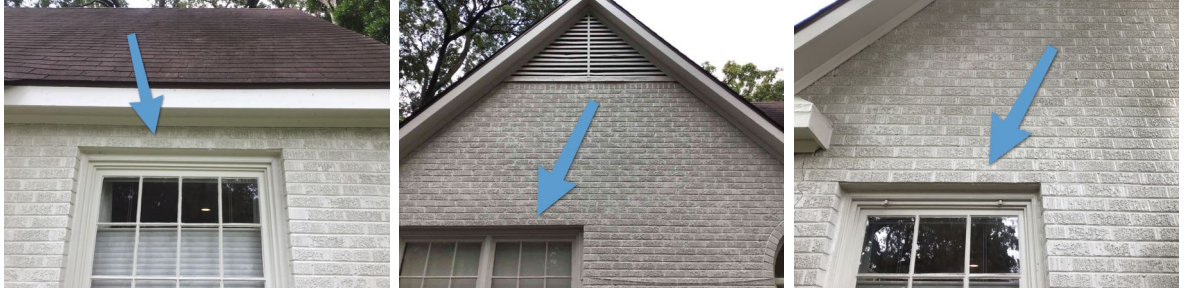
2: Exterior Masonry: Cracks

Cracks were observed in the brick/masonry siding. Common causes may include:

- building settlement,
- thermal expansion and contraction, or
- mechanical damage.

Cracked masonry or mortar may be cosmetic, but also may allow water into the wall which could damage the interior structure of the building. Cracks may grow with time at a constant (increasing or decreasing) rate and may open and close as seasons change. Remedy as needed.

Recommendation: Contact a qualified masonry professional.

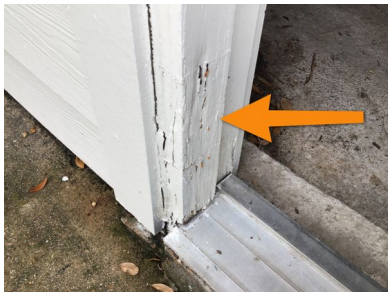
1: Door: Wood Rot at Base of Frame

Wood rot was observed at the base of a door frame. Remedy as needed.

Recommendation: Contact a qualified handyman.

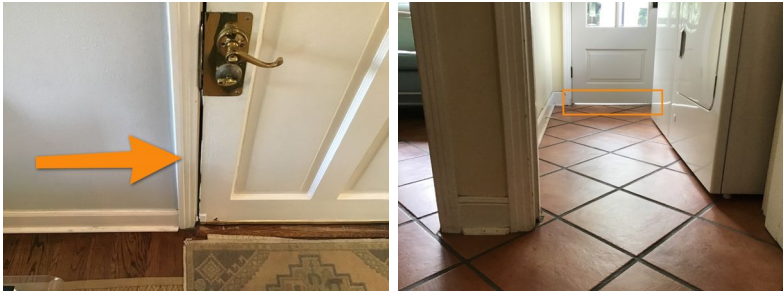
3: Door: Noticeable Gap at Frame

Gaps were observed between the door and frame, which could result in energy loss. Evaluate and remedy as needed.

Recommendation: Contact a qualified door repair/installation contractor.

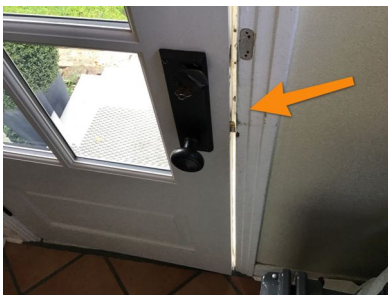
4: Door Hardware: Doesn't Latch

Door did not latch properly. Handyman repair of latch and/or strike plate is recommended.

Recommendation: Contact a qualified handyman.

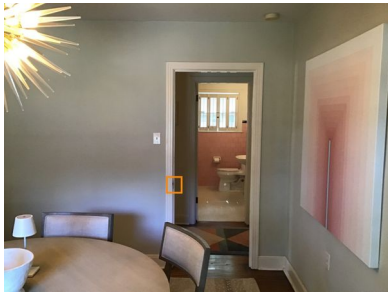
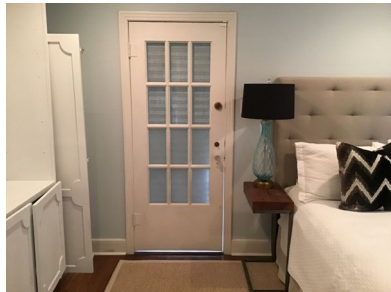
6: Door: Missing

Hardware still present, however, door is not present.

Recommendation: Contact a qualified professional.

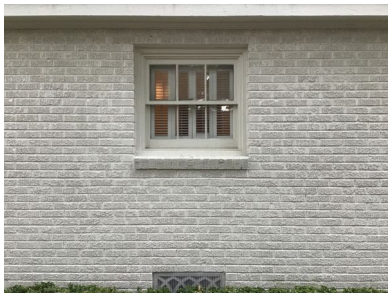
1: Missing/Damaged Screen(s)

One or more windows are missing a screen or had a damaged screen. Replacement of screens is recommended.

Recommendation: Contact a qualified window repair/installation contractor.

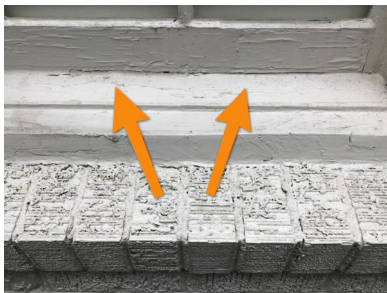
4: Caulking: Missing/Damaged

Multiple Locations

Recommendation: Contact a qualified professional.

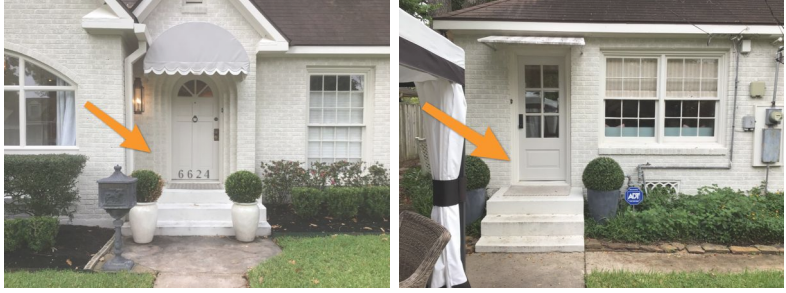
1: Handrails/Guardrails: Missing

Staircase had no handrails and/or a guardrail was missing. This is a safety hazard. Installation of a handrail or guardrail by a qualified professional is recommended.

Recommendation: Contact a qualified professional.

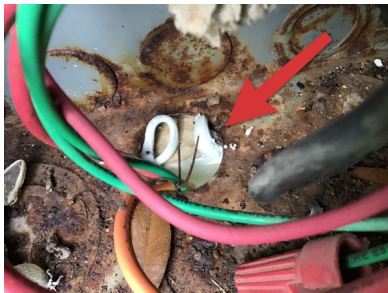
4: Missing Wire Bushing

There was no bushing around wires that pass through the panel into the wall to protect them from abrasion. Evaluation and/or remediation by a licensed electrician is recommended.

Recommendation: Contact a qualified electrical contractor.

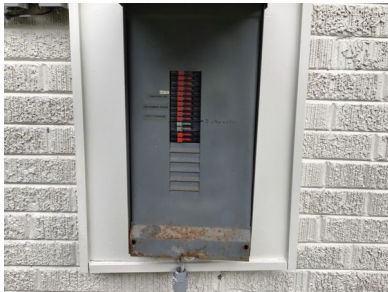
9: Improper Disconnection Means

There was no single main disconnect, and the process to turn off power to the home required more than 6 throws of a switch. Evaluation and/or remediation by a licensed electrician is recommended.

Recommendation: Contact a qualified electrical contractor.

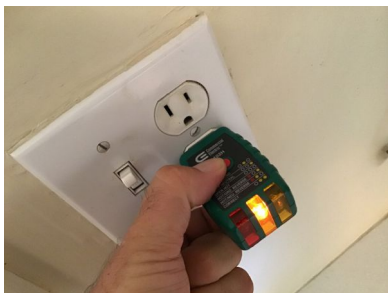
4: Receptacles: No GFCI Protection Observed

There was no GFCI protection observed. Current building standards recommend the installation of ground fault protection:

Recommendation: Contact a qualified electrical contractor.

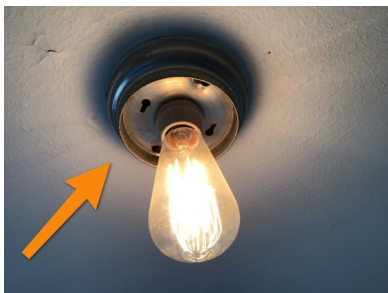
8: Light: Globe Damaged/Missing

Missing/damaged light globe was observed. Remedy as needed.

Recommendation: Recommended DIY Project

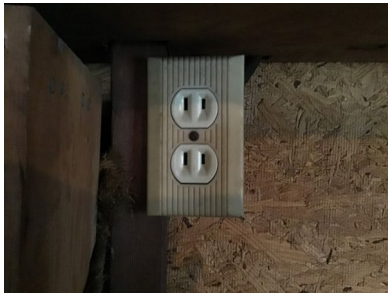
13: Wiring: Older Home with 2-wire system

Note: This home has an older two-wire system, which does not include grounding. If further evaluation is desired, consult with a qualified electrician.

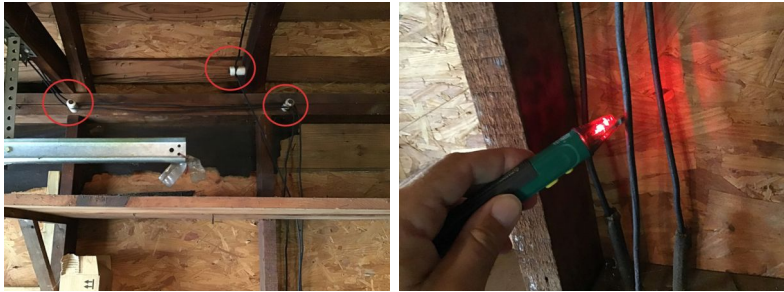
14: Wiring: Knob & Tube in use

Knob and tube wiring was present and in use in the home. Evaluation and/or remediation by a licensed electrician is recommended.

Recommendation: Contact a qualified electrical contractor.
