PROPERTY INSPECTION REPORT

Concerning: 69 N. Old Cedar Circle, The Woodlands, TX 77382
(Address or Other Identification of Inspected Property)

By: Chris Stull, Lic #20945 04/03/2017
(Name and License Number of Inspector) (Date)

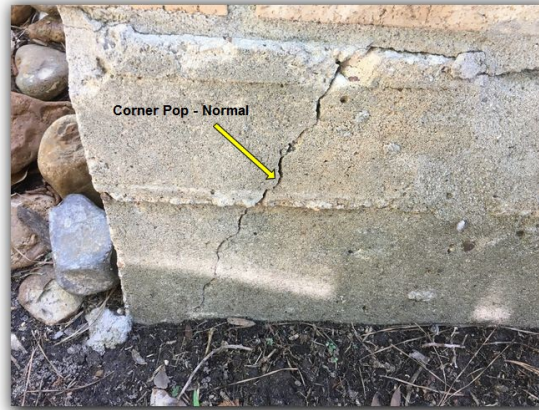
Spalling (i.e., corner pops) at one or more corner(s), Corner spalling is common to slab foundations and does not affect the structural integrity of the foundation.

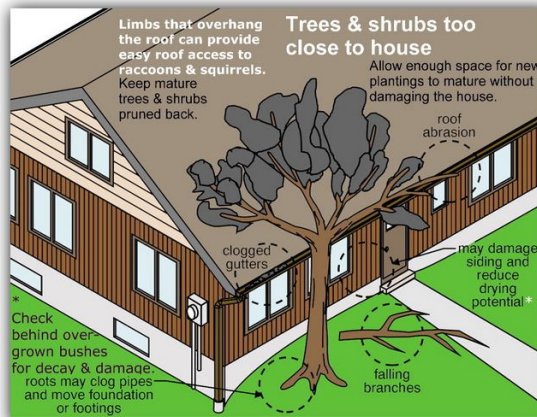
Recommend vegetation be cut back away from exterior of home to prevent damage.

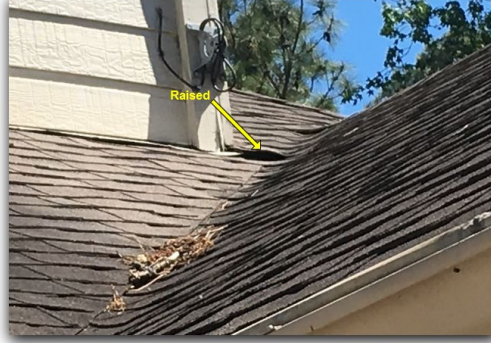
Observed raised shingles in one or more areas of roof. Recommend securing all shingles to prevent water penetration from wind driven rain.

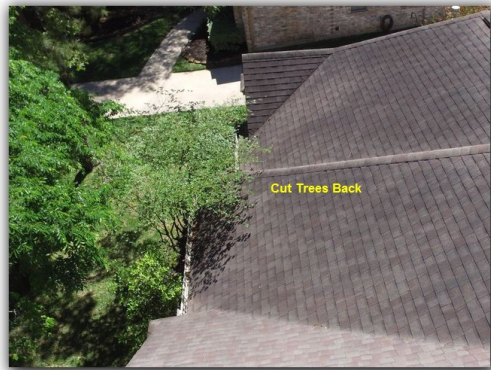
Recommend cutting trees back away from roof surface to prevent damage.

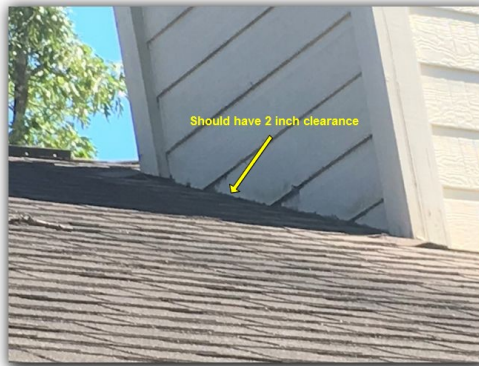
Observed siding touching shingles around the chimney. Common industry practice calls for at least a two inch separation from bottom edge of siding and roof surface. The two inch separation helps prevent moisture from being trapped which can cause deterioration. Note: This is common to find after a roof has been replaced.

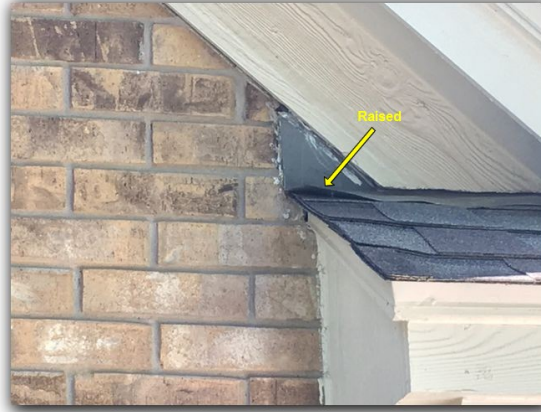
Observed bent/raised flashing in one or more areas. Recommend securing all flashing to prevent water penetration from wind driven rain.

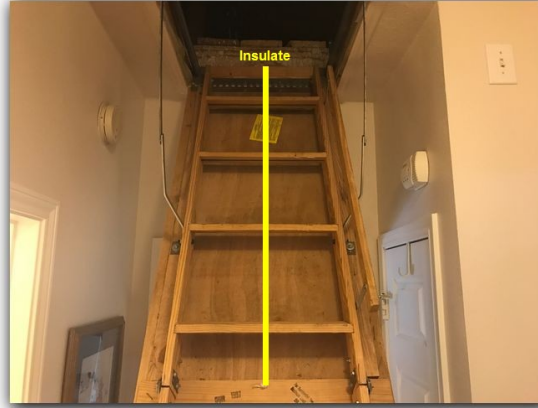
For optimum energy efficiency, I recommend insulating the pull down attic access.

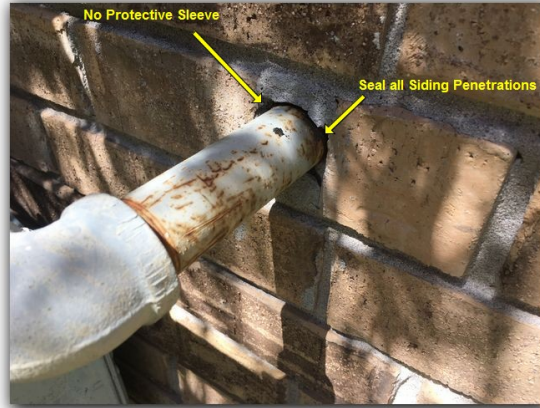
Did not observe a protective sleeve installed around the gas line at exterior wall. Although this may not have been required at time of construction, current standards call for a protective sleeve to be installed anytime a gas line penetrates a masonry wall.

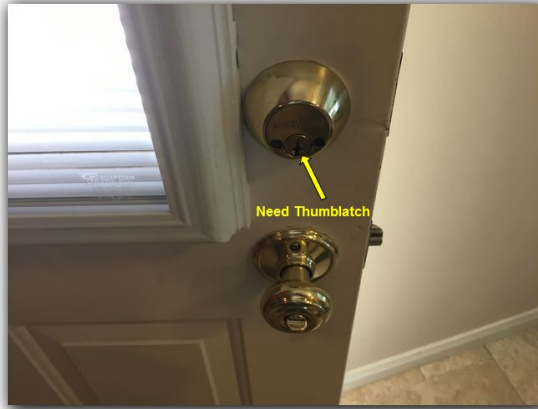
One or more exterior doors use "keyed deadbolt locks " on the inside. Although commonly used for security against intruders, this is not the best practice. For safety purposes in case of fire, all exterior locks on egress doors should be thumbblatched on the inside.

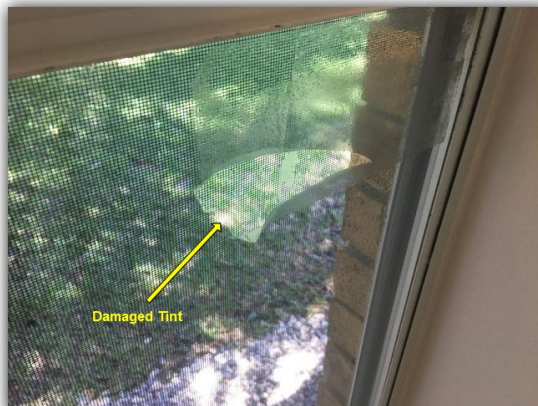
Observed the tint was damaged on one or more windows in the master bedroom.

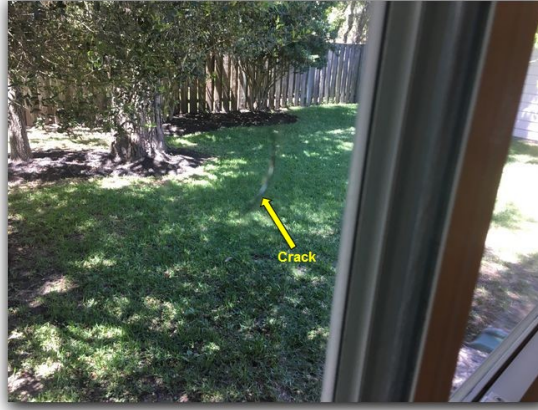
Observed a crack in the left window in master bedroom.

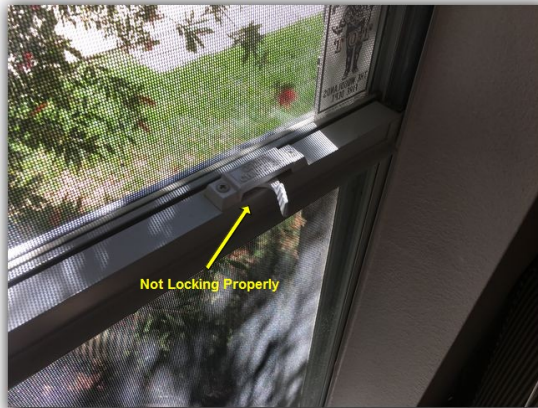
I was unable to lock one lock in the right guest bedroom (right window). In need of adjustment or repair.

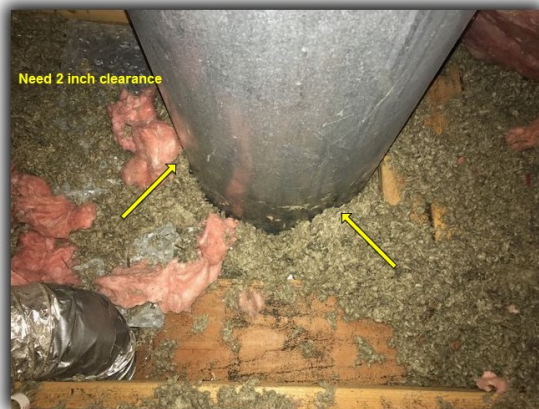
Observed the chimney flue was in contact with attic insulation. Current standards call for the chimney flue to have at least a 2 inch clearance from combustibles including attic insulation. Recommend moving insulation back away from chimney flue to reduce the risk of fire.

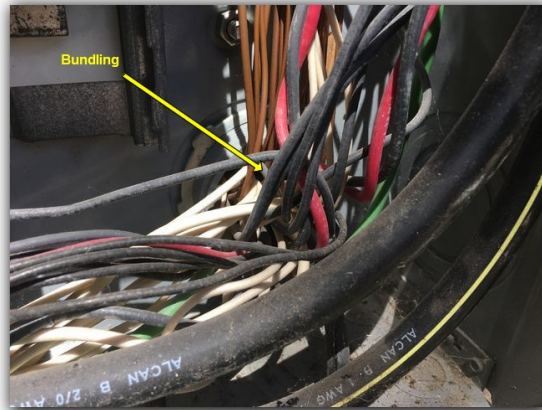
Observed multiple wires entering the panel through the same knockout (bundling). Bundling has been common practice for many years and was allowed at time of construction, but current standards now call for wiring to be separated and secured to the panel.

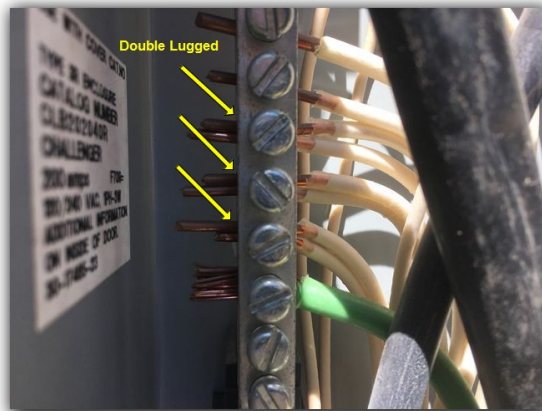
Observed two conductors under one screw lug (Double Lugged). Current electric codes permit only one conductor under one screw lug.

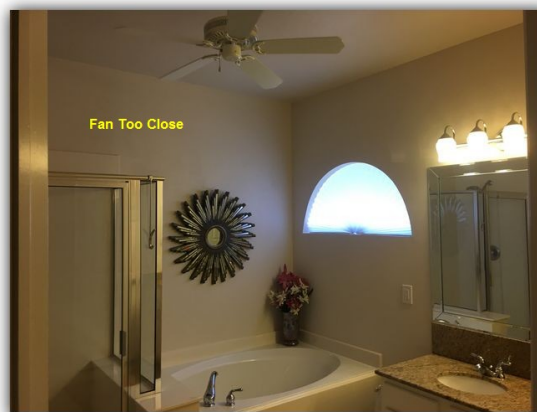
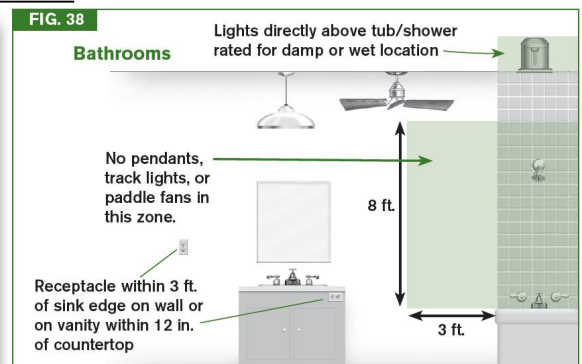
Observed the ceiling fan was too close to the tub in master bathroom. Current standards call for ceiling fans to be at least 3 feet away from the bathtub.

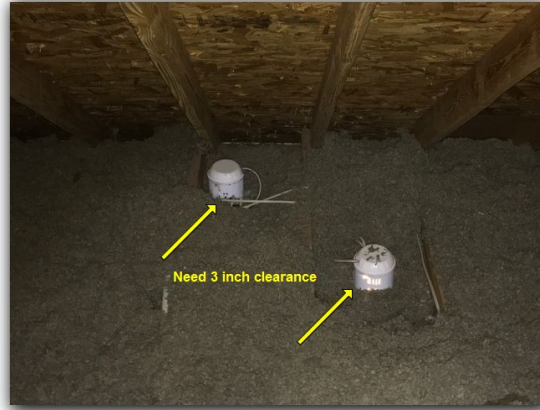
Did not observe an IC (insulation contact) rating for the can lights in the attic. Recommend moving insulation away from the can lights to reduce the risk of fire.

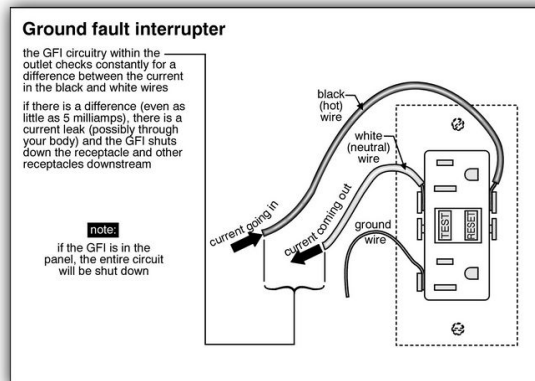
Did not observe GFCI protection for all outlets in the laundry room. This was not required at time of construction, but current standards call for all laundry room outlets to have GFCI protection.

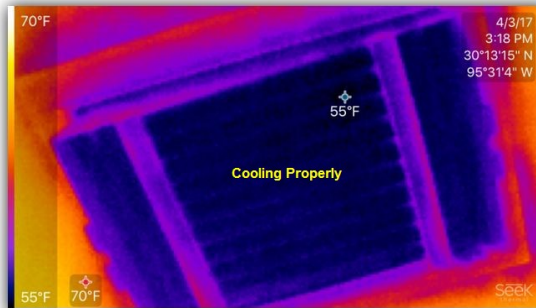
A thermal image of the air vents show the air conditioning unit was cooling properly at time of inspection.

TEMPERATURE DIFFERENTIAL: 18 degrees (73, 55)

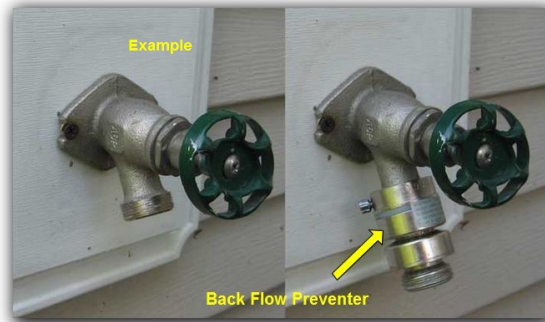
Some exterior hose spigot(s) do not have code approved anti-back flow devices installed. *Note: Back flow preventers cost approximately \$5.00 and are easy to install.*

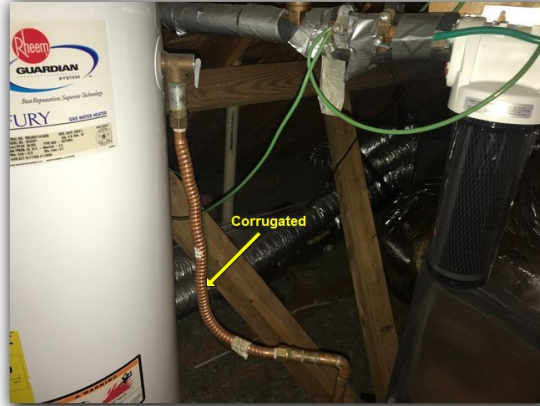
Observed improper piping used for the TPR drain line. Although I have never observed a problem using corrugated piping on TPR drain lines, the drain line should be made of smoothed walled material only.

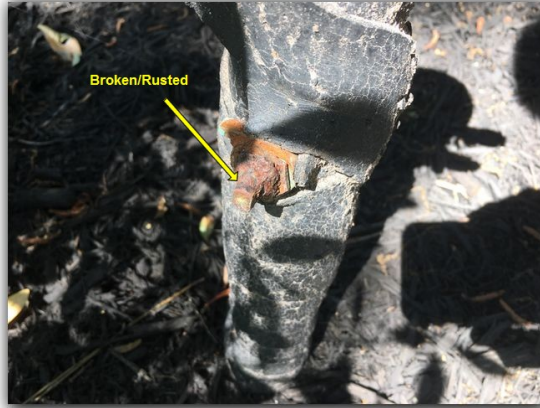
Observed one sprinkler shutoff handle that was rusted and broken. In need of replacement.
