Moisture Assessment Report- Reinspection

809 Willard St.
Houston, TX 77006
07/19/18

Moisture Inspection Summary-Reinspection

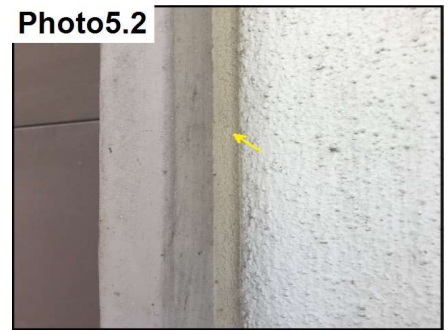
- Assess and reseal all windows, doors, flashing terminations and penetrations.
- Aged sealant joint noted at garage door. See detail #5.2. It is suggested to reseal as needed.

Reseal garage door as needed.

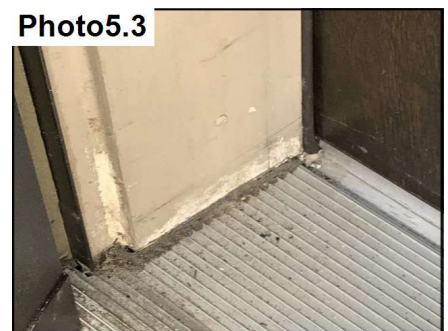
- Sealant separation noted at door miters. See detail #5.3. Reseal all door miters as needed.
- Moisture stains are present at bottom of wall. See detail #5.4.

Reseal door miters as needed.

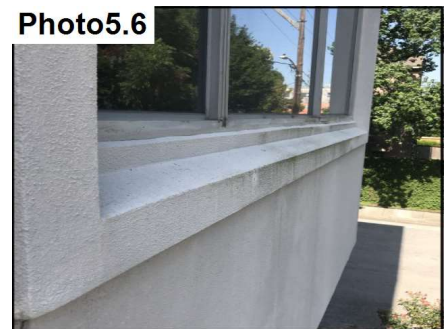
Blue Line	Semi-Flat Wall			It is suggested to apply elastomeric coating on top of semi-flat wall to minimize moisture intrusion. Se detail #5.6.

Apply elastomeric coating on top of semi-flat wall.

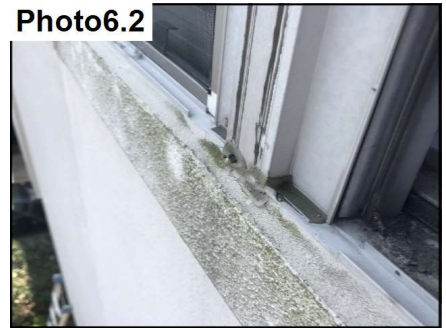
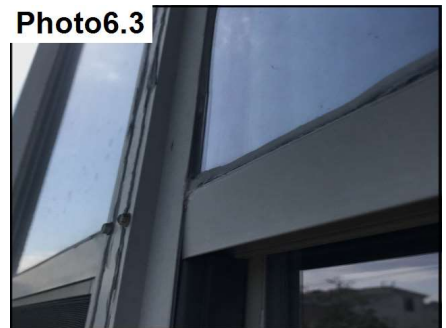
- It is suggested to apply elastomeric coating on top of semi-flat wall to minimize moisture intrusion. See detail #5.6.
- Sealant joints at windows are aged and starting to separate. See detail #5.6, 6.2 and 6.3. Assess all window frames, miters and mullions and reseal as needed.

Reseal windows as needed.

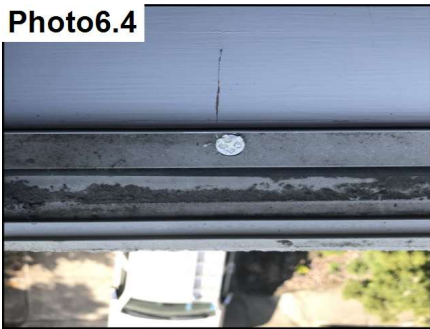
- Alarm sensors are present. See detail #6.4. It is suggested to assess all alarm sensors and seal with silicone sealants to minimize moisture intrusion.

Seal alarm sensors as needed.

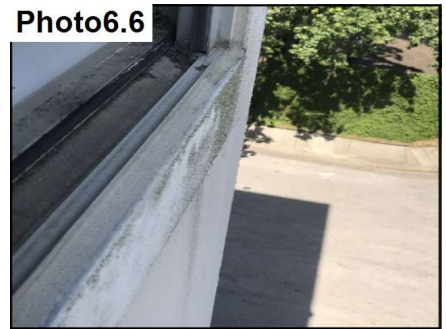
- Sealant separation noted at flat accents. See detail #6.5. Reseal as needed.
- Mildew noted in this area. It should be removed with a mild soap or cleaner recommended by the stucco manufacturers. Never use a high-pressure sprayer. Apply the cleaner using a sponge or brush. See detail #6.6.

Clean mildew as needed.

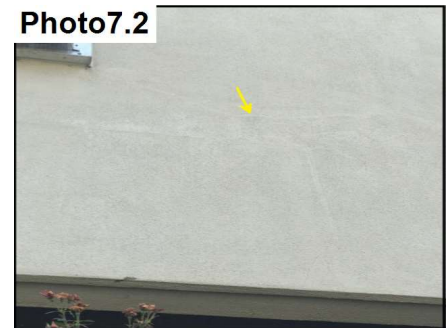
- Hairline crack is present. See detail #7.2. To temporarily cover hairline cracks in the future, it is suggested to re-paint the entirety of home with an elastomeric paint.

Photo7.2
 Hairline cracks are present.

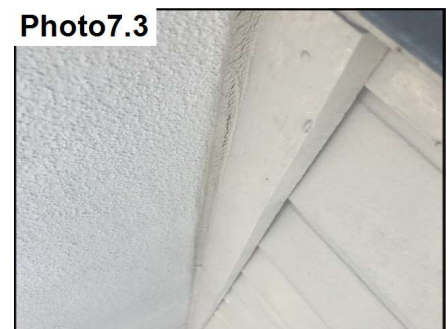
- Sealant separation noted at siding transitions. See detail #7.3. Reseal as needed.
- Crack is present at corner of wall. See detail #8.2. Seal / Repair as needed.

Photo7.3
 Reseal siding transitions as needed.

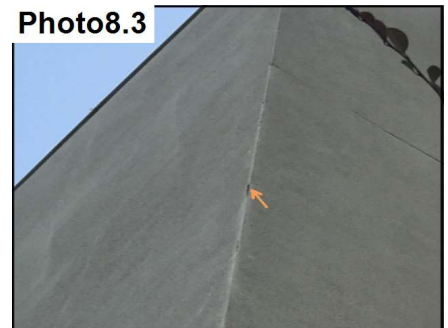
Rust noted at corner of wall.

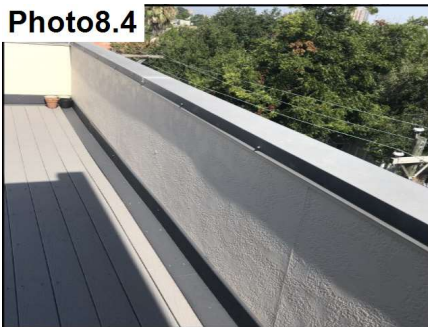
- Rust is present at corner of wall. See detail #8.3. Clean and re-paint as needed.
- Metal cap is present at flat wall. See detail #8.4, 8.5, 8.6 and 9.1. Assess all metal cap joints and terminations and reseal as needed.

Metal caps are present at terrace.

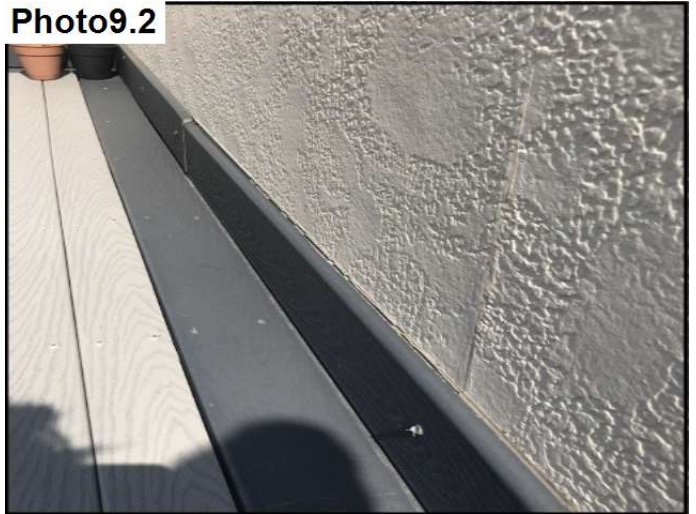
Photo9.2

- Sealant separation noted at terrace floor terminations. See detail #9.2. Assess all terrace flashings, fasteners and terminations and seal as needed.

Seal balcony floor terminations as needed.
